**BOARD OF ZONING ADJUSTMENT**  
District of Columbia  
CASE NO. 18446  
EXHIBIT NO. 9

# **SITE INSPECTION REPORT**

1308 Euclid St. NW  
Washington DC-20010  
Inspection date: June 20, 2012  
Report Prepared on: July 3, 2012

**Re: 1308 Euclid St. NW, WDC- 20010**

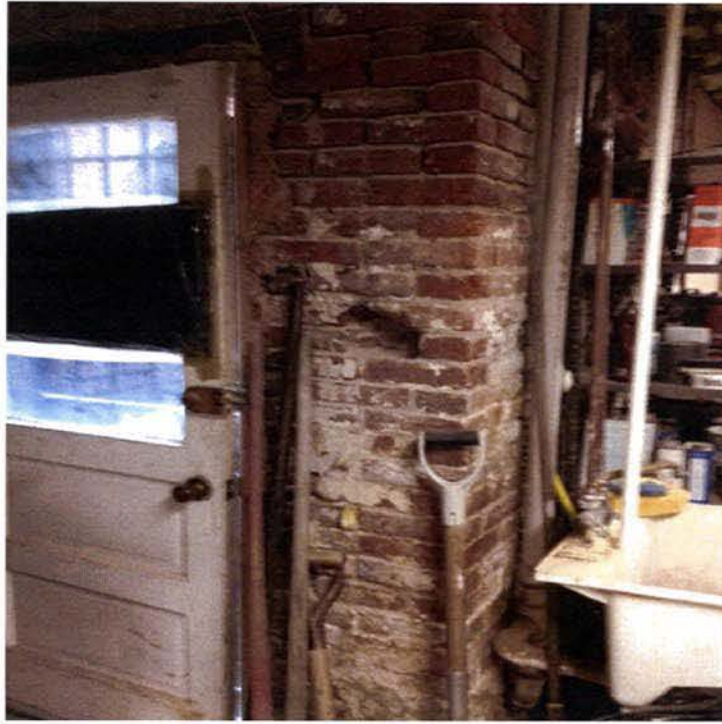
1. We noticed that mortar of brick wall of basement @ several locations was loose and few bricks were also missing. See Figs. (1) & (2). It can lead to the settlement of the wall and cause structural damage to the house. It should be addressed.

*Fig. 1: Front Wall in the Basement*

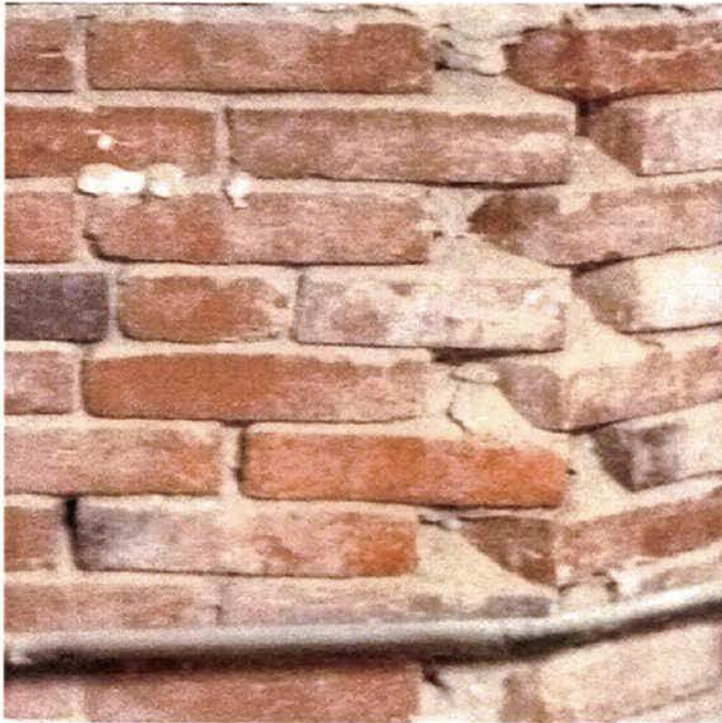
*Fig. 2: Wall of Basement*

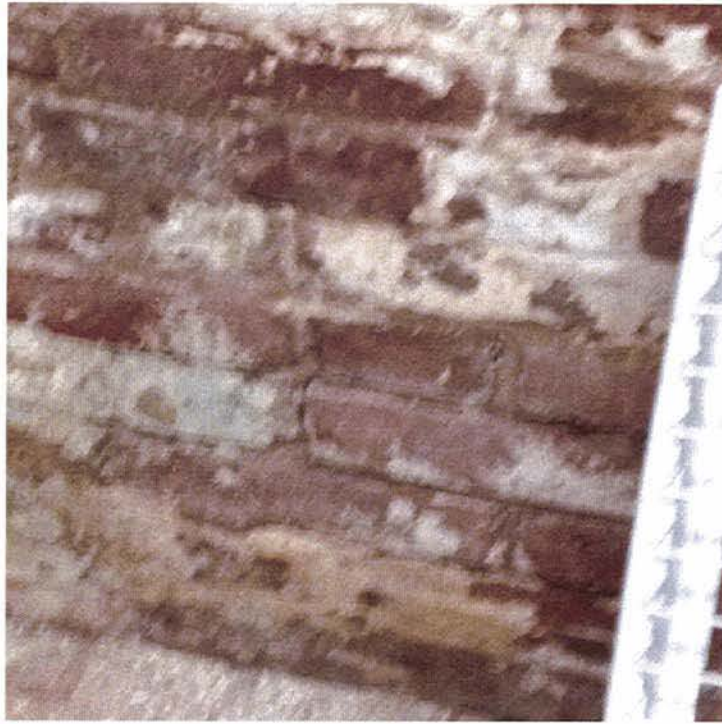
2. We also observed the water seepage at the rear and left basement walls near the back door. See Figs. (3), (4), & (5). The brick wall in this area is structurally in poor condition. The water seepage could undermine the structural integrity of the house and should be addressed. We suggest parging and waterproofing of the wall, replacing the loose mortar and providing a proper drainage system behind the wall to minimize the water seepage.

*Fig. 3: Left Wall of Basement @ Rear of House*

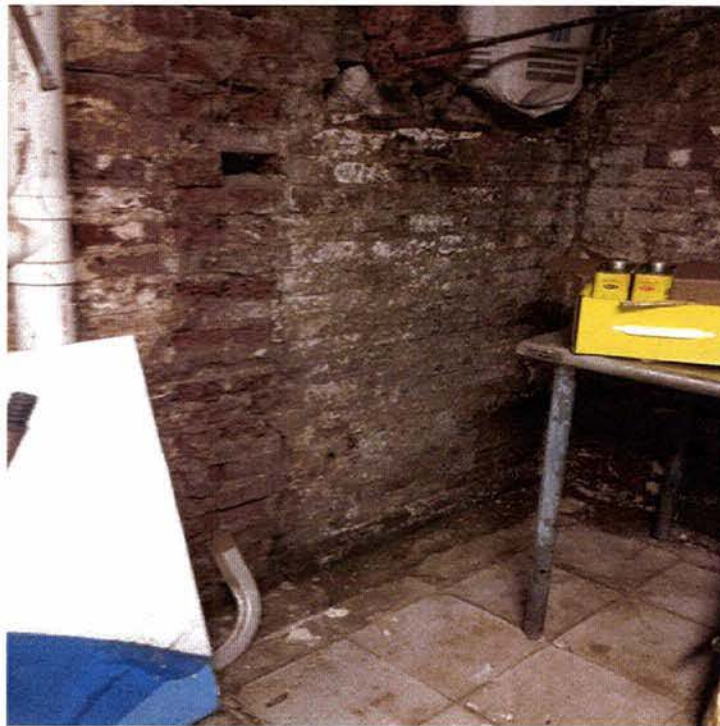
*Fig. 4: Left Wall of Basement @ Rear of House*

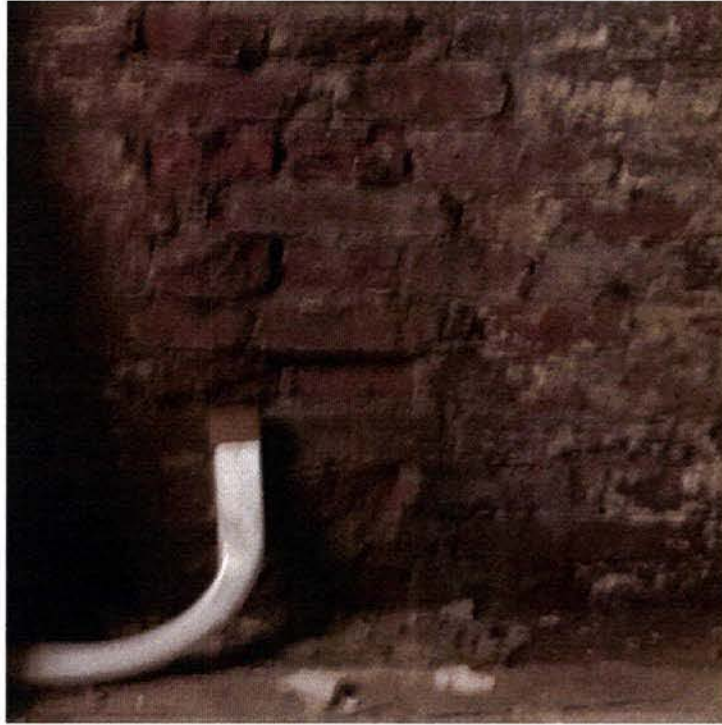
*Fig. 5: Left Wall of Basement @ Rear of House*

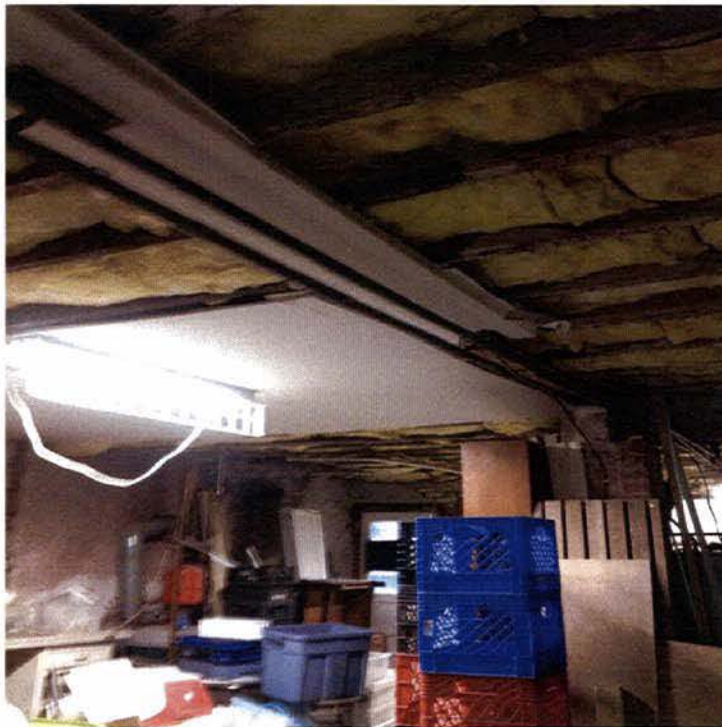
3. A steel beam supporting the first floor joists at the front portion of the house was missing. See Fig. (6). Removal of steel beam will reduce the load carrying capacity of the framing system in this area. The floor framing in this area needs to be reviewed and a proper structural solution is required to address the issue.

*Fig. 6: Steel Beam @ First Floor Framing is removed*

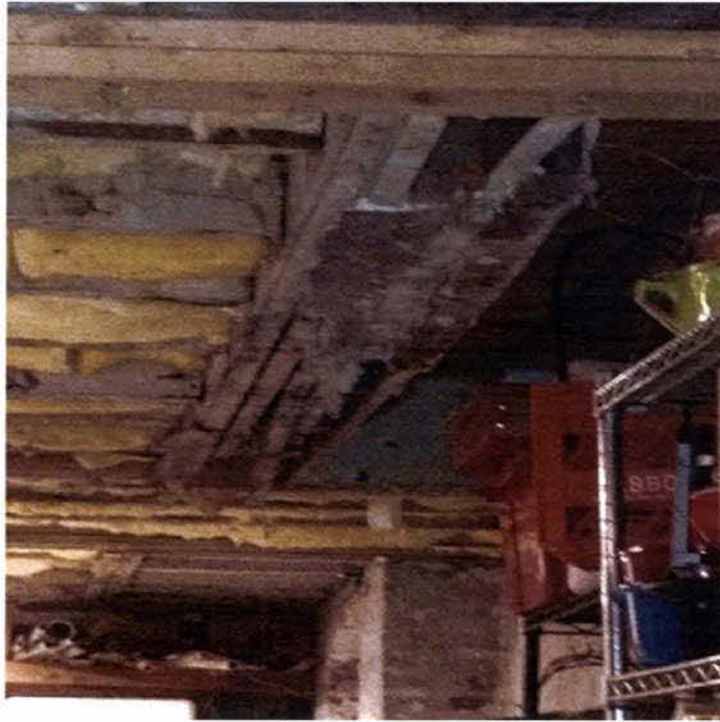
4. We also noticed that first floor framing joists at the stair opening (which has been closed) were in bad shape. See Figs. (7) & (8). The framing in this area needs to be addressed.

*Fig. 7: First Floor Framing @ Stair Opening*

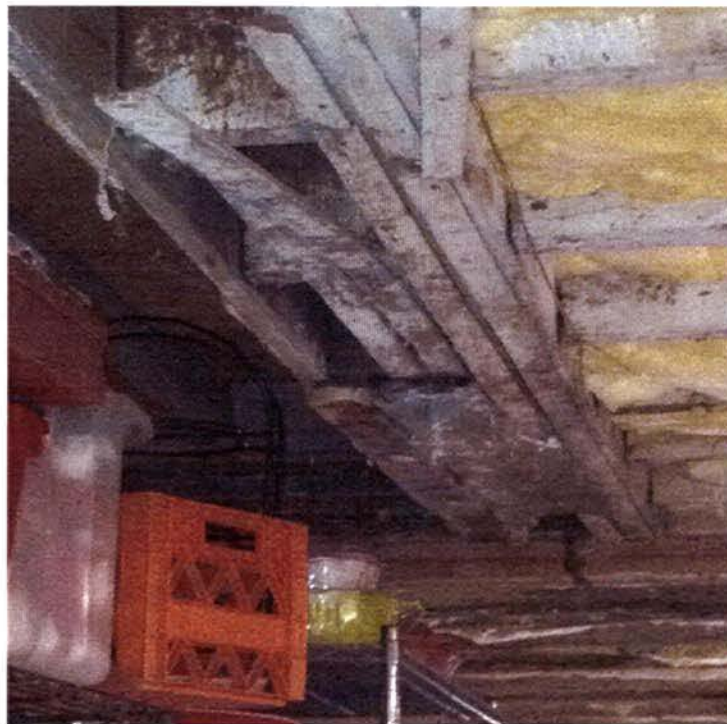
*Fig. 8: First Floor Framing @ Stair Opening*

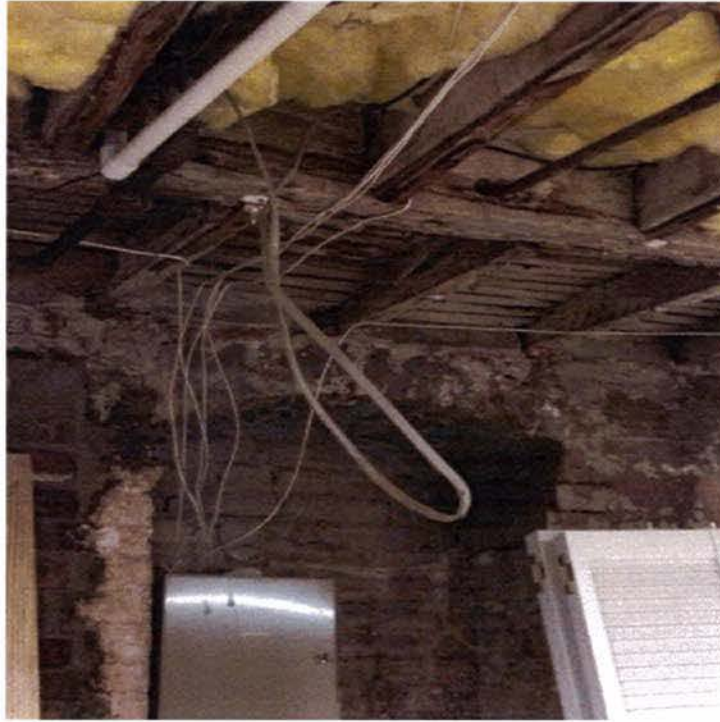
5. First floor framing at chimney was also deteriorated. See Fig. (9). The framing needs to be addressed.
6. The floor of basement was not structurally sound. It was uneven and has cracks. It needs to be addressed.

*Fig. 9: First Floor Framing @ Chimney*

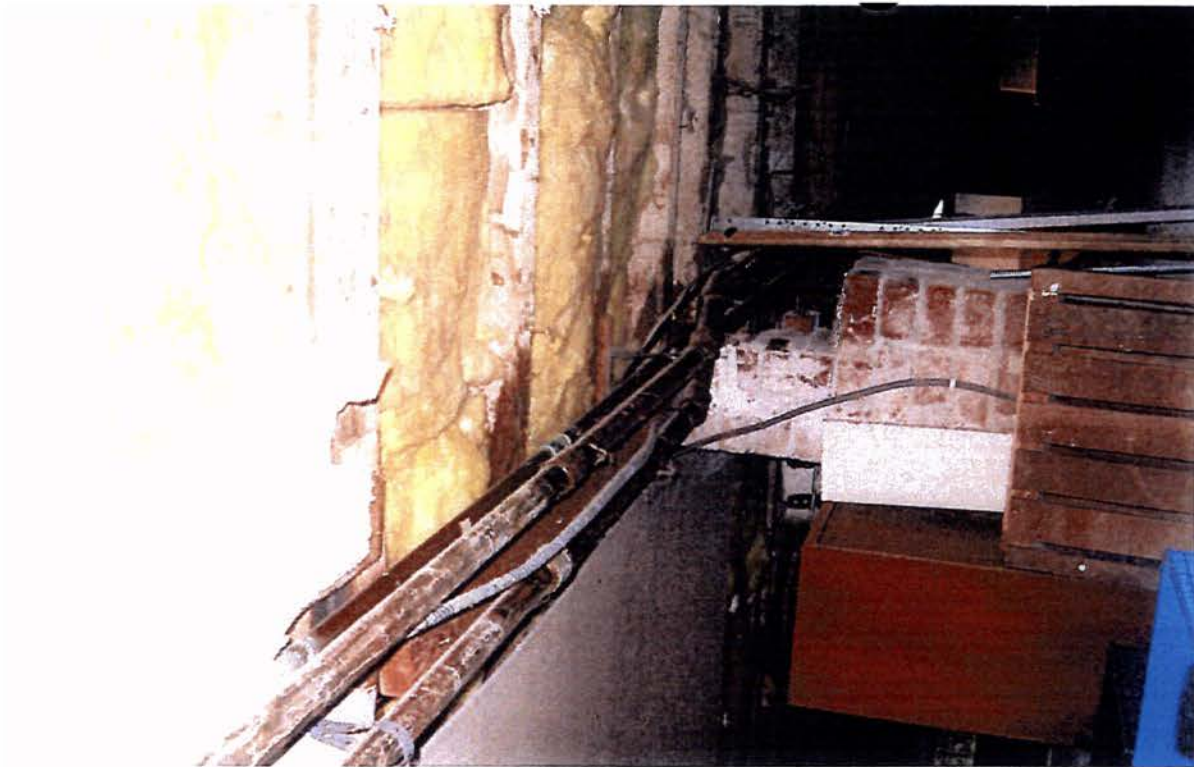
Basement Photo Showing a Slot for the Missing Beam

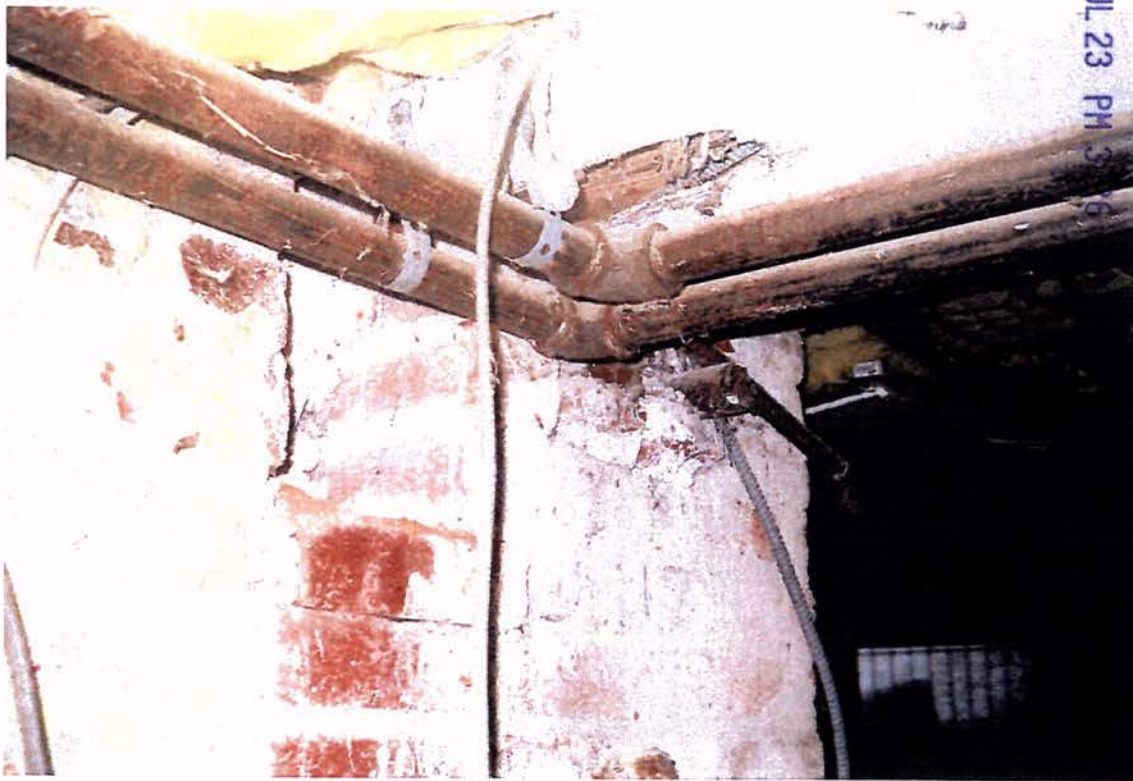
Basement- View of Hole for Missing Beam
