ADDITIONAL PHOTO EVIDENCE OF THE  
CONDITION OF 3612-3614 PARK PLACE NW

BZA APPLICATION NO. 18598

CASE NO. 18598

EXHIBIT NO. 30

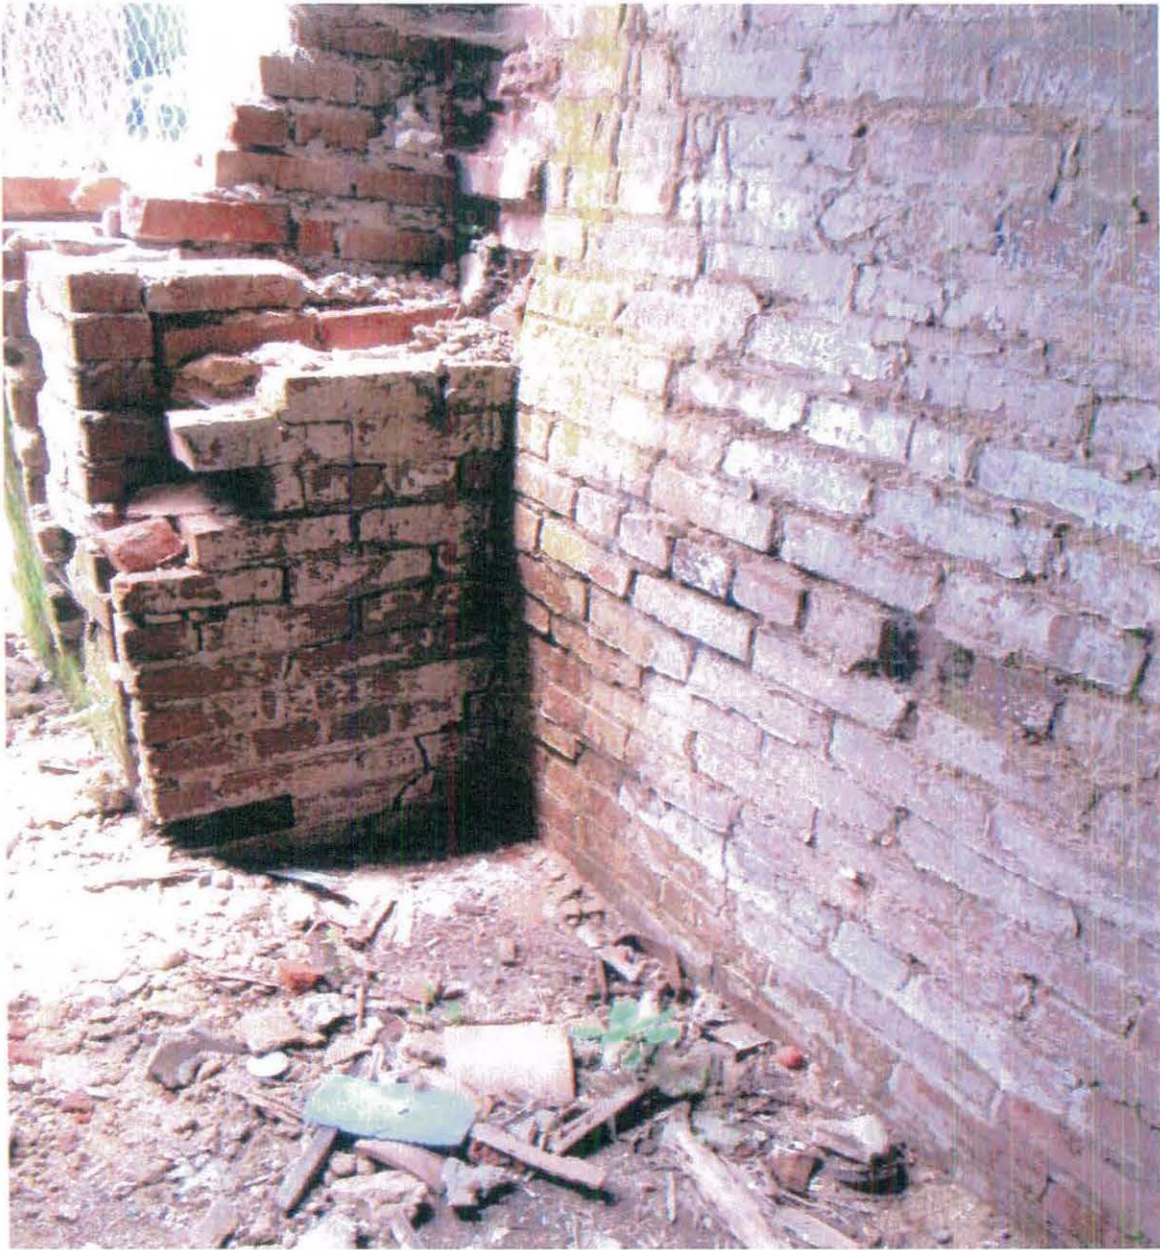
**Hydrostatic Pressure on Masonry Walls**

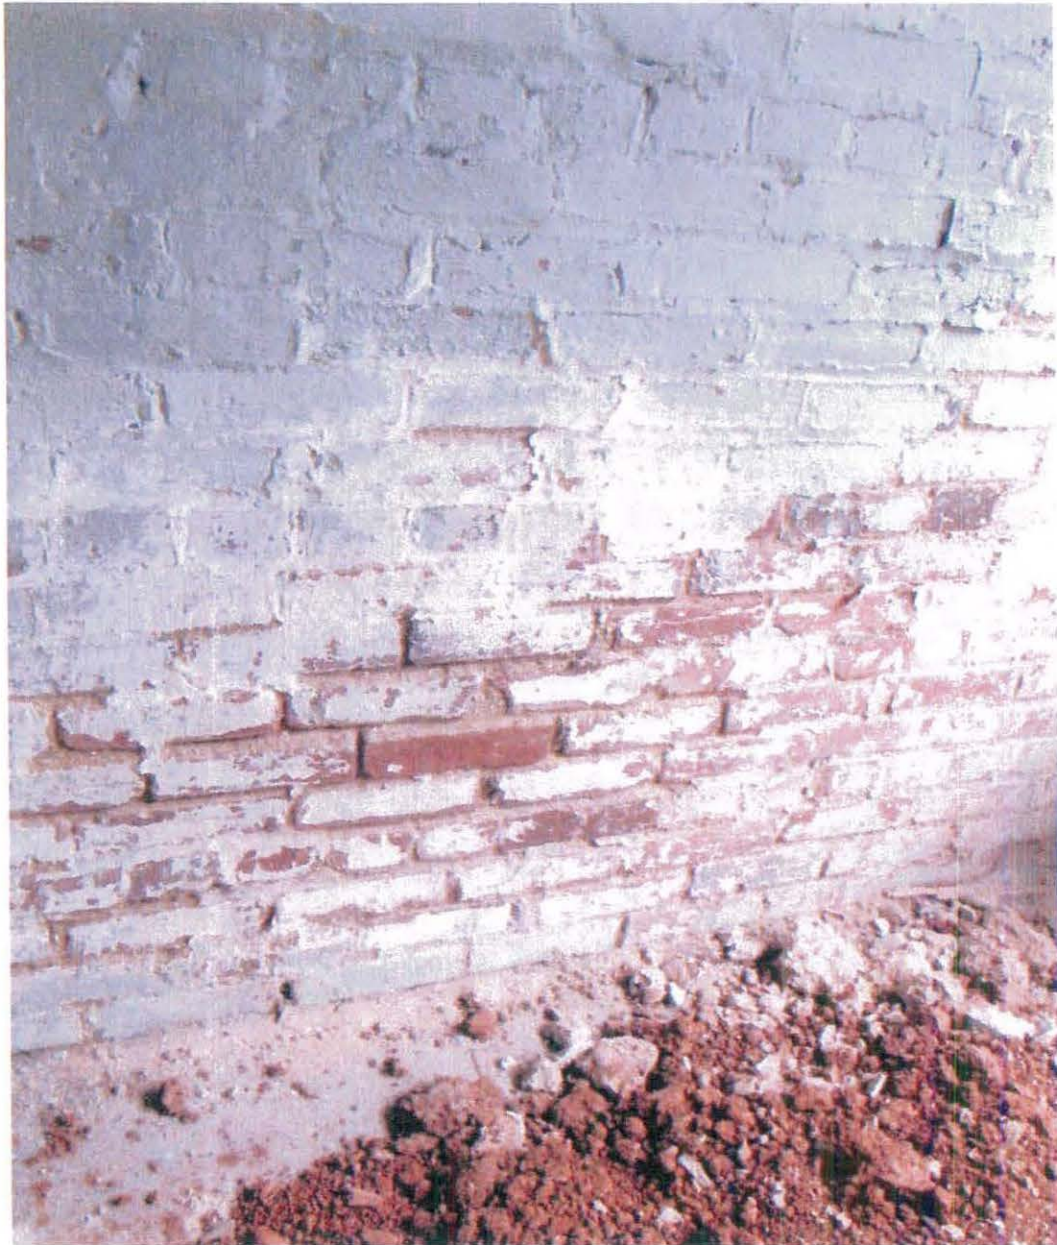
**3614 Mortar Deterioration**

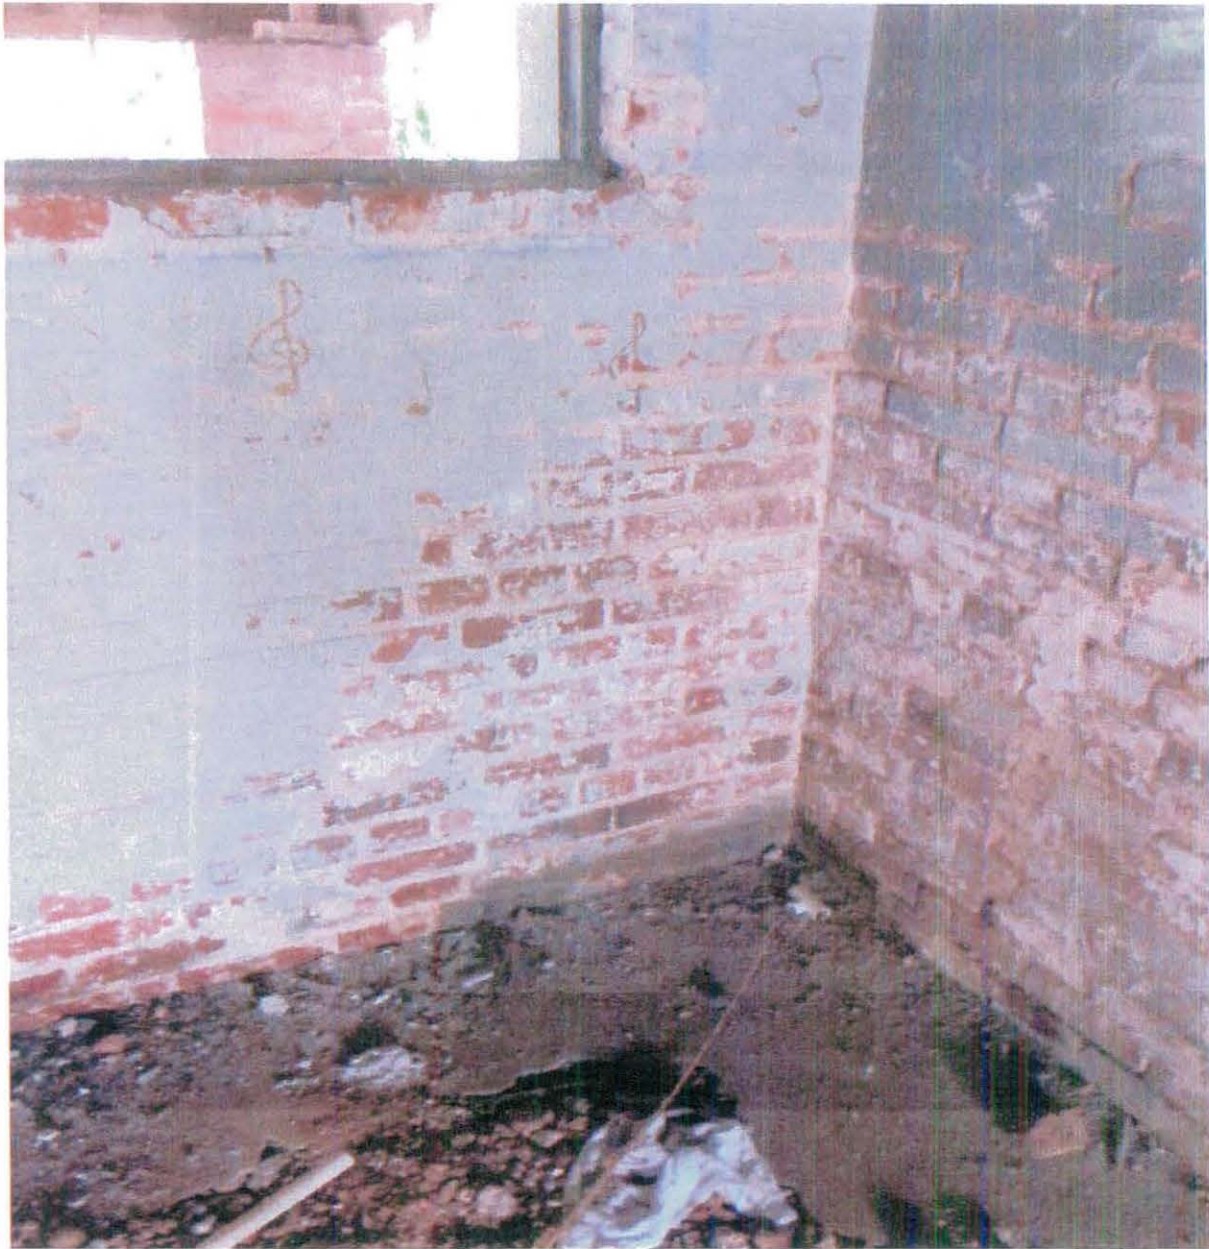
**3612 - Slab Displacement – Mortar Deterioration**

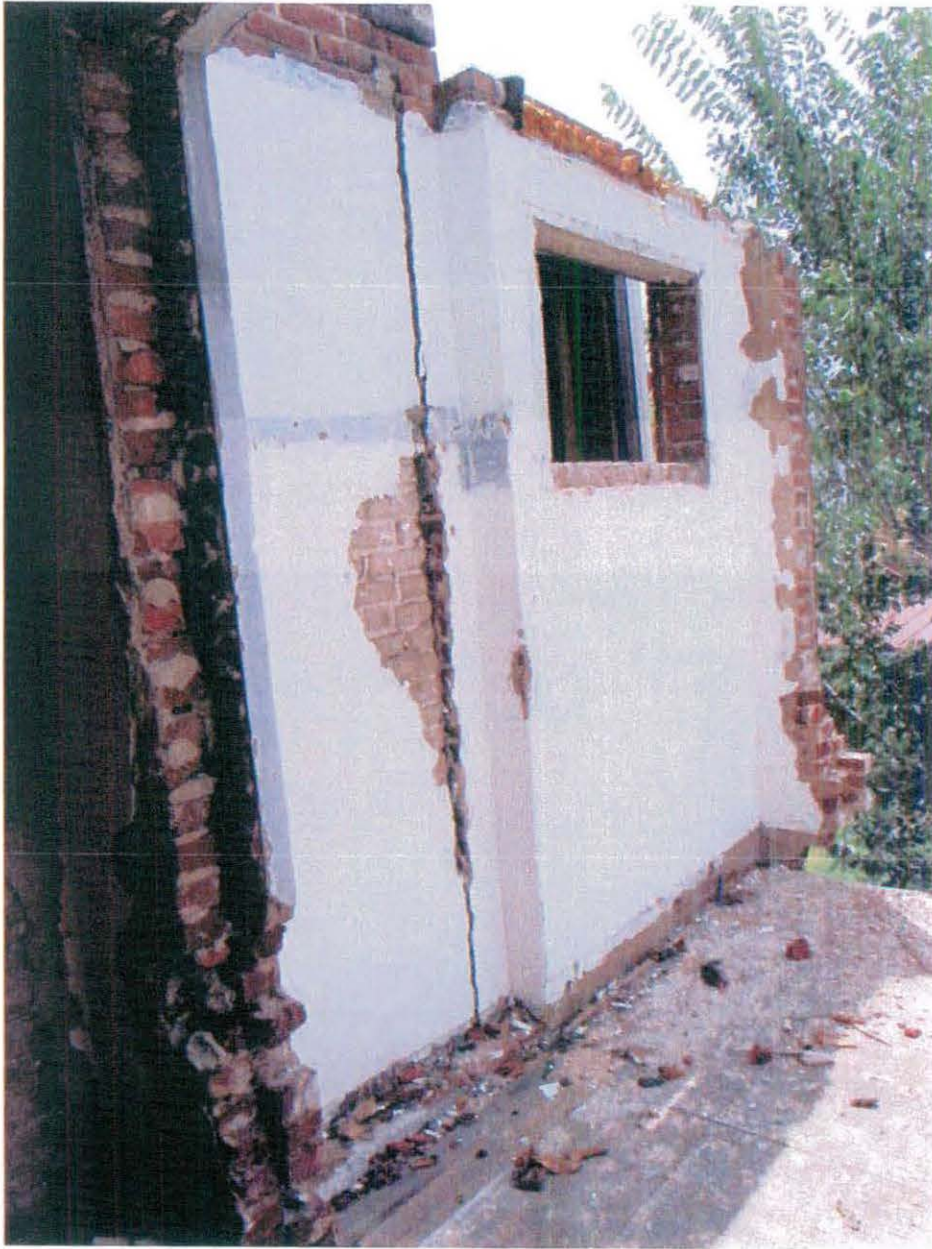
**Unstable Brick Addition Had to Be Demolished**

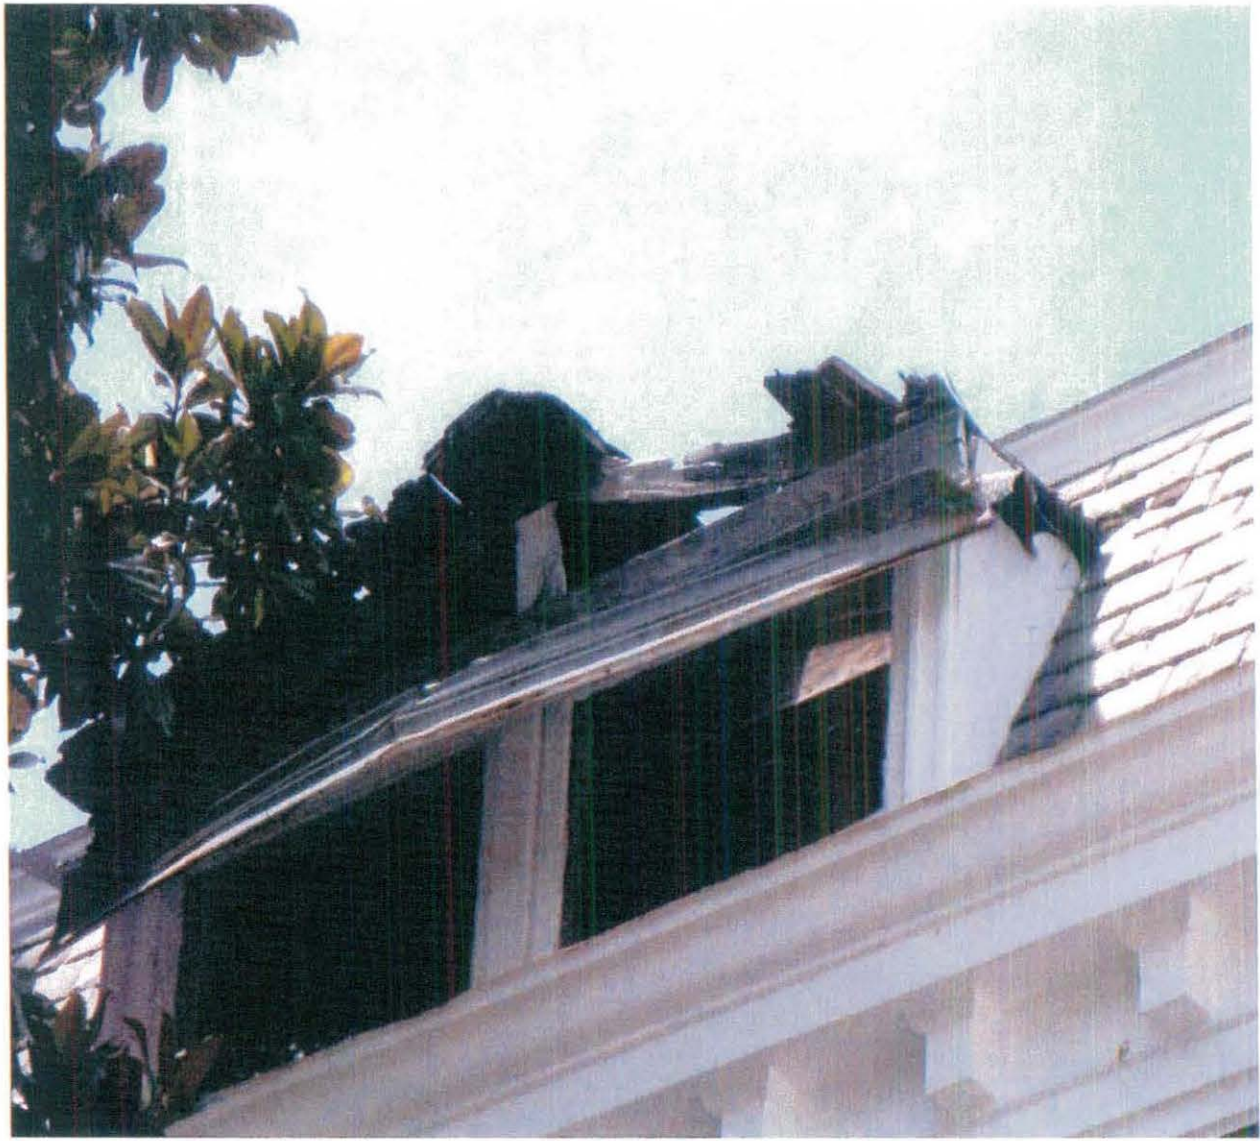
**3612 - Dormer Roof and Window Damage**

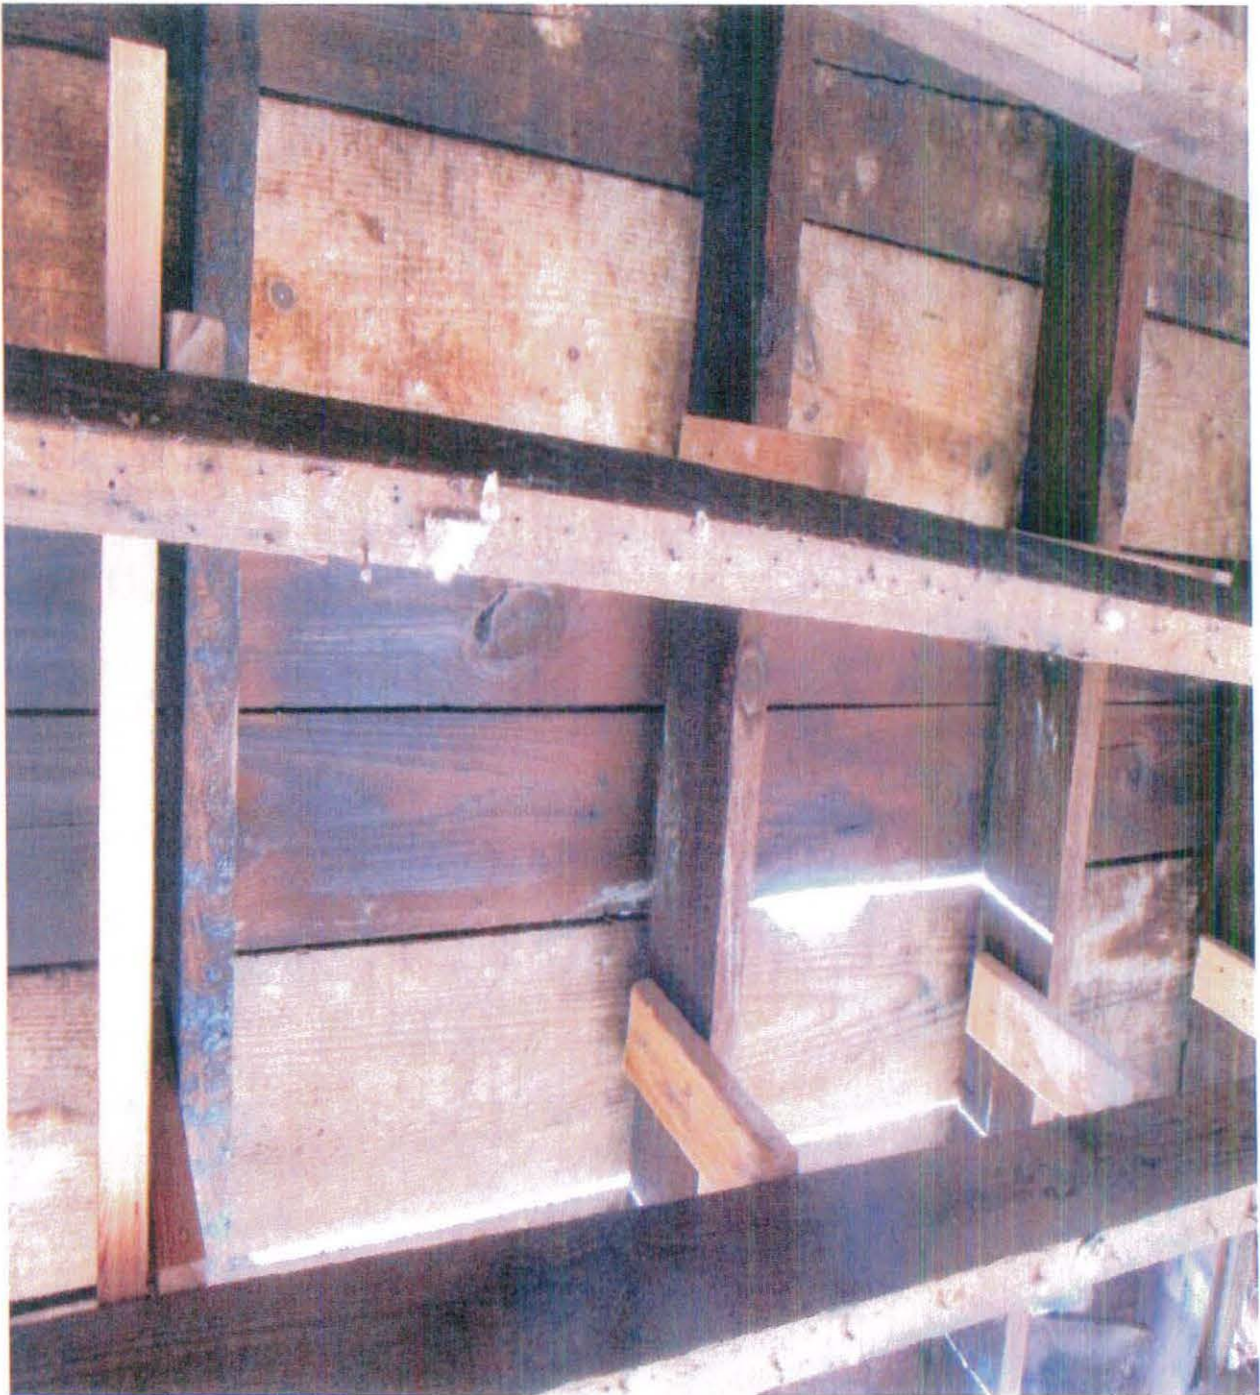
**3614 Park – Hole in Roof and Mold Damage**

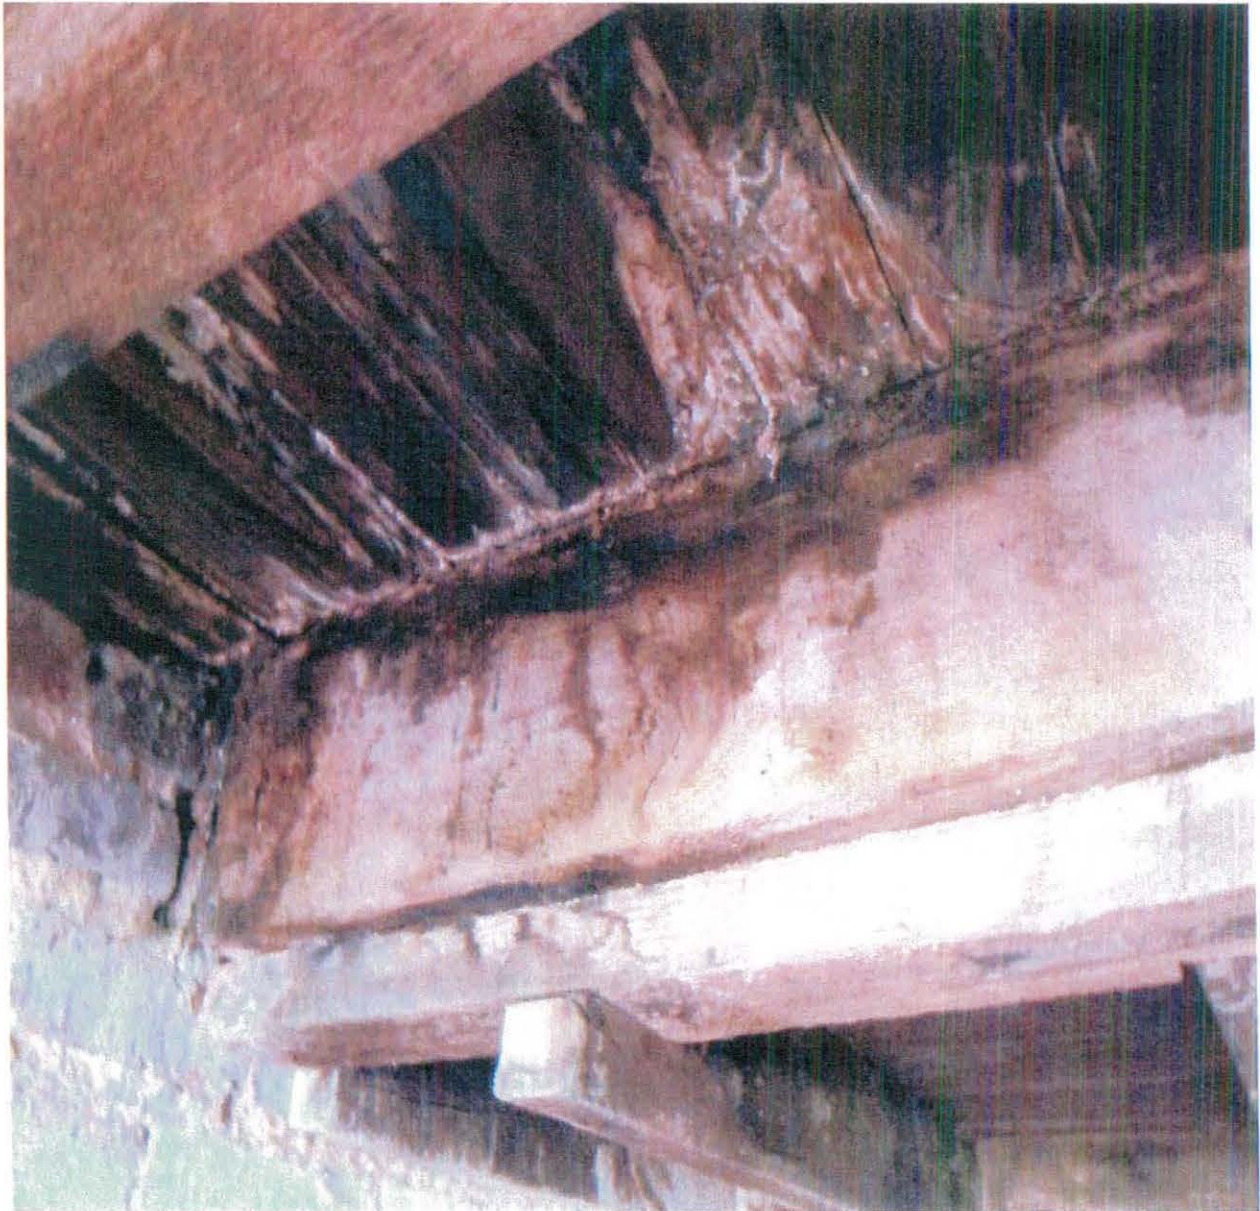
**3612 – Mold and Termite Damage**

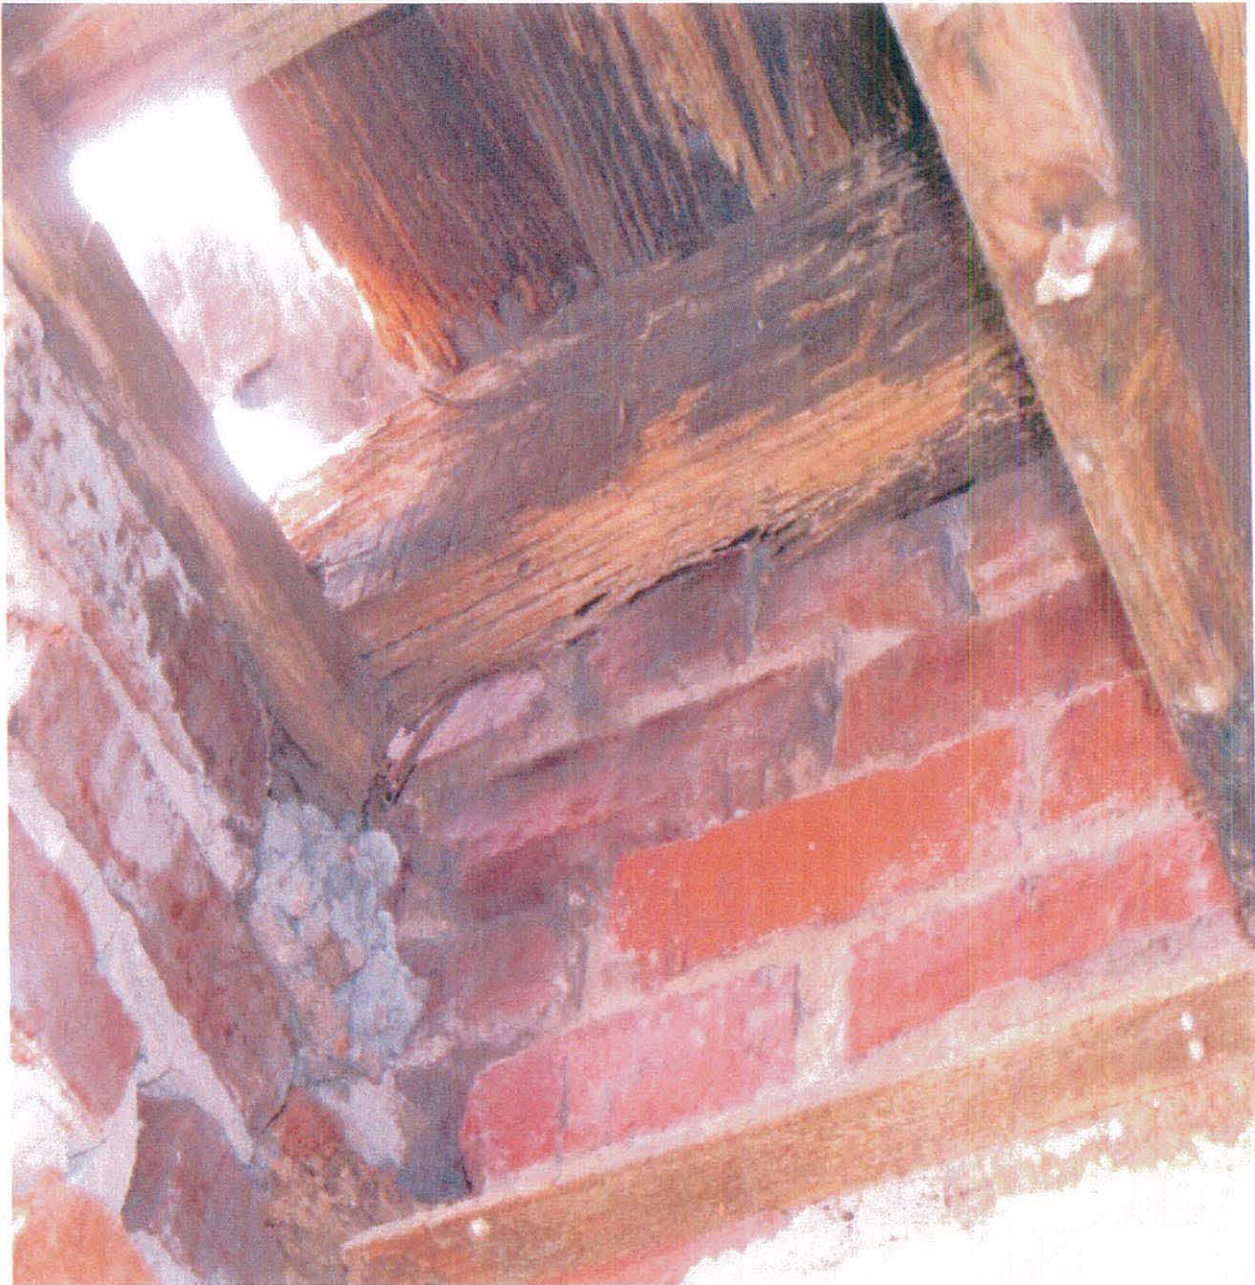
3614 Park- Termite Damage

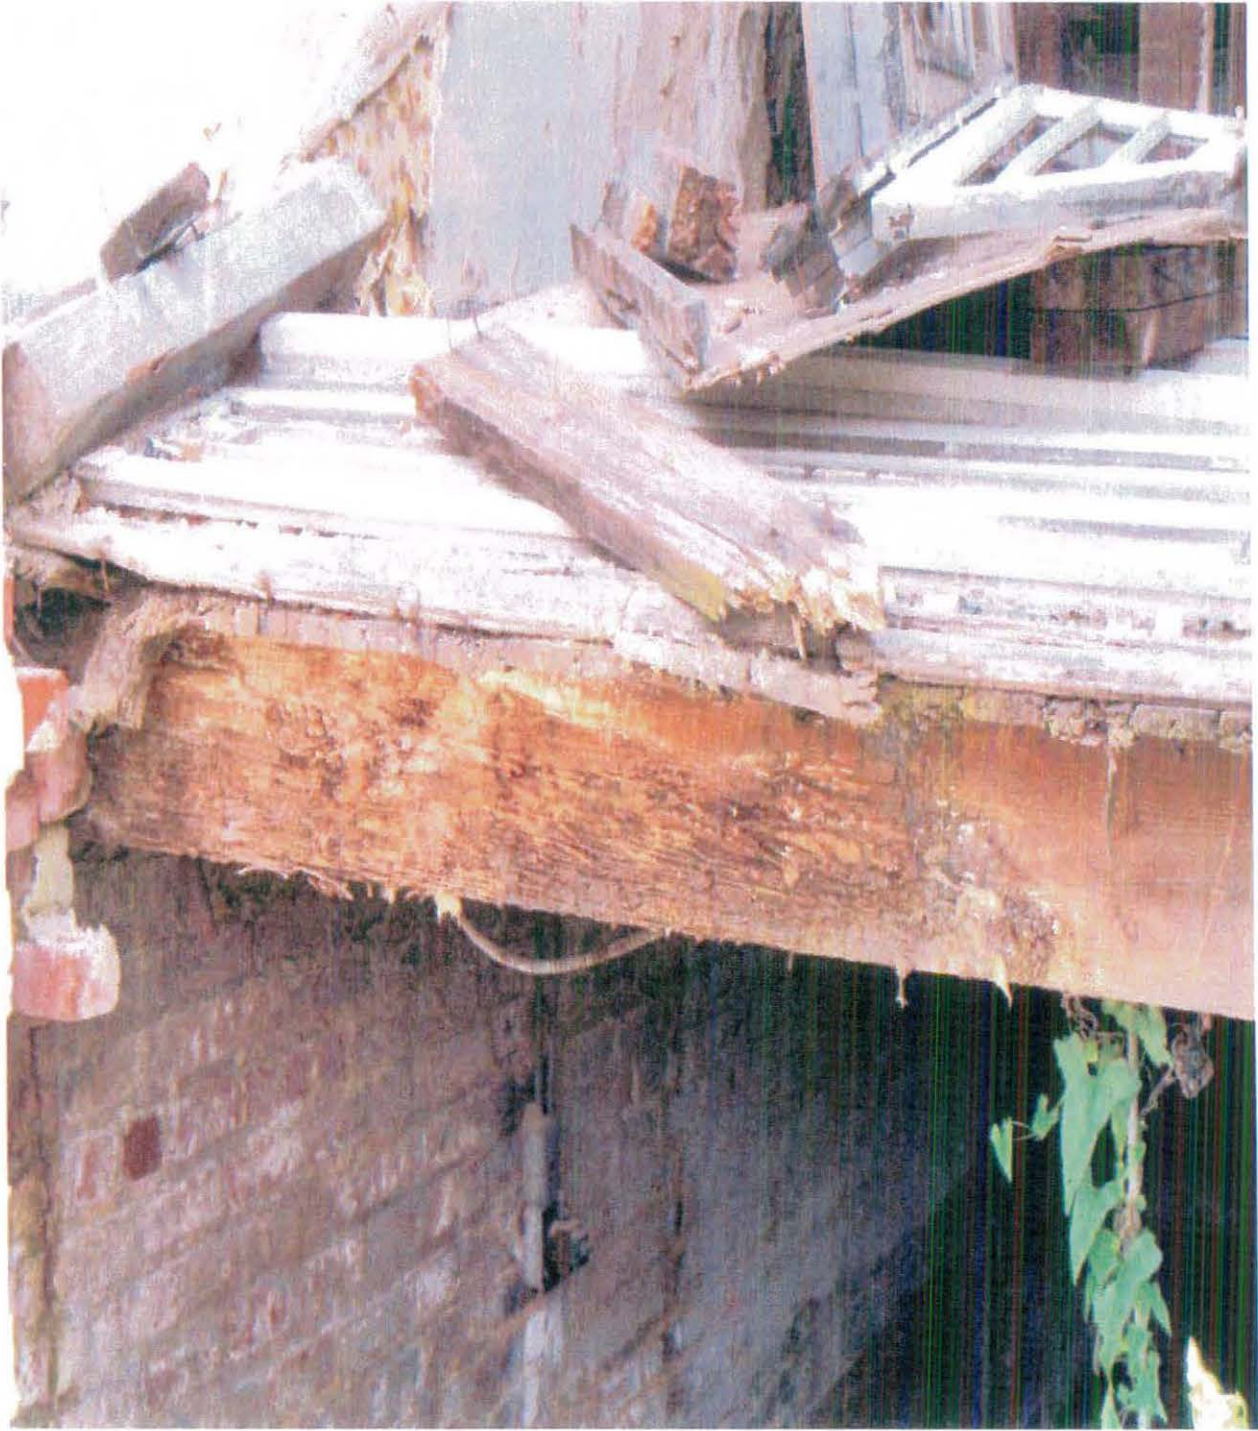
**3614 Park – Termite Damage**

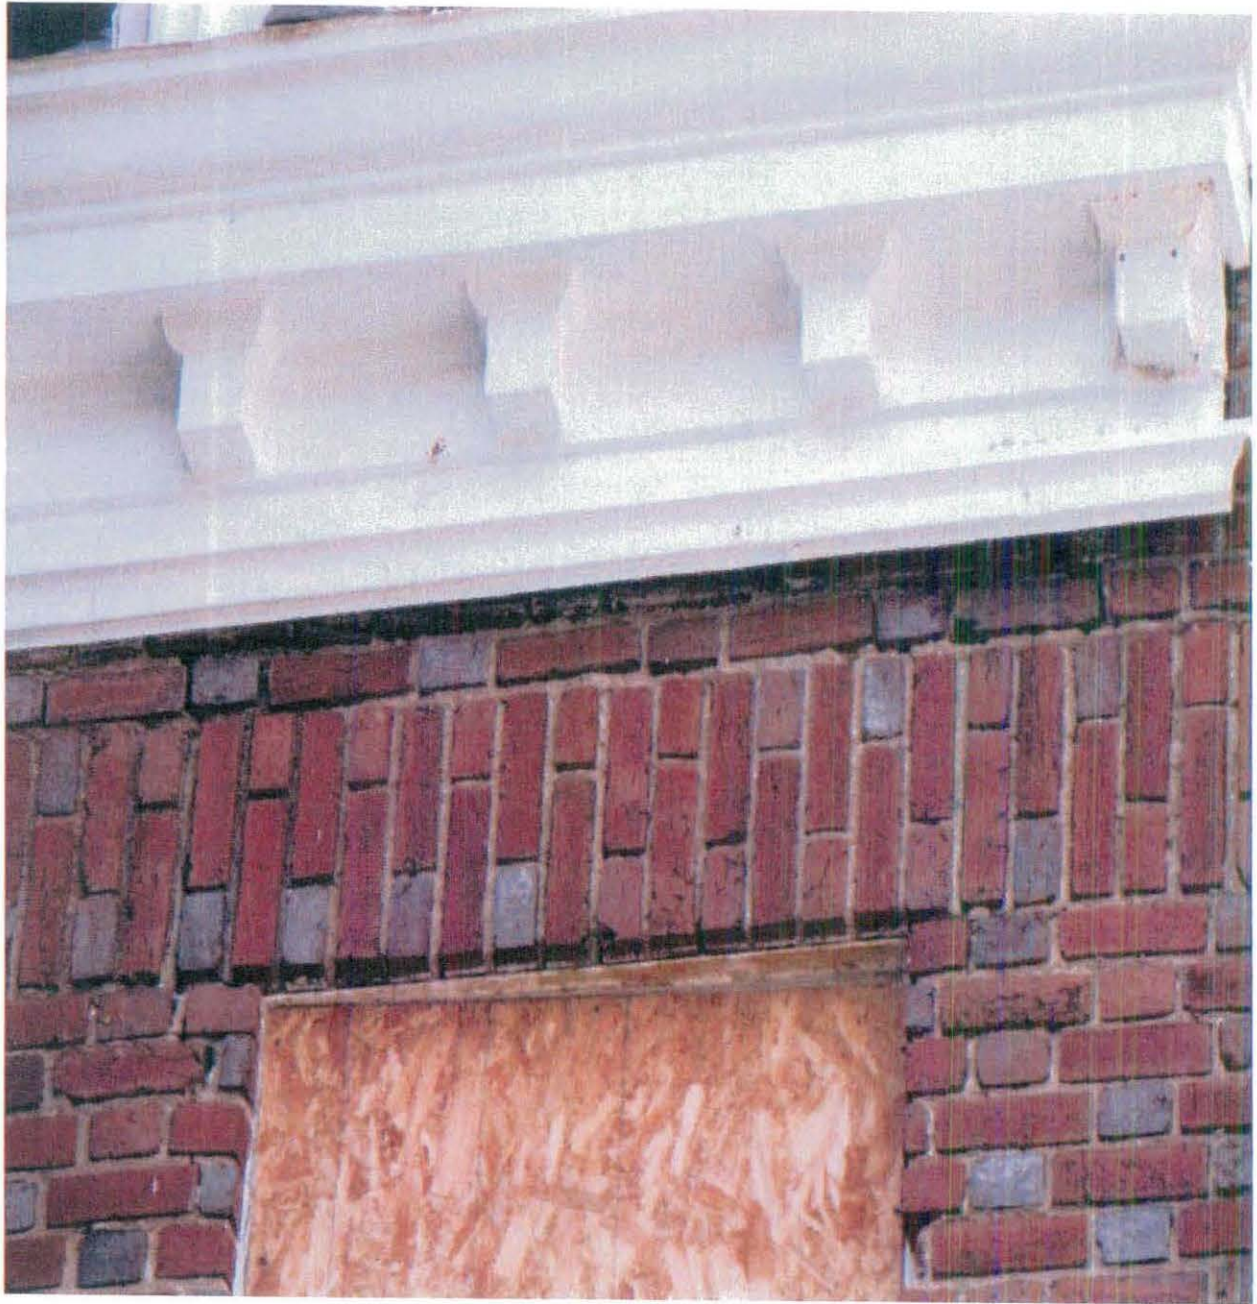
3614 Park – Mortar Deterioration and Cornice Spreading

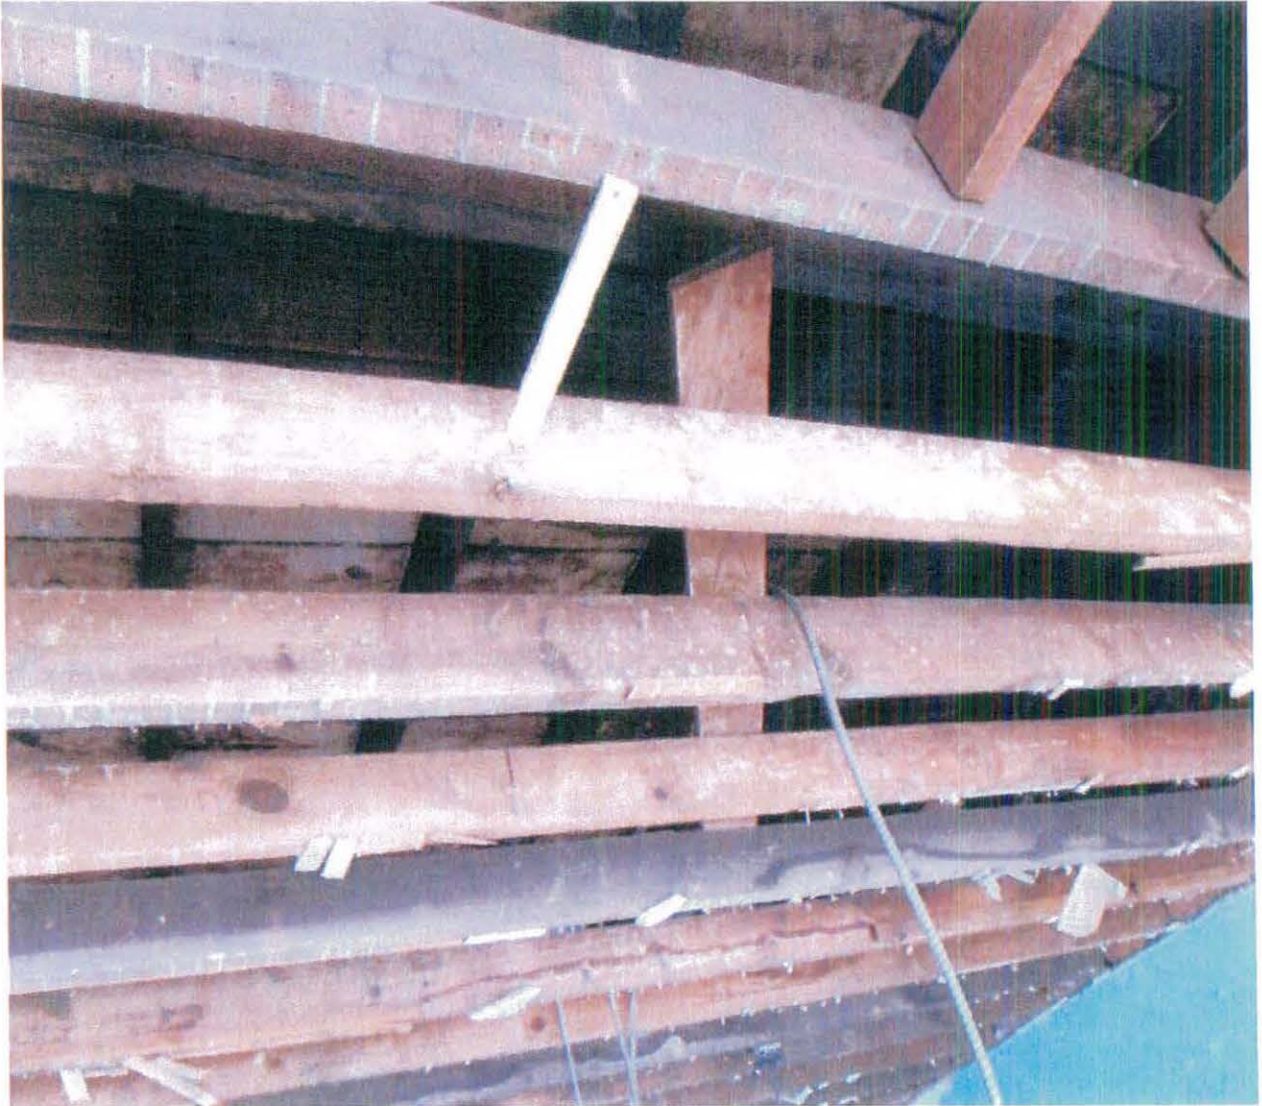
**3612 - Mold on Joists**

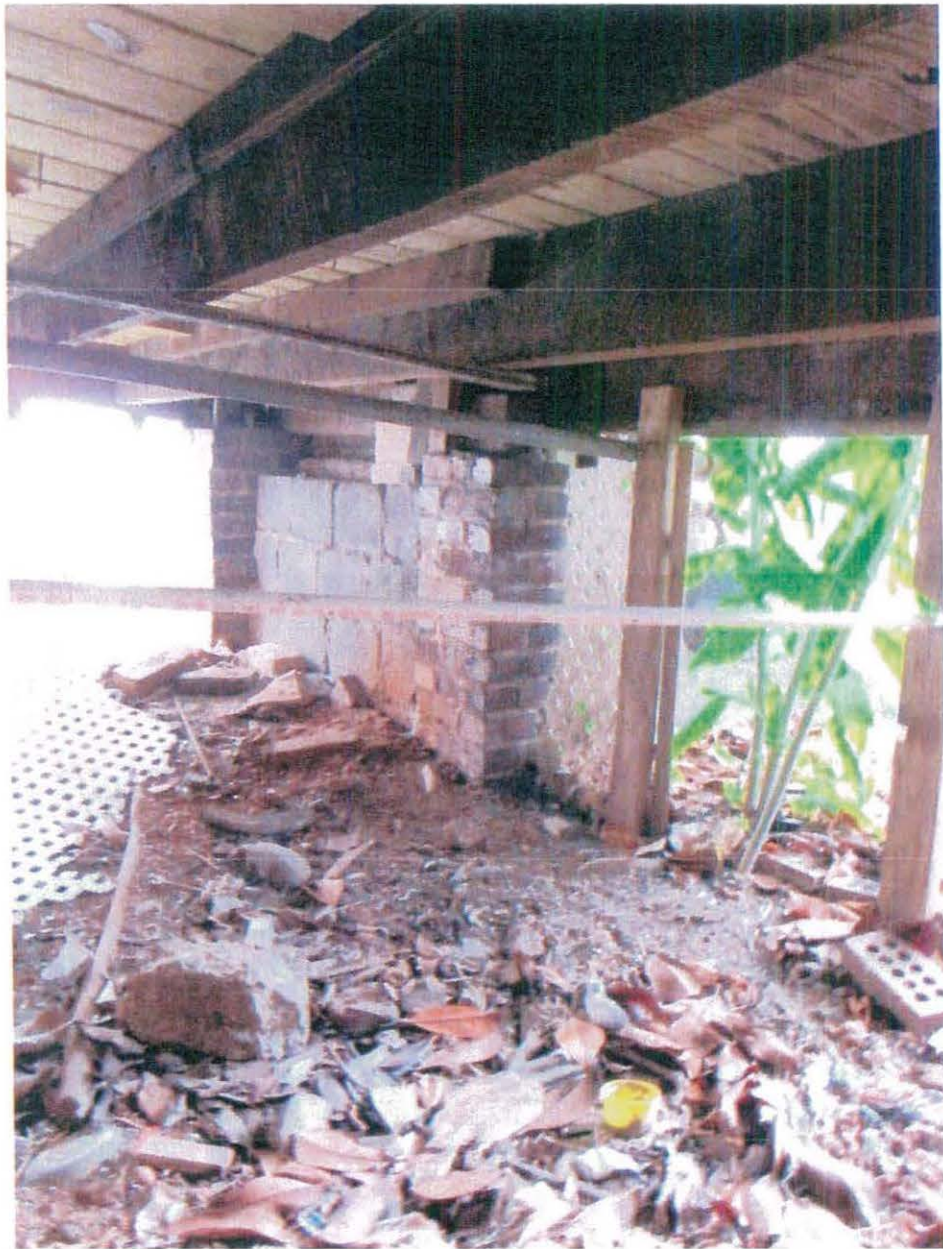
**3614 Porch Pier Settlement**

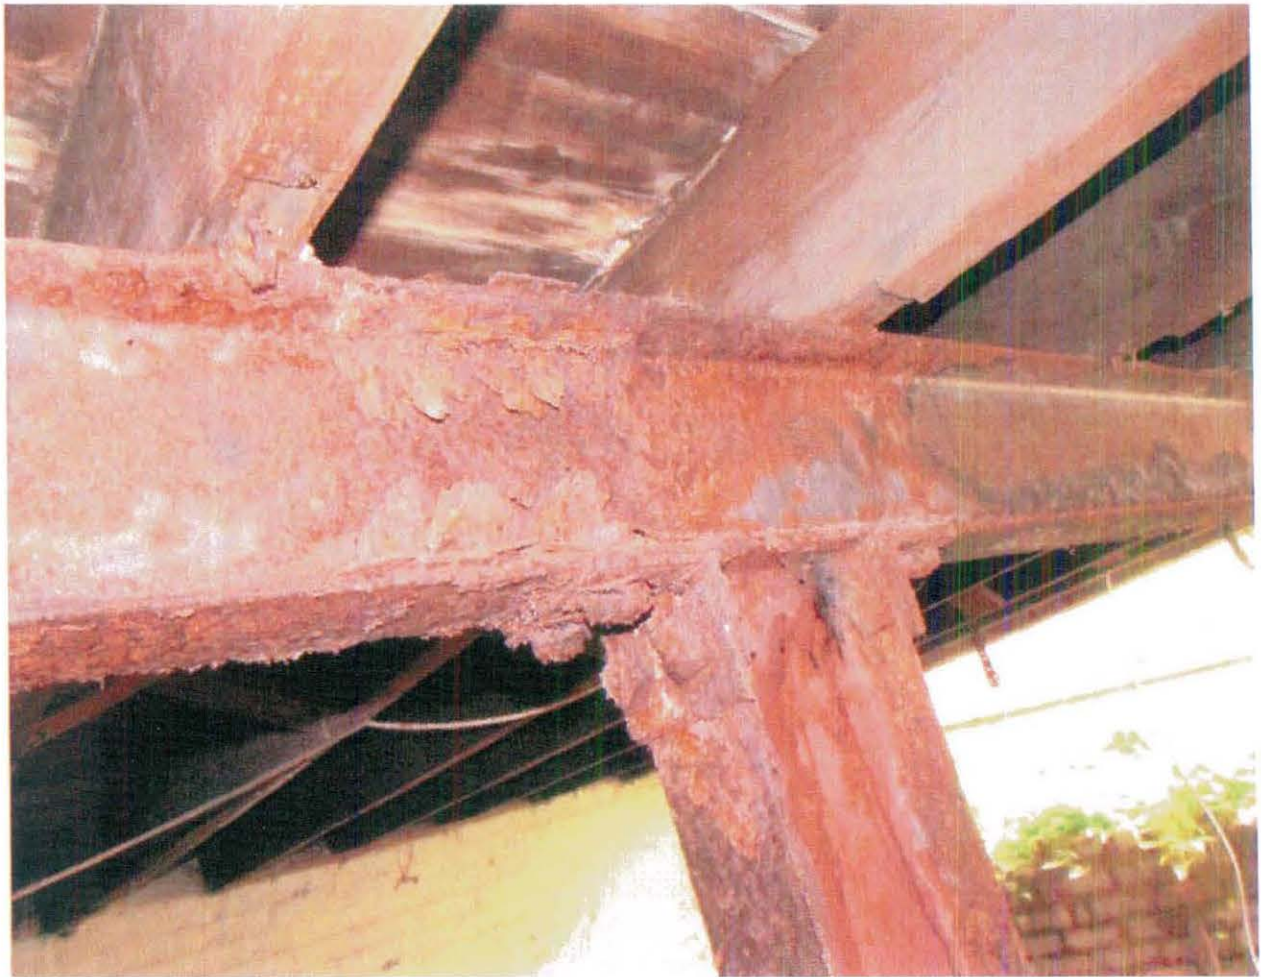
**3612 Park – Rusted Beam and Column**

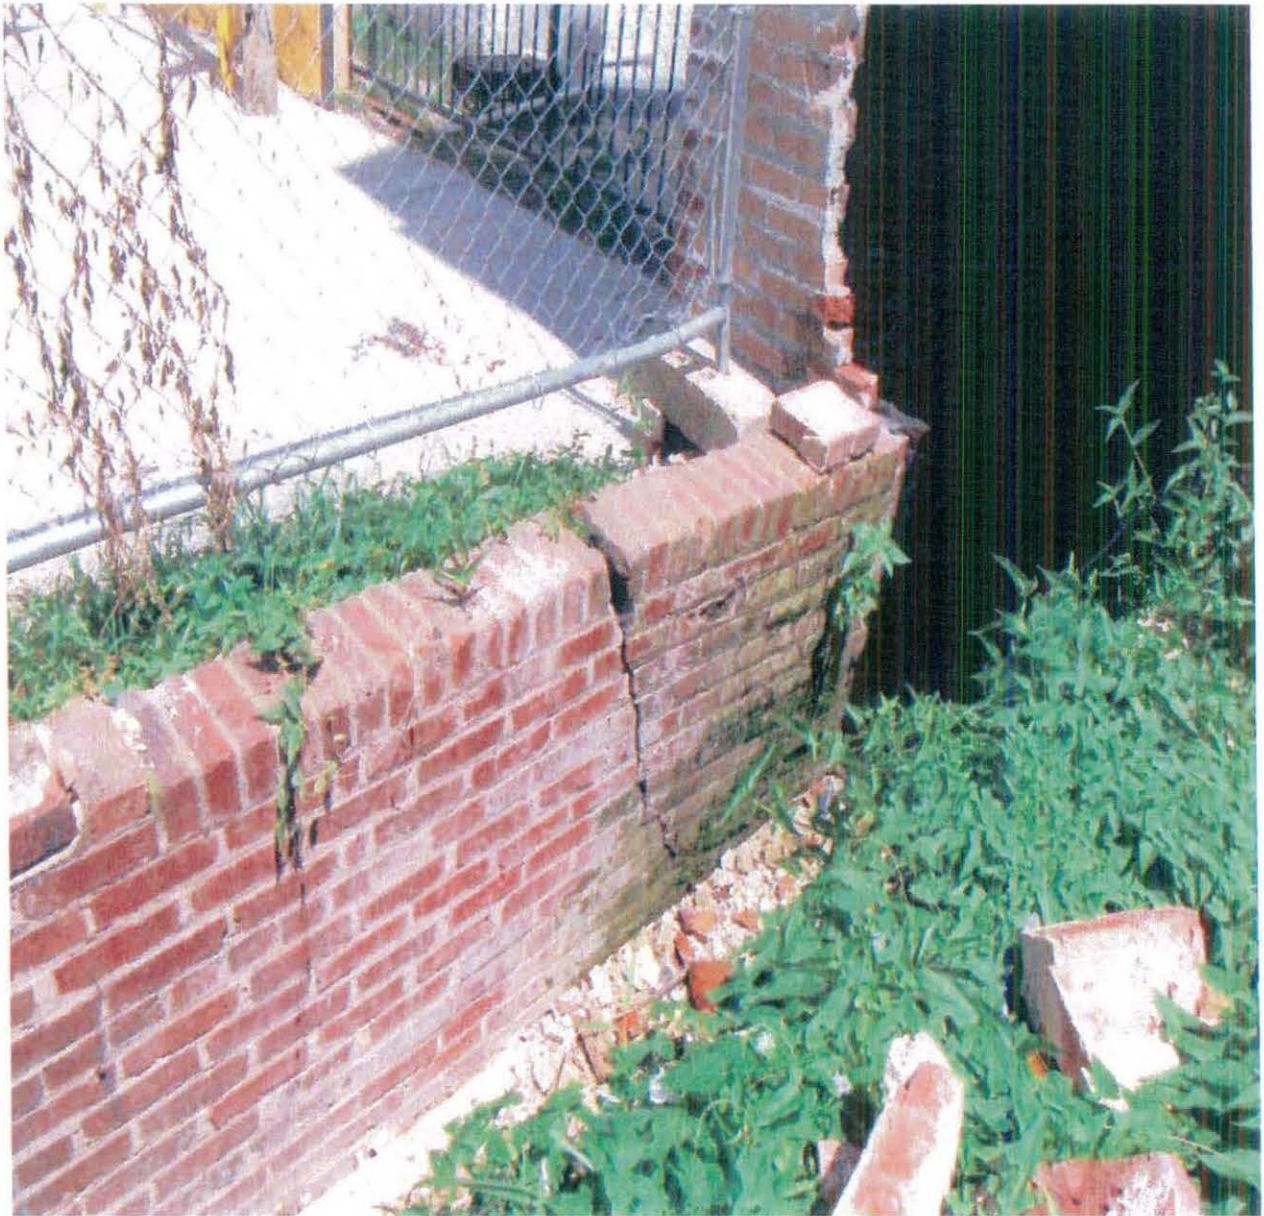
**Soil Pressure and Areaway Damage**

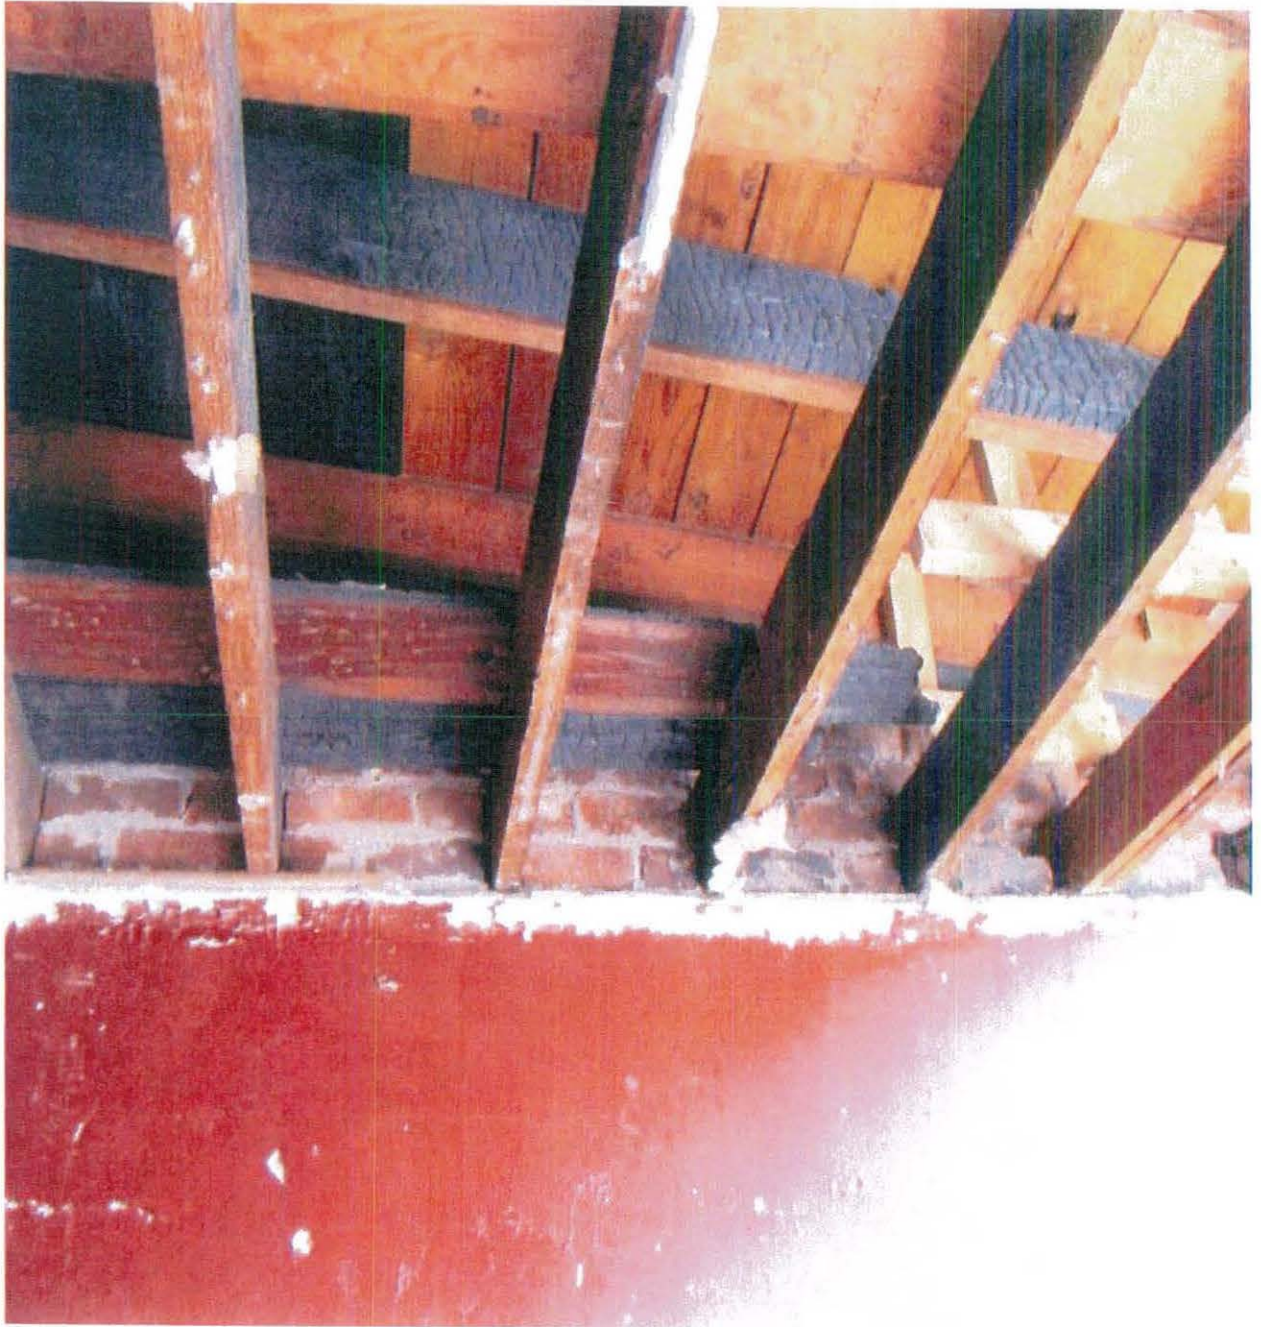
**Fire Damage**
