ADDITIONAL PHOTO EVIDENCE OF THE  
CONDITION OF 3612-3614 PARK PLACE NW

BZA APPLICATION NO. 18598

CASE NO. 18598

EXHIBIT NO. 30

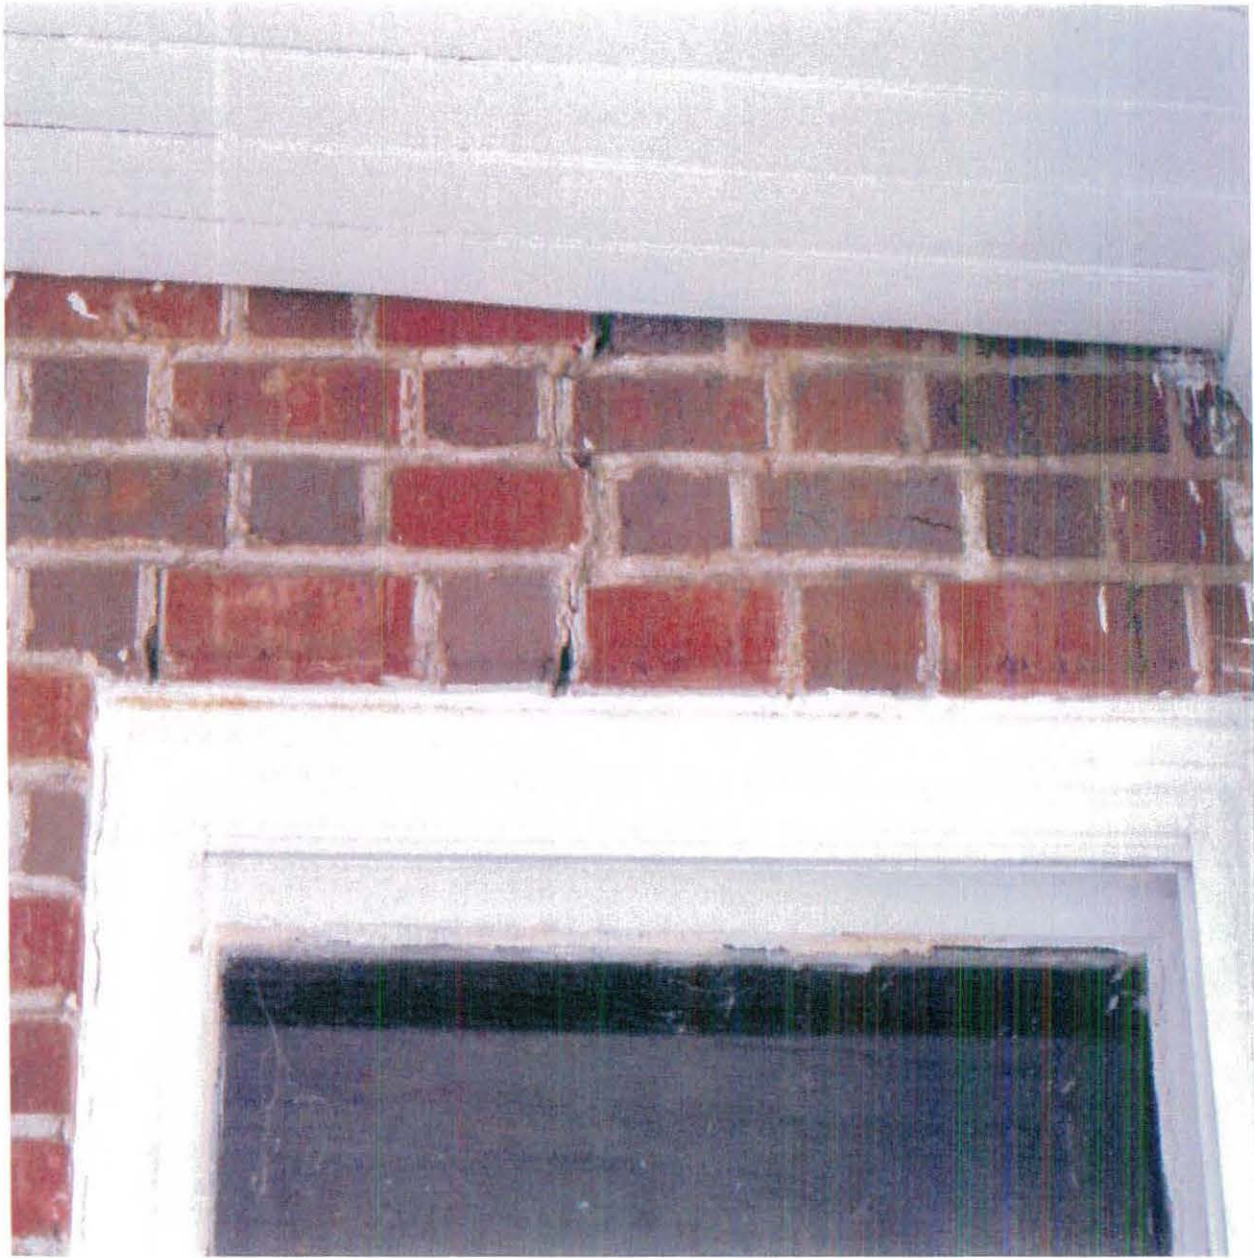
**Settlement Cracks in Masonry**

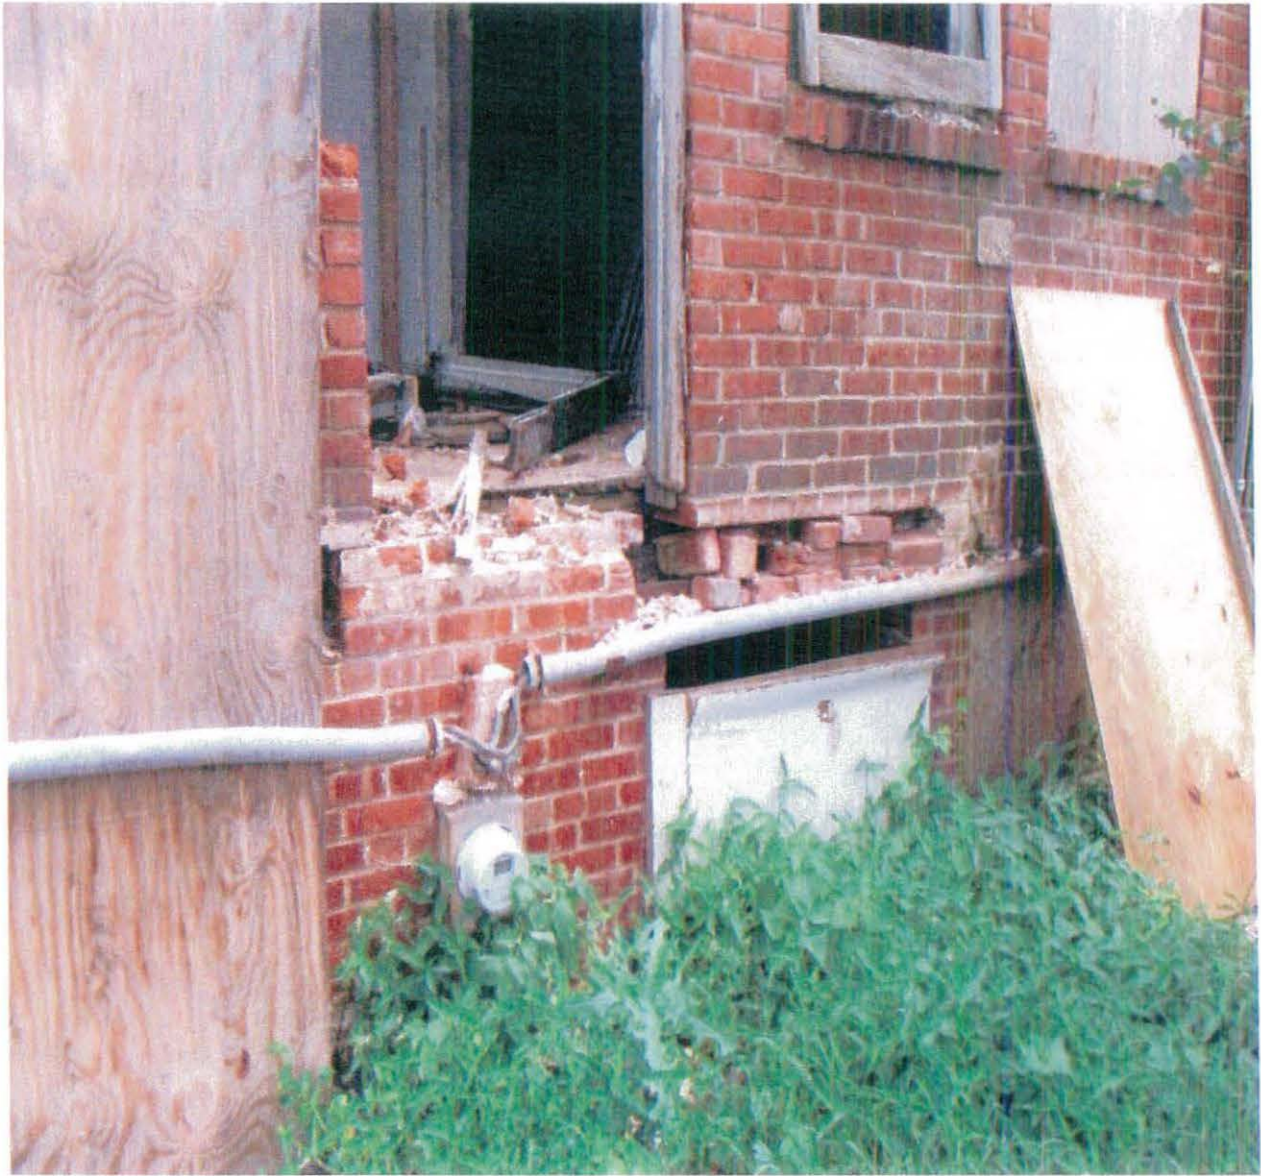
**Settlement Damage to Masonry**

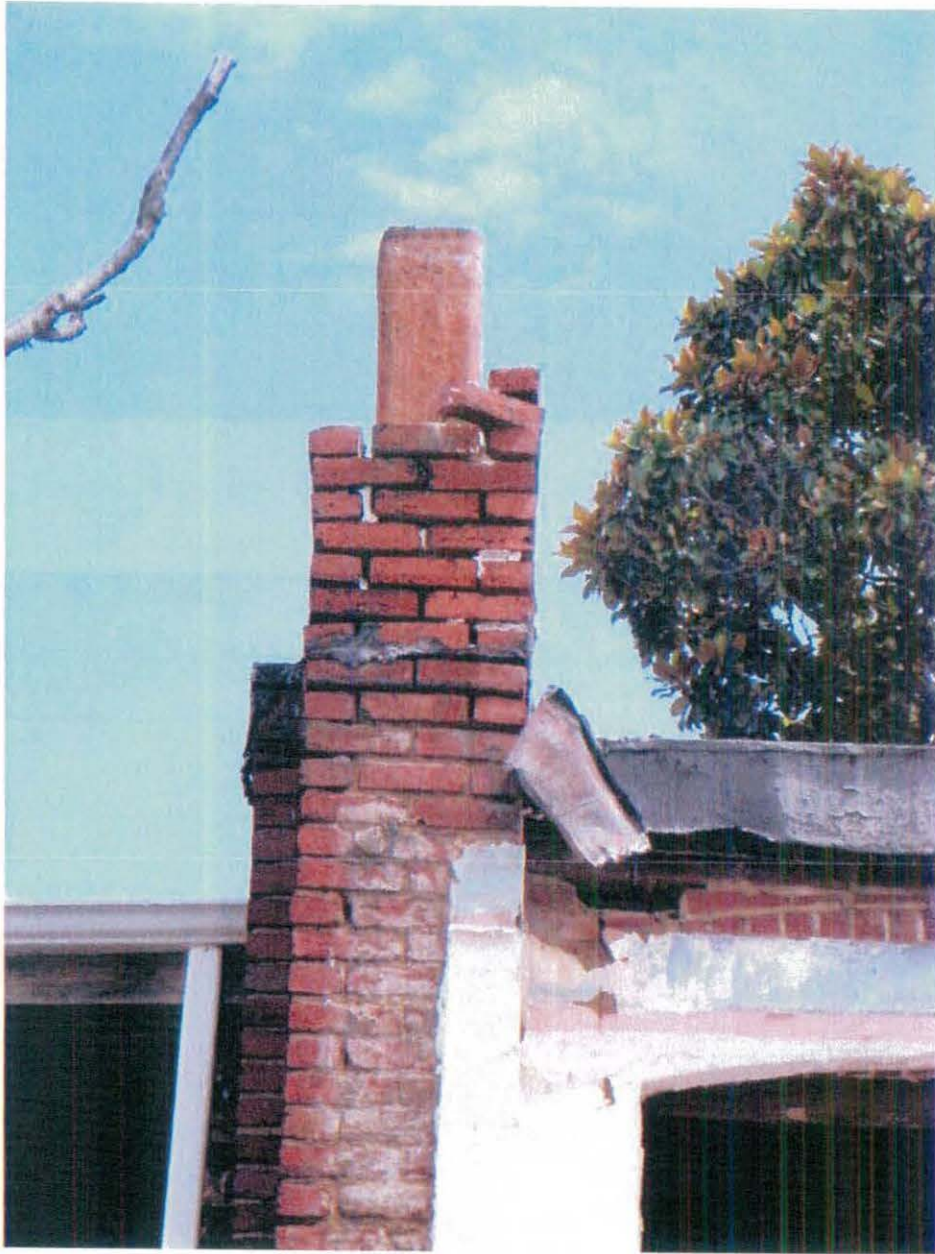
**Deteriorated Masonry**
