BOARD OF ZONING ADJUSTMENT
PREHEARING STATEMENT OF THE APPLICANT

BZA APPLICATION No. 18790
JEFFERSON-11TH STREET LLC (the “Applicant”)
2724 11th Street, NW (the “Subject Property”)

**2724 11th Street, NW
Condition Assessment Report
FINAL**

RSA PROJECT NO. W3179
October 28, 2014

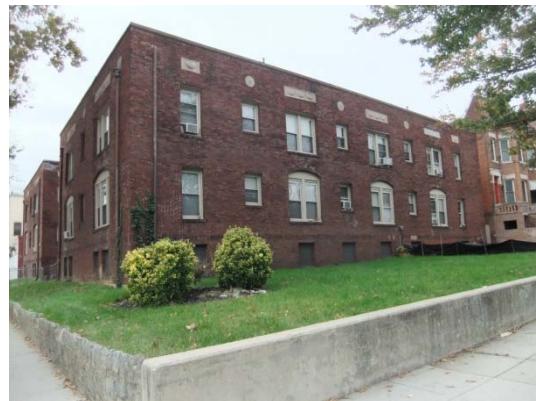
Photo 1: View of building from 11th Street and Girard Street.

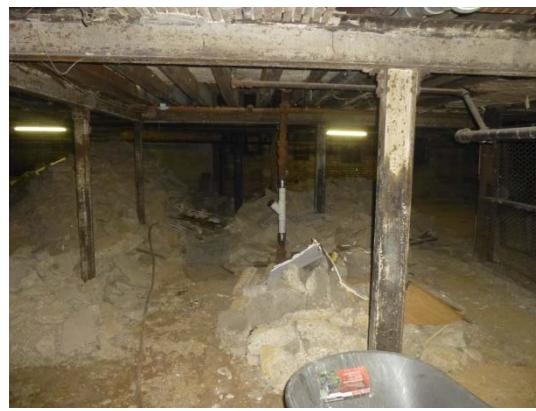
Photo 2: View of northern half of basement level showing piles of debris from slab on grade removal. Note the steel beam and column lines.

1. At the basement level, a large expanse of the existing concrete slab on grade in the northern half of the building had been removed in a recent renovation, exposing the soil beneath. Remnants of the demolished slab had been piled in the northwest corner of the basement (Photo 2). Ponding water is present at some locations where the slab on grade is still present (Photo 3). The water appears to be primarily attributed to leaking water lines within the building; however, signs of water intrusion are also visible on the face of the foundation walls as well as at their base.

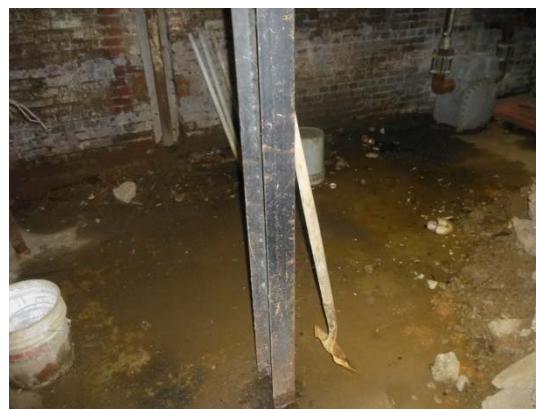
Photo 3: Ponding water visible at the slab on grade in the northwest corner of the basement.

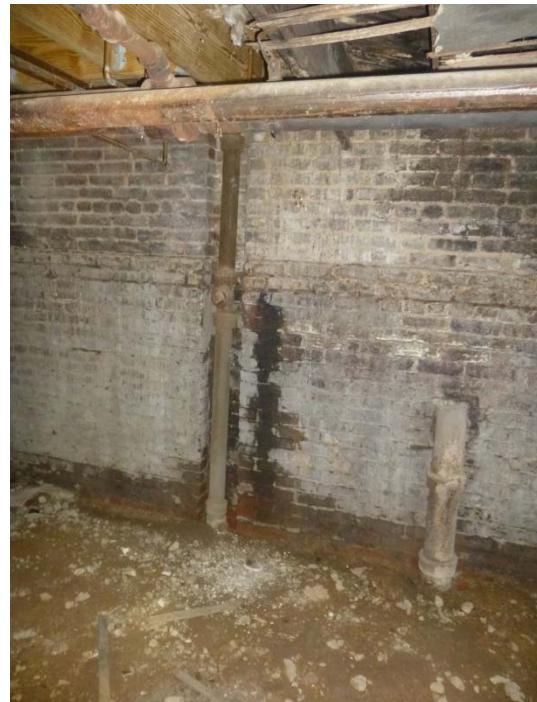
2. The brick masonry foundation walls show signs of water staining, efflorescence, and mortar loss due to the presence of moisture within and behind the wall (Photo 4).

Photo 4: Interior view of the west foundation wall. Note the efflorescence and presence of moisture at the base of the wall.

- Repoint the interior of the existing brick masonry foundation walls where the mortar is loose, deteriorated, or washed out. Locally replace bricks that are missing or damaged with new bricks to match the original wall construction. Special attention should be paid to wall sections beneath beam bearing locations.
- The steel beams and columns in the basement should be cleaned of corrosion and painted with a corrosion inhibiting paint. Evaluate the base of all steel columns for section loss and repair as required. Drainage and slab on grade modifications should be provided to prevent standing water at the basement columns.

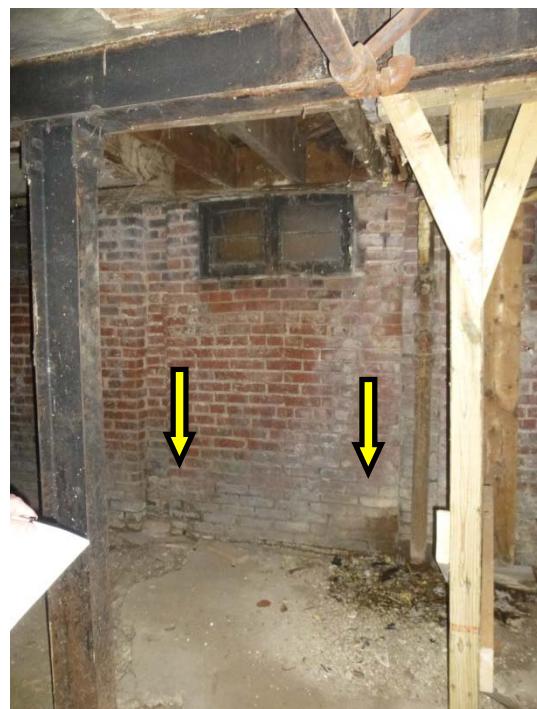
3. Localized settlement is apparent in the foundation wall at the south facing windows at the north side of the entrance walkway (Photo 5). The amount of settlement seen in the foundation walls is expected for a building of this era of construction.

Photo 5: Settlement of the foundation wall at either side of the basement window which faces the entrance walkway. Note the temporary wood shoring at the right edge.

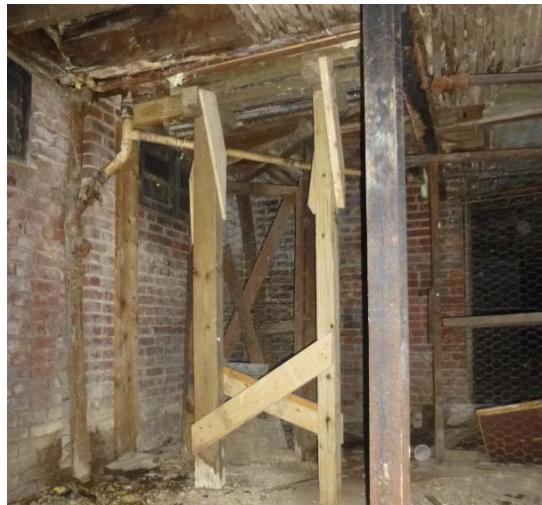
Photo 9: Temporary shoring structure for support of wood framing above.

- Temporary wood shoring seen in the basement is not intended to be permanent. The wood shoring is showing signs of moisture at their base. Permanent repairs should be designed and implemented to facilitate the removal of temporary shoring.

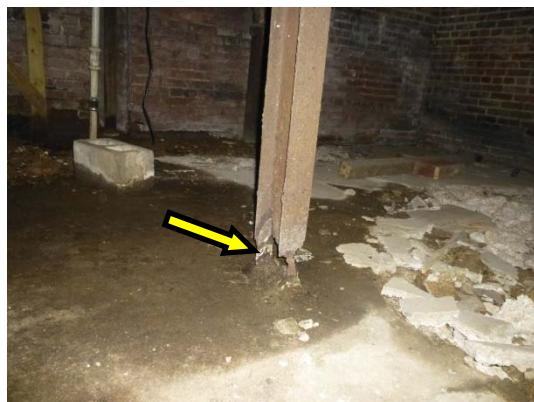
4. A number of the steel support columns exhibit corrosion at their base due to the presence of standing water around the column bases and elevated moisture levels in the basement level. One particular column, located in the southwest quadrant of the building exhibited severe corrosion with nearly full section loss at its base (Photo 6). Due to life safety concerns, RSA notified the owner's representative of this condition and recommended immediate installation of shoring posts to support the framing above.

Photo 6: Steel support column in the southwest quadrant of the basement with nearly full section loss at its base.

Install post shores immediately to support the beam above at either side of the deteriorated column in the southwest quadrant of the basement level. This column has near complete section loss at its base. Any shoring installed is temporary and a permanent repair of this column should be designed and implemented. **Note:** RSA notified the owner's representative of this condition and immediate shoring recommendations on 10/10/2014.

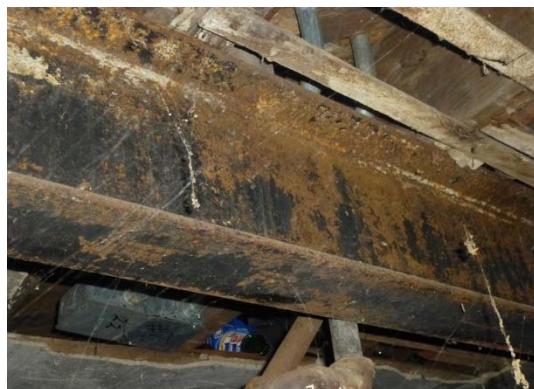
5. Surface corrosion is visible along various steel beams

(Photo 7). These beams are pocketed into the exterior masonry walls along the perimeter of the building. A single shoring post was positioned beneath the beam end in the northeast quadrant of the basement (Photo 8). Deterioration of steel embedded within exterior masonry wall is a common issue of structures of this period. Therefore this shoring post was presumably installed to provide support for a compromised bearing condition at the exterior masonry wall.

Photo 7: Corrosion of steel beam in north east quadrant of building.

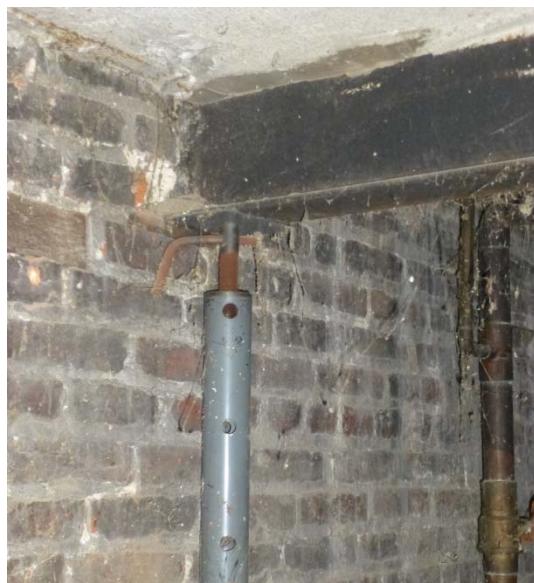
Photo 8: Steel post shore positioned beneath a steel beam presumably to provide support for a compromised bearing condition at the exterior masonry wall

- The steel beam with adjacent shoring post should be investigated further to determine the intention of the shoring post.
- Deteriorated wood headers above the basement windows shall be replaced with new pressure-treated wood ledgers. Existing floor joist perpendicular to the ledger shall be fastened to the new ledger

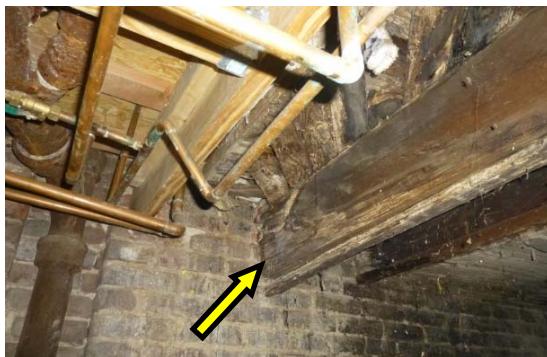
Photo 10: Wood joist with full bearing loss at west exterior masonry wall.

- Wood joist exhibiting deterioration along their length and/or at their bearing end should be sistered or replaced to match existing in kind. Provide temporary shoring where existing joists have failed at their bearing ends until a permanent repair is implemented. (See Photo 10)

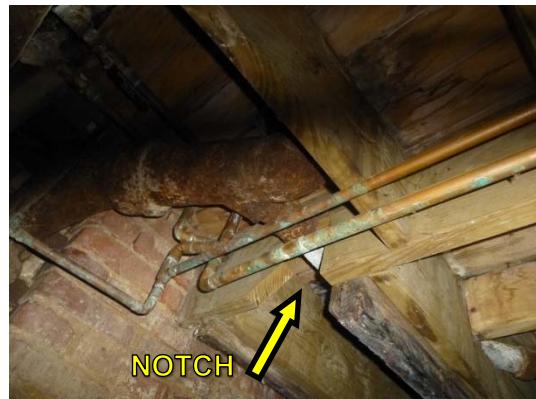
7. Several floor joists have been notched to allow the passage of pipes. Notches range in depth from approximately three to six inches, and are located at both the top and bottom edges of the joists (Photo 11).

Photo 11: Floor joist notched for passage of drain line.

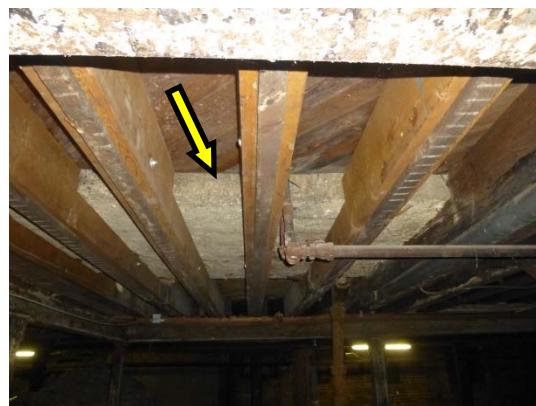
8. A few joists north of the main stairwell show signs of charring which appears to be a result of fire damage. These joists have been repaired by sistering a new joist on either side of the existing damaged joists (Photo 12). A thicker concrete mud slab appears to have been added at the locations of the fire damaged joists mentioned earlier. The tops of the sistered joist were notched for approximately five feet along the length of their span to accommodate the mud slab (Photo 12).

Photo 12: Original fire damaged joists with wood sister at either face. Note that the sisters have been notch to incorporate the additional cementitious material.

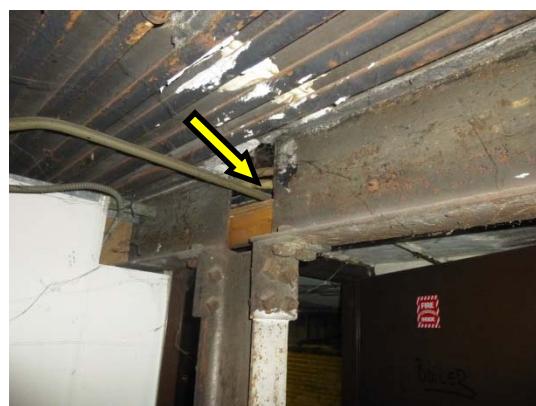
9. In the typical basement framing condition, steel beams that support the first floor joists frame continuous overtop of the steel column; however, in the boiler room located to the south of the main stairwell, it appears that the beam has been cut out over top of the column to allow for the passage of piping. This loss in continuity results in a reduced capacity of the steel beam at this location. It is unclear whether this detail is original construction or if the beam was modified at a later date (Photo 13).

Photo 13: Atypical beam framing at top of steel column; the steel beam is not continuous over top of the column.

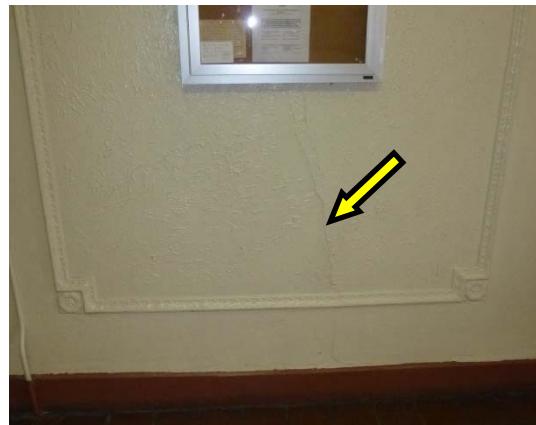
1. The lobby of the building appears to have cracks in the walls that were previously repaired and re-plastered (Photo 14). There is also a sag in the floor at the location of entry to the stairway that leads to the basement.

Photo 14: Plaster repair of crack on north wall of lobby.

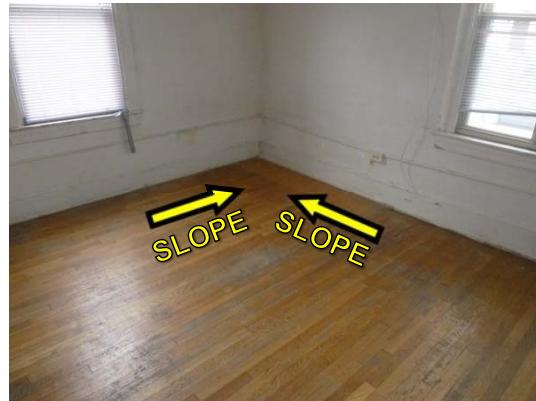
In Unit A on the First Floor, there was a noticeable slope in the floor in the Living Room towards the northeast corner of the room (Photo 15). A slight bowing and separation of the floor boards was also visible adjacent to the settlement of the floor framing in the northeast corner of the unit. Floor settlement was also noticeable in the Bedroom of Unit A. The floor framing sloped downwards toward the north side of the building. This correlates to cracks observed in the plaster and racking of the doorframe on the east wall of the bedroom. This settlement is likely related to a combination the settlement of the exterior masonry bearing walls as seen in the basement and deterioration of the first floor joists.

Photo 15: Floor slopes toward northeast corner of living room in Unit A at the northeast corner of the first floor.

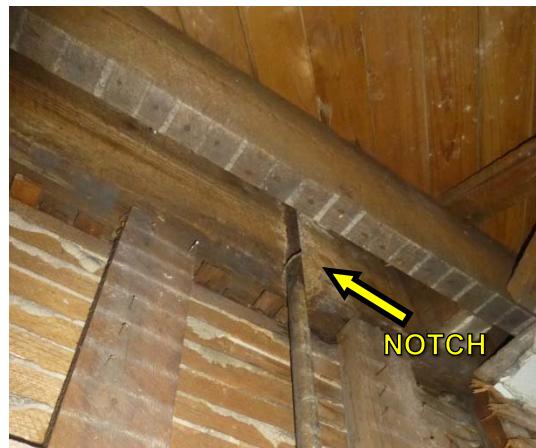
Photo 16: Full depth notch in outer ply of built-up wood beam above the north wall of living room in Unit D to the south of the main stair on the first floor.

to no deterioration visible at the joist pockets. One ply of the built-up beam above the north wall of the Living Room was completely cut through to allow for the passage of a plumbing line (Photo 16).

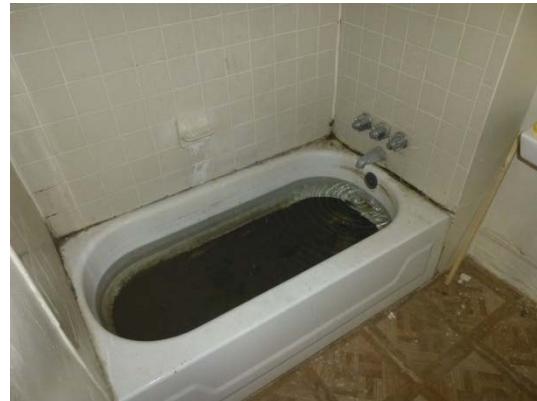
The bath tub in the bathroom was filled with water and did not appear to be draining (Photo 17). The floor in the bathroom had a slight downward slope towards the full tub of water. Also, when entering the apartment unit, there was noticeable slope in the floor towards the west, also in the direction of the full tub of water. Based on the typical moisture damage and deterioration to the first floor joists near existing plumbing lines, it is likely that the deflection is partially caused by the deterioration of the floor joists, and the weight of the full tub of water is exacerbating the adjacent floor to slope downward towards the tub. The doorframe on the south wall of the living room is racked correlating with the slope seen in the floor.

Photo 17: Bath tub in Unit D. Note that the tub does not appear to be draining.

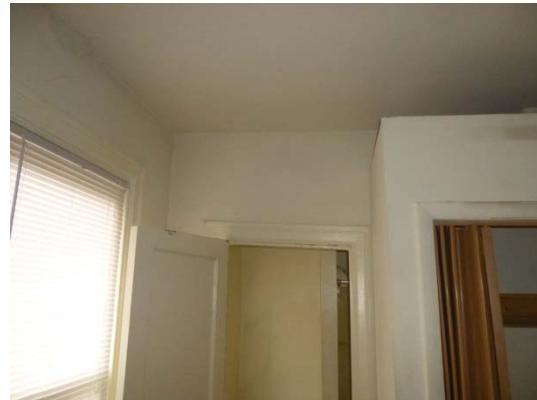
Unit F has a noticeable floor settlement with all the floor slopes converging to the bathroom. It is suspected that the settlement observed in the floor is due to a similar deteriorated framing condition seen beneath the first floor bathrooms. Cracks in the plaster wall and racking of the doorway on the south wall of the Living Room correspond to the settlement observed in the floor (Photo 18).

Photo 18: Racking of bathroom doorframe in Unit F on the second floor.

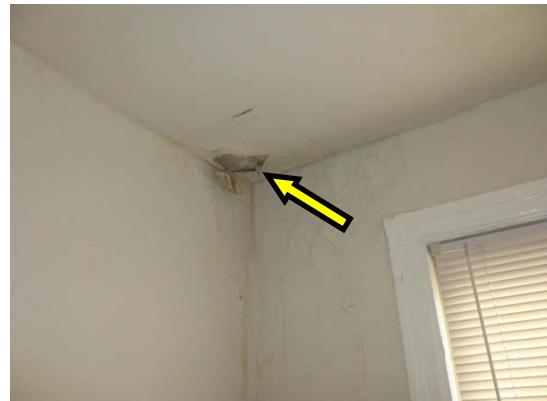
The ceiling of the living room in Unit A appears to have some minor water staining. There is a noticeable sag in the ceiling near the main window; however, it is unclear what is causing this deformation. Water damage and infiltration is evident at the ceiling in the southeast corner of the bedroom. This damage likely stems from a roof leak above (Photo 19).

Photo 19: Water damage at ceiling of bedroom in Unit A at the southeast corner of the second floor

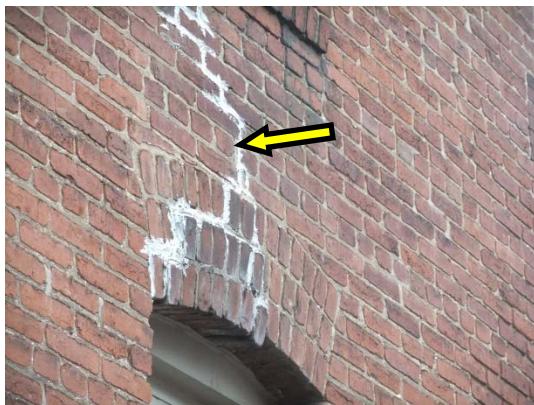
previously repointed using mortar; however, in some instances it appears that caulking was used in an attempt to repair/seal the deteriorating mortar joints (Photo 20). Caulking is not an appropriate repair for deterioration or loss of mortar, because it does not bond properly to the brick material or allow moisture to escape from the wall assembly. This traps moisture within the wall assembly and can result in further damage through expansion and contraction of water during freeze-thaw cycles.

Photo 20: Brick arch at the south façade with displaced brick. Note the white caulking used in an attempt to repair the deteriorated mortar.

5. The south façade of the structure has similar deterioration to that of the west façade. Some brick arches exhibit signs of settlement and brick displacement. In particular the brick arch above the easternmost first floor window on the south façade is exhibiting significant brick displacement. It appears that caulking was used in an attempt to repair this brick arch; however, as stated previously this is not an appropriate repair for this condition (Photo 20).

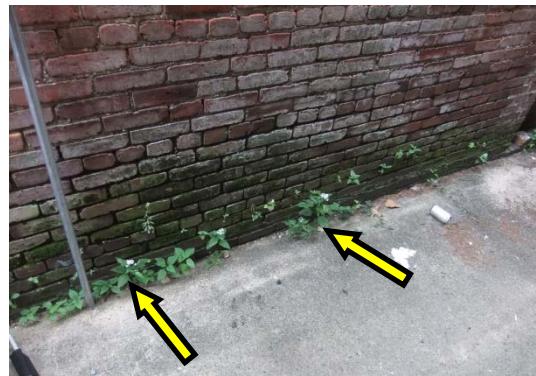
Photo 21: Vegetation growth along the base of the exterior masonry at the west façade.

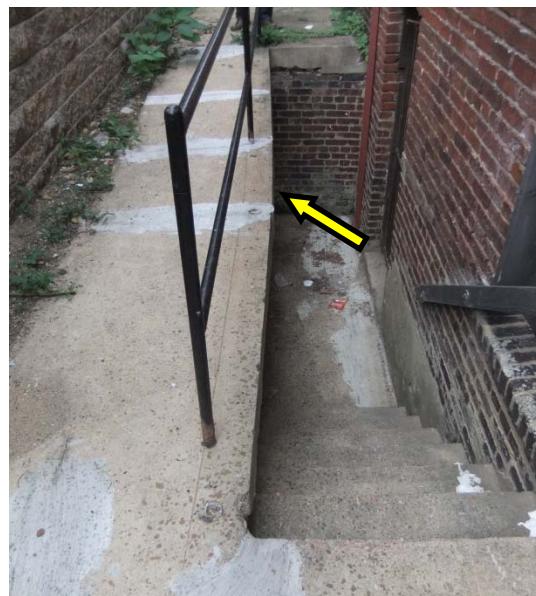
Photo 22: Exterior stairwell at west façade with horizontal bow noticeable in brick retaining wall and exterior slab on grade.

cracks near the mid span of the retaining wall. This bowing and wall cracking is a sign of the wall beginning to fail. Further investigation is required to determine the cause of the failure.

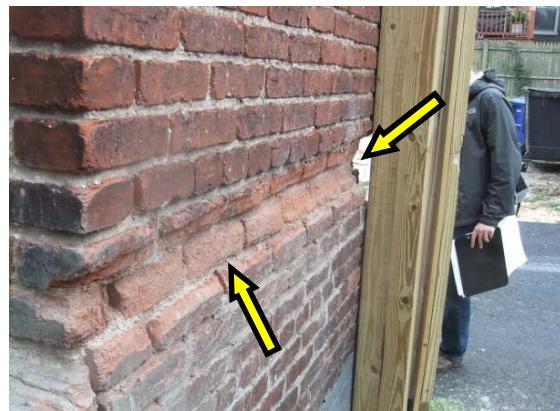
Photo 23: Brick damage at southwest corner of building

4. Brick deterioration and displaced bricks are apparent at the southwest corner of the building. This may be due to vehicular impact or a previously removed structure (Photo 23).

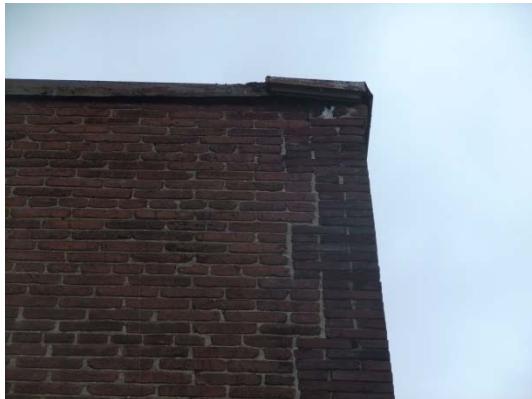
Photo 24: Toothed wall construction at southeast corner of the building, tying the south and east facades together.

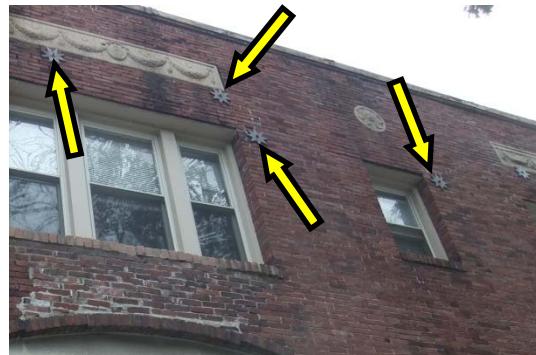
1. Based on the difference in color, the north and east façades of the building appear to be constructed of three-wythe masonry with the outer wythe being a facing brick. Unlike the south and west facades of the building, no header courses are visible at the north and east facades. The two types of wall construction are toothed together at the northwest and southeast corners of the building (Photo 24). Star anchors are visible at several locations on the east façade. Star anchors are most commonly used to tie exterior masonry walls to the interior floor framing to prevent bowing of the wall; however, based on their placement, it appears that these anchors are potentially tying the outermost wythe of masonry (facing brick) to the inner two wythes in the absence

Photo 25: East façade of building showing locations of star anchors.

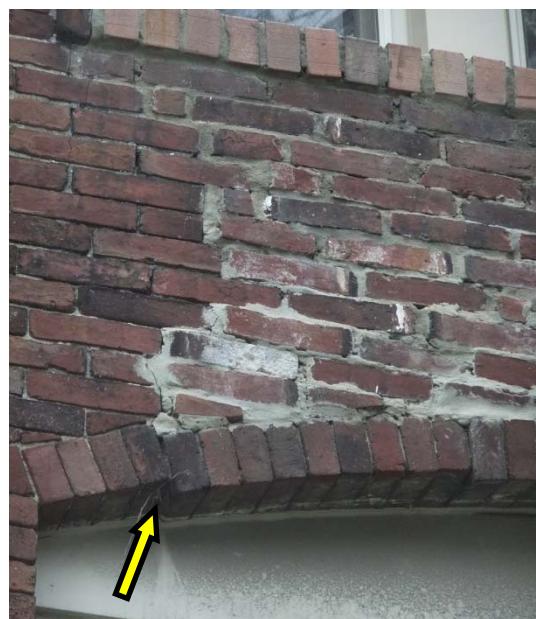
Photo 26: Displaced brick arch with previous repair at the east façade.

2. Mortar loss is visible at various locations along the north and west facades. Once again caulking appears to be used as a repair for the deteriorated mortar joints; however, this is not acceptable. The window openings on the north and east façades are primarily supported by steel lintels; however, single wythe brick arches are used to support the openings above the triple windows at the first floor. Nearly all of these brick arches have brick displacement and arch settlement, and show signs of previous repair work (Photo 26).

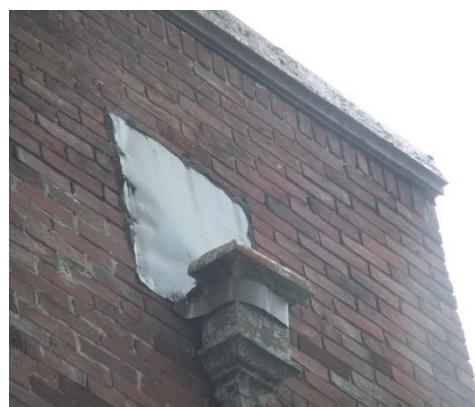
Photo 27: Disconnected drain scupper at northeast corner of the building.

4. A drain scupper appears disconnected at the northeast corner of the building (Photo 27). Since RSA could not access the roof, it is unclear what the current drainage system is on the roof. There is visible vegetation growing in the mortar joints along the north façade, indicating the presence of water and inadequate drainage/water infiltration in the vicinity of these locations.

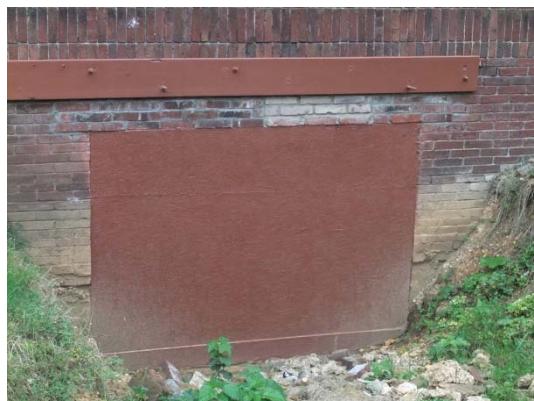
Photo 28: Opening at base of exterior foundation wall along the north façade has been covered with plywood.

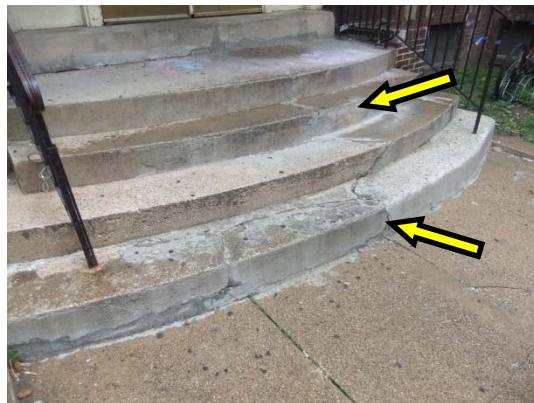
6. The stair concrete stairs leading up to the entry of the building are cracked and spalling. This condition may create a trip hazard for residents and guests entering and leaving the building (Photo 29)

Photo 29: Cracked and spalled concrete on the exterior stairs at the entry to the building.

- Repair and seal leaks in the building envelope and piping that are related to water intrusion.
- Provide surface repair at spalled/cracked concrete steps at entry to prevent trip hazards.

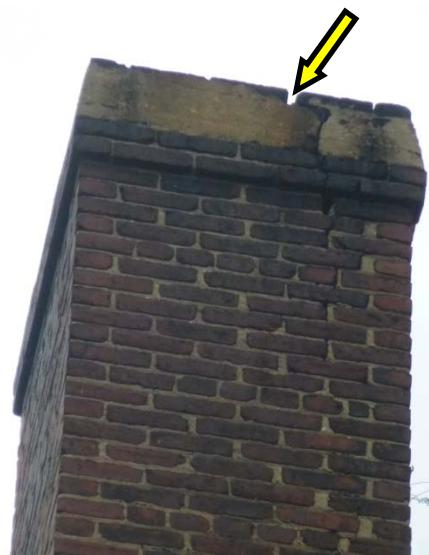
1. A single brick masonry chimney is located midway along the west façade of the building. Mortar loss and loose bricks are visible near the top of the chimney. Parging at the top of the chimney appears to be deteriorated, and cracks are visible through the chimney cap (Photo 30).

Photo 30: Deterioration of parging and cracks through the chimney cap.
