# Capitol Hill Home Inspection, LLC

Confidential - Property Inspection Report - Confidential

5330 42nd St NW, Washington, MD 20015  
Inspection prepared for: Jon Brumer & Diana Kurnite  
Date of Inspection: 10/12/2013 Time: 3.00 pm  
Age of Home: 1925 Size: 1,840 Sq Ft  
Weather: 64 and clear

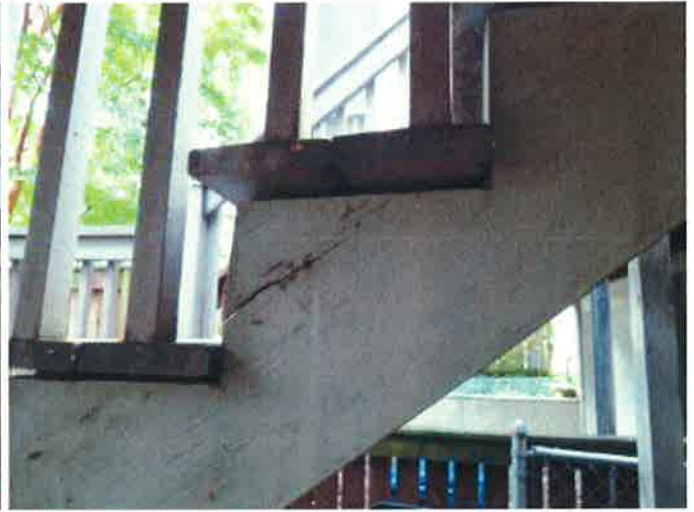
Deteriorated stairs at rear wall.

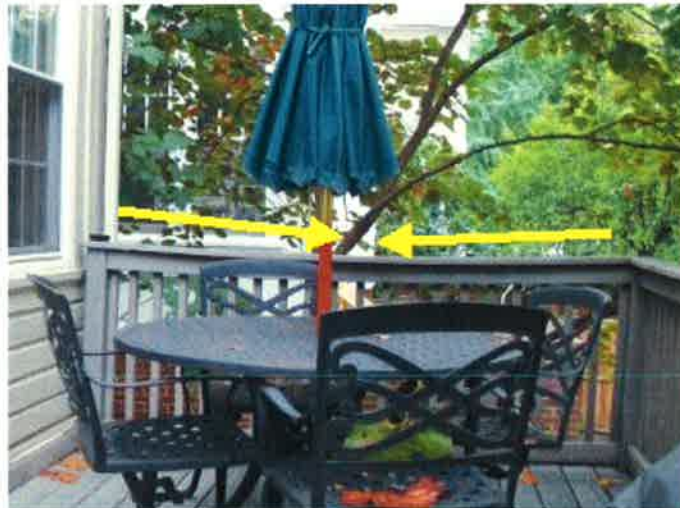
Page 10 Item: 5	Deck	<ul style="list-style-type: none"> <li>• Ledger board at rear deck lacked flashing at the wall. The lack of flashing appeared to contribute to the rotten ledger board. The wood rot makes the deck unsafe. Recommend evaluation by a licensed deck contractor for scope of work required for repair.</li> <li>• Ledger board at rear deck landing was nailed to the wall. Generally, ledger boards are bolted to the wall structure.</li> <li>• Rear deck was twisted and sagging. Recommend monitoring and repairing/replacing in the near future.</li> </ul>
<b>Foundation/Structure</b>		
Page 11 Item: 1	Foundation	<ul style="list-style-type: none"> <li>• A crack was present at basement front wall in the basement mechanical closet. Recommend farther evaluation and repair by a licensed masonry contractor.</li> <li>• Foundation walls were not fully visible at the time of the inspection. Confirm condition with seller.</li> </ul>

sagging rear deck.
