# Exhibit O

July 13, 2015

Re: Structural Concerns in your detached garage

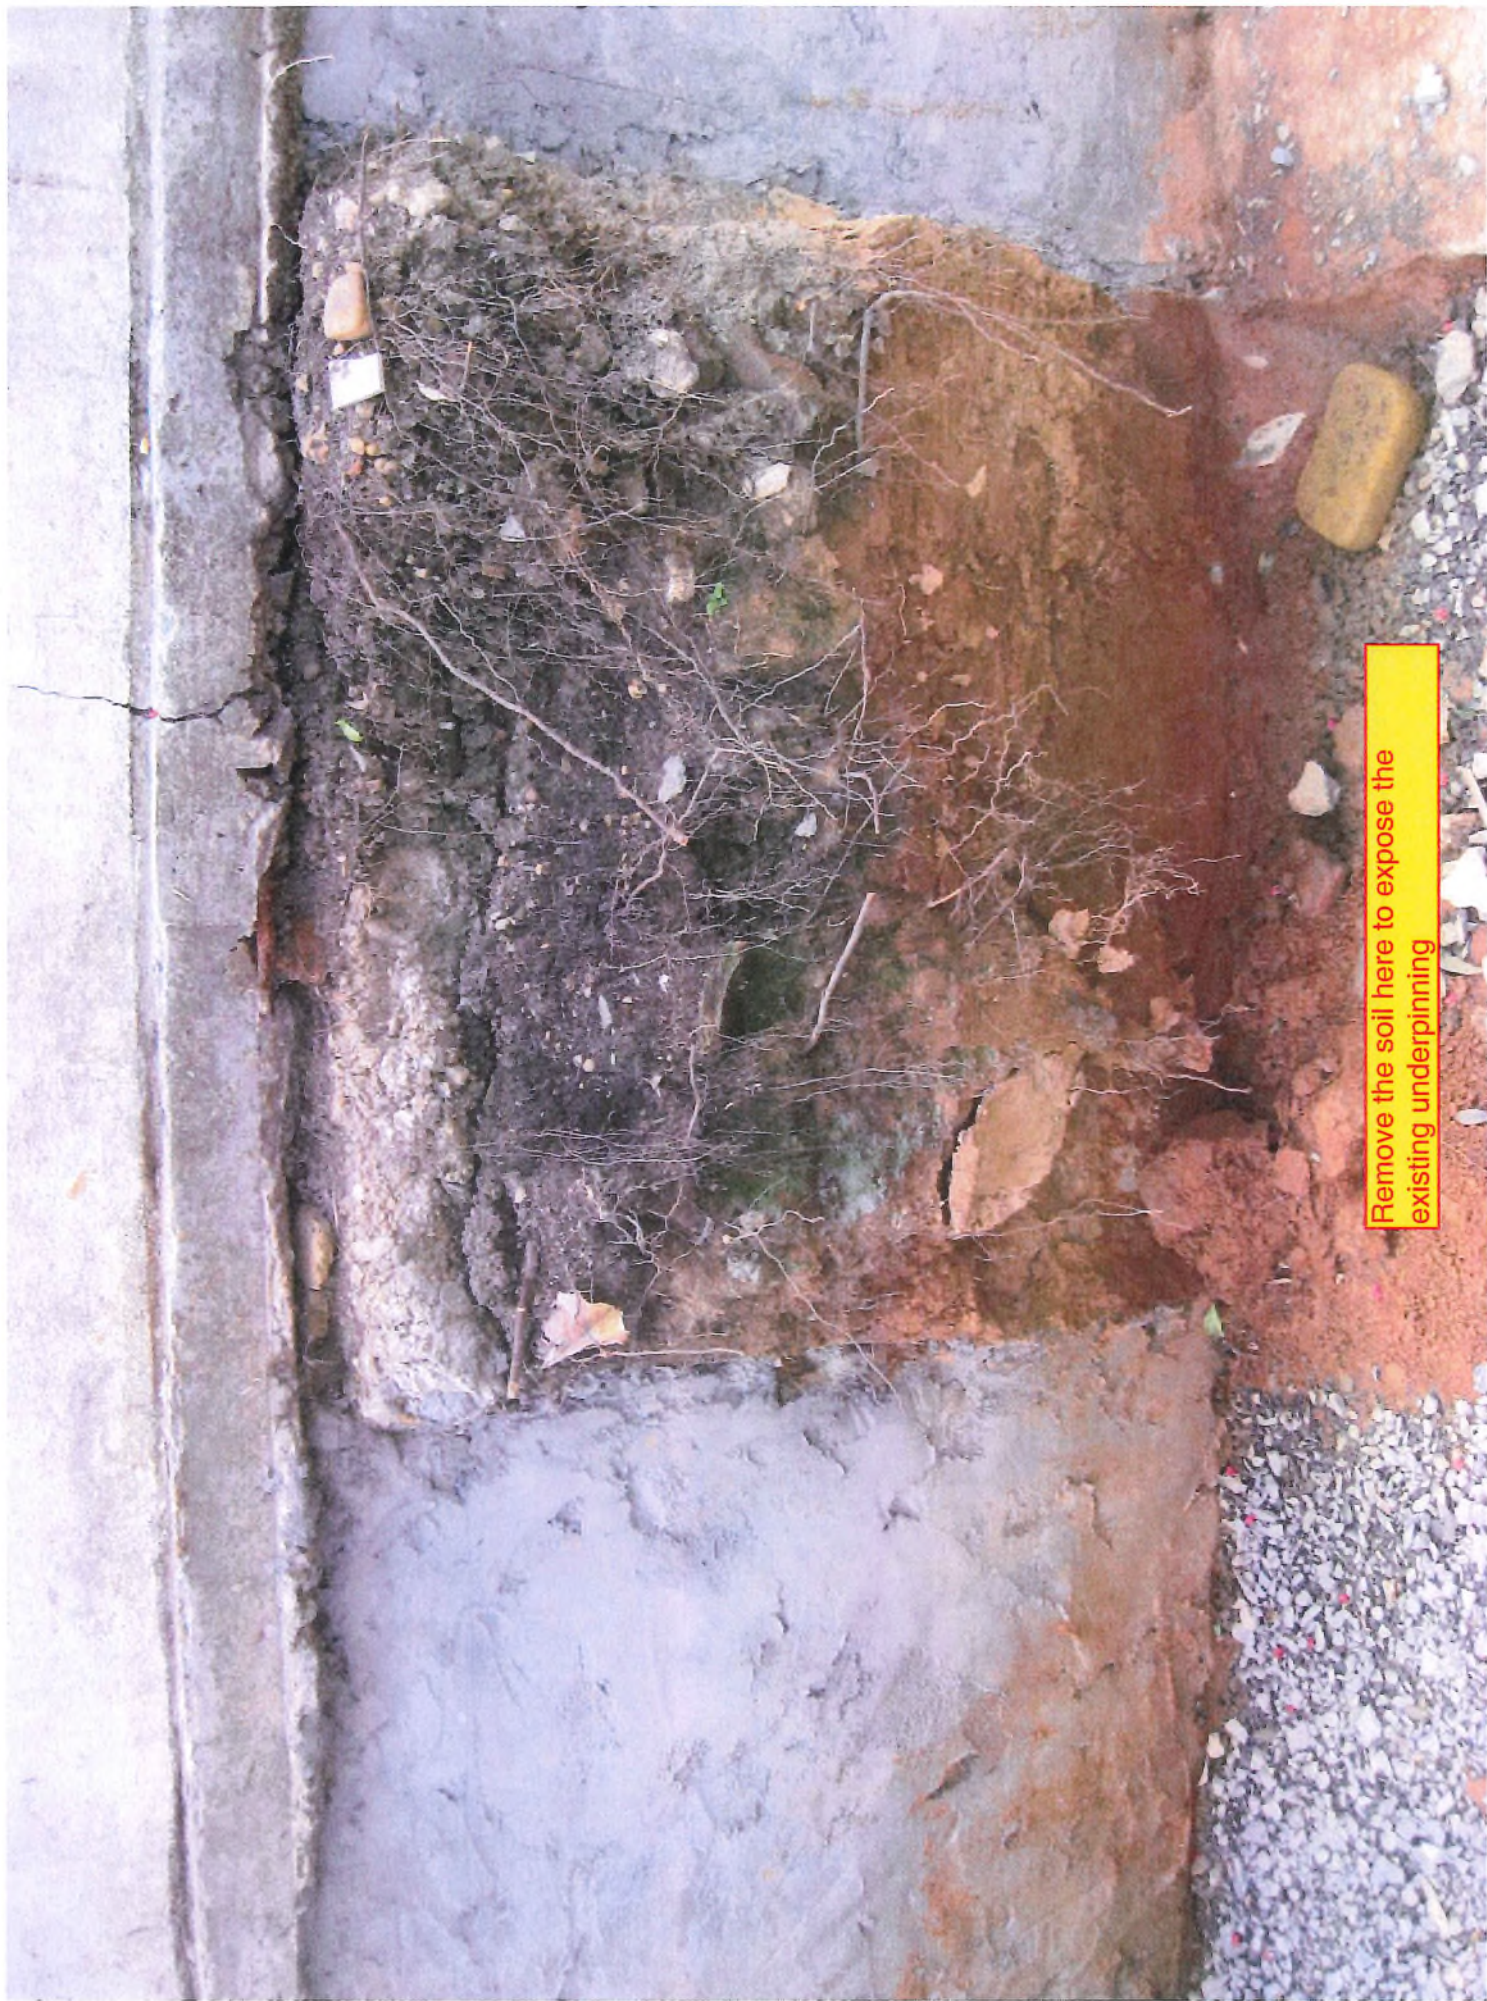
- b. There are three diagonal cracks in the East wall of the garage.
  - c. The top of the East Wall was checked and found to slope  $\frac{3}{4}$ " toward the front of the home.

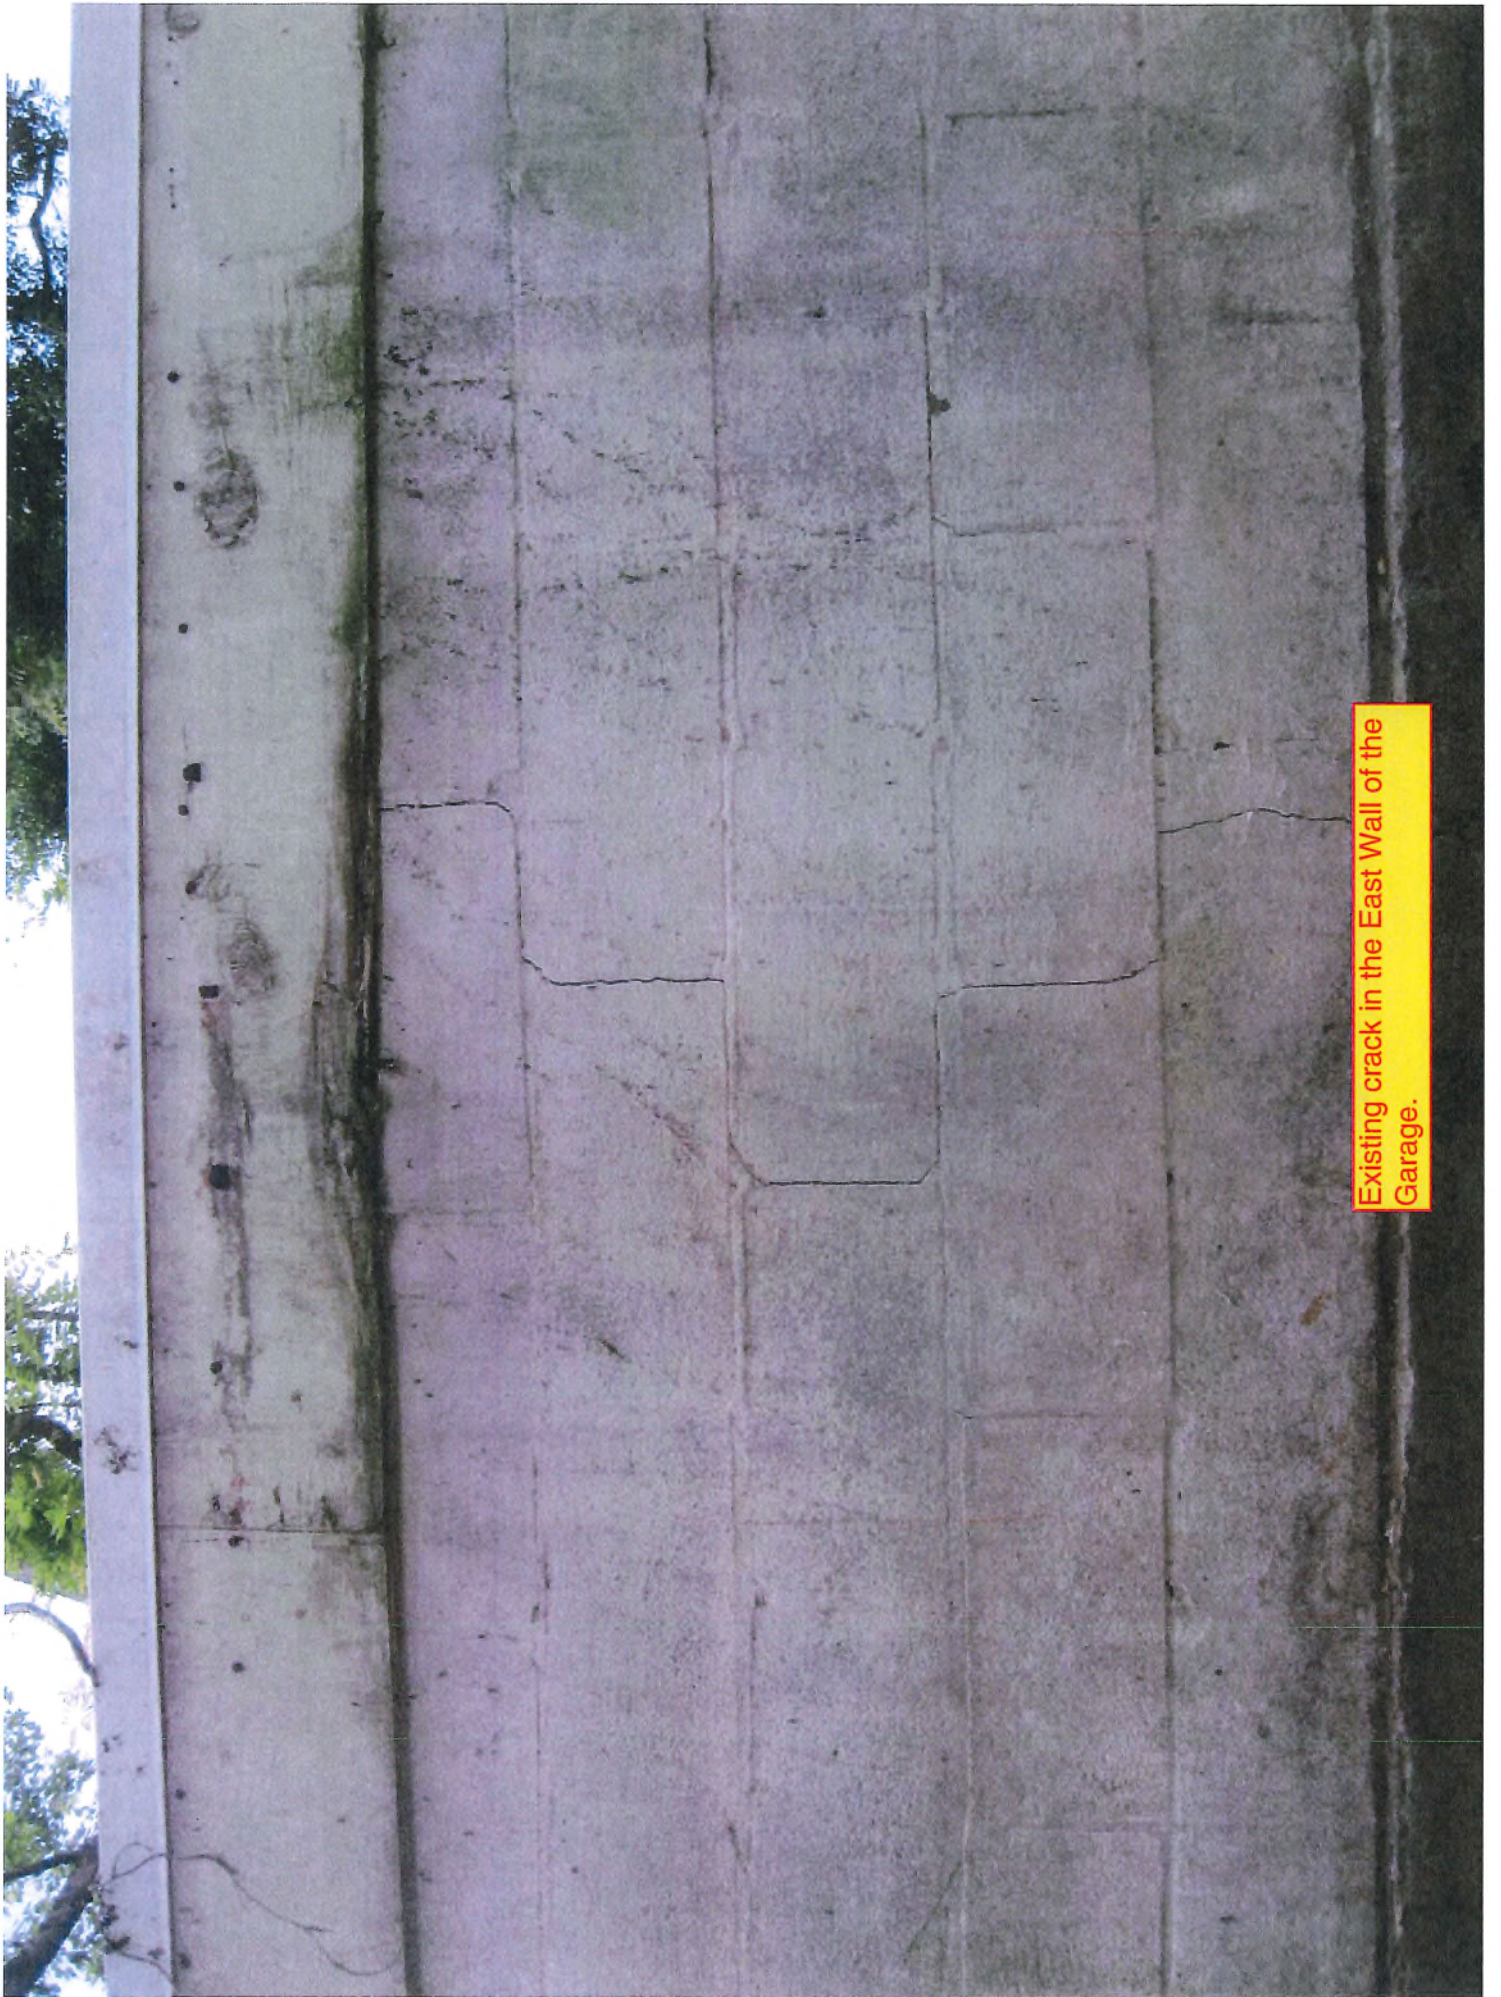
We are of the opinion that the observations listed above indicate that the foundations of the garage have experienced differential settlement. In other words the foundations below the NE corner of the garage has moved downward more than the adjacent walls. We are of the opinion that the foundation settlement observed today is noticeable but has not reached the point where it requires structural repairs. At this time we are of the opinion that the garage is structurally stable in its current condition. We expect the settlement to continue and cause cracking in the walls and cause door jambs to disorient and require adjustment from time to time. Given the use of the structure we would expect you to be able to allow the settlement to continue into the future with little negative impact to the garage.

Existing crack in the East Wall of the Garage.

The cracks in the exterior walls of the garage should be filled with mortar in a process known as tuck pointing and observed over time. This should be done to determine how quickly the foundations of the home are continuing to move and to deter water and insects from entering the garage. You can expect to need to plane and adjust the doors from time to time as part of normal maintenance. If a crack reappears four times, a structural engineering should be hired to determine if the East wall of the garage should be underpinned with helical piers. We are of the opinion that there is a low probability that the East foundation will settle to the point that it requires underpinning in the next 5 years.
