# Town Center Park - West Park

## Report of Current Conditions and Recommendations

Washington, District of Columbia

December 21, 2007

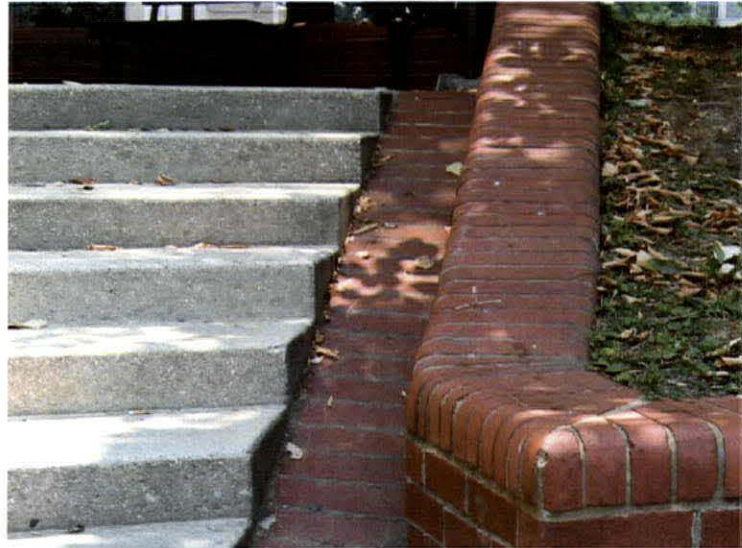
Overall, the hardscape has weathered well. Some design details, such as the runnels along the sides of the steps, continue to function as intended (Fig. 1) – the colored concrete has since faded but is otherwise in good condition. However, a few of the brick retaining walls have suffered extensive damage as a result of tree root growth (Fig. 2). While efforts have been made to repair these walls, the source of the problem, trees planted too close to the walls, persists.

Figure 1  
Brick runnel and concrete steps

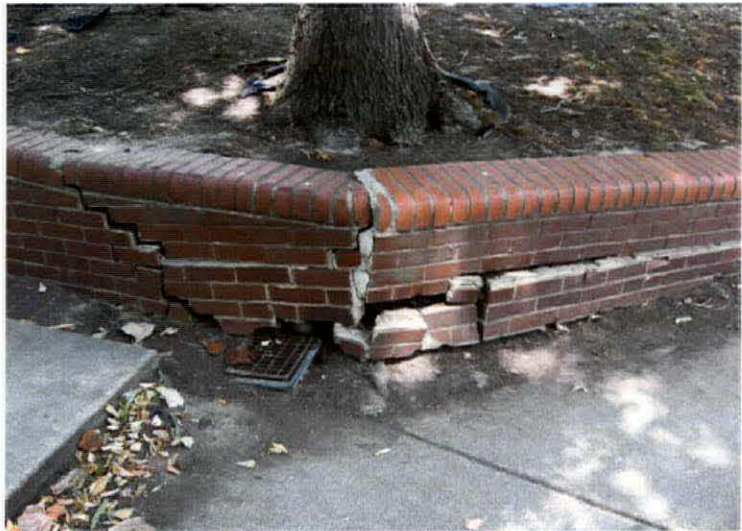
Figure 2  
Damaged brick retaining wall

Recommended improvements to the park's hardscape are mainly limited to the compromised brick retaining walls. Removing trees affecting the walls and replacing the damaged walls would greatly improve the park's appearance. Careful consideration should be made about the quality of the materials and workmanship devoted to correcting the walls. If materials that closely match those existing are not available, then alternative approaches will be required.

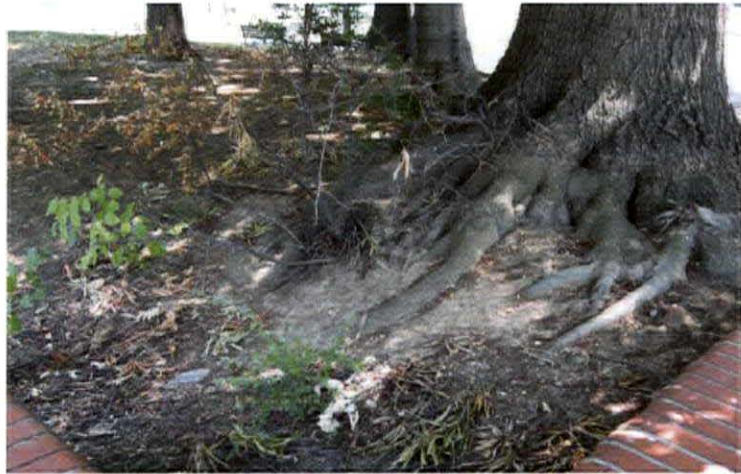
As a result of the tight spacing during installation and lack of subsequent thinning, the park's trees are not fairing well. Though they have grown substantially, many suffer from root binding (Figs. 3 and 4) and all would benefit from professional pruning. Trees closest to the brick retaining walls are compromising the structural integrity and appearance of those walls, as discussed in the previous section. Aside from a few azaleas and other small shrubs, the park features few plants smaller than the large canopy trees – no sign of the multiple layers indicated in the original plans exists today.

Figure 3  
Current conditions of planting

Retaining an arborist to perform an extensive study of the current conditions of the plant material would help determine the health of the existing plants. Removal of some large trees would promote healthier growth in the remaining trees, and strategic pruning would thin the canopy (we suggest removing up to 30% of the existing canopy ), thus allowing other plants and lawn areas to grow in the

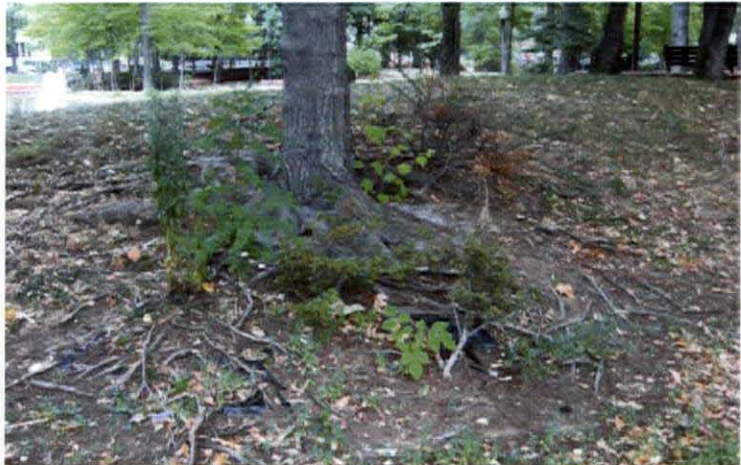
Figure 4  
Current conditions of planting

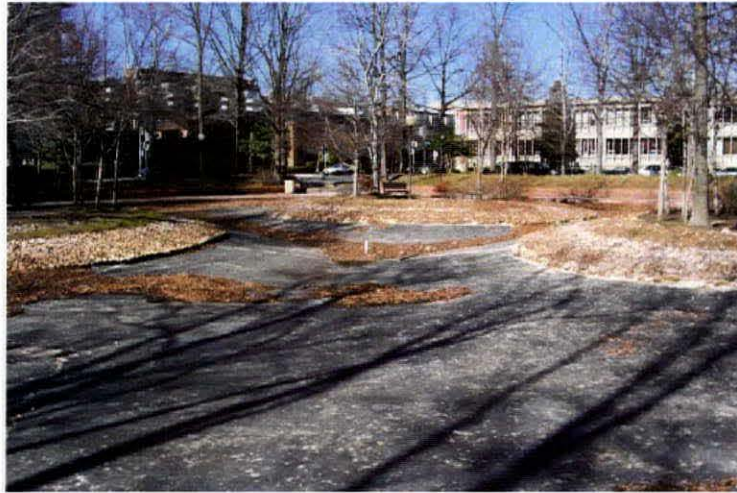
The pond basin appears to be in good condition and the stones embedded in the promontories remain intact (Fig. 6). The four fountain jets (Fig. 7) work but behave erratically, which may be symptomatic of a malfunction in the pump equipment.

Figure 6  
Pond basin - January 2006

Assessment of the age and condition of the fountain equipment and basin would determine the extent of repairs, if any, the pond might need to serve for the long term. At the very least, the fountain jets should be better coordinated and the basin inspected for any possible defects.

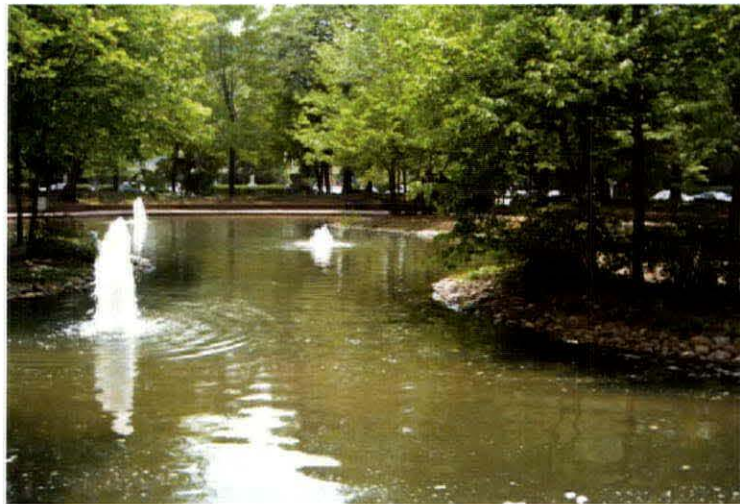
Figure 7  
Pond with fountains - June 2007

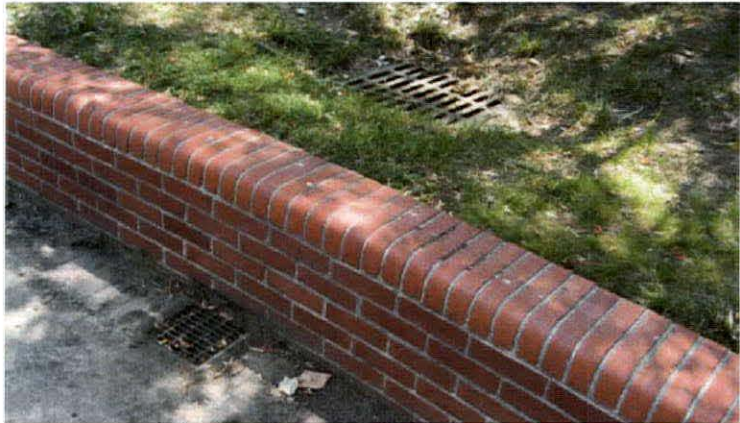
Due to the lack of available utility information, WRT could only evaluate the visible appearance of the park's infrastructure. An obvious concern for the park is its drainage. Many area drains were surrounded by dirt and debris, which is both aesthetically unappealing and indicative of drainage problems (Fig. 9). NPS standard pole-mounted lights have taken the place of the original fixtures (Fig. 10). A nighttime inspection of the park lighting was not performed for this report, so current lighting may not adequately illuminate all areas of the park.

Figure 9  
Area drain surrounded by dirt and debris

Both the lighting and drainage systems need to be properly inspected to make sure they are functioning correctly. The drainage system should be cleaned out and renovated where required. At a minimum, any existing light fixtures that do not work should be replaced. A full lighting study should be performed to make sure that all areas of the park are adequately illuminated. New light poles and fixtures that relate to site furnishing requirements of the proposed AWI Transportation Architecture Design Standards should also be considered.

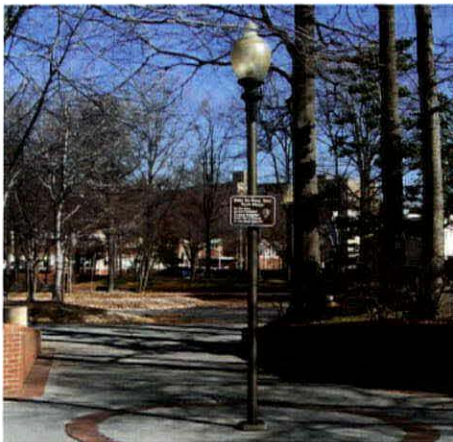
Figure 10  
Current pole-mounted lights

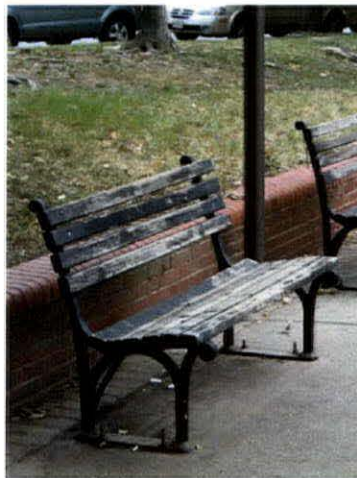
Almost all of the original site furnishings in the park have been removed or replaced. The custom timber benches have been substituted with standard NPS site furnishings (Fig. 12), and all of the original play structures have been removed. A nondescript plastic and aluminum slide (Fig. 13) has taken the place of the slide once located at the southeast corner of the park while nothing was put in place of the ship's wheel that used to occupy the northeast alcove. Though the water fountain remains, it is no longer functional. Only the concrete trash receptacles continue to be used as designed.

Figure 12  
Current bench

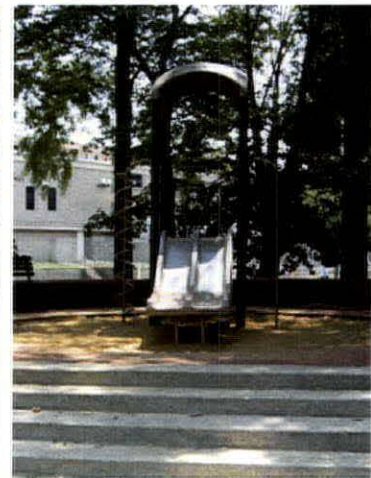
Figure 13  
Current play structure

Though the standard NPS site furnishings make the park less distinctive, they do not detract from the character of the space. The lone play structure, however, has an ad hoc quality that is not appropriate for the park. Any improvements to the park should include new play equipment because neither of the other two parks features any. Also, children were observed playing on the slide during WRT's second site visit, so there appears to be

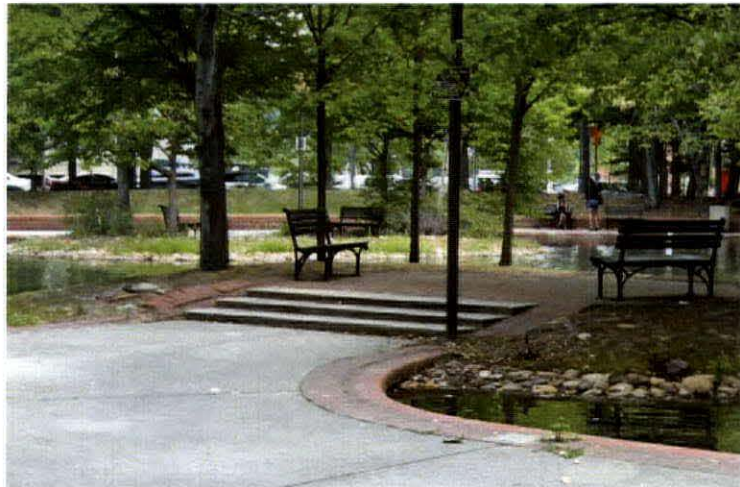
West Park's three access points connect to the primary circular promenade that surrounds the pond. Although most of the park is accessible, there are several instances to the contrary – steps up to the southeast space and the west promontory (Fig. 18), the stepped ramp at the northwest corner and steps down to the east promontory.

Figure 18  
Steps up to west promontory

It would be to the detriment of the park if the identified areas were retrofitted so as to make them universally accessible. Still, the addition of handrails to the steps could be useful for visitors. The three existing entrances function well, but an additional entry through the northeast alcove should be considered. Currently, this area, with its high retaining walls, large trees and lack of site furniture, is inhospitable and neglected (Fig. 19). Opening up the space and installing a play sculpture would make it more welcoming and attractive. Given West Park's small scale, every area should present visitors with an opportunity to enjoy the park.
