WILLIAMSBURG ENVIRONMENTAL GROUP, INC.

Re: **Tree Evaluation**  
**Canal Parc, Washington, DC**  
WEG Project # 3424B

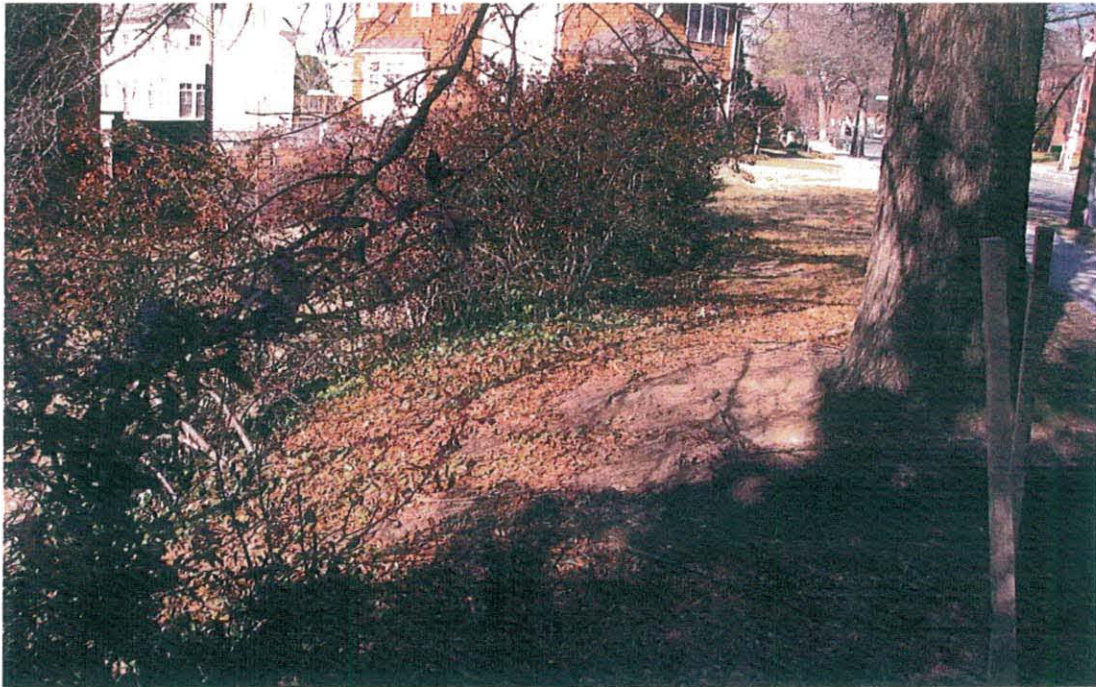
Based on the proximity of proposed development, the likelihood of survival for these trees following construction activities is very low. Based on construction plans, it is estimated that over 50 percent of each of these trees root zones will be impacted by construction. Although willow oaks are fairly tolerant to disturbance, such significant loss in rooting area will greatly impact the health and survivability of these stems. Excavation and fill activities are proposed to occur within such close proximity to the subject trees that root and crown damage will be unavoidable. It is anticipated that up to 6 feet of fill may be placed behind these trees to alleviate the existing steep grade. Damaging impacts to roots associated with this amount of fill may include soil compaction, decreasing the roots ability to take in nutrients and water, potentially resulting in stem mortality. The most significant impact associated with excavation and construction around the base of the subject trees is severed roots. Due to the proximity of excavation, it is anticipated that a significant amount of structural roots over 3 inches in diameter will be severed, resulting in immediate impact to the structural integrity of the trees and a significant increase in hazard potential.

**Photograph 1** – Photo depicting grade proposed to be filled behind Trees 1-3. Up to 6 feet of fill may be required in some areas.

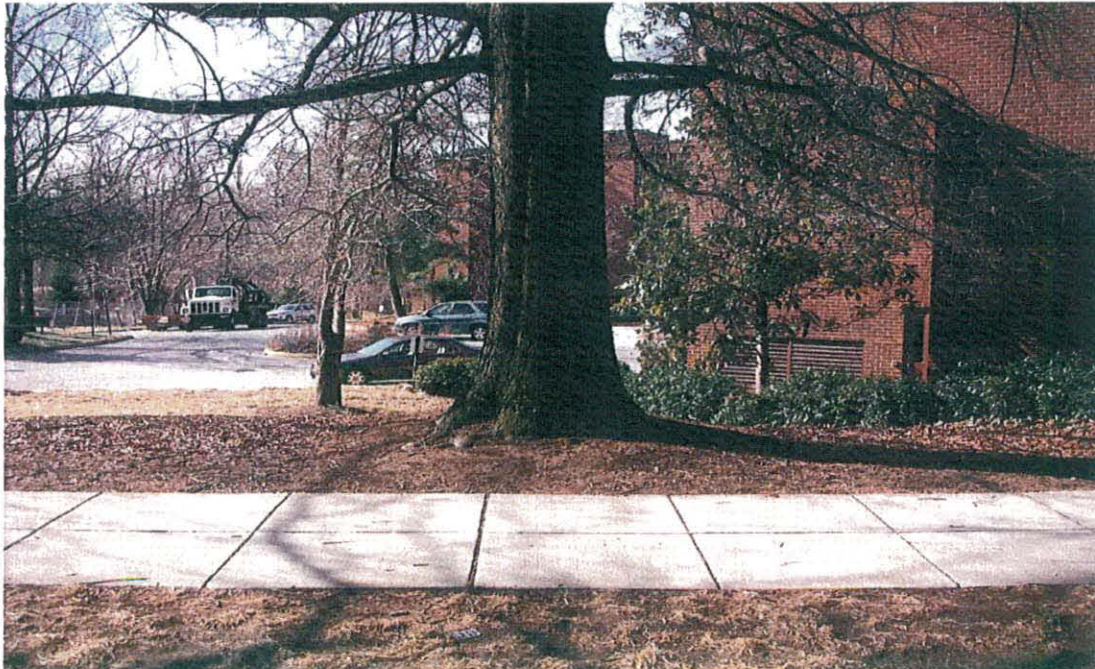
**Photograph 2** – Photo depicting proximity of existing sidewalk to Tree 1. Existing sidewalk is also within close proximity to Trees 2 and 3. Existing underground utilities are present under the sidewalk.

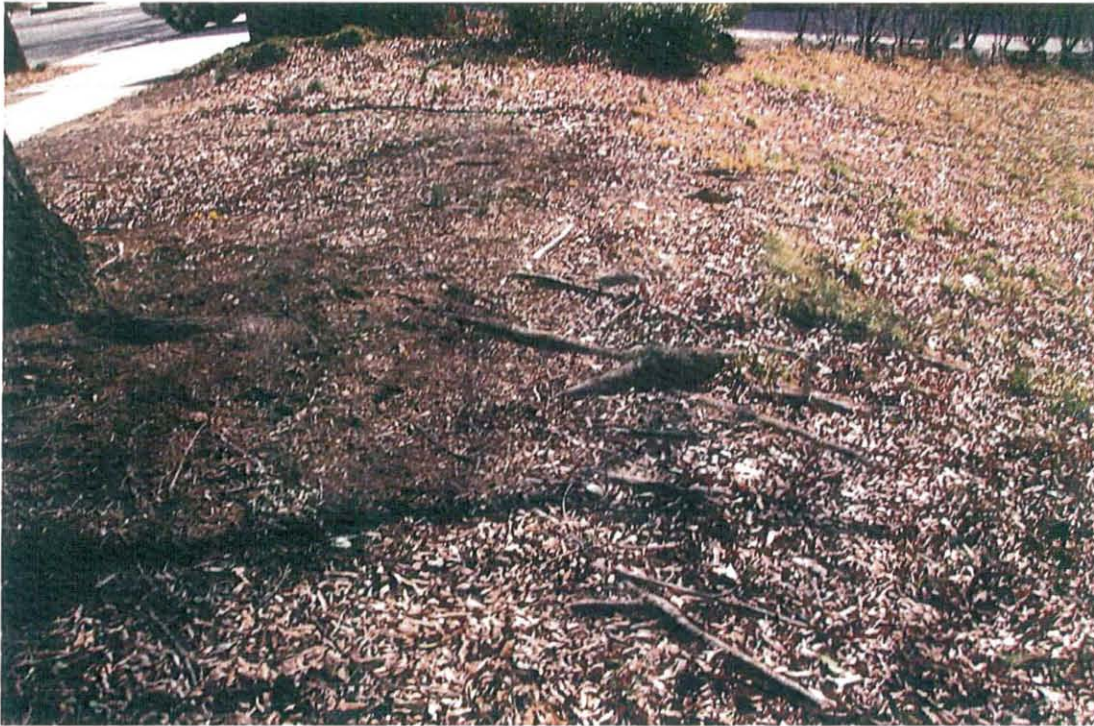
This stem is being affected by girdling roots which can constrict not only the growth of the stem, but flow of water and nutrients through its cambium layer. These roots are of small diameter, but if left untreated will increase in size and may cause irreparable damage to the stem. Girdling roots are often associated with trees that were not planted properly and/or planted in urban environments with rooting obstructions. It is estimated that up to 40 percent of this tree's surface roots are exposed and showing signs of anthropogenic, as well as mechanical damage. These exposed roots can become a conduit for fungal based tree diseases. Further up the main stem of the tree, wounds from previous pruning operations were observed. All of the subject trees have been historically maintained through pruning due to their close proximity to the sidewalk which receives heavy pedestrian traffic and the presence of overhead utilities. Some of these pruning wounds have not properly healed, resulting in callus wood growth and poor compartmentalization. Within the crown of this tree, large deadwood was observed within scaffold branches, some of which is currently overhanging the sidewalk, public parking area, and a portion of MacArthur Boulevard as depicted in

**Photograph 3** – Exposed roots associated with Tree 1.

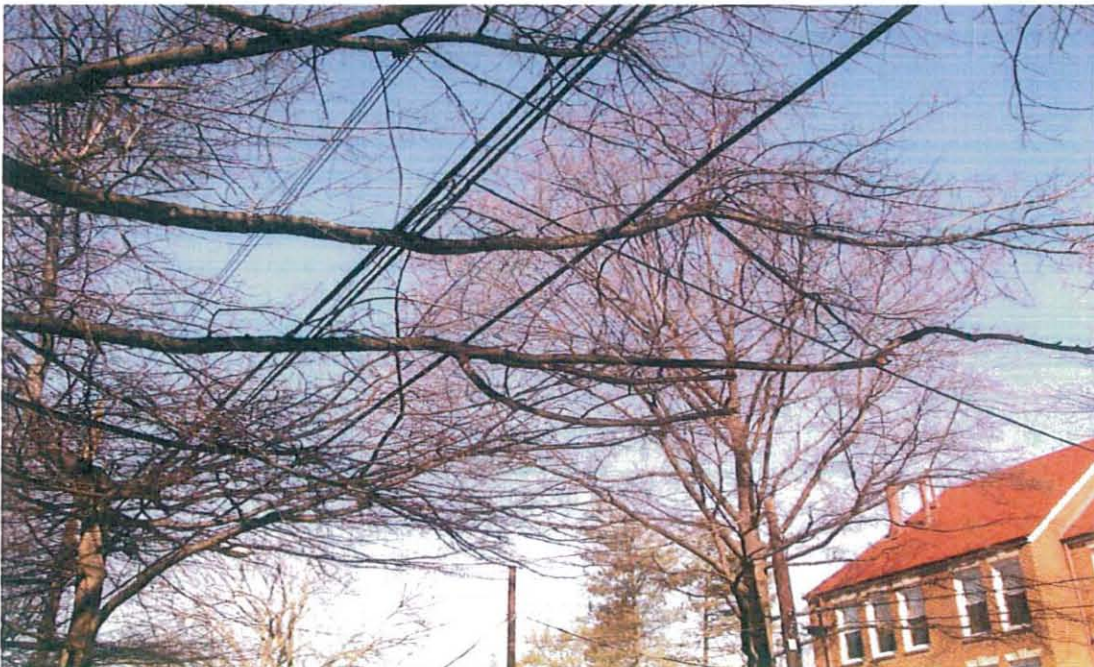
Photograph 4 (see attached Photo Layout). Smaller diameter deadwood and broken limbs are also present within the crown. This is typical of self-pruning species such as willow oaks.

**Photograph 4** – Large deadwood in scaffold branches of Tree 1 (lower branch) overhanging sidewalk and MacArthur Boulevard. Note overhead utilities in crown of tree.

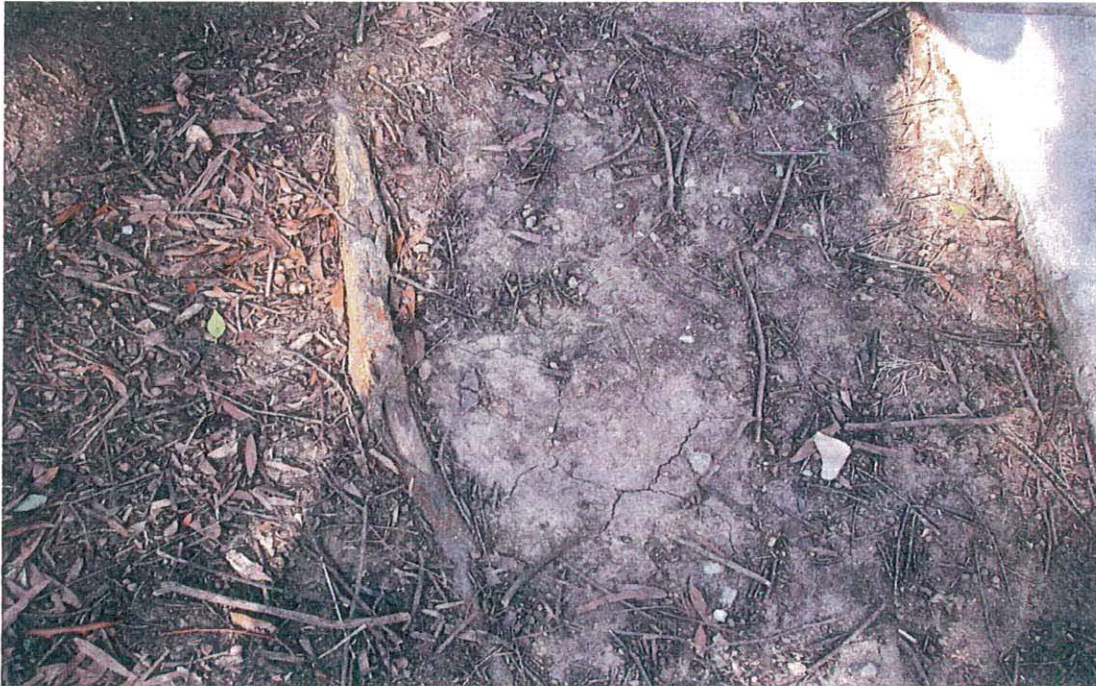
This tree contains a small amount of exposed surface roots, some of which have been damaged either by mechanical or anthropogenic means, and show signs of decay. The presence of decay is evident through the presence of fungal growth as noted in Photograph 5. Further up the main stem, pruning wounds are present that have not healed properly and contain poorly compartmentalized wood. Large deadwood as well as smaller diameter deadwood and broken limbs are present within the crown of this tree. It is believed that this deadwood is associated to the stems nature of self pruning.

**Photograph 5** – Damage of exposed root associated with Tree 2. Note orange-colored fungus on root which may signify decay.

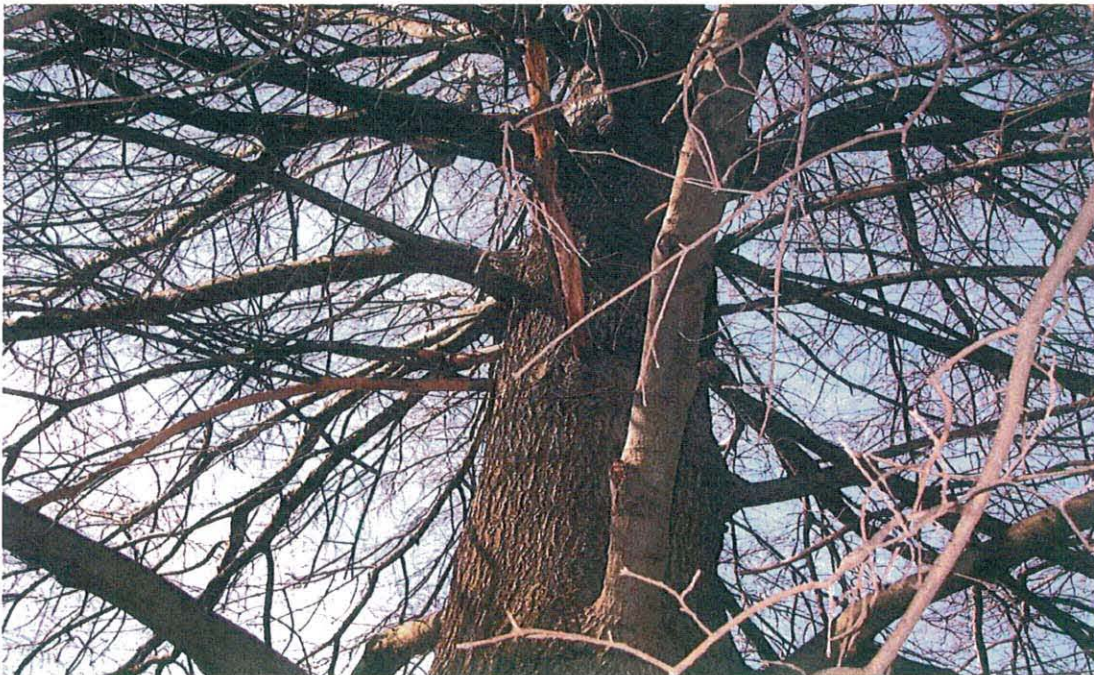
**Photograph 6** – Large and smaller diameter deadwood present within the crown of Tree 2.

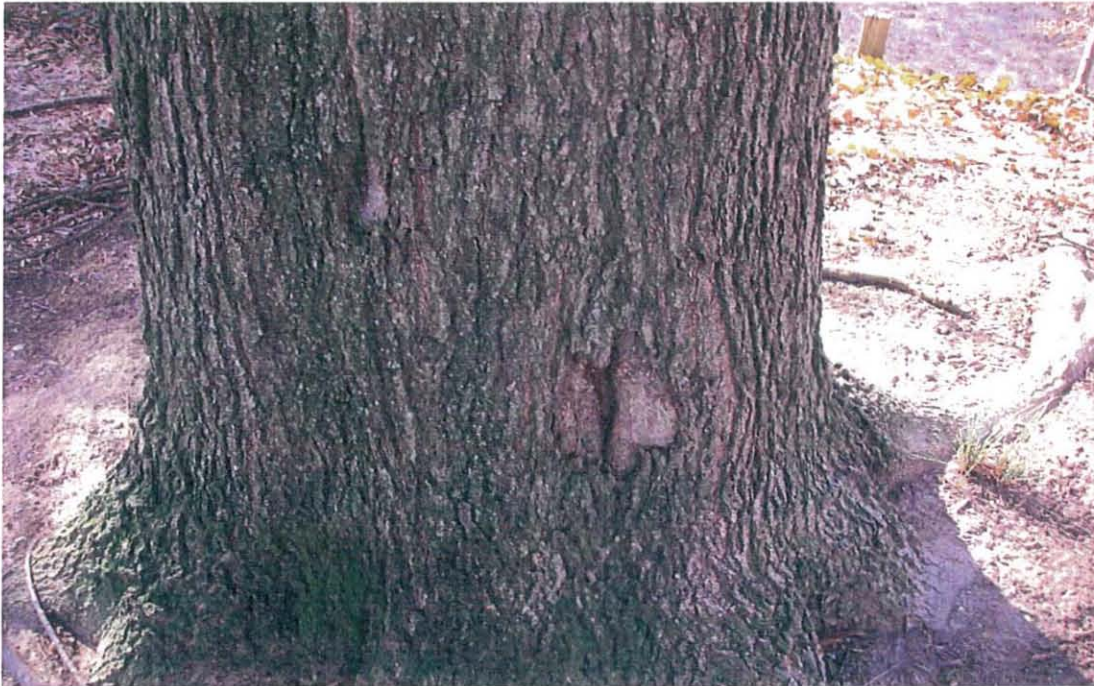
This tree also contains a small amount of exposed surface roots and has smaller diameter girdling roots present at its base. There are trunk wounds present at the base of the main stem of this tree that have not completely sealed with callus growth as depicted in Photograph 7 and there is deadwood present within the main stem. Like the other trees, pruning wounds are present that contain deadwood. Smaller diameter deadwood and broken limbs are present within the crown of this tree.

**Photograph 7** – Trunk wound on base of Tree 3. Note opening between callus growth which may serve as an entry point for disease causing organisms. Deadwood is present inside of this wound.

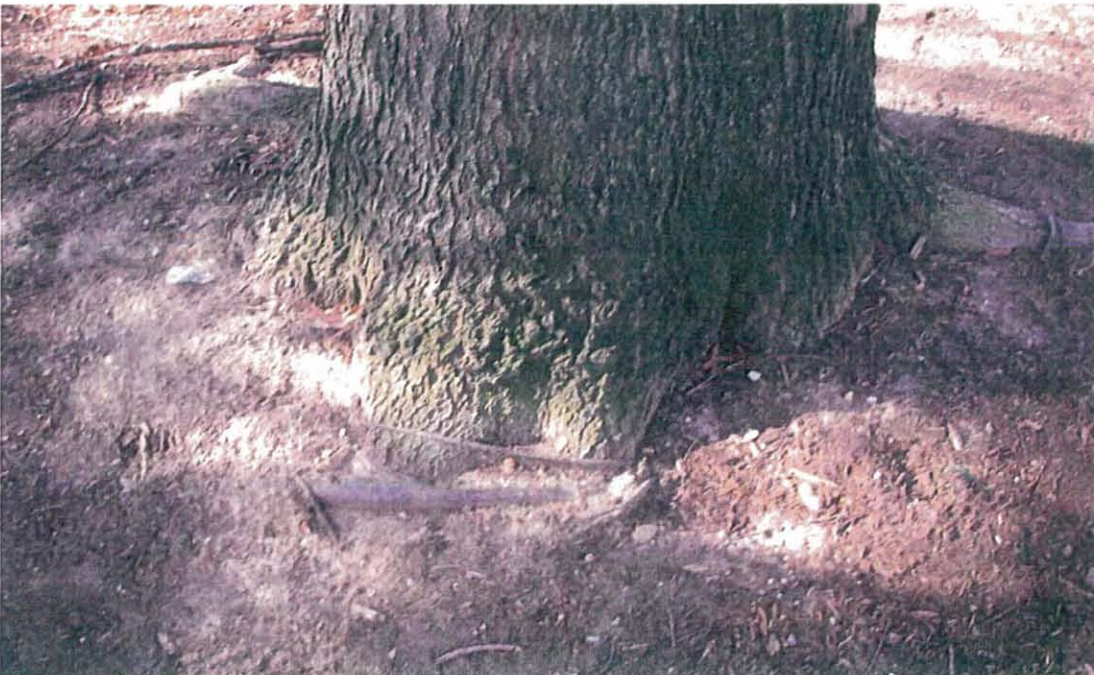
**Photograph 8** – Exposed girdling root at the base of Tree 3.
