# Diagram of "Exterior Wall "3" - 4825 Dexter Terrace, NW

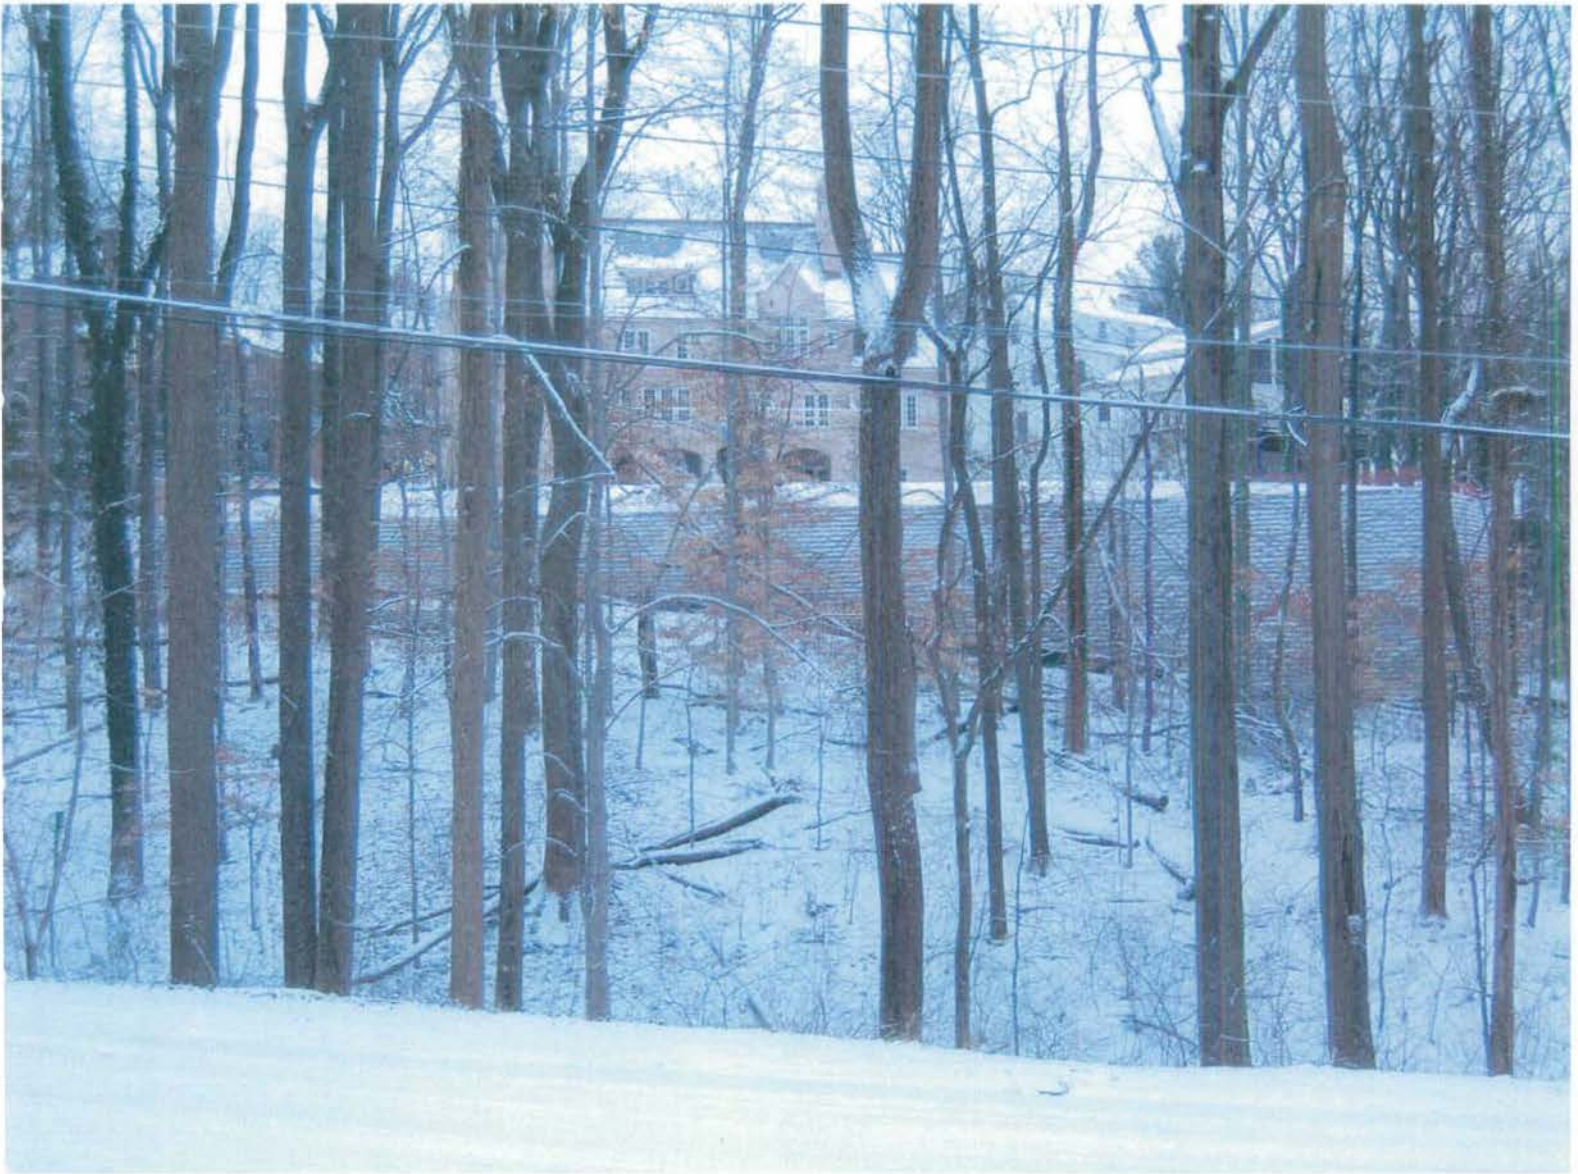
View of Economides Walled Platform Structure  
and new house, as seen from Appellant's  
property in winter.

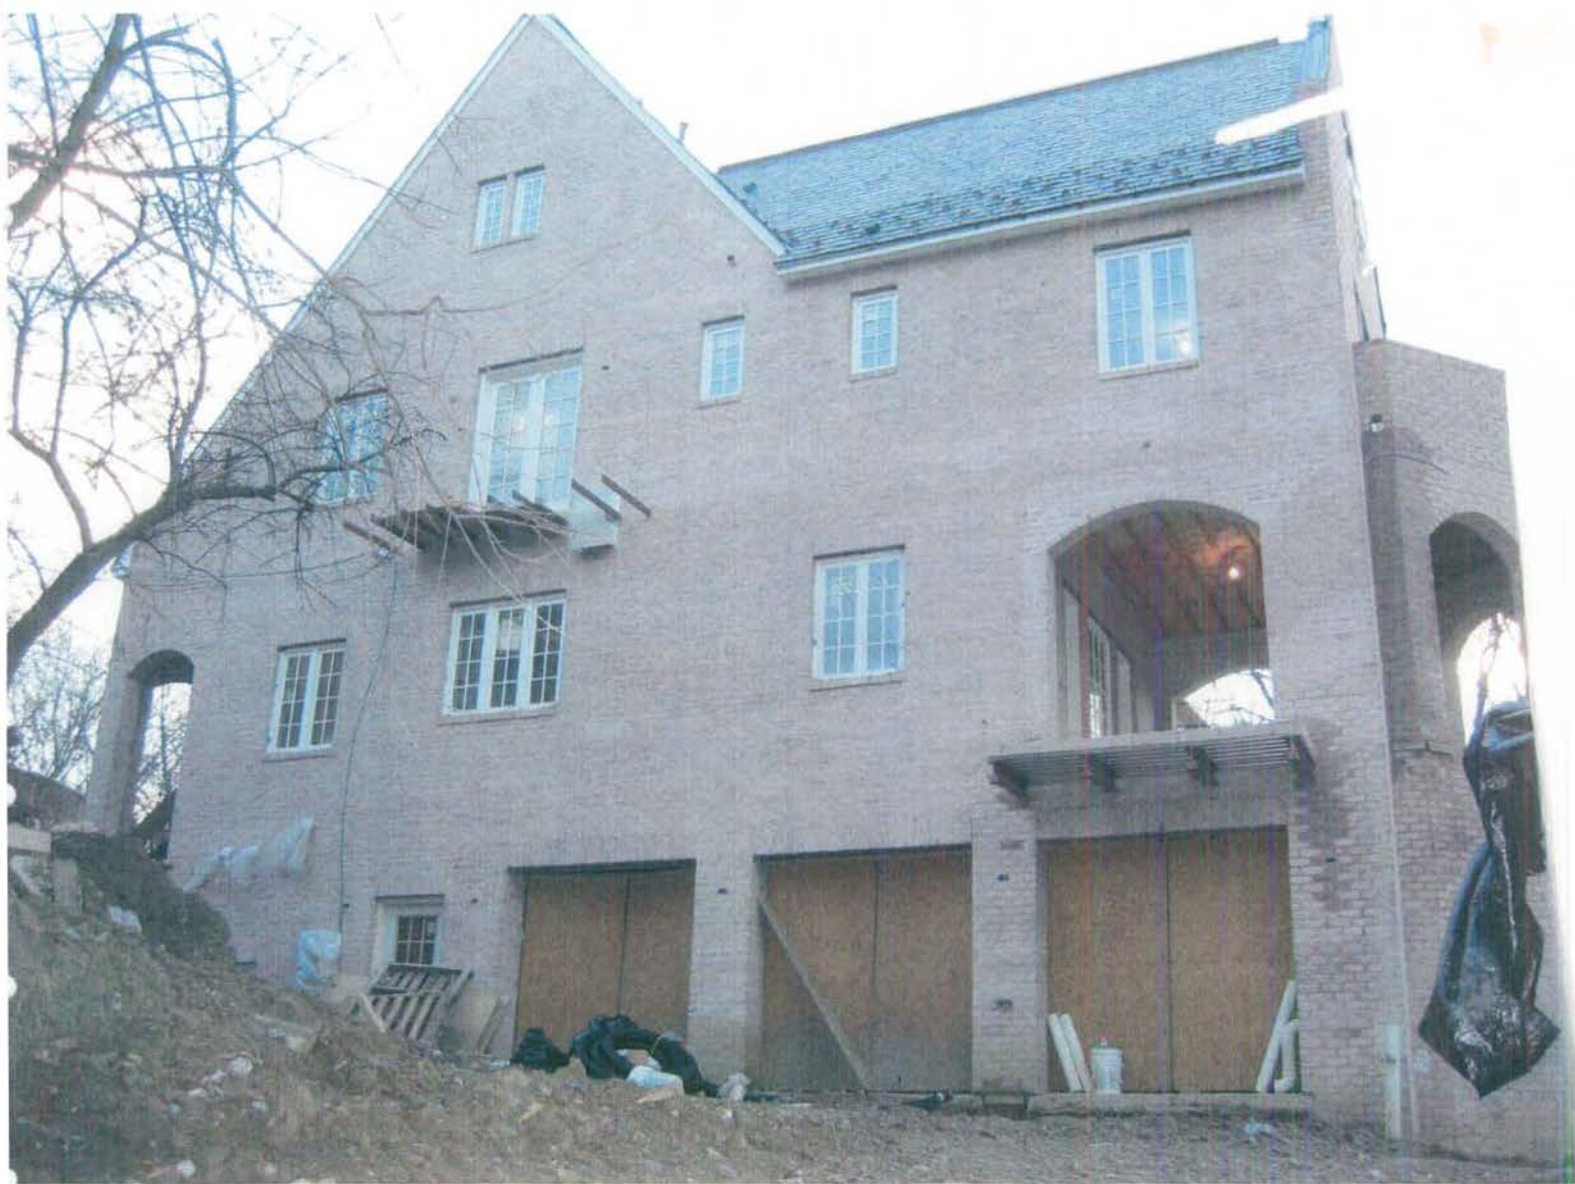
View of new house from its east side

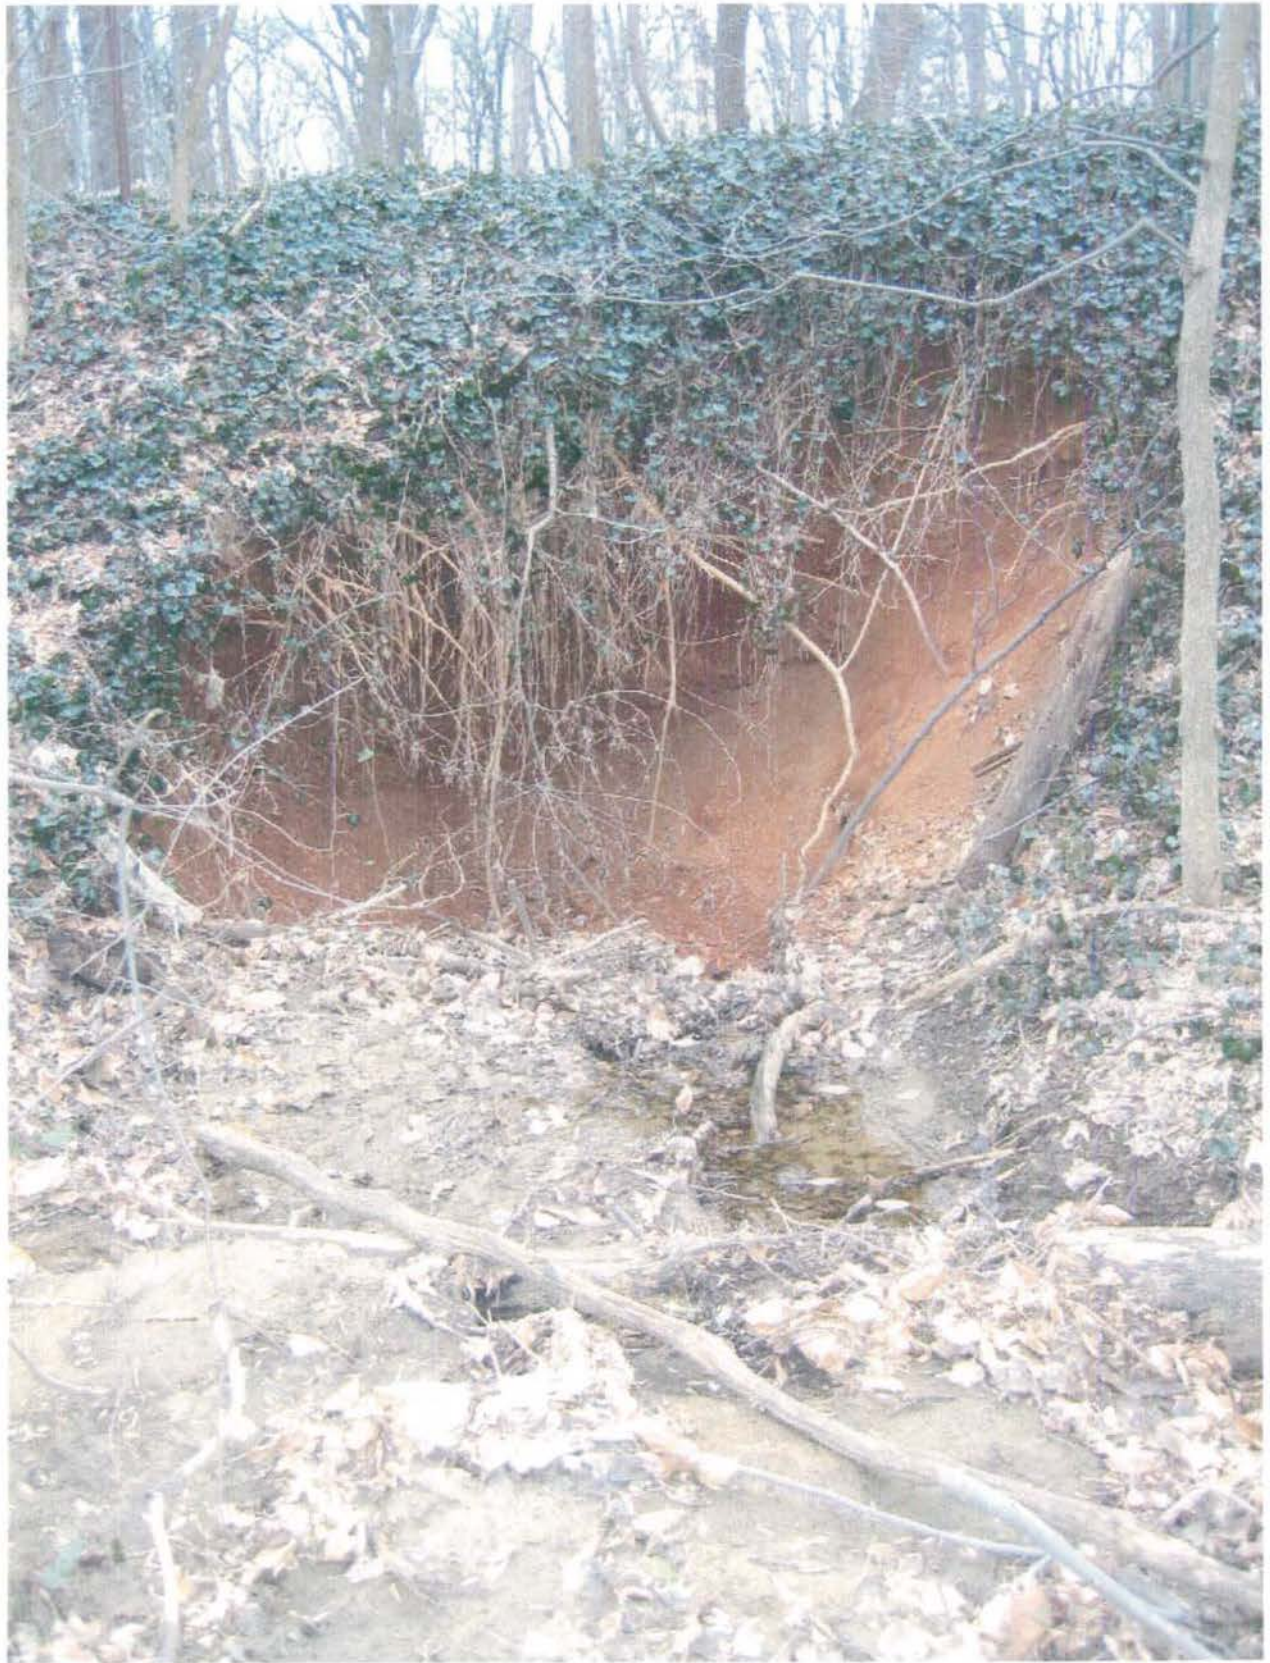
2-13-05- Collapsing tunnel that takes stream under  
49th St., N.W., from Wesley Heights Park  
to Battery Kimble Park - resulting from mud and  
silt flows from Economides wall structure.

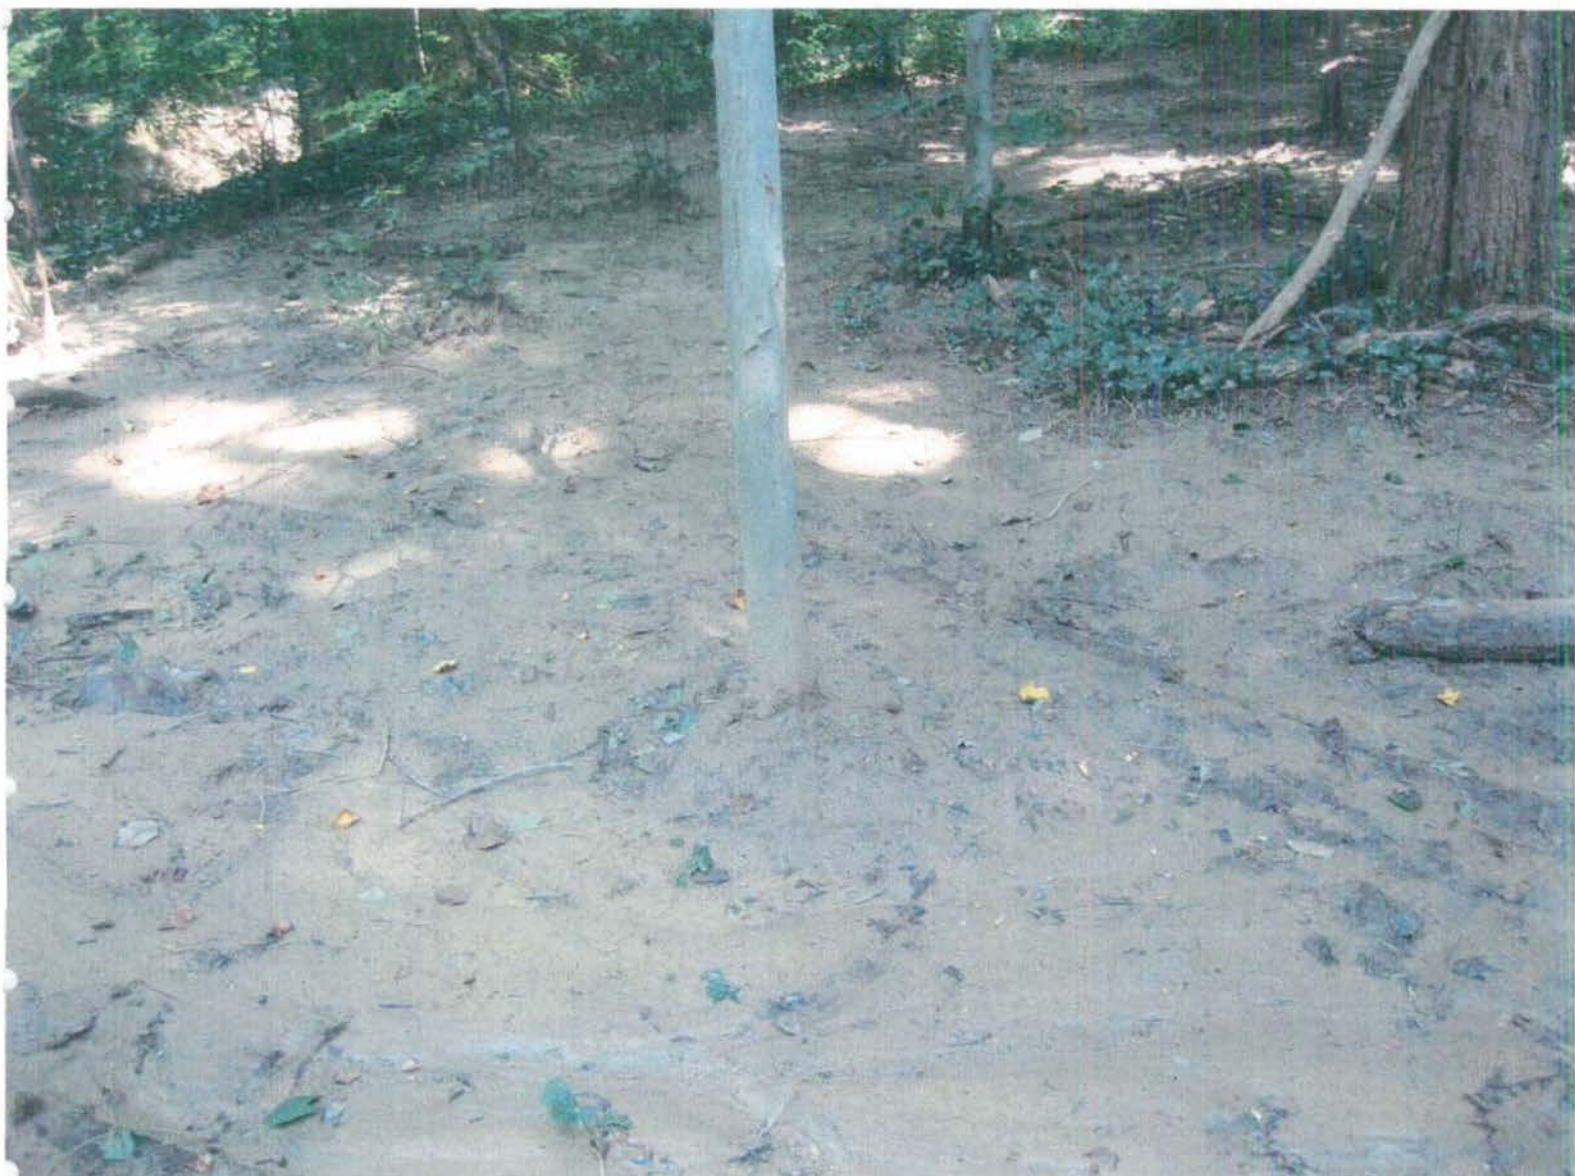
Damage in Wesley Heights Park from silt flowing  
from Economides' Walled Platform Structure.

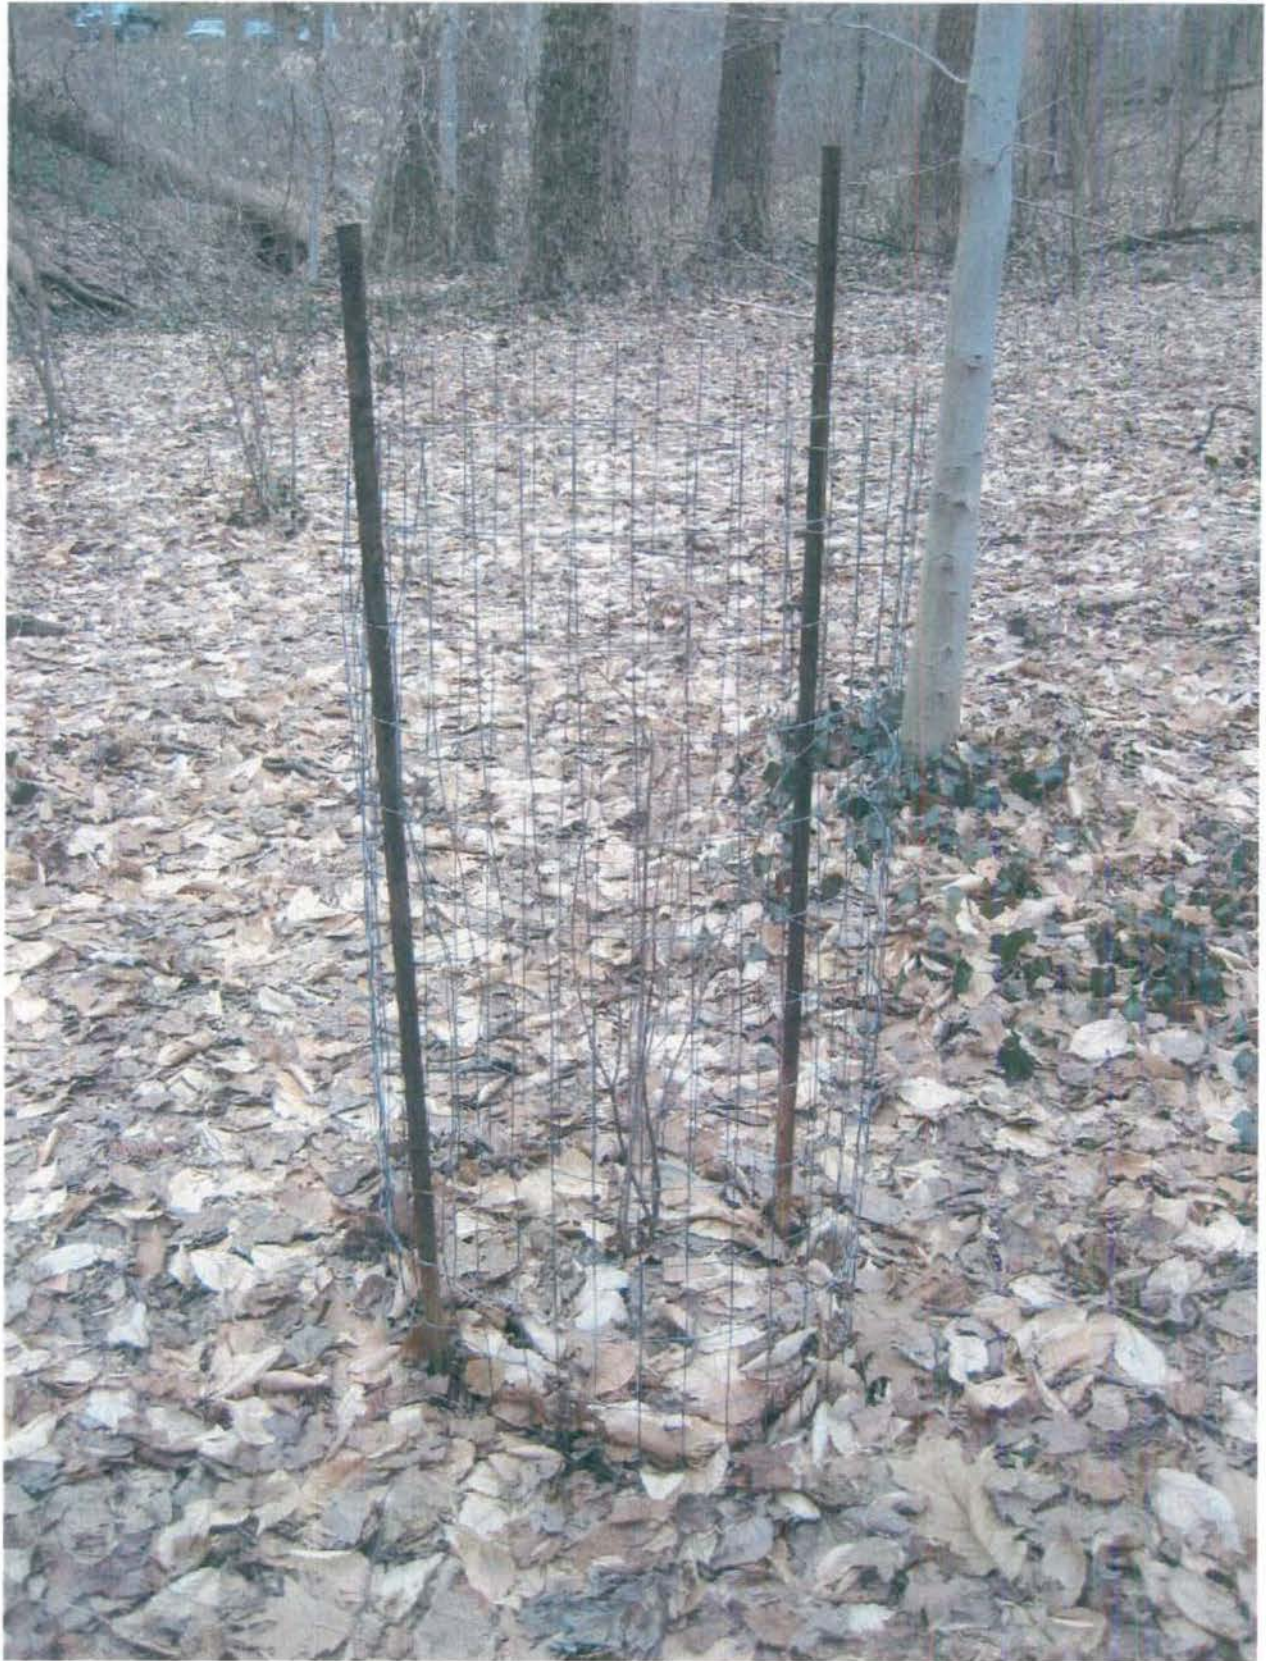
Special fencing erected to try to protect young trees swamped by silt damage

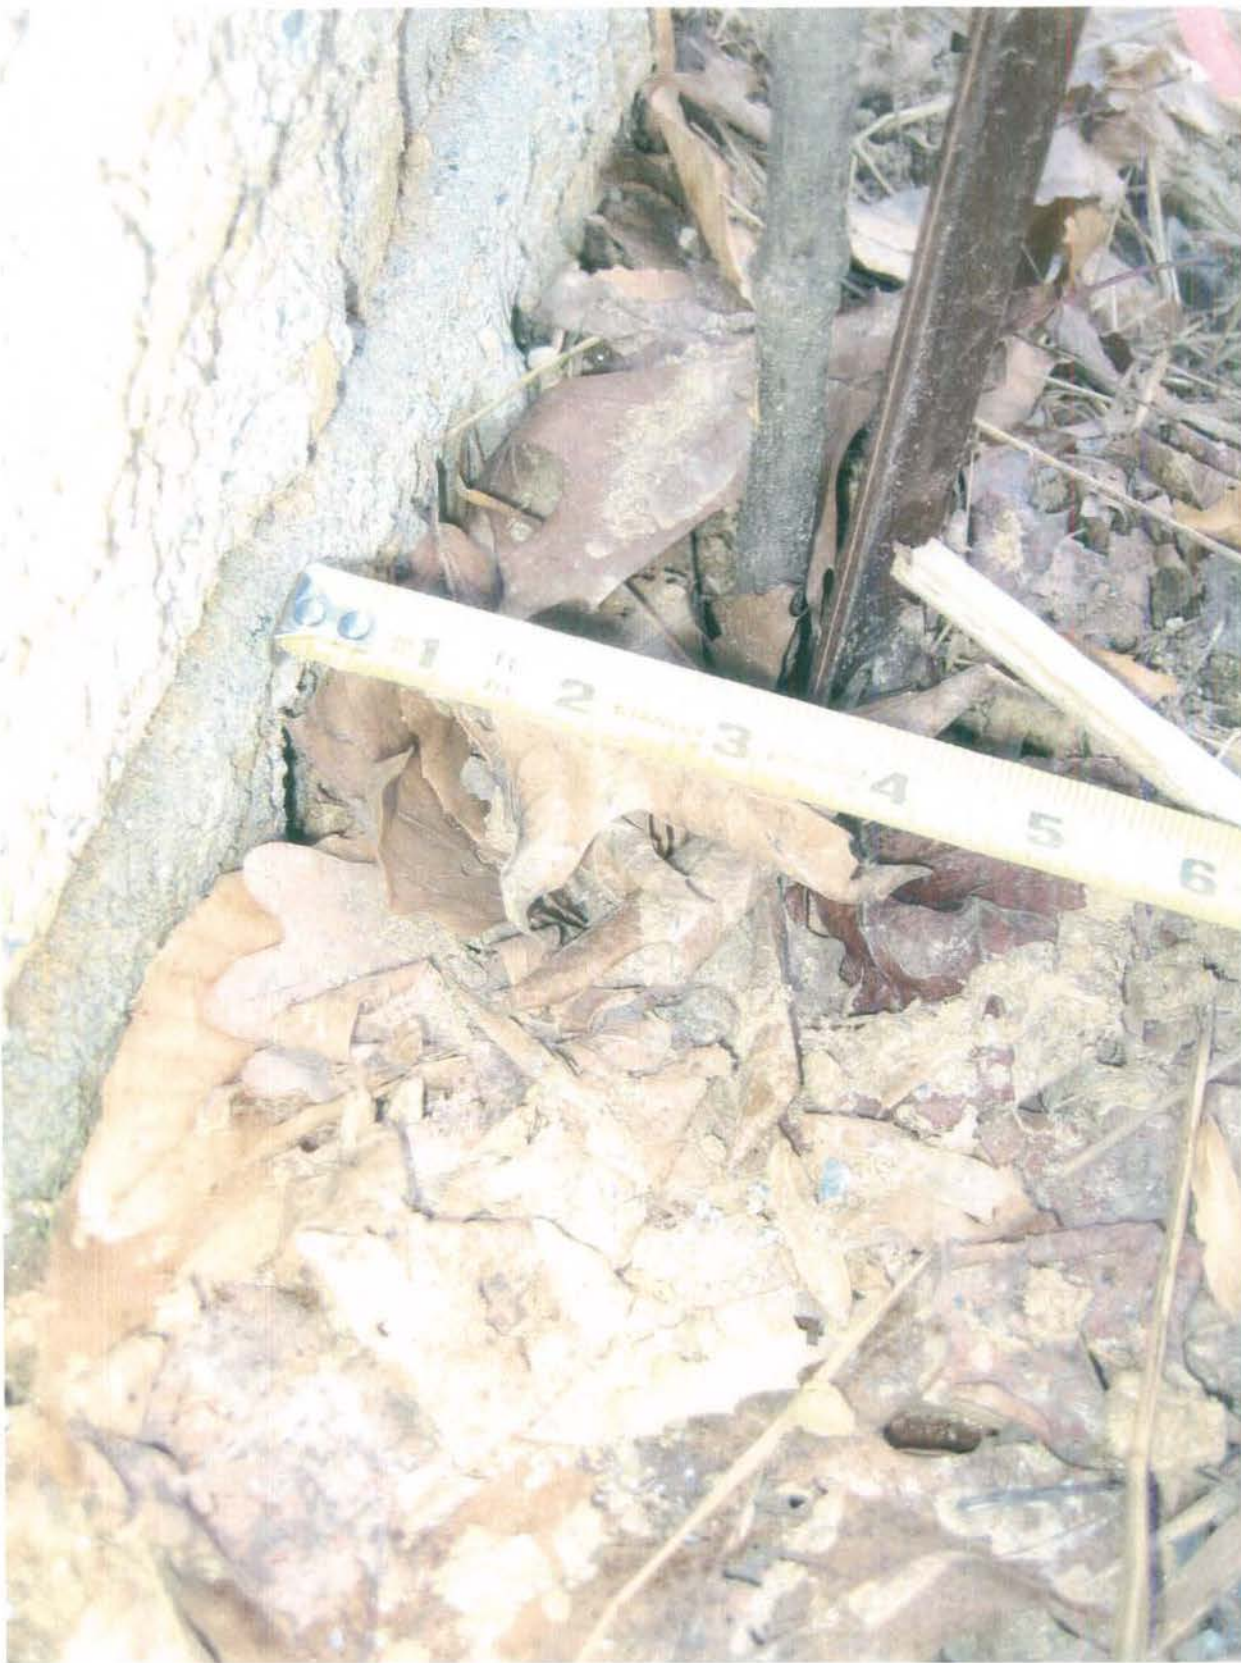
Photo Evidencing Wall's Encroachment on Parkland

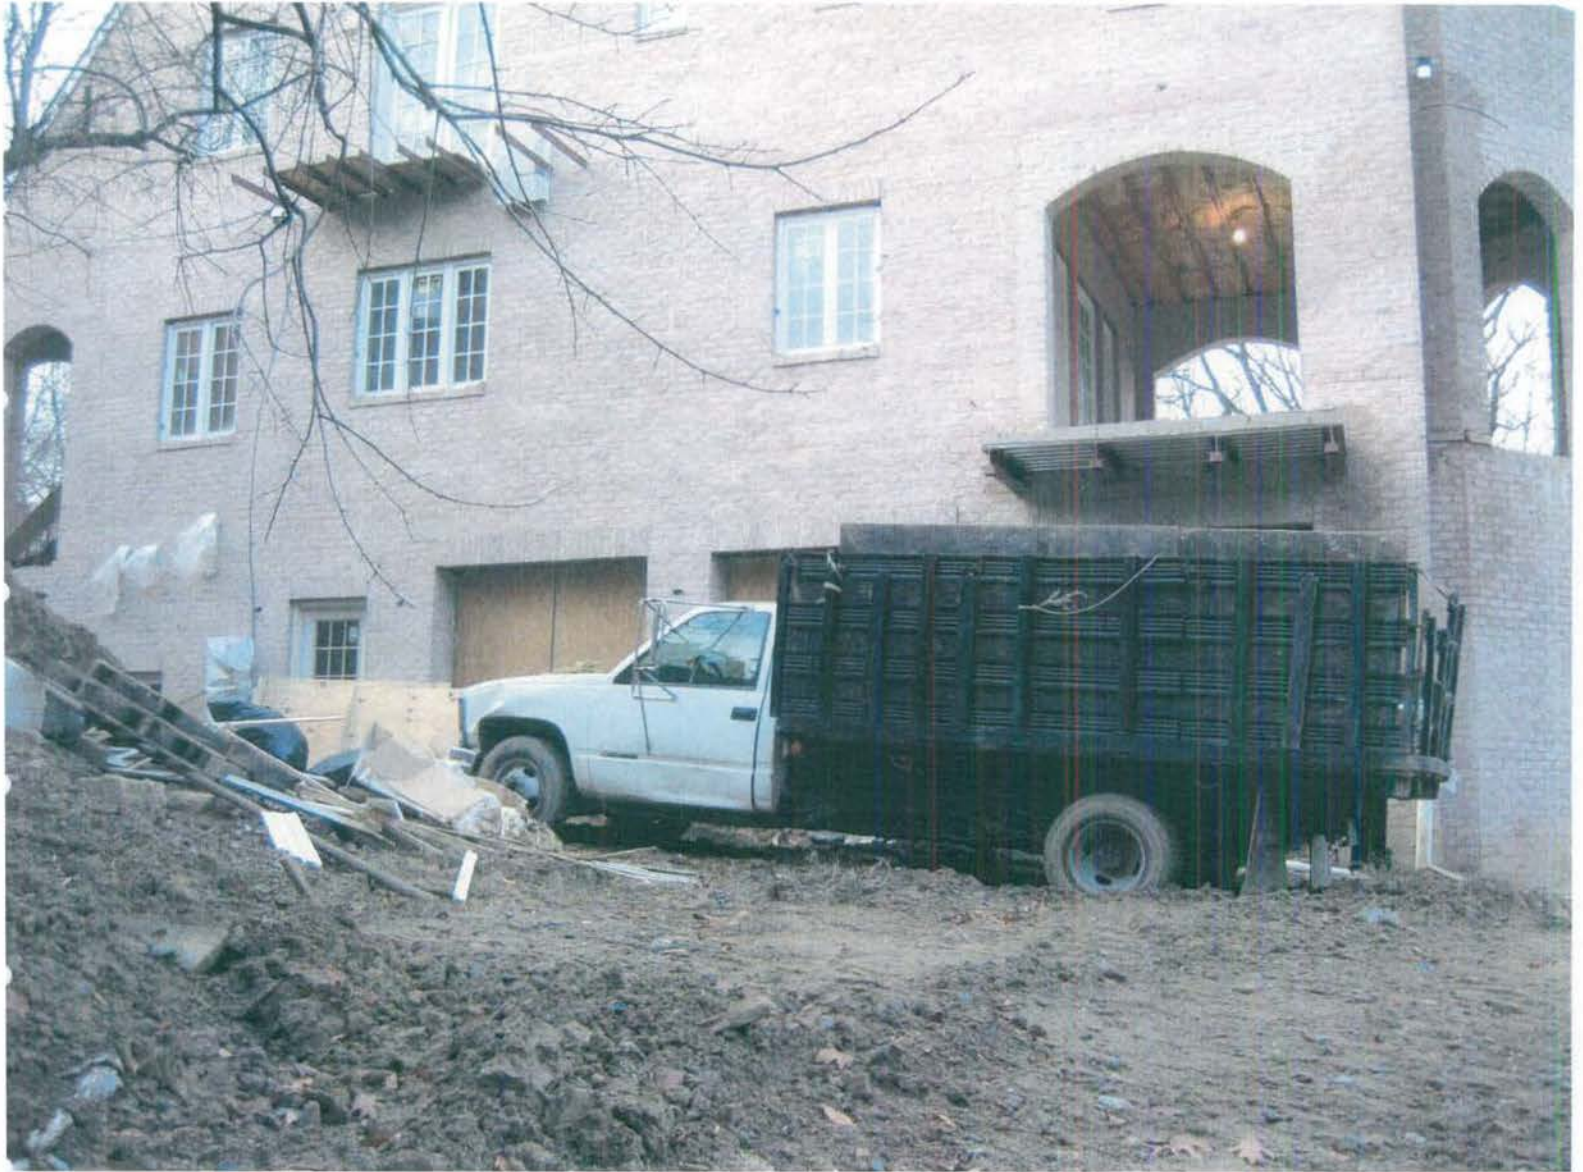
Activity during Stop Work ~~at~~ Order(s) in Nov/Dec. 2006

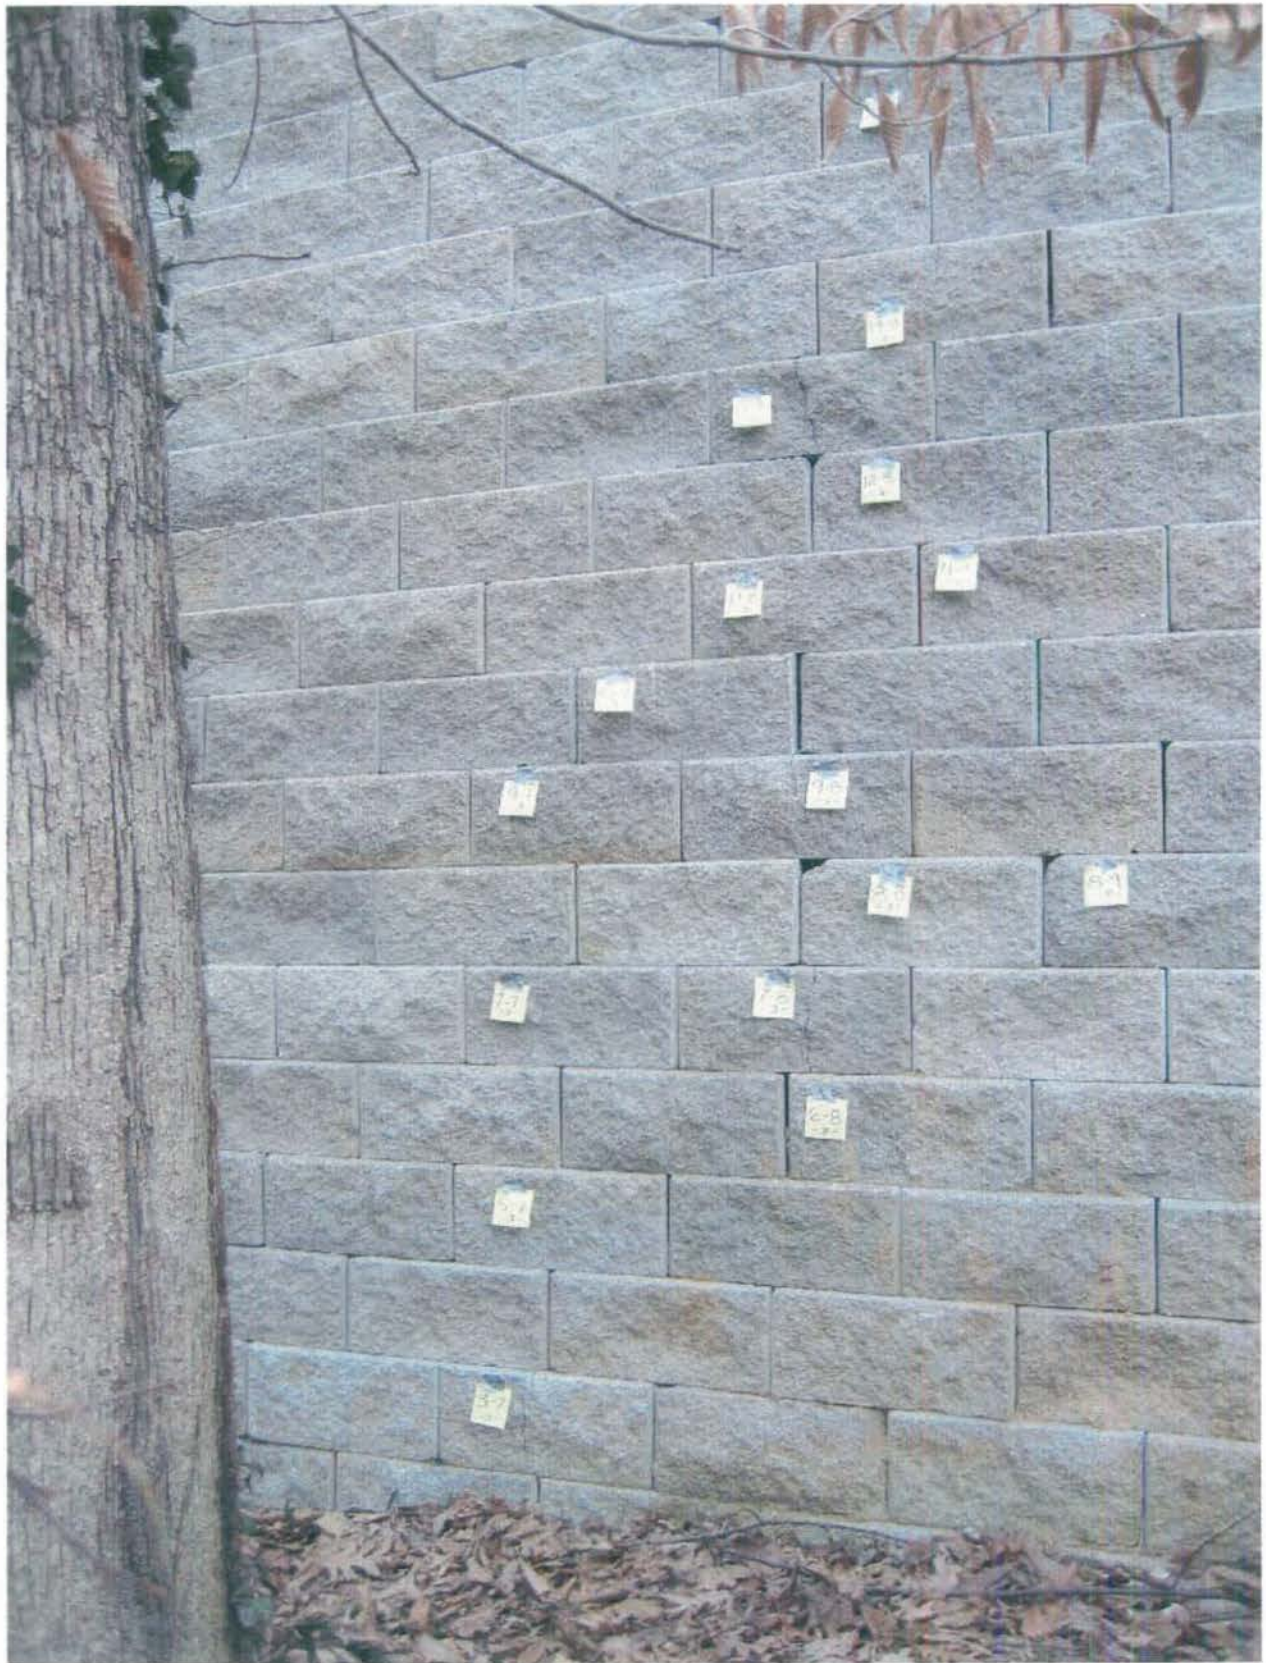
Examples of Cracks Developing Systemmatically  
in groups of mesa blocks (c 2/13/05)
