Re: *BZA Appeal No. 17285*

4825 Dexter Terrace, NW  
Frank & Dina Economides, Owners

BZA Appeal No. 17285

**THIRD AFFIDAVIT OF PATRICK J. CAROME**

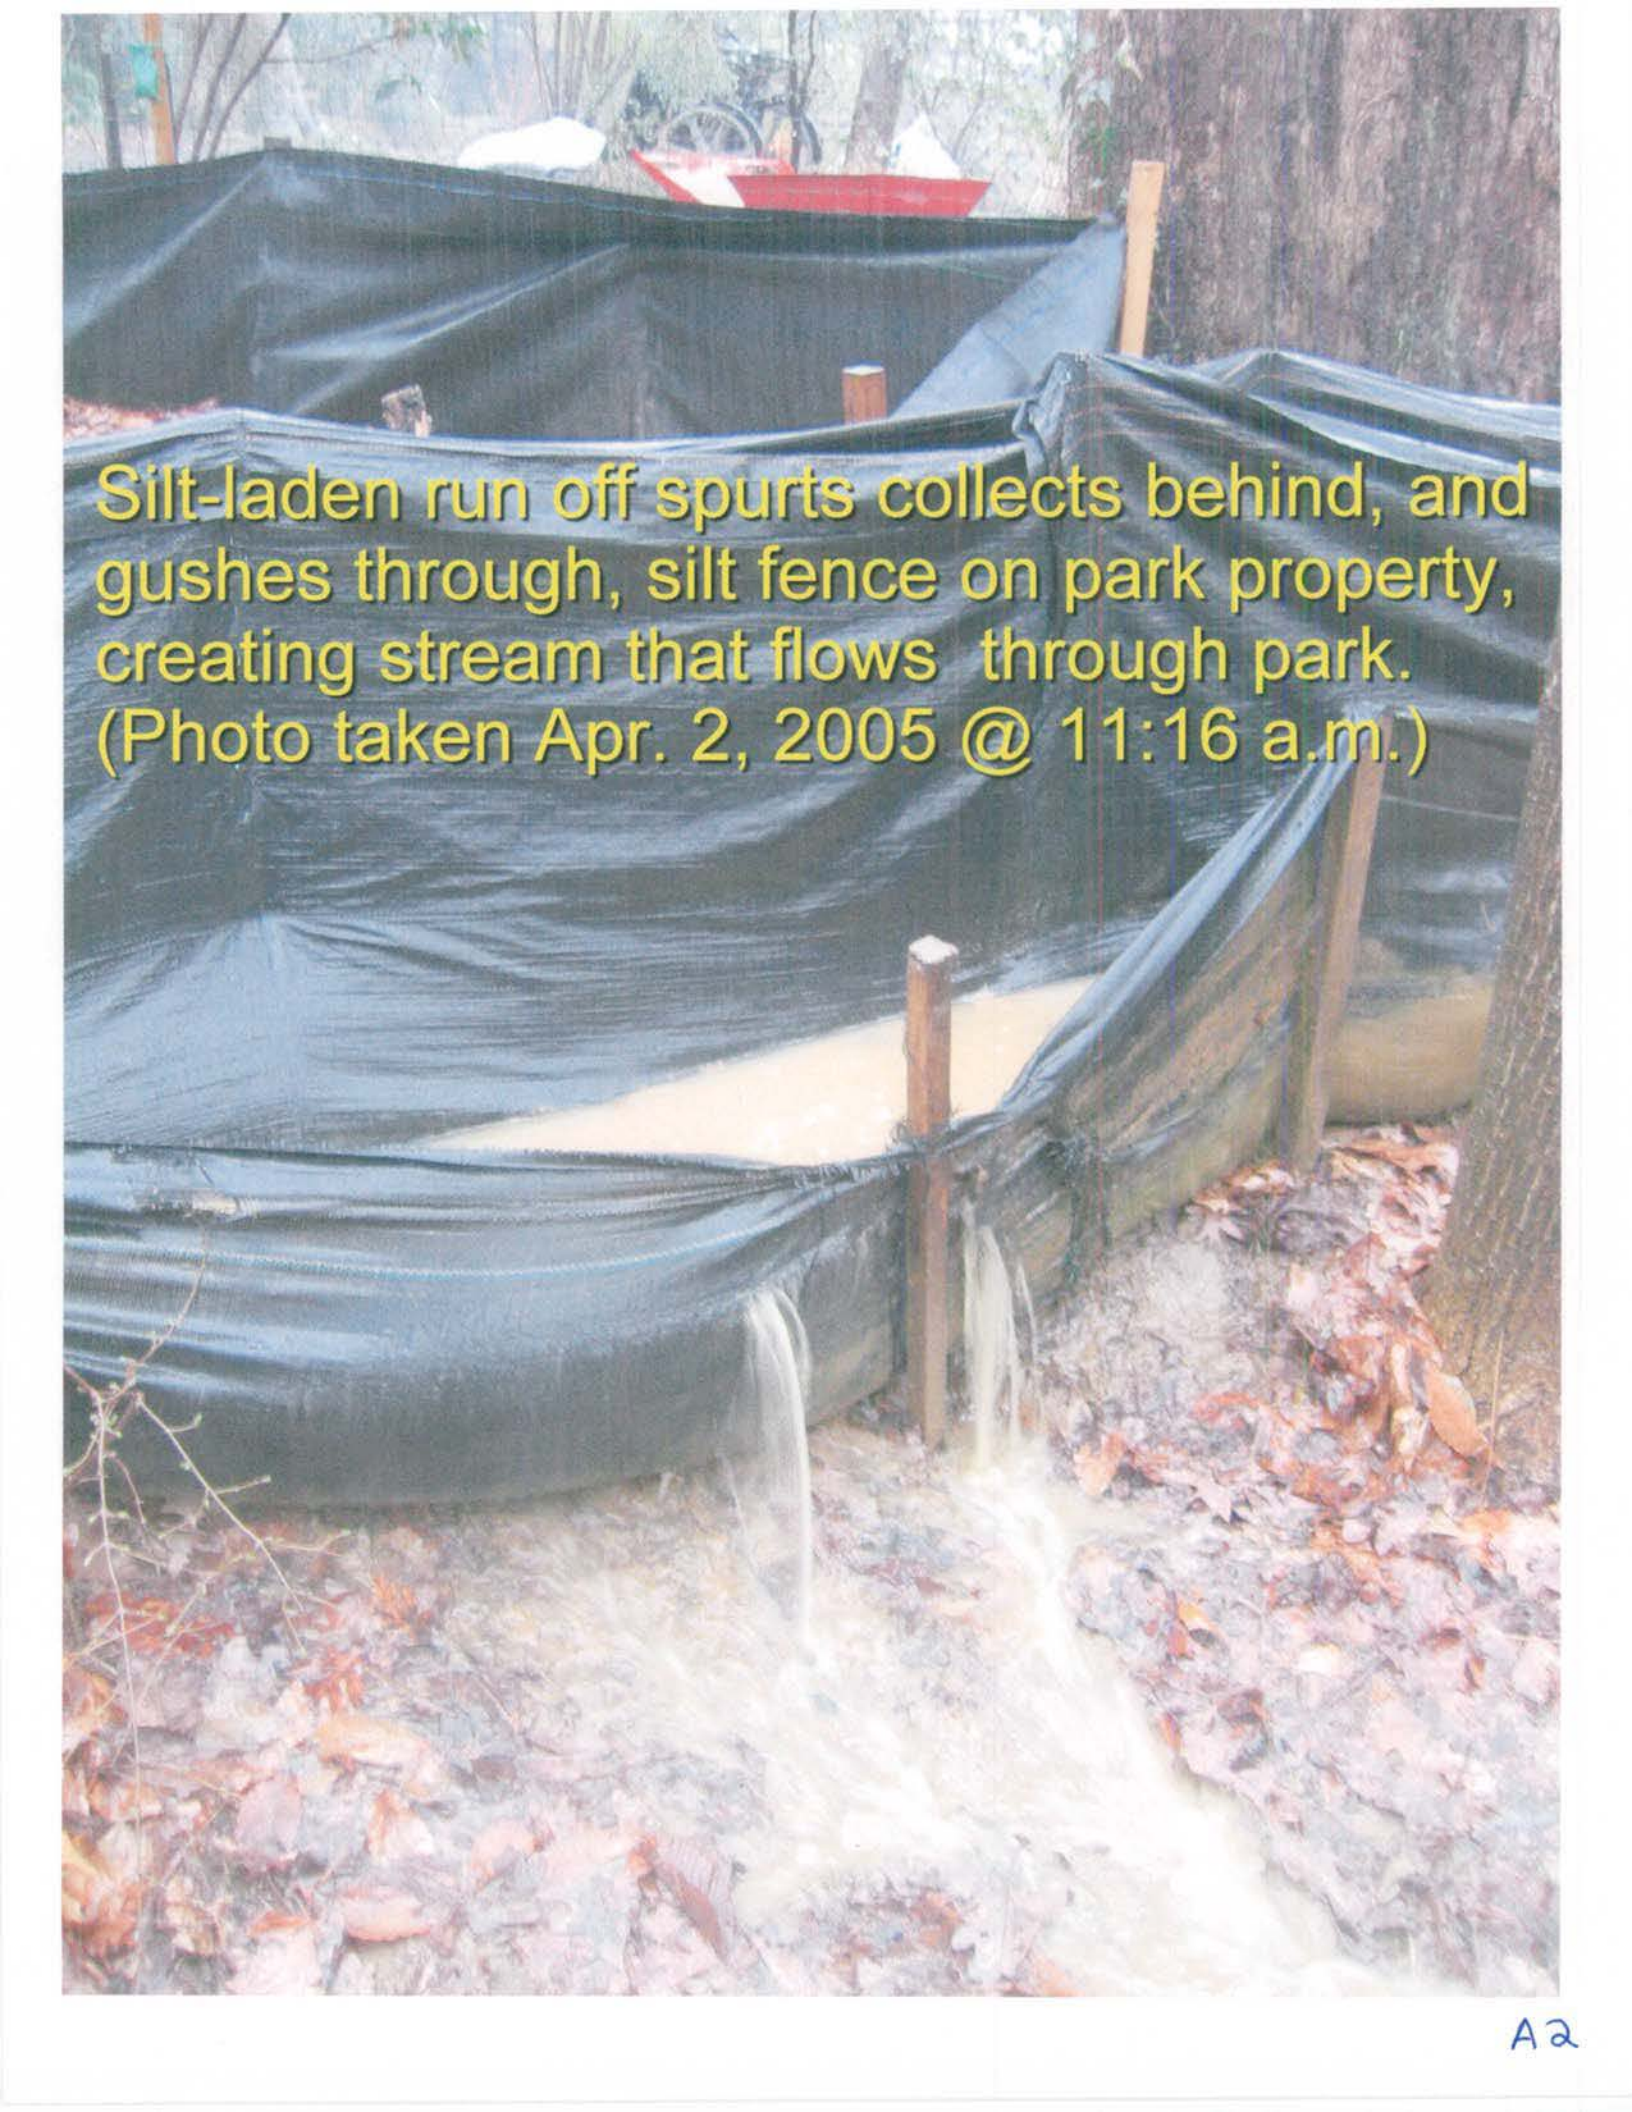
# Drainage Back-up Behind Silt Fence at Northwest Exterior Corner of Walled Platform Structure

Approx. Location of Drainage Hose Outflow

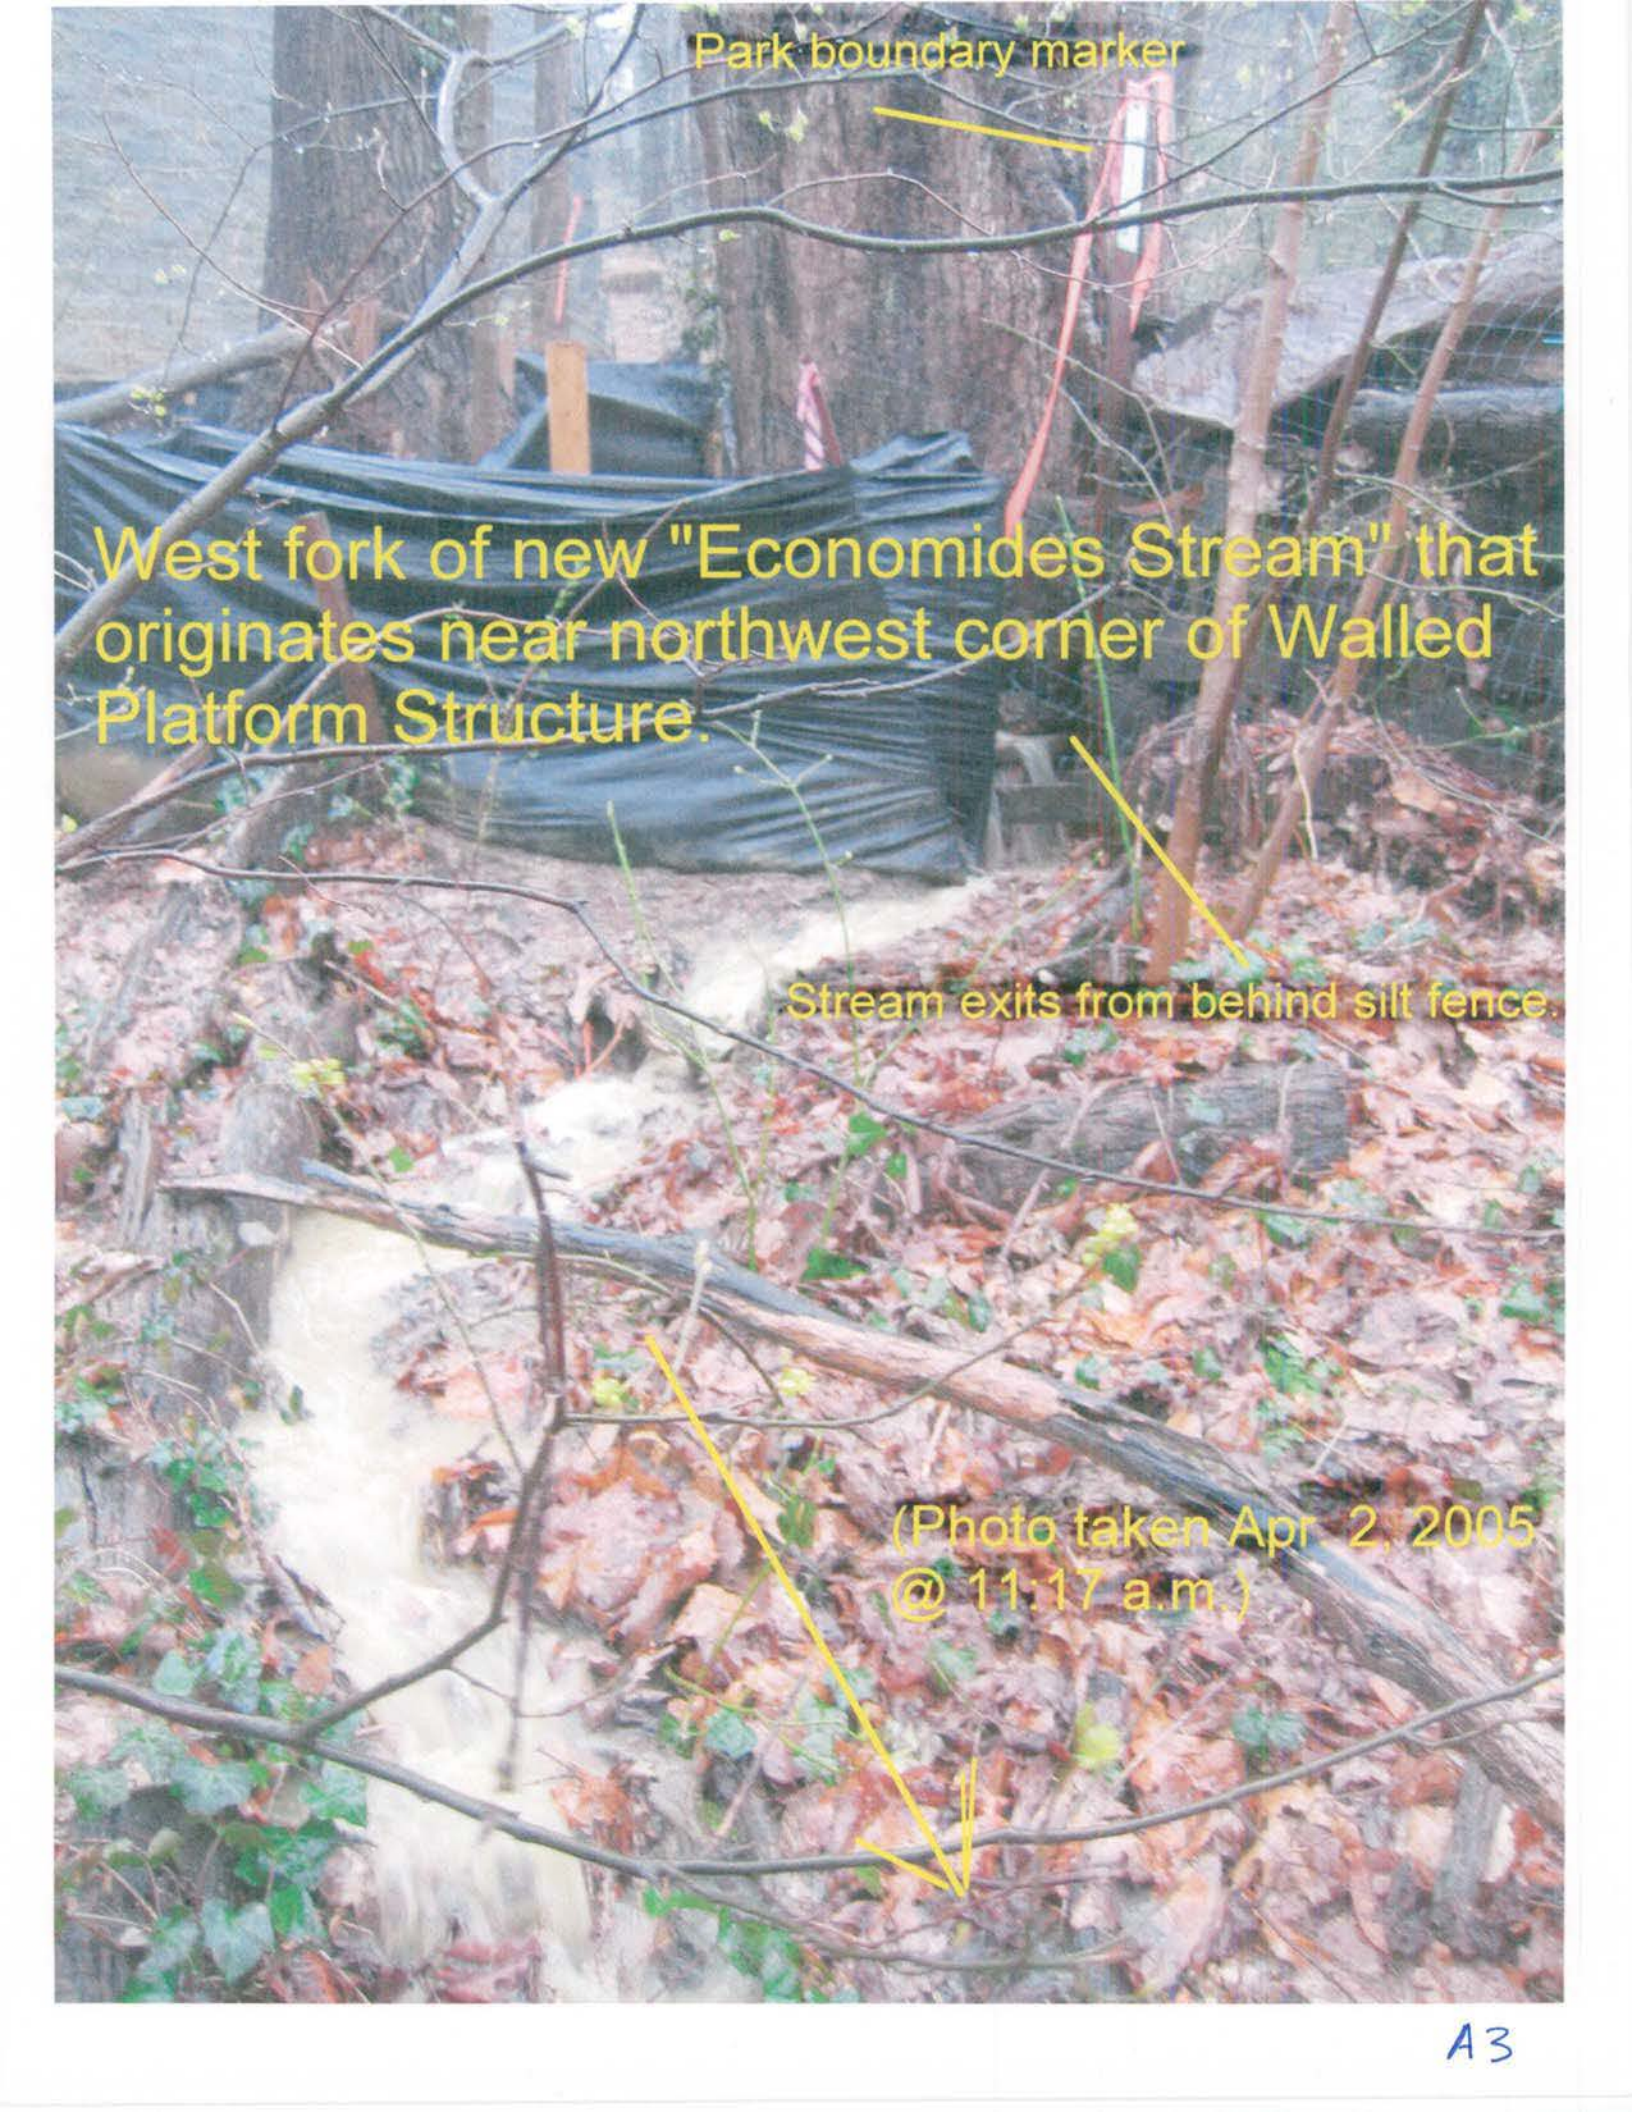
Silt-laden run off spurts collects behind, and gushes through, silt fence on park property, creating stream that flows through park. (Photo taken Apr. 2, 2005 @ 11:16 a.m.)

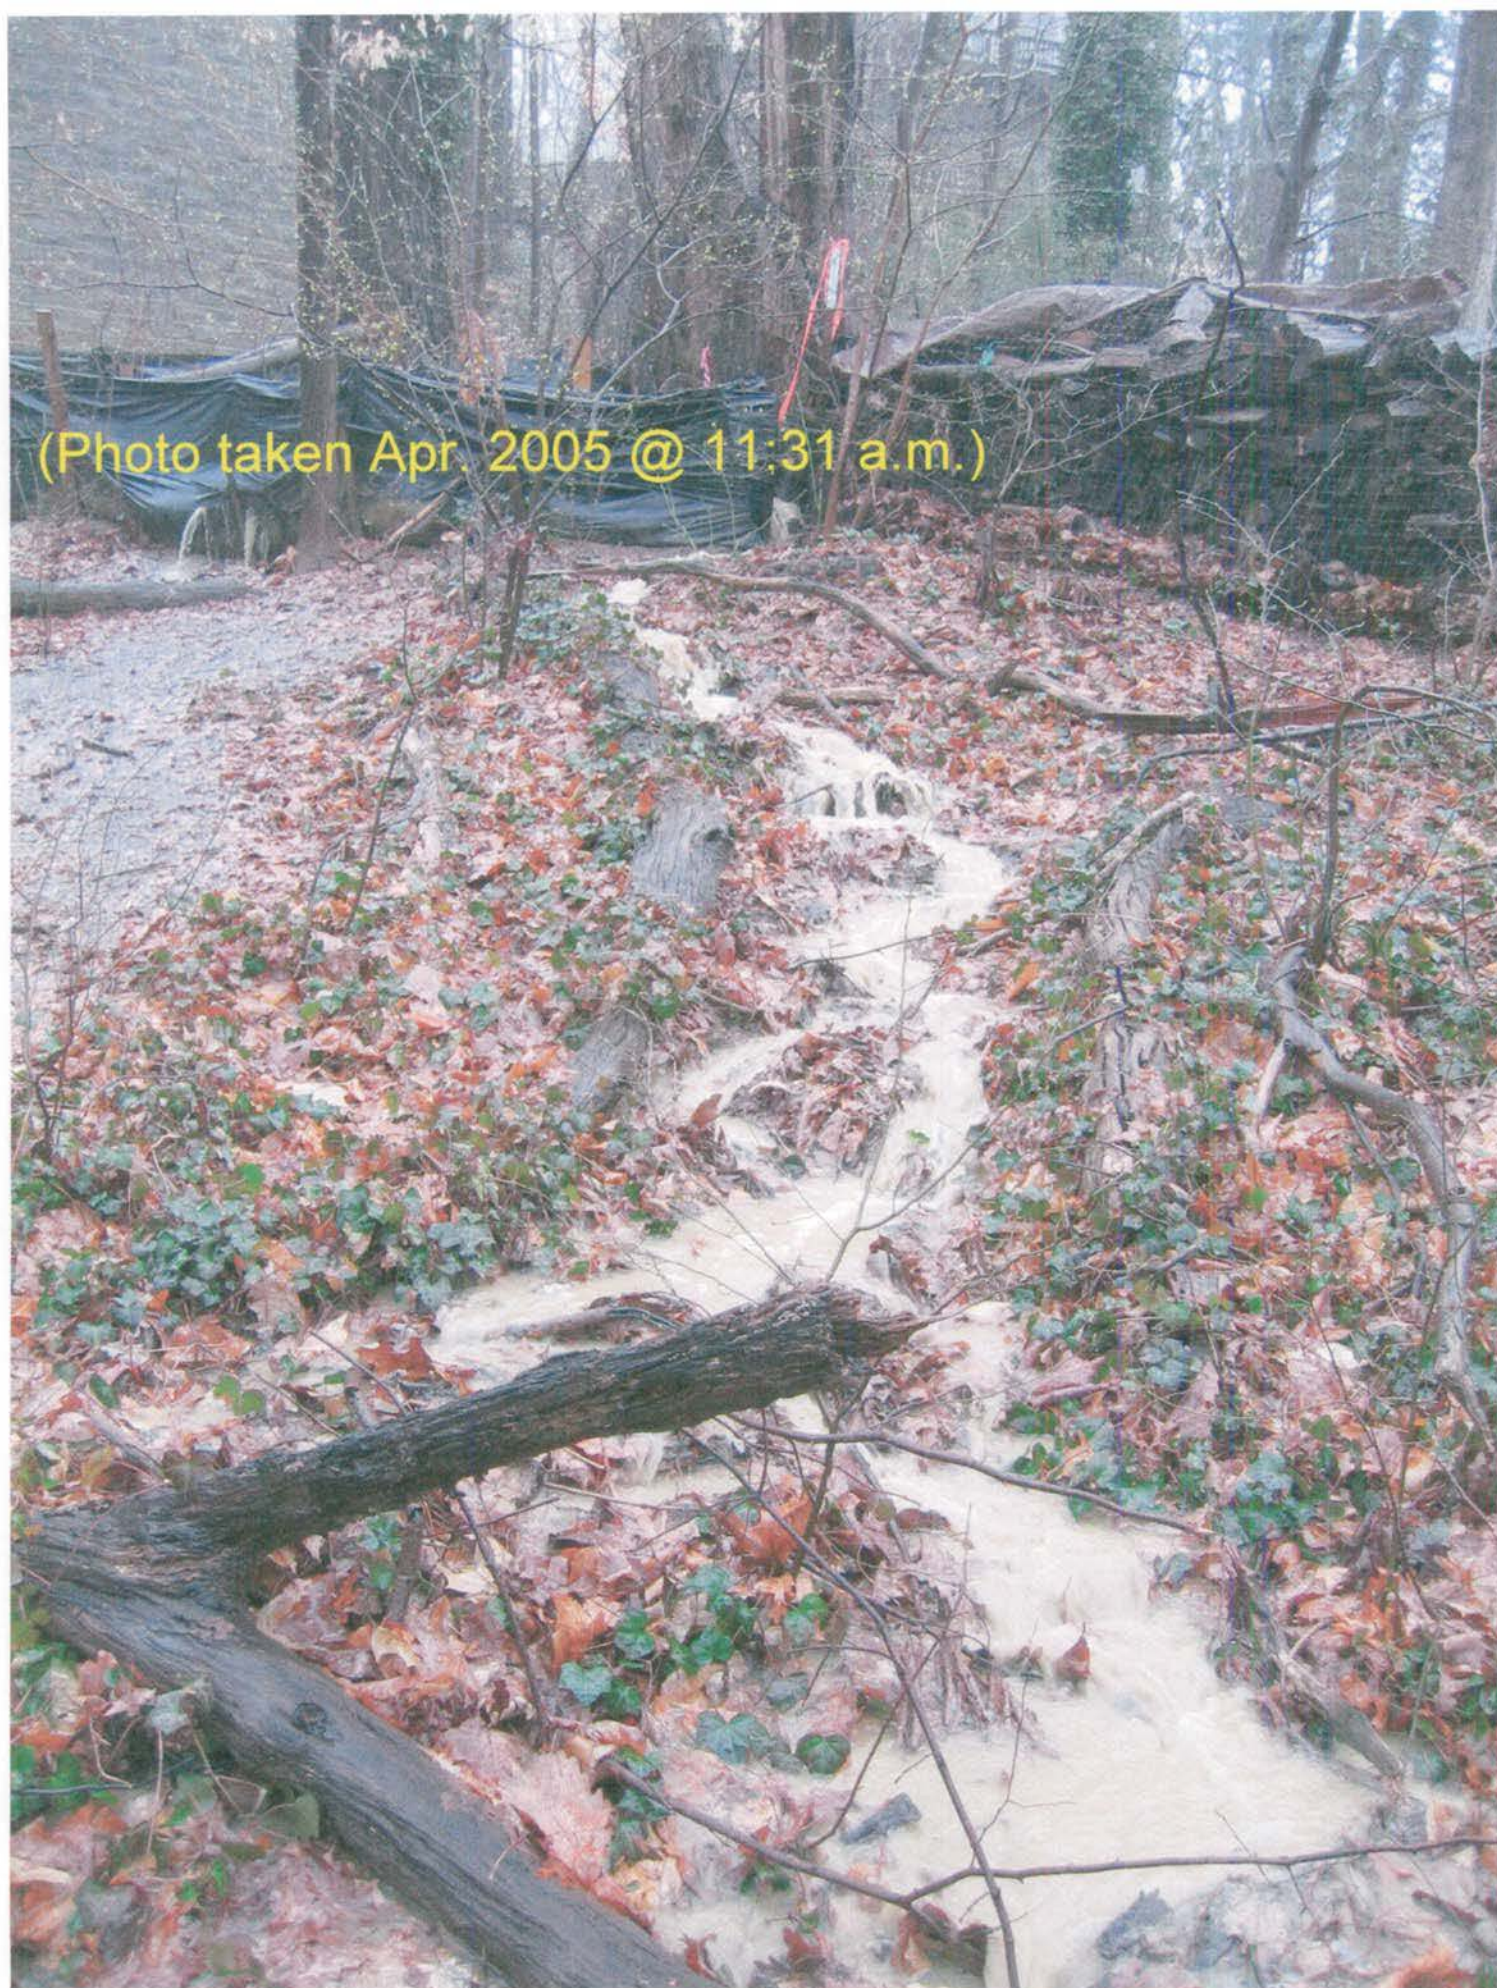
Park boundary marker

West fork of new "Economides Stream" that originates near northwest corner of Walled Platform Structure.

Stream exits from behind silt fence.

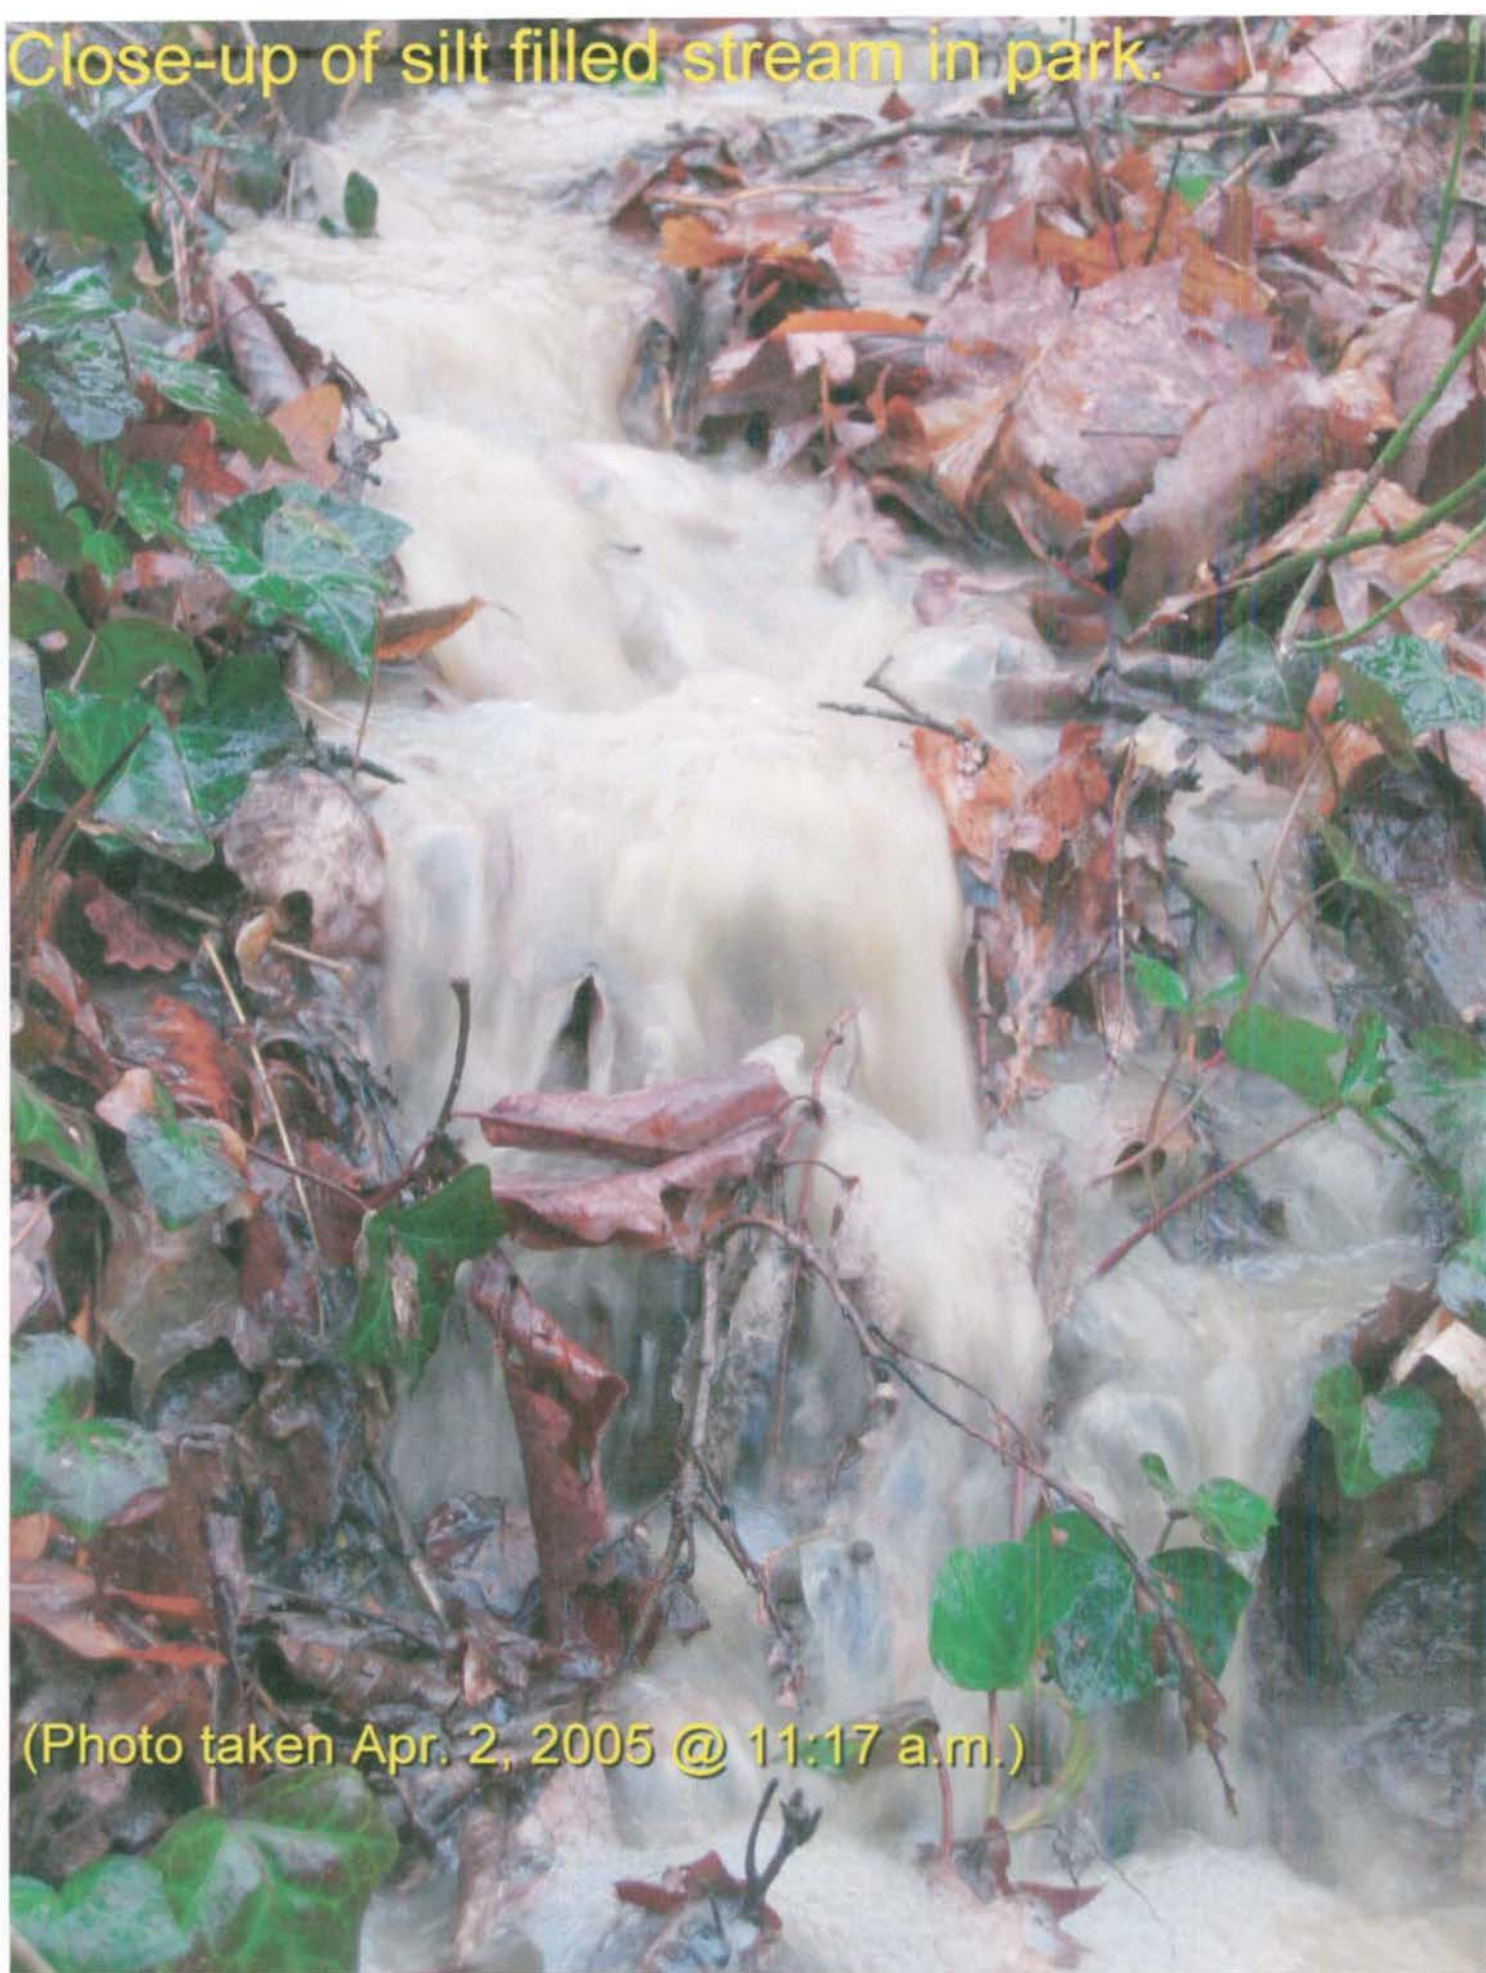
Close-up of silt filled stream in park.

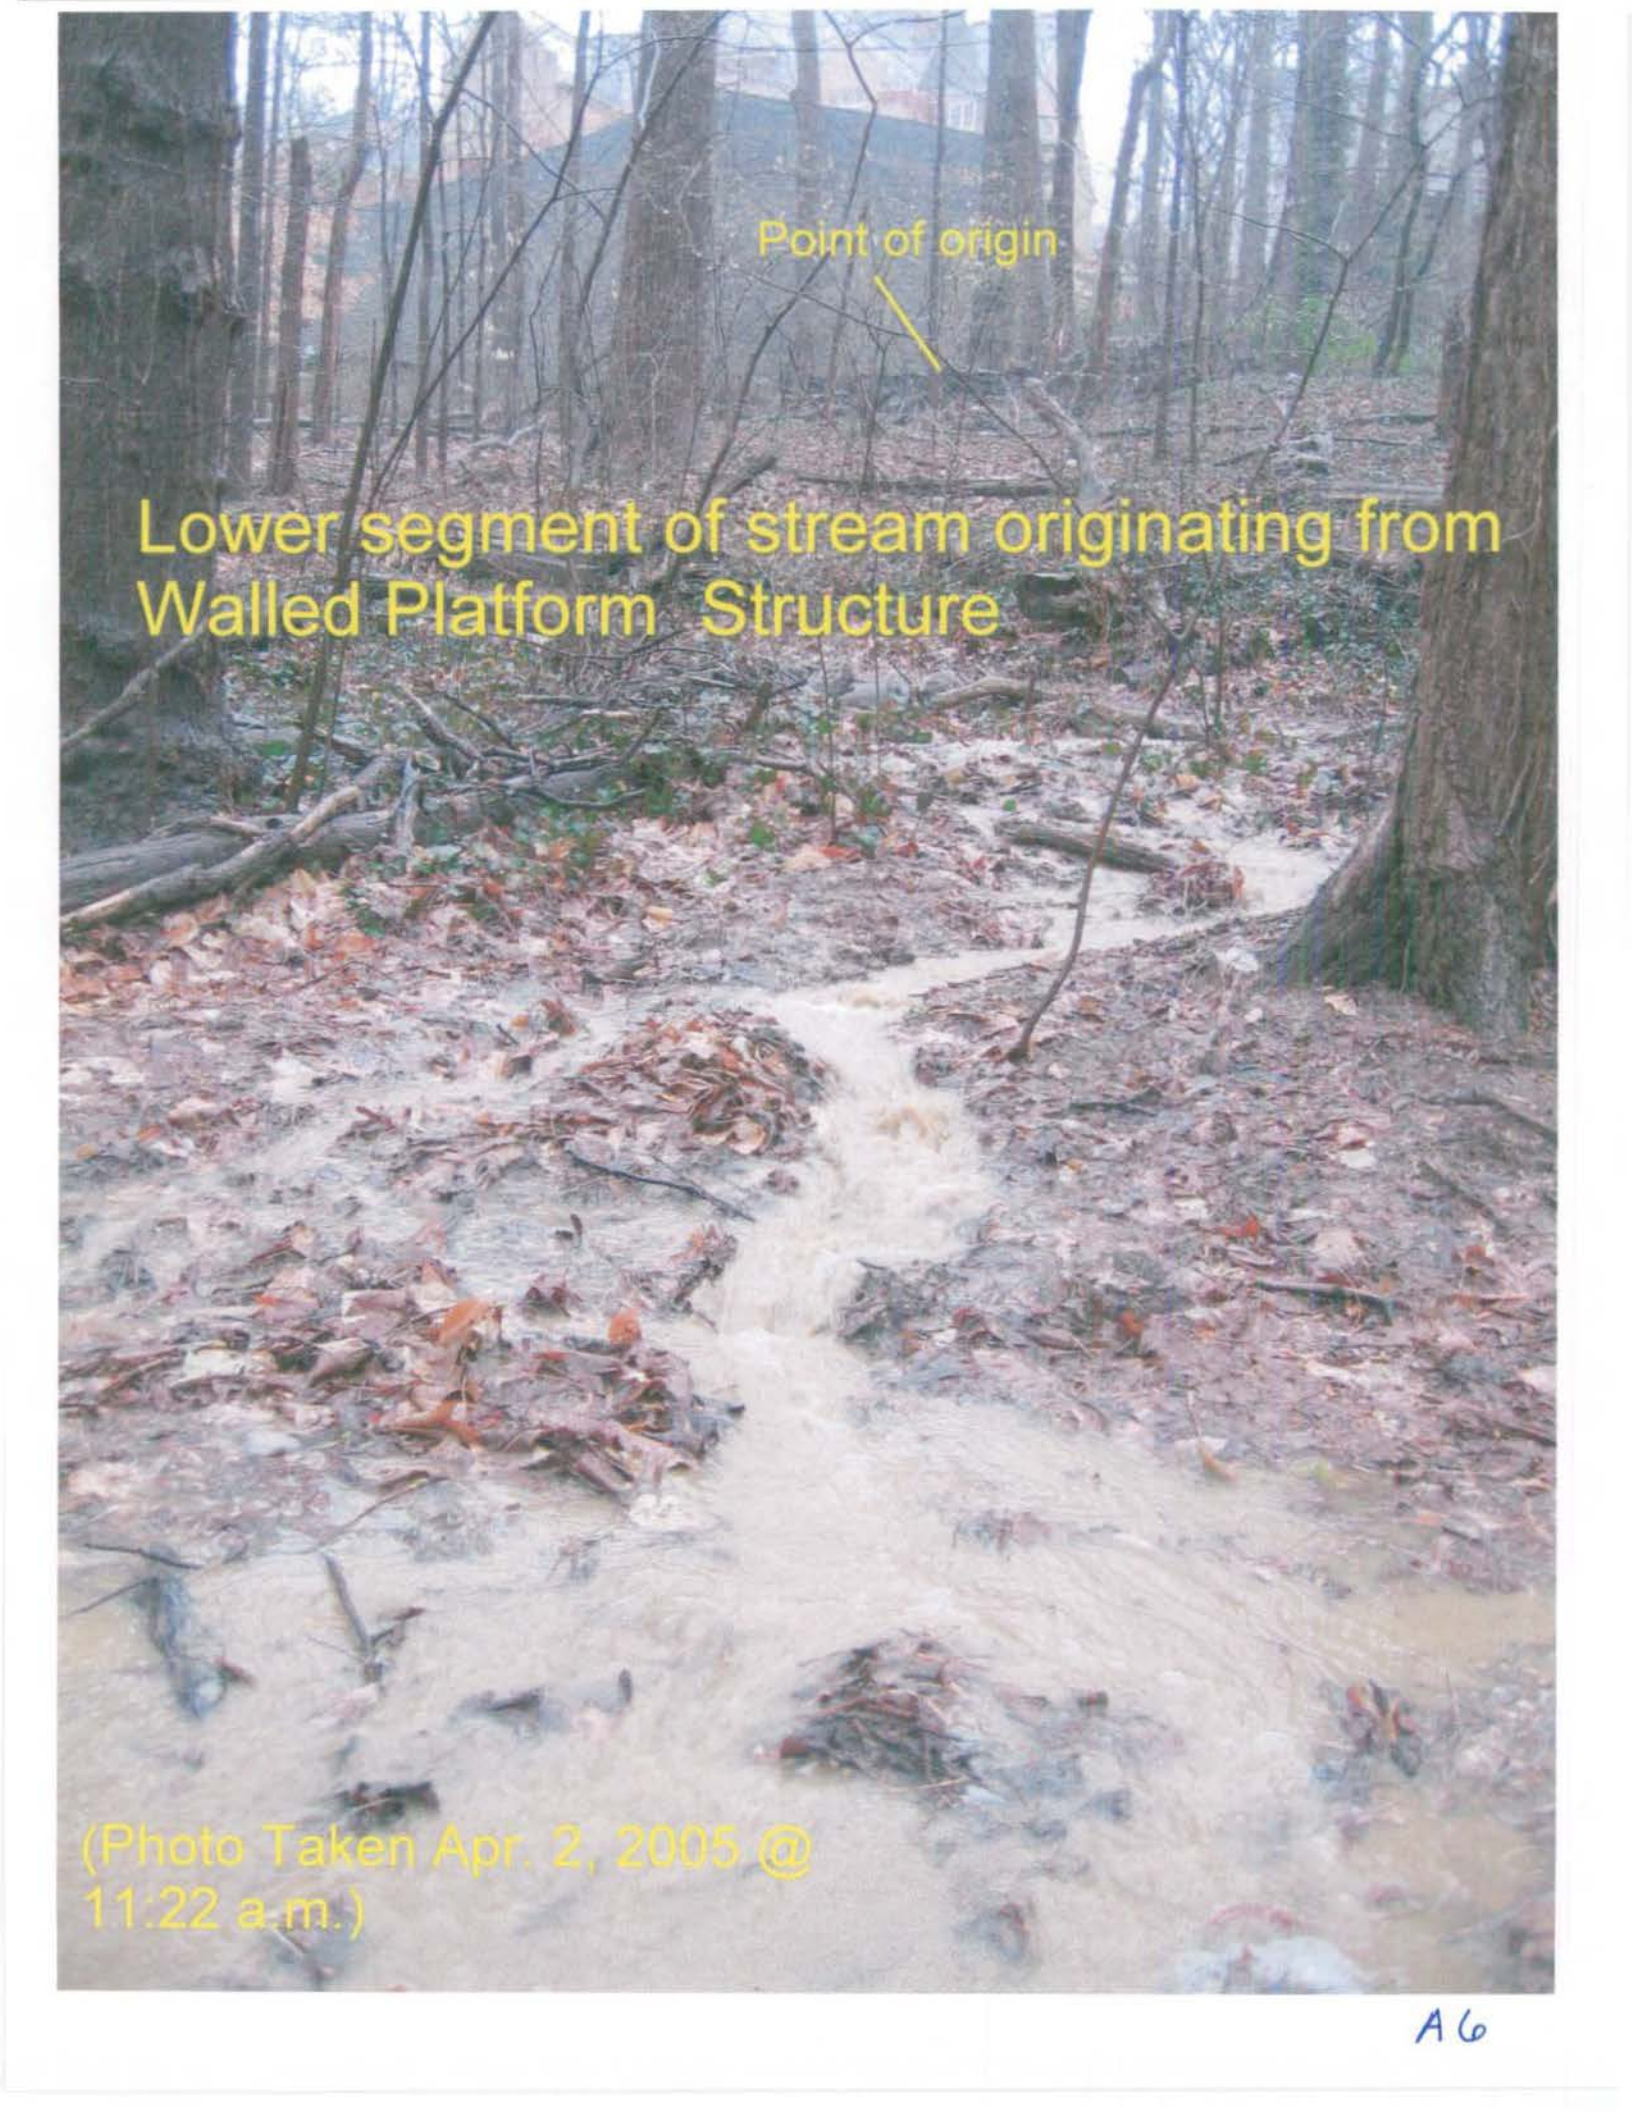
Point of origin

Lower segment of stream originating from  
Walled Platform Structure

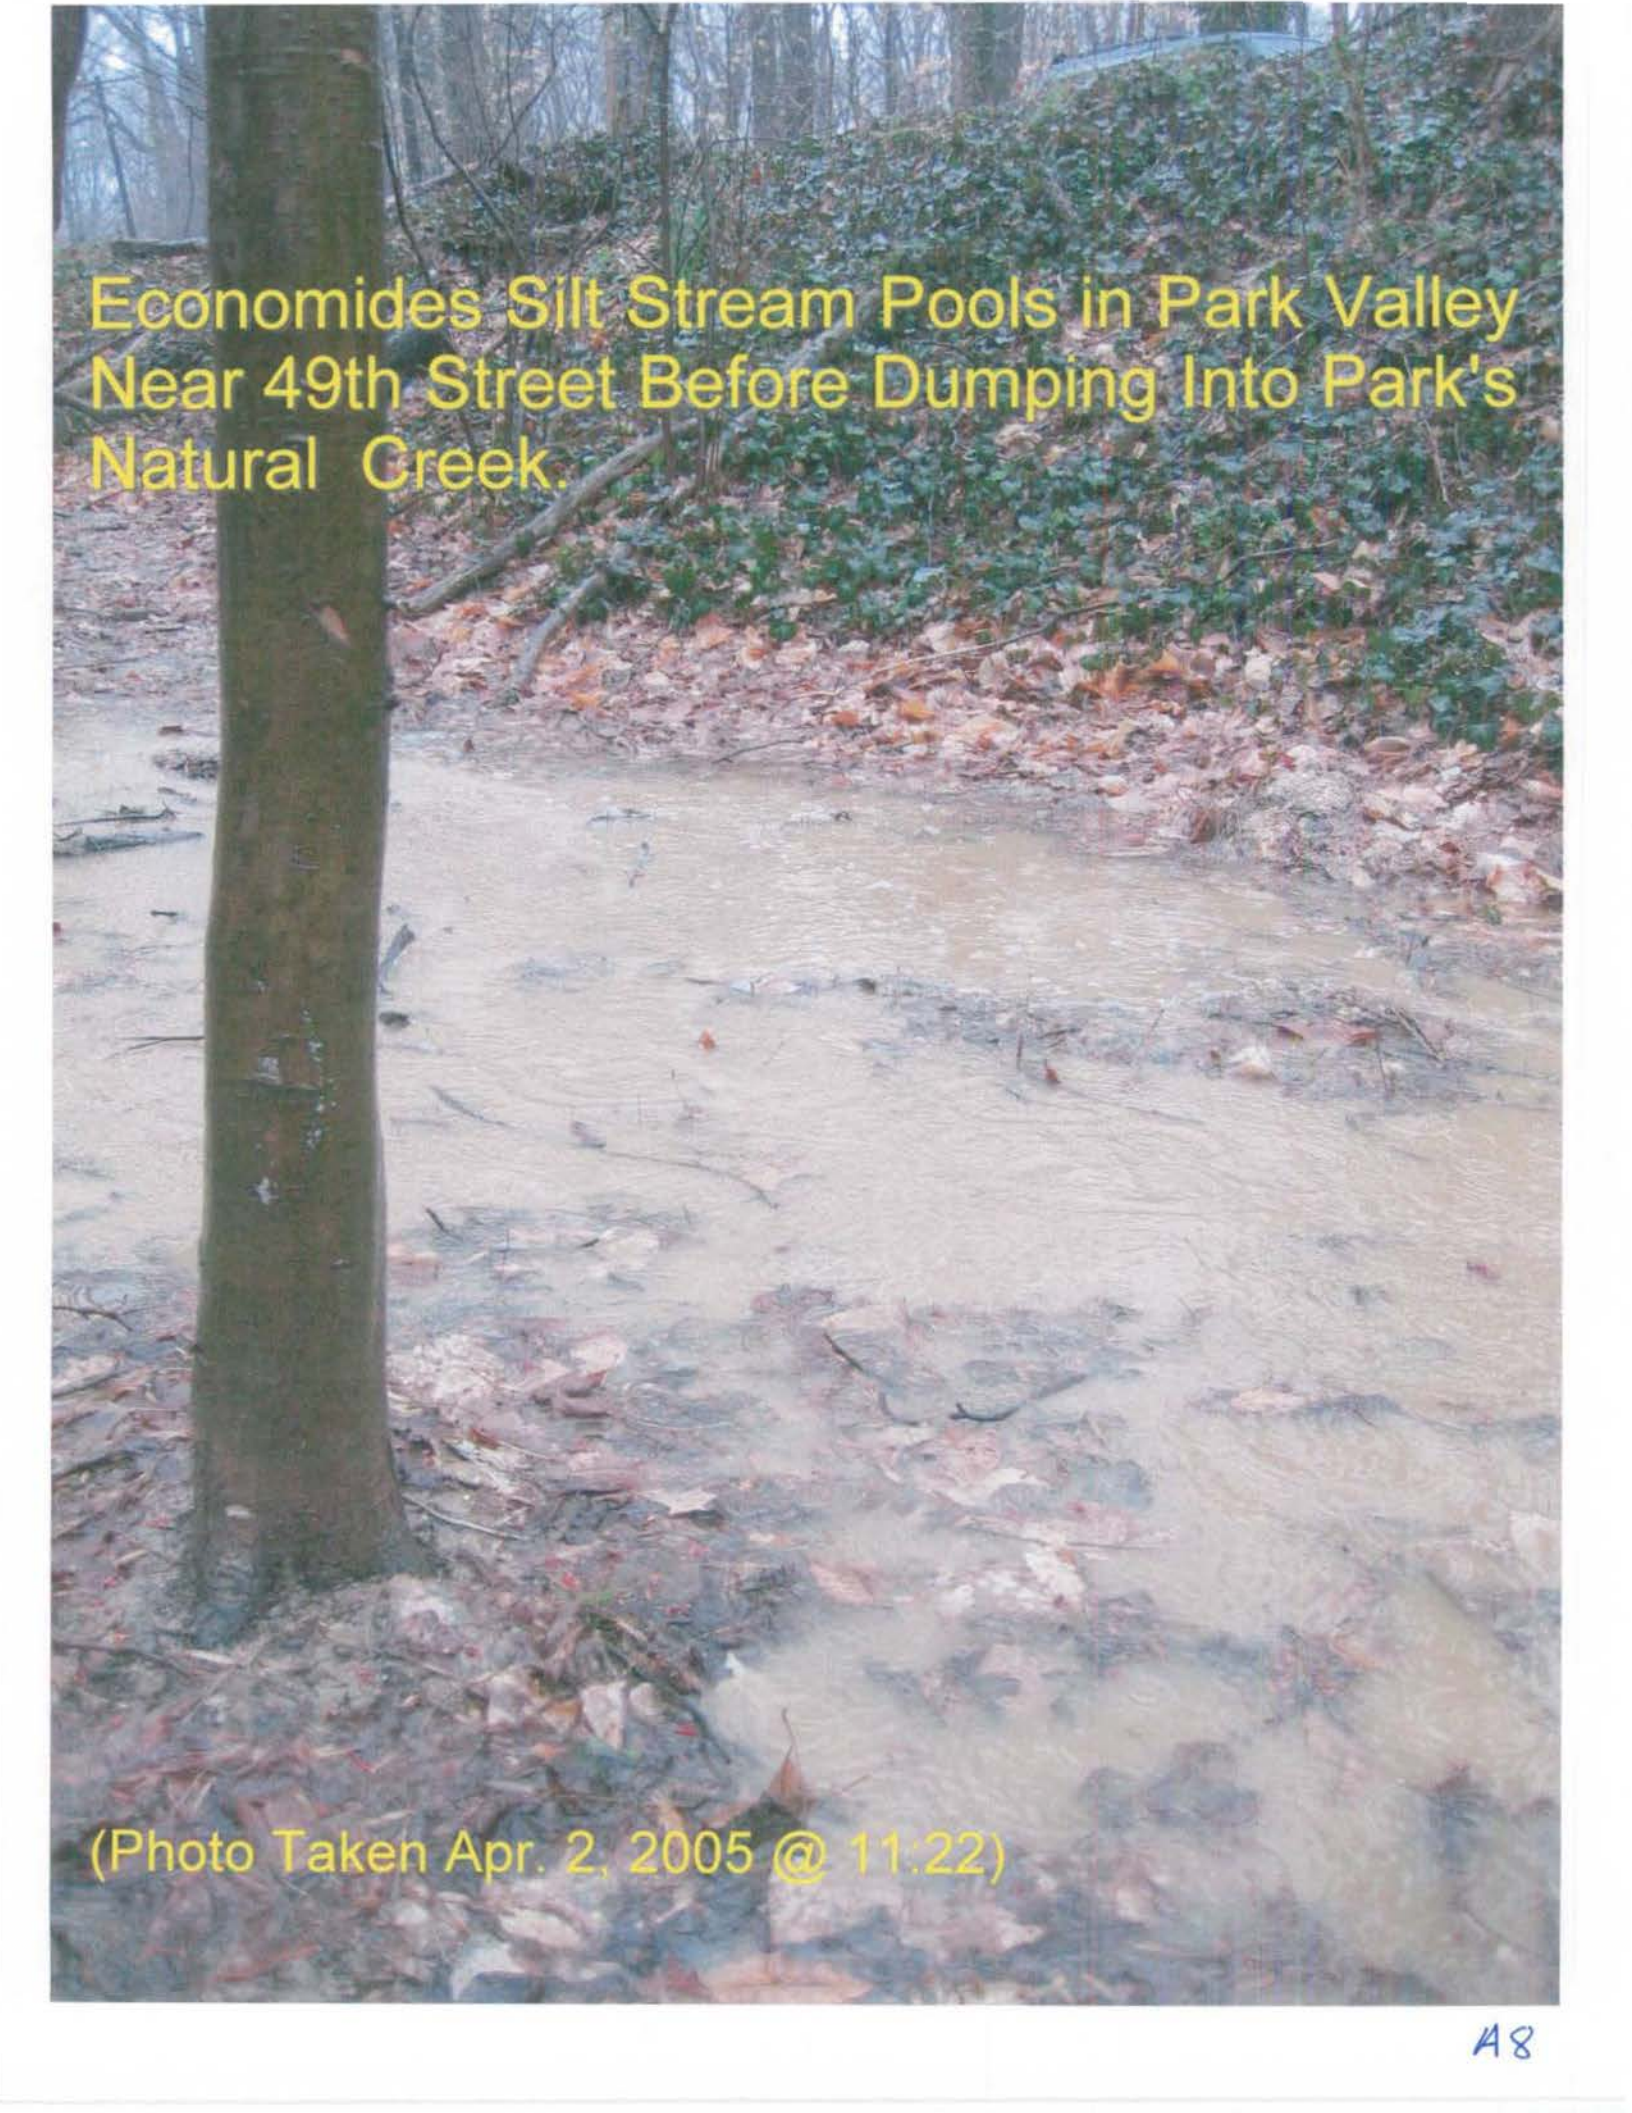
Economides Silt Stream Swamps and Ruins  
Running Path in Wesley Heights Park.

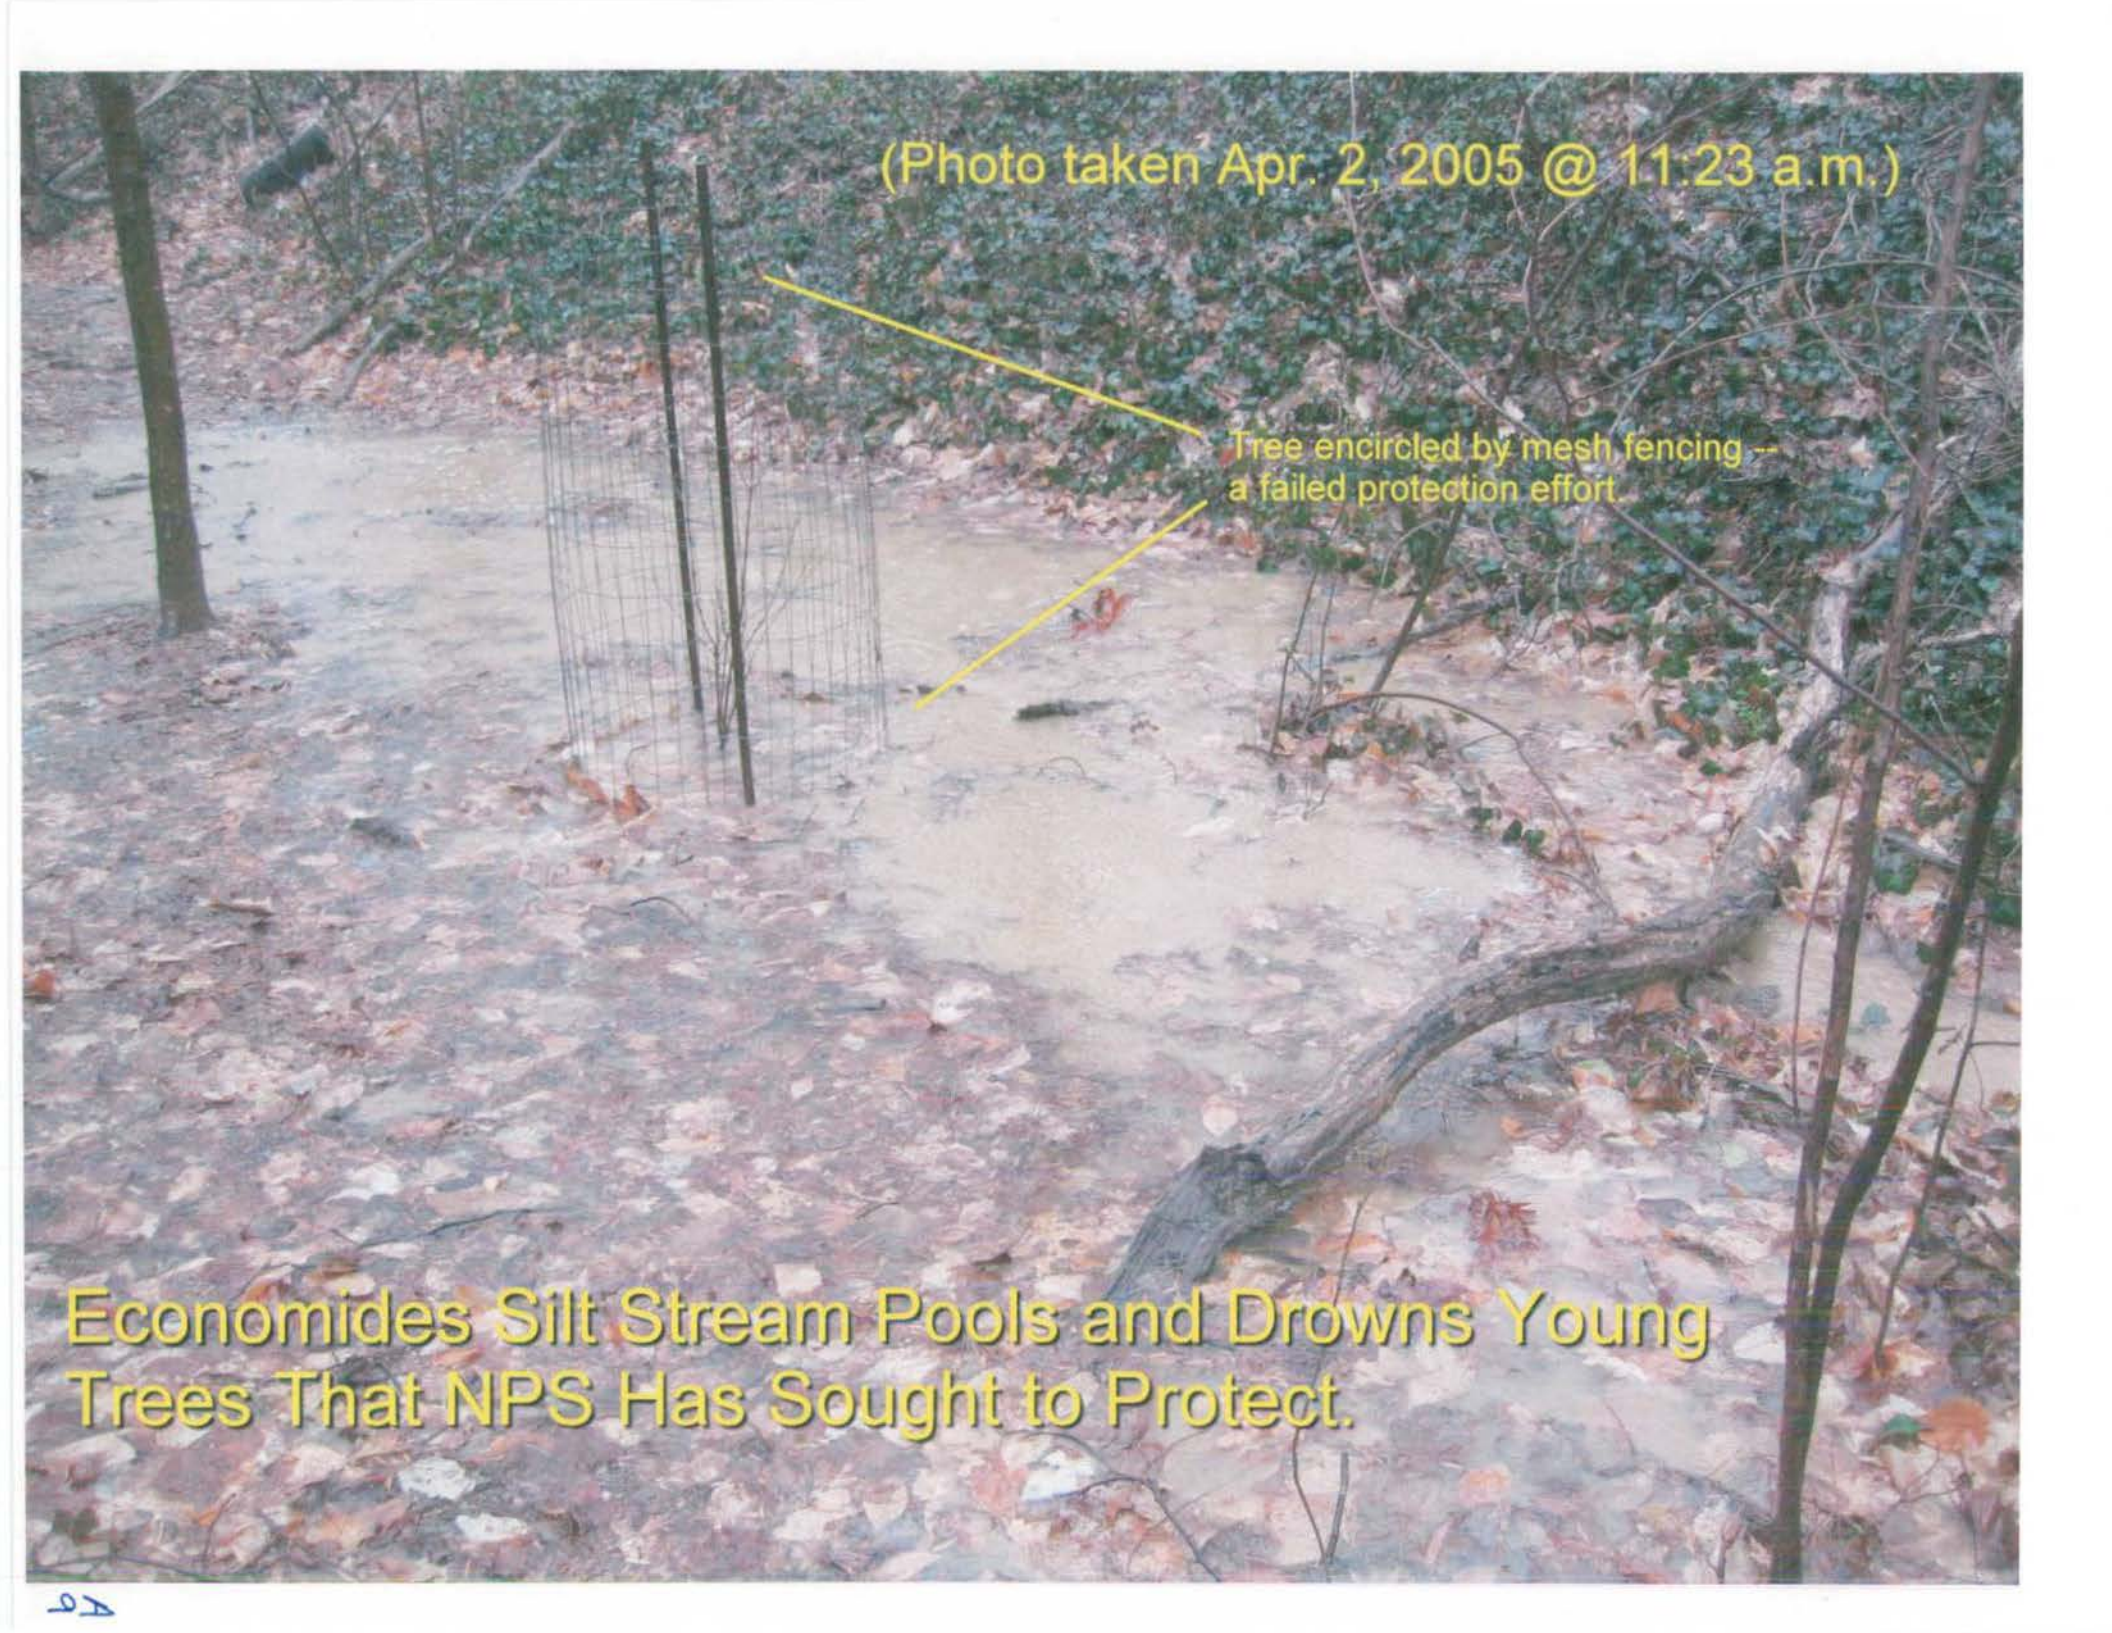
Economides Silt Stream Pools in Park Valley  
Near 49th Street Before Dumping Into Park's  
Natural Creek.
