Re: *BZA Appeal No. 17285*

4825 Dexter Terrace, NW  
Frank & Dina Economides, Owners

BZA Appeal No. 17285

**THIRD AFFIDAVIT OF PATRICK J. CAROME**

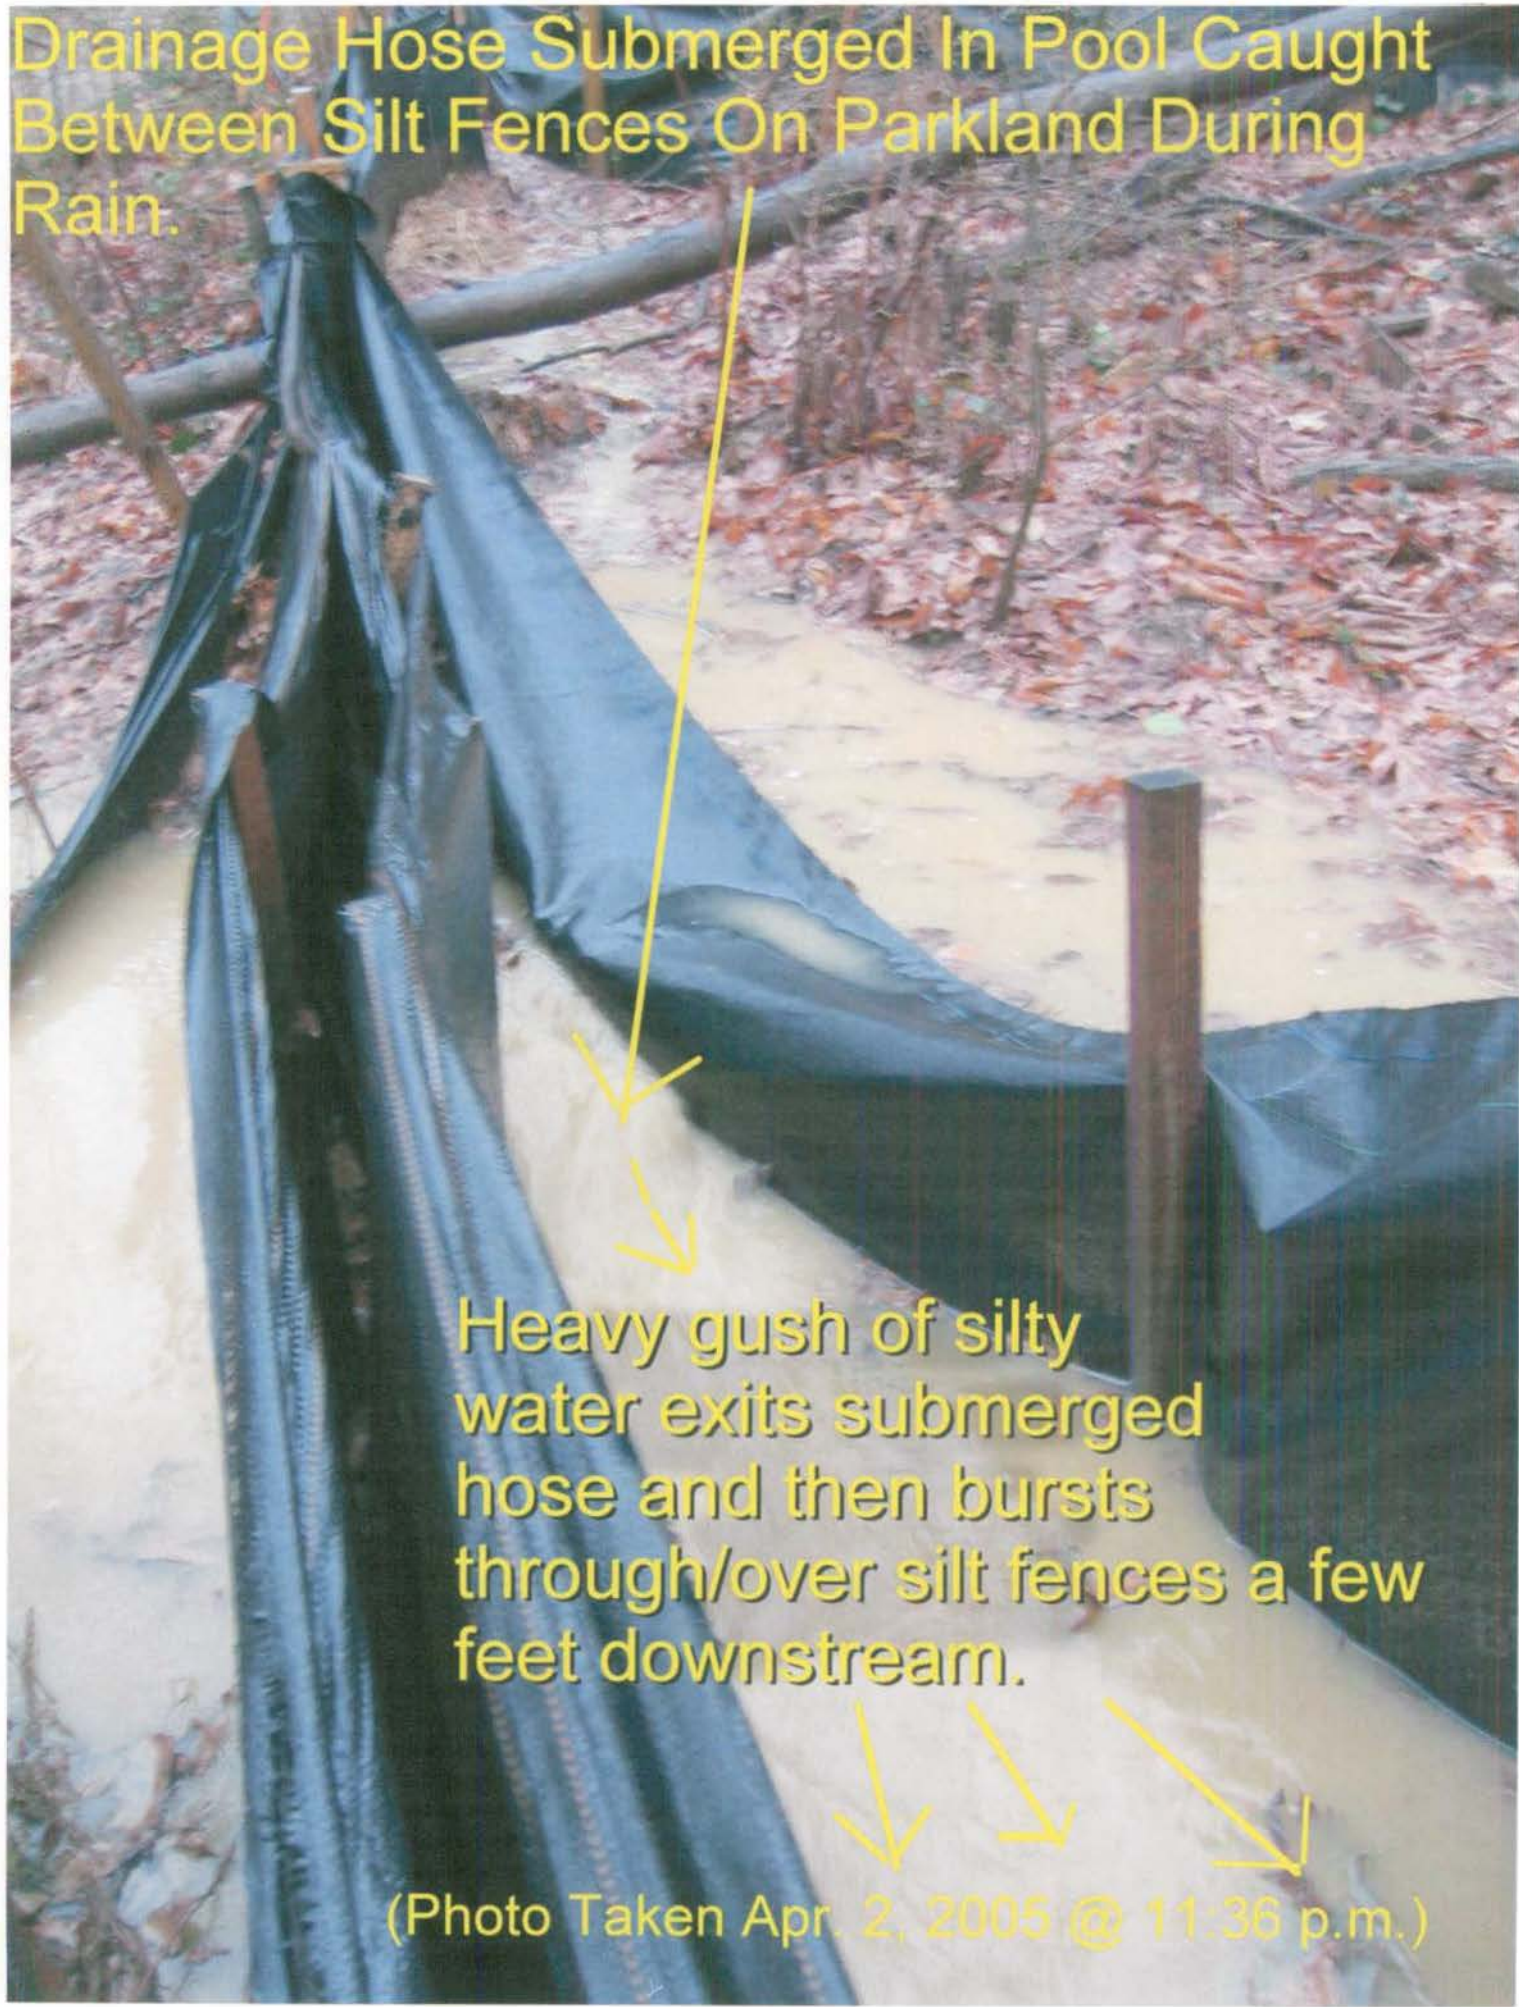
Tree encircled by mesh fencing ---  
a failed protection effort.

Economides Silt Stream Pools and Drowns Young  
Trees That NPS Has Sought to Protect.

Drainage Hose Submerged In Pool Caught  
Between Silt Fences On Parkland During  
Rain.

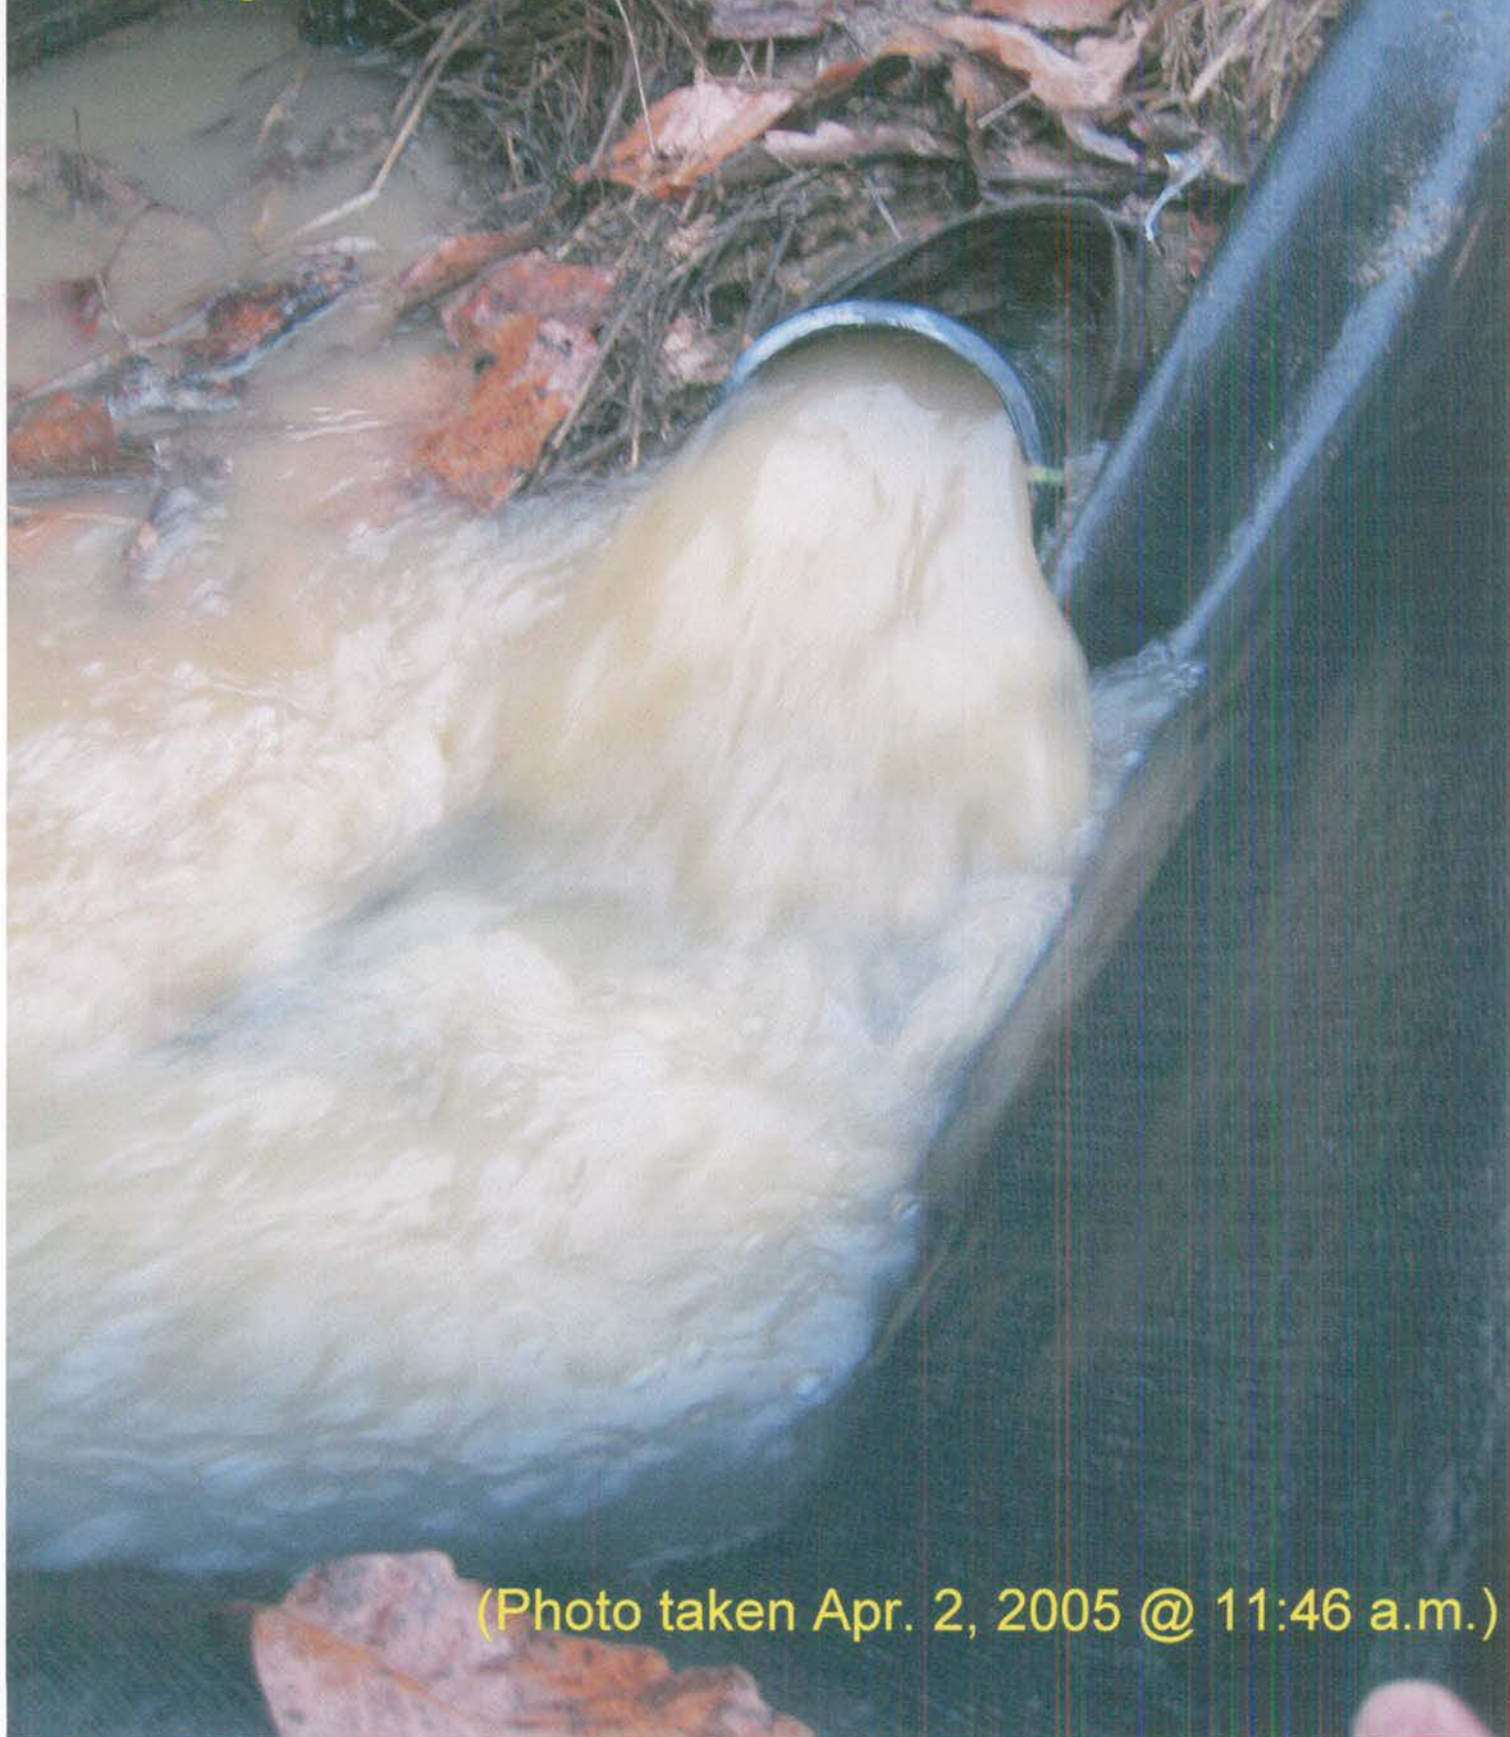
Heavy gush of silty  
water exits submerged  
hose and then bursts  
through/over silt fences a few  
feet downstream.

Silt-filled water gushes from end of drainage hose on park property -- concecntrated drainage from Walled Platform Structure.

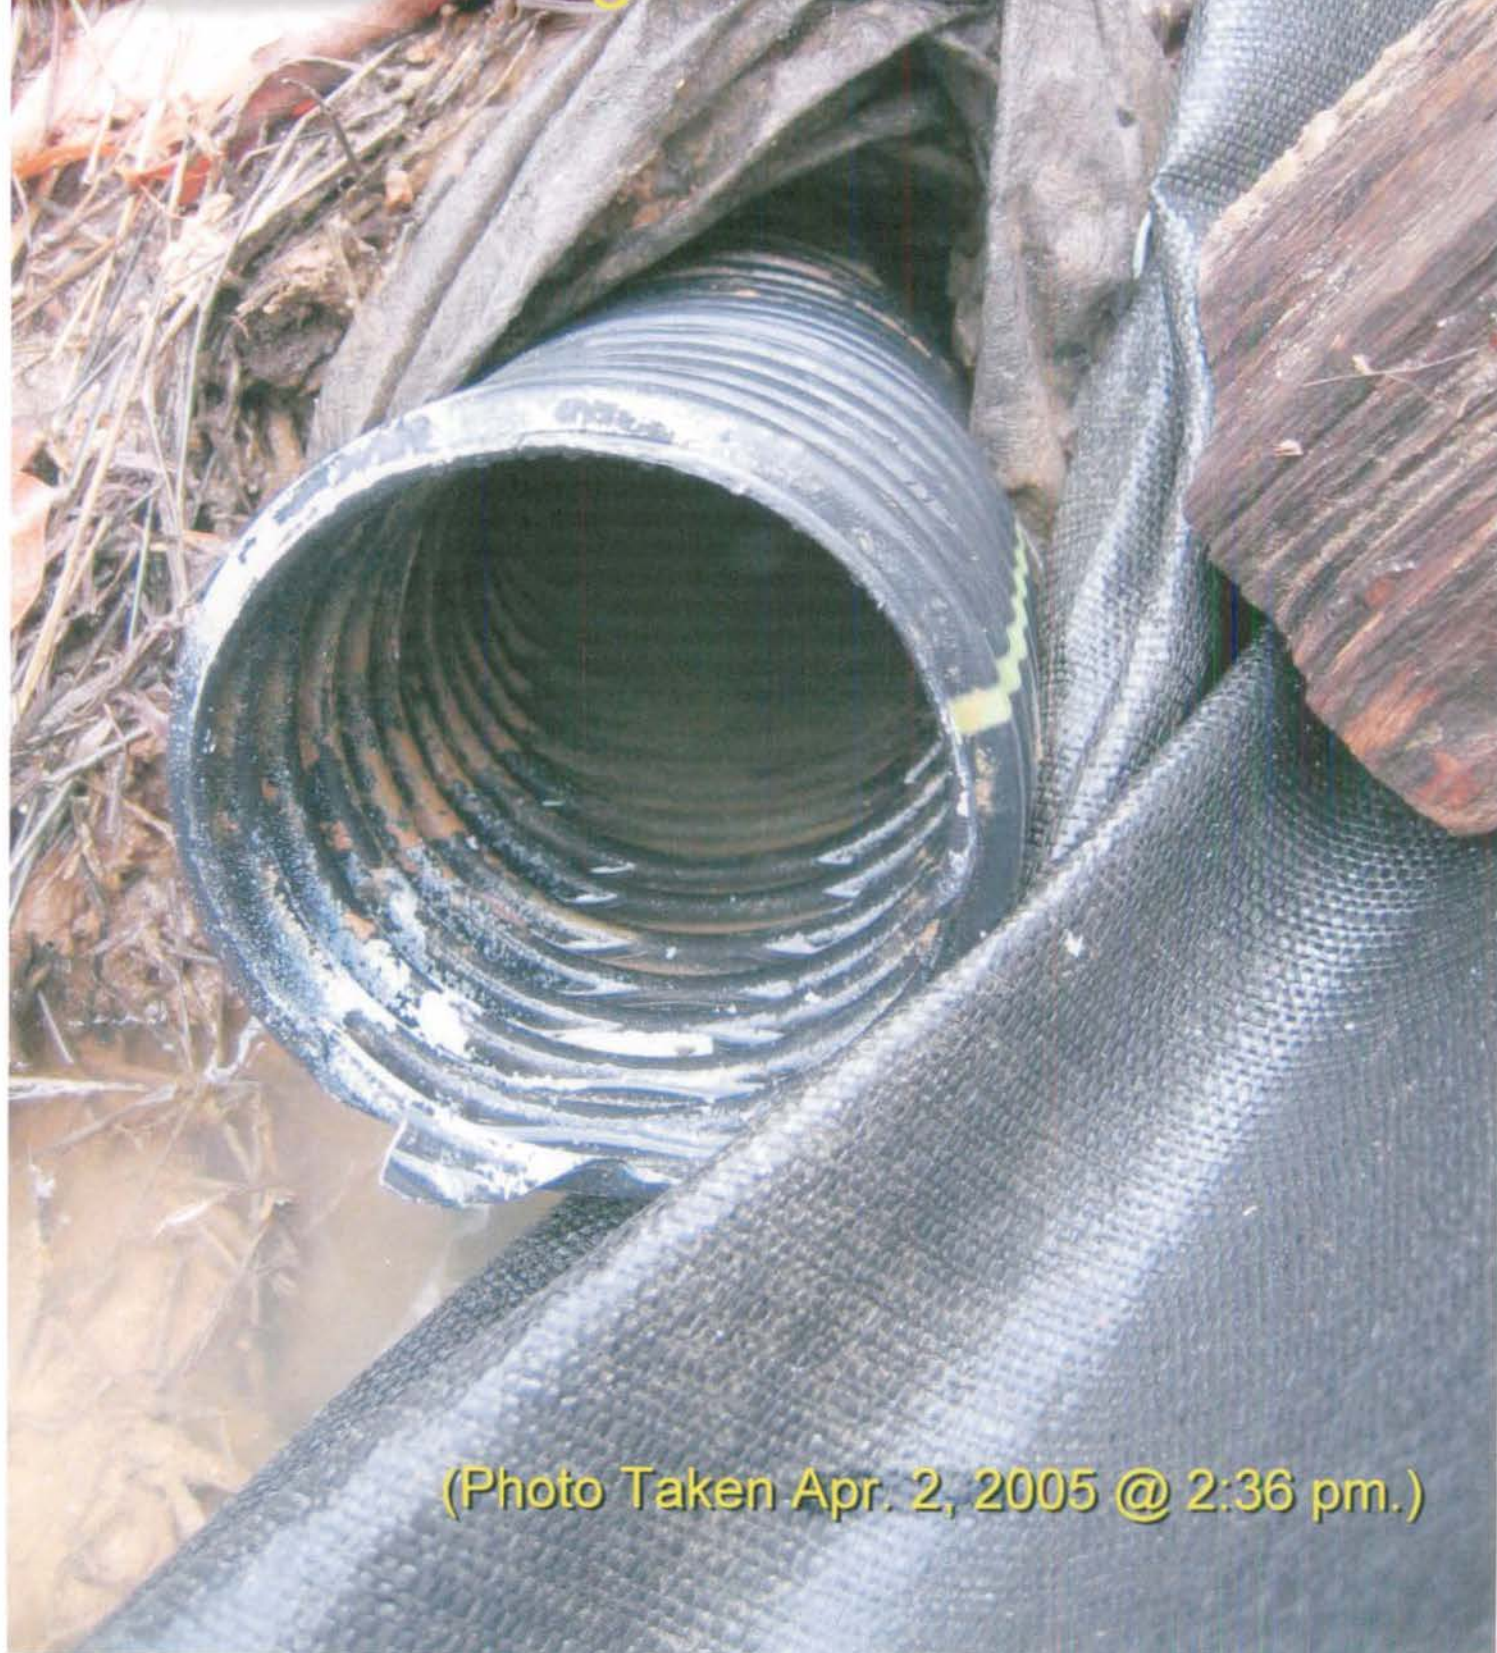
Buried Drainage Hose for Economides  
Walled Platform Structure Surfaces on  
Parkland. This Is Source For Economides  
Streams That Plague Park.

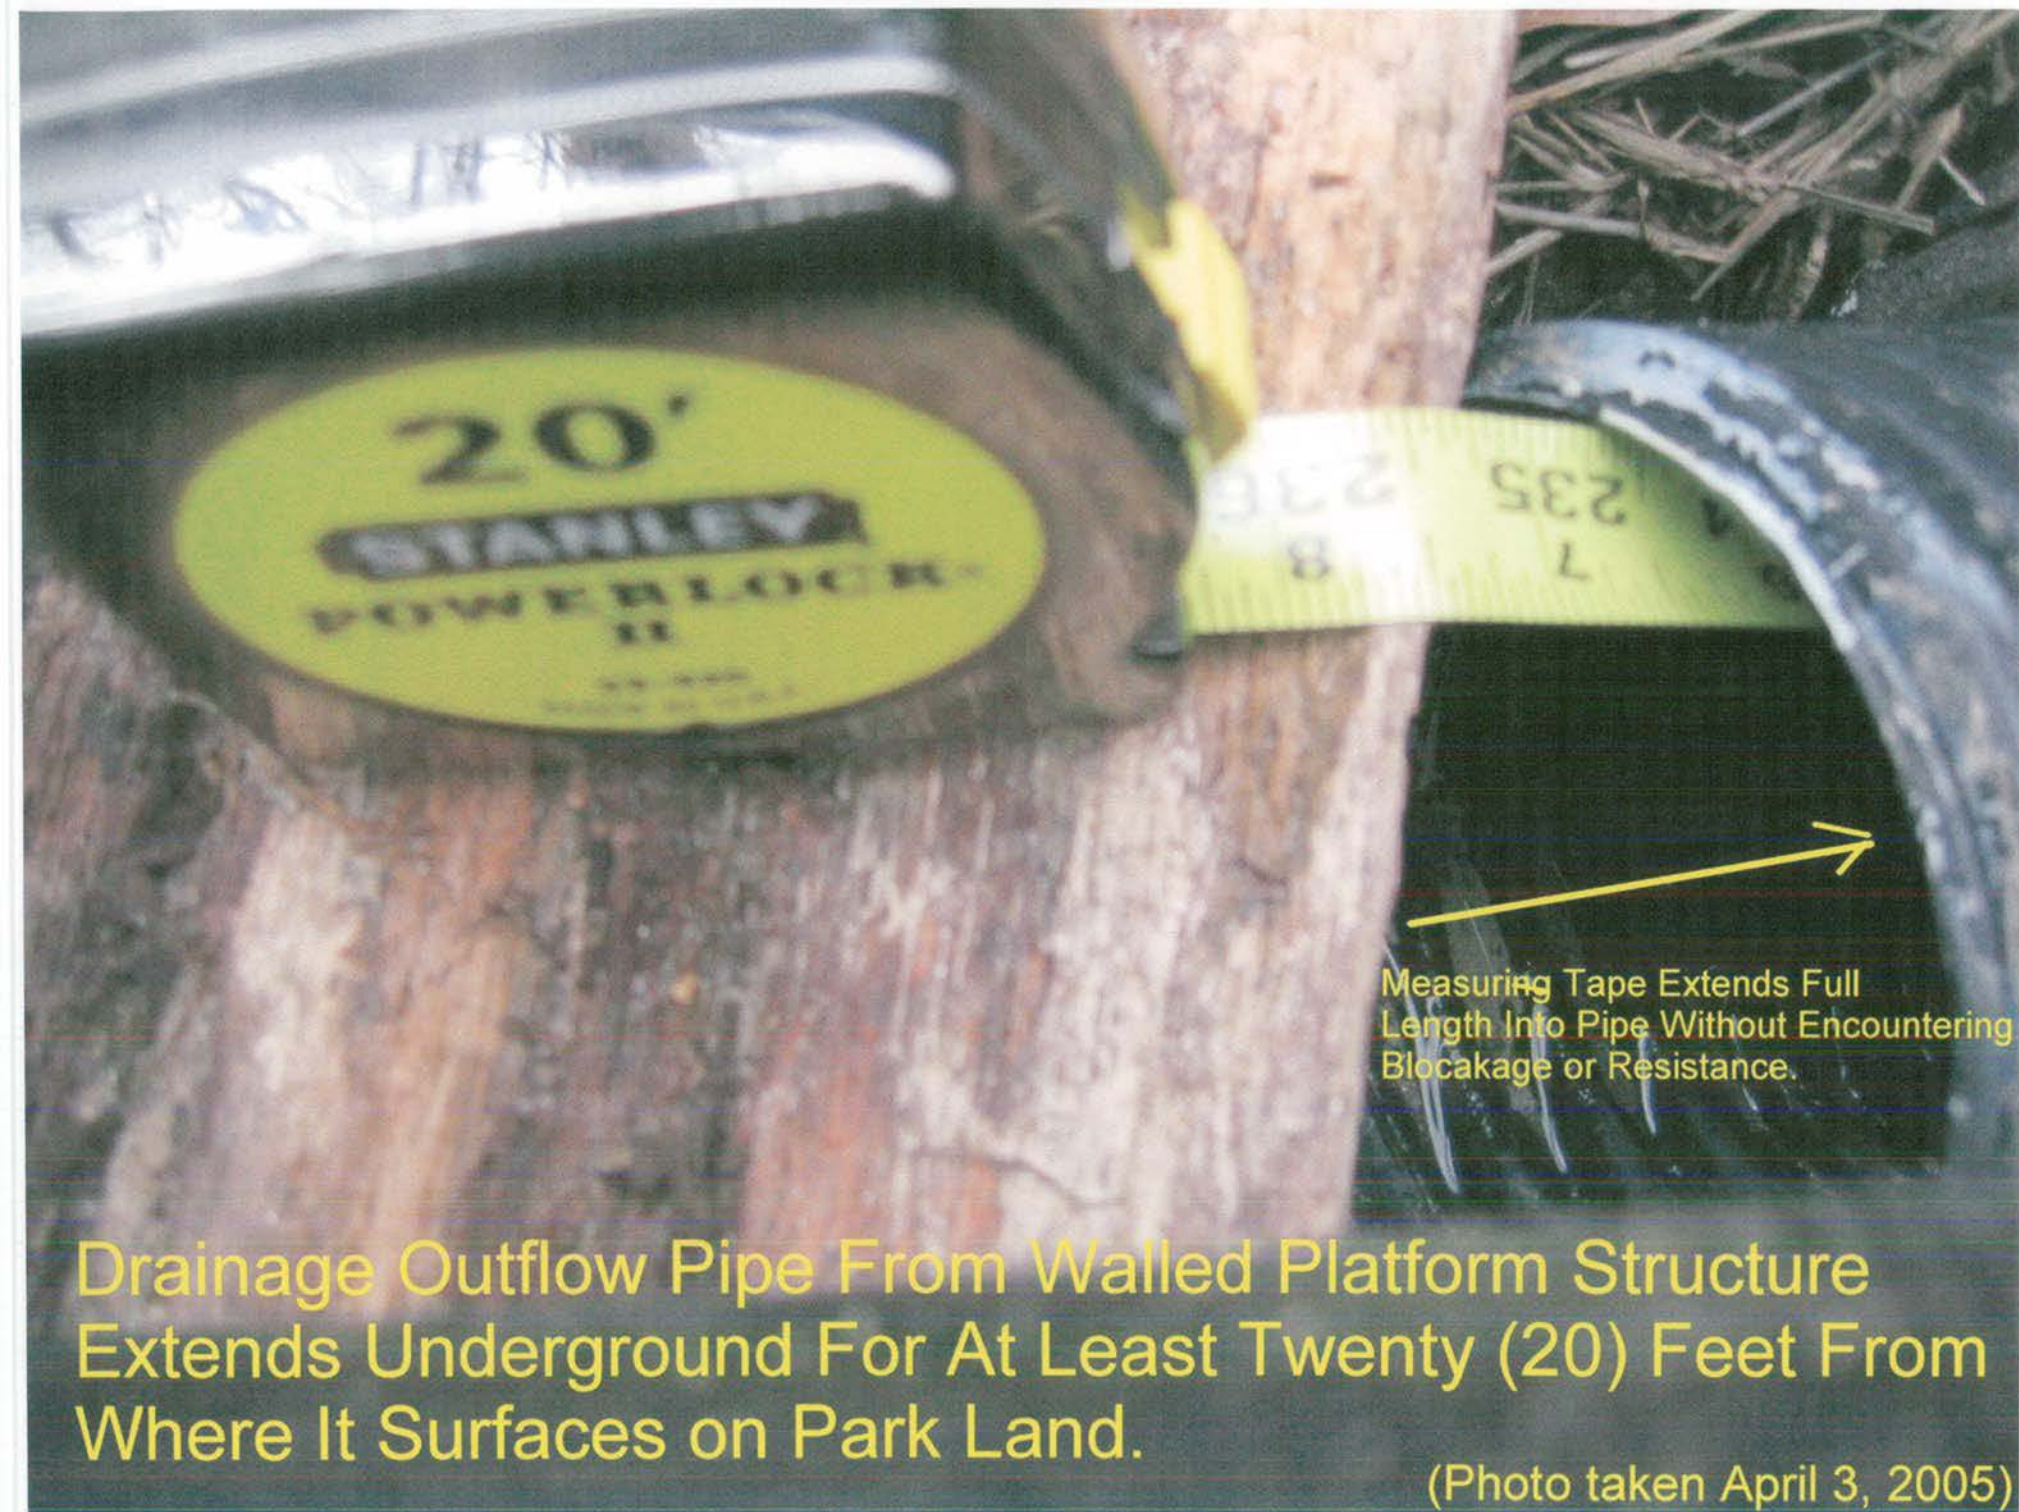
## Drainage Pipe from Walled Platform Structure Emerges on Parkland.

Note: Buried Pipe Is  
Wrapped In Waterproof Sheeting.

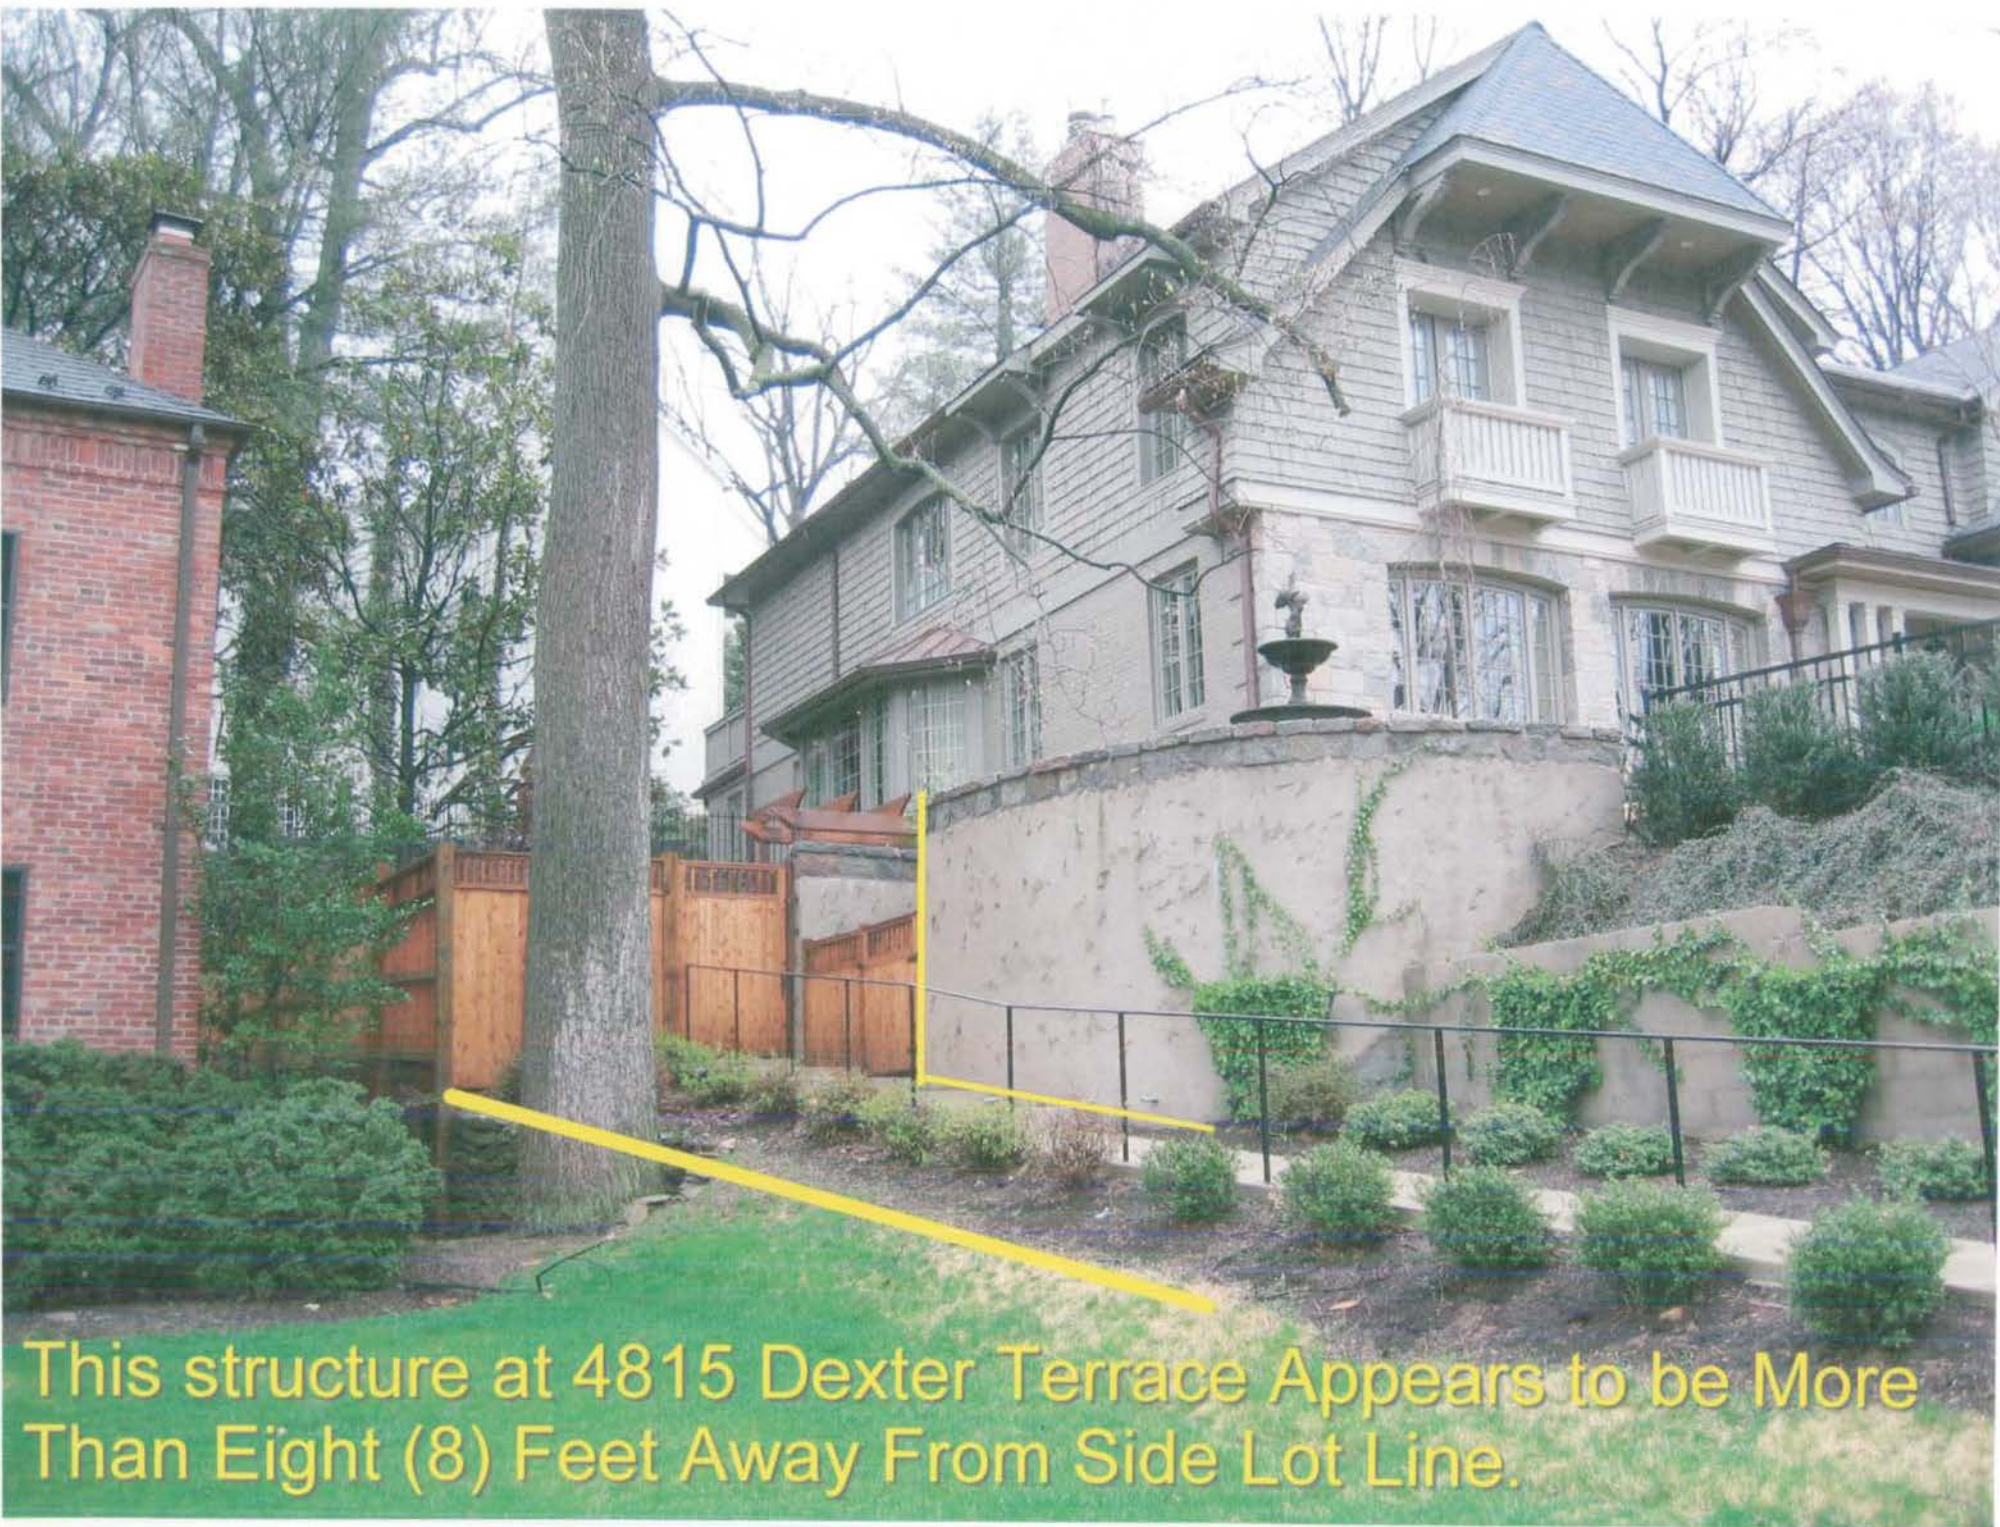
4. Attached as Exhibit D hereto is an annotated photograph that fairly and accurately depicts a concentrated stream of water cascading from between two courses of mesa blocks near the top of the exterior northern wall of the Walled Platform Structure during a period of rain on April 2, 2005.

Water Cascades From Between Blocks of Northern Exterior Wall of Walled Platform Structure During Rain. (Photo taken Apr. 2, 2005.)

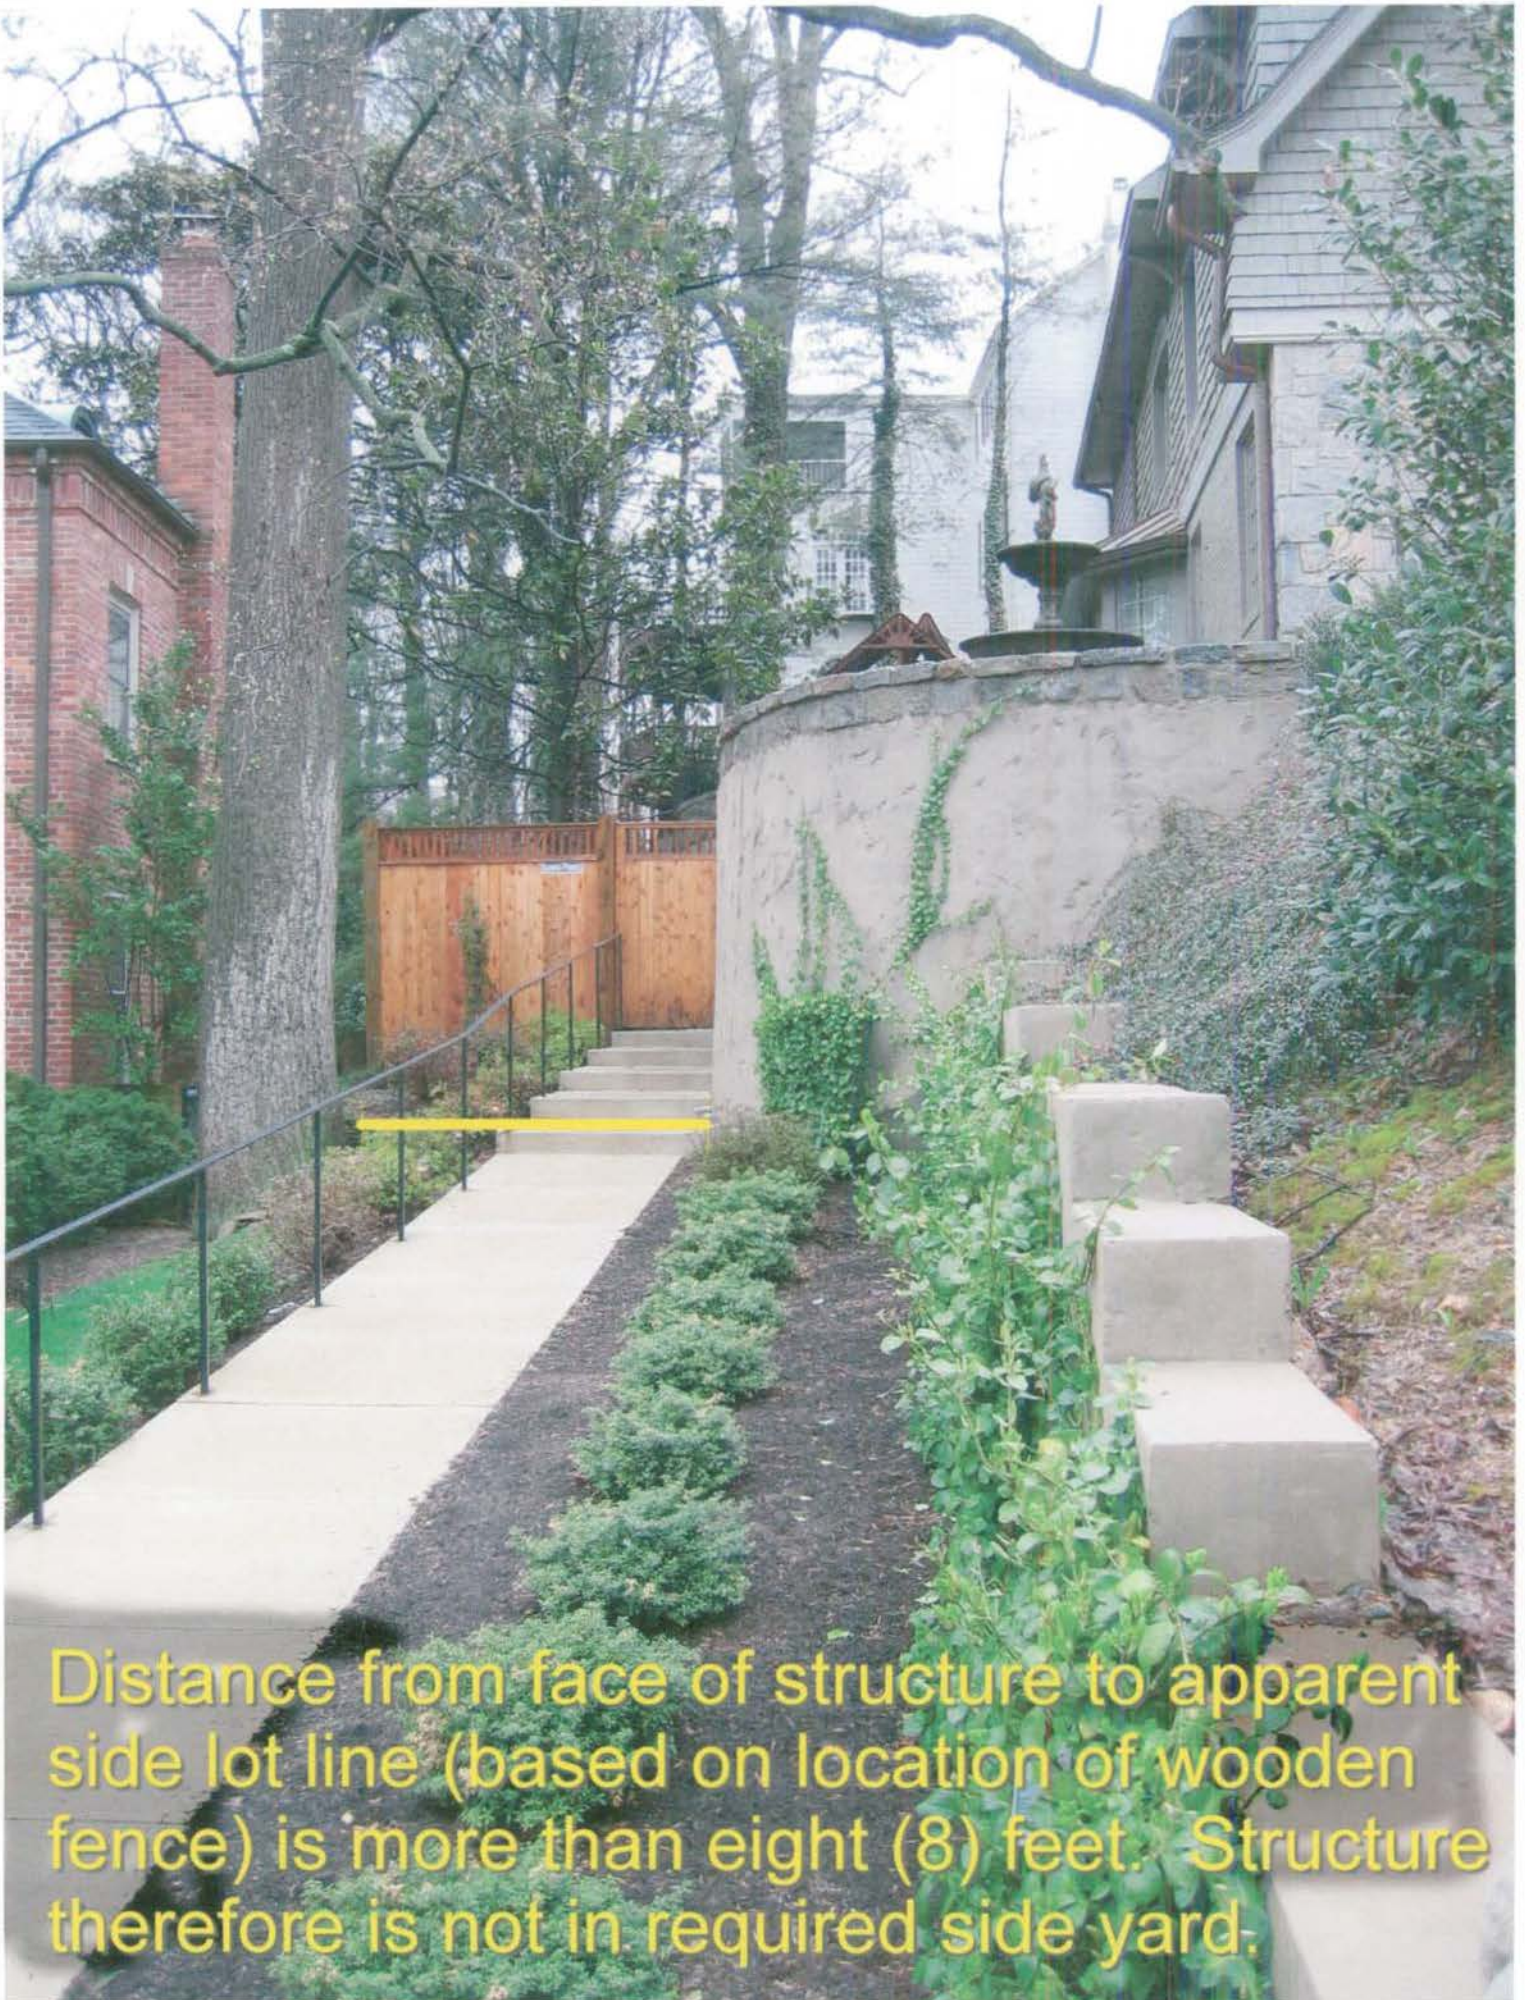
This structure at 4815 Dexter Terrace Appears to be More Than Eight (8) Feet Away From Side Lot Line.
