Re: *BZA Appeal No. 17285*

4825 Dexter Terrace, NW  
Frank & Dina Economides, Owners

BZA Appeal No. 17285

**THIRD AFFIDAVIT OF PATRICK J. CAROME**

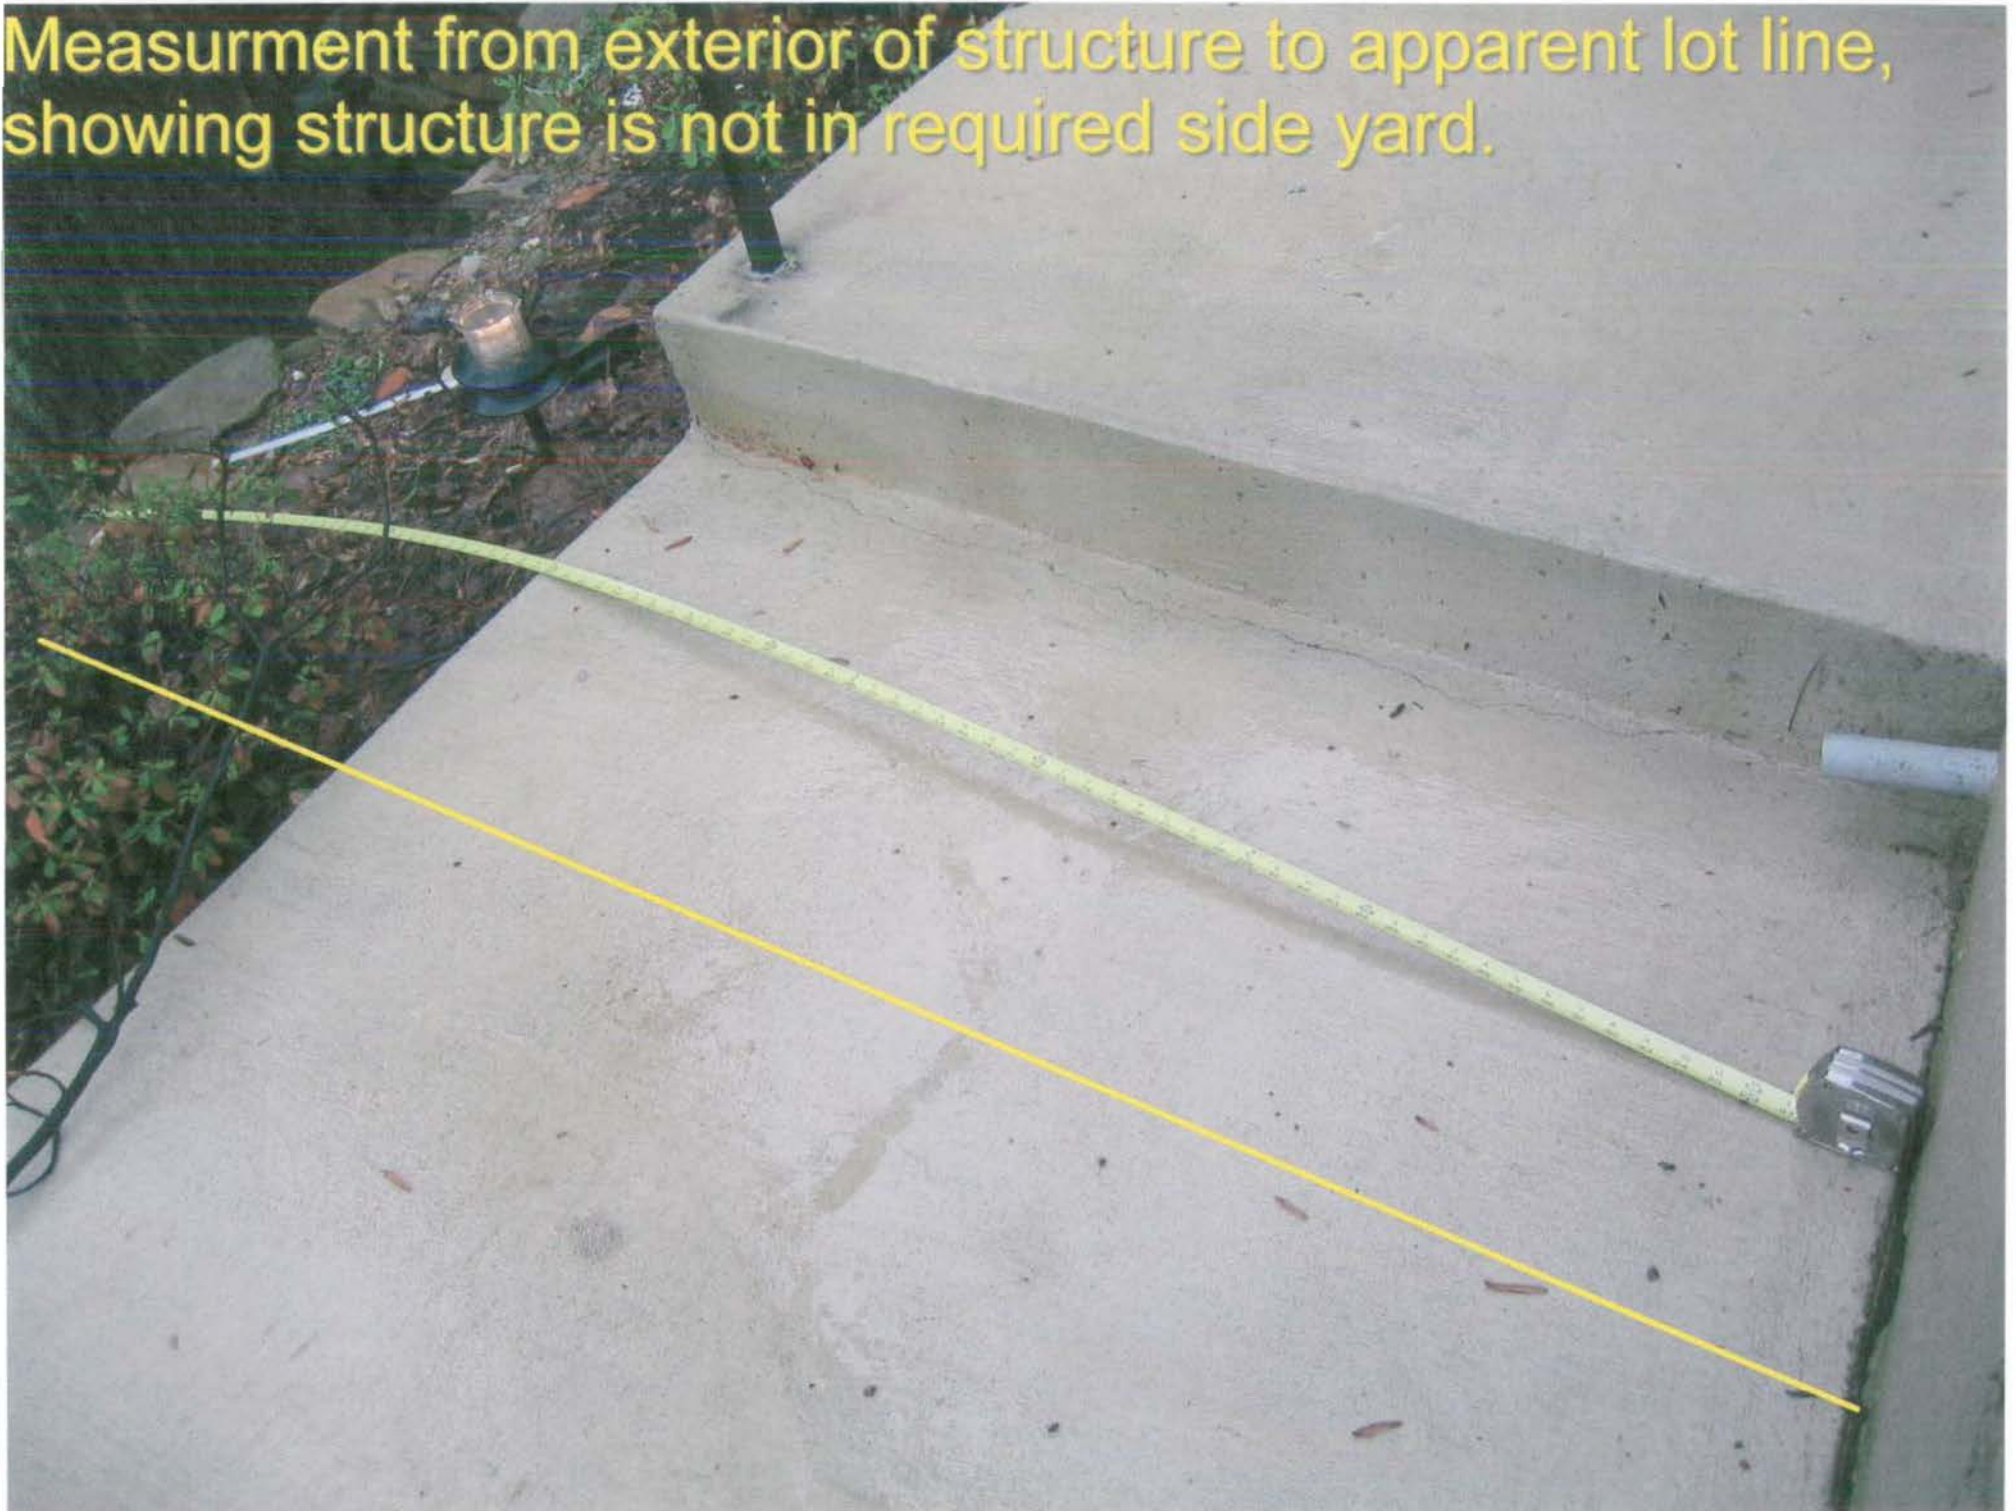
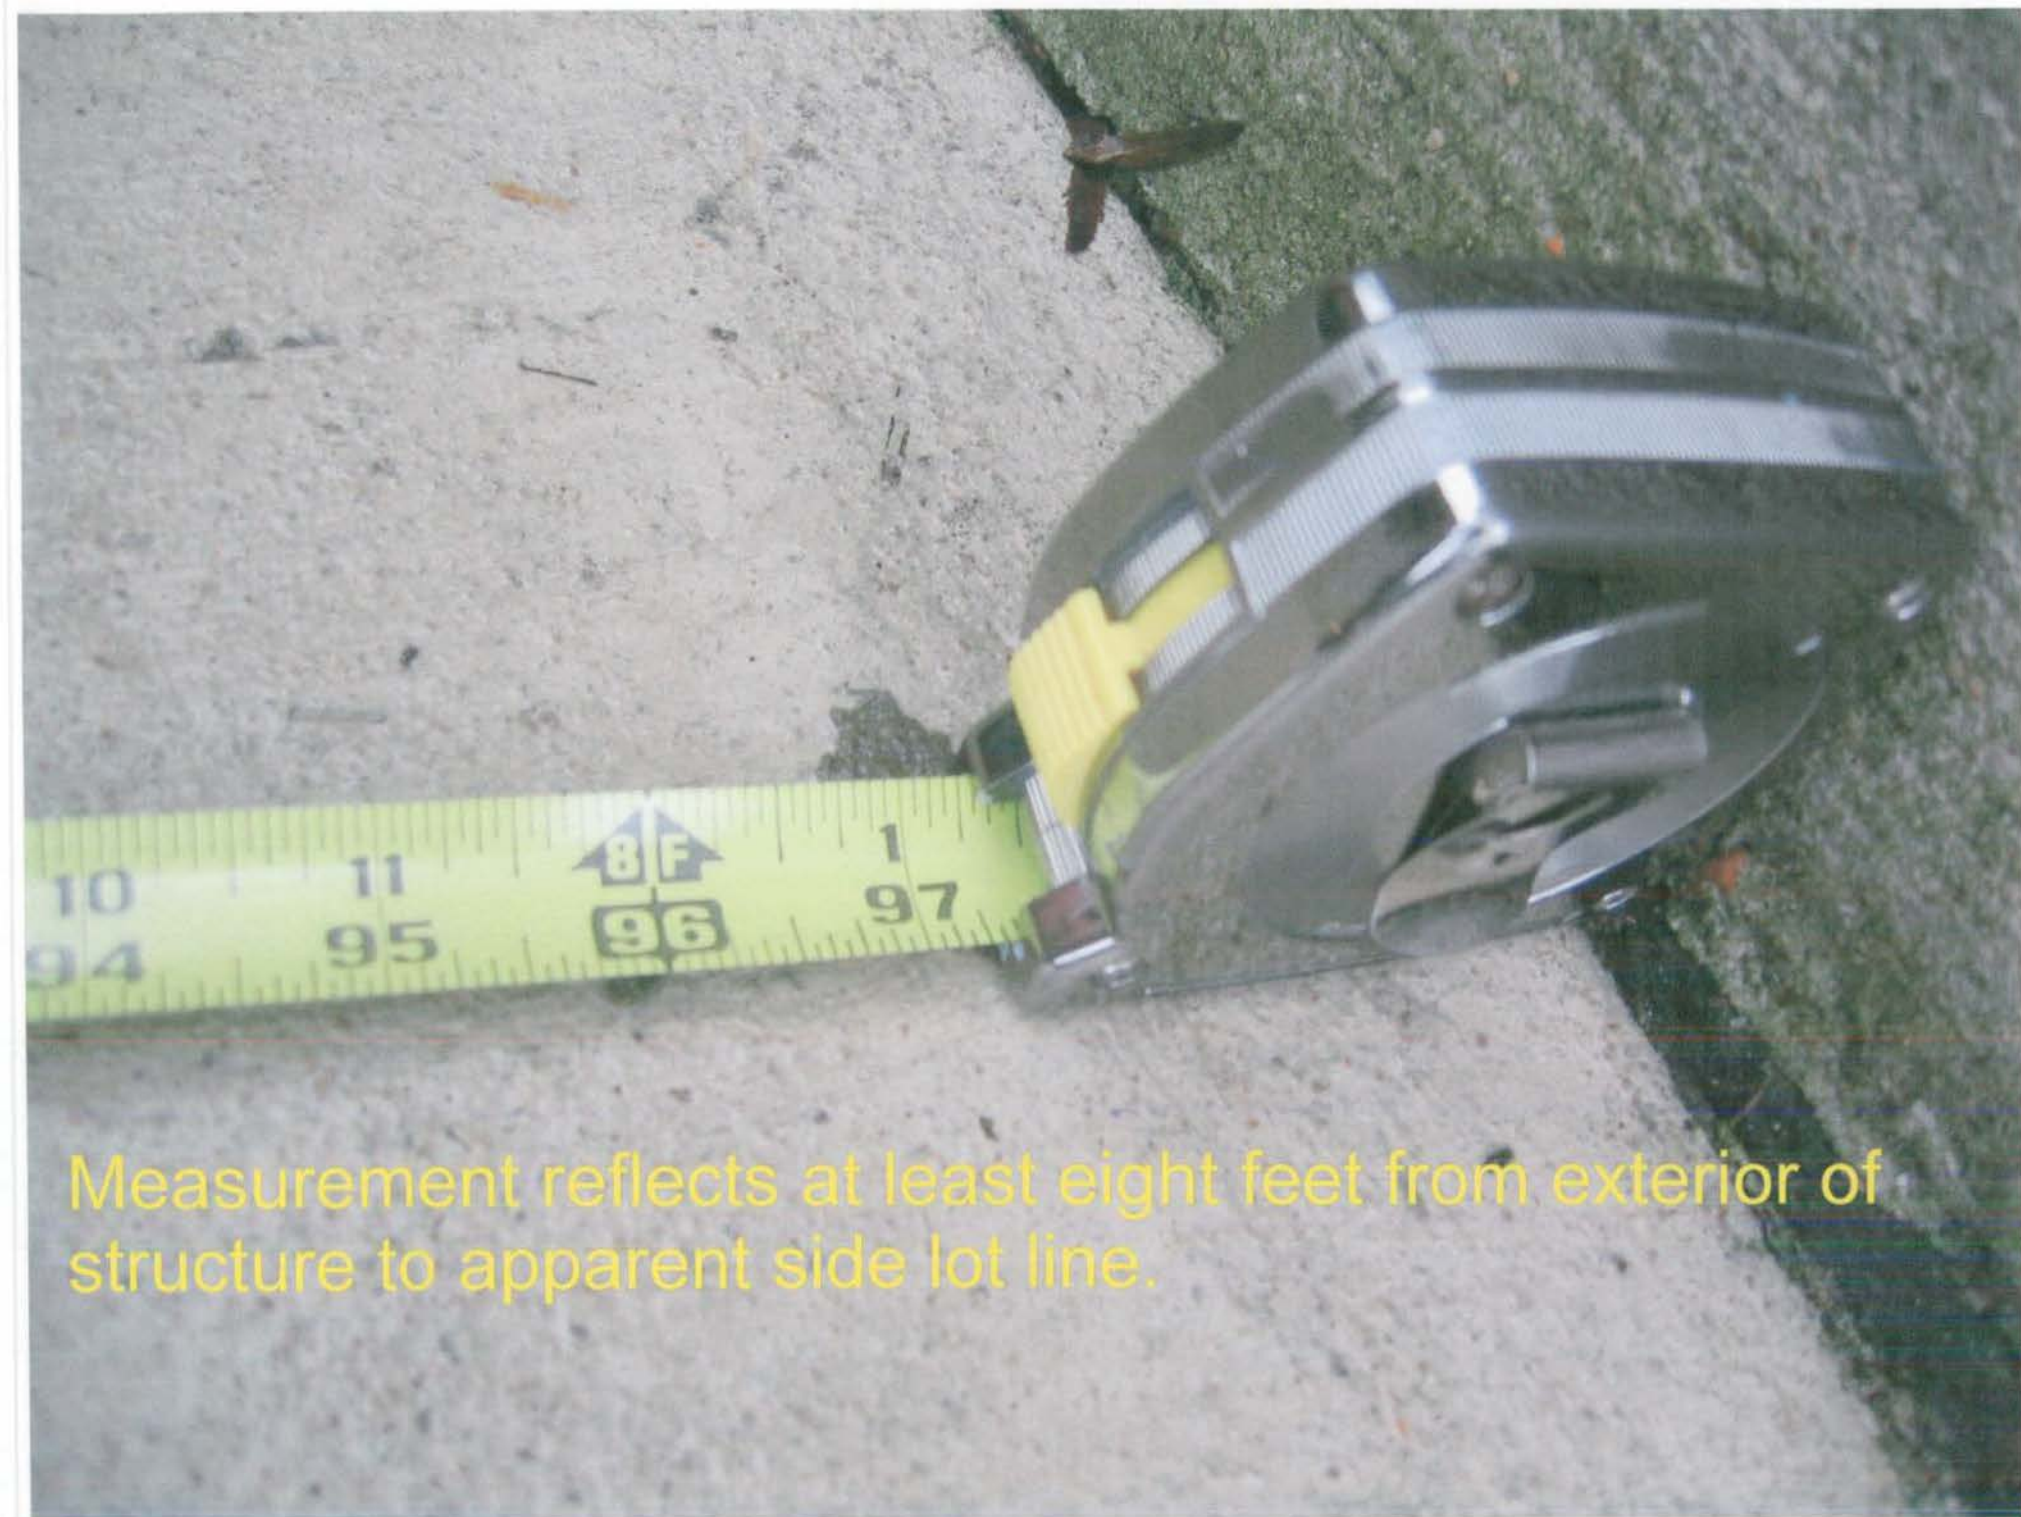
Measurement from exterior of structure to apparent lot line, showing structure is not in required side yard.

Measurement reflects at least eight feet from exterior of structure to apparent side lot line.

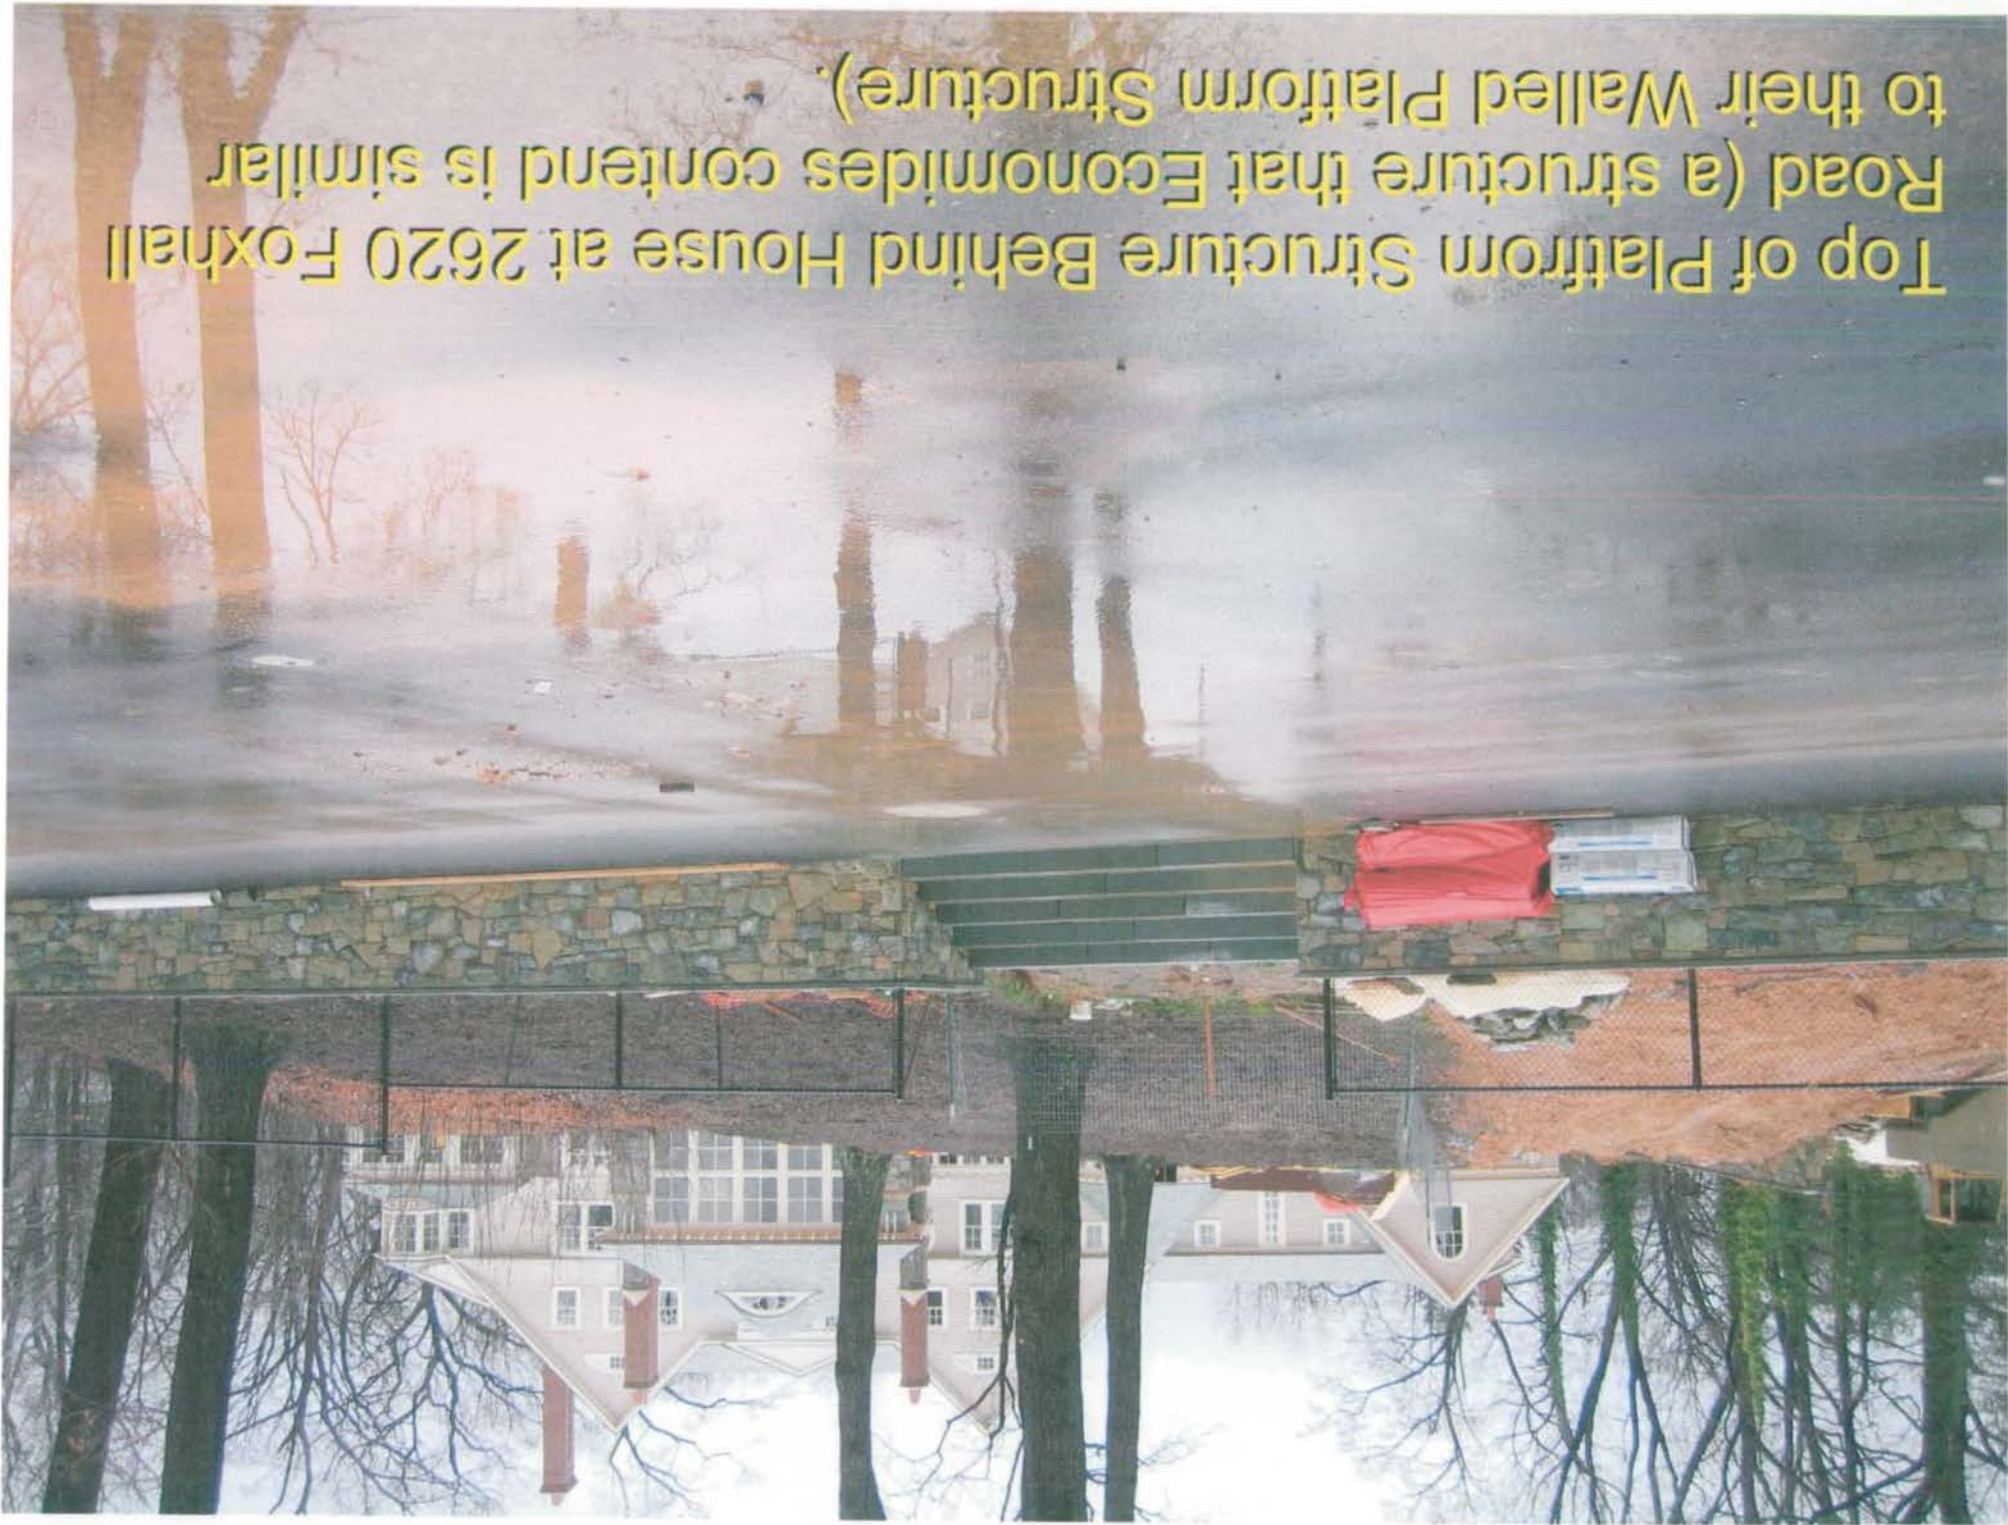
Top of Platform Structure Behind House at 2620 Foxhall Road (a structure that Economides contend is similar to their Walled Platform Structure).

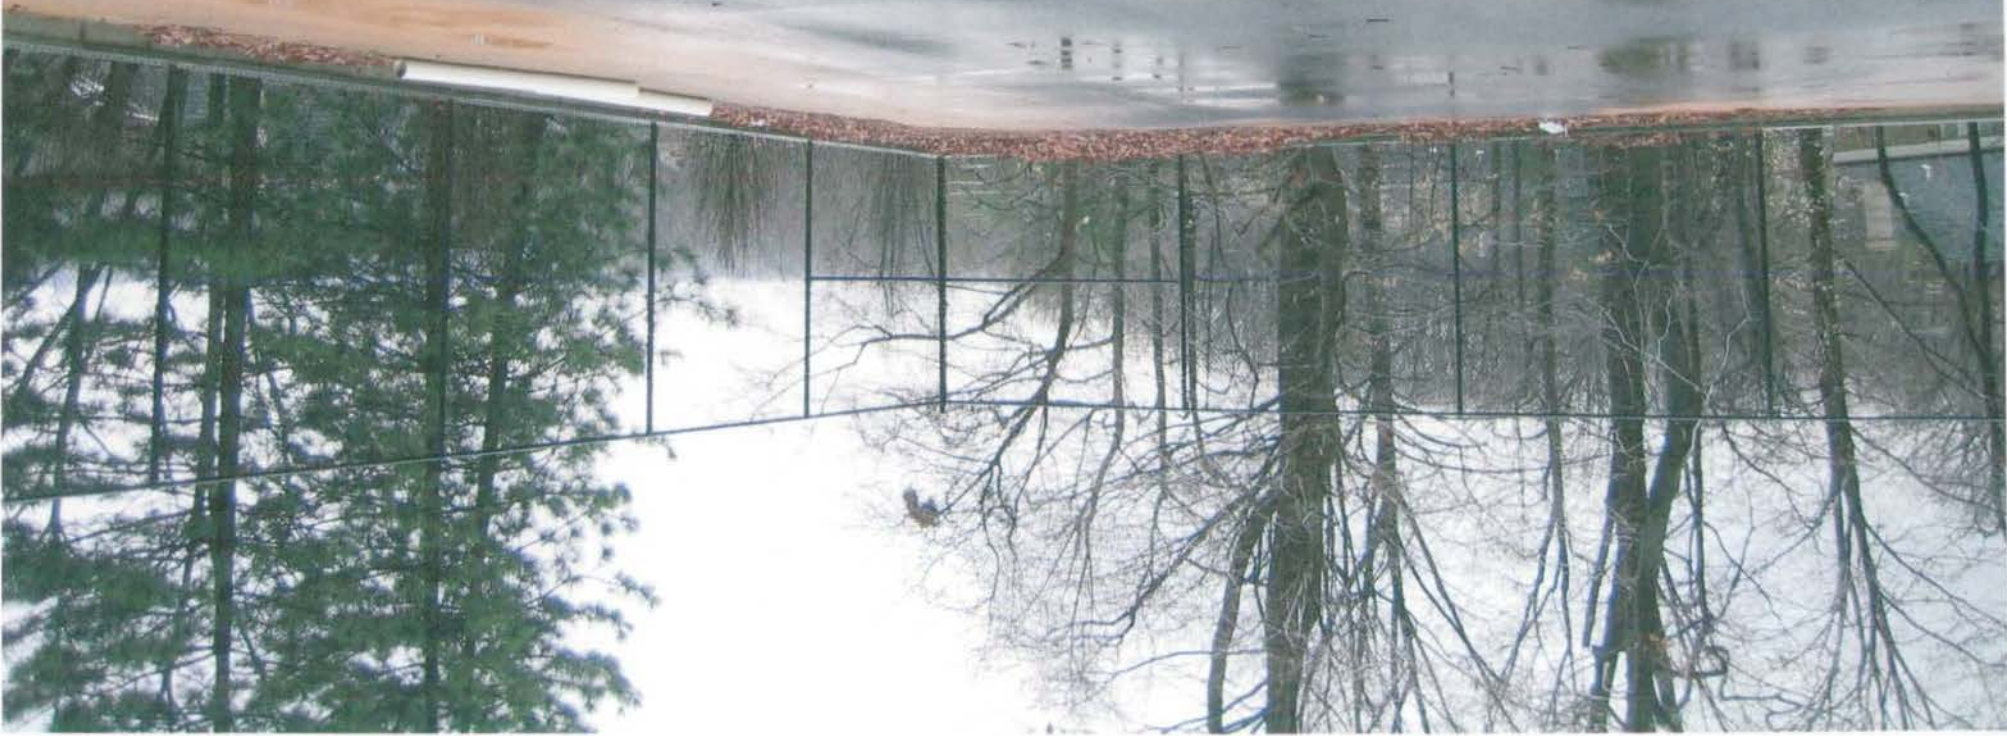
Another View of Paved Top Surface of Platform Structure at 2620 Foxhall Road (supposedly comparable structure identified by Economides) (outside of WHOD) (no evidence in record regarding proximity to lot lines or any relevant zoning decision).

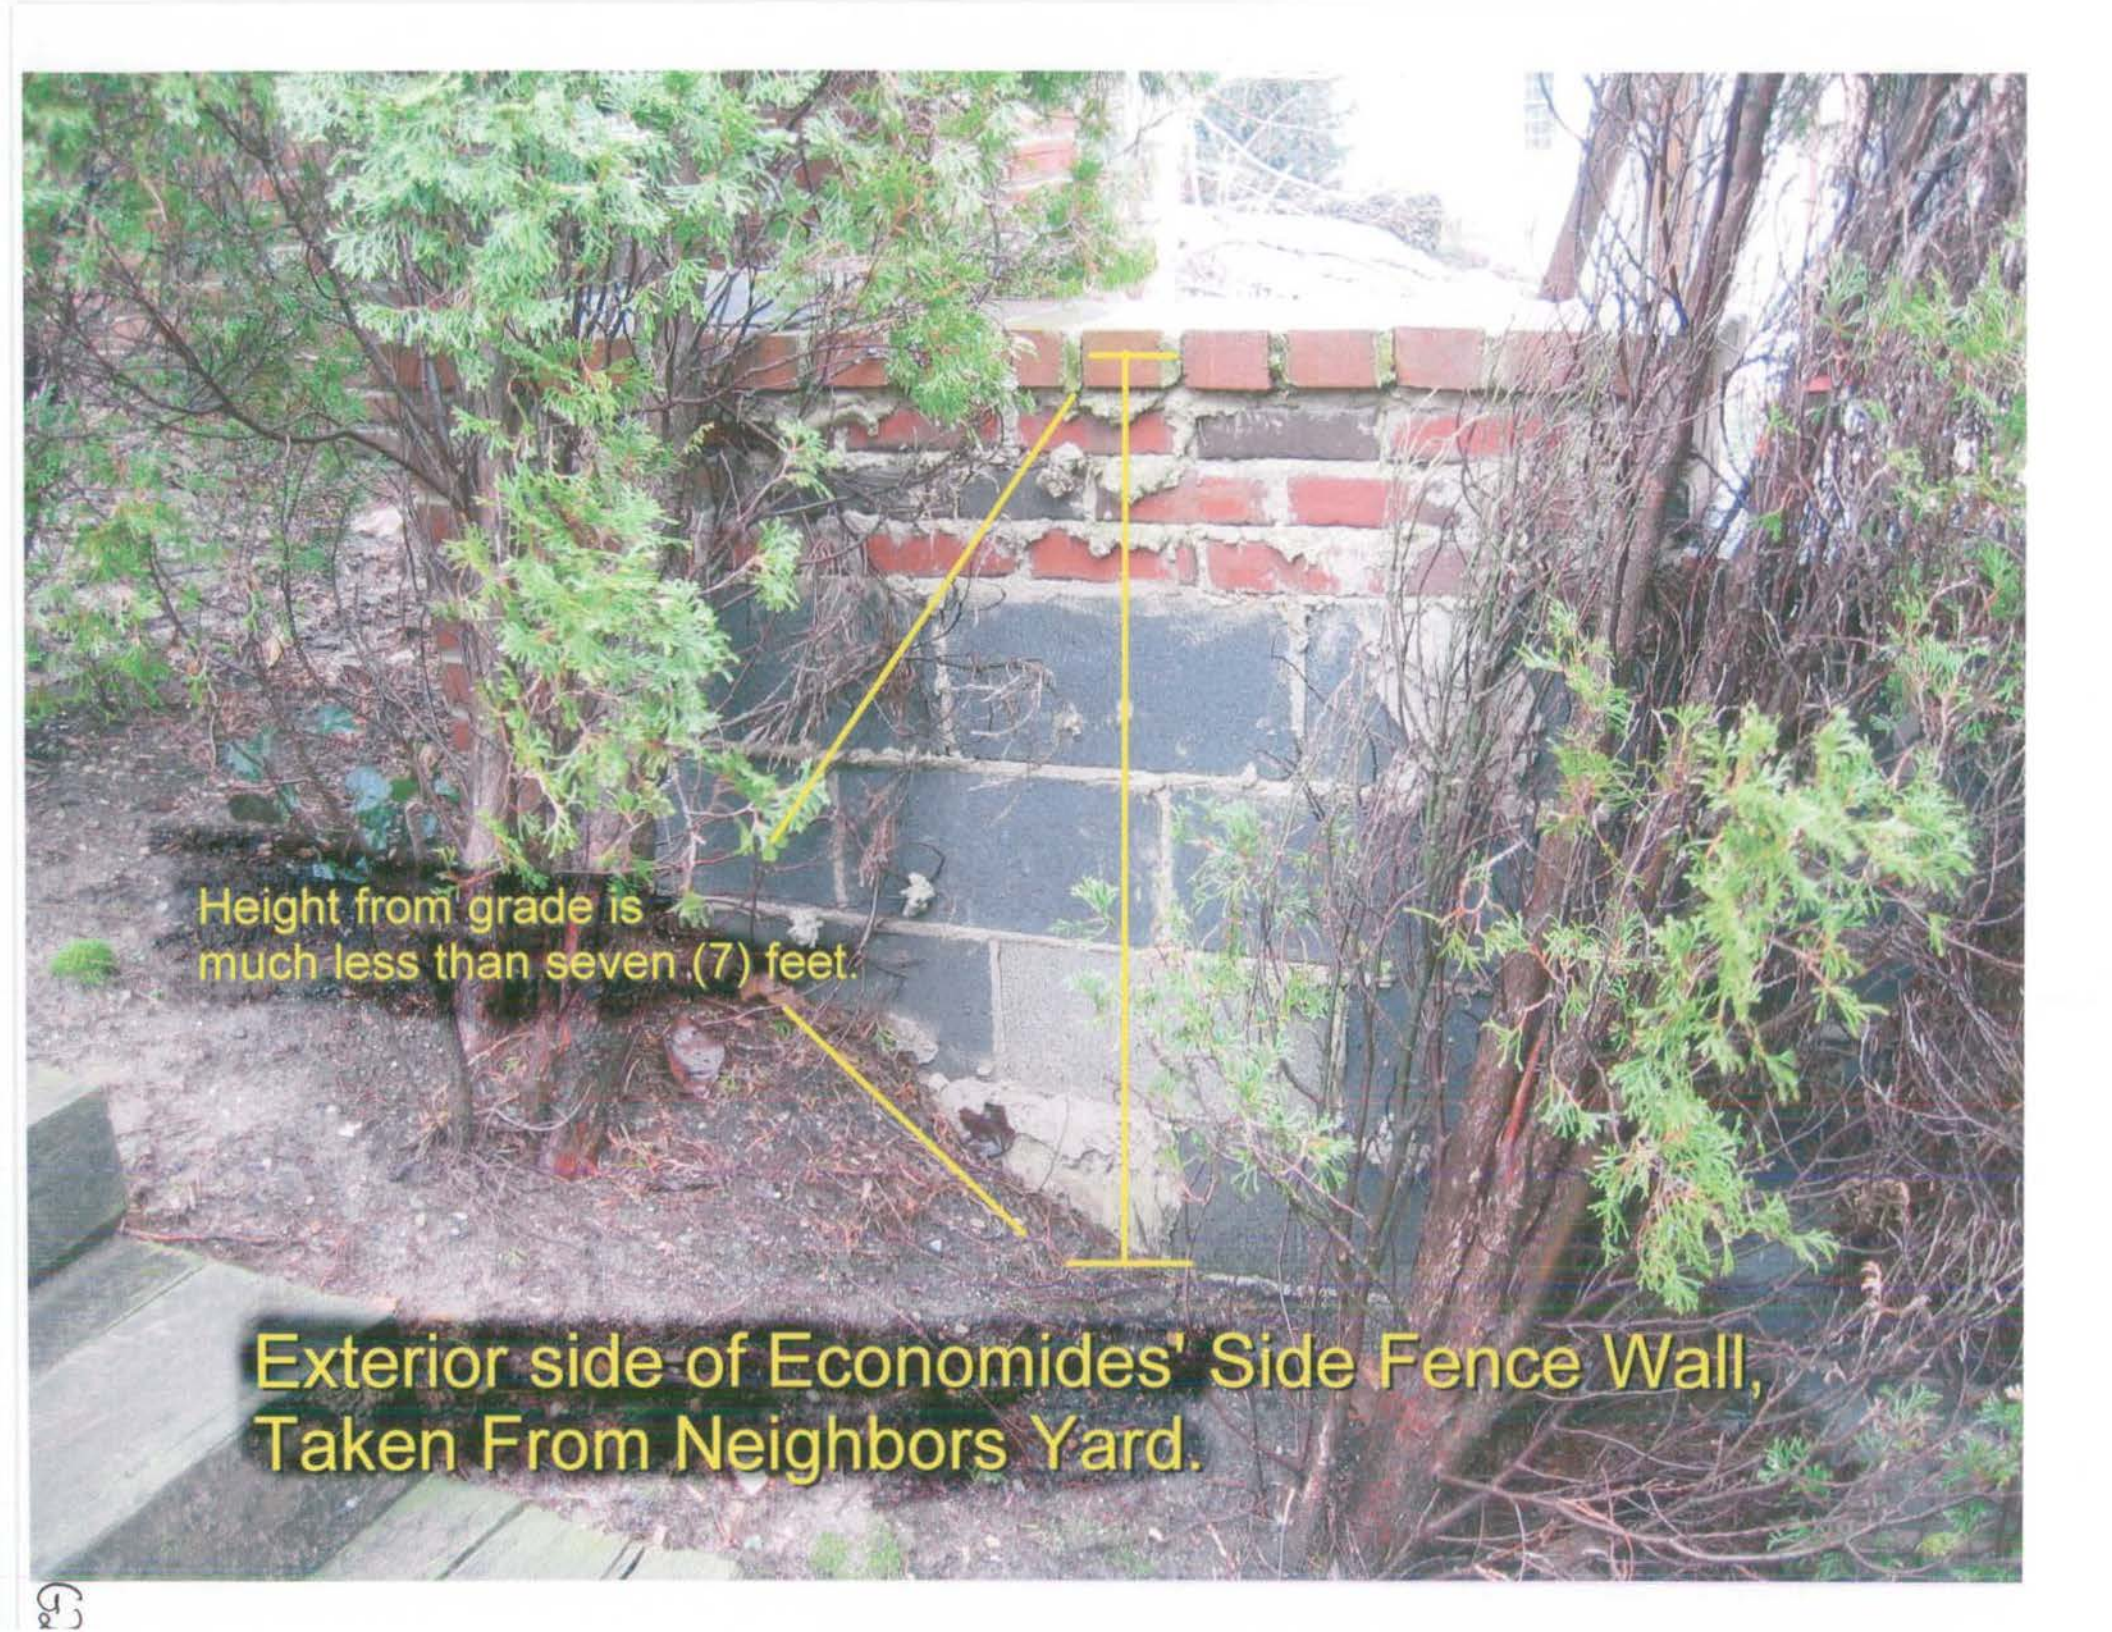
Note: pre-existing grade on outside of wall is just a few feet below top of wall.

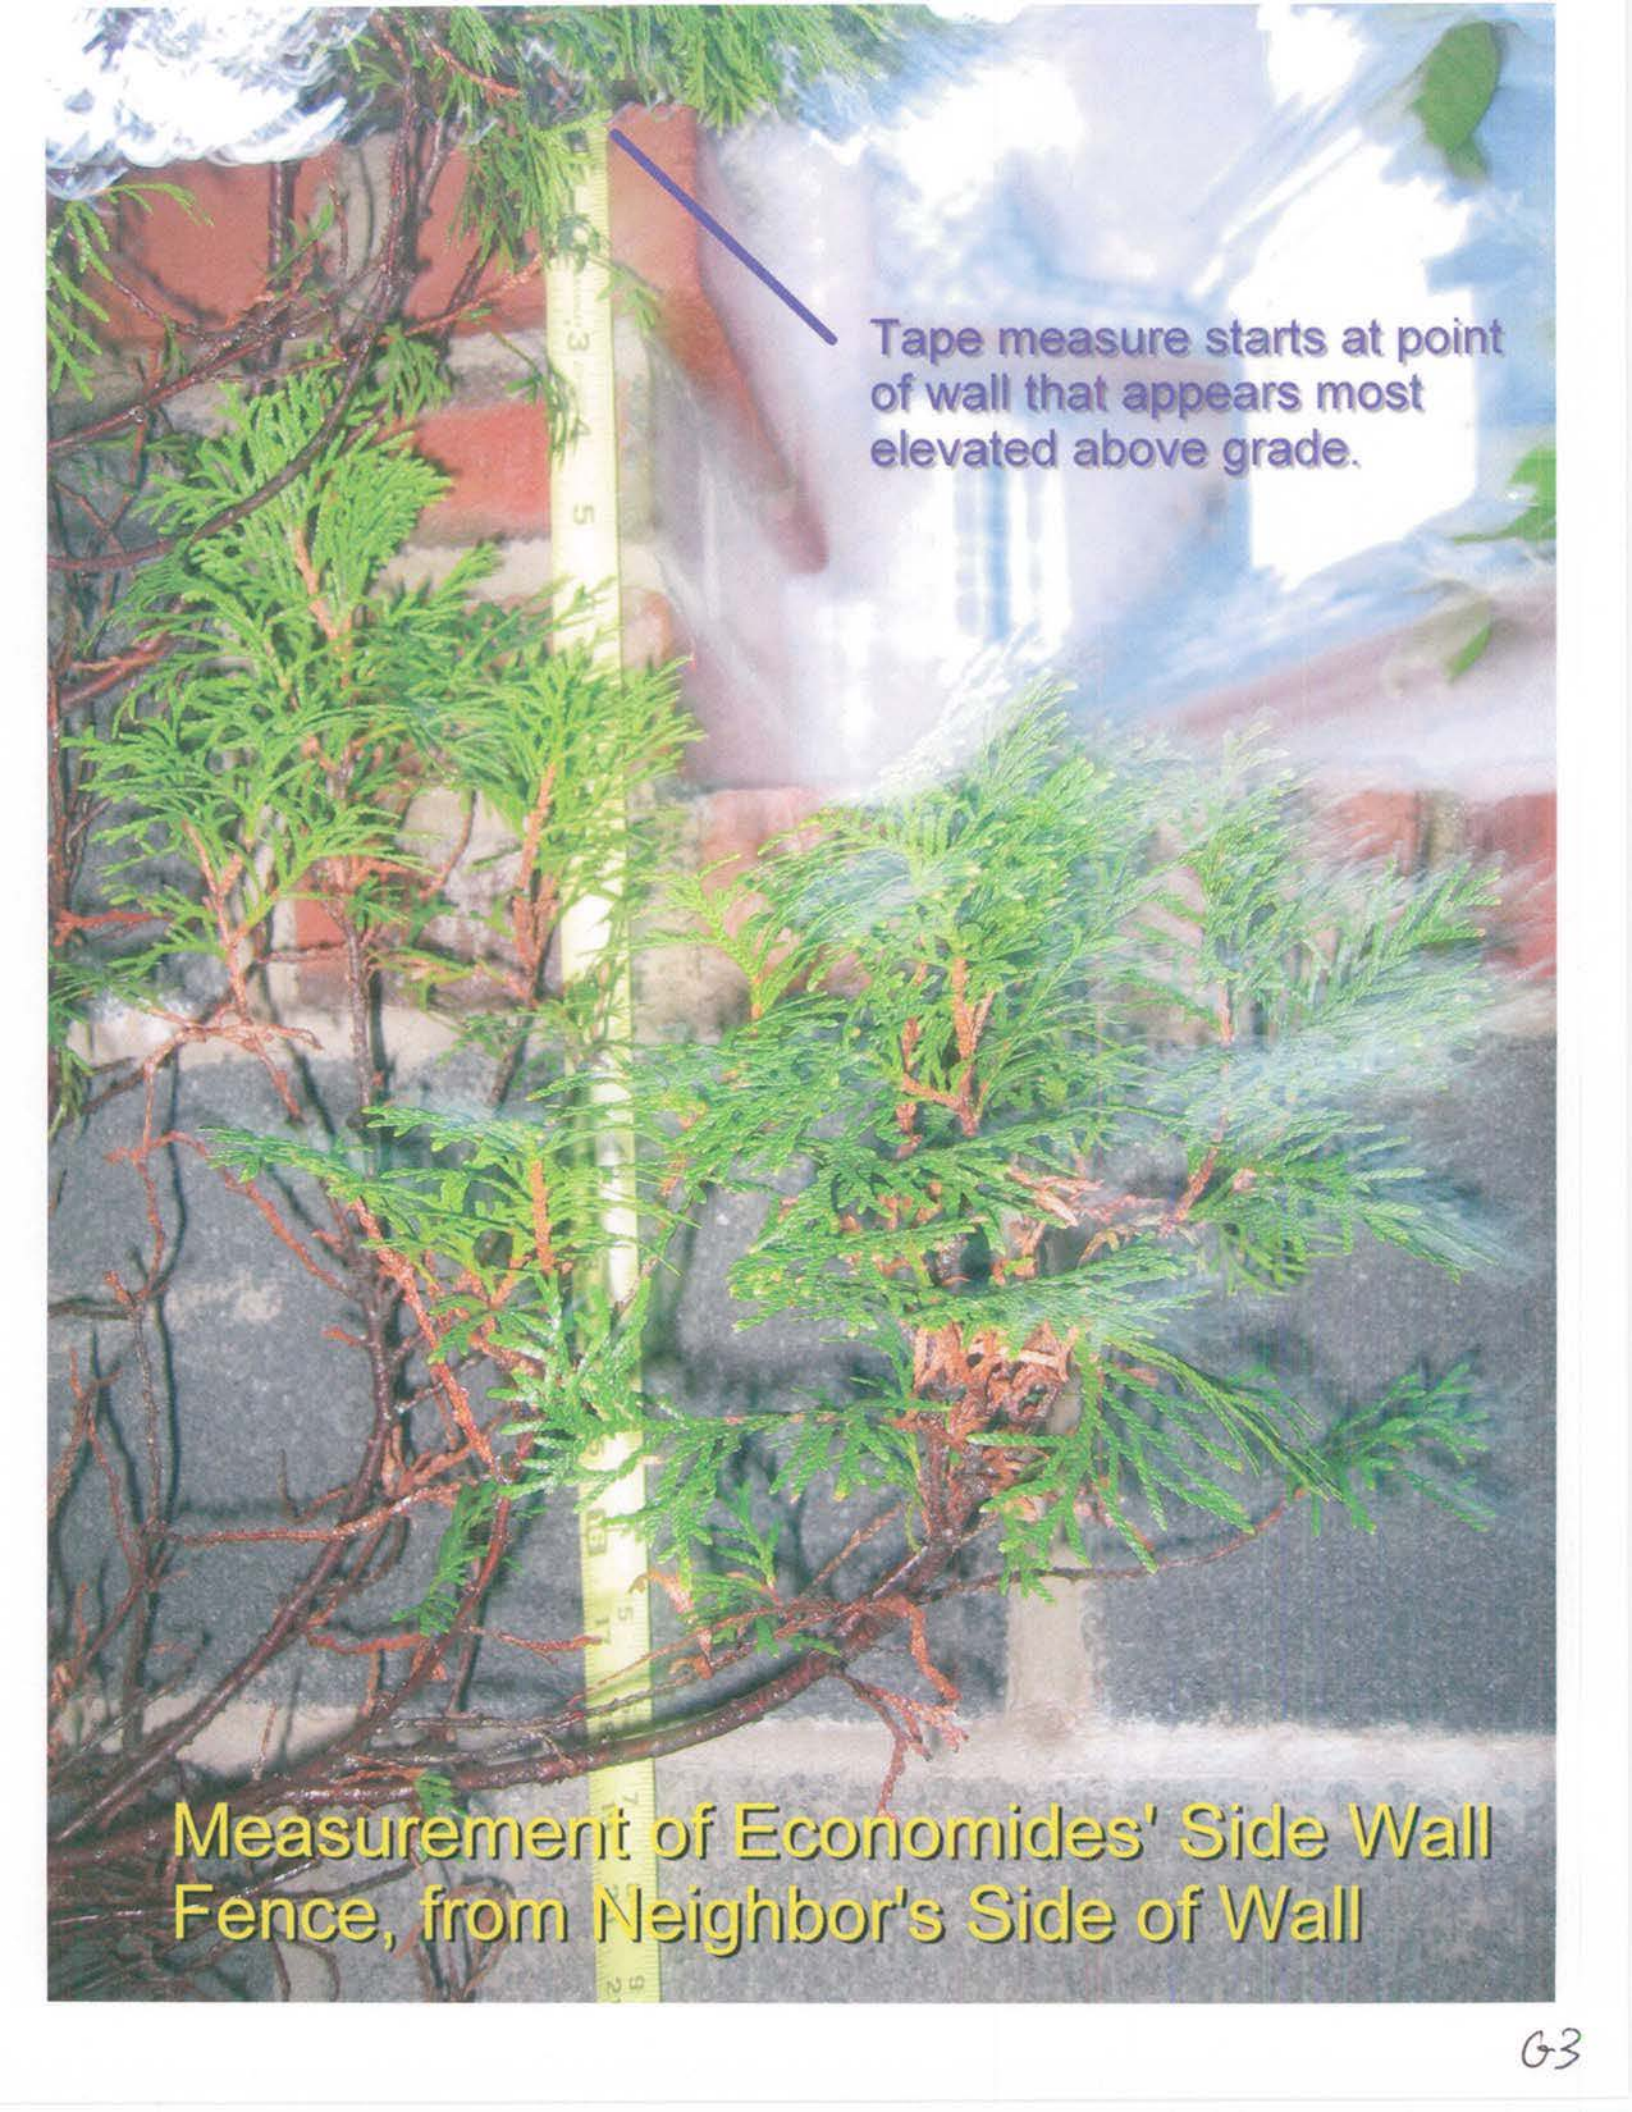
Height from grade is  
much less than seven (7) feet.

Exterior side of Economides' Side Fence Wall,  
Taken From Neighbors Yard.

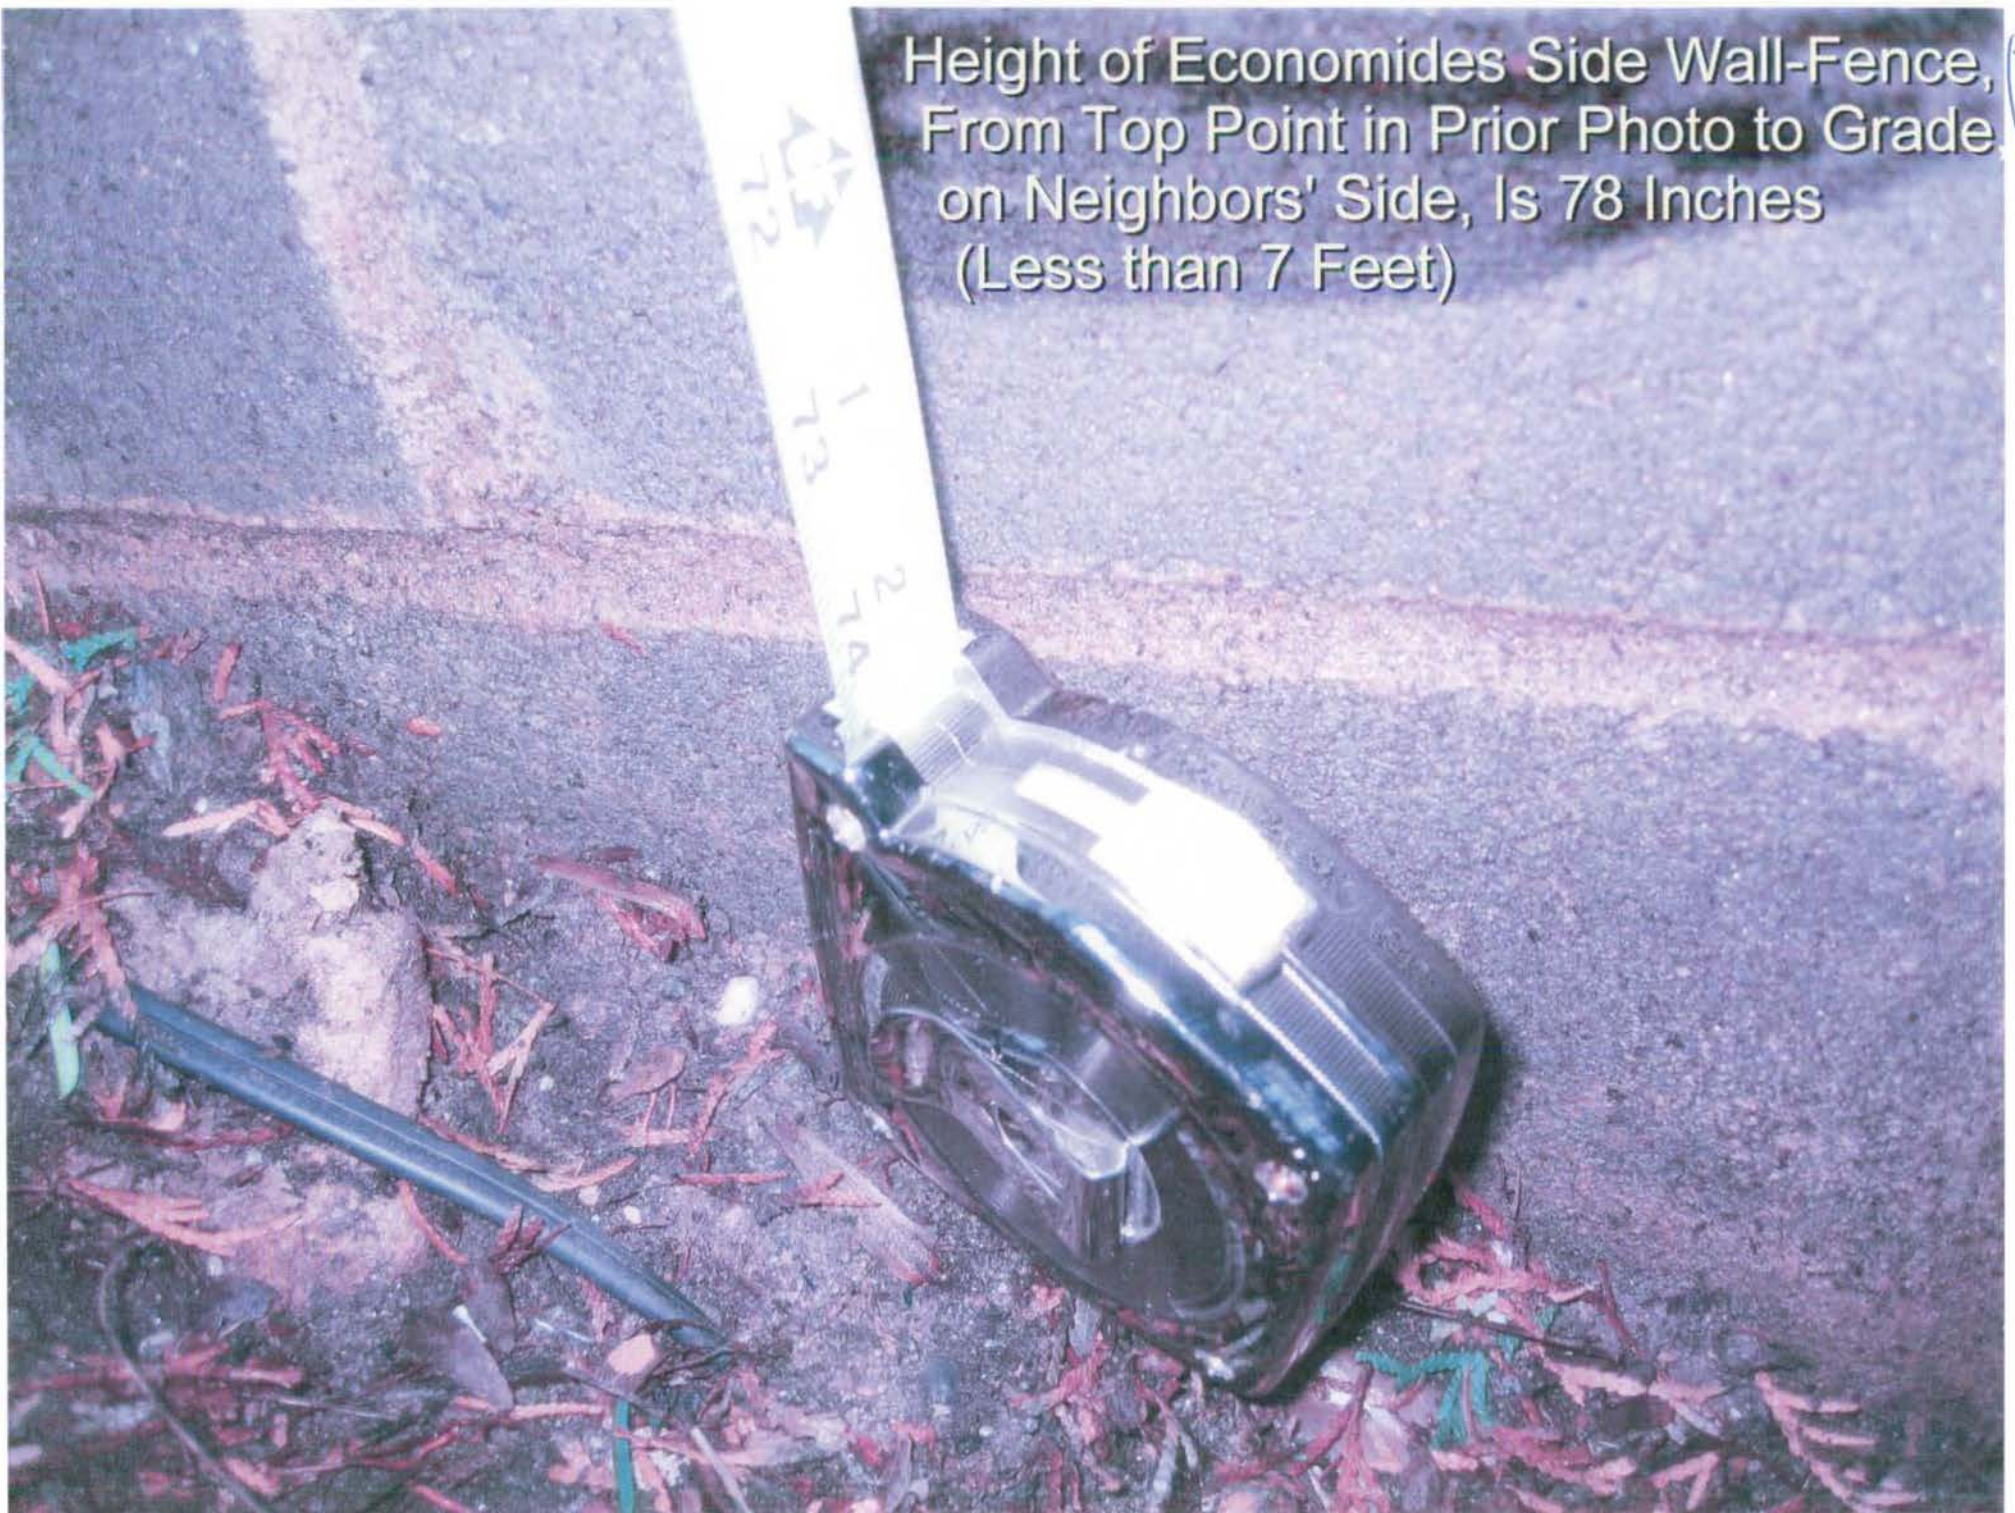
Tape measure starts at point  
of wall that appears most  
elevated above grade.

Measurement of Economides' Side Wall  
Fence, from Neighbor's Side of Wall

Height of Economides Side Wall-Fence,  
From Top Point in Prior Photo to Grade  
on Neighbors' Side, Is 78 Inches  
(Less than 7 Feet)
