Richard Jones, Consulting Arborist

Arborist Narrative

6629 Piney Branch Rd NW

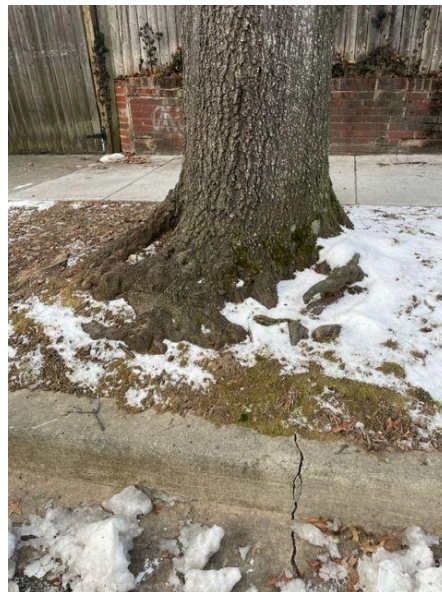
23" Scarlet oak. Notice cracking curb, recently repaired sidewalk, retaining wall, girdling roots and mounded root flares.

The scarlet oak is in fair condition. It is situated between the road and sidewalk in a planting space, and has very limited soil volume for the species and size of the tree. There is also a retaining wall close to the tree and a grade change of at least 3 feet. Additional signs of limited soil volume include cracked curbing, recently repaired sidewalk, girdling roots, and a significant amount of mounding in the root flares. When there is not sufficient soil volume for root development, root flares often become enlarged as structural roots concentrate there to stabilize the tree.

Because of these existing conditions, I do not believe that the scarlet oak's roots have extended beyond the planting space and sidewalk. The retaining wall does not show signs of any failure or cracking that would be expected from root intrusion, and the grade change would also discourage this.

Additional Notes: This tree may decline on its own due to very limited soil volume or the sidewalk replacement. Future decline should not necessarily be attributed to this proposed project. Also, I would recommend that this tree be periodically inspected for signs of root rot, as the loss of structural roots will potentially undermine tree stability.

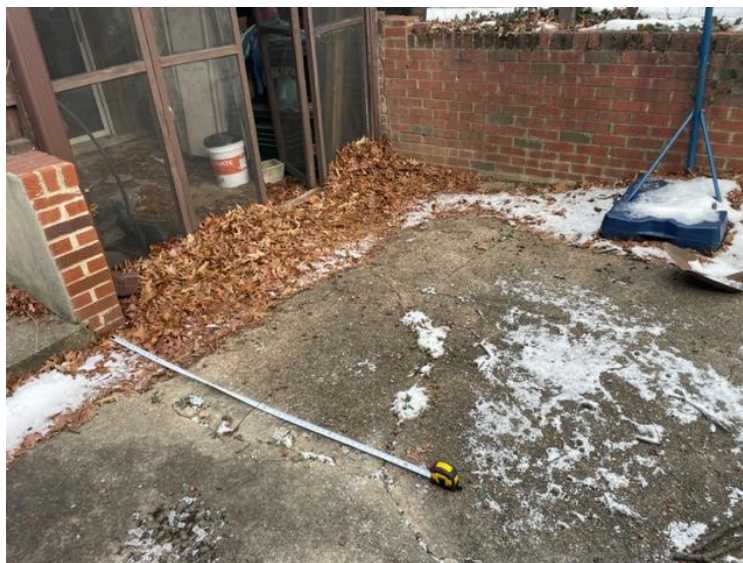
The calculated CRZ ends at roughly 5' off the existing structure. There may be some limited excavation close to the existing building face. Excavation will occur with hand tools, any tree roots found will be cleanly cut, and if any roots over 2" in diameter are encountered, the UFA arborist will be contacted.

Calculated CRZ boundary ends 5' from existing structure

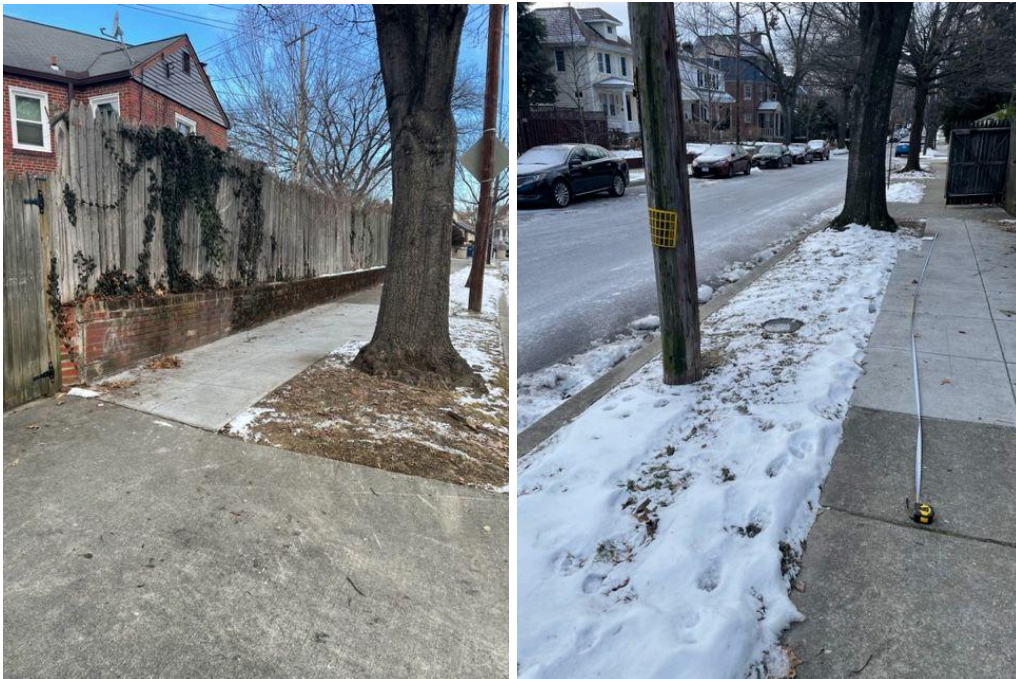
The soil compaction and root damage risks to this tree are primarily going to be in the roadside planting space. The project does not call for heavy equipment, and material delivery and staging will occur on the existing driveway.

Planting space will be enclosed with tree protection fence/signage. Limit of fencing indicated by tape measure/sidewalk seam location.

- The planting space will be fenced in to encompass the tree's calculated CRZ of 23'. This fencing will begin at the edge of the driveway apron, and continue down roughly 25' along the sidewalk and enclosed on all signs. DDOT approved signage will be placed at least every 20' on the fencing, and it will be maintained throughout the project.

- No entrance to this area will be allowed without permission from DC UFA arborist. No excavation, material stockpiling, fuel storage, equipment entry, other other construction activities may occur inside this fencing.
- DDOT specifications indicate this fencing should be sturdy. It should not be composed of a snow fence, or something else that is easily removed. Approved materials include welded-wire fence on t-posts or chain link fence.
- Some light pruning may be required to allow enough room for building of the two story addition without causing damage to the scarlet oak branches. Any pruning will be limited to under 20% of the living canopy, and will follow the applicable ANSI A300 standard.

Post care will depend on this fenced off area not being entered during construction, and that any pruning needed is done correctly. If post care is required, it may involve compaction relief/air spading, supplemental irrigation, or monitoring.
