## 5310 Cathedral Ave NW Previous Condition Photos

Board of Zoning Adjustment  
District of Columbia  
CASE NO.21232  
EXHIBIT NO.25

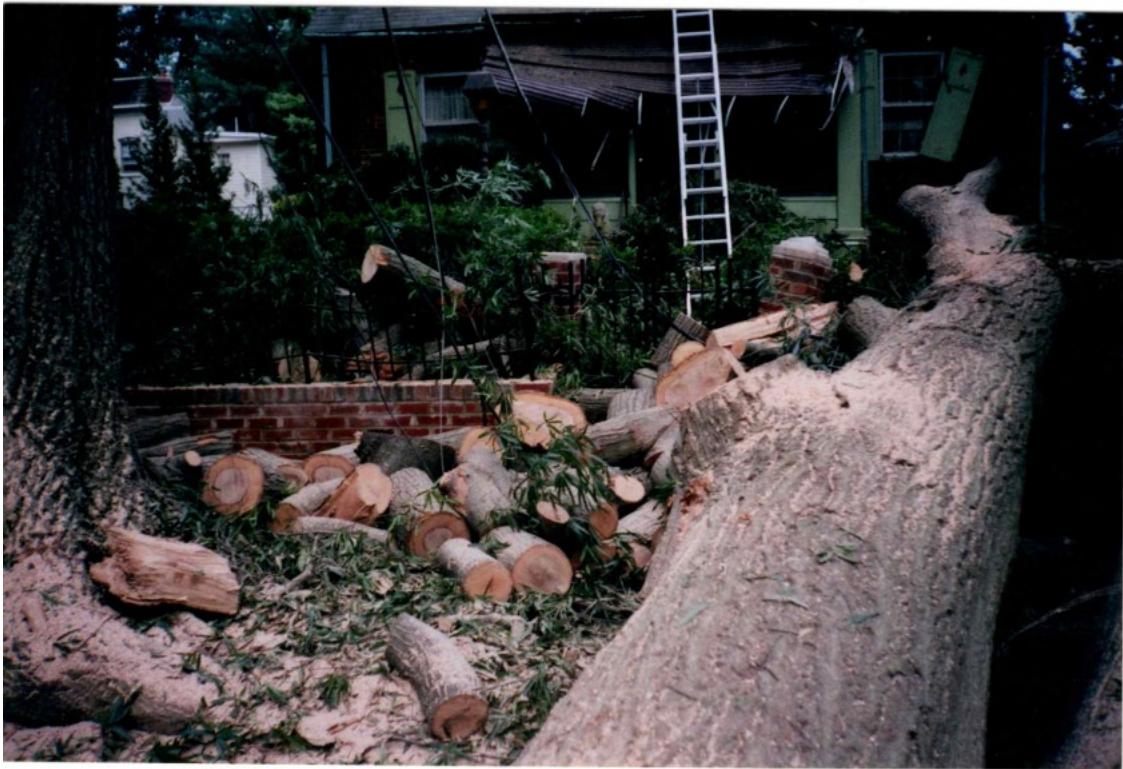
Severe Tree Damage to structure and roof (est. mid 2000s), I got this photo from my neighbors and learned about the incident a few months after buying the house and mentioning my ongoing problems with the structure of the house.

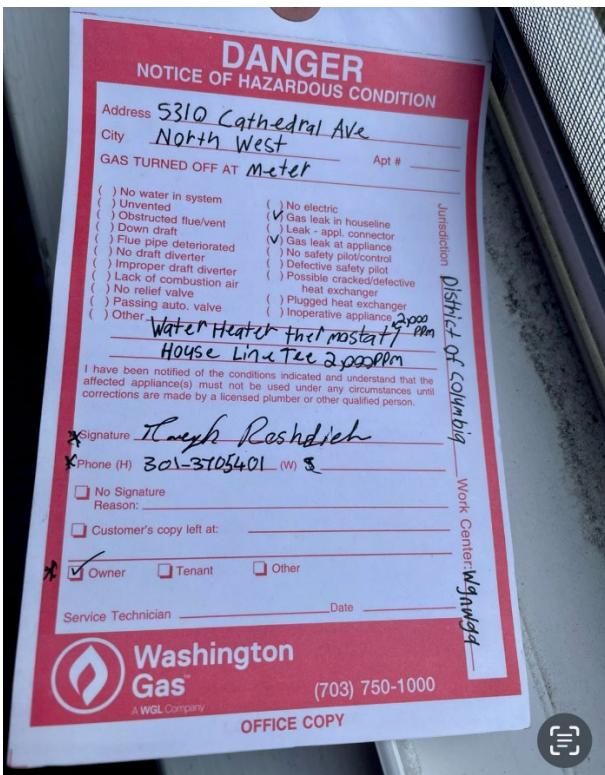
February 9, 2023 Washington Gas Shutoff Order due to extensive leaking (signed by my mother who was able to meet the technician fastest on that day)

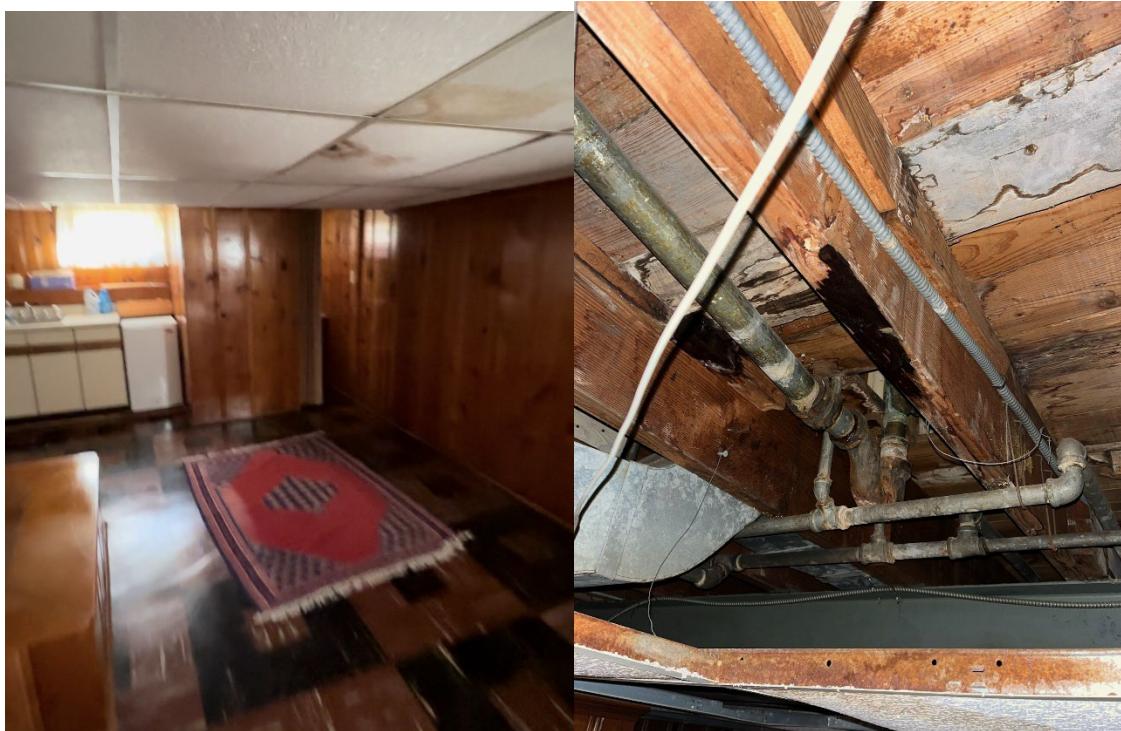
Early evidence of water leakage throughout pipes in the cellar ceiling once I moved into the home in late 2022. These ceiling panels later totally collapsed but I could not find a photo of that. The photo on the right is showing some of the mold/rotting surrounding some of those pipes throughout the cellar.

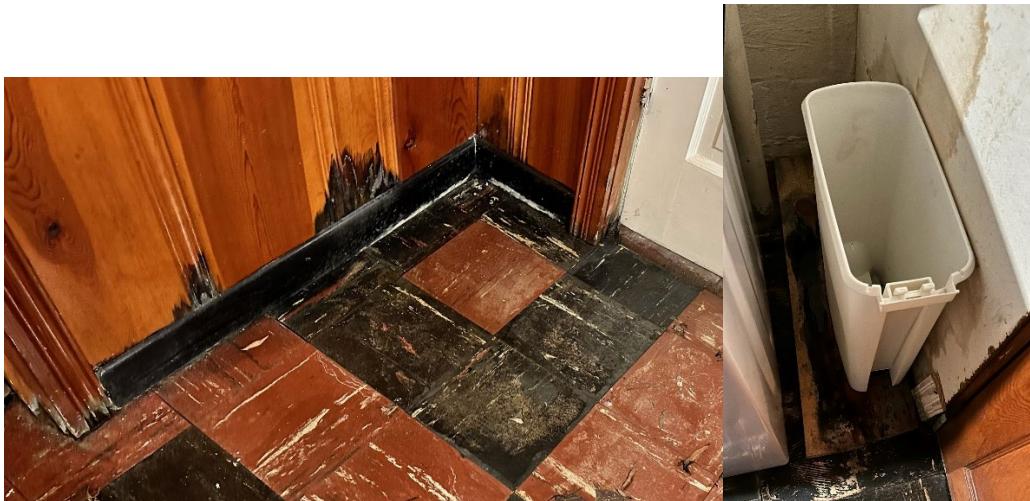
More examples of water damage rotting wood throughout the cellar. I quickly learned that the previous owner had put the trash bin on the right in that location to collect constant water dripping from above.

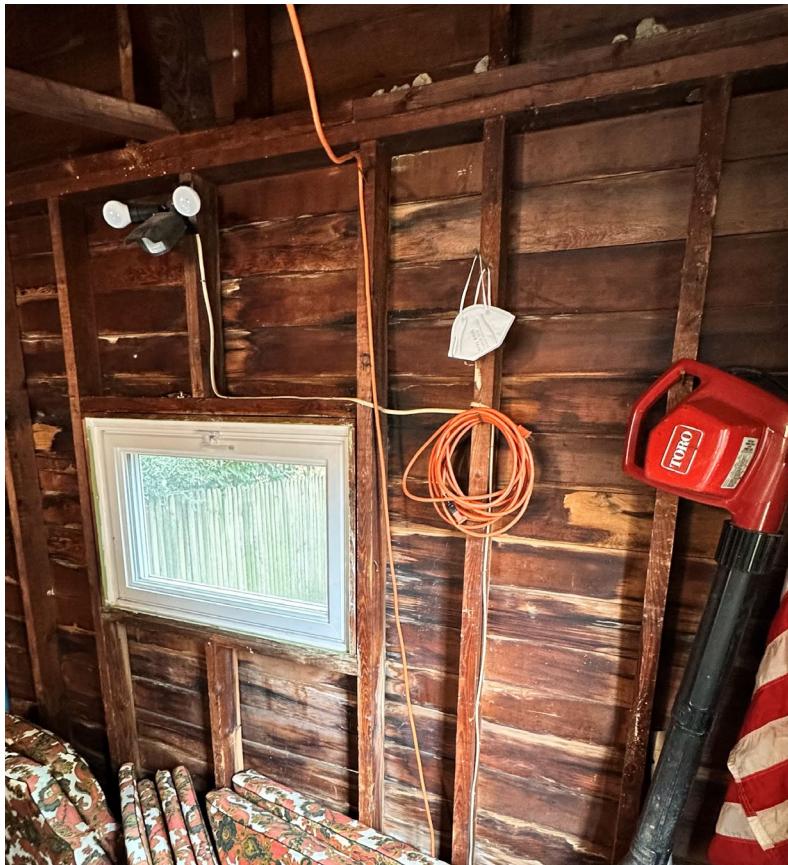
I was able to find this early photo of the garage (since removed per DOB's instructions and zoning requirements) in which you can make out some of the termite damage above the floodlight and around the window. This same termite damage was found throughout the main house structure after we started our renovation and exposed the wood frame.

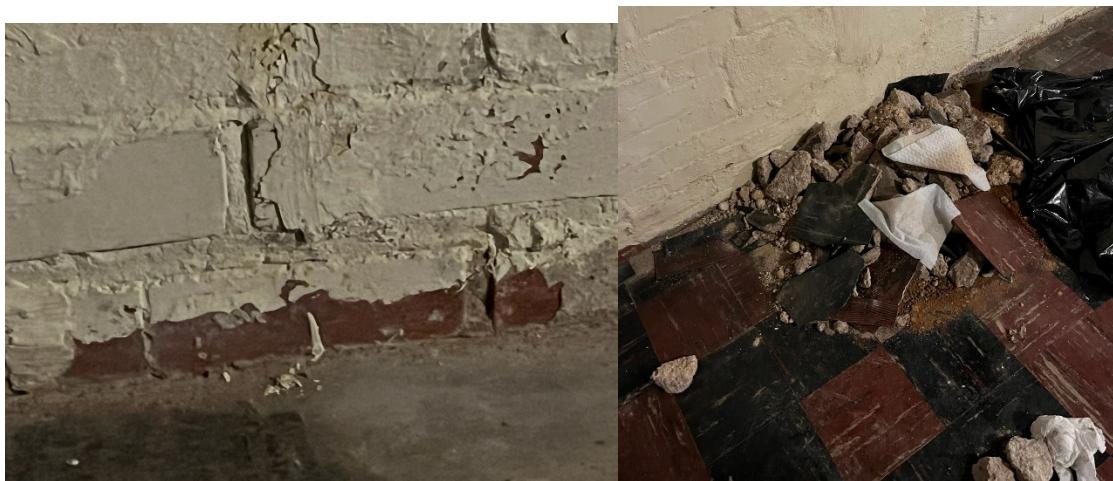
Photos showing structural issues we discovered later, such as cracks in the foundation wall leading to leakage on the left and part of the cellar floor we had to dig into to fix a damaged drain pipe.

\*\*To note, we intentionally made sure to preserve the **entirety** of the foundation wall per our plans to comply with zoning instructions, when it would have been easier/better to change that otherwise.

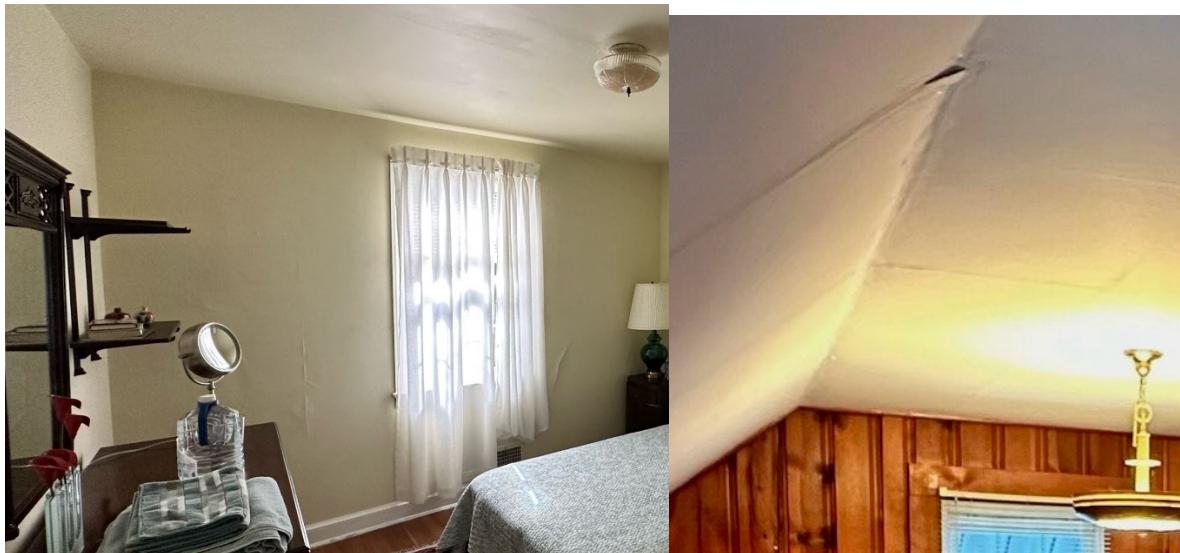
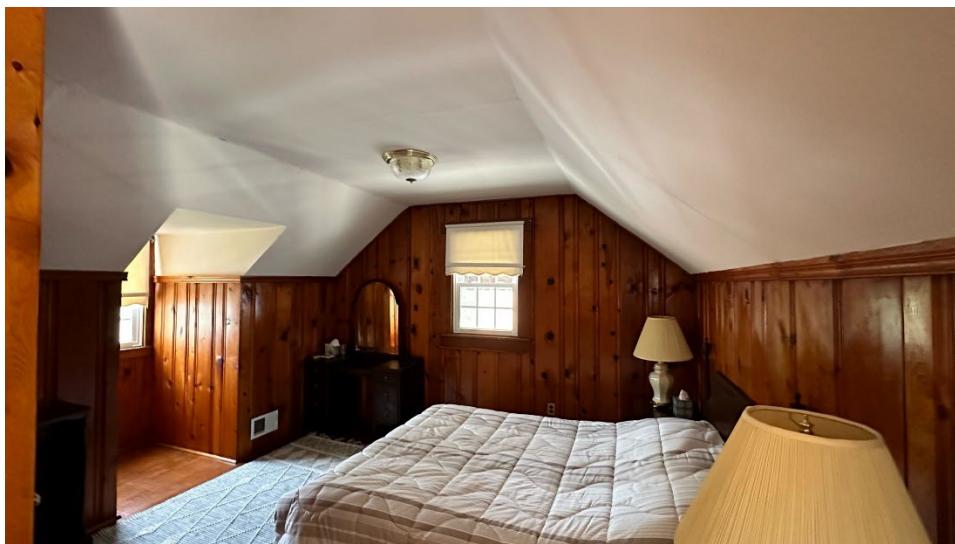
It is hard to see but these are early photos after I moved in which show some of the shoddy wall and ceiling conditions which quickly became worse over time, especially after the first winter and rainy seasons when water permeated and soaked through. Unfortunately, I don't have photos of the bad parts where the plaster was deteriorated and falling off the walls because I covered those areas with furniture and art to hide it and make my home look better. However, it was clear that the previous owner had tried to cover up the extensive problem with paint and bad patching before selling the home. The photo on the right zooms into the ceiling/roof of the cape cod upper floor early as peeling started. Soon after the first 2 season changes, entire chunks of this ceiling started falling but I did not take photos of that. The closets in this floor and throughout the roof also had evidence of mold and rotting.

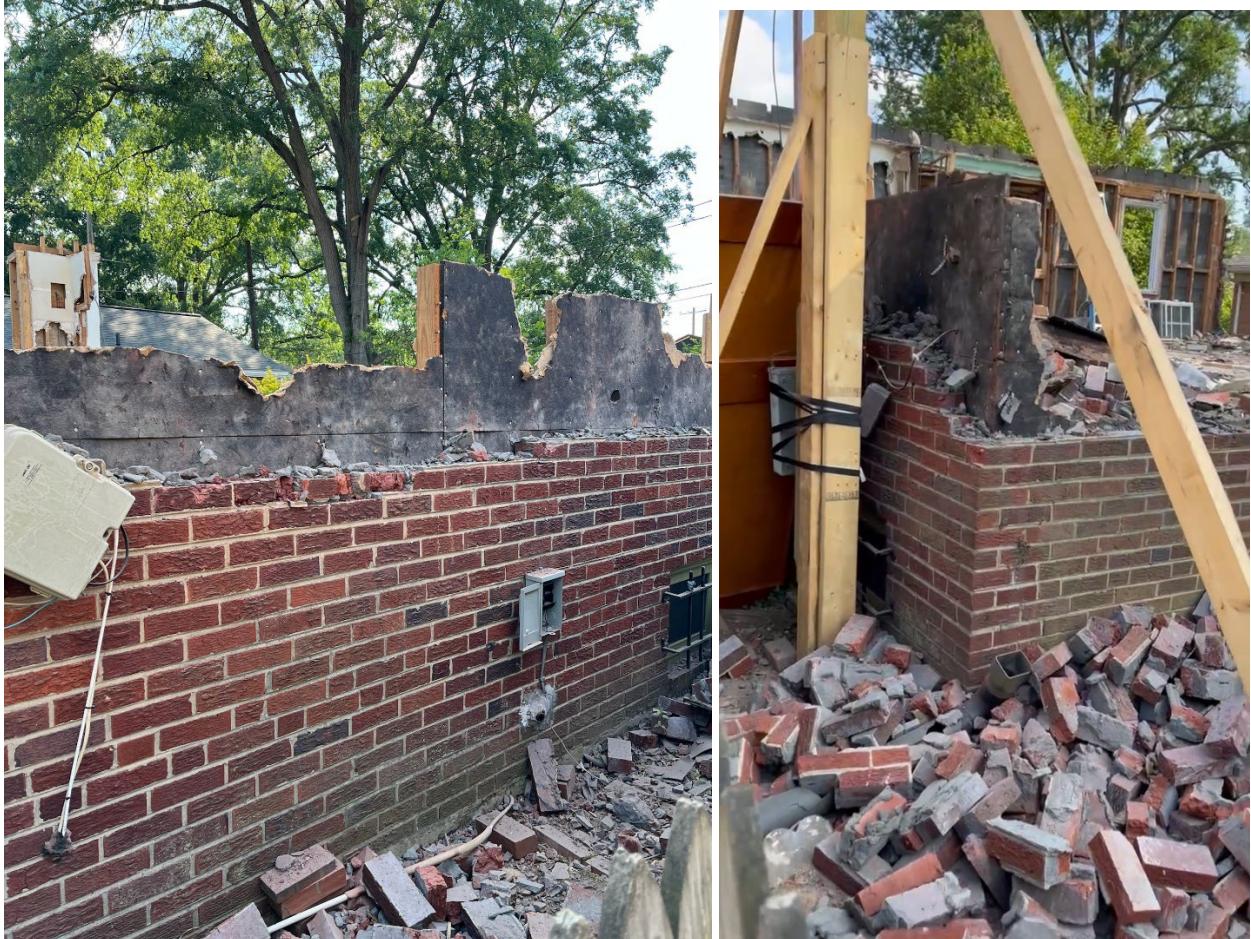
These photos show the problematic wood backing behind the brick that needed to be fixed/replaced. To safely do so, the brick was kept up as high as possible while remaining stable, then the wooden frame was updated behind it, with plywood temporarily sealing off the house above a flat level base of the safe remaining brick, then the temporary plywood cover would be replaced with the brick again once the wood structure behind it is secure to fully repair the original wall (this is where we currently are in the construction process as shown in the latest photos DOB took during inspection).

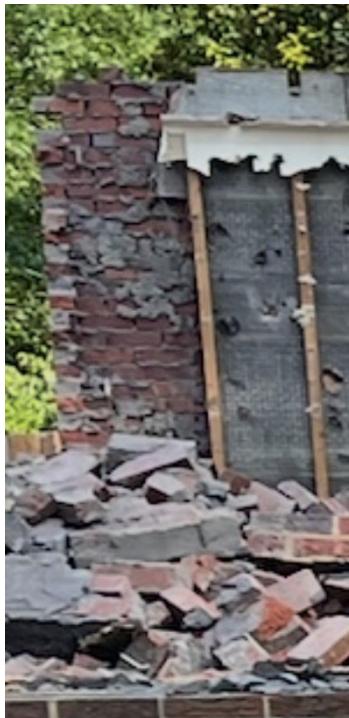
The photo on the left is a zoomed in look at the dangerous condition of the unstable bricks if they were to be left up with no wood backing as is visible on the left. If we were to leave these up while replacing the rotted wood, especially on the alley-adjacent side, it would have been an extreme immediate danger to the public. As mentioned above, step-by-step, we planned to fix the wood backing then restore the brick on the walls of the existing structure, as is also indicated in our plans.

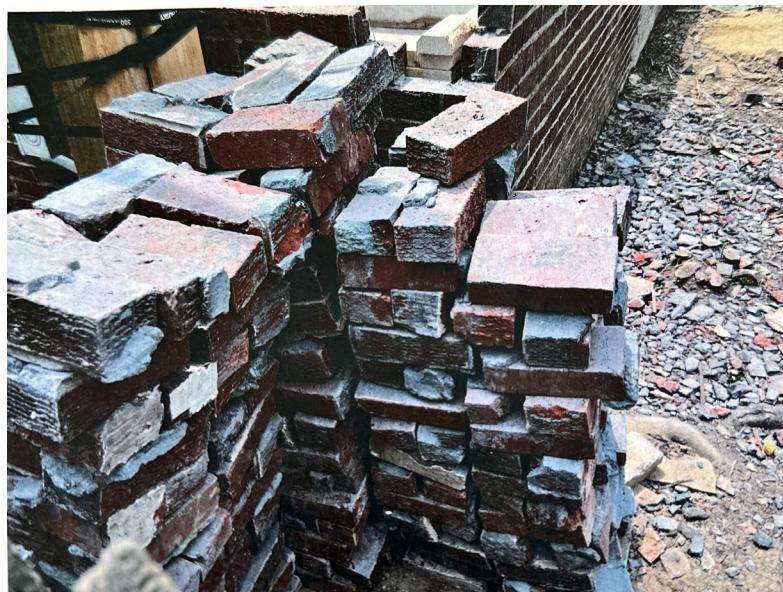
The photo on the right is again showing that we spent the extra money and time to do everything according to the rules with safety in mind. We ensured that our contractors removed bricks tediously by hand in the safest way especially for the neighboring properties and alleyway. This is in line with the fact that this is indeed a renovation, and not a raze—if this was actually a raze, it would have been much easier, faster, and cheaper to demolish the structure all at once by machine.
