# ROYAL EMBASSY OF SAUDI ARABIA WASHINGTON

## 1. West Façade - New Hampshire Avenue, N.W., West Compound Access Control (WCAC)

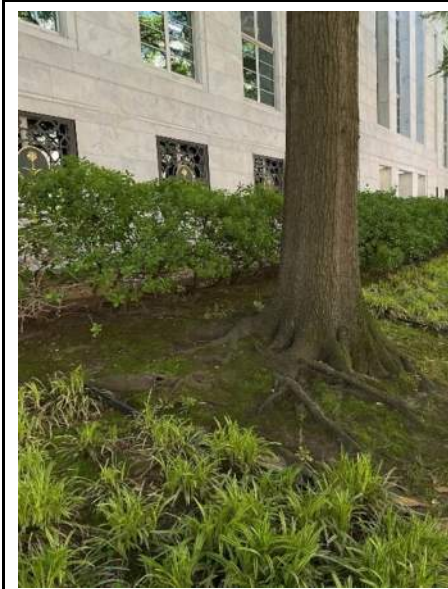
Fig. 1. West façade - Typical landscape bed at the base of willow oak (*Quercus phellos*) (LE03)

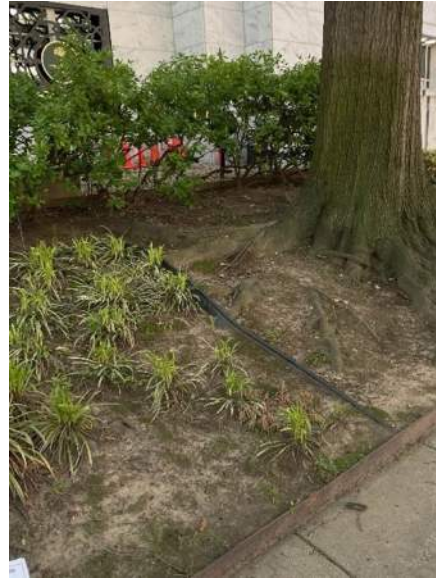
Fig. 2. Eroded and compacted soil conditions around existing willow oak trees; metal and rubber edging (LE04)

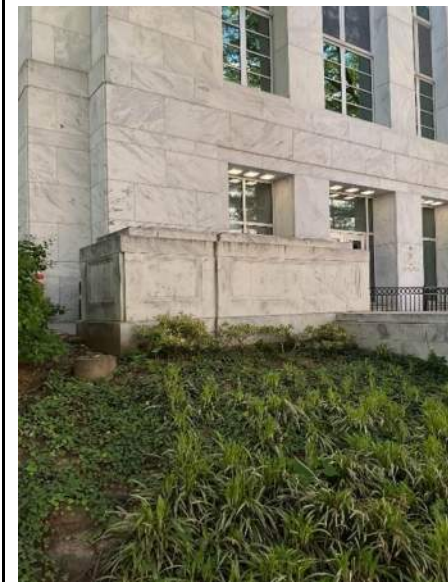
Fig. 3. Invasive plant species – English ivy (*Hedra helix*), Nandina (*Nandina domestica*); Non-native, variegated liriop (*Liriope muscari* 'Variegata') (LE09)

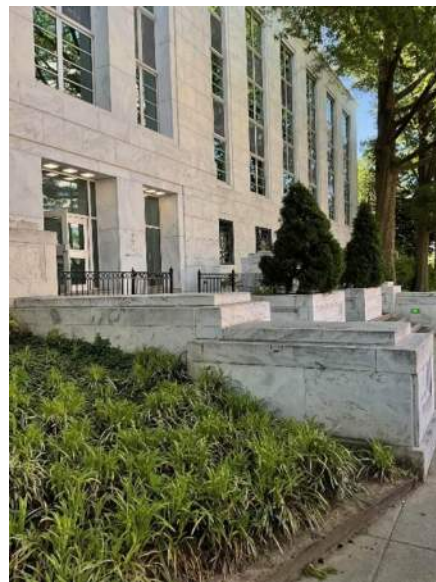
Fig. 4. Marble cheek walls with variegated liriop and English ivy groundcovers at WCAC entrance stairway (LE 09)

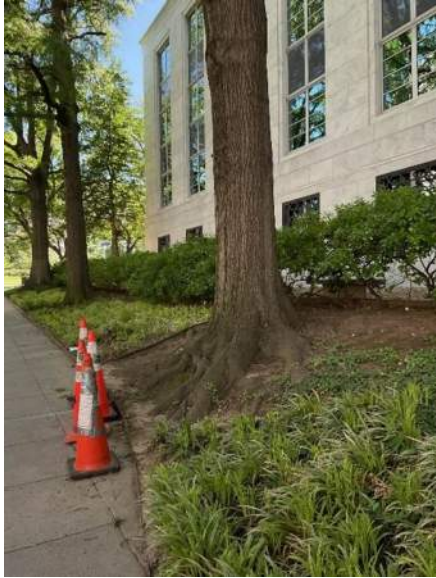
Fig. 5. View north from WCAC stairway to three mature willow oak (*Quercus phellos*) trees, liriope (*Liriope muscari* 'Variegata'), groundcover, and mature euonymus (*Euonymus kaiutschovicus* 'Manhattan') foundation plantings (LE09)

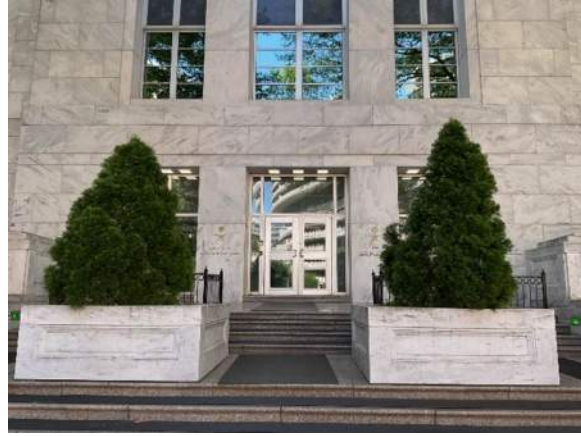
Fig. 6. Two Arborvitae trees (*Thuja occidentalis*) in marble planters on WCAC stairway entrance (LE013)

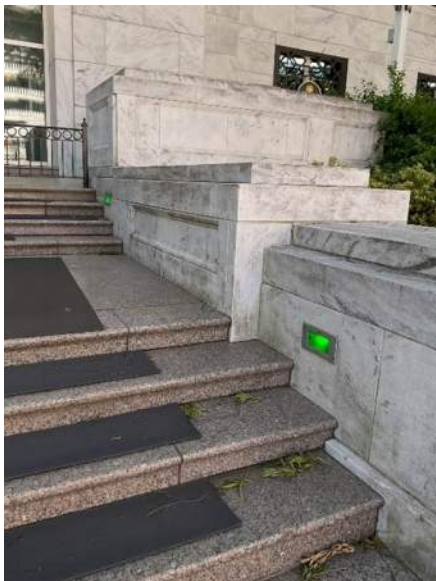
Fig. 7. Upturned anti-slip strips on stairs; green recessed lights in stairway cheek walls (LE010)

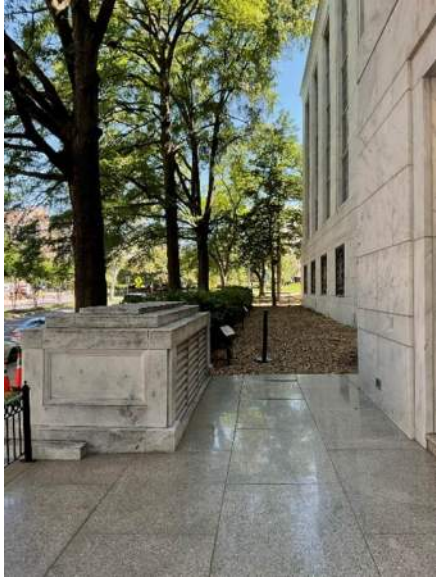
Fig. 9. View north from WCAC entrance upper stairway landing toward loose aggregate strip at foundation (LE011)

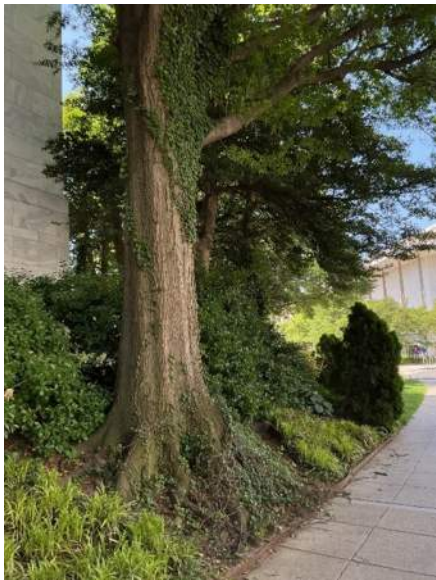
Fig. 19. Invasive English ivy climbing willow oak tree at south façade building corner; euonymus shrubs at the foundation, liriope groundcover, and dark green arborvitae shrub at the sidewalk edge (LE007)

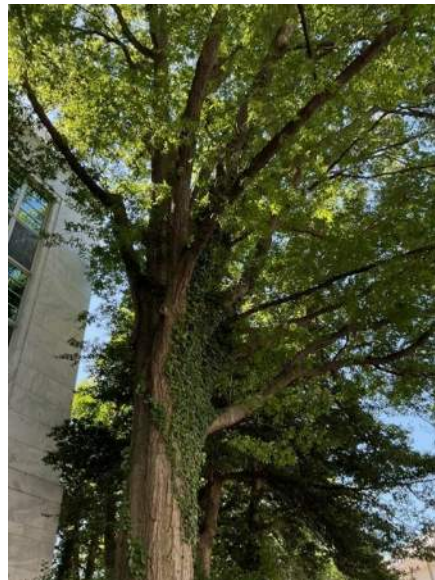
Fig. 20. Invasive English ivy climbing into willow oak canopy; tree at south façade building corner (LE007)

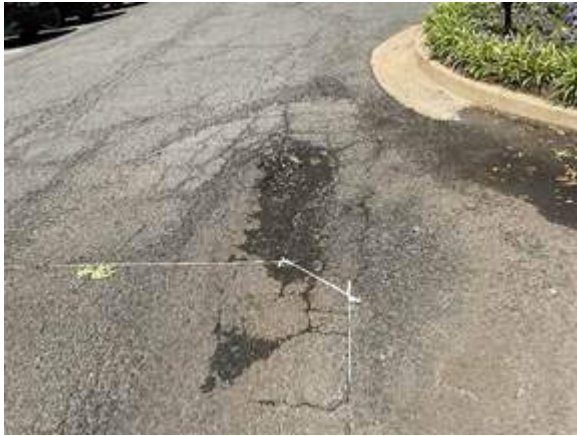
Fig. 65. Cracked asphalt pavement near the flagpole in front of the southeast façade (LE043).

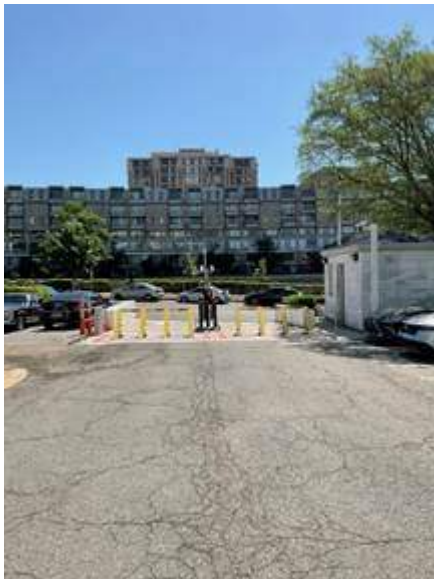
Fig. 67. View east from the parking lot toward the BCAC vehicular screening area and guard house (at right). Cracks spread throughout the asphalt paving (LE055).

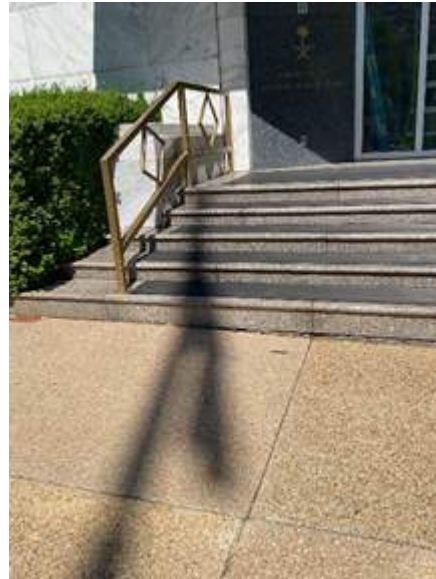
Fig. 76. Exposed aggregate paving and stone stairs to the main entrance at the southeast façade. Rubber mats for slip resistance are warping and creating a trip hazard. Stair railing does not meet accessibility standards (LE045).

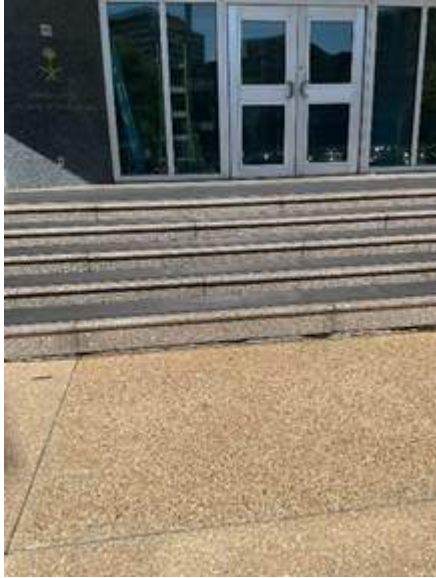
Fig. 77. A wide gap between the stone stairs and exposed aggregate paving reveals settlement of the paving and deteriorating joint material (LE045).

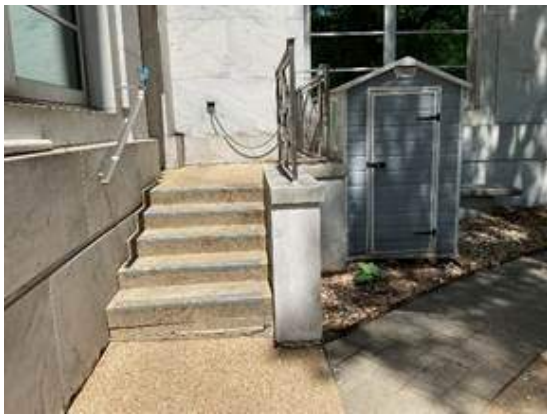
Fig. 83. Stairs lead to a door at the north side of this façade (LE048). A hose bib is located at the top landing. Aggregate paving is cracked and separating from the stair risers. Handrail does not meet accessibility standards. A concrete paver path meets the aggregate paving at right (LE049). A small shed sits in a bed of loose aggregate (LE050).

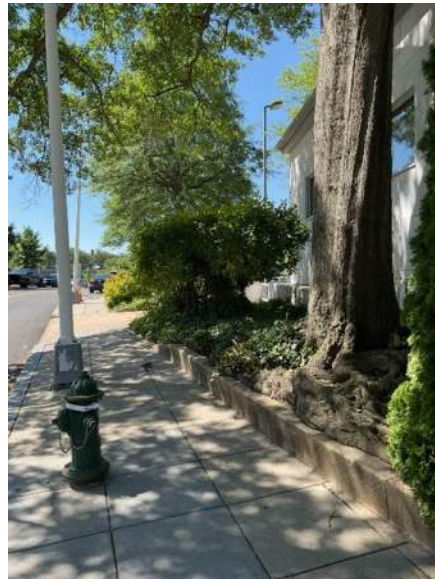
Fig. 94. View south along 25<sup>th</sup> Street, N.W., east of the mail room. A concrete curb defines the planting area border. Roots of the water oak engulf the concrete curb (LE060).

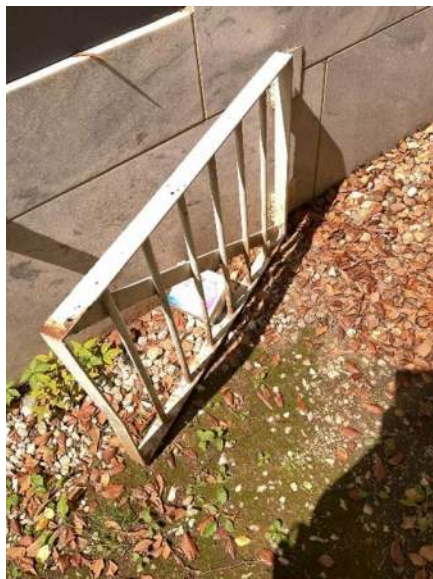
Fig. 108. Metal gate to the utility area at the north façade of the Embassy. The gate does not have a latch, and it does not prevent access to the utility area (LE075).
