# Town Center Park - West Park

## Report of Current Conditions and Recommendations

Washington, District of Columbia

Submitted by  
Wallace Roberts & Todd, LLC  
1700 Market Street  
28th Floor  
Philadelphia, PA 19103  
December 21, 2007

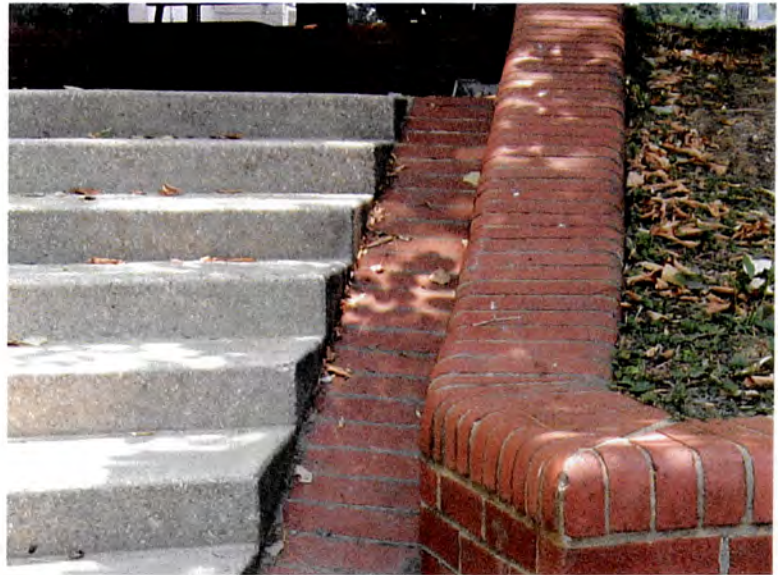
Overall, the hardscape has weathered well. Some design details, such as the runnels along the sides of the steps, continue to function as intended (Fig. 1) – the colored concrete has since faded but is otherwise in good condition. However, a few of the brick retaining walls have suffered extensive damage as a result of tree root growth (Fig. 2). While efforts have been made to repair these walls, the source of the problem, trees planted too close to the walls, persists.

Figure 1  
Brick runnel and concrete steps

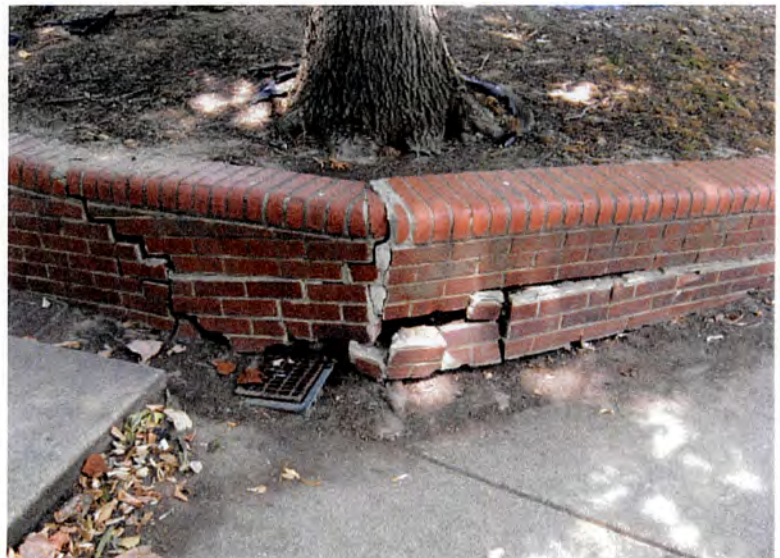
Figure 2  
Damaged brick retaining wall

Recommended improvements to the park's hardscape are mainly limited to the compromised brick retaining walls. Removing trees affecting the walls and replacing the damaged walls would greatly improve the park's appearance. Careful consideration should be made about the quality of the materials and workmanship devoted to correcting the walls. If materials that closely match those existing are not available, then alternative approaches will be required.

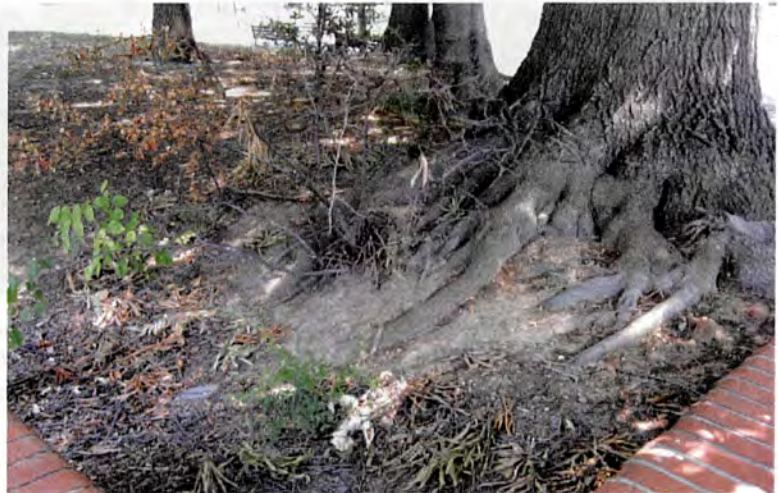
Figure 3

As a result of the tight spacing during installation and lack of subsequent thinning, the park's trees are not fairing well. Though they have grown substantially, many suffer from root binding (Figs. 3 and 4) and all would benefit from professional pruning. Trees closest to the brick retaining walls are compromising the structural integrity and appearance of those walls, as discussed in the previous section. Aside from a few azaleas and other small shrubs, the park features few plants smaller than the large canopy trees – no sign of the multiple layers indicated in the original plans exists today.

Current conditions of planting

Retaining an arborist to perform an extensive study of the current conditions of the plant material would help determine the health of the existing plants. Removal of some large trees would promote healthier growth in the remaining trees, and strategic pruning would thin the canopy (we suggest removing up to 30% of the existing canopy ), thus allowing other plants and lawn areas to grow in the

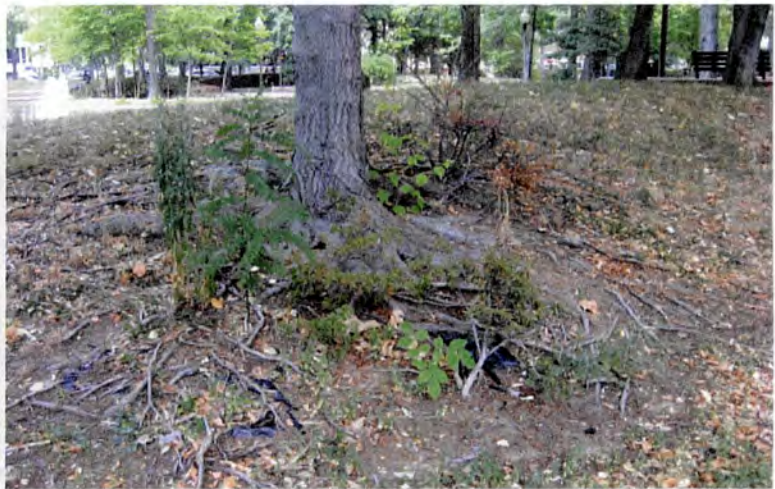
Figure 4

Current conditions of planting

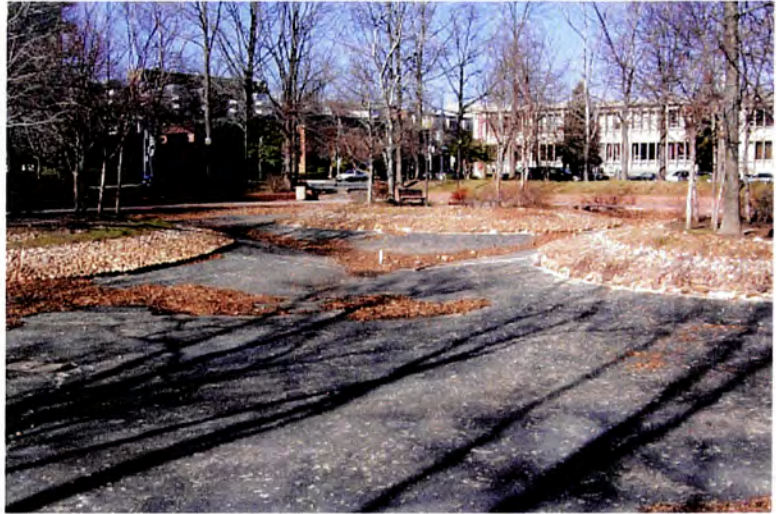
The pond basin appears to be in good condition and the stones embedded in the promontories remain intact (Fig. 6). The four fountain jets (Fig. 7) work but behave erratically, which may be symptomatic of a malfunction in the pump equipment.

Figure 6  
Pond basin - January 2006

Assessment of the age and condition of the fountain equipment and basin would determine the extent of repairs, if any, the pond might need to serve for the long term. At the very least, the fountain jets should be better coordinated and the basin inspected for any possible defects.

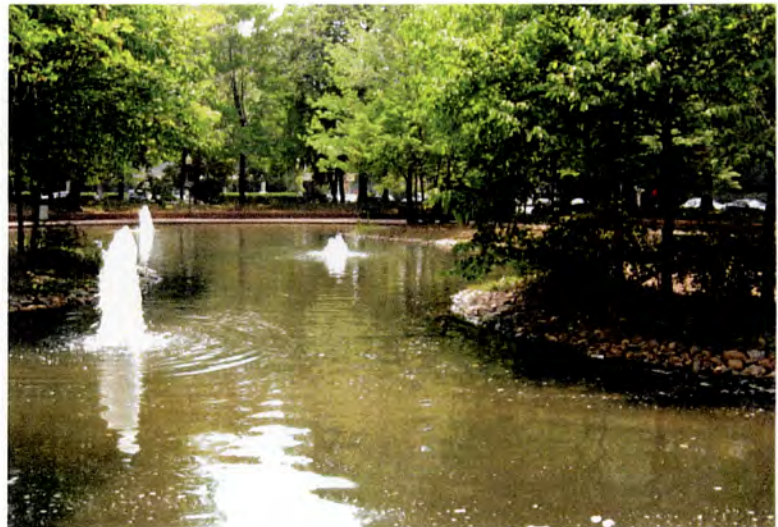
Figure 7  
Pond with fountains - June 2007

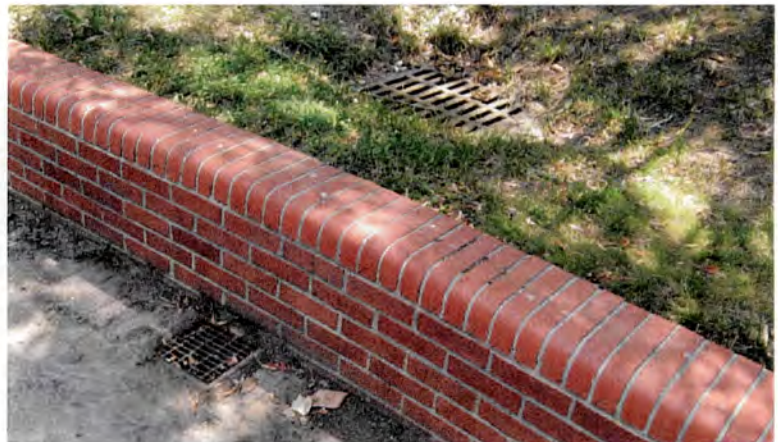
Due to the lack of available utility information, WRT could only evaluate the visible appearance of the park's infrastructure. An obvious concern for the park is its drainage. Many area drains were surrounded by dirt and debris, which is both aesthetically unappealing and indicative of drainage problems (Fig. 9). NPS standard pole-mounted lights have taken the place of the original fixtures (Fig. 10). A nighttime inspection of the park lighting was not performed for this report, so current lighting may not adequately illuminate all areas of the park.

Figure 9  
Area drain surrounded by dirt and debris

Both the lighting and drainage systems need to be properly inspected to make sure they are functioning correctly. The drainage system should be cleaned out and renovated where required. At a minimum, any existing light fixtures that do not work should be replaced. A full lighting study should be performed to make sure that all areas of the park are adequately illuminated. New light poles and fixtures that relate to site furnishing requirements of the proposed AWI Transportation Architecture Design Standards should also be considered.

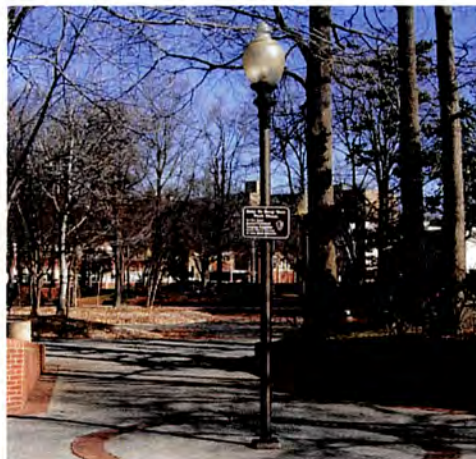
Figure 10  
Current pole-mounted lights

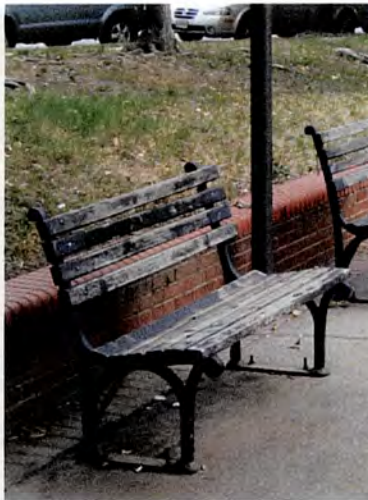
Almost all of the original site furnishings in the park have been removed or replaced. The custom timber benches have been substituted with standard NPS site furnishings (Fig. 12), and all of the original play structures have been removed. A nondescript plastic and aluminum slide (Fig. 13) has taken the place of the slide once located at the southeast corner of the park while nothing was put in place of the ship's wheel that used to occupy the northeast alcove. Though the water fountain remains, it is no longer functional. Only the concrete trash receptacles continue to be used as designed.

Figure 12  
Current bench

Though the standard NPS site furnishings make the park less distinctive, they do not detract from the character of the space. The lone play structure, however, has an ad hoc quality that is not appropriate for the park. Any improvements to the park should include new play equipment because neither of the other two parks features any. Also, children were observed playing on the slide during WRT's second site visit, so there appears to be

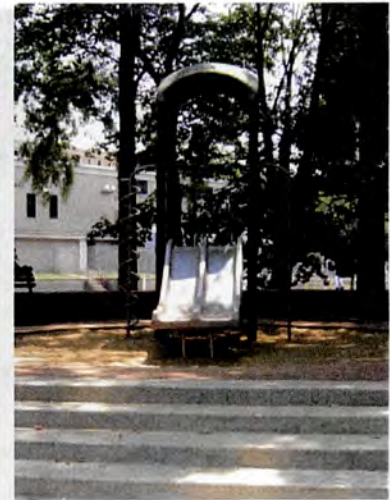
Figure 13  
Current play structure

a demand for such equipment. Since space is limited in the West Park, traditional play structures with their required safety zones and paving requirements may not be feasible. Instead, play sculptures, like those found in Philadelphia's Rittenhouse Square (Fig. 14) or in Boston Common (Fig. 15), are a viable alternative that would complement the park aesthetically and add to its recreational opportunities.

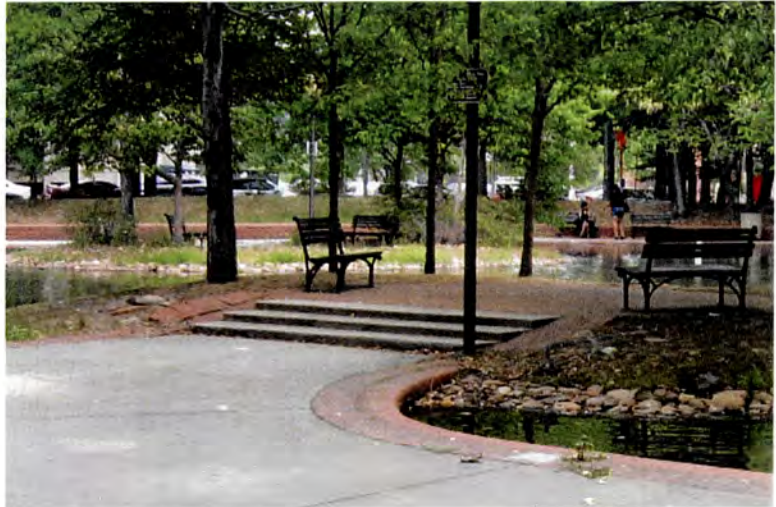
West Park's three access points connect to the primary circular promenade that surrounds the pond. Although most of the park is accessible, there are several instances to the contrary – steps up to the southeast space and the west promontory (Fig. 18), the stepped ramp at the northwest corner and steps down to the east promontory.

Figure 18  
Steps up to west promontory

It would be to the detriment of the park if the identified areas were retrofitted so as to make them universally accessible. Still, the addition of handrails to the steps could be useful for visitors. The three existing entrances function well, but an additional entry through the northeast alcove should be considered. Currently, this area, with its high retaining walls, large trees and lack of site furniture, is inhospitable and neglected (Fig. 19). Opening up the space and installing a play sculpture would make it more welcoming and attractive. Given West Park's small scale, every area should present visitors with an opportunity to enjoy the park.

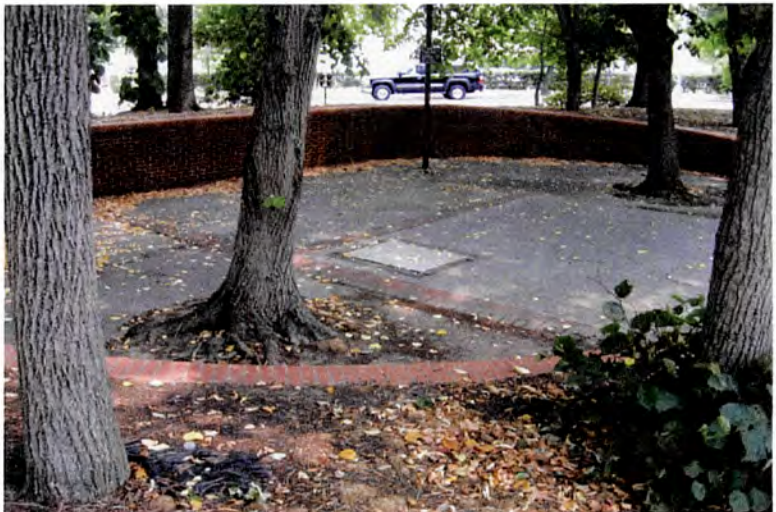
Figure 19  
Northeast alcove
