EXISTING CONDITIONS ASSESSMENT & FEASIBILITY EVALUATION

McMillan Slow Sand Filtration Plant Site
Washington, DC

April 10, 2014

prepared by
Robert Silman Associates
1053 31st Street NW
Washington, DC 20007

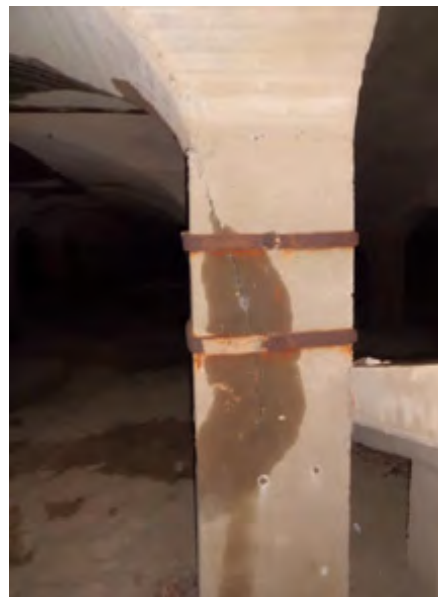
The banding system approach can be effective at balancing these forces, however it was noted at the site that piers at the entrance portal with these straps had typically cracked as depicted in Figure 13. At other filters where these restraints were not present, a rotation at the entrance ramp pier-to-vault joint was observed without any pier cracks (see Figure C-5, in the appendix). Thus, although the banding may have limited some lateral movement or rotation, the unreinforced piers did not have sufficient capacity to transfer forces at this added connection.

FIGURE 13: PORTAL ENTRANCE PIER AT SLOW SAND FILTER No. 26

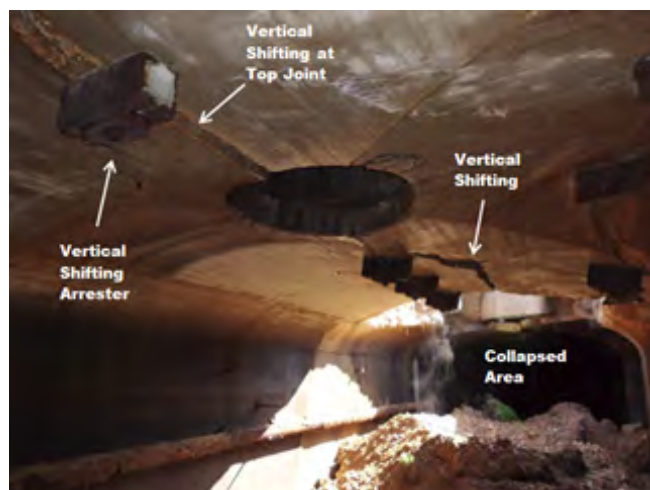
FIGURE 15: CEILING VAULT DAMAGE NEAR COLLAPSED BAY

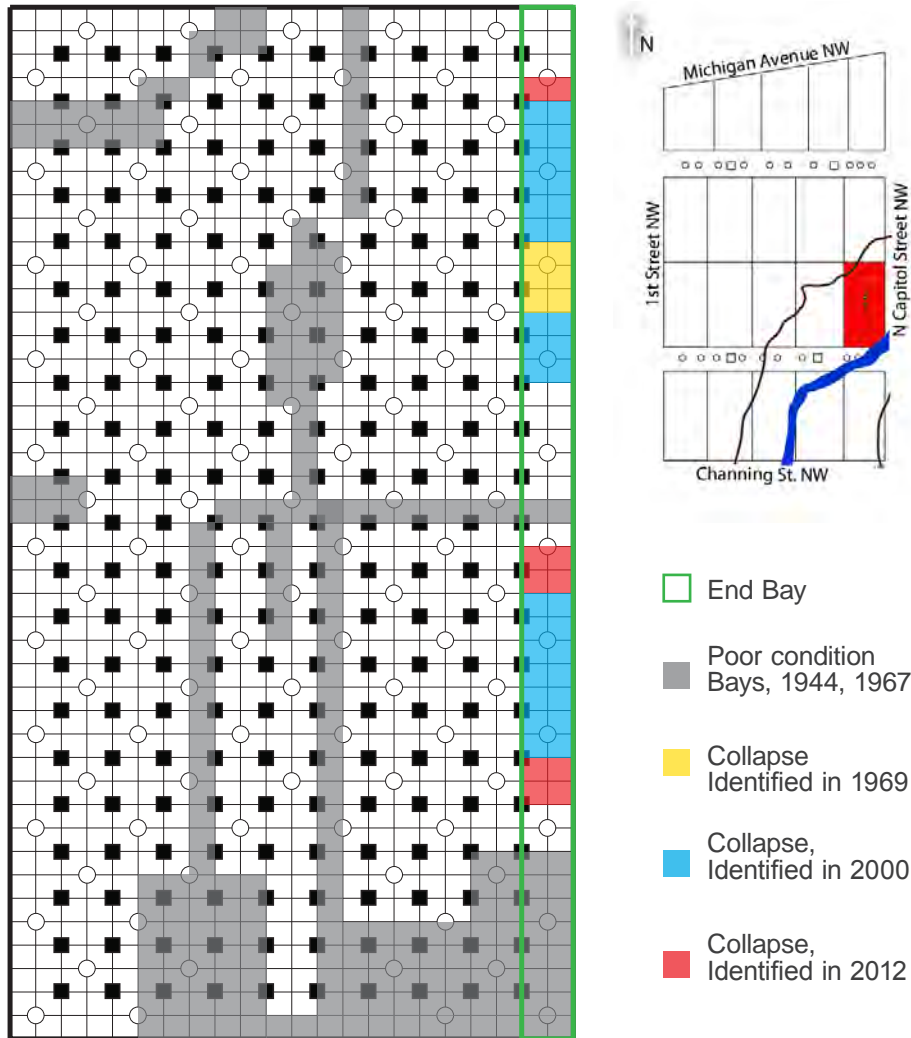
The collapsed area found at filter No. 24 is more extensive and has continued to progress since the 1944, 1967 and 2000 condition investigations (see Figure 16). The collapsed area found at filter No. 19 is much smaller and newer but the conditions leading to collapse also date back to the 1967 survey. More specific information about the collapsed vaults is provided in more detail in Appendix D

FIGURE 16: FILTER No. 24, DAMAGED AND COLLAPSED BAYS

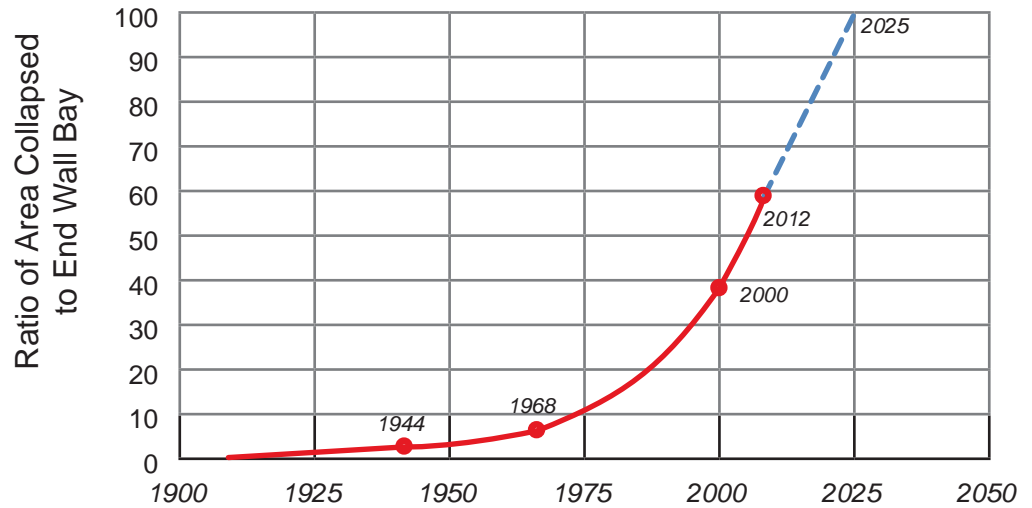
The collapsed areas at filter No. 24 reported in the 1944, 1967 and 2000 surveys, and areas that have been identified as recent collapse by RSA, were plotted as a function of a percentage of a total end bay area. The graph (Figure 17) shows a higher rate of collapse between 1968 and 2012. Assuming a current and steady rate of collapse, extrapolating the rate of collapse indicates that sometime by year 2025 the entire eastern end bay of this filter will have collapsed as depicted in Figure 17.

FIGURE 17: RATE OF COLLAPSED AT SLOW SAND FILTER NO. 24

As the collapsed area increases, the rate of collapse is expected to accelerate due to new mechanisms in play. It is expected that, as this happens, adjacent bays within filter No. 24 will either collapse or initiate a collapse mechanism at other areas. This is due to unstable conditions created by the missing bays. Accordingly, it is very possible that, like the increase in collapse rate after 1968, the rate at which these bays are collapsing will continue to accelerate.

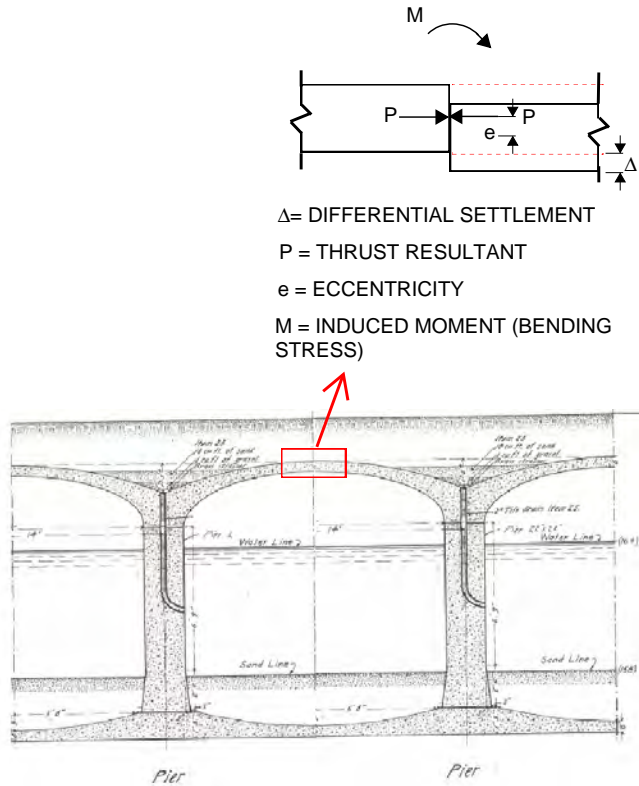
Misalignment at the vault apex may be the result of multiple influences, ranging from shifting due to lateral displacement, foundation settlement, and potential flaws from the original construction. In addition, this condition was commonly observed in the area of the entrance portals. Here, it appears that the misalignment is the result of rotations generated by the eccentricity between thrust lines of the central bay barrel vault and adjacent groin vaults. Figure 20 depicts the condition where misalignment occurs, yet the vaults continue to bear against each other. With this thrust misalignment, local bending stresses are induced at the inter-panel joint which accelerate the formation of cracks or hinges in the vault structure and reduce the effective depth of the arch mechanism.

FIGURE 25: VERTICAL DISPLACEMENT AT VAULT APEX

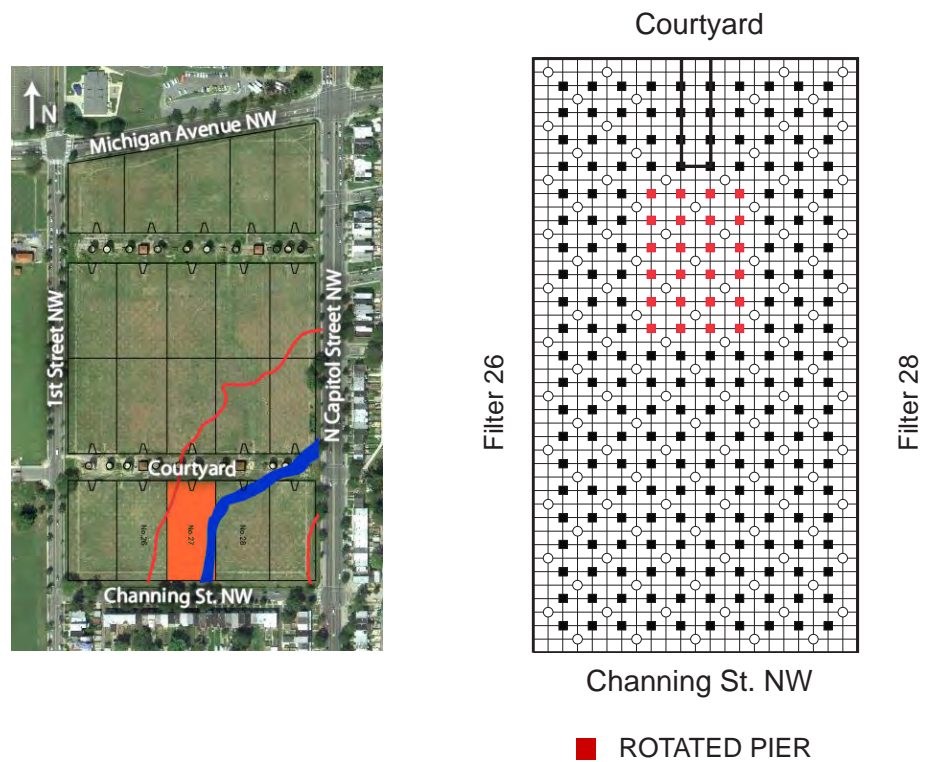
FIGURE 29: SLOW SAND FILTER NO. 27 DAMAGE

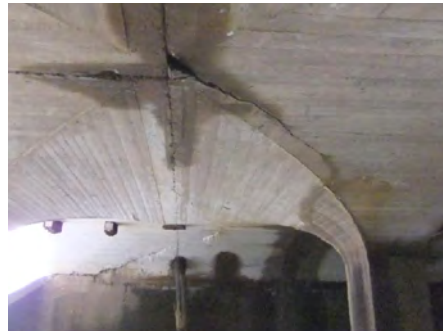
5. Shifting at the top of the vaulted ceiling and concrete spalls were observed near the entrance ramp (Figure B.5) and also at the corners of the filters ceiling vaults (Figure B.6).
6. Hinge formations were observed at the end wall bays and also at interior bays (Figure B.7).
7. Rotations at the columns supporting the entrance barrel vault ceiling were observed. It was observed that some of these columns at the entrance ramp were retrofitted (Figure B.8).

FIG. B.5 -SHIFTING AT THE COLD JOINT AND CONCRETE SPALLING.

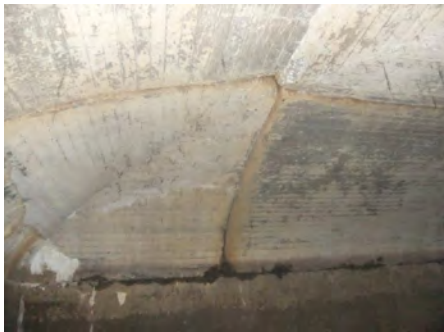
FIG. B.6 - SHIFTING AT VAULTED CEILING JOINT.

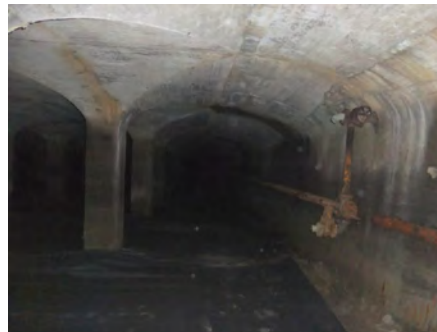
FIG. B.7 - HINGE FORMATIONS ALONG THE END WALLS AND BETWEEN PIERS.

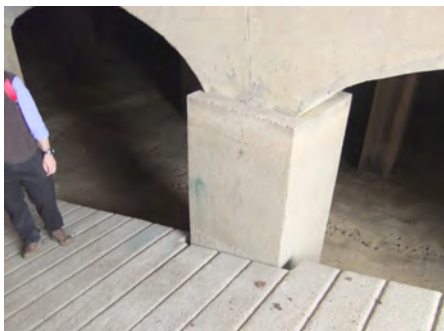
FIG. B.8 - RETROFIT TO COLUMNS AT THE ENTRANCE RAMP.

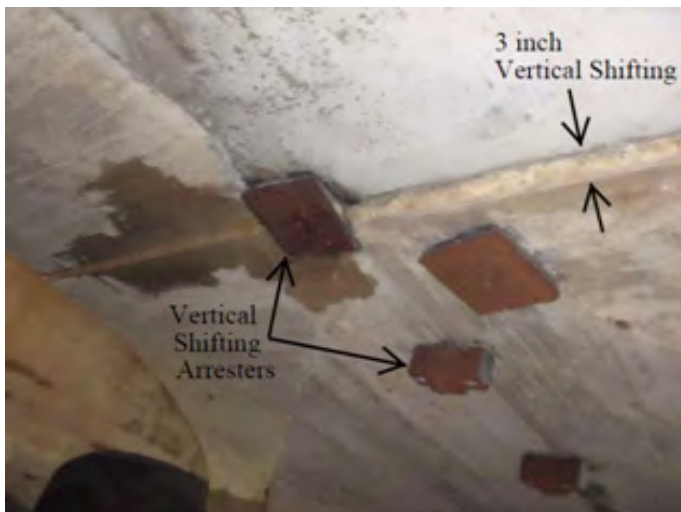
FIG. C.1 - VERTICAL DIFFERENTIAL DISPLACEMENT ARRESTORS AT INTER-PANEL JOINT.

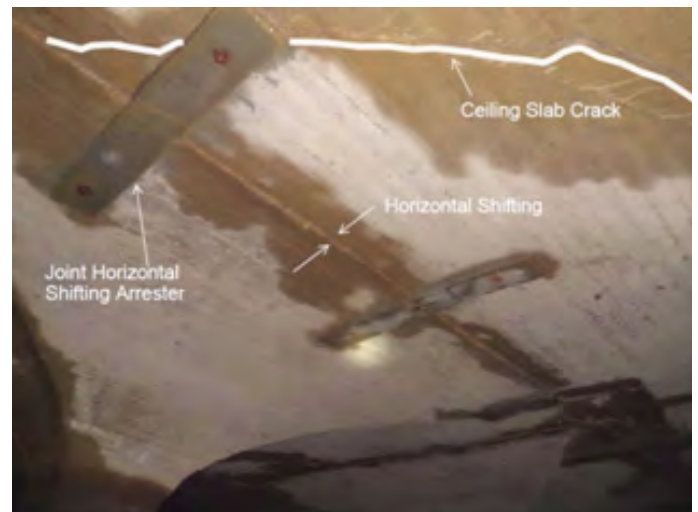
FIG. C.2- HORIZONTAL DISPLACEMENT ARRESTOR AT INTER-PANEL JOINT.

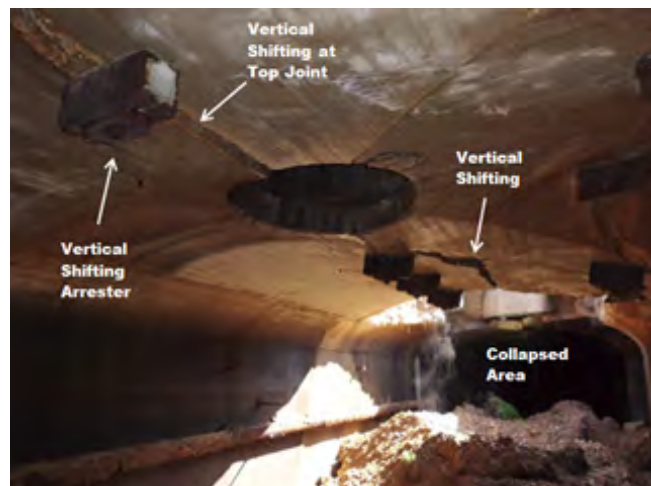
FIG. C.4 - CEILING VAULT DAMAGE NEAR COLLAPSED BAY.

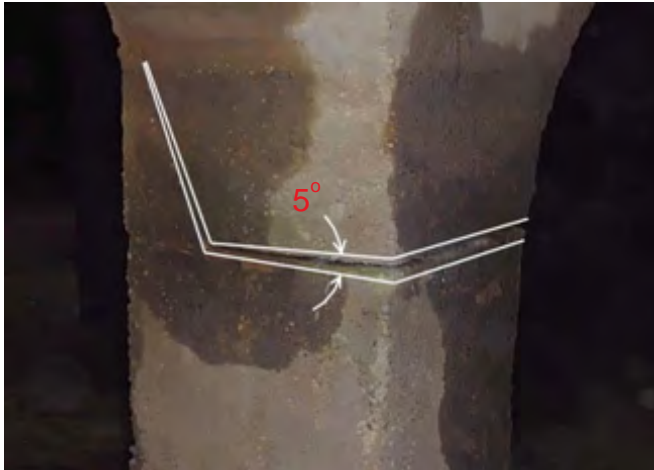
Rotation at the intersection between the top of pier and the ceiling vault slab. This condition was typically observed near the entrance portals where forces from the barrel vaulted center bay most likely induced bending on the pier. This condition was also observed at piers located at the center of the filters away from the end walls and portal. Here, the cause may more likely be differential settlement at the foundation level.

FIG. C.5 - TYPICAL ROTATION AT ENTRANCE RAMP PIER-TO-CEILING JOINT.

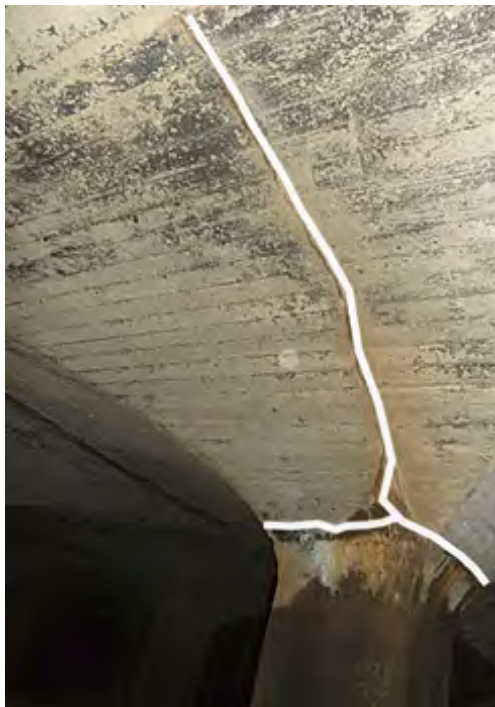
Vault slab cracks around the top of the piers. This vertical cracking emanating from the vault bearings on the piers may be caused by one or a combination of conditions including: differential settlement, and end wall movement. This condition is most common at piers near the end walls.

FIG. C.6 - TYPICAL DAMAGE OBSERVED NEAR THE PIER.

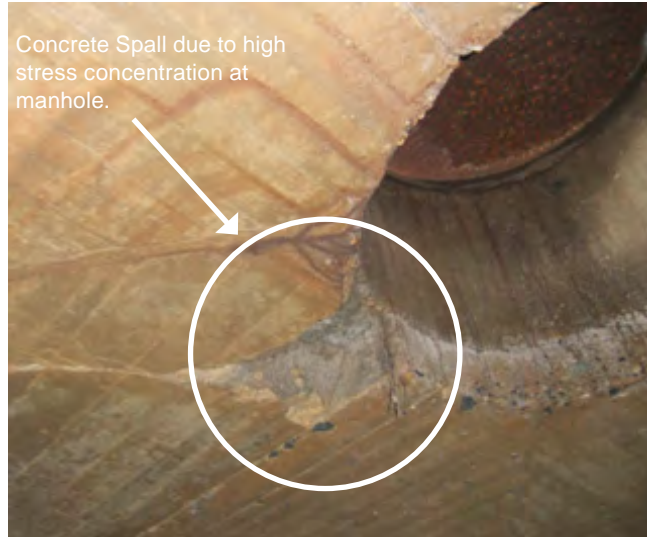
Concrete spalls. This condition was observed by RSA typically near the manholes. These concrete spalls are consistent with anticipated stress concentration at the manhole openings in the vaulting.

FIG. C.7 - SPALL AT UNDERSIDE OF VAULTED CEILING NEAR MANHOLE.

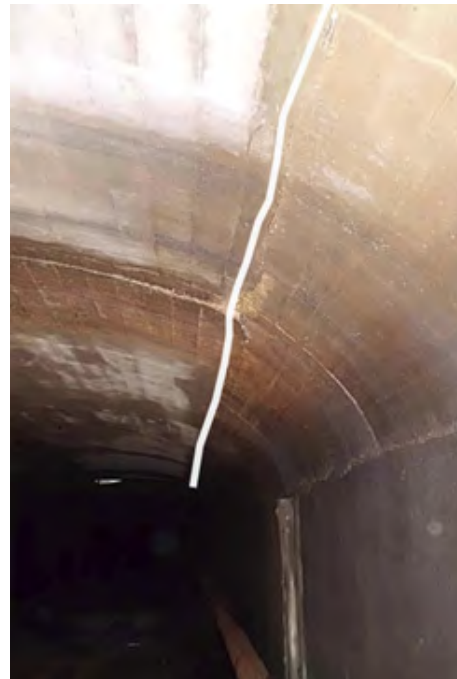
FIG. C.8 - TYPICAL CRACK AT THE BARREL VAULT CEILING NEAR A FILTER END WALL.

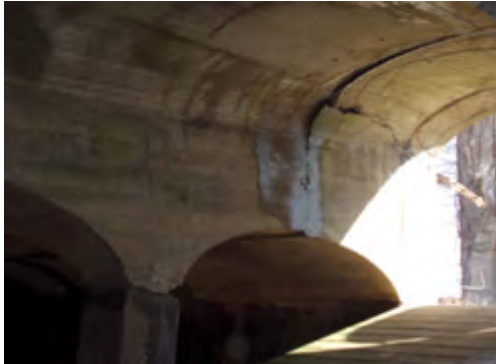
Entrance portal, ramp and adjacent bays. Significant displacements at the vault joints were typically observed at bays near the portal. Cracking and vertical displacement was observed at the underside of the portal ceiling. Rotation at piers supporting the portal barrel vault was also observed. These conditions are most likely caused by disruption of the structural symmetry of the filter at the entrance portal which affects the balance of internal forces. There is a regular pattern of damage at the entrance portal jamb walls caused by a combination of corrosion of the gate metal anchors, and the stress caused by structural rotation of the end wall and the restraint offered by the portal ceiling slab.

FIG. C.9 - TYPICAL DAMAGE AT ENTRANCE PORTAL.
