Square 369

1100 Block Ninth Street, N.W., Washington DC

Building Preservation Plan

Final Report

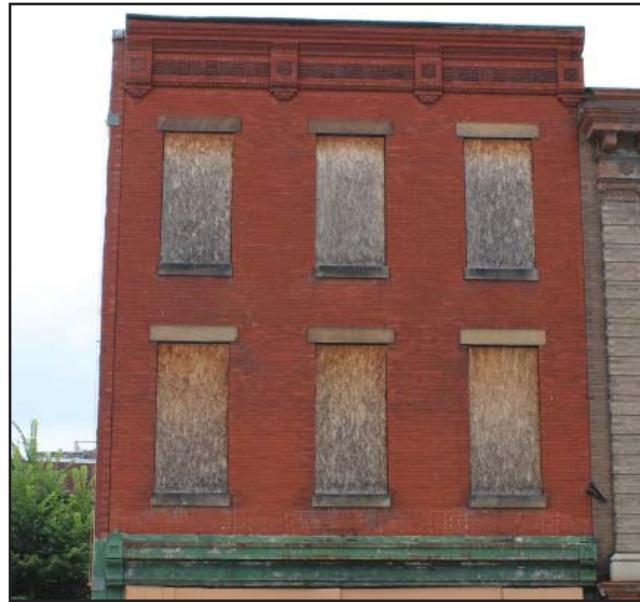
Image 1

Facade: The building facade (Image 1 and 2) is composed of red brick laid in two different configurations. The first floor of the building is laid in a stack bond, with thin, raked mortar joints, painted green to match the pressed metal stringcourse. The second and third stories of the facade are laid in a running bond with thin, raked mortar joints left unpainted. The brick is generally in good condition; there are no major cracks in the facade and only a few spots of efflorescence. Holes have been drilled in a few of the bricks located beneath the second floor windows, which most likely were used to secure an awning. Each second and third floor window has a simple stone, lug sill, as well as a simple flat, stone lintel; cracks are evident, however, the sills and lintels remain in fair condition. Above the third floor lies a corbeled brick cornice and frieze composed of normal and pressed brick, with alternating square and brick tiles of fluted and star medallion motifs. Four symmetrically placed false brackets embellish the frieze, with a brick corbel under each bracket. Decorative strings of dentils and bead and reel motif molding run the length of the cornice and frieze. The brick cornice and frieze remain in good condition, however, they should be further assessed from a closer point once scaffolding is erected.

- **Brick Facade:** Clean brick facade with low (<100 psi) pressured water. Repoint brick where necessary with thin, raked mortar joints and mortar similar in composition, texture, application, and color to the original to reduce spalling and noticeable color differentiation. Test patches should be undertaken to ensure that the cleaning method is not harmful to the historic masonry.
- **Stringcourse/Parapet Molding:** Remove flaking paint on the metal, reshape where necessary, and repaint. If upon closer inspection a new cornice must be fabricated the existing cornice will serve as a model. Make certain that the connections to the brick facade are sound,

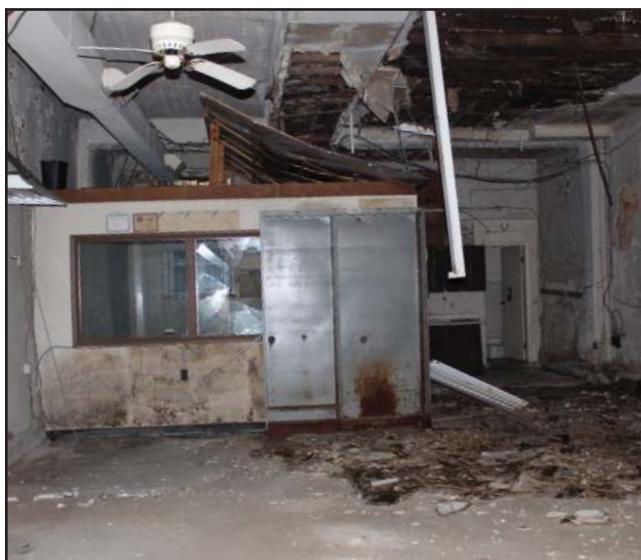
Image 6

Interior: Most of the first floor has been replaced with contemporary material for commercial space, including thin wood paneling, contemporary fixtures, and metal shelving. The second and third floor have been stripped of all architectural details and left to deteriorated after years of neglect. Most of the ceilings have collapsed on the interior doors and fixtures removed (Images 6 and 7).

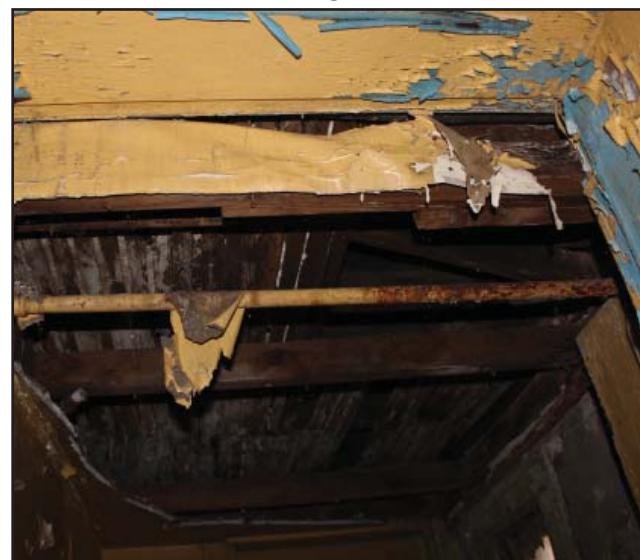
Image 7

Flooring Structure: The second and third floor have begun to deteriorate due to lack of repair; multiple holes can be seen through the building and the wood beams are in poor condition (Image 7).

- **Floor Structure:** Due to dilapidated conditions, replace the flooring systems to match current fire and safety code and allow for seamless connection with the new structure.

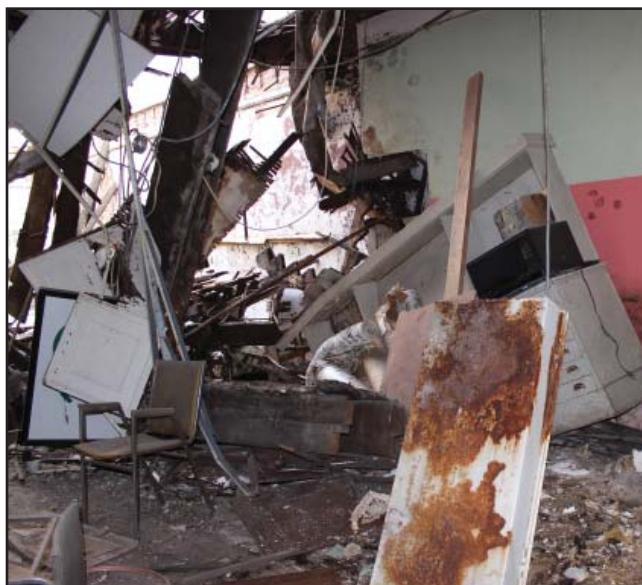
Image 7

Interior/Flooring structure/Roof Structure: The entire interior has collapsed. The roof, third, and second floors have all collapsed limiting access to the first few feet of the building. There is no salvageable material on the building's interior (Images 5, 6, and 7).

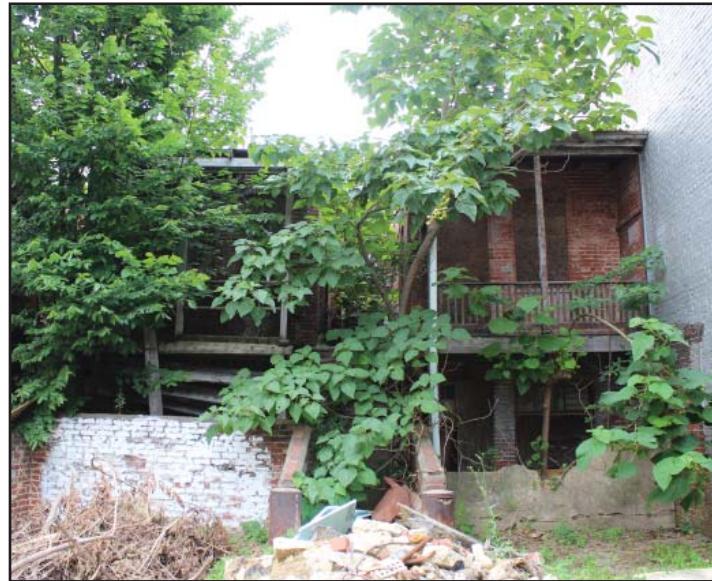
Image 3

The rear elevation of the building is severely deteriorated (Image 3). It is broken into three planes, the central of which is set back to approximately 32' from the building facade and could not be observed at this time, as it is block by thick vegetation. The north and south bays are reflective of each other: the first floor holds a door set beneath an arched soldier course, brick lintel, and a window beneath a flat arch lintel. The second floor elevations are the same, however, the windows rest below an arched brick lintel and the floors are ringed with wooden porches. Vegetation allowed to grow unhampered has compromised the structure and caused irreversible damage. The rear wall of the south commercial space has completely detached (Image 4). Numerous attempts to repair cracked mortar, as well as new cracks that have formed, show the large amount of settlement and damage that the building has undergone. The porch on the north bay has begun to fall off and a tree has broken through the brick wall and doorway of the south bay on the first floor (Image 5), most likely the cause of the separation of the brick wall.

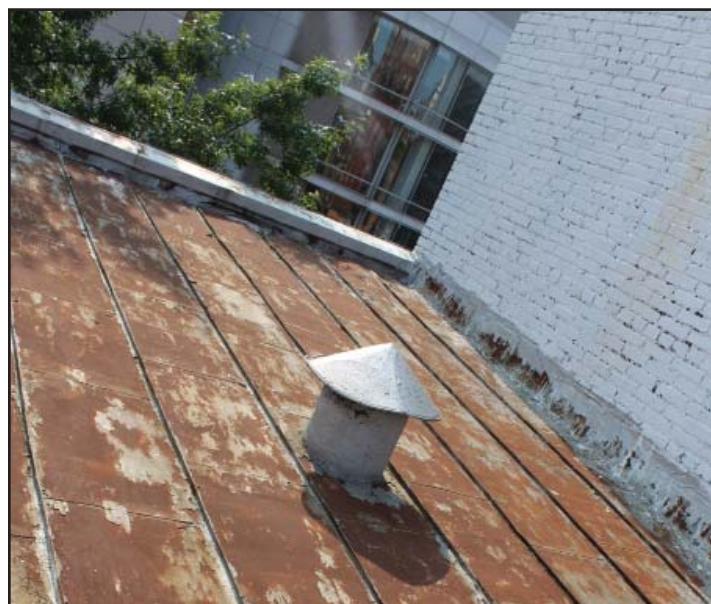
Image 11

Roof: The original, standing-seam, tin roof (Image 11) remains on the building in moderate condition.

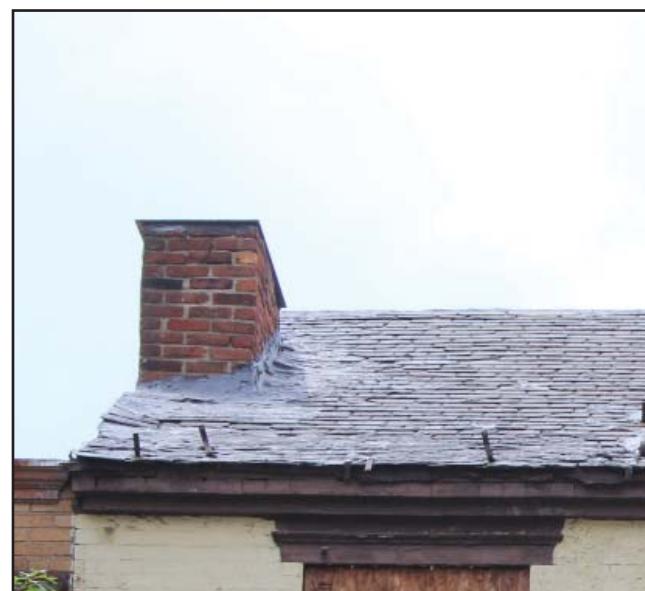
Image 9

Roof Structure: The original, gabled, slate roof and brick chimney, located on the south side, are extant (Image 9); however, both are in very poor condition. Insensitive patching of the slate is clearly visible from the street level.

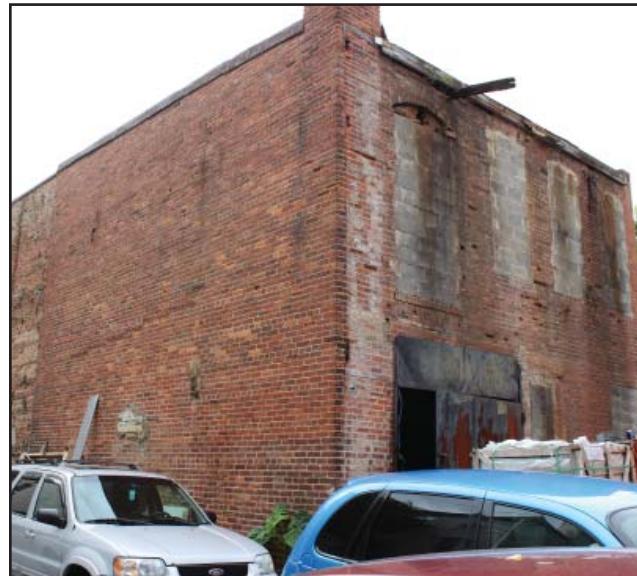
Image 4

The north, south, and rear (east) elevations of the building are composed of exposed brick in poor condition (Image 4 shows the north and rear walls). All three show signs of severe deterioration. The north and south walls have no punctures. There is visible mortar patching and spalling on both sides. The first floor of the elevation wall has one large, metal door to the north, next to two small windows openings, one with an arched brick lintel and the other with no lintel. Both window openings have been closed with cinder blocks. The second floor has a single door opening, also to the north, and three window openings. All four openings have arched, brick lintels, and all four have

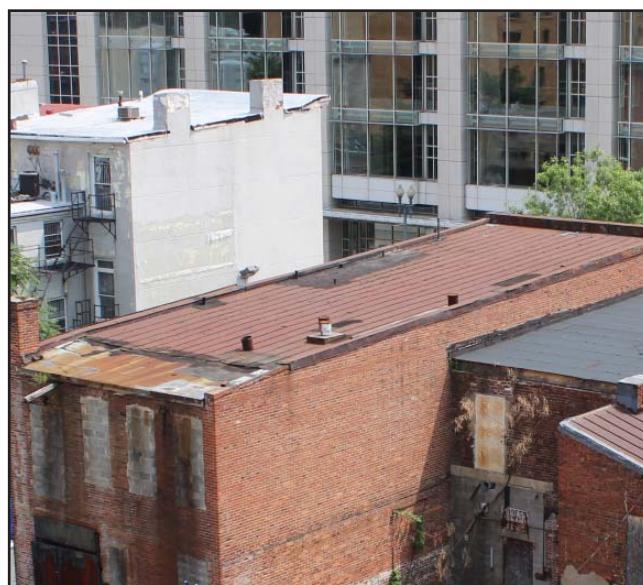
Image 9

Roof Structure: The original standing-seam, tin roof system (Image 9) remains on the building in poor condition.
