# PHASE I ENVIRONMENTAL SITE ASSESSMENT

COMMERCIAL PROPERTY  
3443 BENNING ROAD NE  
WASHINGTON, DC 20019

ICOR Project No. 15NDC05

**June 3, 2015**

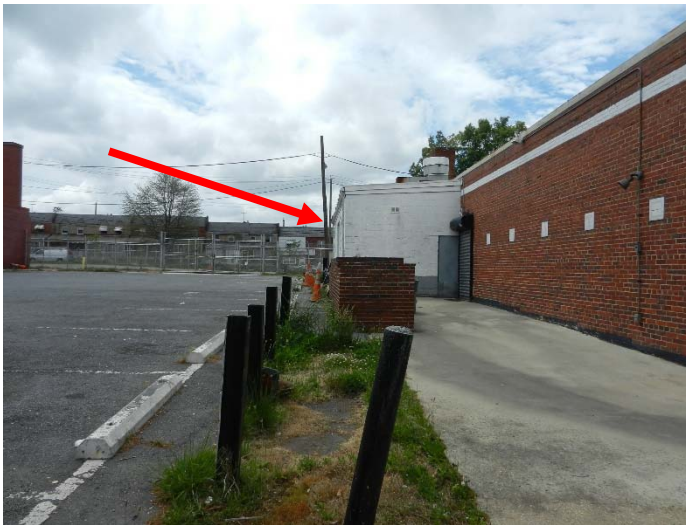
One small shed was present at the northwestern portion of Lot 0842 along Eads Street and a small concrete block structure was present abutting the adjacent retail building to the west in the northern parking lot. Due to a lack of access inside the Property fencing, these structures were not accessed for the ESA. ICOR made several attempts to access the property and to interview the current site owner. In the end, ICOR was not given access or interview. As such, the past and current uses of the small concrete block structure were not determined. Icor was told that the small shed held cones and other items utilized by the parking attendant. Although the uses are not expected to be of environmental concern, this is considered a limiting condition and data failure for this ESA.

1. View of the small concrete block structure located on the western side of the northern fenced lot

- Should access be granted to the storage shed and small concrete block structure and evidence of past or current environmental concern are identified, ICOR will generate an addendum to this report with altered conclusions and recommendations.

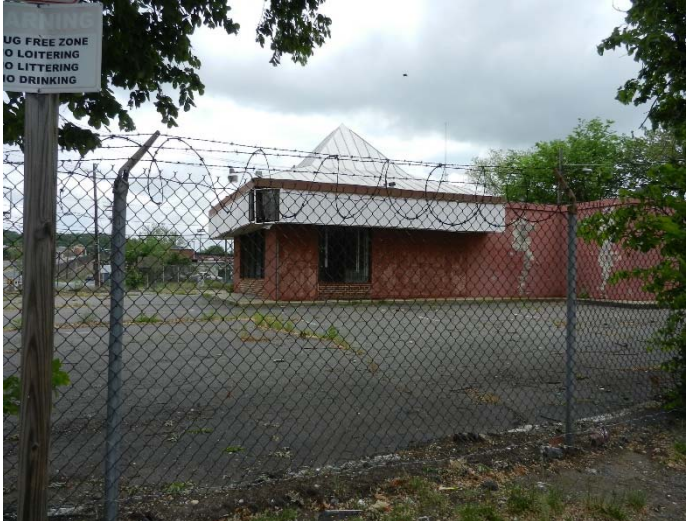
The vacant commercial property to the northeast had a visible AST identified as “used oil” present on the eastern portion of the site. This property was formerly identified as a gas station, auto repair facility, car wash, and used car dealership. The tank was observed to be in good condition with no signs of leaks or damage. The observed tank is not expected to represent a significant environmental concern.

Due to the identification of this property as a gas station and auto repair facility, it is likely that tanks formerly used on site were closed in place, removed, or still remain on site. This property is located cross to downgradient from the Property and as such, has a low potential to impact the Property. However, due to the unknown condition/disposition of the tanks and prior use as a gas station, the potential impacts from this site cannot be ruled out. As such, this former gas station and auto repair facility is considered a di minimis condition for the Property. However, due to the lack of potential current or past uses of the Property involving petroleum products,

5. View of the adjacent former gas station and auto repair facility to the northeast

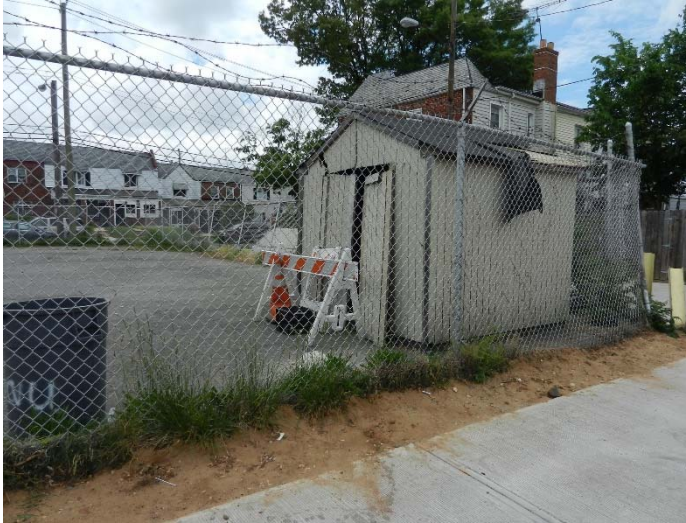
- One small shed was present at the northwestern portion of Lot 0842 along Eads Street and a small concrete block structure was present abutting the adjacent retail building to the west in the northern parking lot. Due to a lack of access inside the Property fencing, these structures were not accessed for the ESA. ICOR made several attempts to access the property and to interview the current site owner. In the end, ICOR was not given access or interview. The small shed was reportedly used by parking attendants and was not used to store any hazardous chemicals or gasoline. The past and current uses of the small concrete block structure were not determined. Although the uses are not expected to be of environmental concern, this is considered a limiting condition for this ESA.

7. View of a small shed located at the northwestern corner of the large parcel located along Eads Street

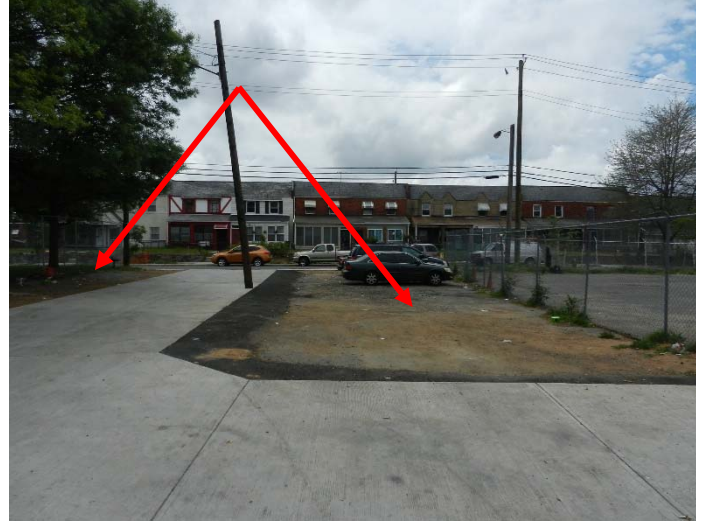
- Minor dumping of typical household and food trash was observed on the two unfenced portions of the Property. No chemical wastes or drums were observed in these areas.

8. View of the two non-paved and unfenced portions of the Property located along Eads Street

- Routine removal of the food waste and household trash in the unfenced areas is recommended.
- A former dry cleaners was present approximately 110-feet to the west and downgradient from the Property and a former gas station, auto repair facility, and used car lot was present to the northeast and cross to slightly upgradient from the Property. No releases have been reported for these two former sites. However, the status of the former gas station tanks is

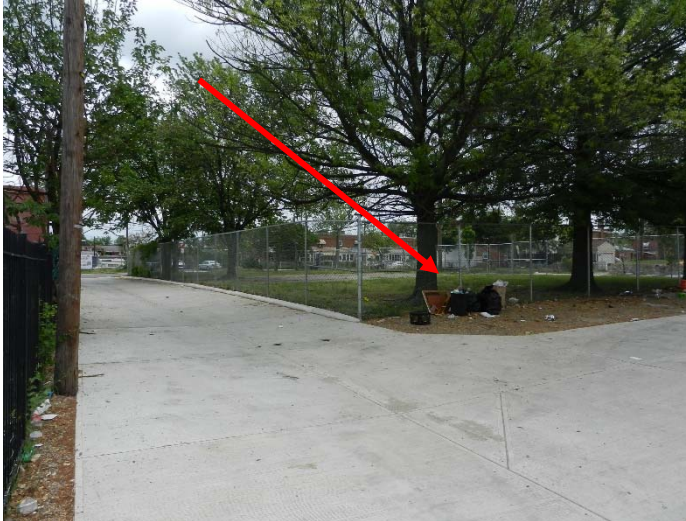
Small areas of dumping were observed around the Property areas, especially the unfenced gravel area at the southeastern portion of the Property. The observed materials were typical municipal trash consisting of food containers and paper.

9. View of the small unpaved strip that is the eastern portion of the Property with an undeveloped, fenced lot beyond (note minor dumping)

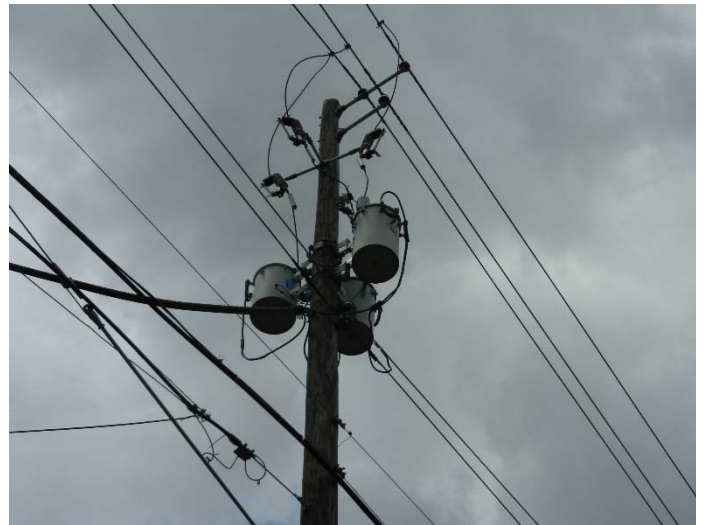
Several pole-mounted transformers were observed on the adjacent sites and along roadways during the site reconnaissance. No spills, staining or leaks were observed on or around the transformers. Based on the good condition of the equipment, the transformers are not expected to represent a significant environmental concern.

14. View of three adjacent transformers located along Benning Road
