EMBASSY OF HUNGARY ANNEX Brodhead-Bell-Morton House

1500 Rhode Island Avenue, NW, Washington, DC 20005

Historic Preservation Plan

Second Draft Submission
April 2018

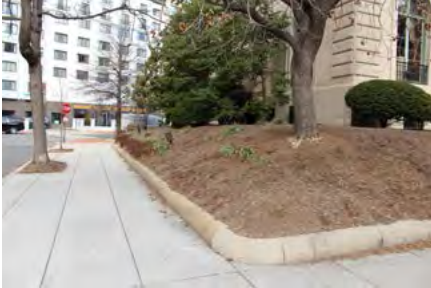
The concrete and exposed aggregate curb that encircles the property features areas of patching and/or mismatched alterations, as evident on the southwest corner of the site.

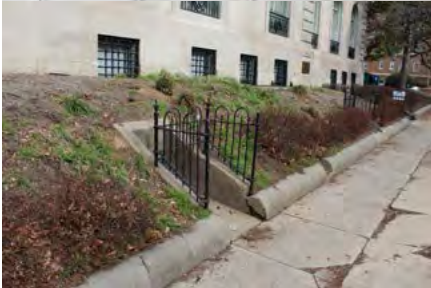
The concrete curb exhibits areas of cracking and missing material along its length, as evident along the N Street side of the site.

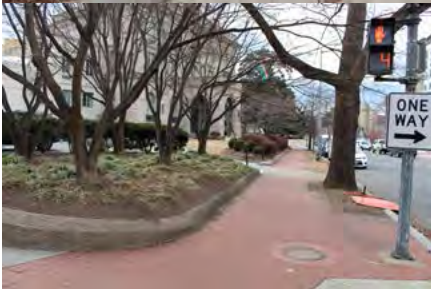
The exposed aggregate curb—particularly along the north and east sides of the site—exhibits general surficial staining, likely from water runoff from the adjacent banked slopes.

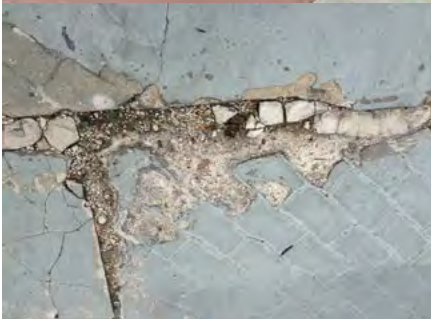
The stamped concrete drive along the northern side of the site features areas of cracking and missing concrete and missing paint. Areas of previous patching campaigns are also evident.

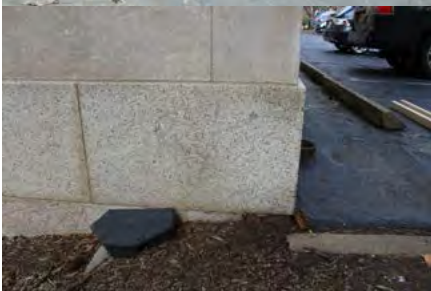
Portions of the brick foundations are visible at the building perimeter, possibly revealed due to settlement of the surrounding ground.

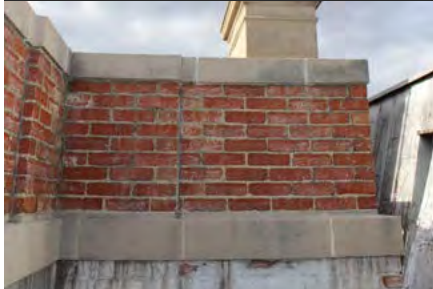
Brick masonry lines the inner face of the upper roof parapet. The brick is in generally good condition but exhibits minor staining and areas of missing mortar.

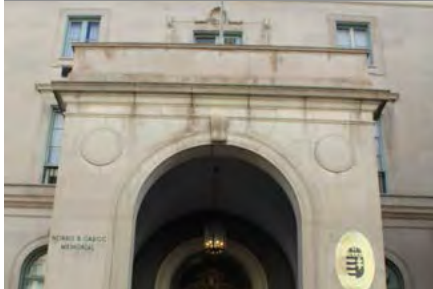
Limestone exhibits general staining resulting from water drainage and runoff. This is particularly visible along horizontal projections (as shown on the porte cochère at left) and along masonry joints. Water infiltration may have damaged or dislodged mortar joints, some of which have been replaced over time.

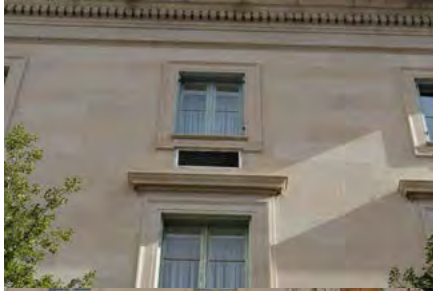
During the 1960s, openings were cut into the limestone façade beneath window openings along the third floor. These openings were infilled with vents to allow for fresh air intake and exhaust.

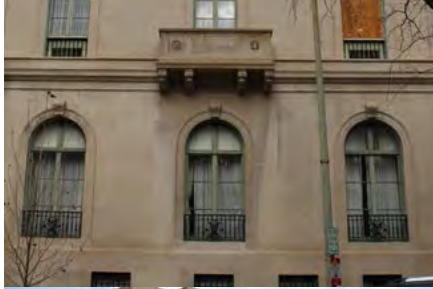
As noted previously, staining from water runoff is visible across all elevations but is particularly evident beneath the projecting balconies on the south and west elevations. The differential coloring of the limestone at present suggests previous cleaning campaigns, although record of previous treatment is unknown.

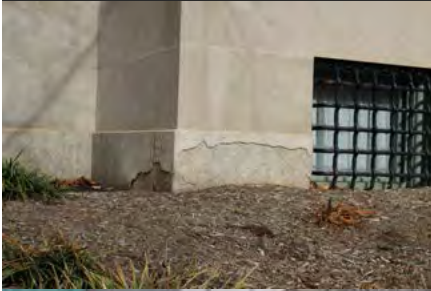
Granite water table exhibits delamination and peeling of the outer layers of stone. This condition is particularly advanced along the lower surface of the stone on the south elevation.

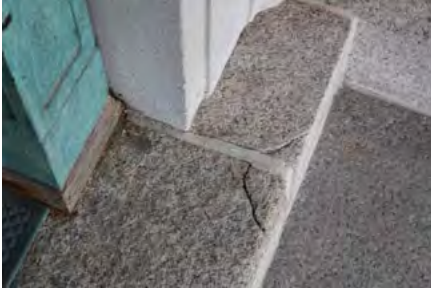
Minor cracking, missing or patched sections, and mechanical damage is visible to a limited degree on granite throughout.

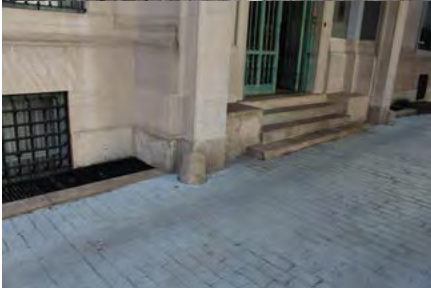
Granite stairs, cheek walls, areaway coping, and water table around the main building entrance and porte cochère exhibit moderate soiling.

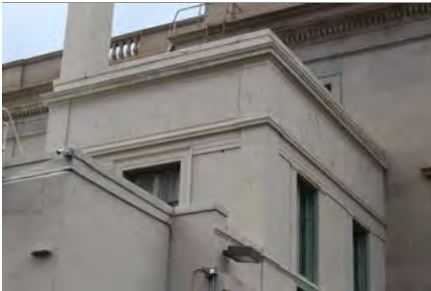
The original stucco cladding on the east wing of the building is in generally good condition. The stucco exhibits limited staining as well as general peeling and crazing of the outer painted surface.

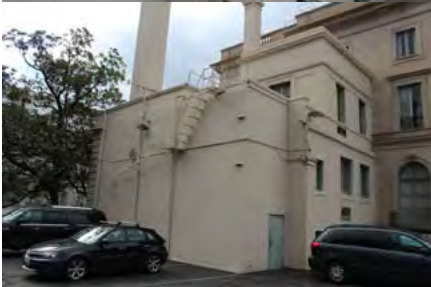
After the kitchen and service wing were removed circa 1940, the newly exposed wall surface was re-clad with stucco. The stucco exhibits hairline surface cracking and crazing and evidence of previous repair campaigns.

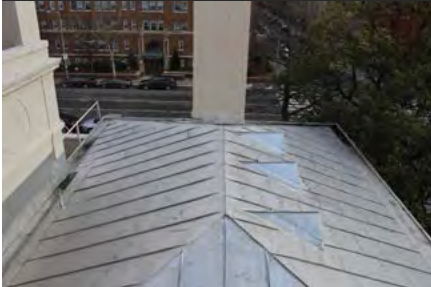
The lower roof on the building's east wing (above the dining room) has a hipped configuration with standing-seam metal cladding and integrated gutters and dormer vents. The roof appears to be in generally good condition.

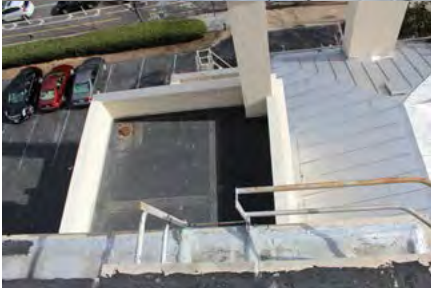
The lower roof on the building's east wing (to the north of the hipped roof above the dining room) is covered in a bituminous membrane. The membrane's seams and associated flashing exhibits general wear from age.

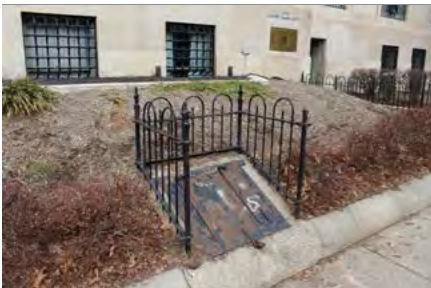
Loss of outer paint finish on cast-iron fencing around the perimeter of the site has resulted in rusting of the metal substrate.

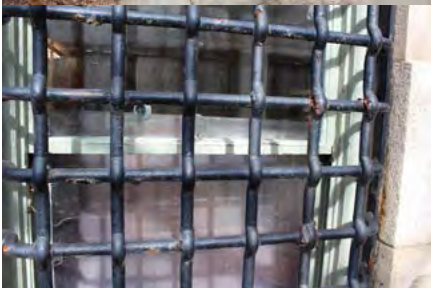
Loss of outer paint finish on cast-iron window grates on the basement story has resulted in rusting of the metal substrate.

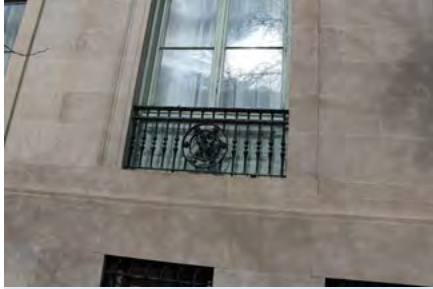
The cast iron grates lining the window openings of the first and second floors appear to be in generally good condition. The upper surfaces feature lost or chipping paint, which could degrade the metal substrate if not corrected.

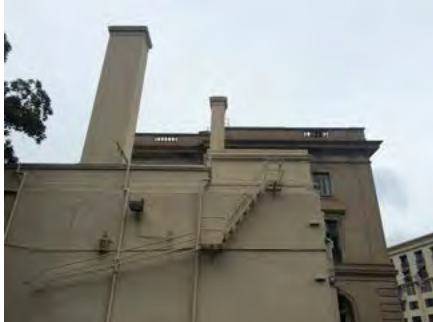
The exterior fire escape stair was likely added to the east elevation of the building after the kitchen and service wing was removed circa 1940. It has been painted to match the color of the underlying stucco.

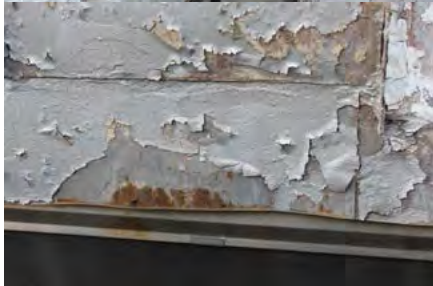
The metal-clad mansard roof on the fourth floor of the building exhibits extensive loss of surface paint finish. Loss of exterior coating has resulted in accelerated oxidization of the underlying metal substrate. In some cases, the metal cladding has been bent or dislodged.

A detail of the condition described above, showing loss of outer paint finish and oxidization of metal roof cladding.

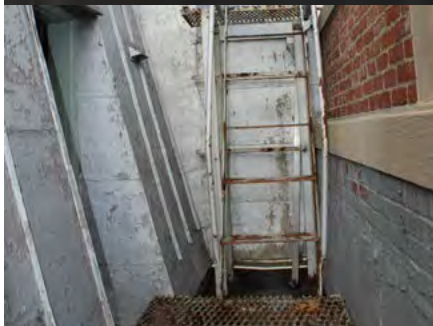
A variety of metal stairs, grates, and other appurtenances are present across the upper and lower roof surface. These are general in poor to fair condition with extensive loss of surface finish, oxidization, and displacement. These features also present safety issues for those accessing and navigating the roofs.

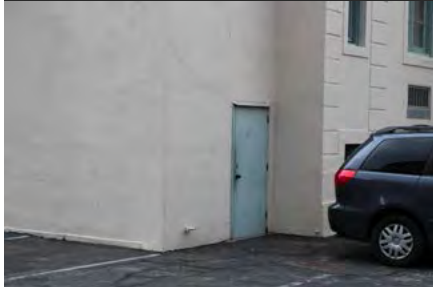
The metal-clad door at the northeast corner of the building connects with the east wing on the ground floor. The opening may be original to the building, but the existing door was likely installed after the kitchen and service wing was demolished circa 1940. The painted surface is mostly intact but has faded over time.

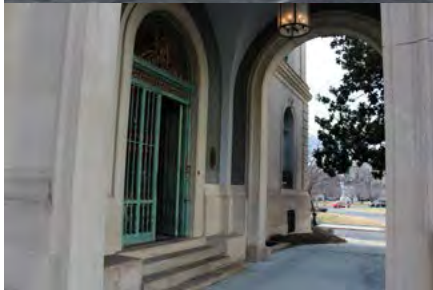
An ornamented metal grille and door provides access to the interior vestibule on the building's main entrance. The faux paint finish does not appear to be original.

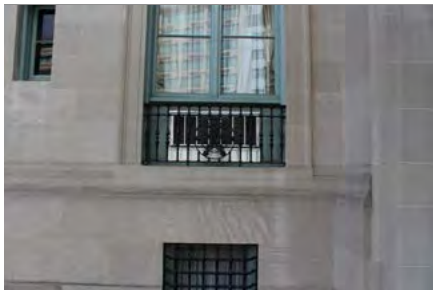
A number of windows on the first and second floors have been modified to allow for the insertion of air conditioning vents. The original wood frames were modified to support this change.

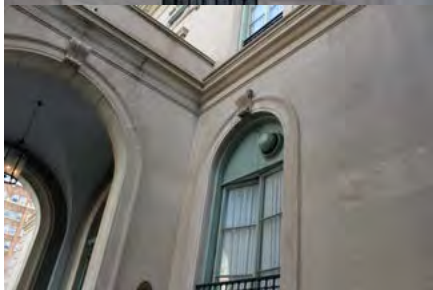
On the window opening to the immediate west of the porte cochère on the north elevation, the transom was infilled to create an exhaust vent for the bathroom inside.

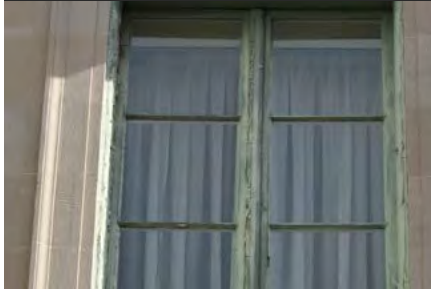
The painted surface of the wood window frames has become brittle over time and exhibits cracking and peelings. This condition is evident throughout. At present, there appears to be little or no damage to the wood substrate resulting from this exposure.

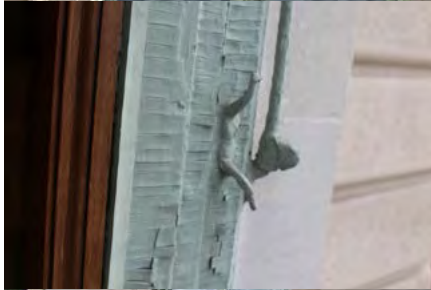
A detail of the condition described above, showing loss of outer paint finish.

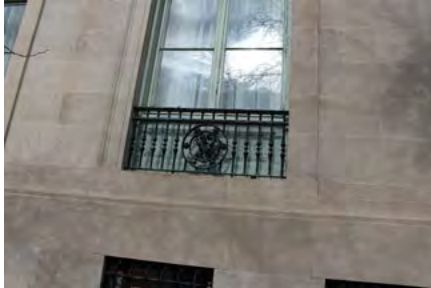
The wood panels at the lower portion of the window openings on the east side of the south elevation (corresponding to the interior dining room) appear to be original to the building. They exhibit the same loss of paint condition described above.

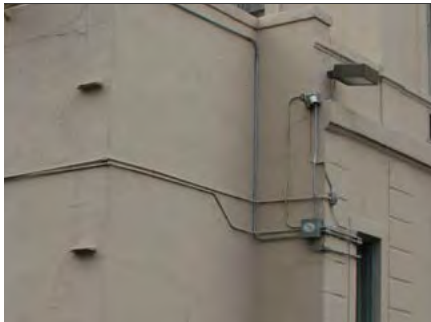
There is extensive, surface-mounted lighting and security equipment and conduit throughout the building exterior. This equipment is non-contributing but does not overwhelmingly detract from the historic character of the building.

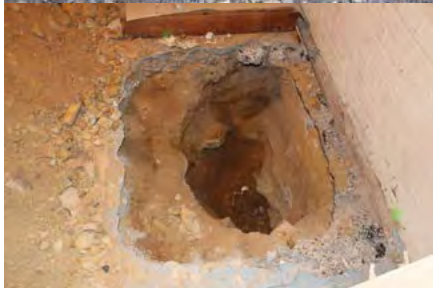
Throughout the building, but especially the basement floors, exploratory demolition has been conducted to determine the composition of floor, wall, ceiling, and foundation elements. The example at left reveals the brick and concrete footings beneath the subbasement floor level.

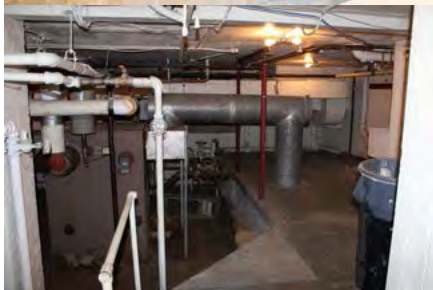
The subbasement floor holds a large collection of mechanical and electrical equipment, some of which appears to be antiquated or no longer in active use.

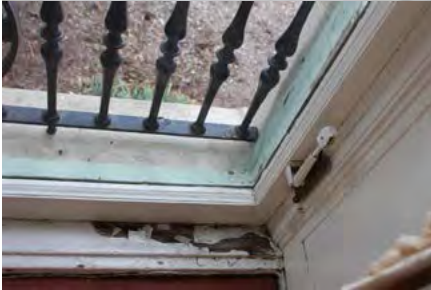
Window sills throughout the building exhibit loss of paint, likely reflecting a high moisture content in the underlying wood substrate. The example shown at left is located in the windows in the first floor Salon.

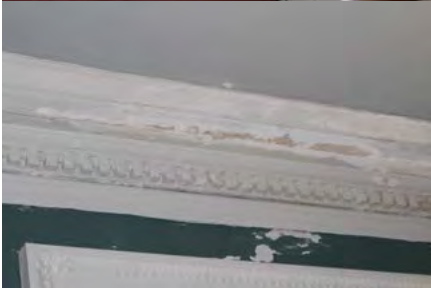
In the office at the northeast corner of the second floor, moisture infiltration has damaged the decorative plaster cornice on the east wall of that room. This condition likely resulted from a failure of the roof membrane above. Evidence of previous repair campaigns is visible on the interior, although it is not known whether the root cause has been addressed.

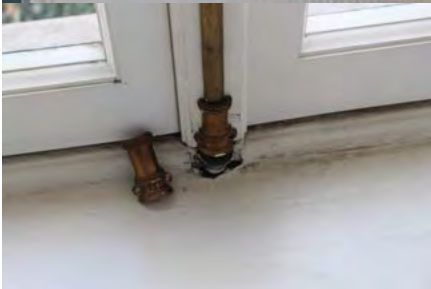
Windows throughout have missing or dislocated hardware. The example at left is located on the third floor.
