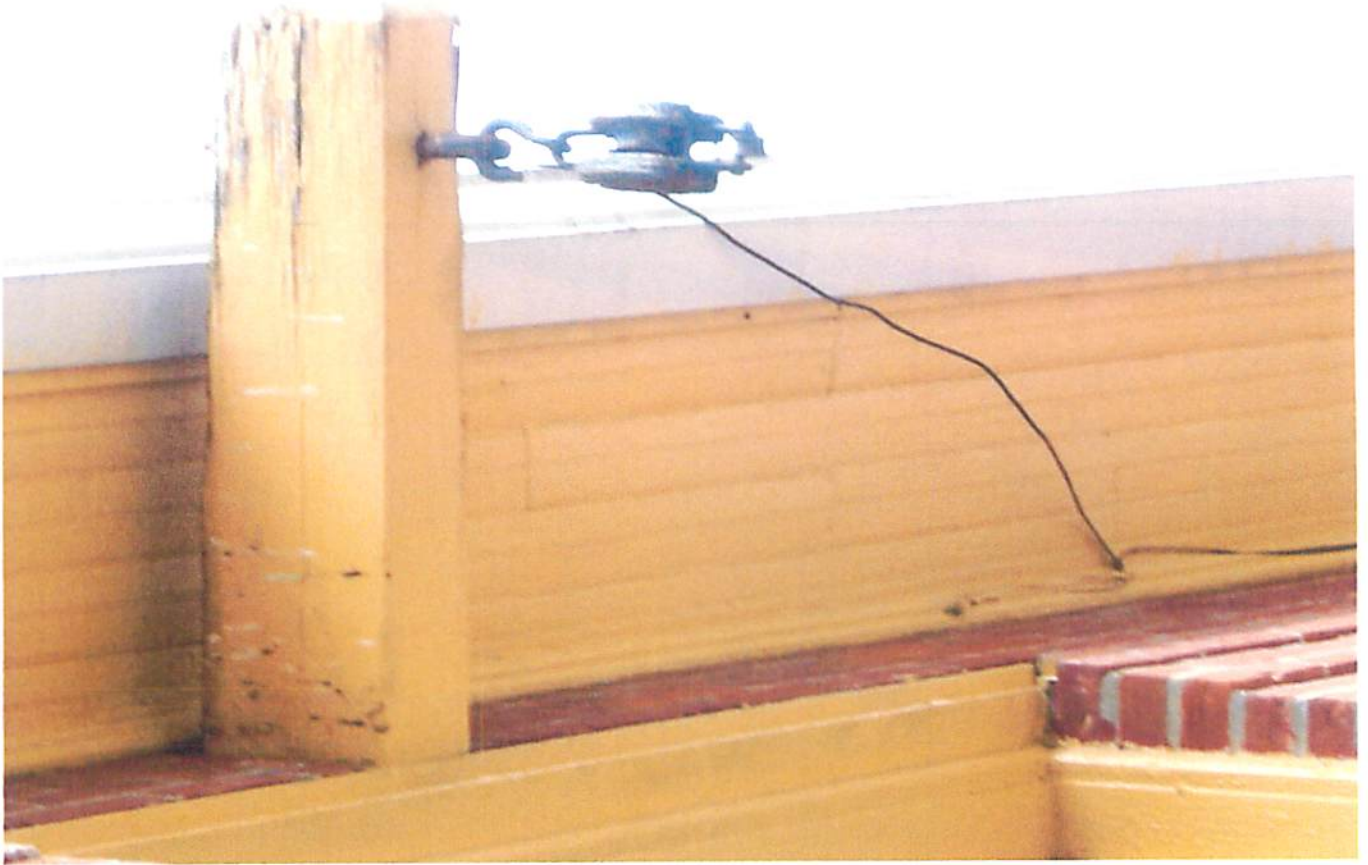
BEAM AND PULLEY AT HAY DOOR

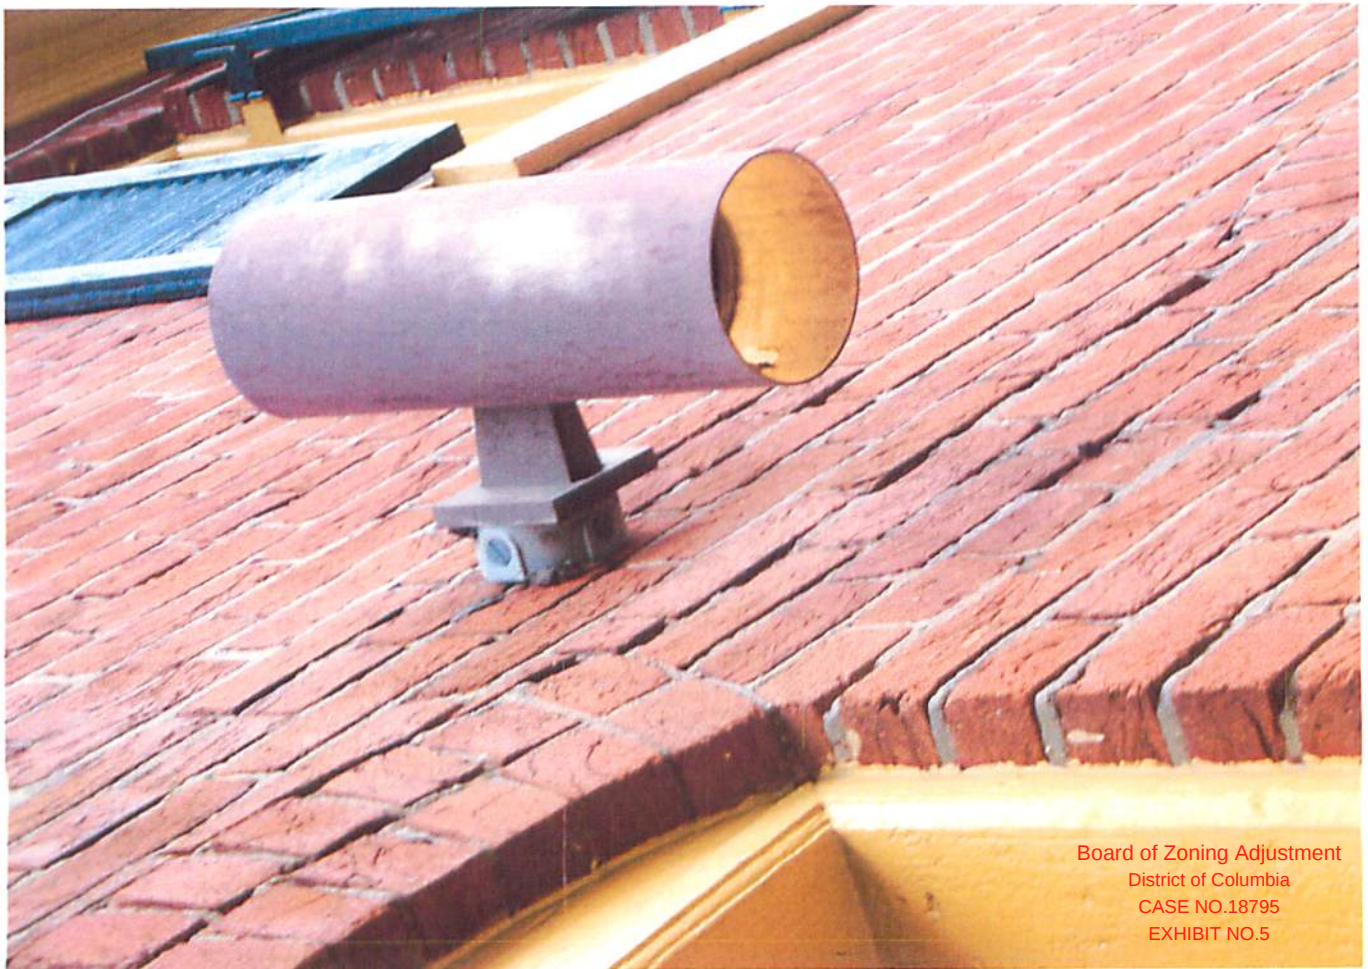
EXISTING LIGHT FIXTURE

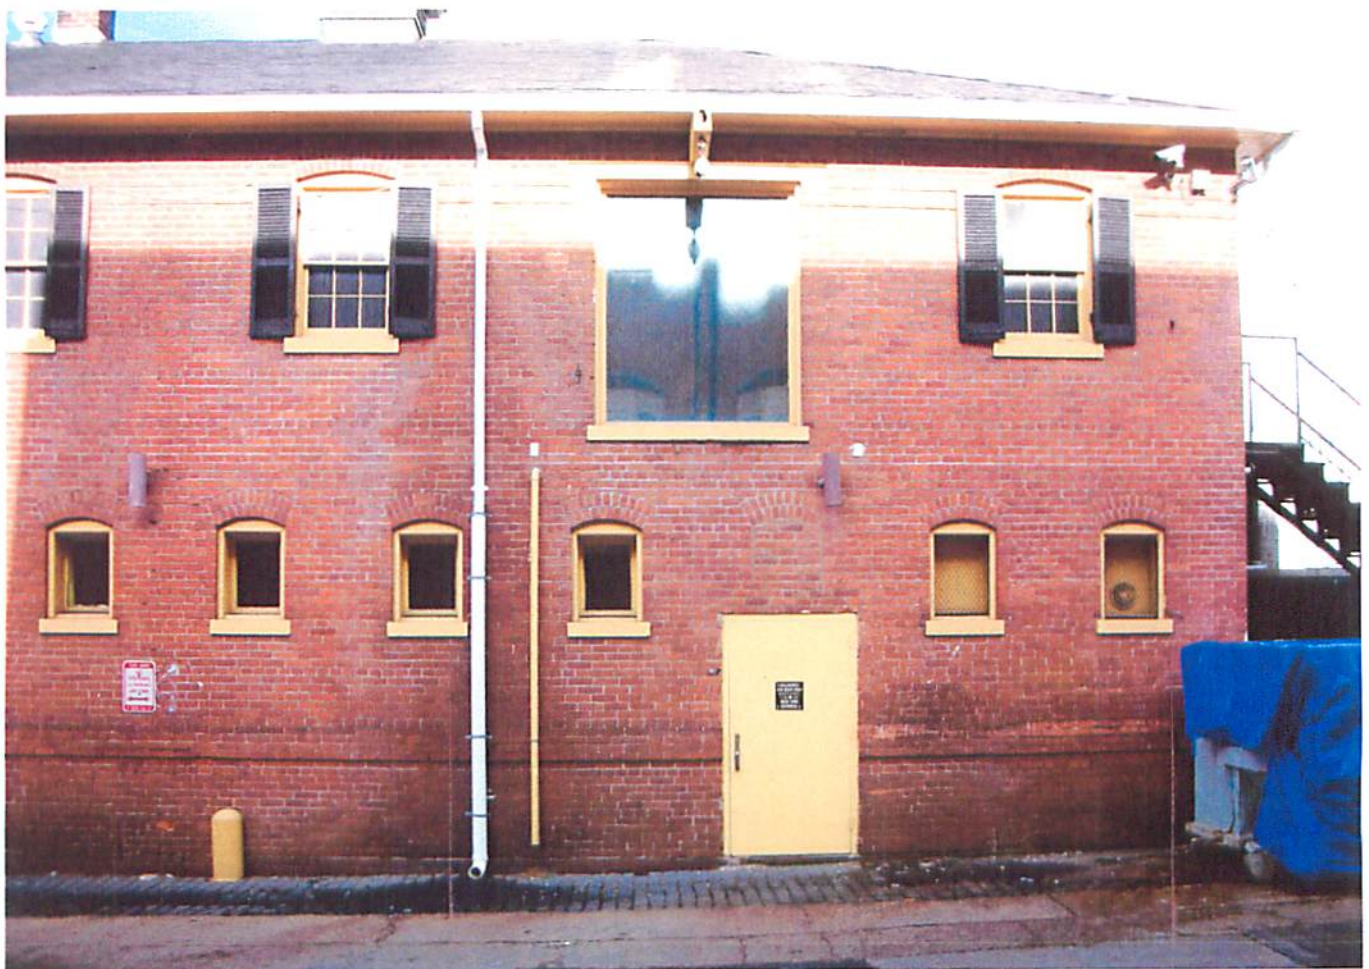
HAY DOOR & BLOCKED STALL WINDOW
