Re: BZA Case No.: 18992

EXHIBIT A

This report will detail my inspection of two trees whose critical root zones will be impacted by the proposed development of 1015 and 1013 E Street, SE, Washington, D.C.

1011 E Street, S.E.

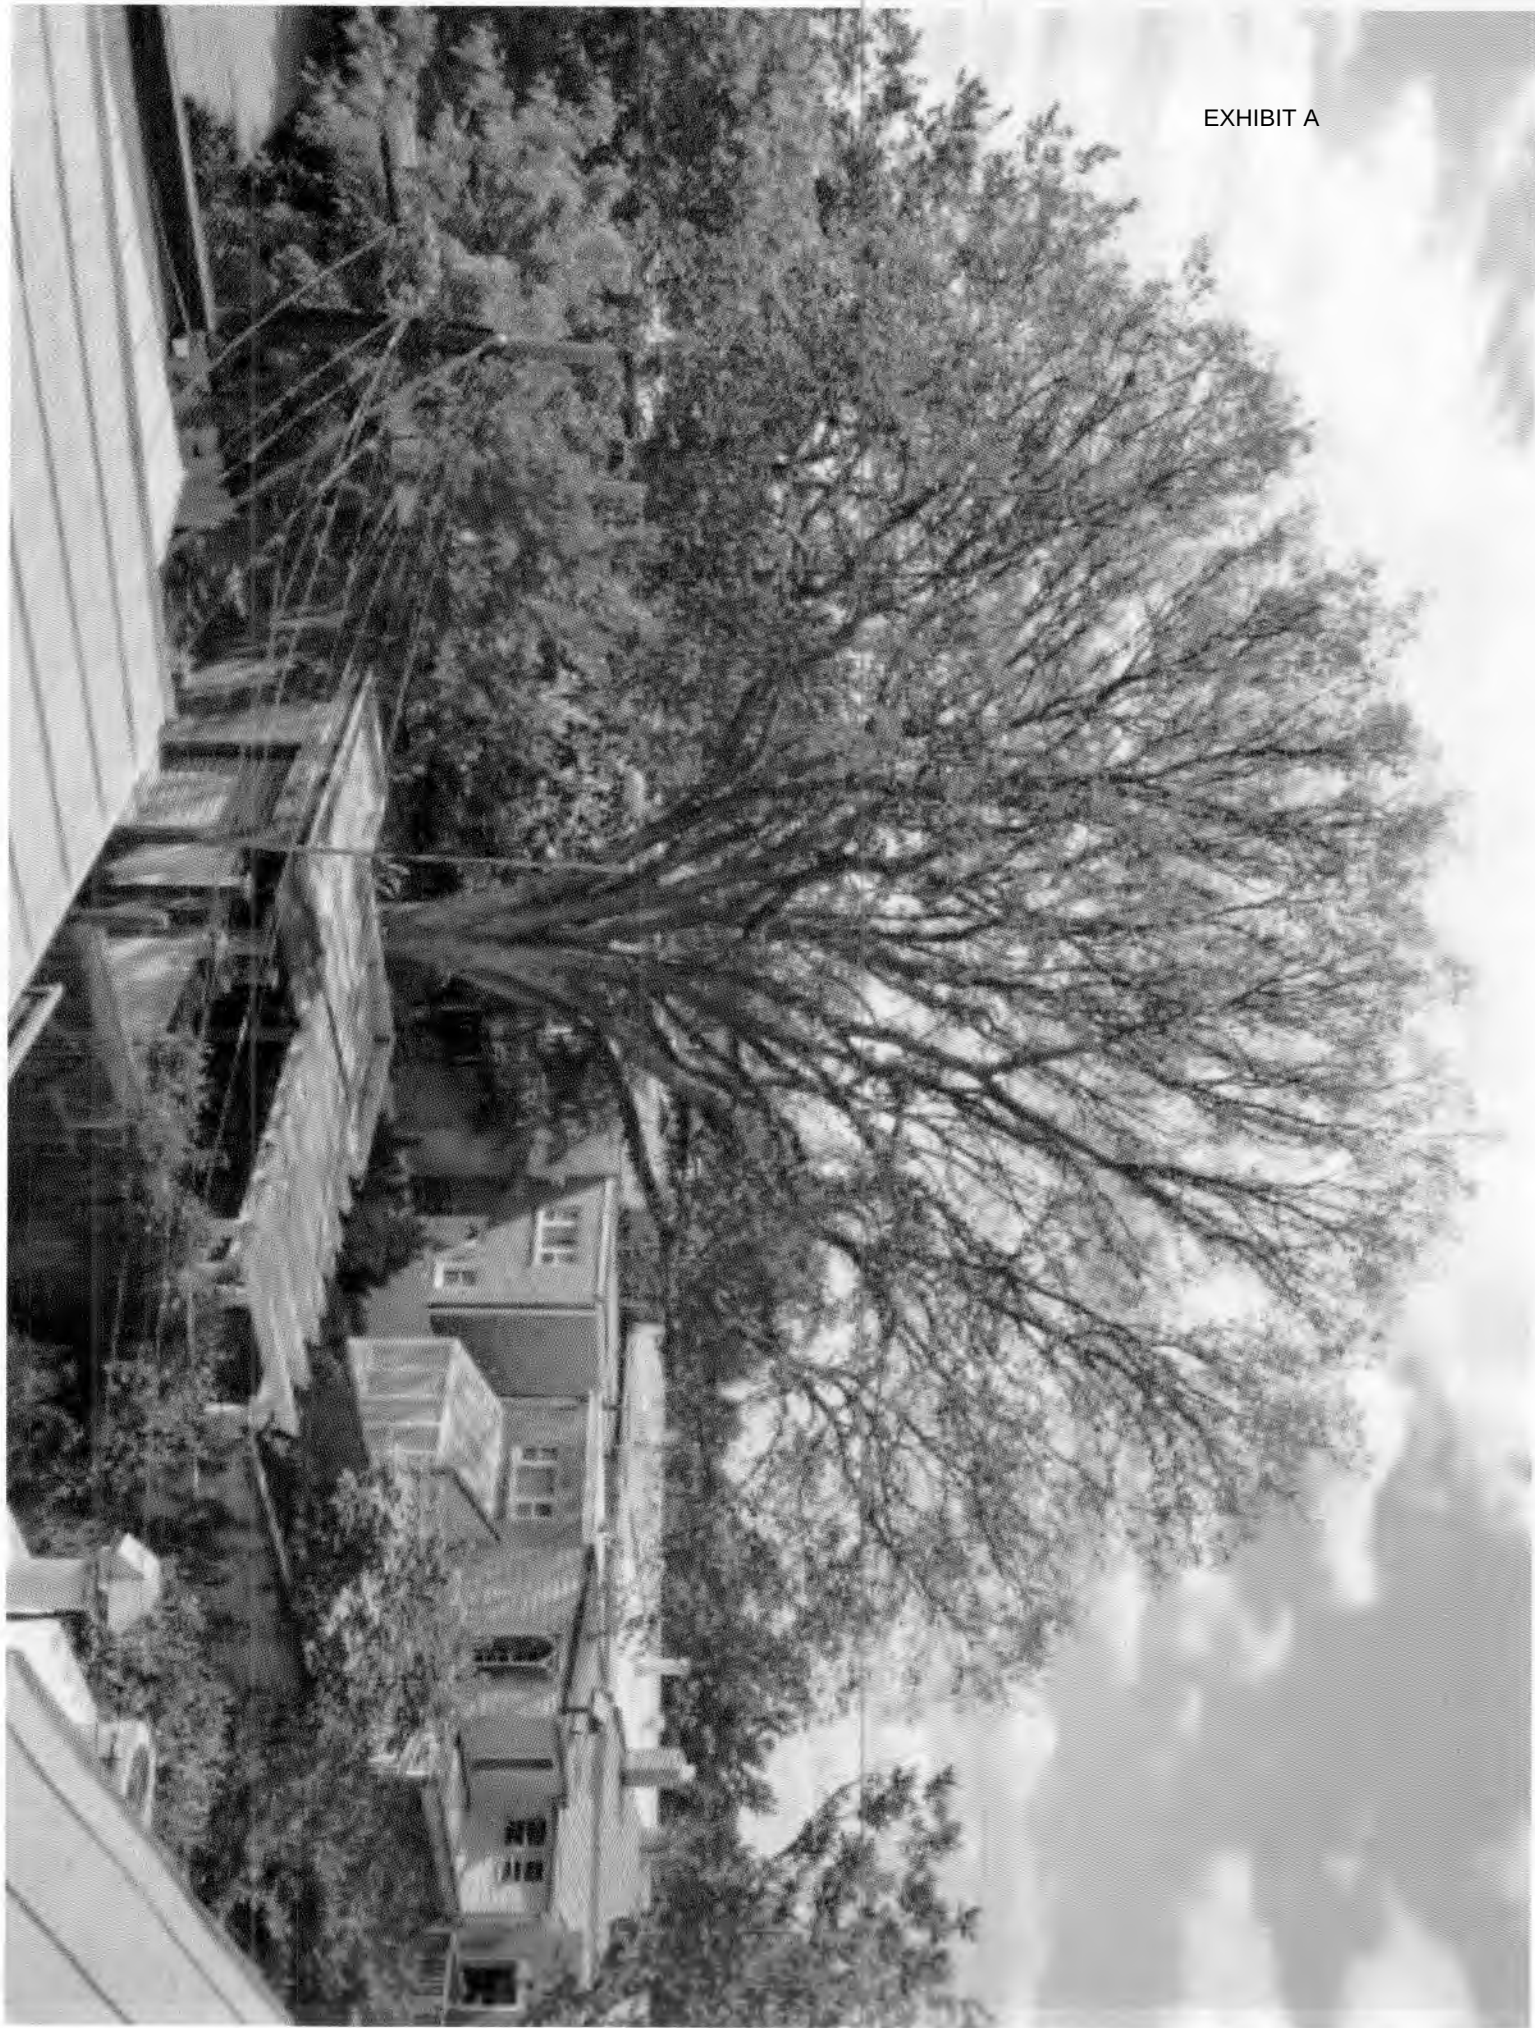
I am a resident of the District of Columbia and reside at 1011 E Street, SE. My home is two doors away from the proposed project at 1013 and 1015 E Street, SE. The purpose of this letter is to express my concern over the potential effect of this construction project on a stately elm that is situated on my property but graces the entire block. Attached to this letter is a picture of the tree, Exhibit A.

The tree in question at this address is an American elm with a diameter at breast height of 42 inches, or 132 inches of circumference. It is located in the right, rear corner of the courtyard, and is in good to fair condition. It is impressive in terms of its diameter and canopy spread. The canopy is perfectly symmetrical, and based upon a Google image I reviewed, it appears to provide shade to at least seven homes. There were no significant defects in the main trunk, root flares or scaffold limbs. However, there is an abundance of sprouts along the larger limbs termed "epicormic" sprouts. These are often an indication of stress. The stress may be due to the limited rooting area, or it may also be from fungal infection of either Dutch elm disease (DED) or black spot disease.

American elm is also a very aggressively rooting tree. I pointed out where roots have surfaced in Mrs. Knapp's courtyard, and which are heading toward the neighboring property at 1013 E Street. These roots are of a large diameter in her courtyard, and I anticipate that they are still quite large when they cross the property line. So, the question becomes how much of the root system will have crossed Mrs. Knapp's courtyard, and are now in the back yard of 1013 E Street, and even into 1015 E Street?

I strongly urge the Board to require the developer to take the steps required to maximize the chances of survival for the tree. This would include, but not be limited to, 1) engagement of a professional with the authority to review and approve the construction plans as they relate to the tree's root system, as well as the opportunity to monitor execution of the approved plan; 2) an opportunity for the community to review this mitigation plan; and 3) that the developer be required to communicate with and accommodate any concerns of Steve McKindley-Ward of the District's Urban Forestry Administration.

According to Ms. Knapp, she has not contracted for a fungicidal protection program in the past that would protect it from DED infection. As such, I think that she has been fortunate to avoid infection in this tree. Going forward, however, I highly recommend this annual treatment. It should be viewed as an investment in the tree's future.
