Re: BZA Application No. 17309 – Chain Bridge Road, N.W.

# **Analysis Of Tree Preservation At The Chain Bridge Road Project**

**for  
The Chain Bridge Road/University Terrace  
Preservation Committee**

**20 April, 2005**

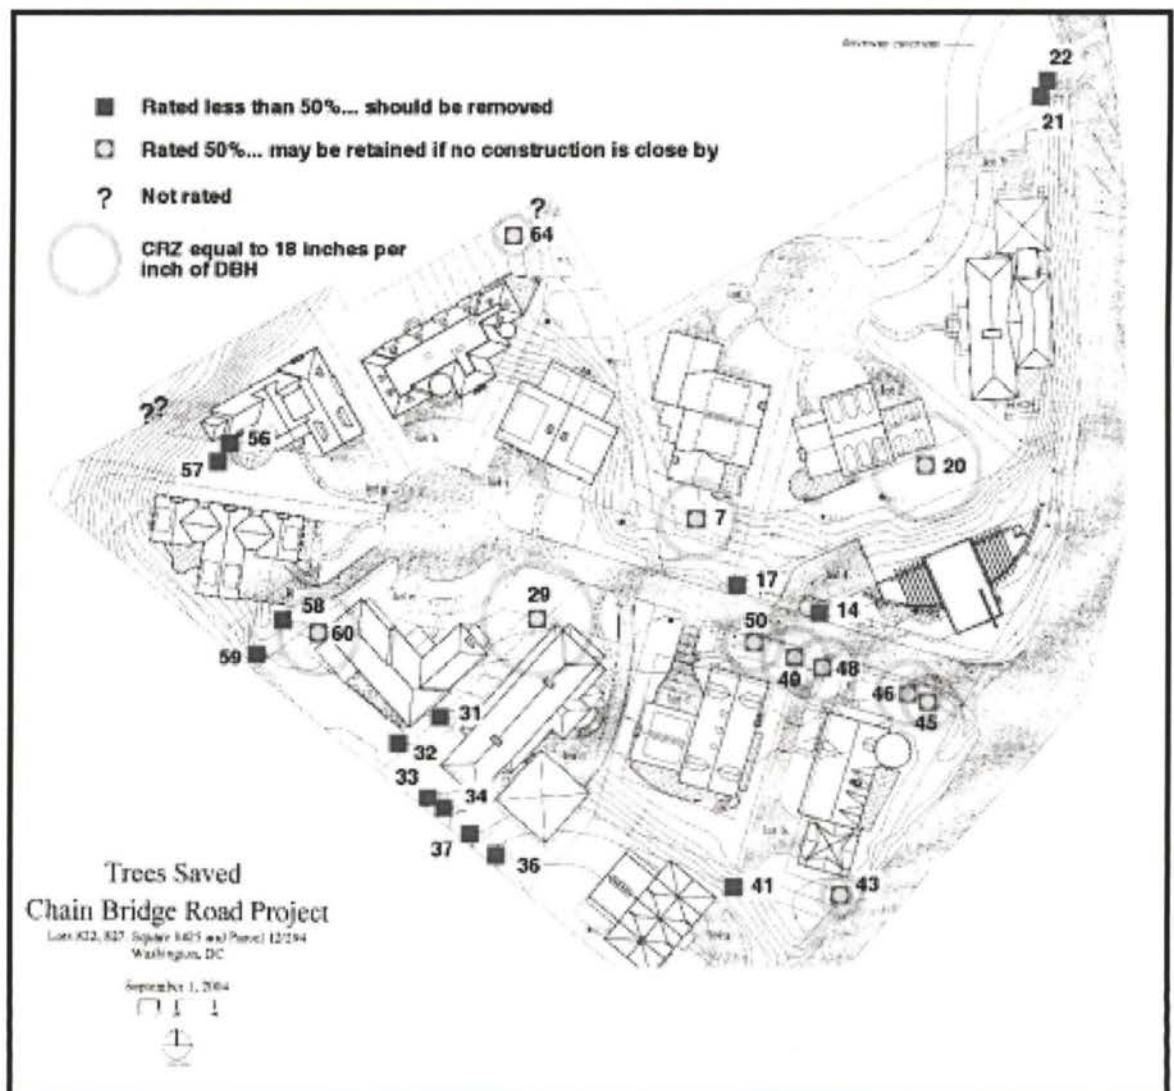
First, let's look at the *Trees Saved* plan focusing on the trees Mr. Bloch rated fifty percent or less; these are trees he stated in his July 20, 2002 letter to Mr. Bender either should be removed now (rated less than 50%), or would not tolerate construction nearby (rated 50%). The *Trees Saved* plan purports to preserve these nonviable trees.

It also is readily apparent that most of the vulnerable, construction-intolerant trees — those Mr. Bloch rated at 50% — are very close to construction. While these trees are shown on the plans as saved, it is obvious that they cannot be saved.

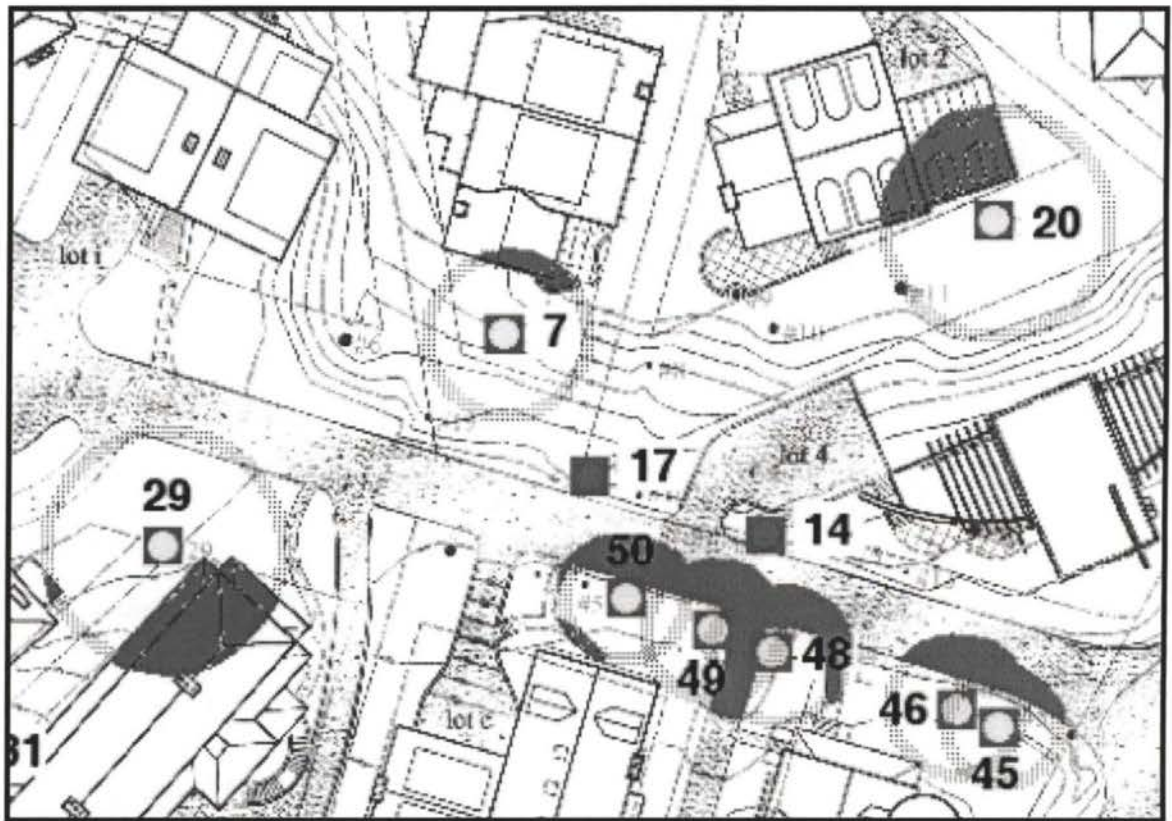
Next, let's look at a closer detail of this part of the plan. The detail below shows the entrance road. It shows only the trees rated fifty percent or less... those that Mr. Bender's arborist says should be removed now or will not tolerate construction nearby. It does not show trees that Mr. Bloch says should remain viable. The plan claims that all the trees shown here will be preserved. The solid rust colored areas are the portions of the CRZ of each tree that will be graded out if the builder manages to dig only the exact footprint of each structure. This is not possible, of course; there is always some over-dig to enable construction of foundations. In fact, only an extremely naïve person would think these huge houses

can be built without substantial grading and disruption of the trees' root zones. Certainly it will be impossible to put tree protection fencing at the drip lines of trees that stand next to houses, as the plan claims will be done. In addition, their canopies<sup>5</sup> will have to be pruned substantially to fit these large houses in. This will dramatically alter the appearance of some of these trees. In the case of the beech trees, radical pruning could be destructive where large branches must be cut off.

The entrance roadway has to be widened significantly to achieve the sixteen-foot width being proposed. The plan does not show where utilities will be located, but along the entrance road is the logical place for water, sewer, and electric.

Given that the beeches are old and that this species is considered one of the most intolerant species there is, their immediate demise is inevitable if this project is carried out as planned.

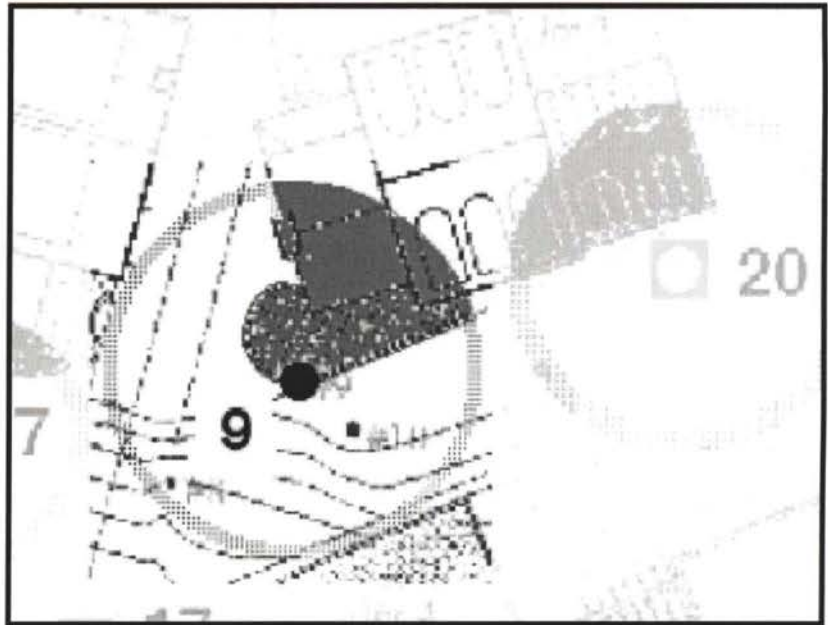
Let's take a close look at one of these highly rated trees: tree #9, a white oak (*Quercus alba*) over twenty-four inches DBH, rated seventy percent by Mr. Bloch. This detail illustrates how overly optimistic the plans for Chain Bridge Road Project are. This tree has a patio built around at least fifty percent of its base. At least one-quarter of its CRZ is lost to building and patio.

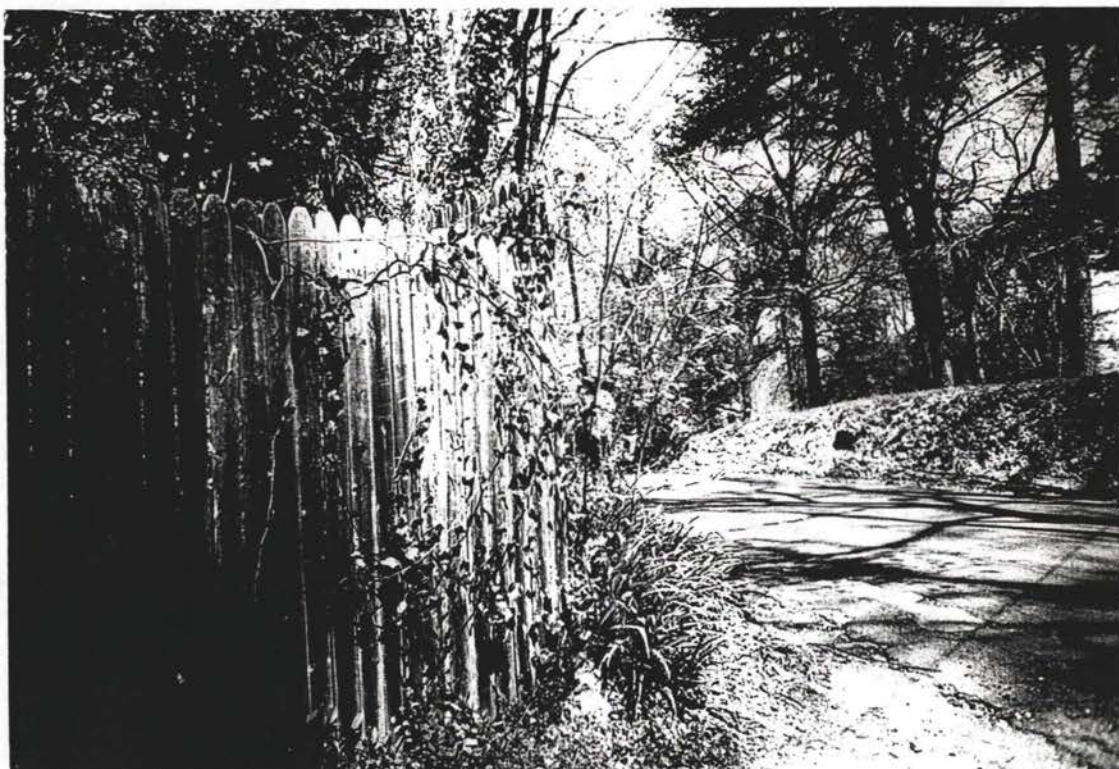
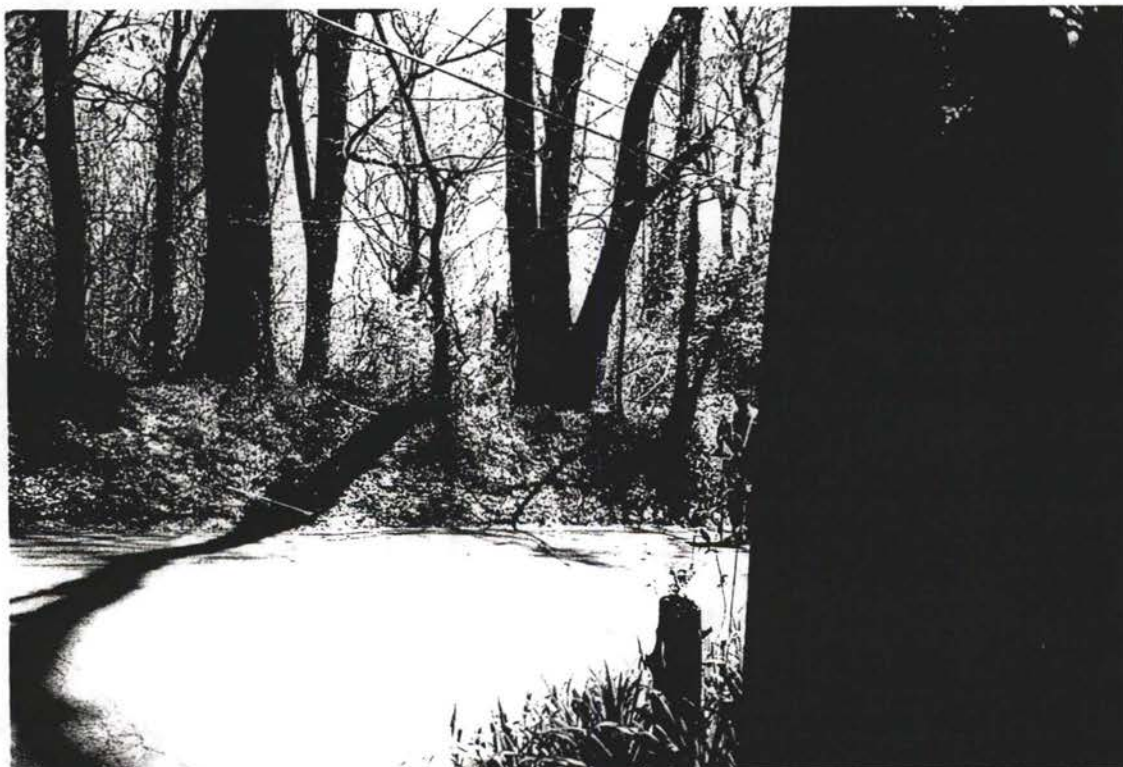
EXHIBIT 3B  
VIEW TO LEFT & RIGHT FOR A DRIVER EXITING  
FROM DRIVEWAY FOR #2800 CHAIN BRIDGE ROAD  
Driver's Eye is Located 10 Feet from Edge of Travel Way

Photographs of what a driver can see from each of the existing driveways under existing conditions are shown on Exhibits 3A and 3B.

A vehicle moving at 30 mph travels 44 feet in one second. Thus, the above distances provide time intervals for a driver to observe conditions, make a decision to proceed and to start moving of 0.7 to 2.3 seconds compared to a 30 mph design value of 4.5 seconds (200 feet divided by 44 feet/second) and a 35 mph design value of 4.9 seconds (250 feet divided by 51 feet/second).

Above - View to Left of Downhill Traffic

Below - View to Right of Uphill Traffic

A proffer to “seek opportunities” to enhance sight distance is far too weak. If this development is to be approved, the condition should be that a minimum of 200 feet of sight distance, and preferably 250 feet, each way will be provided and maintained.

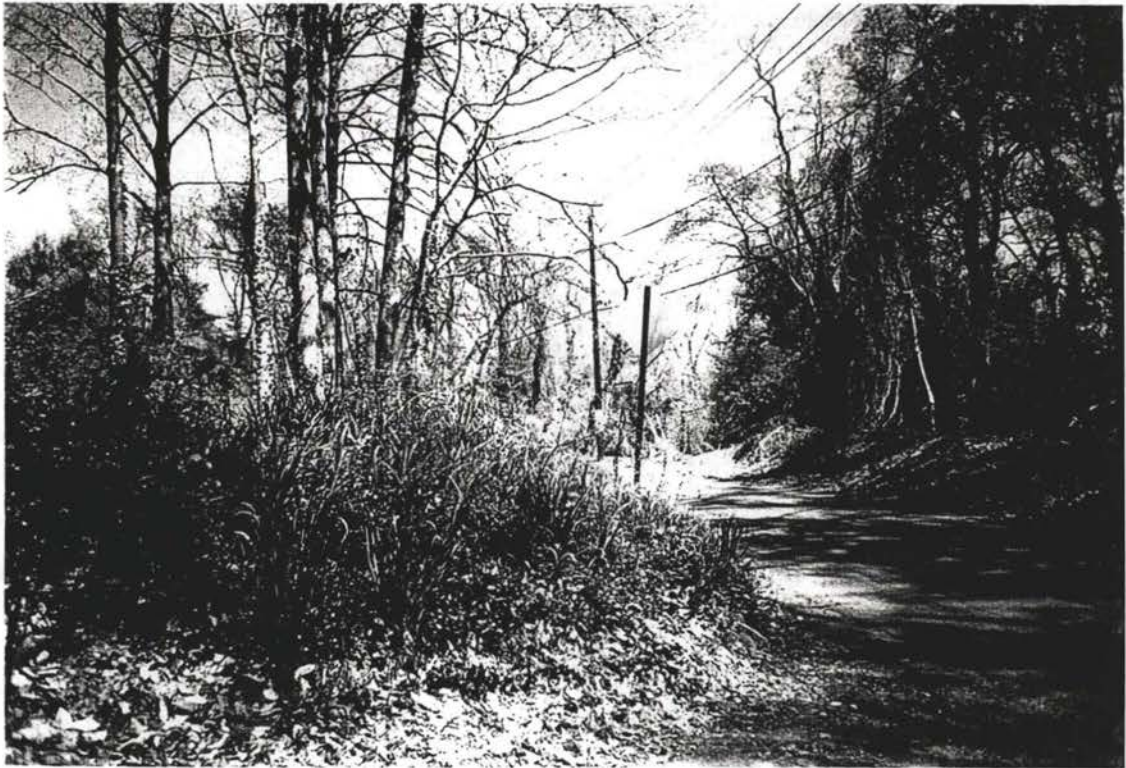
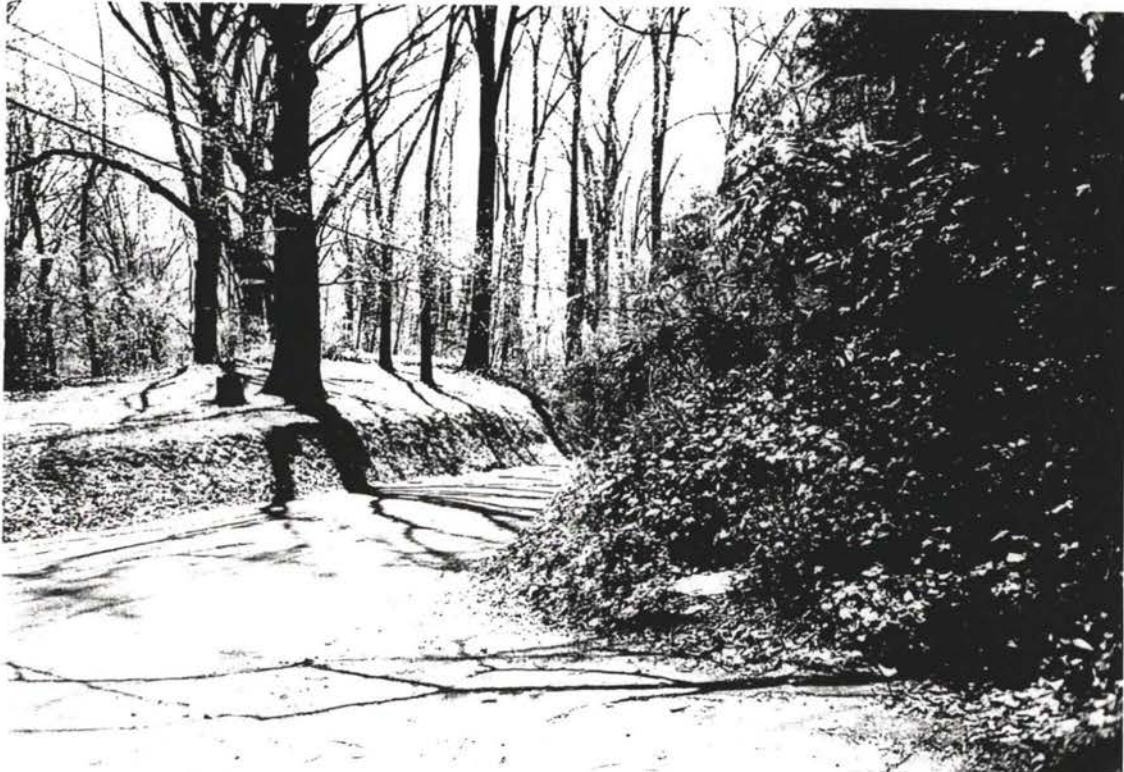
EXHIBIT 3A  
VIEW TO LEFT & RIGHT FOR A DRIVER EXITING  
FROM DRIVEWAY FOR #2762 CHAIN BRIDGE ROAD  
Driver's Eye is Located 10 Feet from Edge of Travel Way

Above - View to Left of Downhill Traffic

Below - View to Right of Uphill Traffic
