# DAWN LEA PARTY IN OPPOSITION BZA APPLICATION NO. 20380

JULY 14, 2021

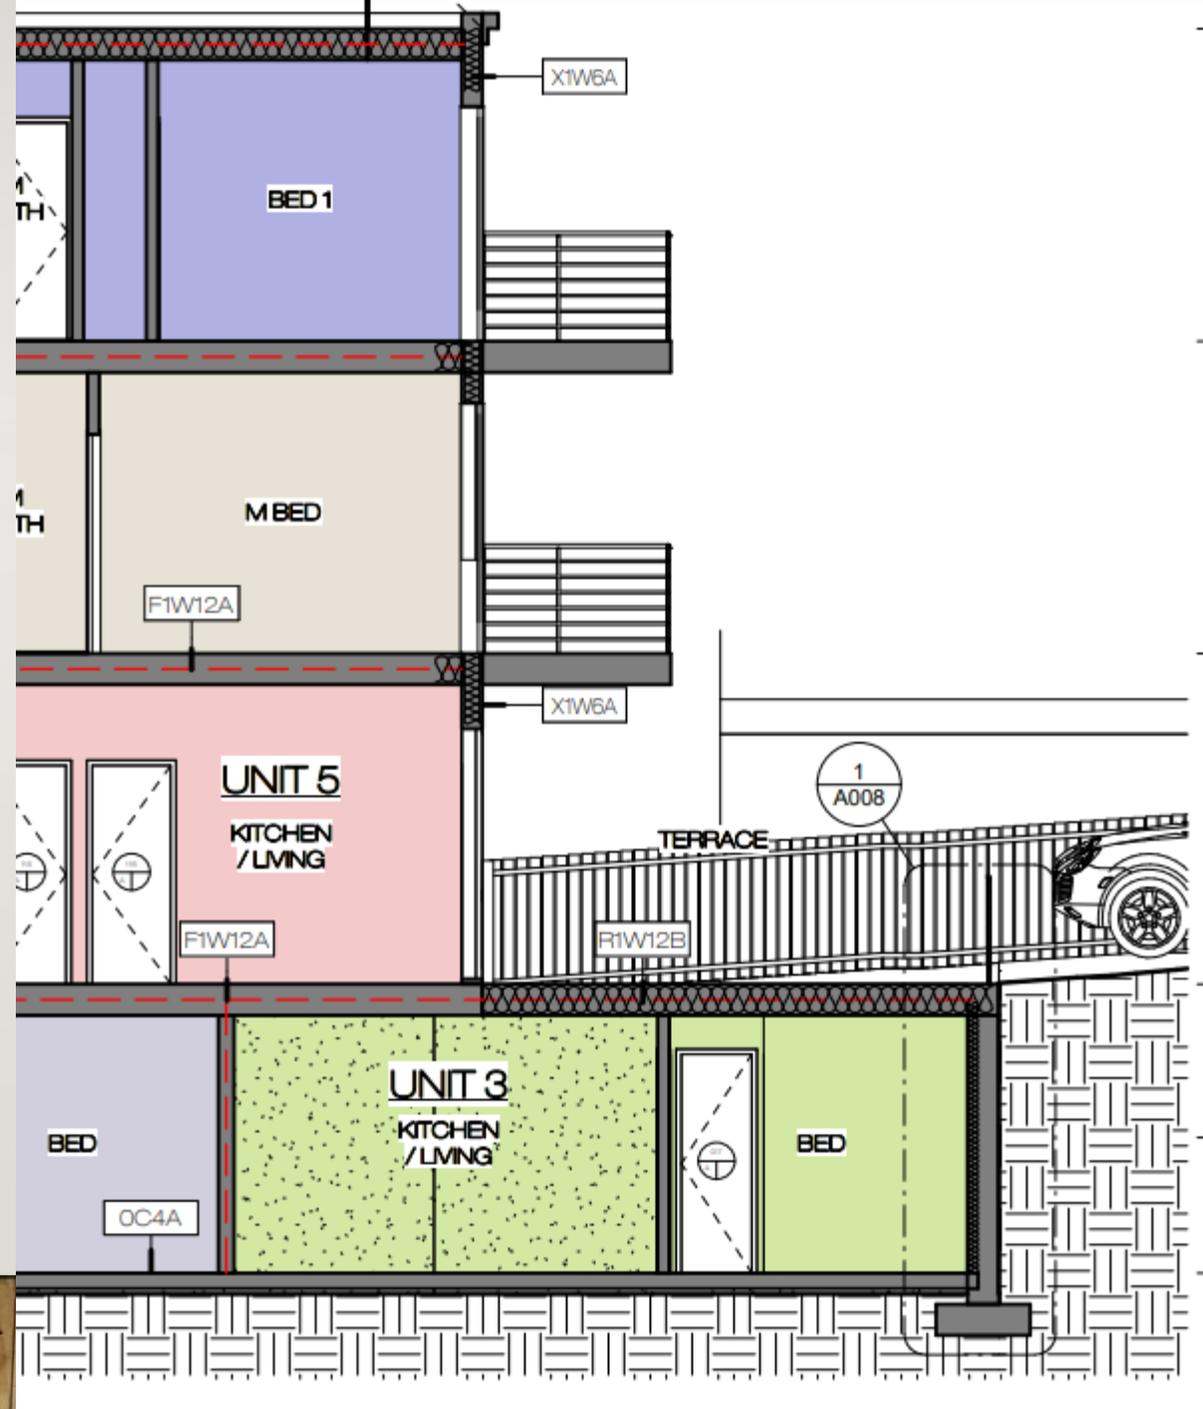
*It appears the 'deck' is now placed at grade with a slope towards the structure (Longitudinal Section, Drawing 14)– at question is the downward slope and appears without a proper grade away from the property thus potentially impacting 4459 with water issues.*

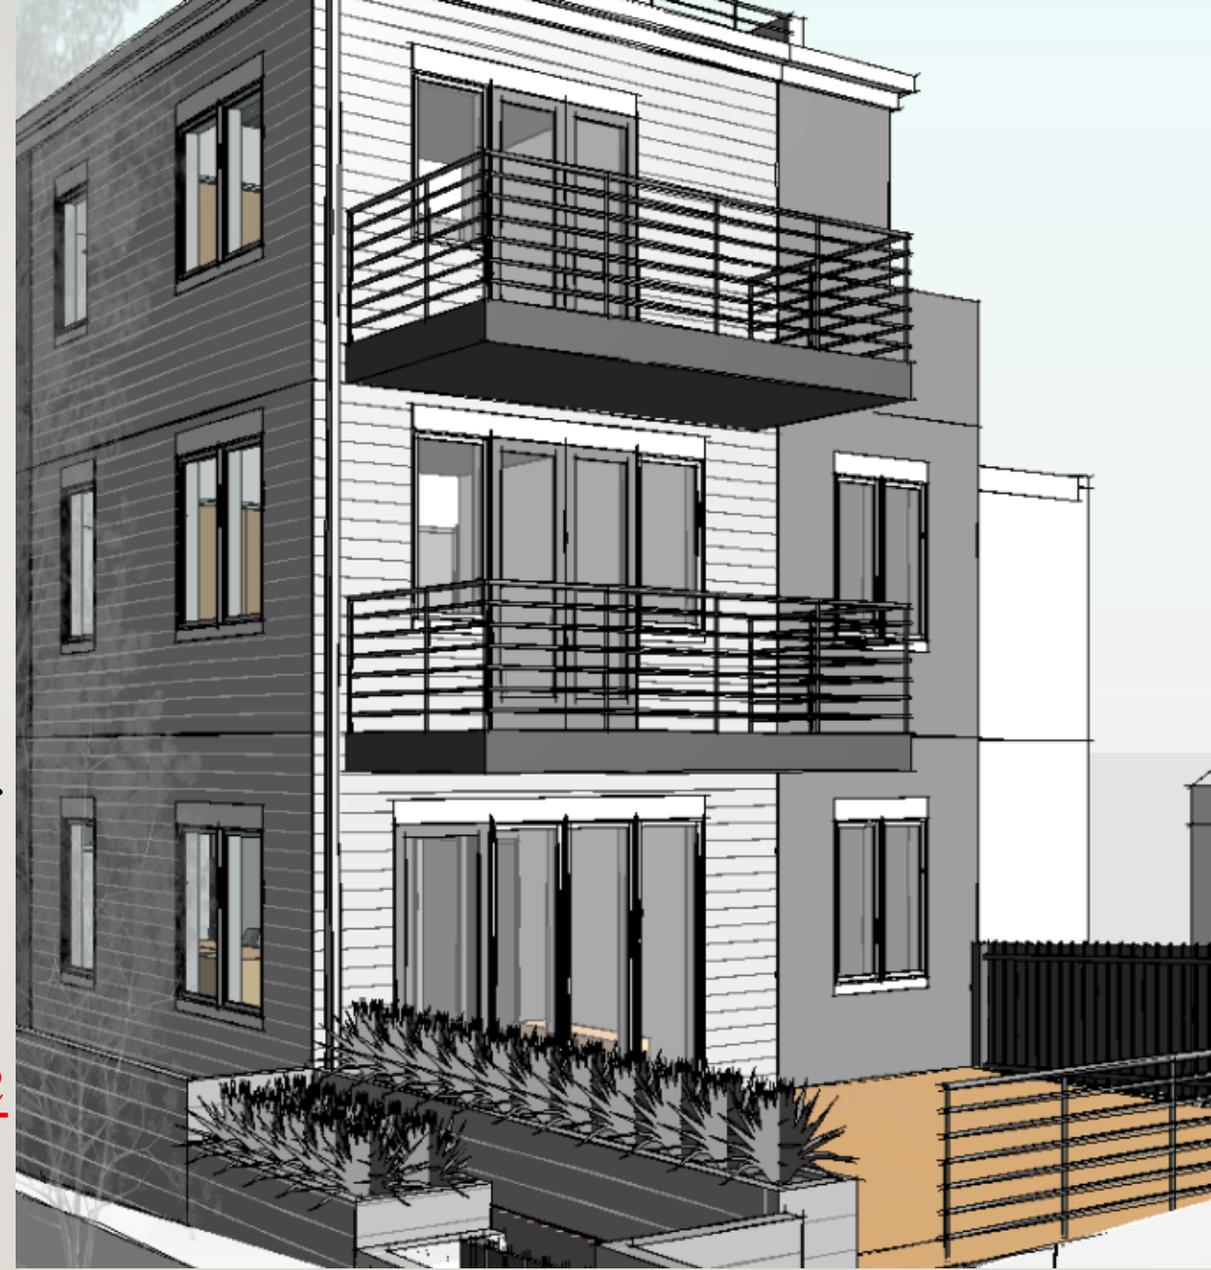
- As noted in 4459 owner's prior comments, a deck was identified at the rear of the 4457 building (Exhibit 33c page 2) and directly overlooked the patio at 4459 – the applicant was requested by BZA to address the issue of the deck.
- *There are NOW two balconies off the rear of the proposed development which double the lack of privacy for 4459.*

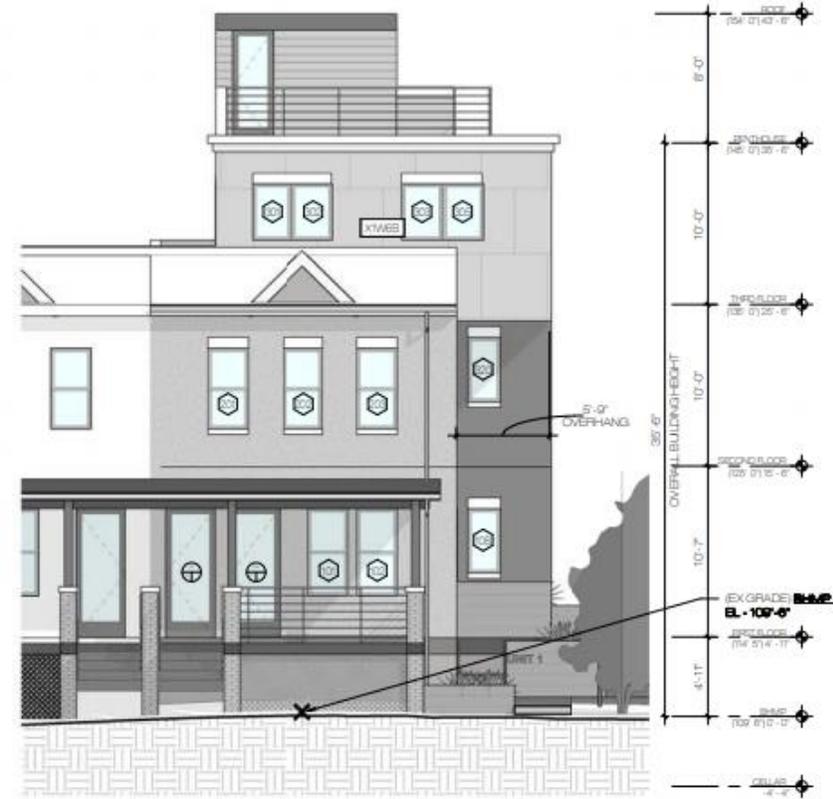
- Drawing from page 11 identified as “southwest (street elevation): Cantilevered third floor indicated in other drawings **is not evident on the street view.** Can you confirm that the **penthouse still exist in this drawing** from page 11 identified as “southwest (street elevation)?

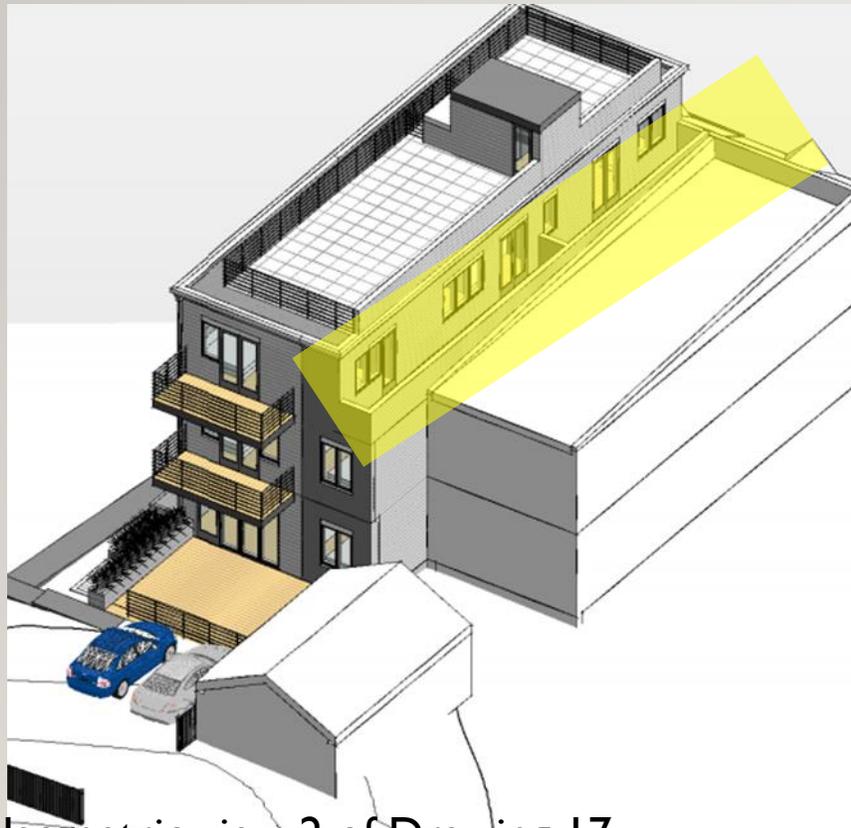
Isometric view 2 of Drawing 17

1. Despite set back on the last floor, the Snowdrift issue is not eliminated. The parapet on the upper floor will still cause snow drift accumulation. This is obvious in Isometric view 2 of Drawing 17, Cross Section 3 on Drawing 14, and Cross Section 2 on Drawing 13.

The snowdrift horizontal length is 6.5 feet. Therefore, any obstacle placed within 6.5 feet of the property line will cause snowdrift accumulation.

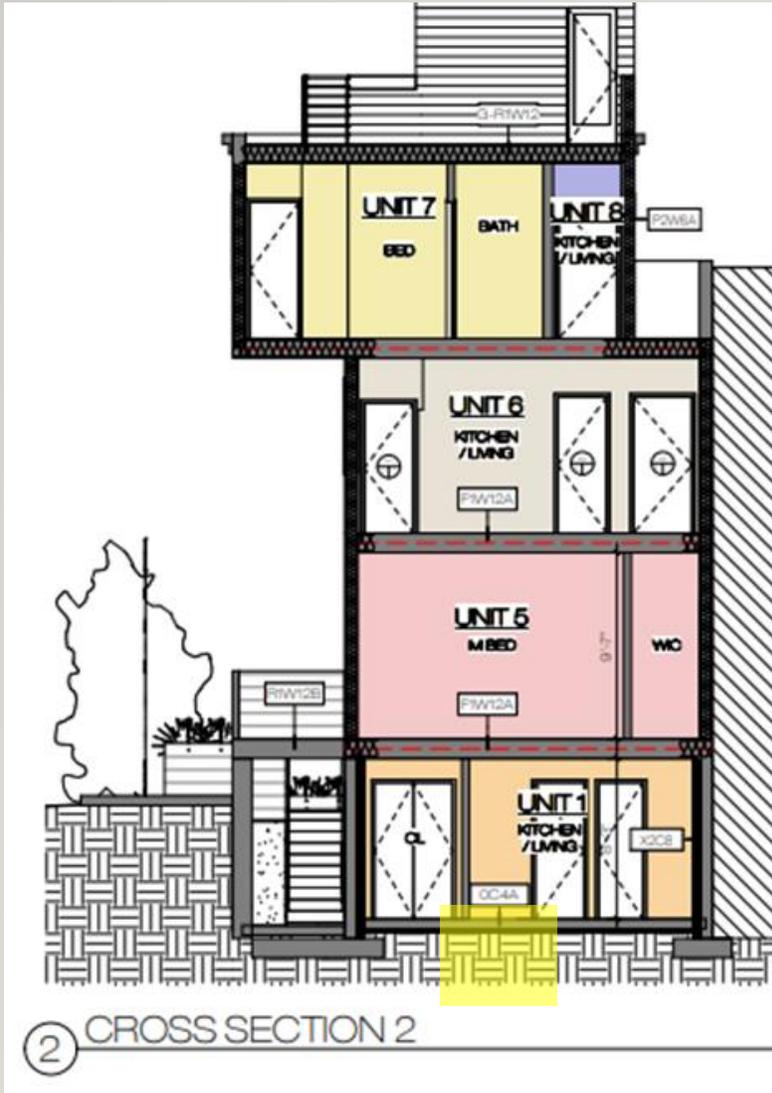
Cross Section 2 of Drawing 13

4- It is not clear how the underpinning will be done in the basement. The plans shall show the extent and depth of underpinning. Cross Section 2 of Drawing I3 and Cross Section 3 of Drawing I4 show the new foundation encroaches into your property. The new foundation section and plan are required to show the new footing will not pass beyond the surface of the party wall.
