McMillan Sand Filtration Plant

Historic Preservation Plan

May 2016

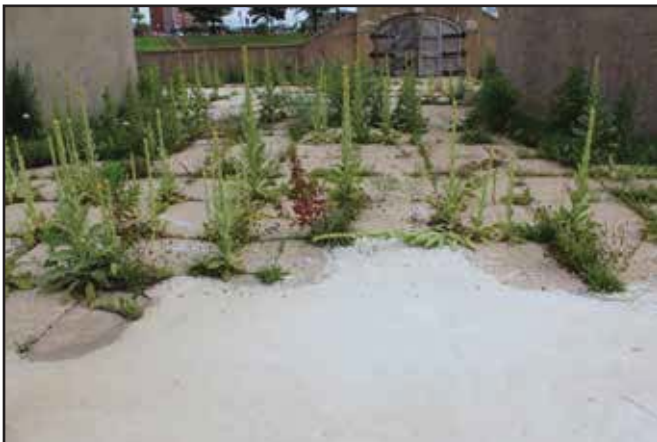
The surface of the service court is clad with square concrete pavers of varying dimensions. The concrete pavers are in very poor condition. Over time, in some areas, cracks in the pavers have been poorly patched with inconsistent concrete or removed in their entirety. Where removed, poured concrete stamped with a variety of patterns inconsistent with the original design are found. Small herbaceous plant material is growing along the edges of the pavers, obscuring the continuous expanse of concrete associated with their original design.

Detail of paving at Service Court 2, looking southeast from First Street. 2015.

Recommendations: The service court concrete pavers will be removed in their entirety and replaced with new masonry pavers. This removal and replacement is consistent with the Mayor's Agent Decision and Order HPA No. 14-393. The design of the new service court should be stamped or scored concrete, per the original service court design. Masonry and concrete should be neutral in color, referencing the industrial character of the service court. Curbs should be avoided if possible; pedestrian and vehicular areas should be differentiated using pattern, texture, and color. This area will be shared by pedestrians and vehicles, and additional safety requirements that were not previously required will be needed. The new design and safety components should take into account the historic appearance of the service courts.

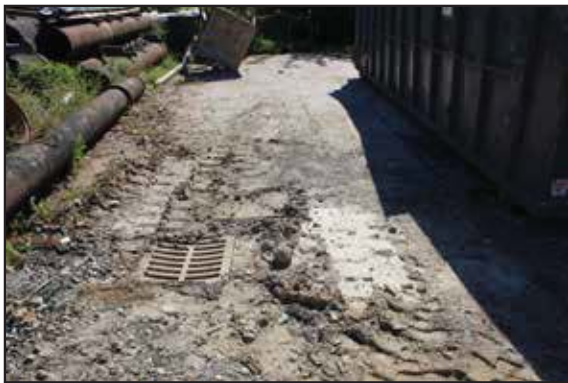
Detail of paving at Service Court 3, looking east from Filter Bed 24. 2015.

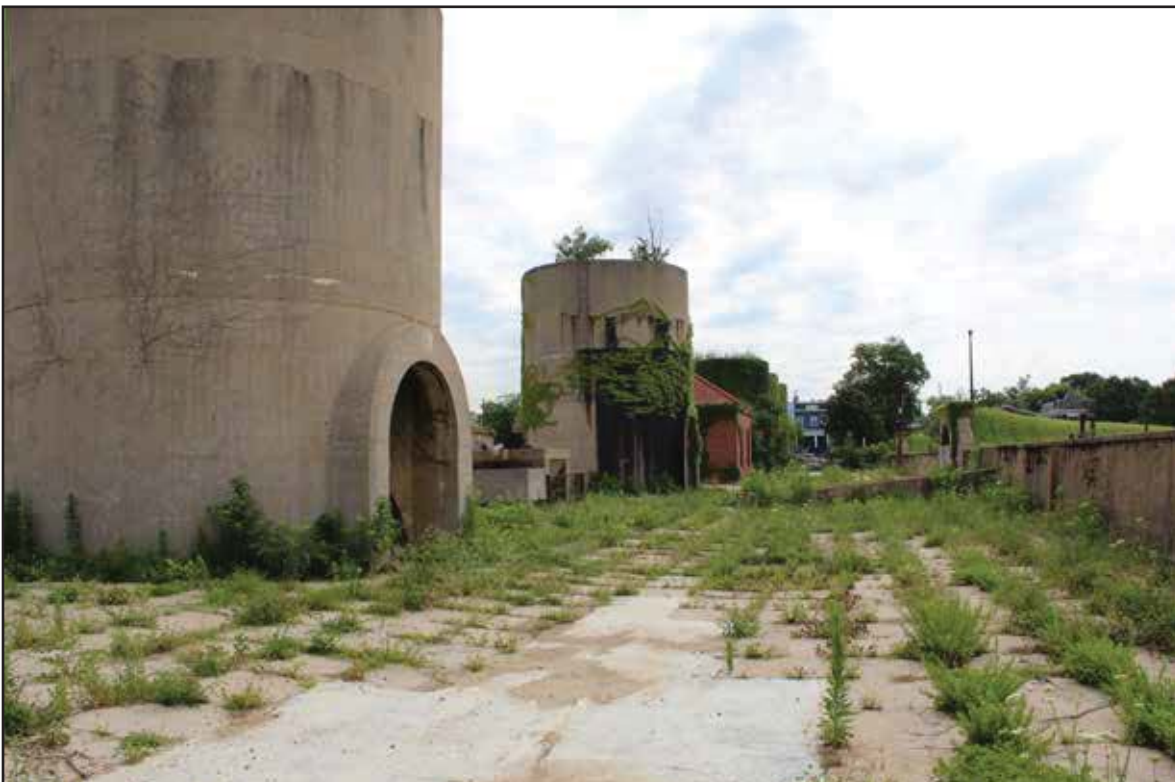
Service Court 2 from about center, looking east. 2015.

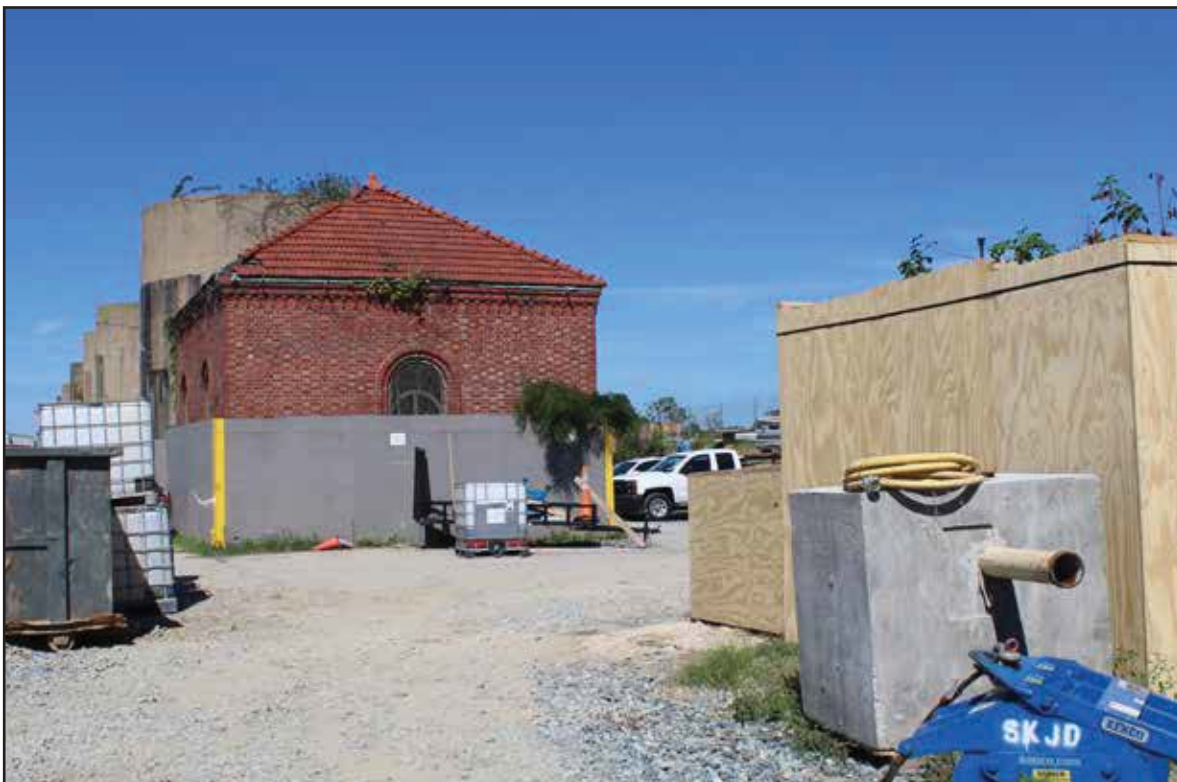
Service Court 3, looking west. 2015.

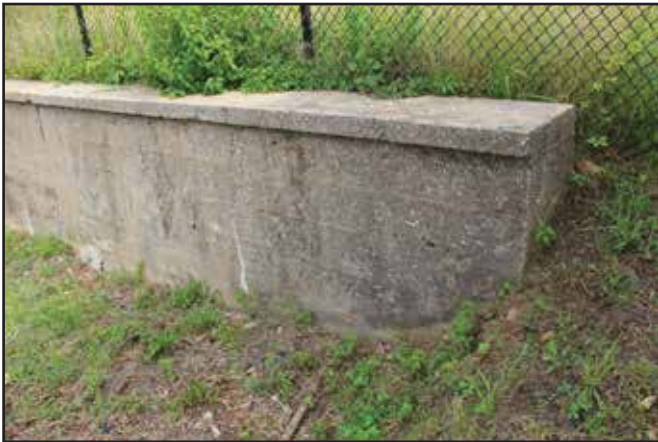
North wall at Service Court 2, near North Capitol Street. 2015.

Following structural stabilization, the sections of the concrete wall to be retained will be restored in accordance with National Park Service Preservation Brief 15: Preservation of Historic Concrete. Where the wall is removed adjacent to Filter Bed 14, the demolition shall be accomplished by hand to avoid any additional damage to the structure. Upon removal of the section, the repair work shall be accomplished using a concrete mix compatible with the material of the original concrete; however it should not replicate the original material, but instead use a texture and/or color that will allow for a visual differentiation between the original and new concrete work. Test patches of potential concrete mixes and applications should be prepared and reviewed by DC HPO.

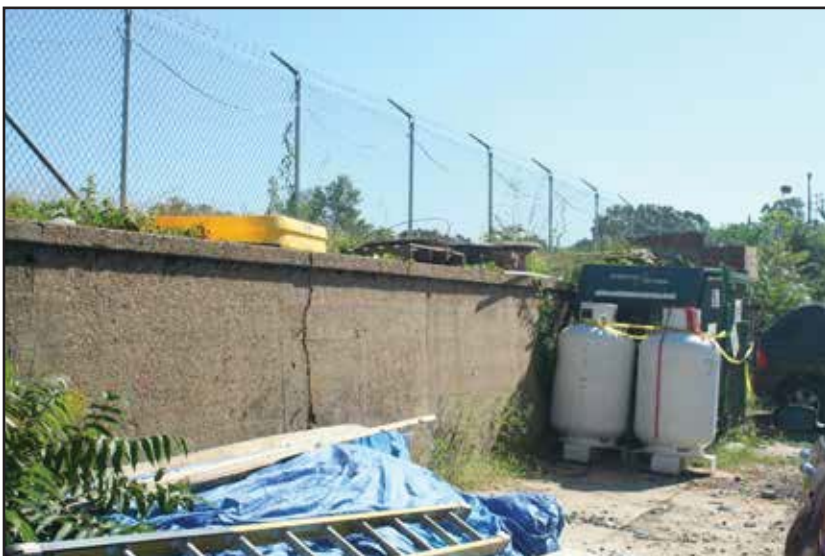
North Wall at Service Court 3. 2015.

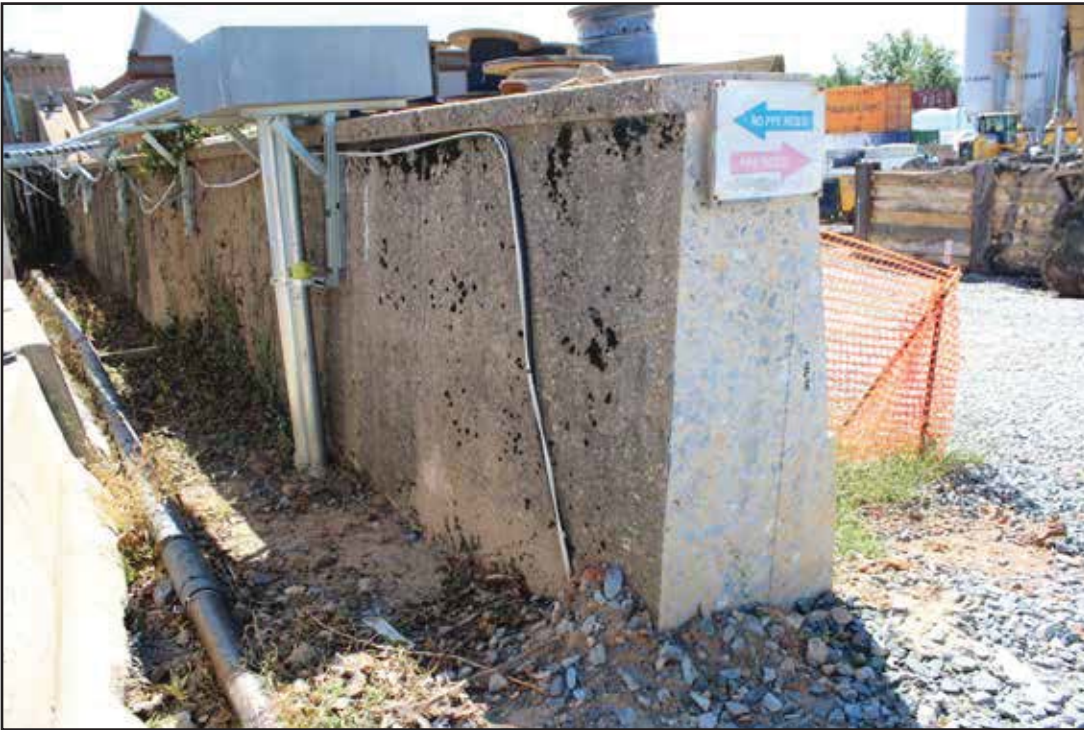
South Wall at Service Court 3, near Filter Bed. 2015.

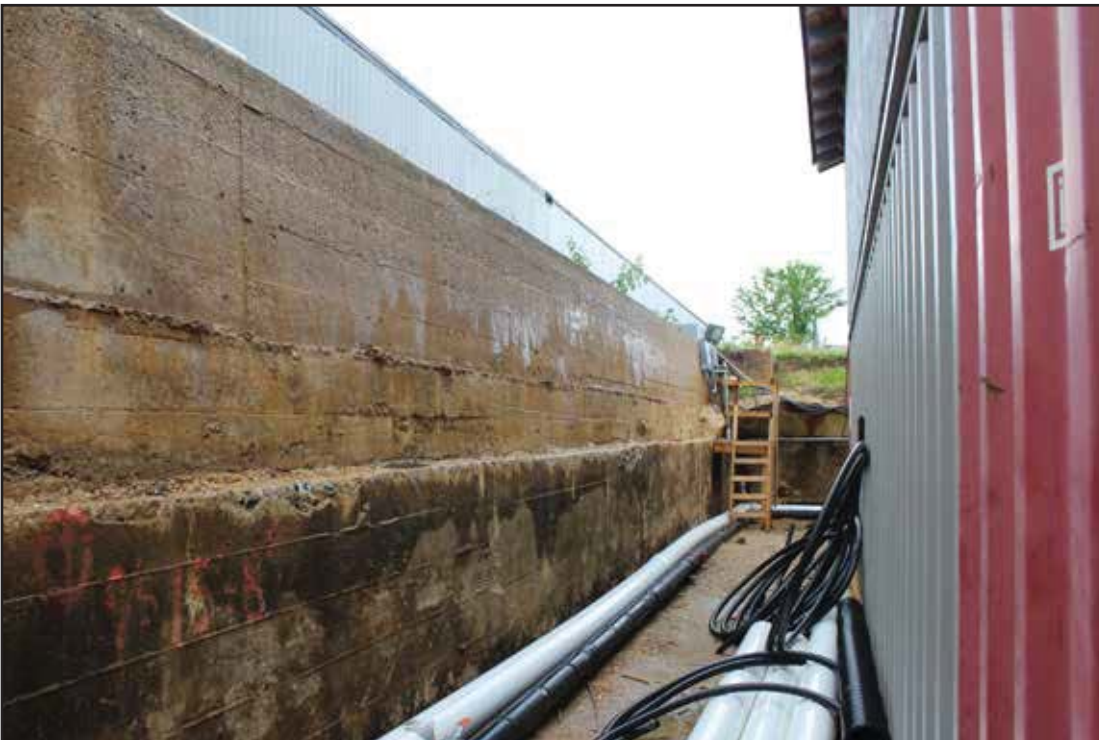
South Wall at Service Court 3, near Filter Bed. Looking northeast from south of the wall. 2015.

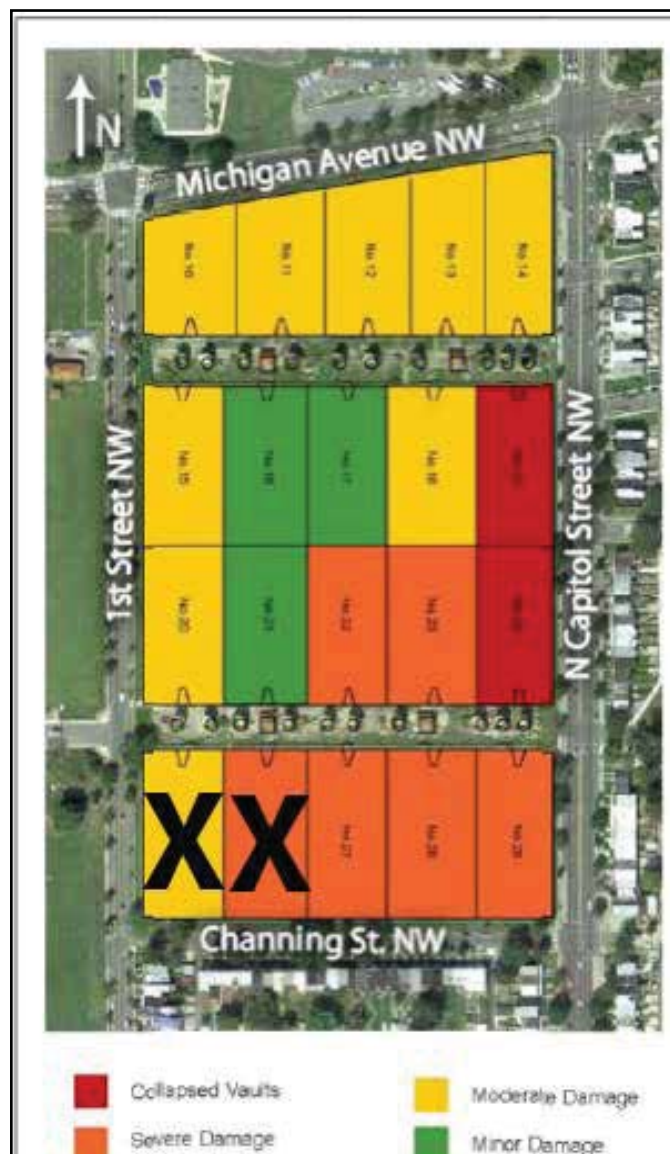
Context: The site features twenty unreinforced concrete filter beds, each of which is approximately one acre in area. All of the filter beds are concealed beneath a thin concrete slab (ceiling/roof) that is covered with a layer of fill and appear from above-grade as flat plains of grass. Each filter bed is independent of the other filter beds and has its own entrance that opens into the service courts. The floors of the filter beds are inverted, groined arches that carry piers with a slight batter near the bottom. The roof consists of elliptical groin arches that are pierced with holes serving as access to the Filter Beds below. The walls of the beds are built in sections not exceeding 30 feet in length, the joints being tongued and grooved. The filter beds have substantial parapets along the perimeter that act as retaining walls along the north and south sides of the service courts. For the facility to operate properly, substantial re-grading of the site was completed to allow the filter beds to be constructed at a level grade across the site, resulting in a maximum depth of cut of 35 feet and a maximum height of 30 feet at the top of the fill. Several of the filter beds that were constructed on fill settled substantially within the first few years of the facility's operation. The rapid settlement led to chronic structural issues that have resulted in partial collapse of some of the filter bed roofs.

Filter Bed conditions diagram; X denotes demolished Filter Beds per DC Water project.

Recommendations: These filters on site will be removed for development. Removal is consistent with the Mayor's Agent decision and order (HPA No. 14-393).

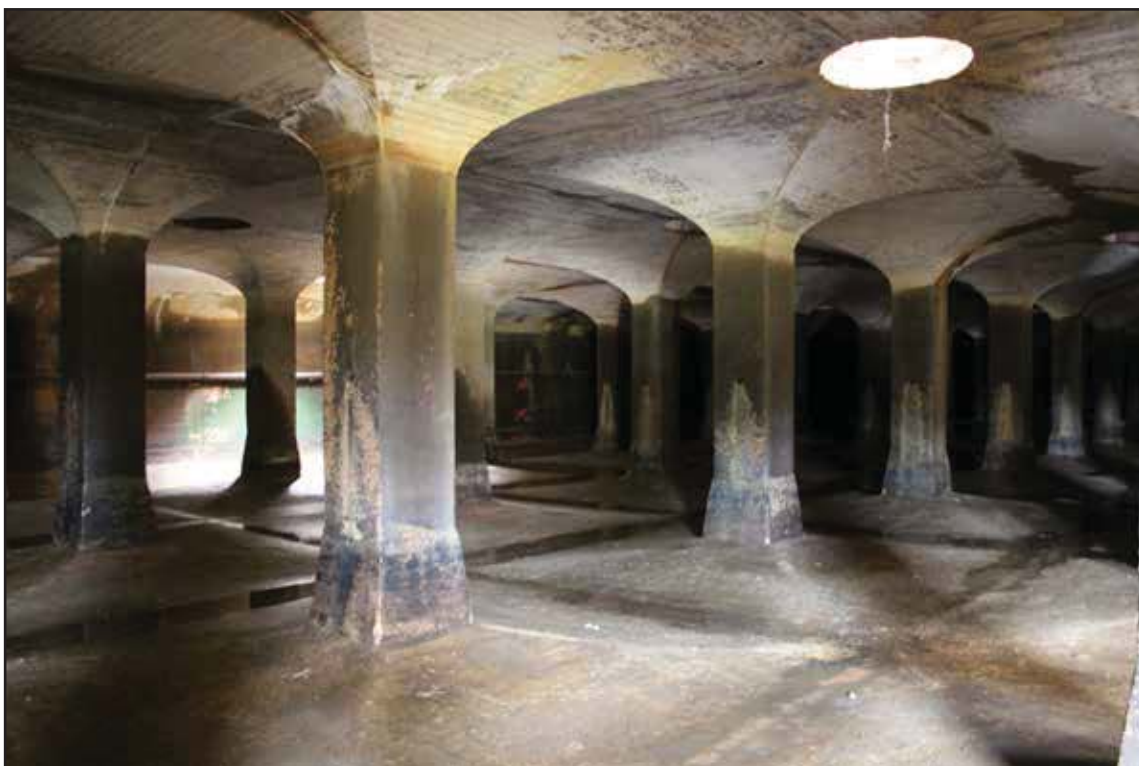
Filter Bed 15. 2015.

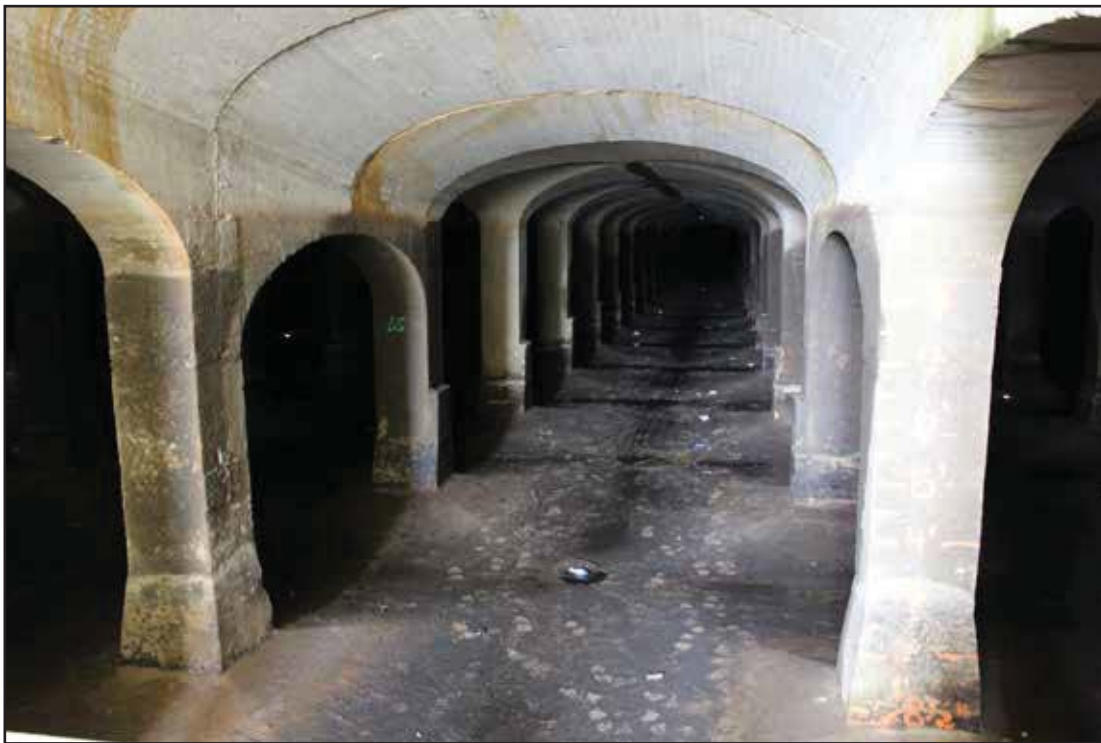
Filter Bed 14. 2015.

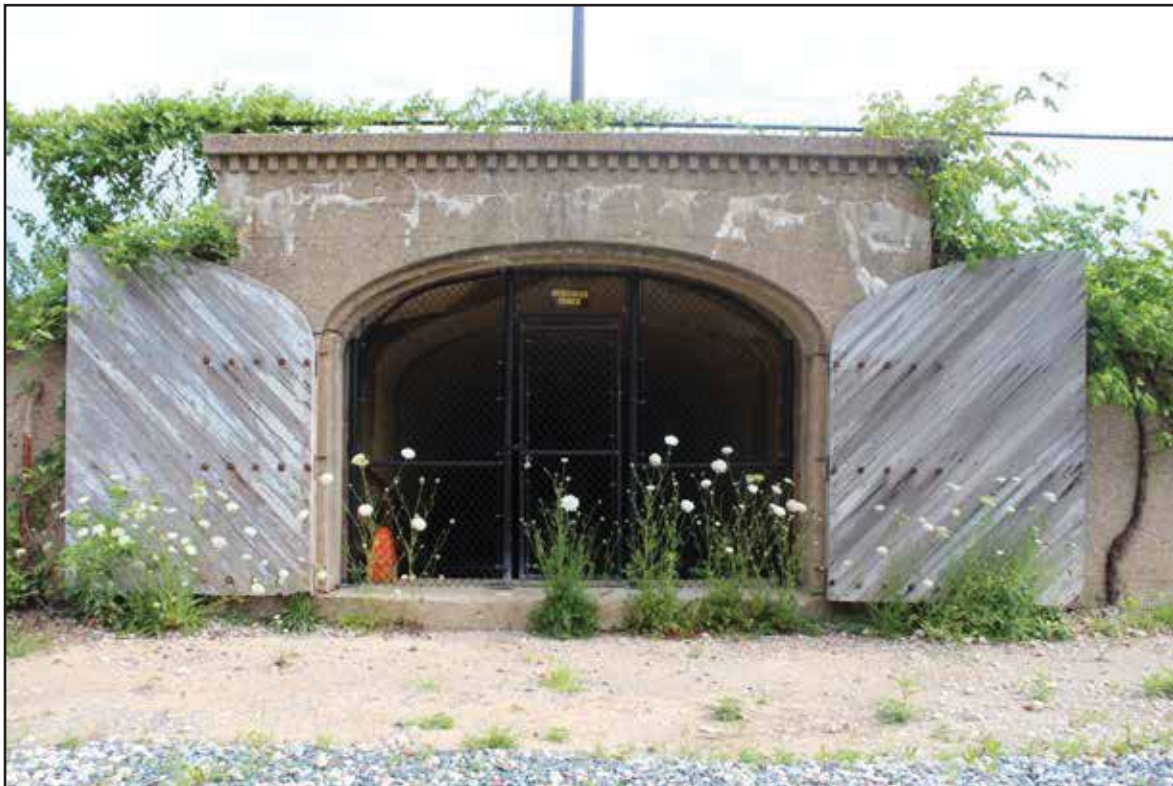
Existing Conditions: Many of the filter bed portals are extant and intact. The parged brick portion of the majority of the portals exhibit moderate to severe cracking, especially at the arched openings. In most locations, cracks have formed at the door hinge, extending away into the wall, (Silman Figures 15 and 16). Several arched openings feature a crack at the very top (Silman Figure 16). Many locations also exhibit cracks along the top of the arch under the cornice (Silman Figure 17). The cracks in the arched openings typically extend through the thickness of the wall (Silman Figure 18), and in certain cases into the arched roof of the filter beyond. Where exposed, the hairline cracks are observed along the length of the portal wall at regular intervals of several feet. (Silman Figure 19)¹

Filter Bed Portal 14. 2015.

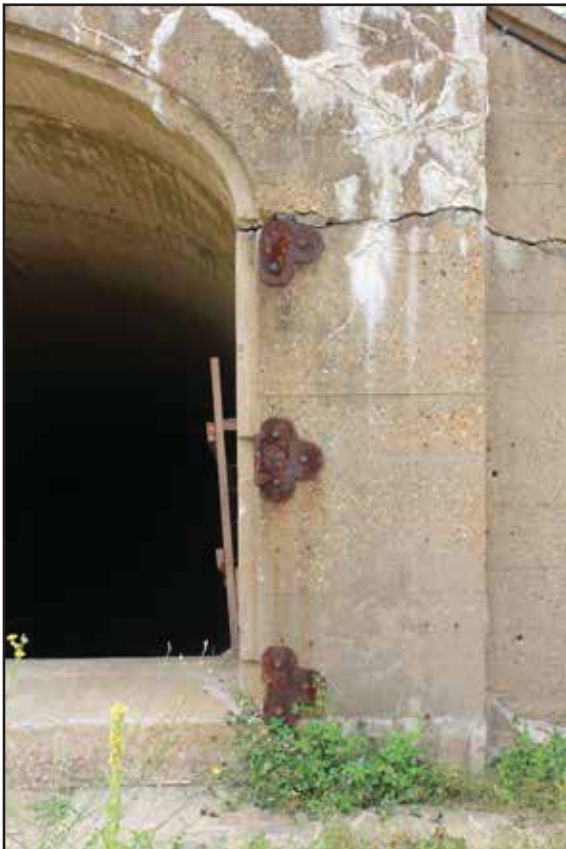
Crack at arch spring on Filter Bed Portal 15. 2015.

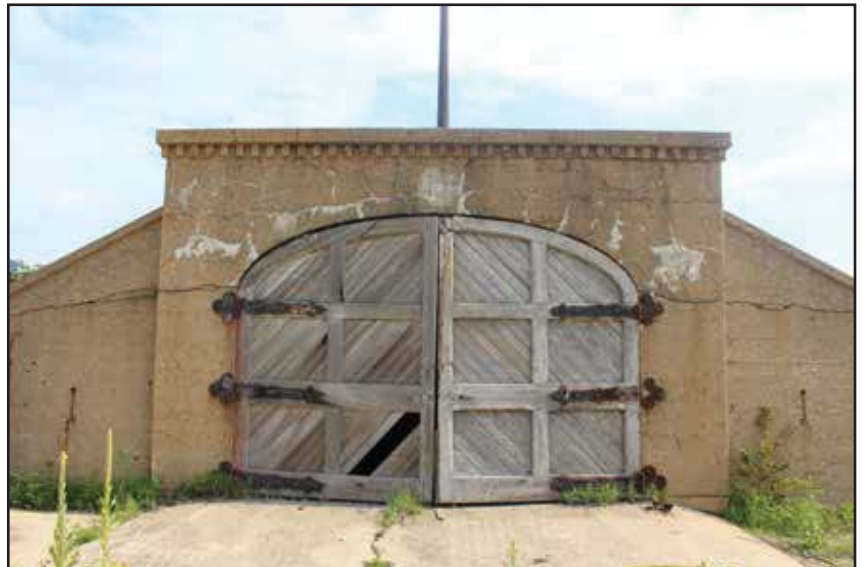
Filter Bed Portal 10, showing wood doors, hardware, and cracks along arch and walls. 2015.

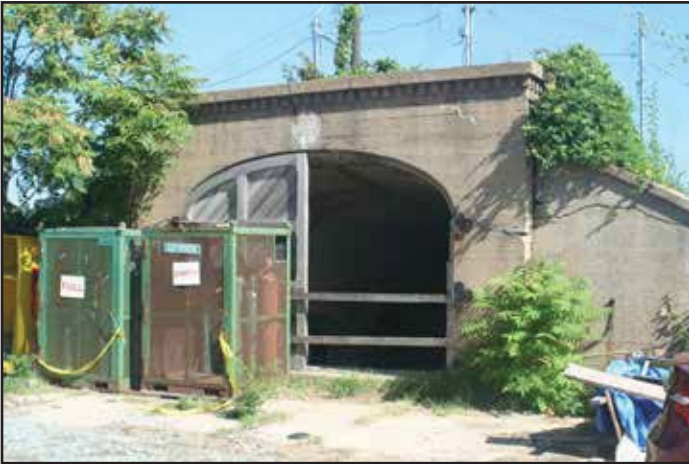
Filter Bed Portal 22. 2015.

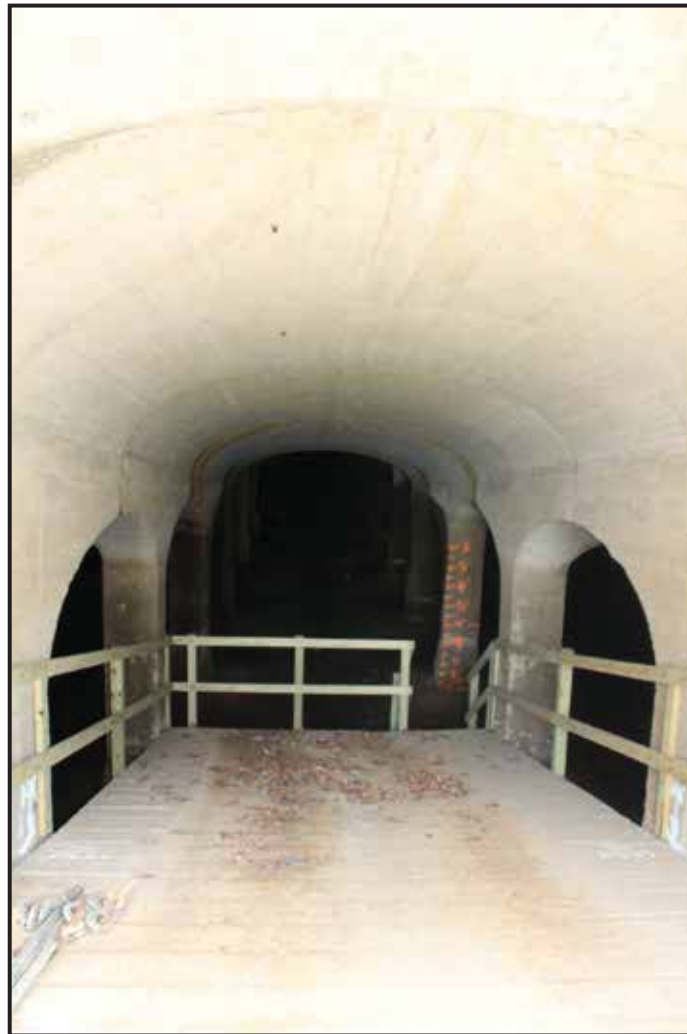
Ramp in Filter Bed 14. 2015.

During Construction: It is anticipated that DC Water will control this structure until 2022. DC Government should inform DC Water that proper precautions will be taken during construction to stabilize the structure.

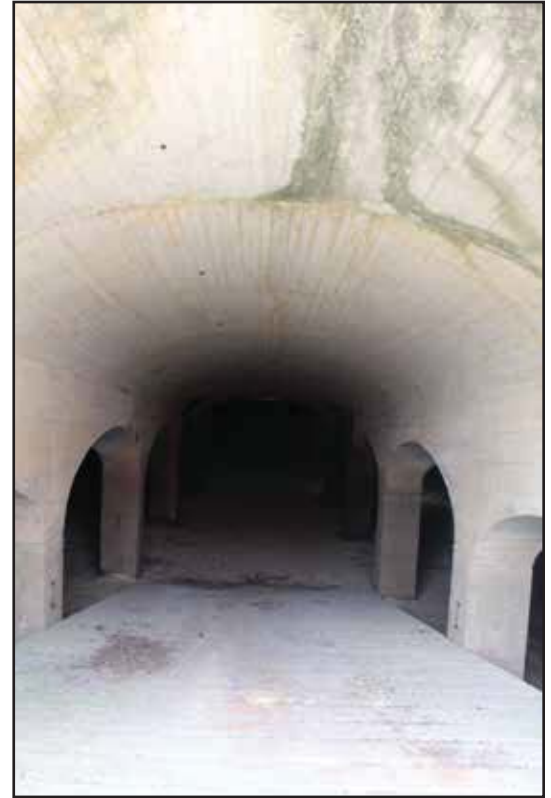
Ramp in Filter Bed 16. 2015.

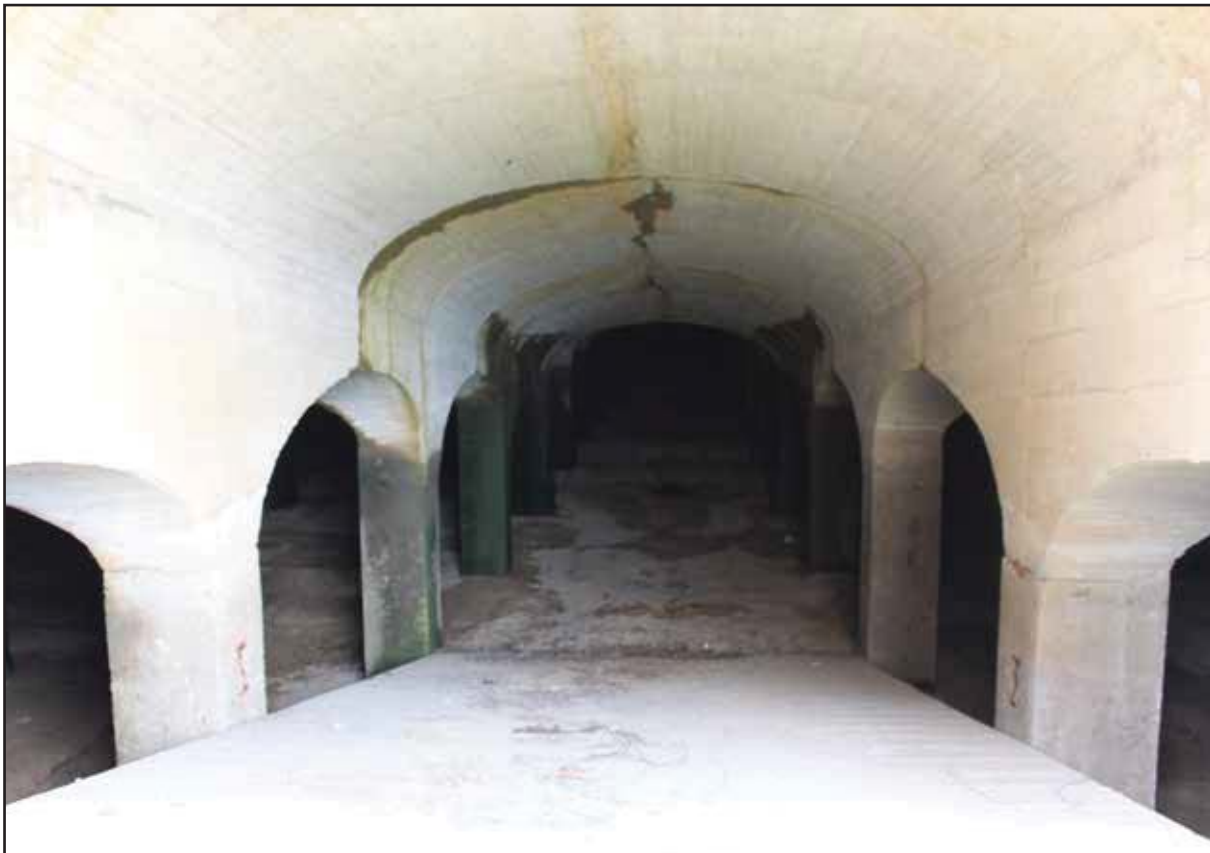
Ramp in Filter Bed 11. 2015.

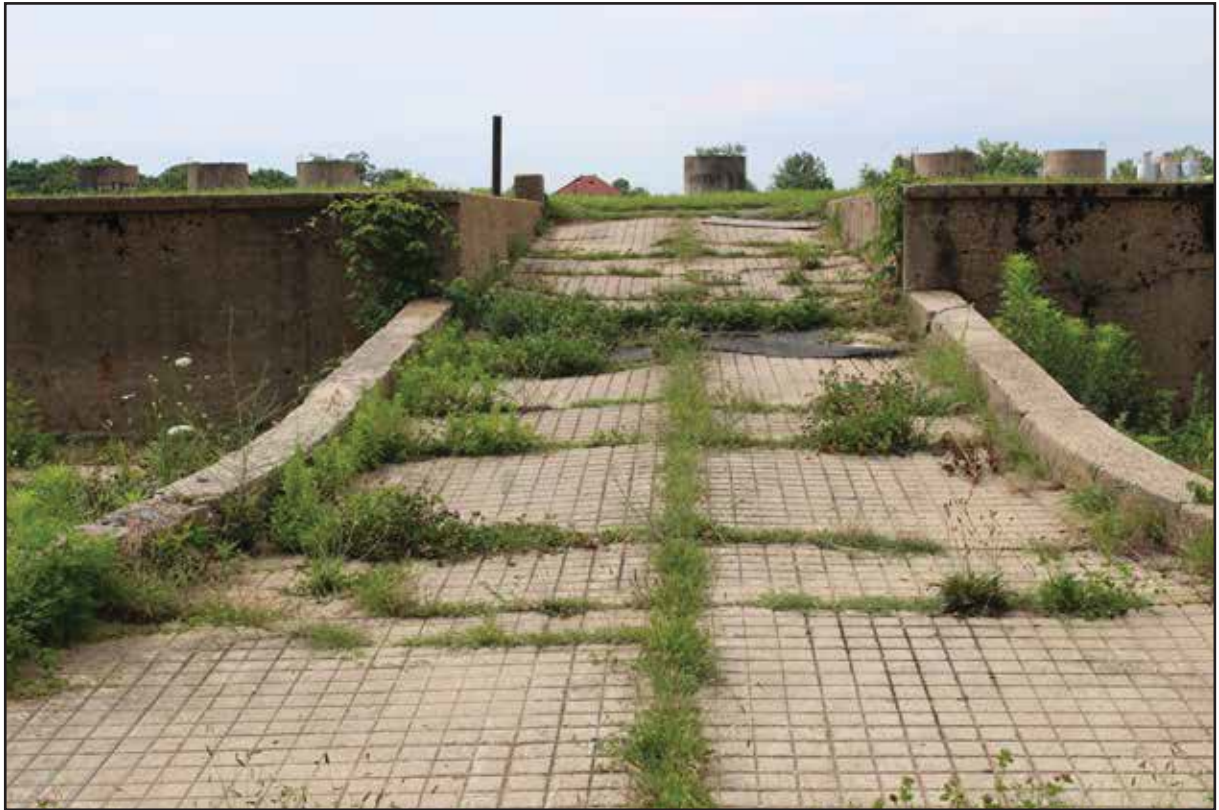
Ramp leading from Service Court 2 to top of Filter Bed 18. 2015.

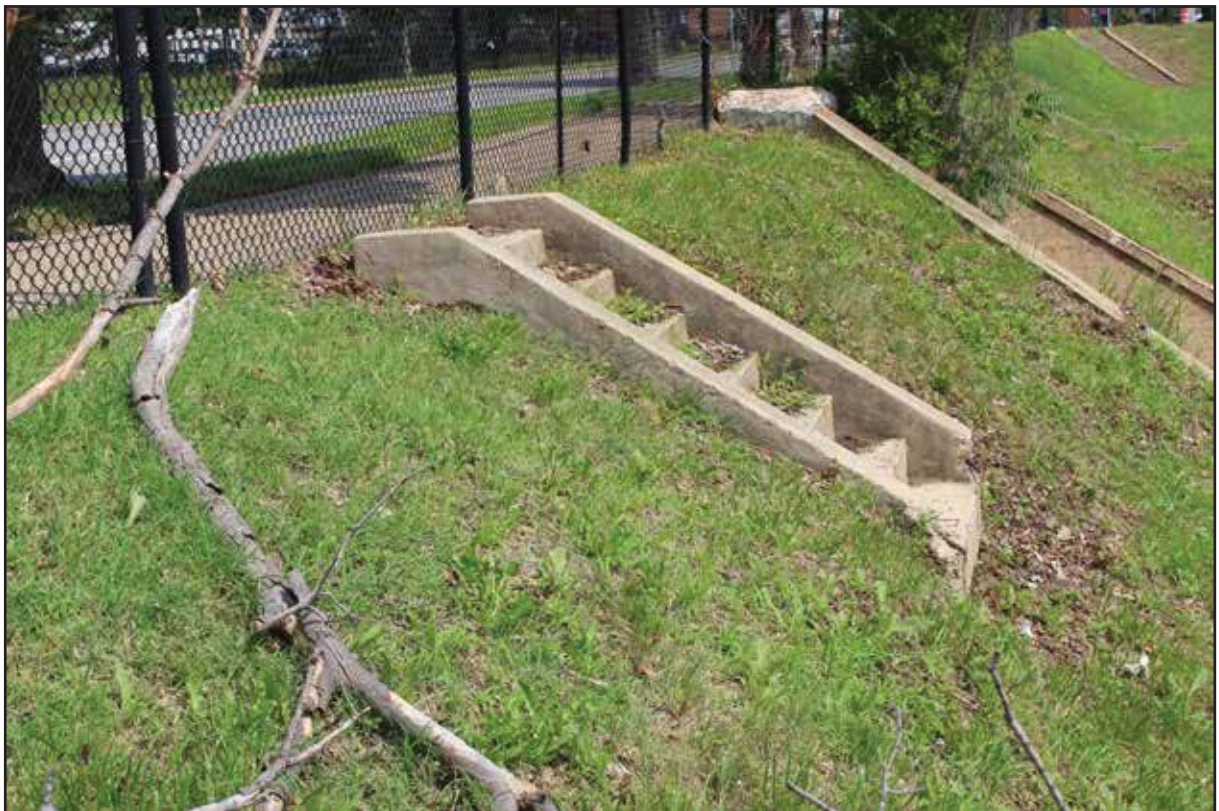
Stairs leading from Service Court 2 to First Street. 2015.

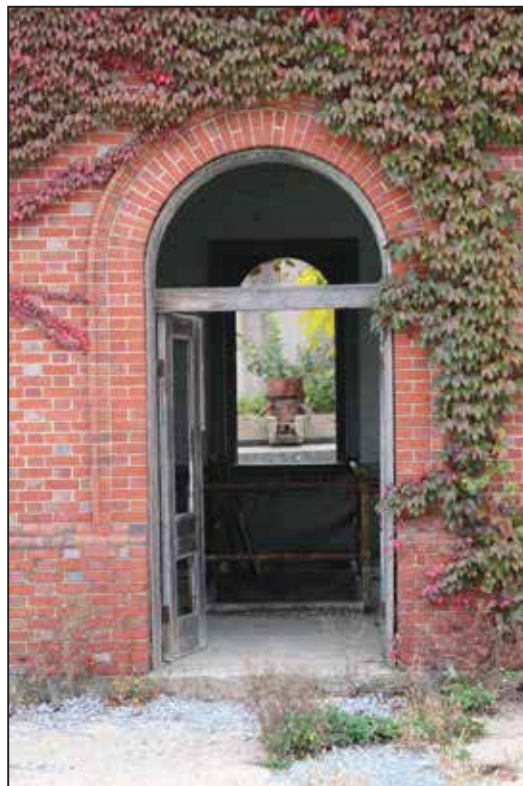
Existing Conditions: All four brick structures are extant in their original locations, and some original wood elements are extant although in various states of deterioration. The regulator houses were found to be in good condition overall. Walls and the concrete slabs are generally in good condition, where observable. The majority of issues observed stem from problems with the roofs, including leaks that have resulted in decay of the underlying sheathing and framing. The lack of gutters and downspouts has likely contributed to some of the observed masonry conditions.

Cracks at the exterior corners of the foundation slabs are consistently present where the slabs are visible. The cause of the cracking is unknown, however, Silman notes that potential causes include subsidence of the underlying soil at the corner of the buildings, or an interaction with the concrete tunnels and other substructures below the building.

Regulator House 5, looking east. 2015.

During Construction: In the event of unanticipated damage during construction, the regulator houses should be repaired in kind, or reconstructed with the original materials, and using original drawings.

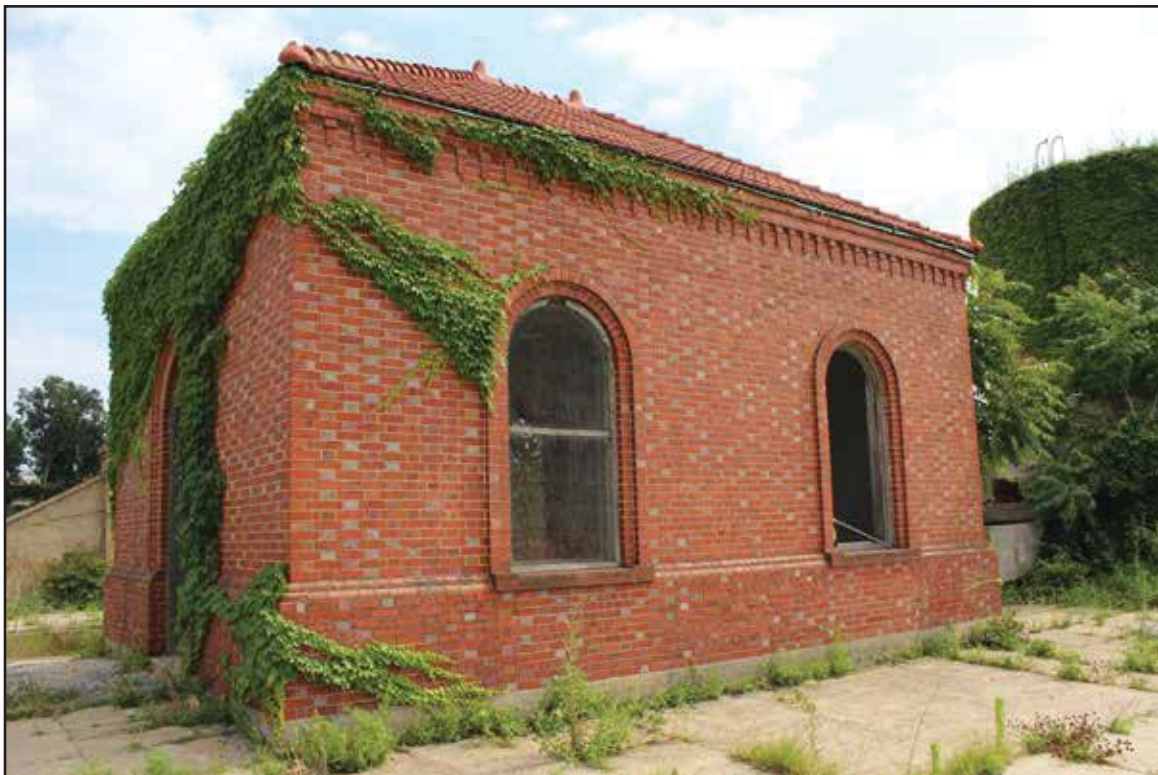
Regulator House 5, looking northeast. 2015.

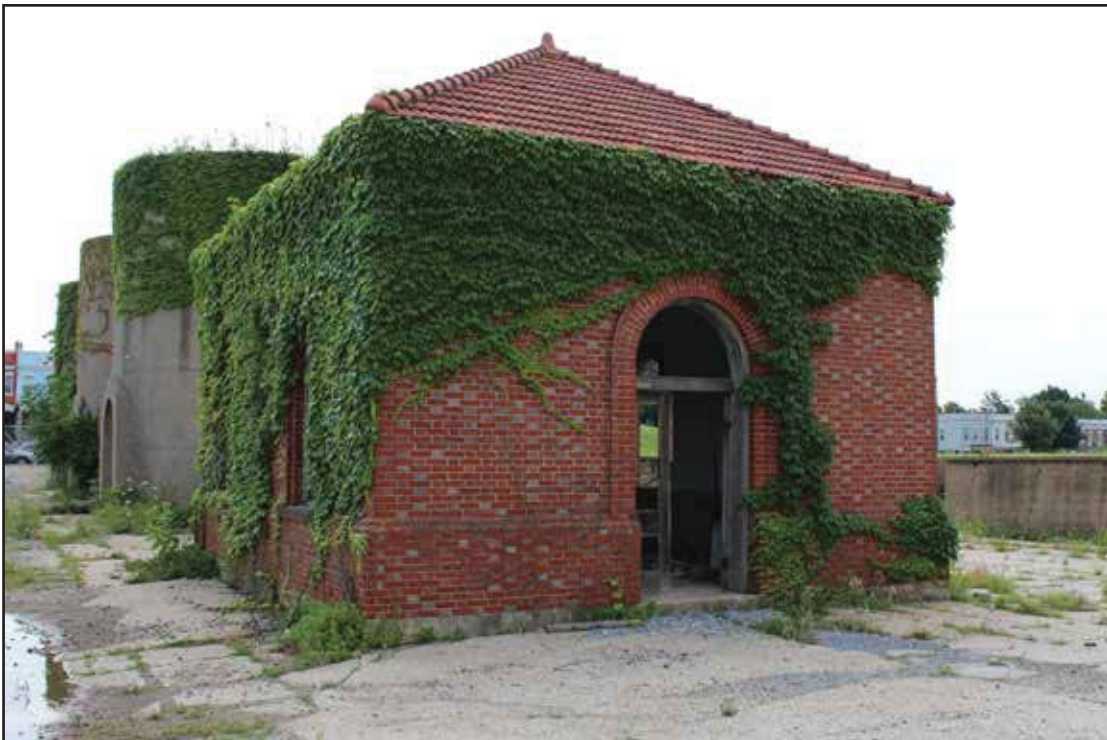
Regulator House 5, looking southeast. 2015.

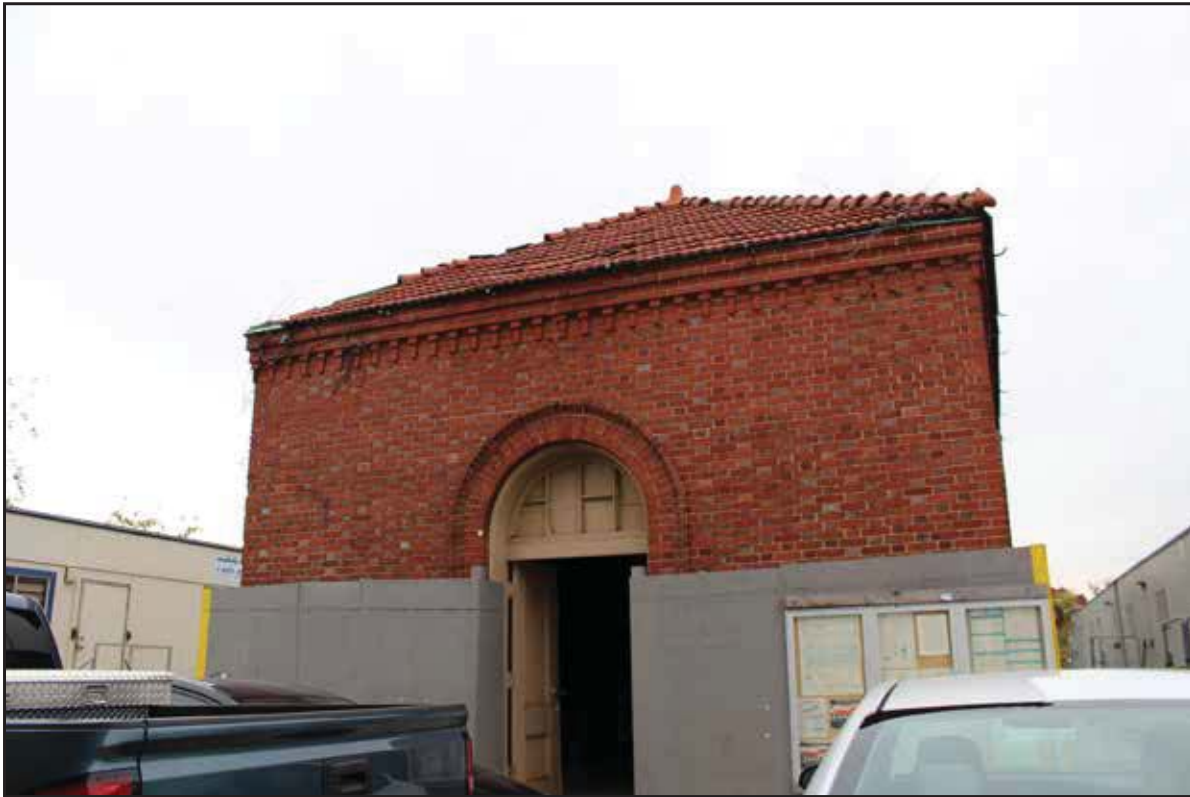
Regulator House 6, looking east. 2015.

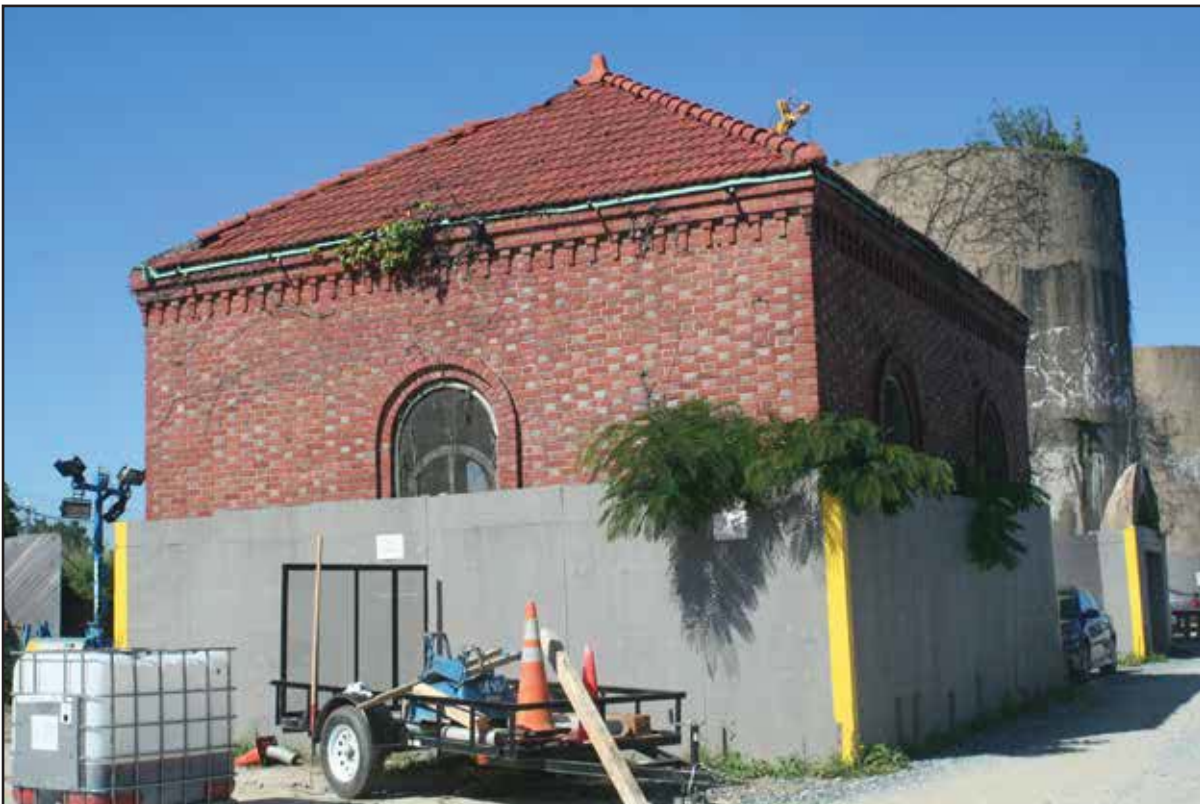
Regulator House 7, looking southeast. 2015

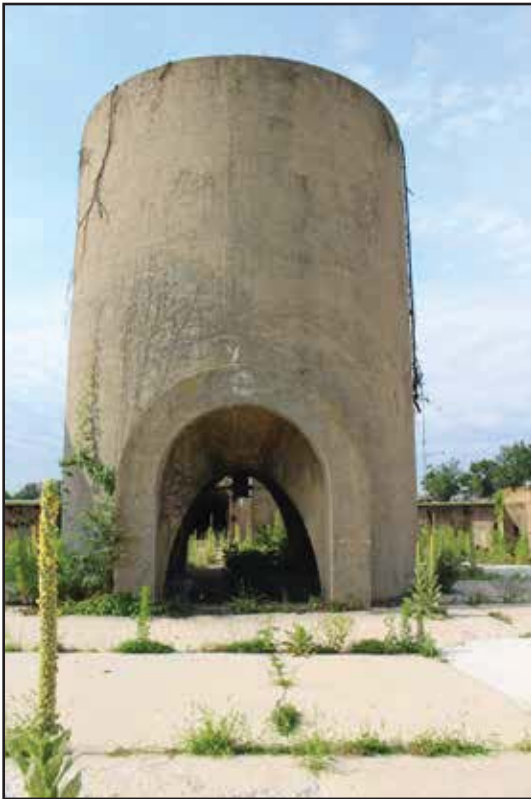
Existing Conditions: The condition assessment was limited due to a number of obstructions. All of the sand bins were found to be filled with sand and/or water, and vegetation at the time of the survey, resulting in incomplete findings. Existing bathroom partitions obstructed the interior survey of several sand bins. Plywood protective sheeting obstructed the lowest 8' of all sand bins located in Service Court 3, and the interiors of several sand bins were being used for construction material storage and were not accessible at the time of the survey. Construction activity and the placement of storage trailers limited the ability to survey the upper portions of several sand bins in Service Court 3. Vegetation growth along the walls of the sand bins, in addition to the an unknown white substance were observed on the majority of the resources. All observations are limited to the exterior of the sand bins.

Sand bin 10, looking south. 2015.

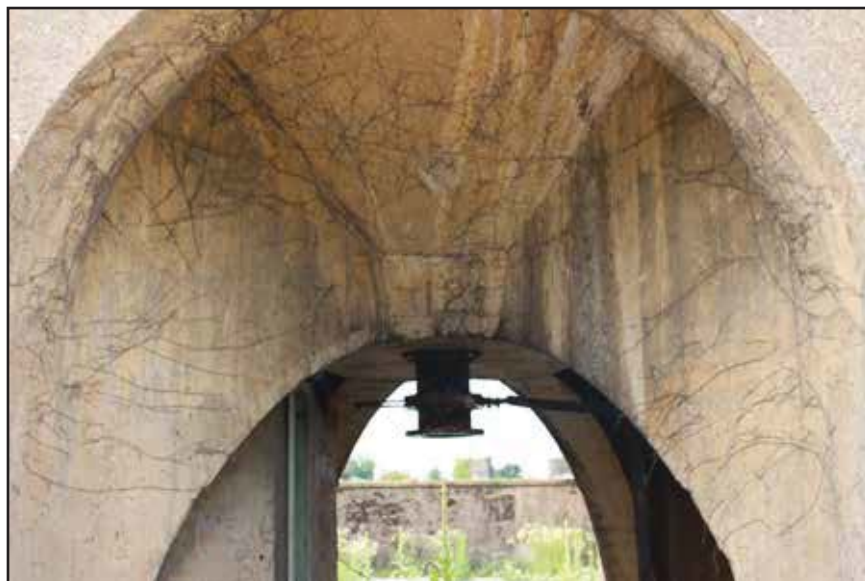
Interior of sand bin 12, looking south. 2015.

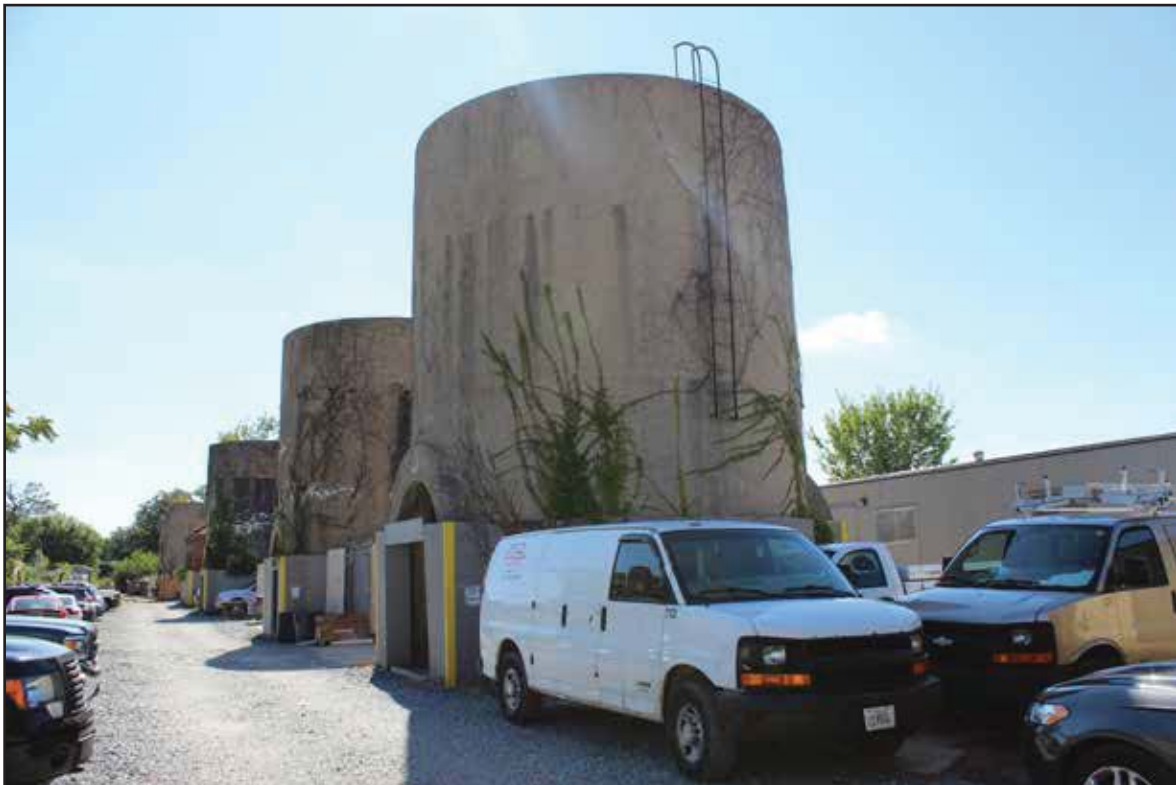
Looking southeast from Sand bin 24. 2015.
