McMillan Sand Filtration Plant

Historic Preservation Plan

May 2016

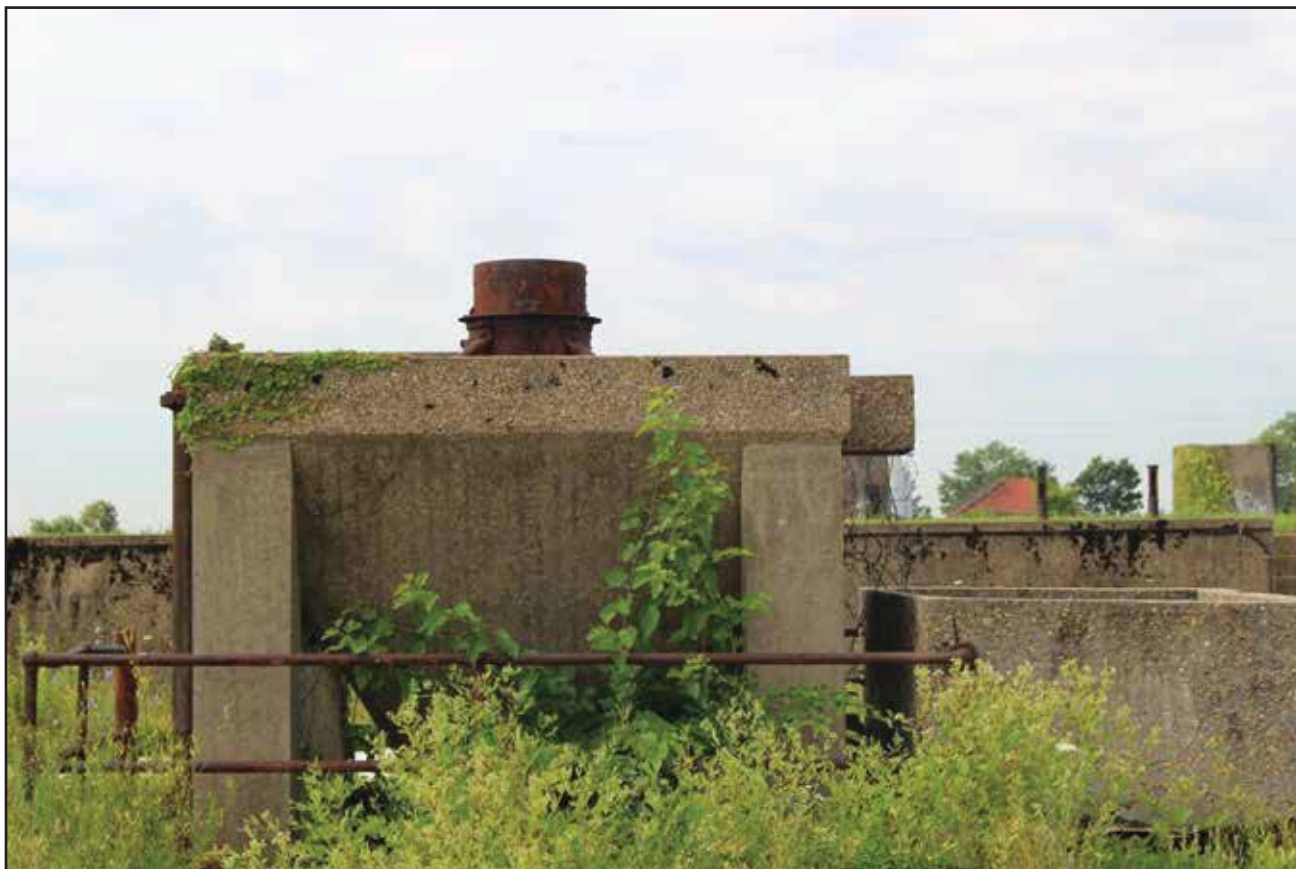
Existing Conditions: All of the sand washers are extant and in their original locations. Visual observations were made in all readily accessible areas. Visibility of the exterior of several of the sand washers and discharge bins was limited by vegetative growth and protective plywood boards. Some discharge bins were found to be filled with water, limited visibility of the bin interior. Locations where observations were obscured are included in Appendix A of Silman's *Existing Condition Assessment & Feasibility Evaluation - Sand Washers and Discharge Bins*.

Sand washer 10 in Service Court 2, looking south. 2015.

- All sand washers would be retained.
- The sand washers would be rehabilitated in accordance with the SOI Standards and Guidelines for Rehabilitation.
- An assessment would be conducted to determine the best method for relocating the sand washers elsewhere on site, and/or accommodate alterations for cultural installations or to be used as landscape features, such as planters.
- Sand washers would be preserved or restored in place, where possible.
- Relocation of 6 sand washers, when necessary, is appropriate.
- Documentation of the original design is available and should be referenced during design. See below, and Appendix A, A-44.

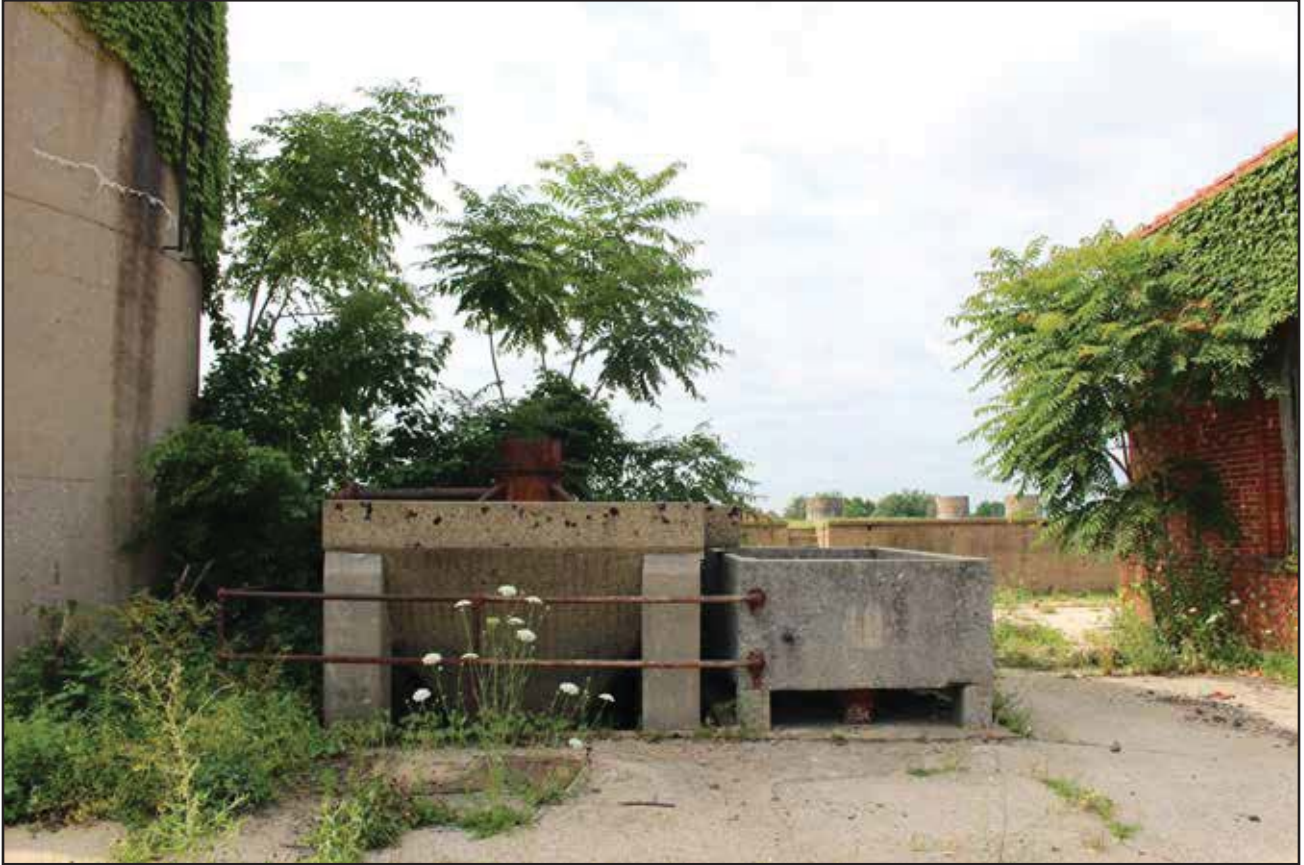
Sand washer 12 in Service Court 2, looking south. 2015.

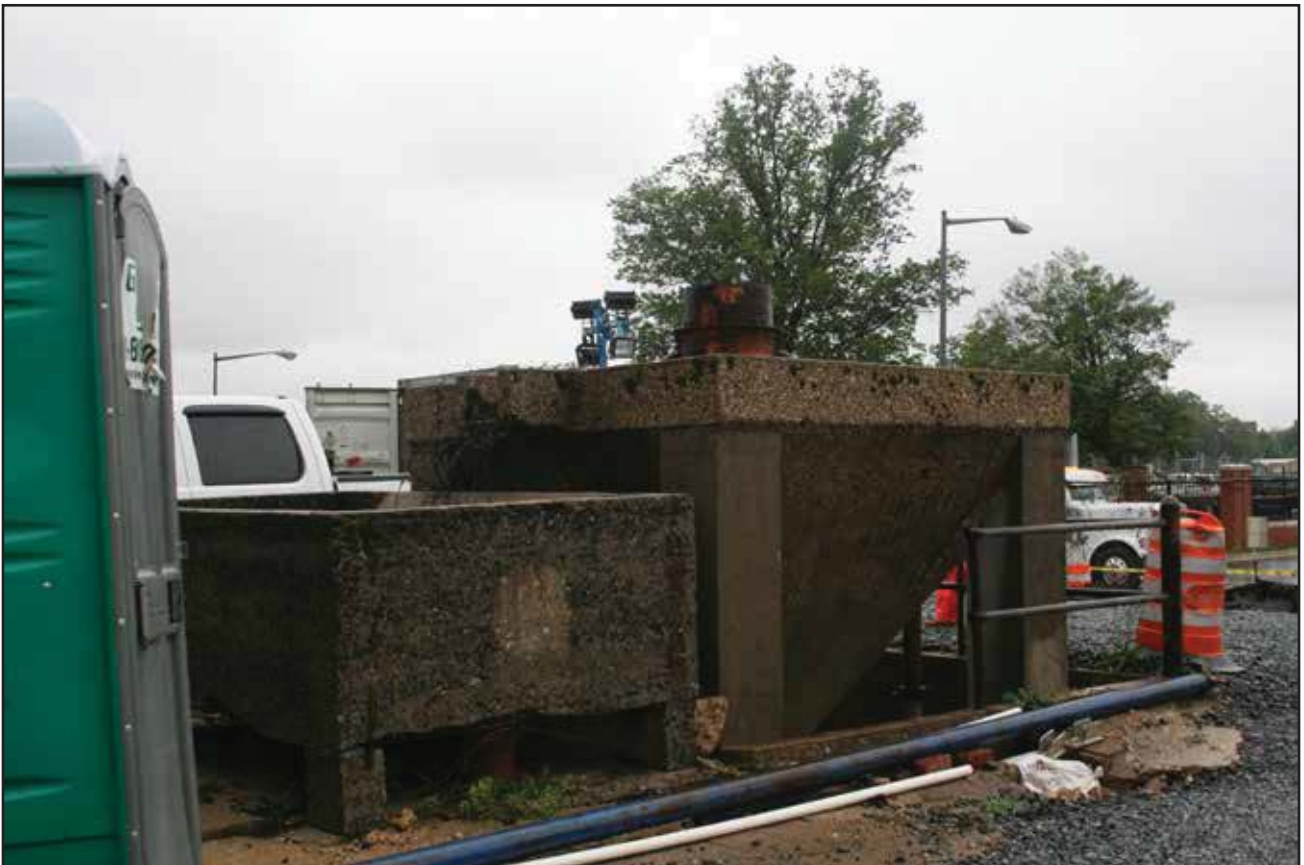
Sand washer 14 in Service Court 2, looking southwest. 2015.

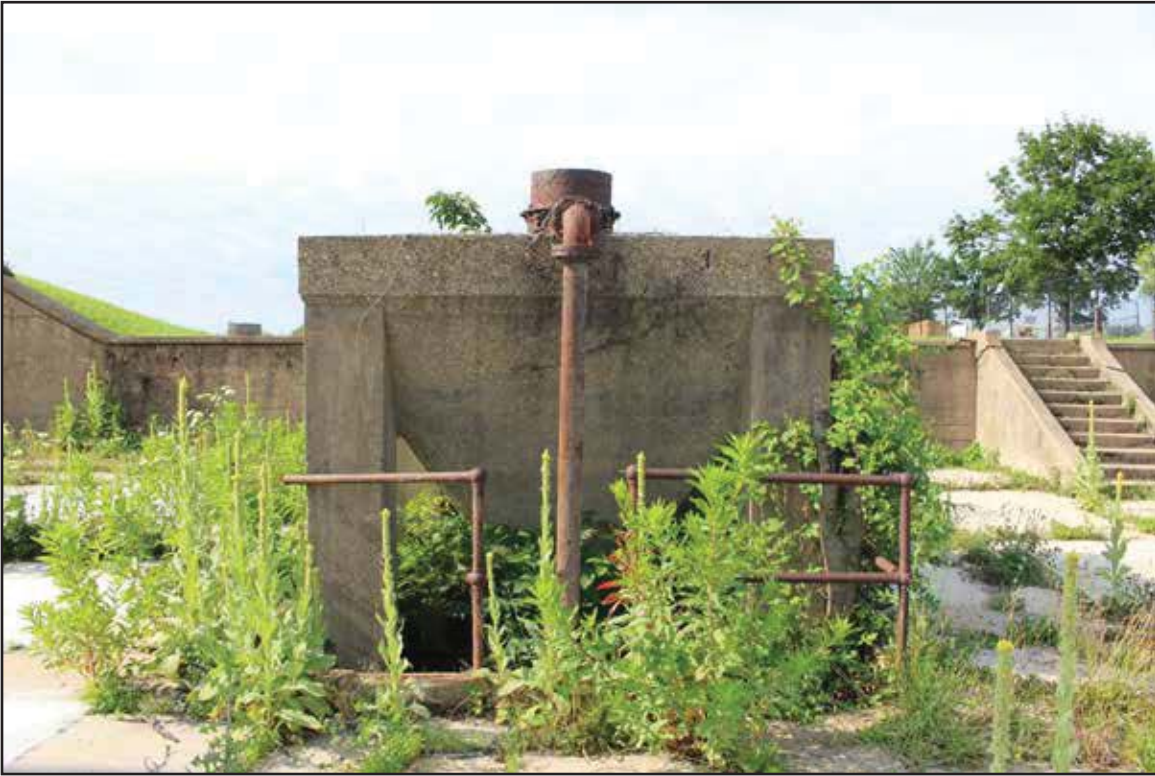
Sand washer 8 in Service Court 2, looking south. 2015.

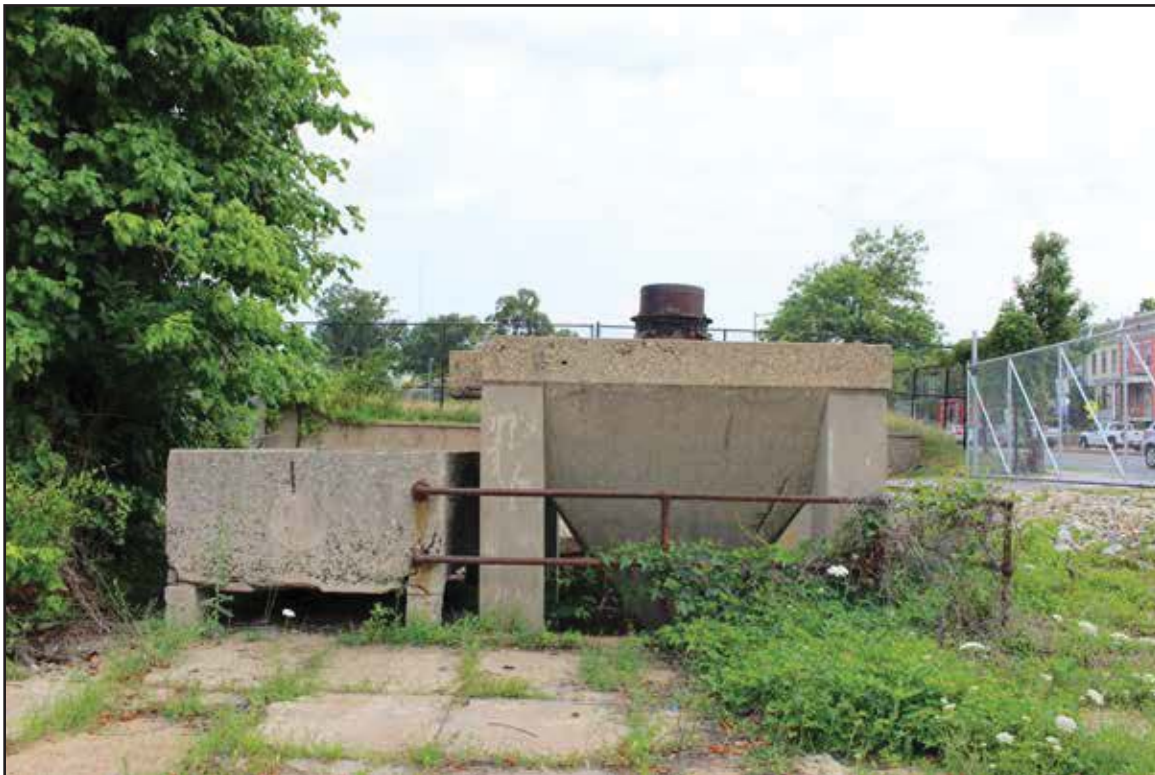
Sand washer 13 and discharge bin in Service Court 2, looking north. 2015.

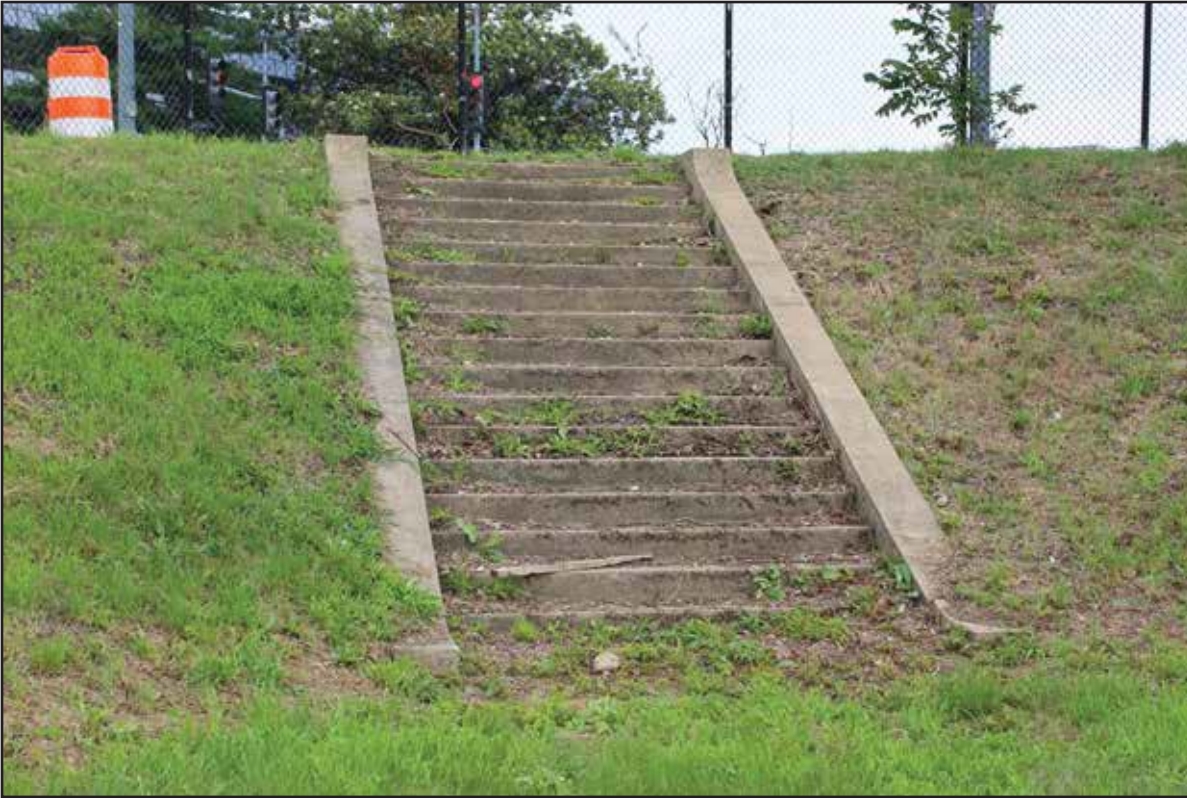
Stairs at northwest corner, looking northwest. 2015.

The extant concrete stairs will be removed in their entirety. This removal is consistent with the Mayor's Agent Decision and Order HPA No. 14-393.

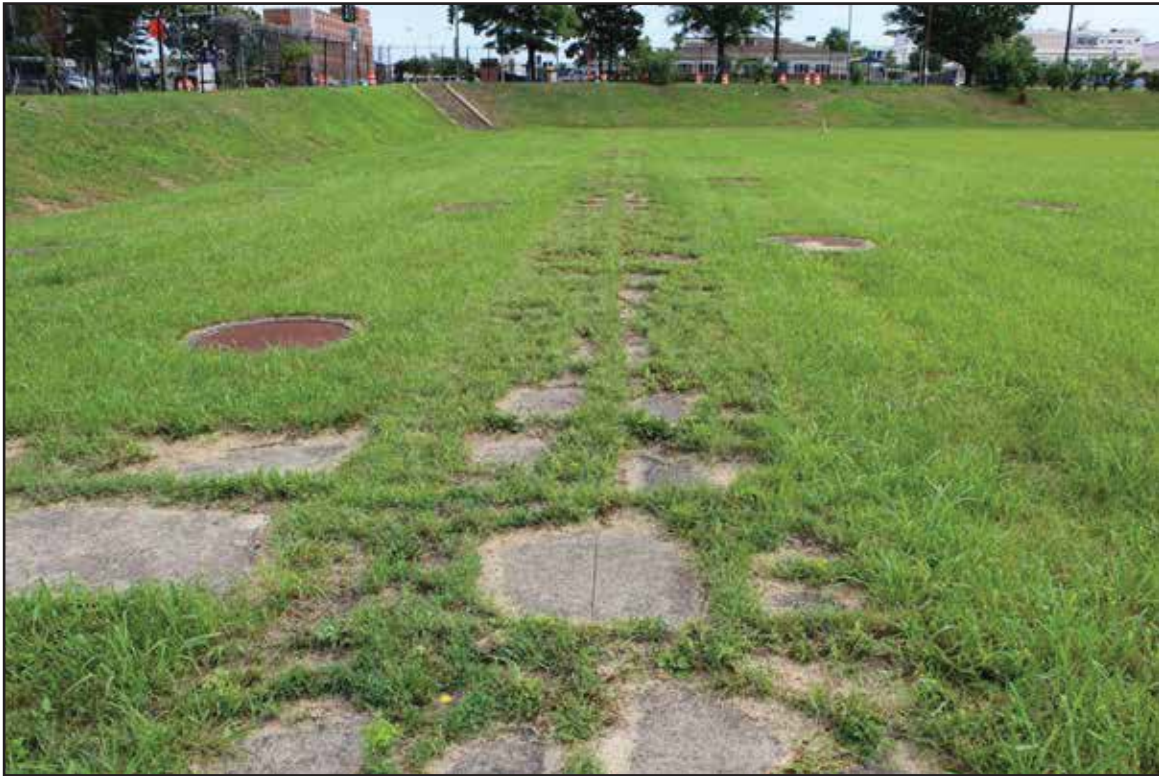
Remnants of pedestrian path, north of Service Court 2. 2015.

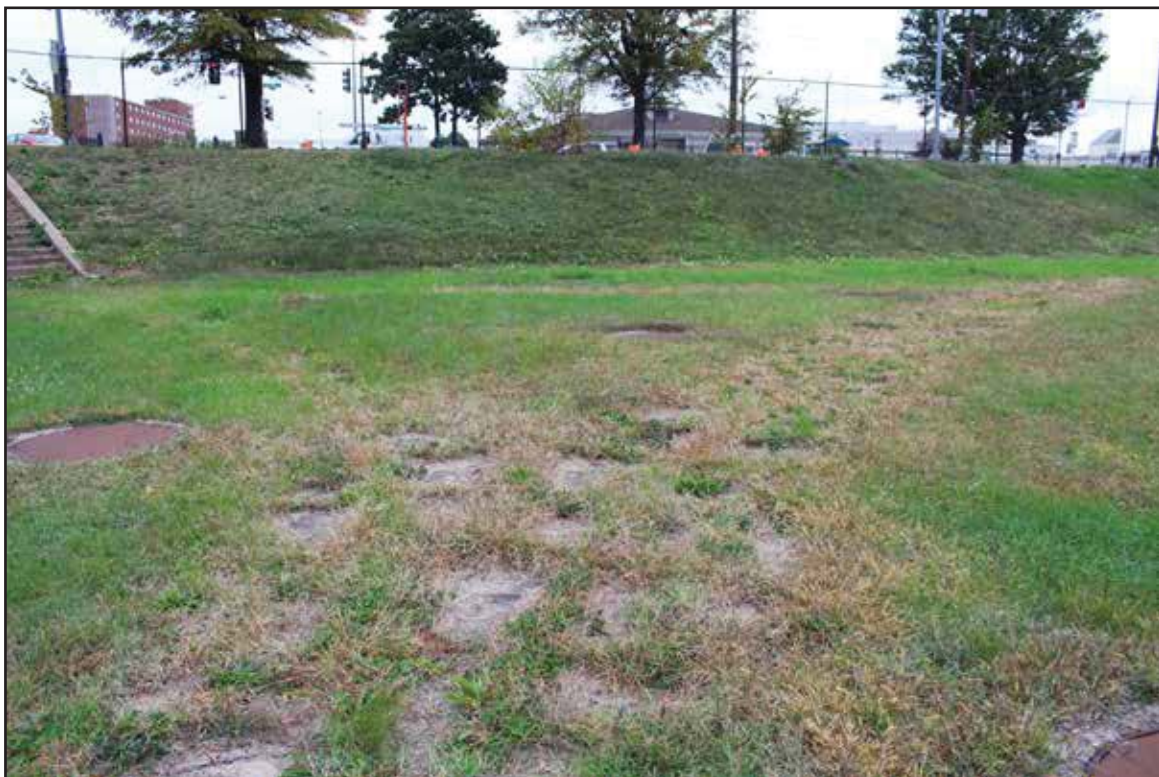
Remnants of pedestrian path at NW corner of site. 2015.

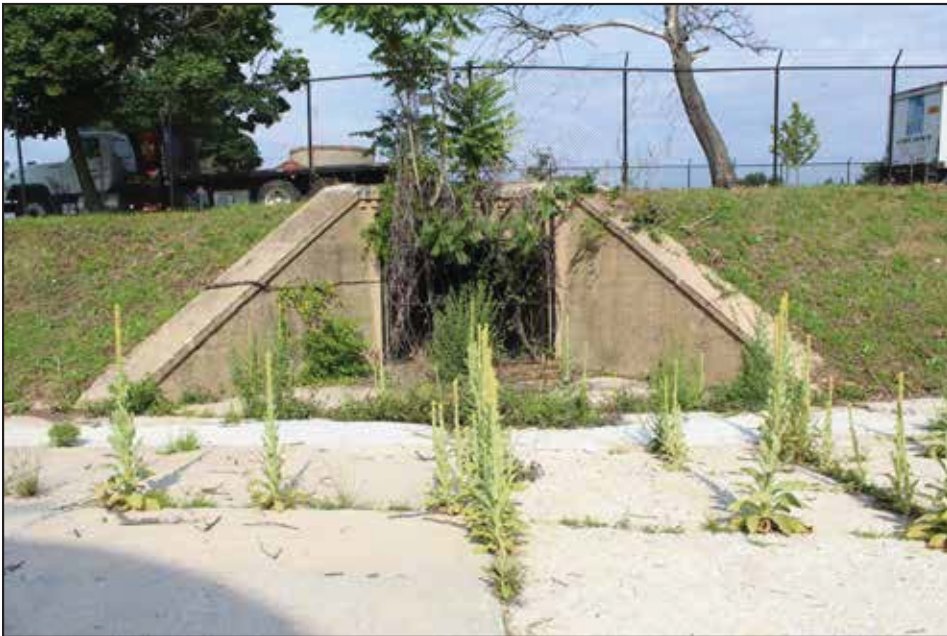
First Street Tunnel, looking west. 2015.

- The existing tunnel would be preserved in place in accordance with the SOI Standards and Guidelines for Preservation
- The tunnel will be filled in and closed off to preclude access.

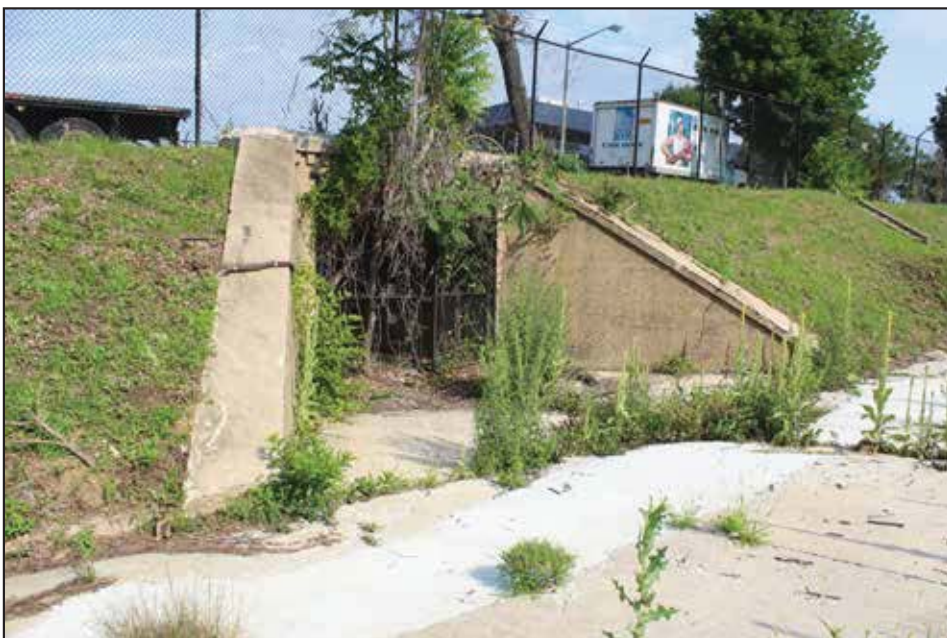
First Street Tunnel, looking northwest. 2015.

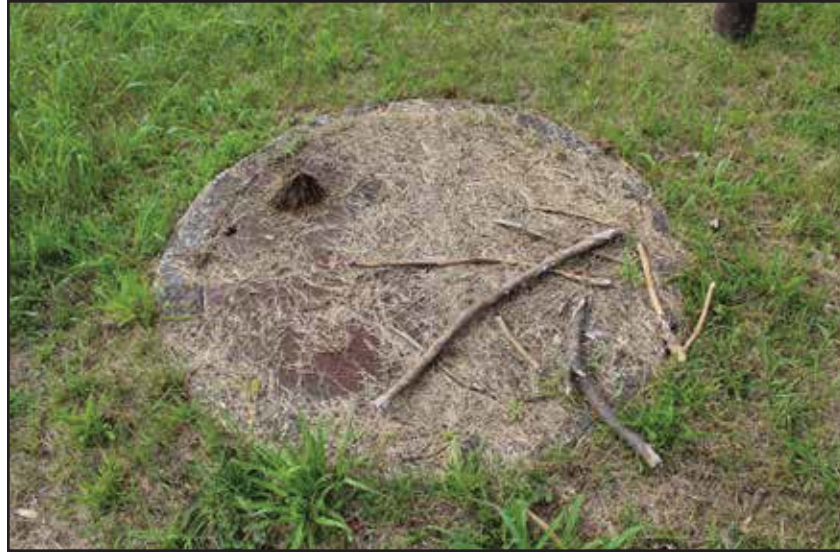
Manhole cover at southwest corner of filter bed 10. 2015.

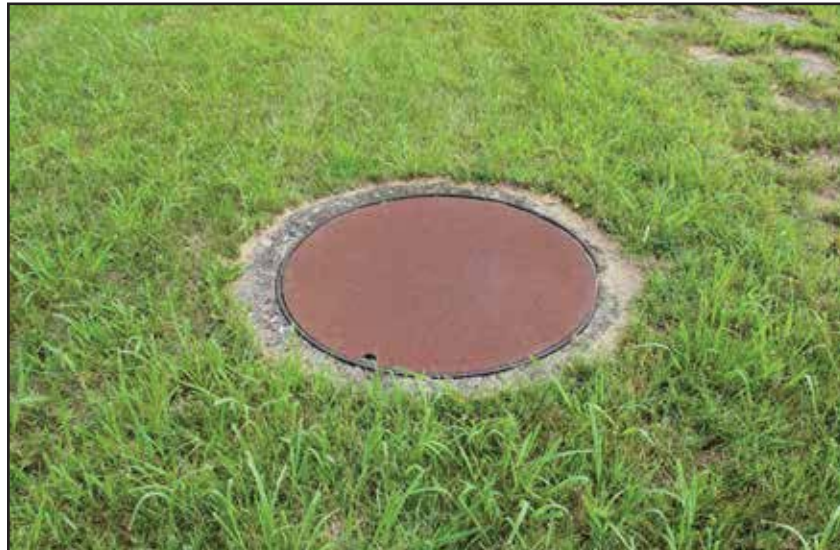
Intact manhole cover. 2015.

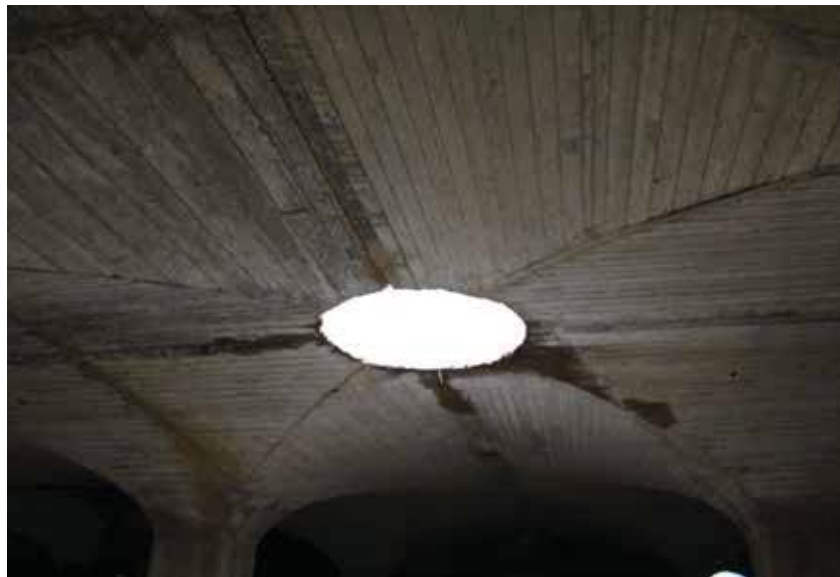
Manhole in Filter Bed 29. 2015.
