Subject: Environmental Investigation Findings Report  
Diamond Cab Property  
Northwest, Washington, DC

Reference: ICOR Project No. 13-CAS.02

# SITE PLAN

SITE PLAN WITH TANK LOCATIONS

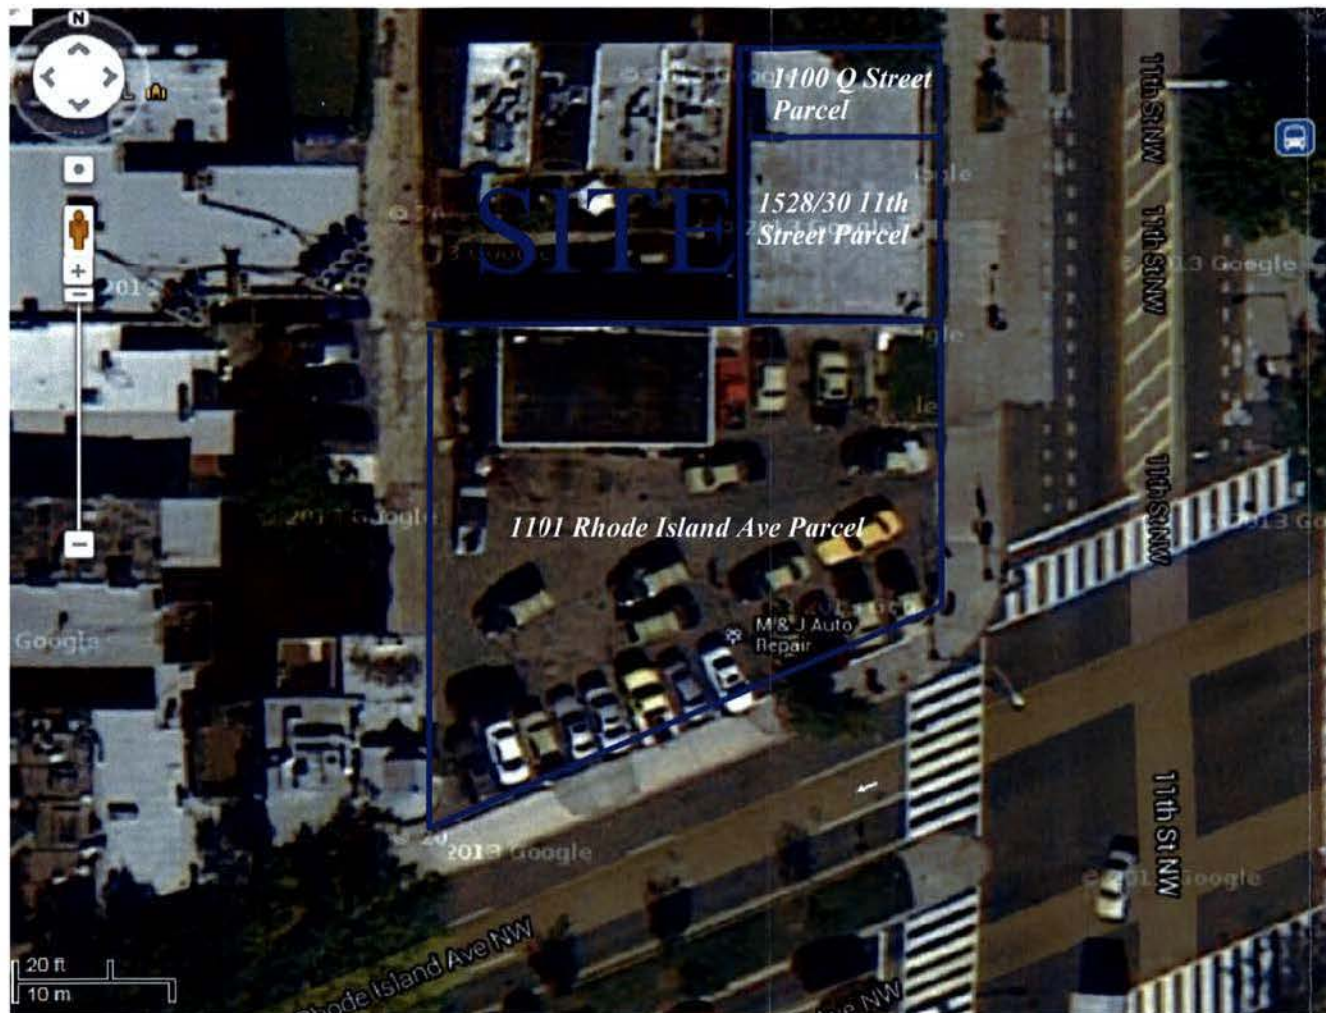
FIGURE 1

The SITE is located at 1101 Rhode Island Avenue, 1528/1530 11<sup>th</sup> Street, and 1100 Q Street, in Northwest, Washington, DC. The SITE is comprised of two lots (Lots 33 & 807) on Square 310 and is improved with three row house style structures, gasoline services station, and associated asphalt and concrete-paved parking lots and driveways. A site plan depicting pertinent SITE features is included as Figure 1.

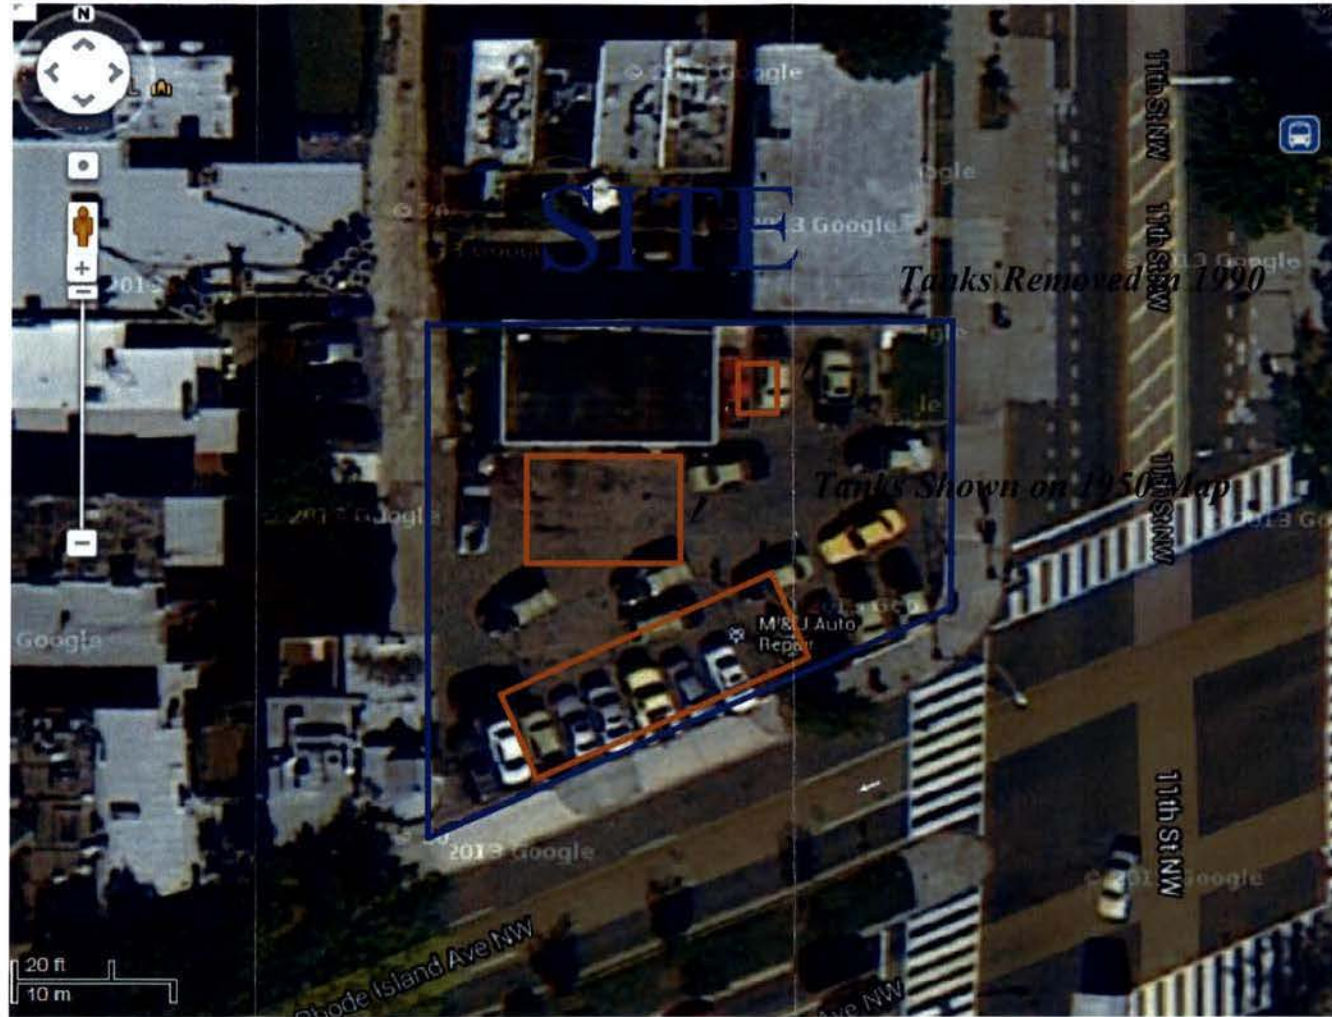
| | | FIGURE 2 |

The fate of the seven USTs depicted at the gasoline filling station on the 1959 SFI map is unknown. The locations of the four removed and seven suspect UST locations are depicted on Figure 2.

Based on the absence of closure information during our review of environmental documents, up to seven out of service USTs may exist beneath the asphalt and concrete-paved parking area near Rhode Island Avenue. To investigate if USTs were present in this area, ICOR contracted Ground Penetrating Radar Systems, Inc. (GPRS) to conduct a non-intrusive, geophysical survey in the area. On July 11, 2013 GPRS used ground penetrating radar survey techniques to determine if USTs were present. The areas investigated are depicted on Figure 2.

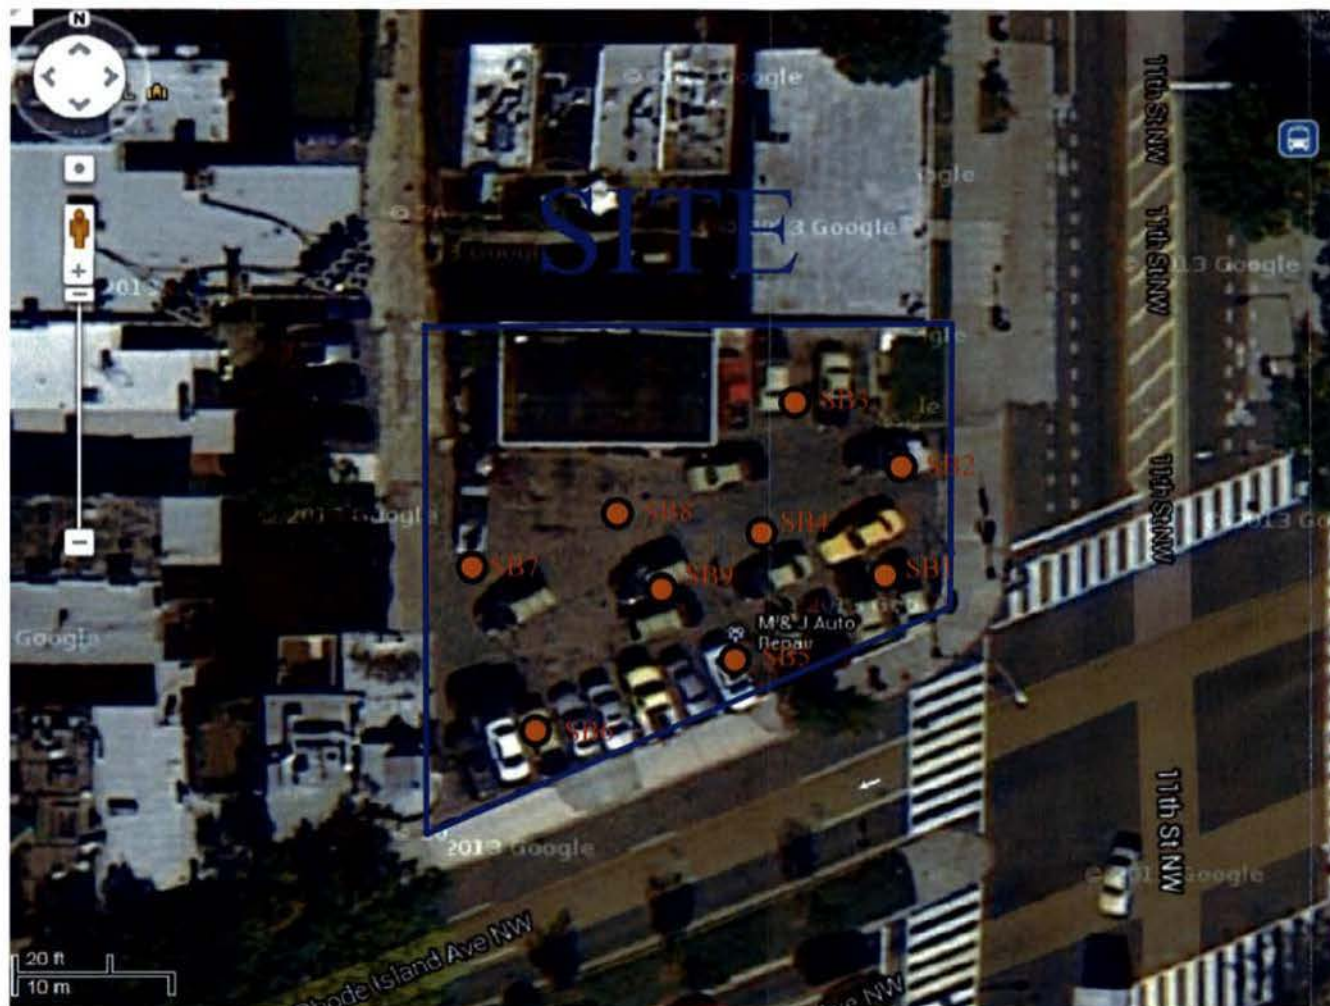
| ICOR <sub>inc</sub><br>ENVIRONMENTAL SERVICES | | FIGURE 3 |

On July 11, 2013, ICOR completed 9 test borings at the SITE (designated SB1 through SB9). The borings were completed to assess former and suspect UST locations across the entire 1101 RIA Parcel. The test boring locations are depicted on Figure 3.

#### SITE PLAN WITH SOIL BORING LOCATIONS

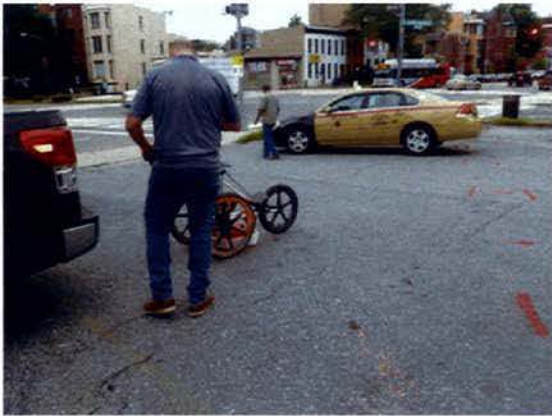
View of GPR Survey.

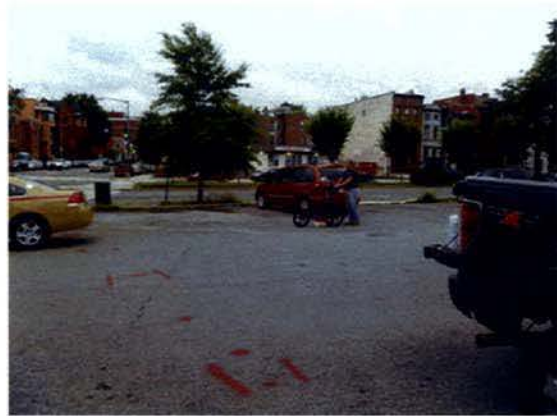
View of GPR Survey.

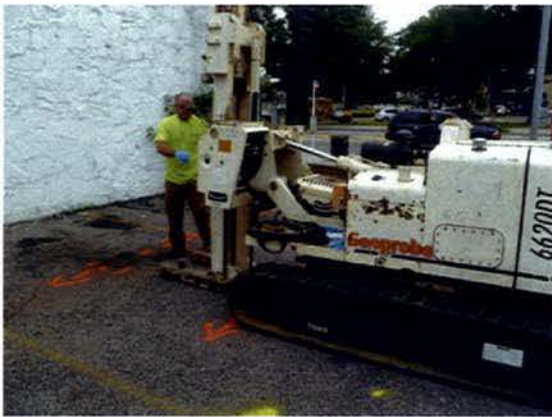
View of test boring SB3 being advanced.

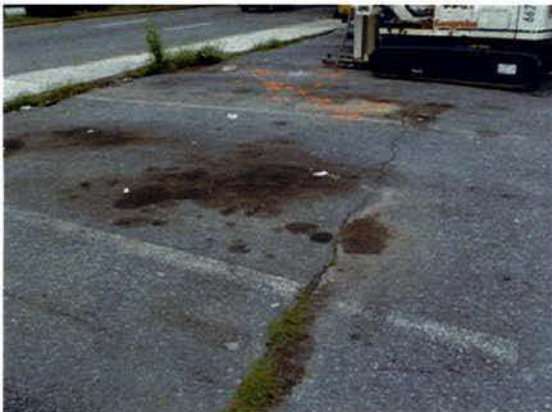
GPRS identified no subsurface anomalies suggestive of out of service USTs beneath the SITE. In addition, upon closer inspection, an asphalt patch was observed along the southern portion of the SITE in the area where the seven USTs were depicted on the 1959 Map. The presence of the patch suggests that the tanks may have been removed in the past.

View of asphalt patch over old tank locations.

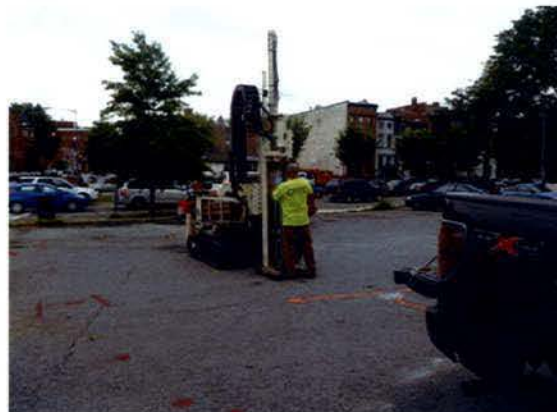
View of SB 9 being advanced.

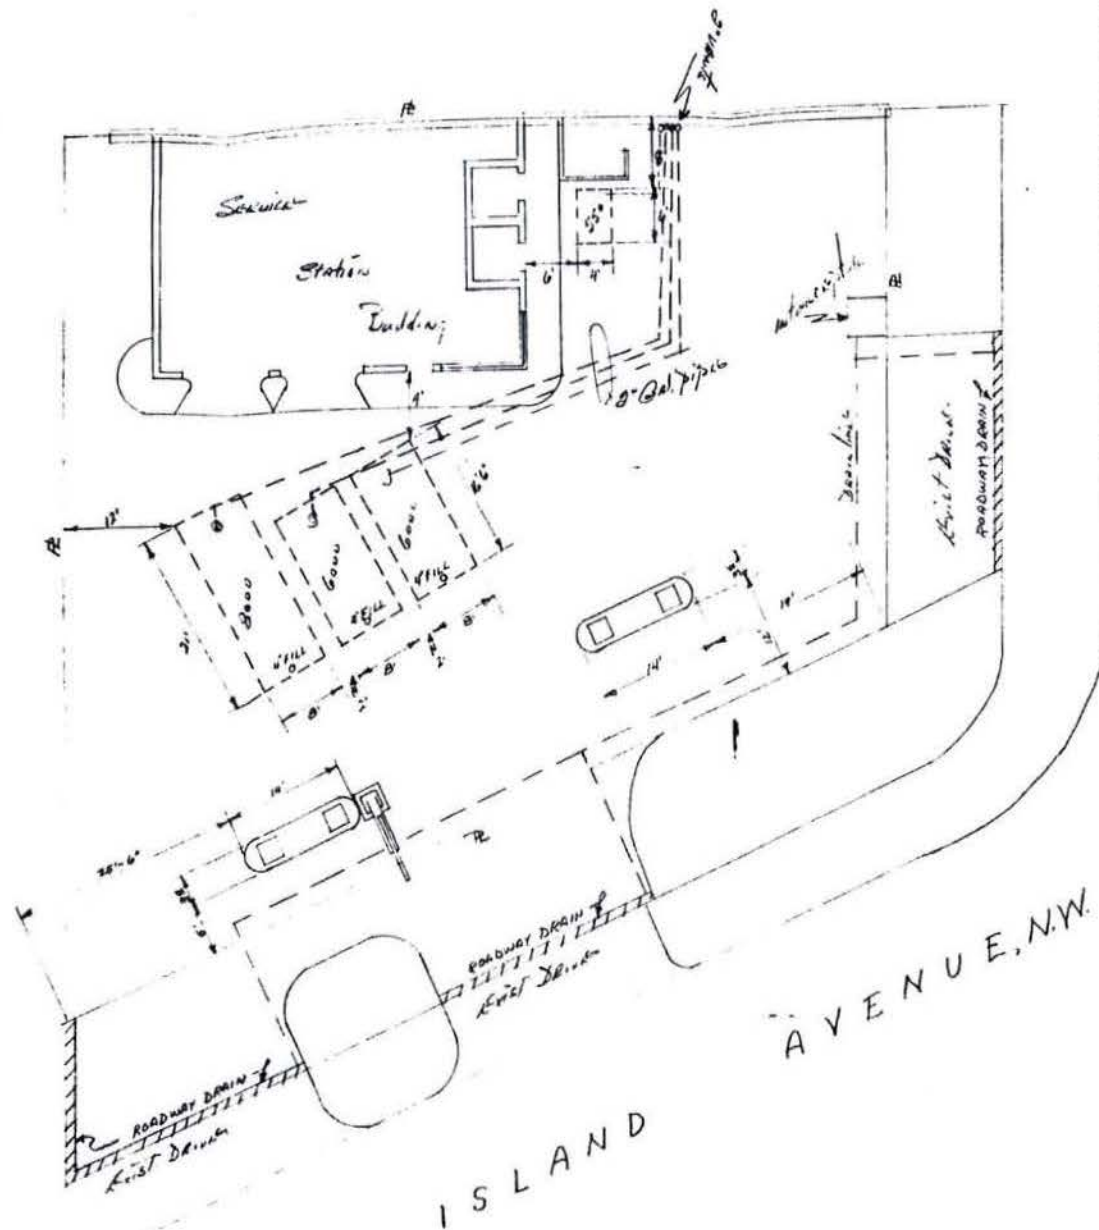
Excavate for & install 2-6000 and 1-6000 gallon oil tanks with two submerged pumps and 4-dispensers for gasoline storage. Install 1-500 gallon oil tank for waste oil. Tanks to be installed in accordance with applicable D.C. codes and to meet S.D. of D.C. Code.

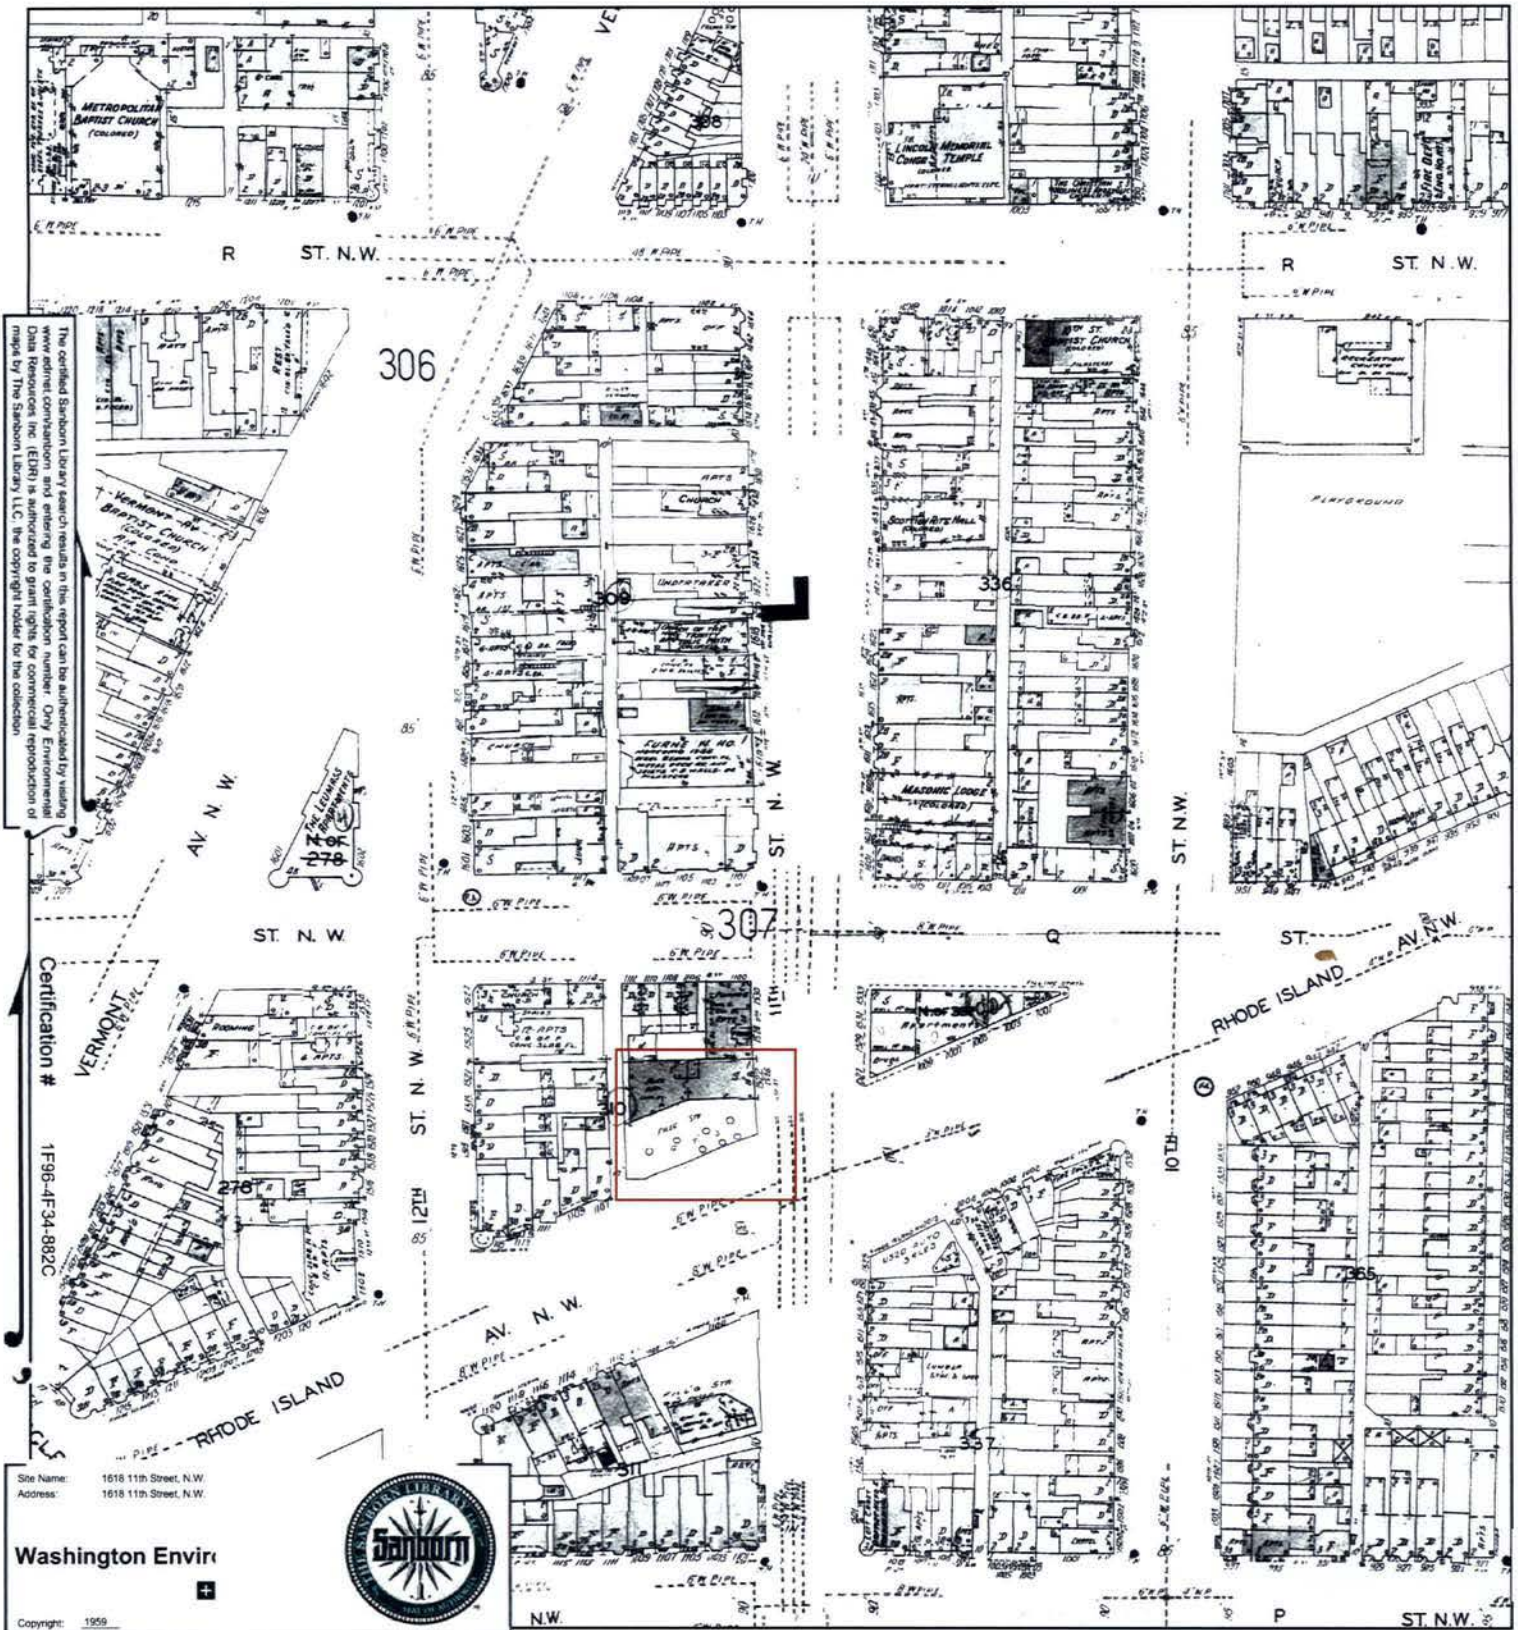
# 1959 Certified Sanborn Map

The 1959 Sanborn Fire Insurance Map depicts 7 gasoline tanks along the south portion of the 1101 RIA Parcel.

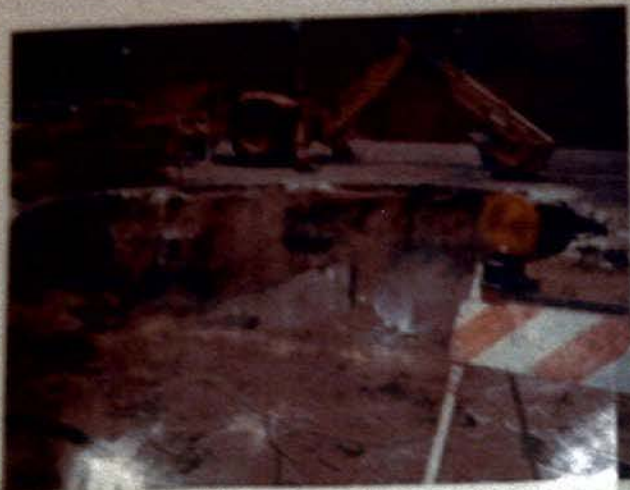
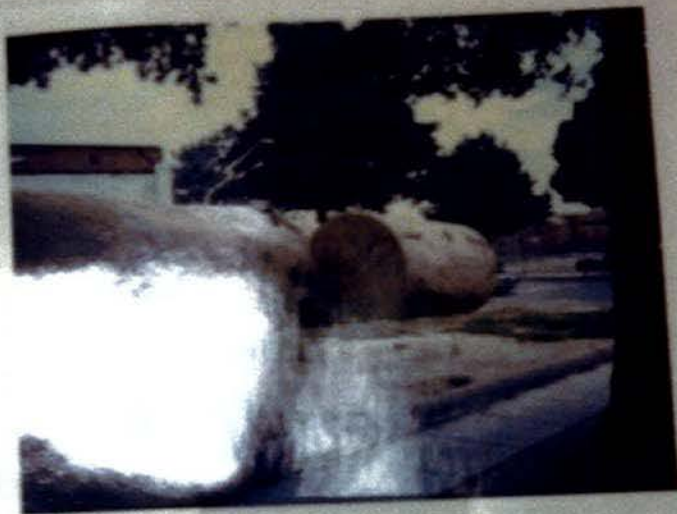
← Tank erection - note water in hole  
↓ Gas tanks following removal - note  
3rd tank in back between tanks in front

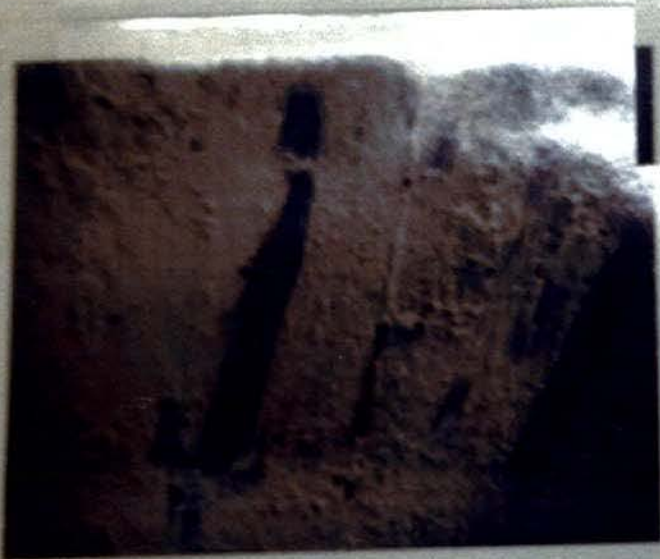
← Close up of 3000g tank - note pitting  
from corrosion

↓ Waste oil tank pit after tank  
removed Note stored soil to right

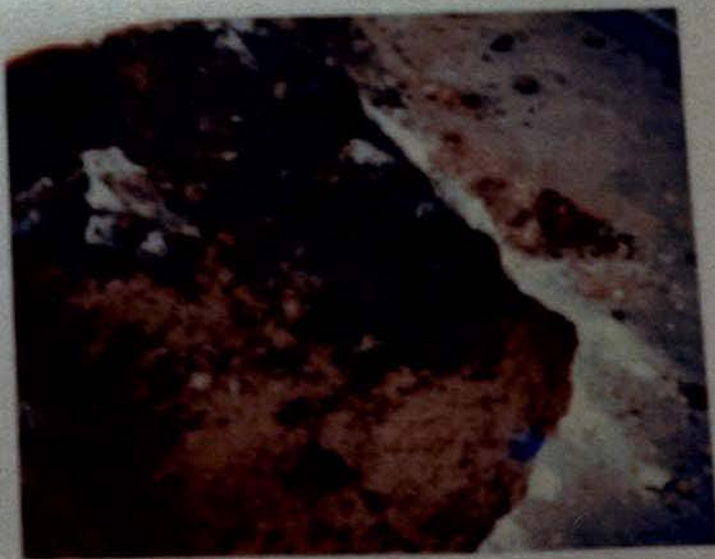
← Waste oil tank. Note black  
skins on bottom of tank
