# Introduction

## Adding Porches and Steps

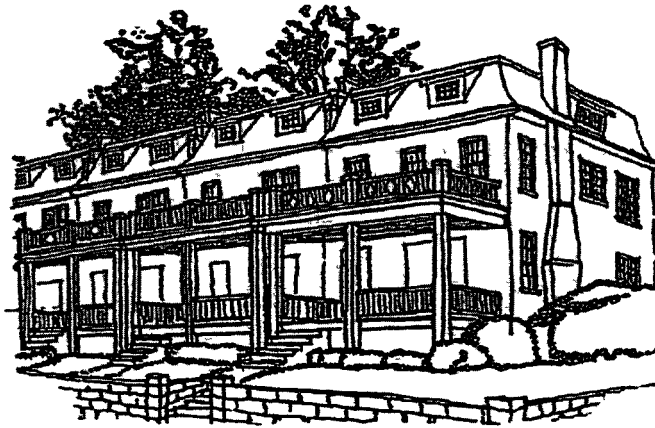
Porches consist of several different components: the structure and decking, the stairs and railing, the supporting columns or structure, and the roof. Each of these components may be found in a variety of materials including wood, brick, metal, stone and concrete. Front and rear porches may be open without a roof or side walls, have a roof but no side walls, or be enclosed by screens or side walls. Most Victorian era rowhouses in Washington have cast iron stoops and railings, while many Victorian era detached houses and twentieth century rowhouses have porches with wood posts, columns and decorative millwork.

Porches and steps are usually character-defining features on residential buildings.
