WILLIAMSBURG ENVIRONMENTAL GROUP, INC.

**Re: Canal Parc**  
WEG Project #3424A

**ZONING COMMISSION**  
CASE No. 08-21  
EXHIBIT No. 71

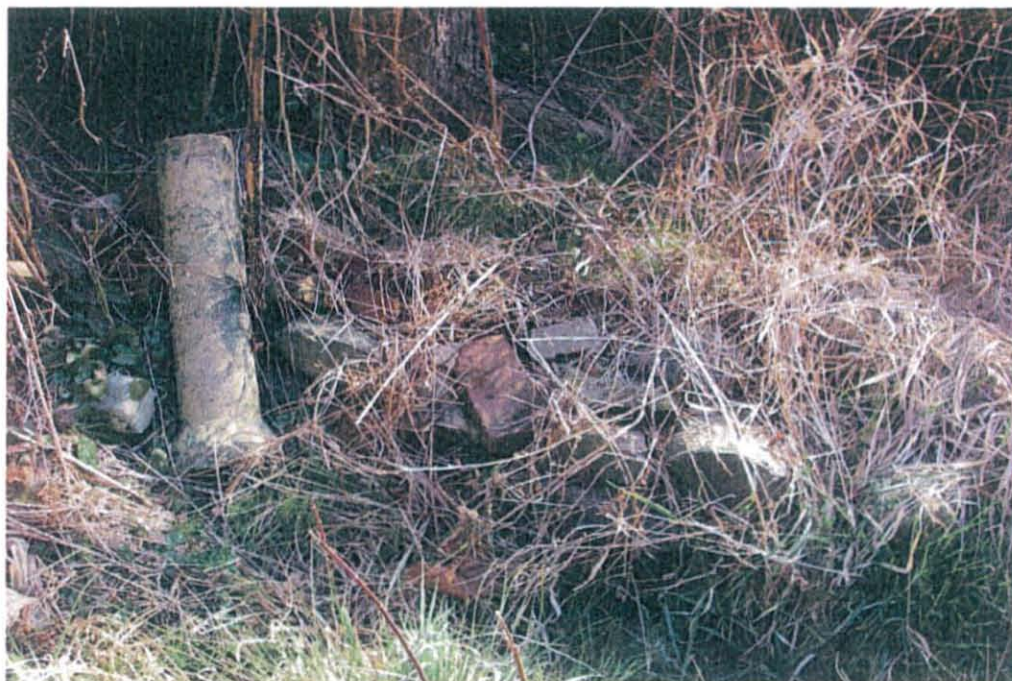
**Photograph 1:** Existing groundwater seep/ spring near the end of Lingan Way.

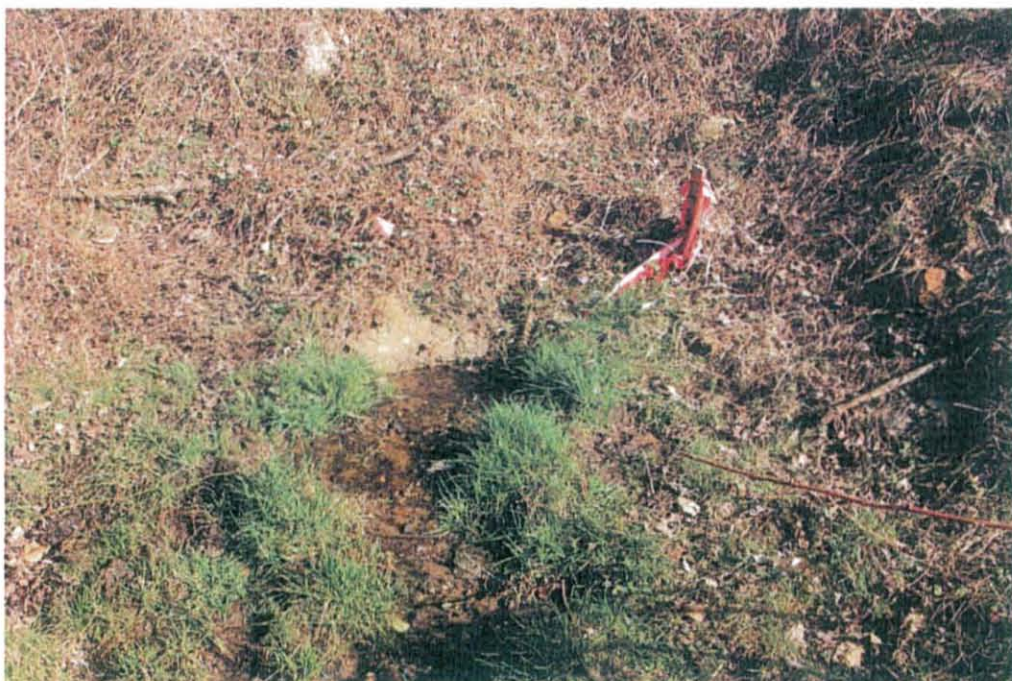
**Photograph 2:** Existing groundwater seep/ spring near abandoned Riverside Hospital recreation area that has not been impacted by current site conditions, i.e. impervious area. Note: flagged stake is wetland boundary marker.

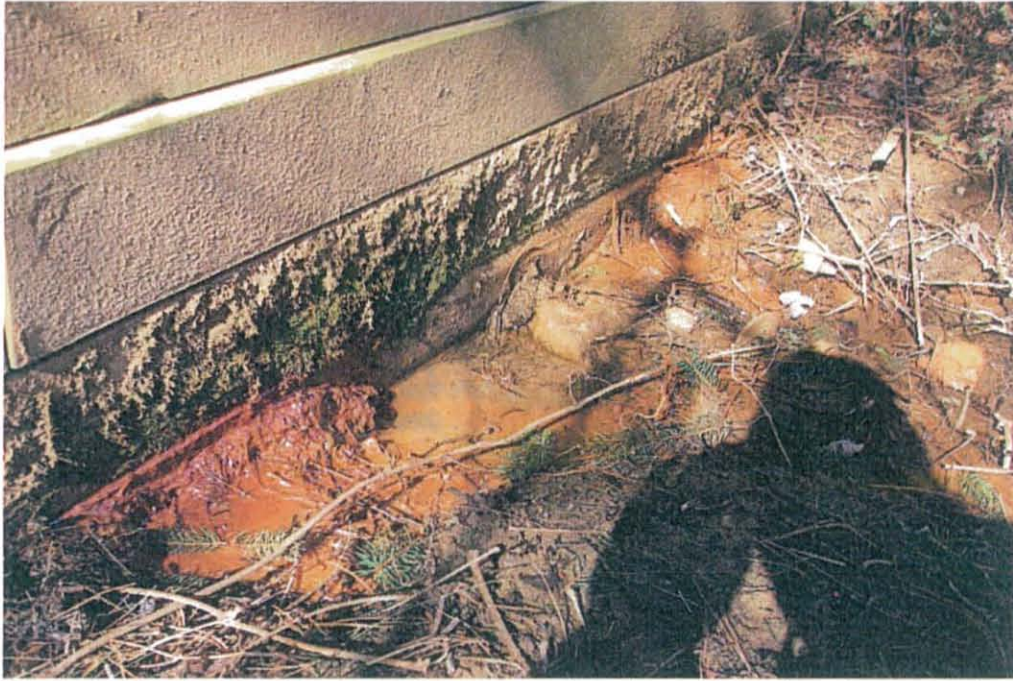
**Photograph 3:** Existing groundwater seep/ spring originating from existing retaining wall on Canal View community property.

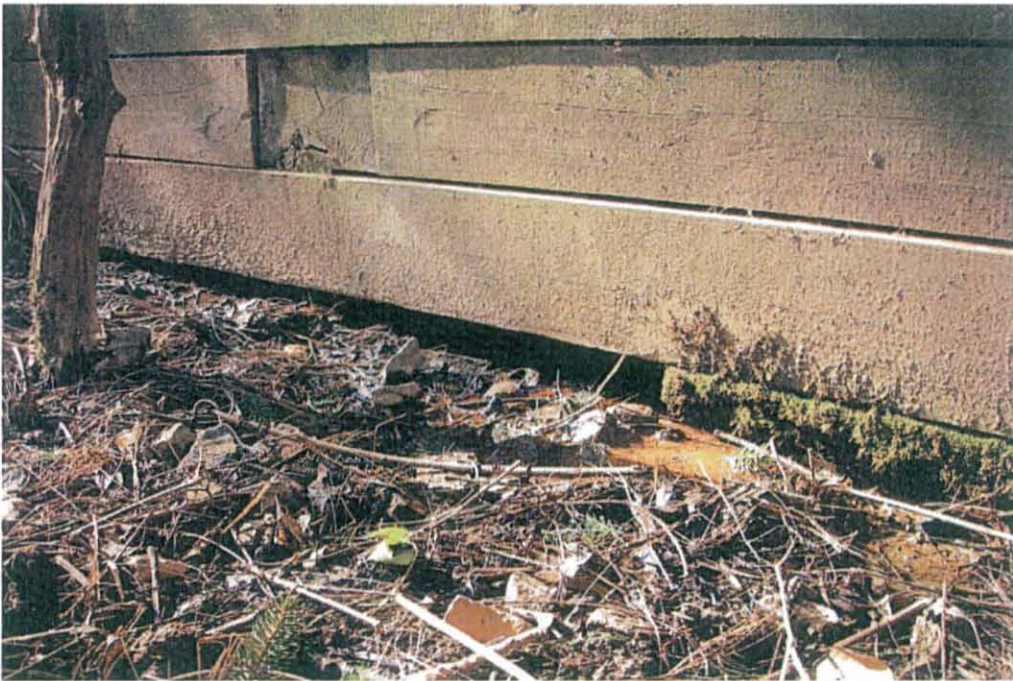
**Photograph 4:** Additional picture of groundwater seep/ spring originating from existing Canal View retaining wall.

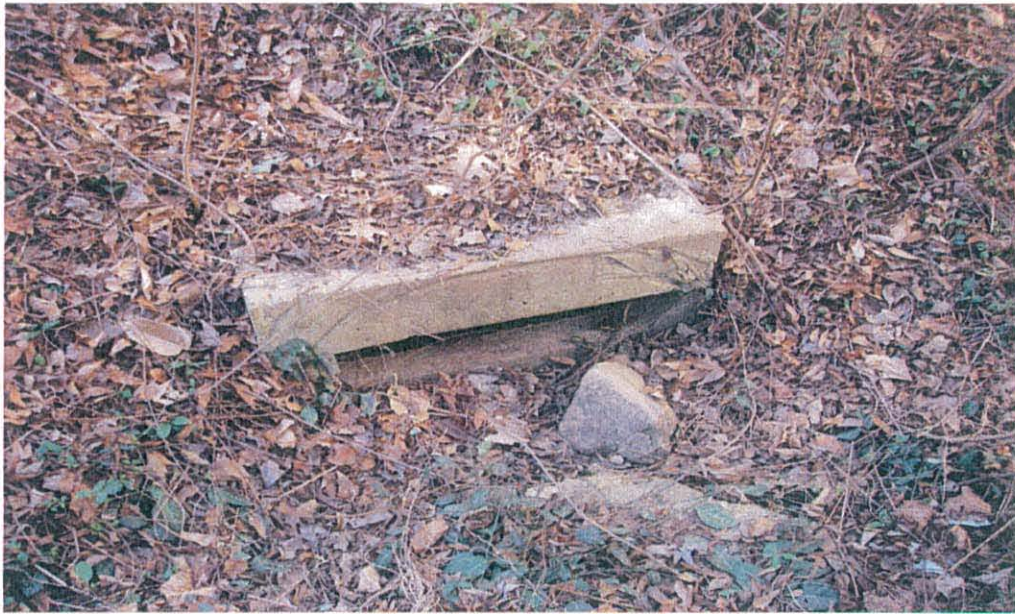
**Photograph 5:** Existing drain inlet near Riverside Hospital exercise area in the northwest portion of the property.
