EXHIBIT 10  
SITE PHOTOGRAPHS  
SKYLAND TOWN CENTER  
WSSI #21806.02

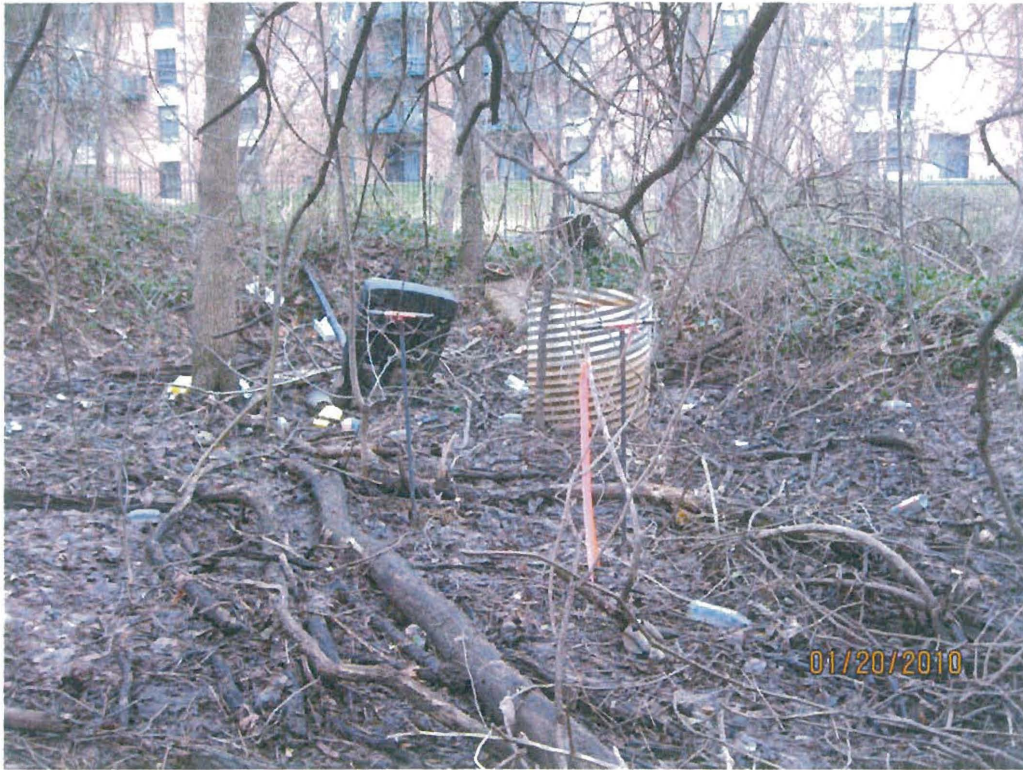
1. Looking northwest at Data Point 1. This data point characterizes the detention basin in the northern tip of the site. This basin exhibits evidence of hydrology and supports a hydrophytic plant community but does not contain hydric soil. This feature does not meet the three parameters of a jurisdictional wetland and in WSSI's opinion was constructed in uplands and thus, is not a jurisdictional water of the U.S. (subject to COE concurrence).

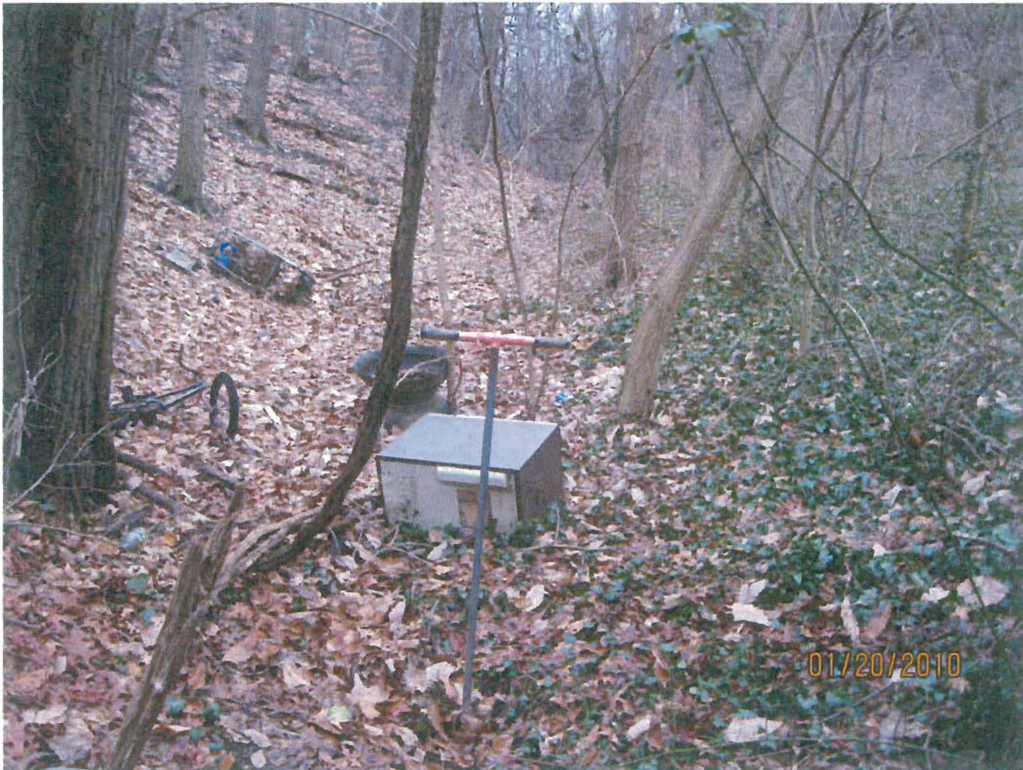
2. Looking southeast and upslope of the detention basin. This swale does not exhibit an ordinary high water mark and does not exhibit a defined bed and bank.

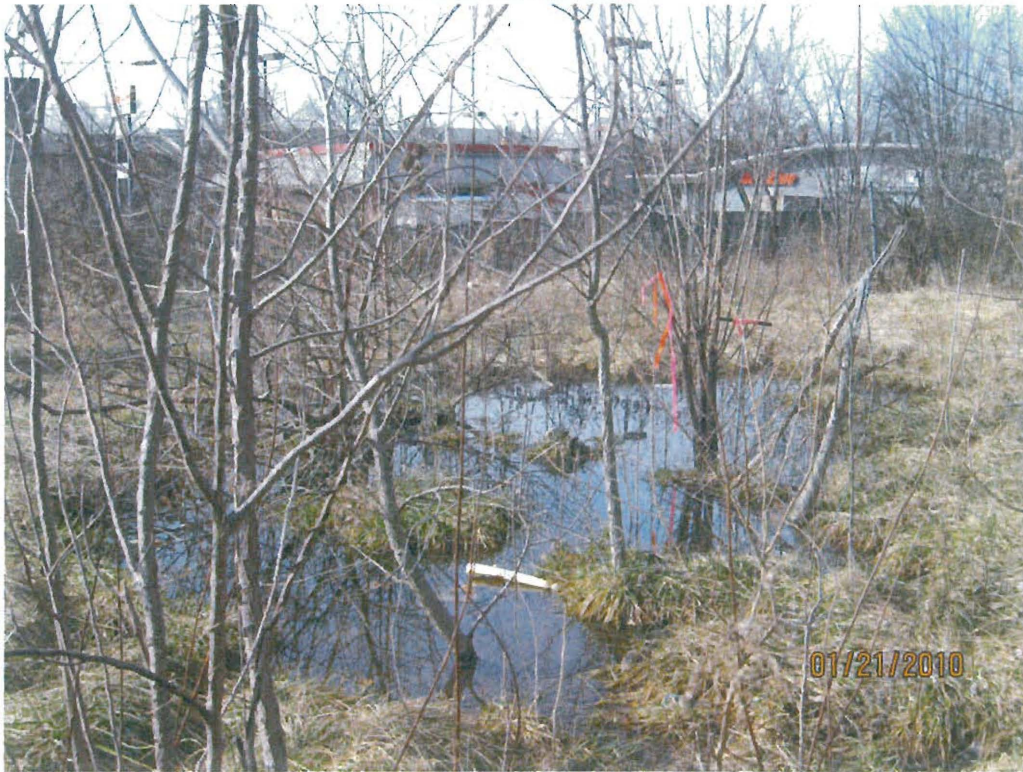
3. Looking northwest at the wet depression characterized by Data Point 3. This data point does not exhibit field indicators of hydric soils. In WSSI's opinion, this depression was created by human activities in an upland and is not a jurisdictional feature (subject to COE concurrence).

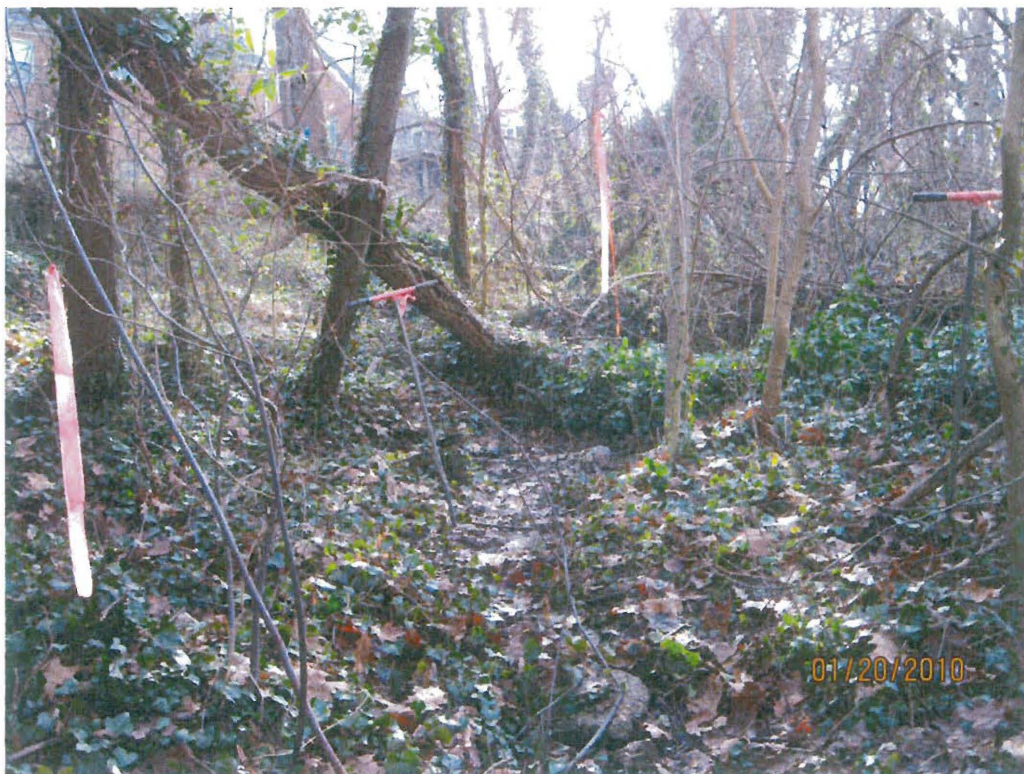
4. Data Point 2, looking southwest, characterizes a swale in the eastern portion of the site. This swale does not have an ordinary high water mark or a defined bed and bank. This data point does not meet the three parameters of a jurisdictional wetland.

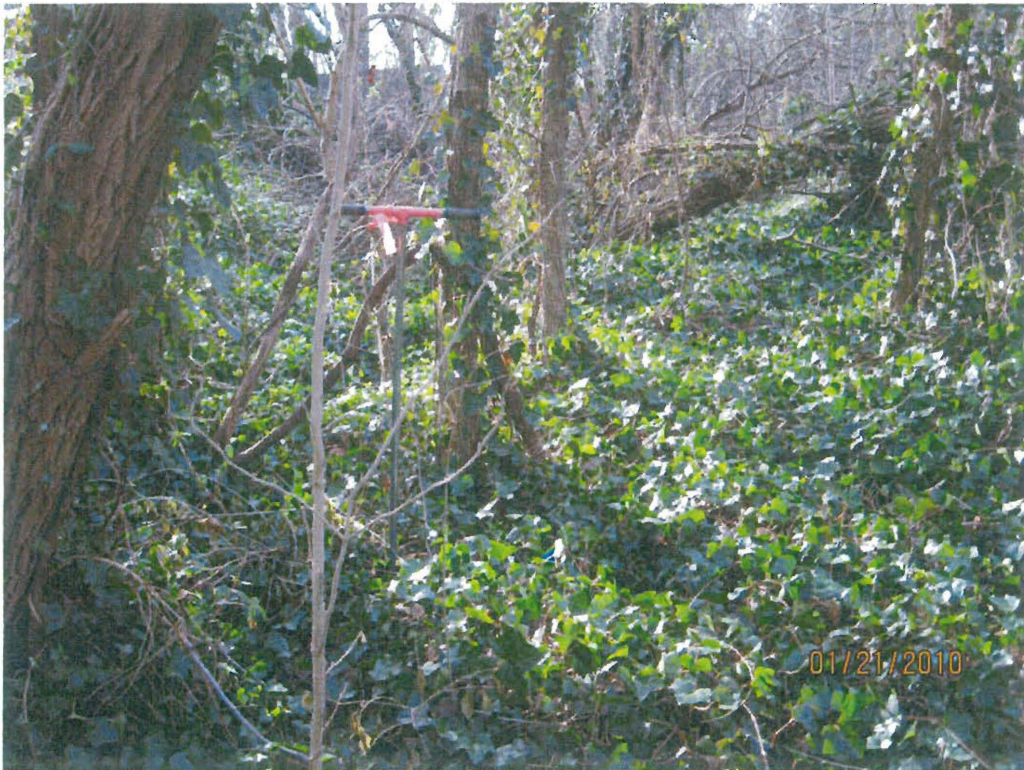
5. Looking southwest, upslope of Data Point 2. This swale does not exhibit an ordinary high water mark or a defined bed and bank.

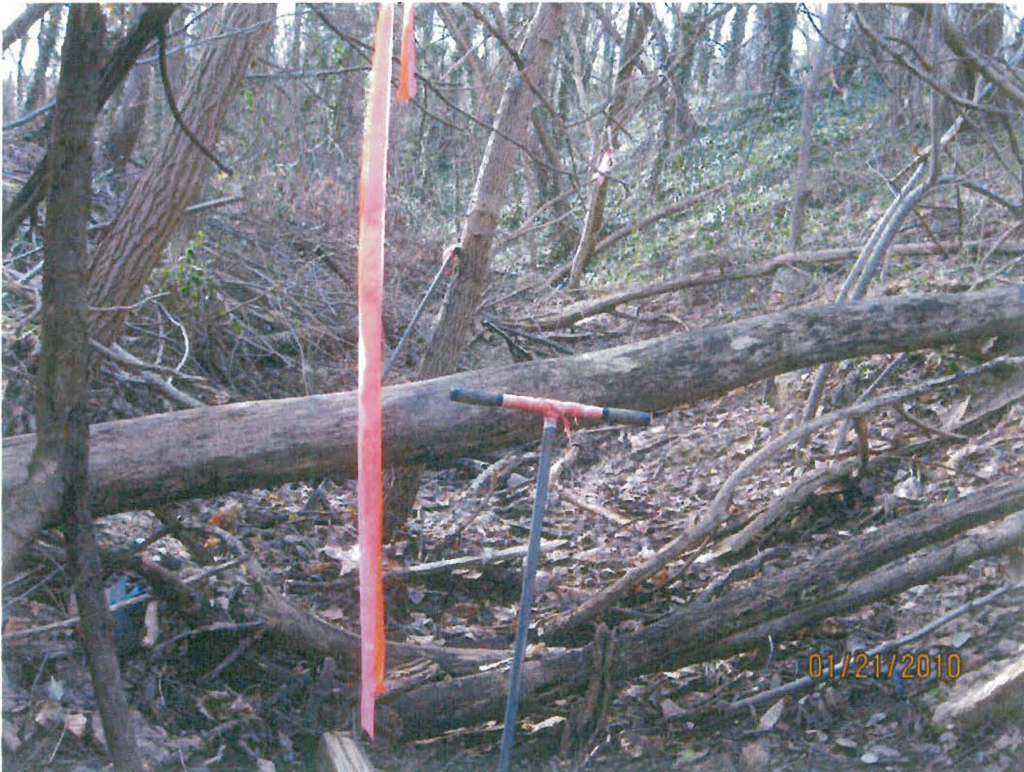
6. Data Point 4, looking west, characterizes a depression within the swale upslope of Data Point 2. This data point only meets one of the three wetland parameters (i.e., evidence of wetland hydrology) and in WSSI's opinion, is not a jurisdictional feature (subject to COE concurrence).

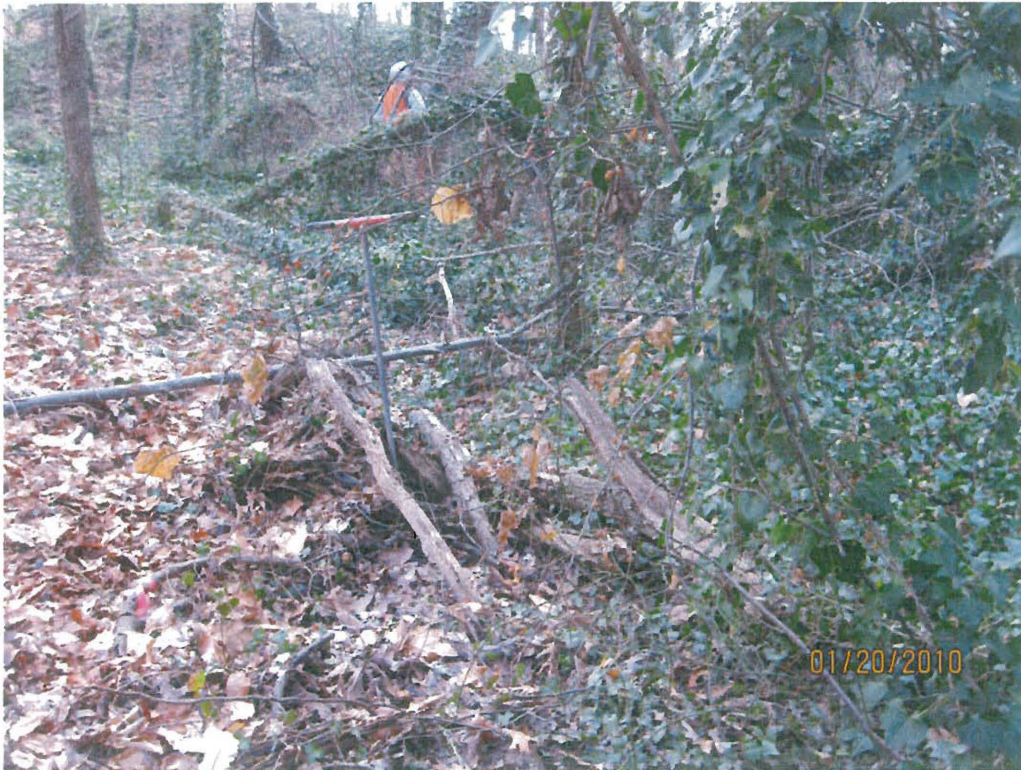
7. Looking south at a non-wetland swale in the eastern portion of the site. None of the three wetland parameters are met at this data location. This swale does not contain a defined bed and bank.
