# **Georgetown University Campus Plan 2011-2020**

## **Zoning Commission Case No. 10-32**

### **Analysis of Noise from Buses Along Proposed Park Bus Road**

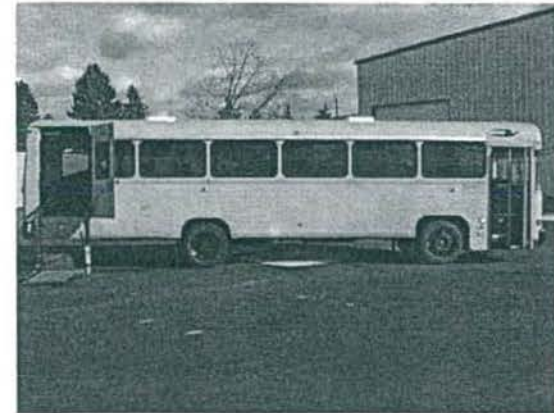
BLUE BIRD CORPORATON'S  
MODEL  
ALL AMERICAN  
EQUIPPED WITH A  
BRAUN MODEL L919F1B HANDICAP LIFT

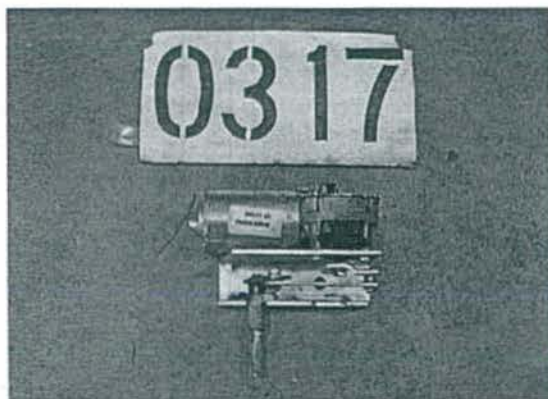
WIPER MOTOR REMOVAL AND REPLACEMENT  
(0.50 MAN HOURS)

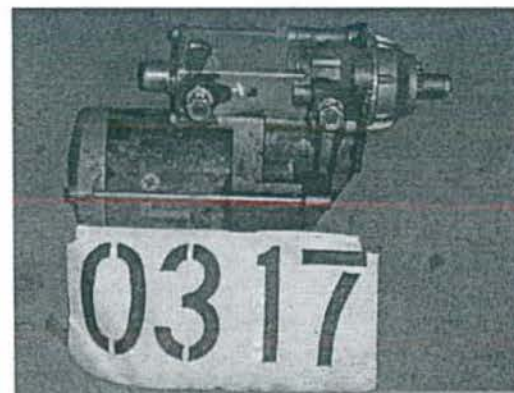
STARTER REMOVAL AND REPLACEMENT  
(0.75 MAN HOURS)

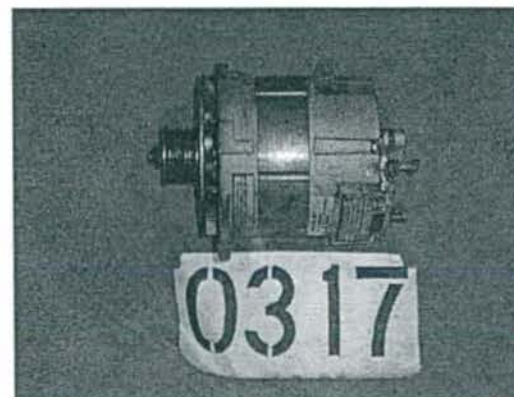
ALTERNATOR REMOVAL AND REPLACEMENT  
(1.00 MAN HOURS)

Accessibility, in general, was adequate. Components covered in Section 1.3 (repair and/or replacement of selected subsystems), with the exception of the alternator, were found to be readily accessible and no restrictions were noted. The alternator along with the accessories belt had limited access.

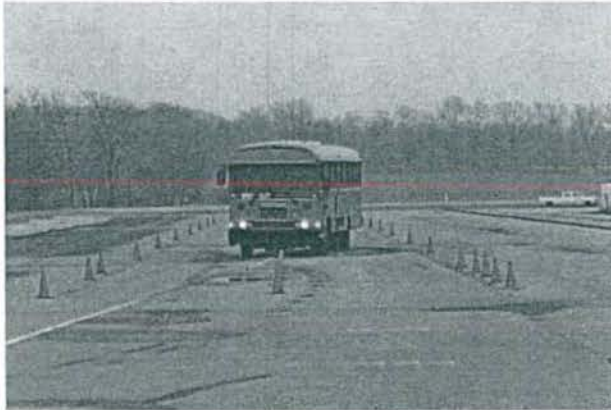
RIGHT - HAND APPROACH

The Safety Test is a vehicle handling and stability test. The bus will be operated at SLW on a smooth and level test track. The bus will be driven through a double lane change course at increasing speed until the test is considered unsafe or a speed of 45 mph is reached. The lane change course will be set up using pylons to mark off two 12 foot center to center lanes with two 100 foot lane change areas 100 feet apart. The bus will begin in one lane, change to the other lane in a 100 foot span, travel 100 feet, and return to the original lane in another 100 foot span. This procedure will be repeated, starting first in the right-hand and then in the left-hand lane.

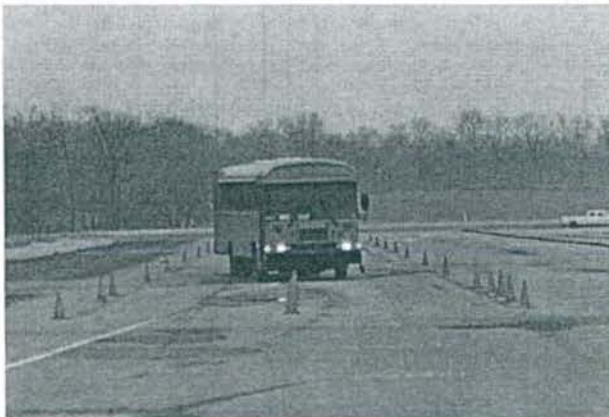
LEFT - HAND APPROACH

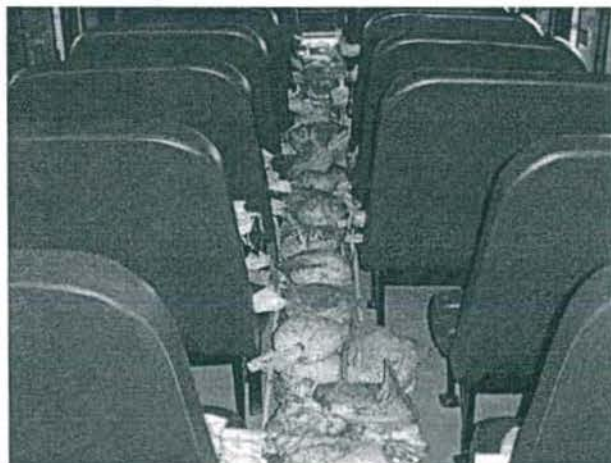
BUS LOADED TO 2.5 TIMES GVL  
(19,575 LBS)

The Shakedown Test produced a maximum final loaded deflection of 0.160 inches with a permanent set ranging between 0.001 to 0.006 inches under a distributed static load of 19,575 lbs. The Distortion Test was completed with all subsystems, doors and escape mechanisms operating properly. Water leakage was observed during the test at the 6<sup>th</sup> window on the left and leakage was also found around the frame on the right rear emergency windows.

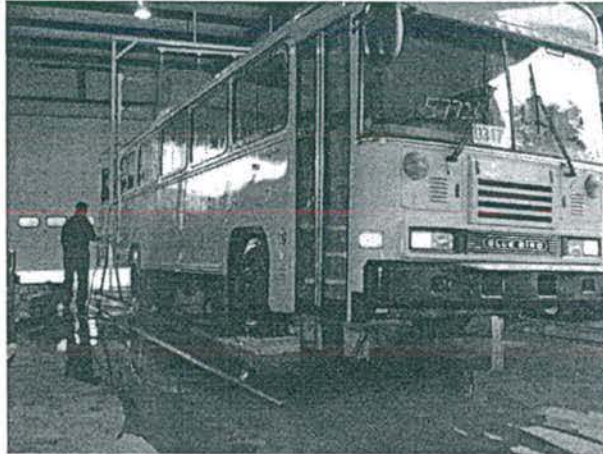
RIGHT FRONT WHEEL SIX INCHES HIGHER

All doors, windows, escape mechanisms, engine, steering and handicapped devices operated normally throughout the test. The undercarriage and body indicated no deficiencies. Water leakage was observed during the test at the 6<sup>th</sup> window on the left and the right rear emergency windows are leaking around the frame. The results of this test are indicated on the following data forms.

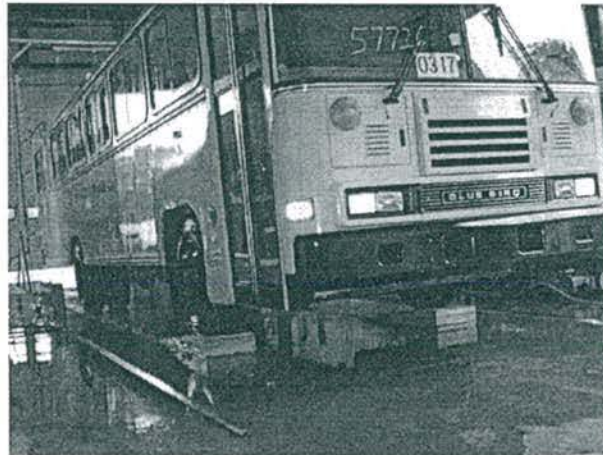
RIGHT REAR WHEEL SIX INCHES LOWER

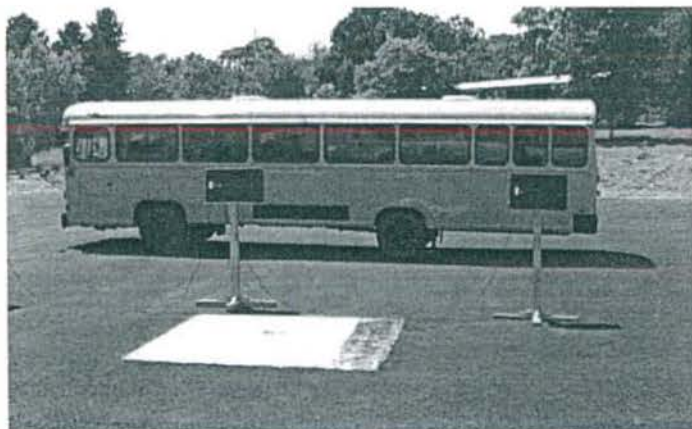
TEST BUS SET-UP FOR 80 dB(A)  
INTERIOR NOISE TEST
