Statement before the Board of Zoning Adjustment April 5, 2005

BZA Appeal No. 17285

4825 Dexter Terrace, N.W. Square 1381, Lot 806

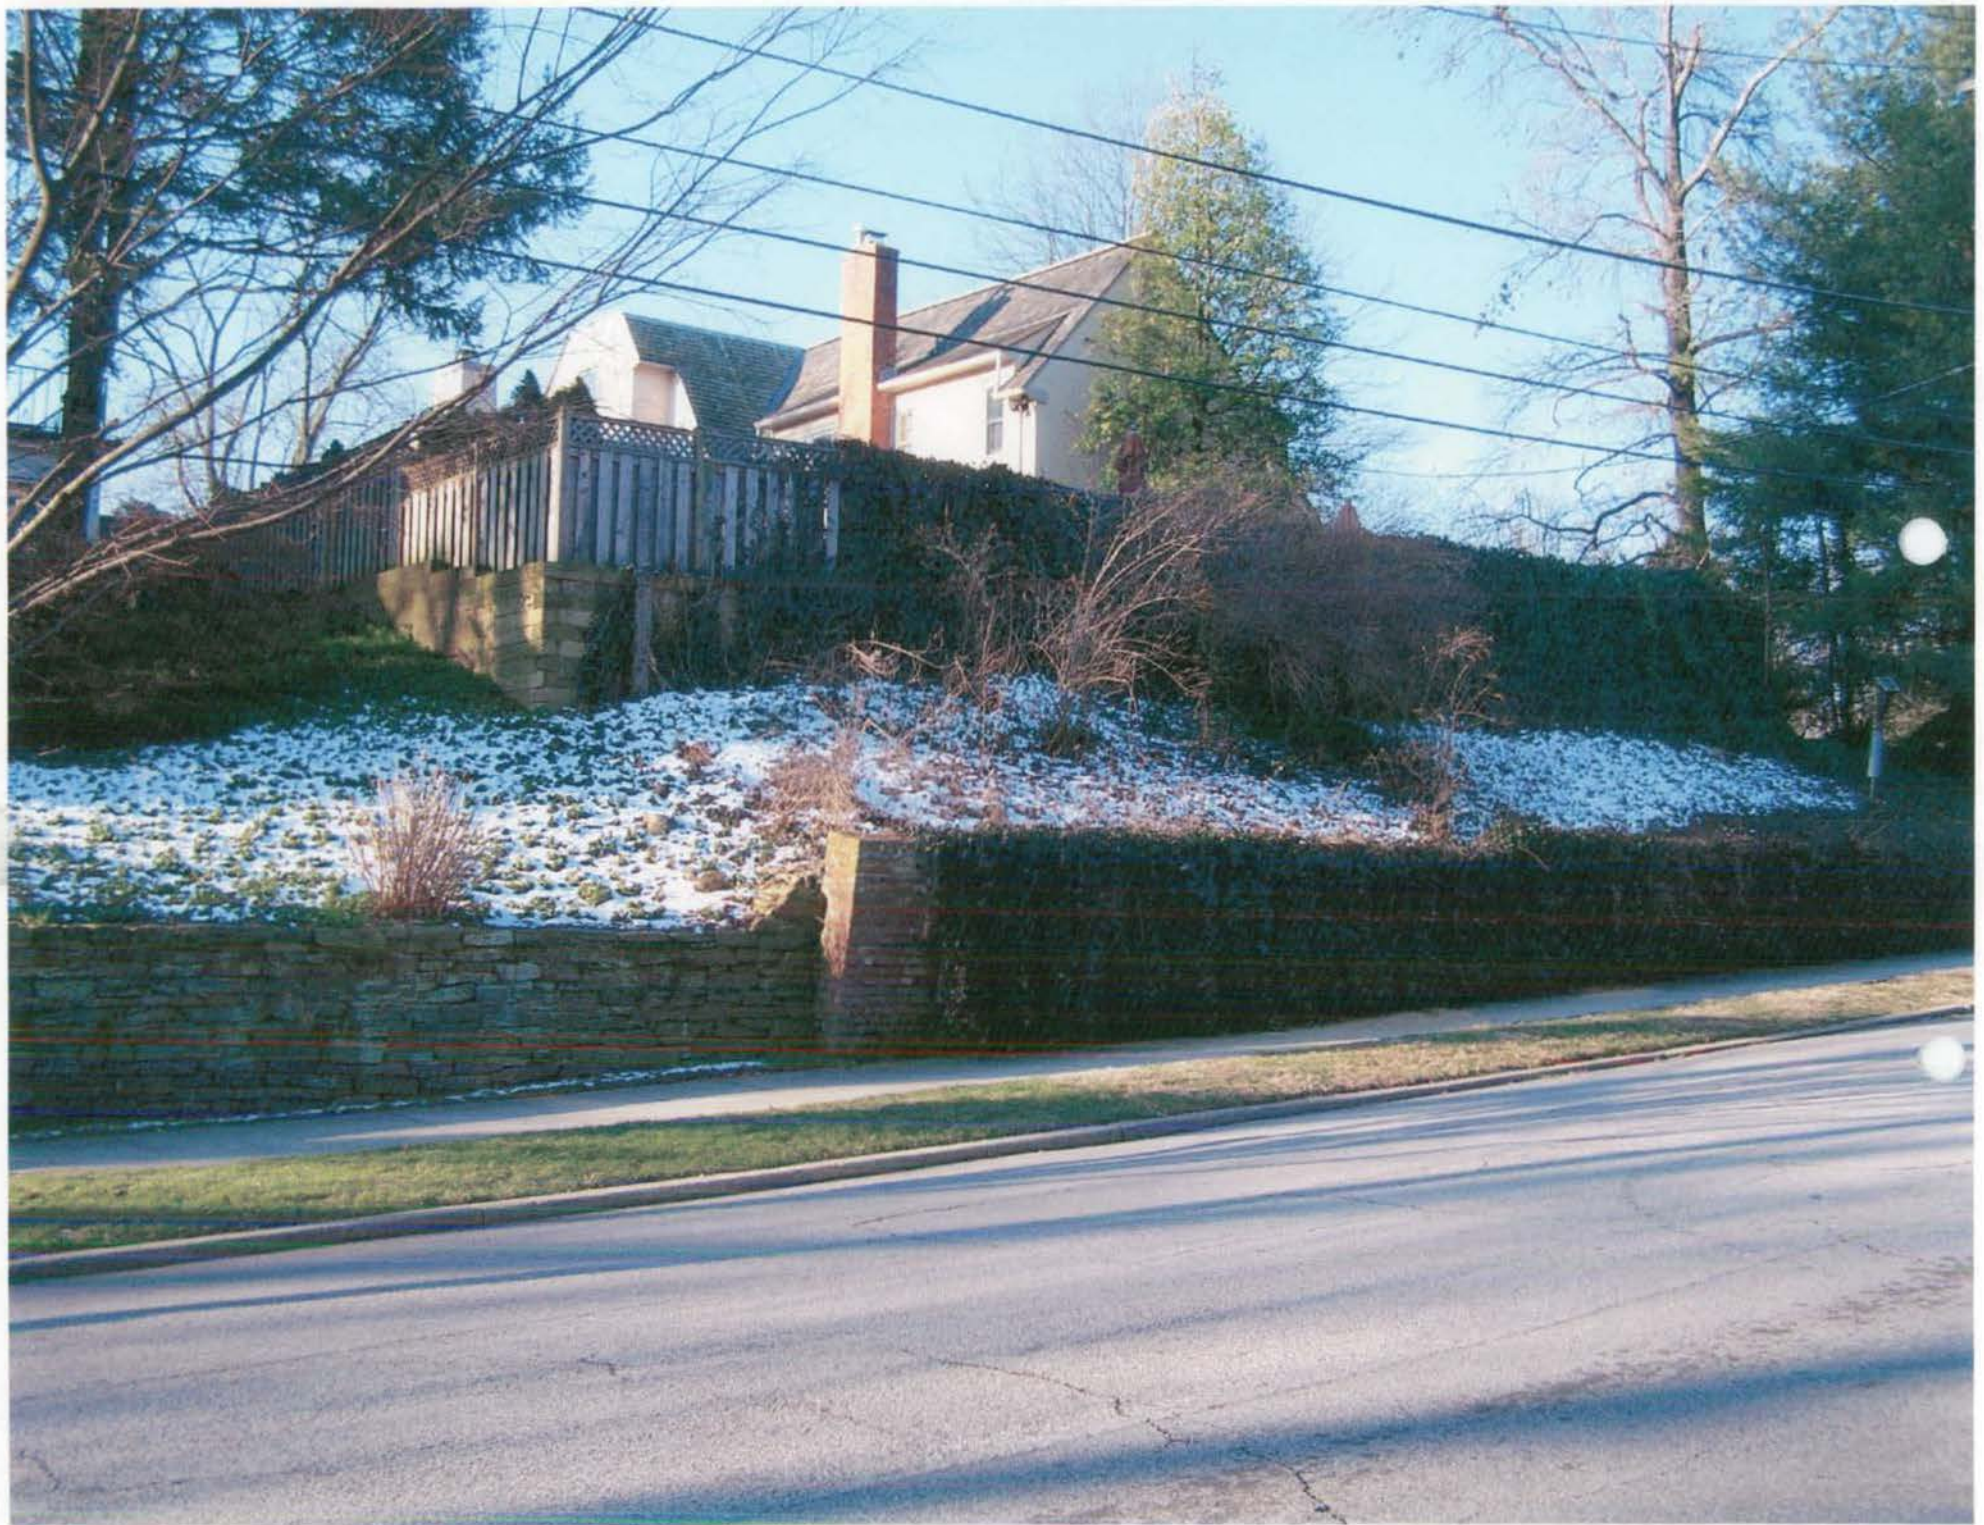
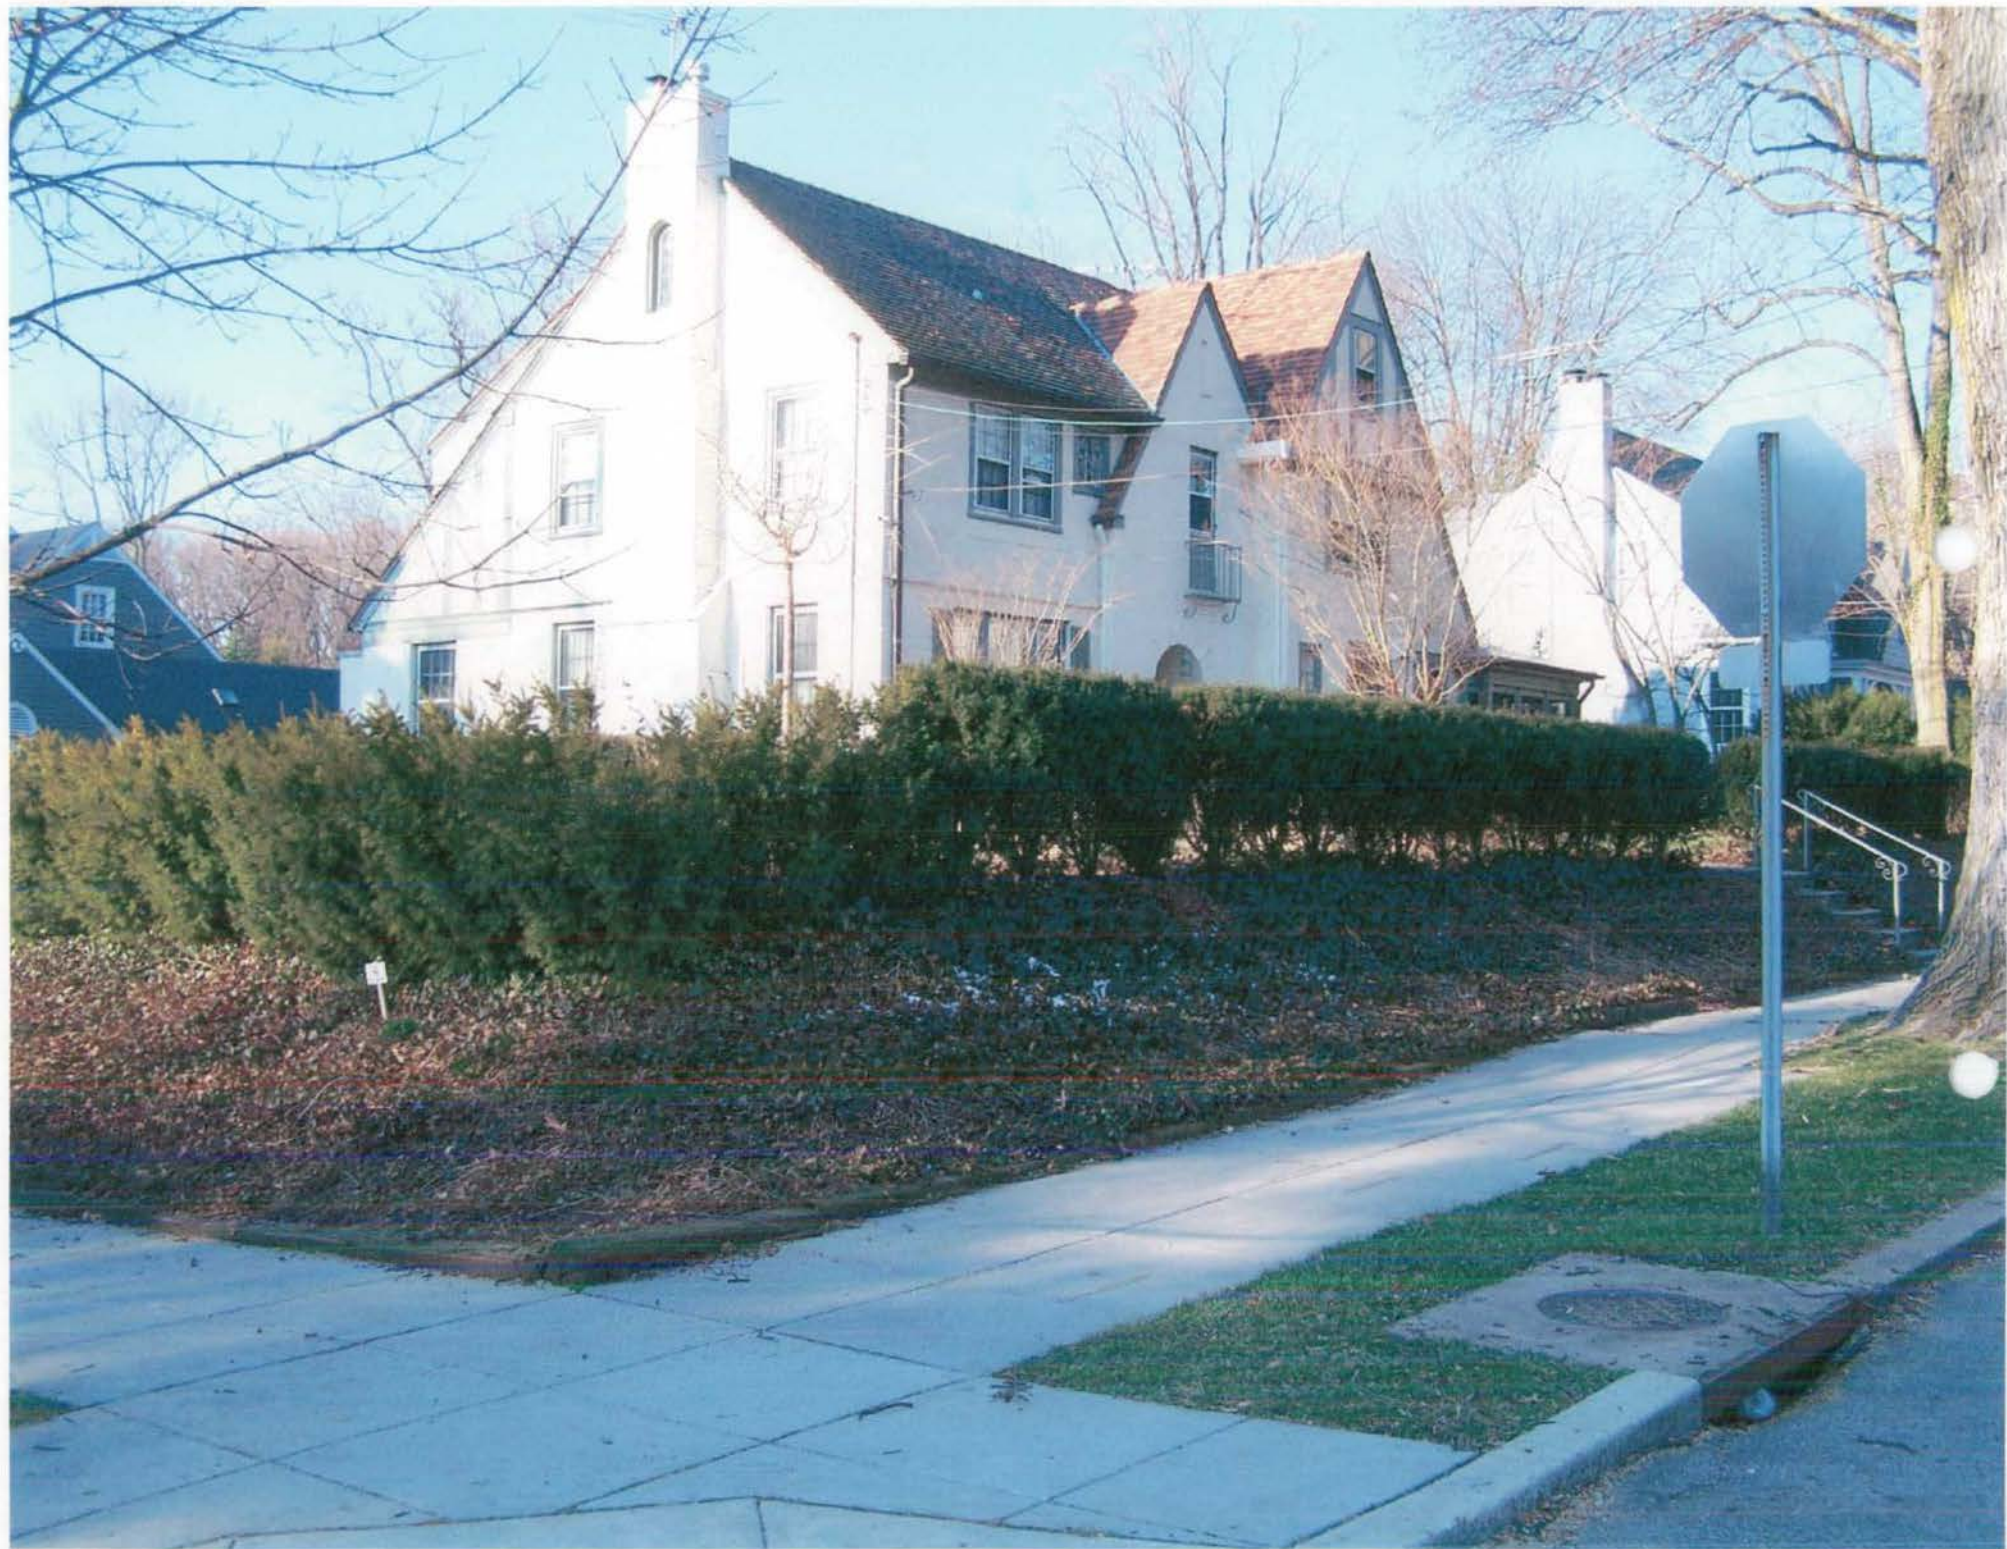
Two photographs that I took of Wesley Heights slopes in lots at the intersection of 44<sup>th</sup> and Hawthorne Streets in early morning, Thursday, March 10, graphically illustrate that effect. A light snow had fallen the day before and snow still covered almost all of the north-facing slope beneath a modest four-foot-high retaining wall and wood fence at 2927 44<sup>th</sup> Street. In contrast, in front of the house immediately across 44th Street at 4400 Hawthorne Street, where there is no wall below the yew hedge, only a smidgen of snow persists. This shading effect is even greater under the 30-foot wall at 4825 Dexter Terrace during the winter and early spring.

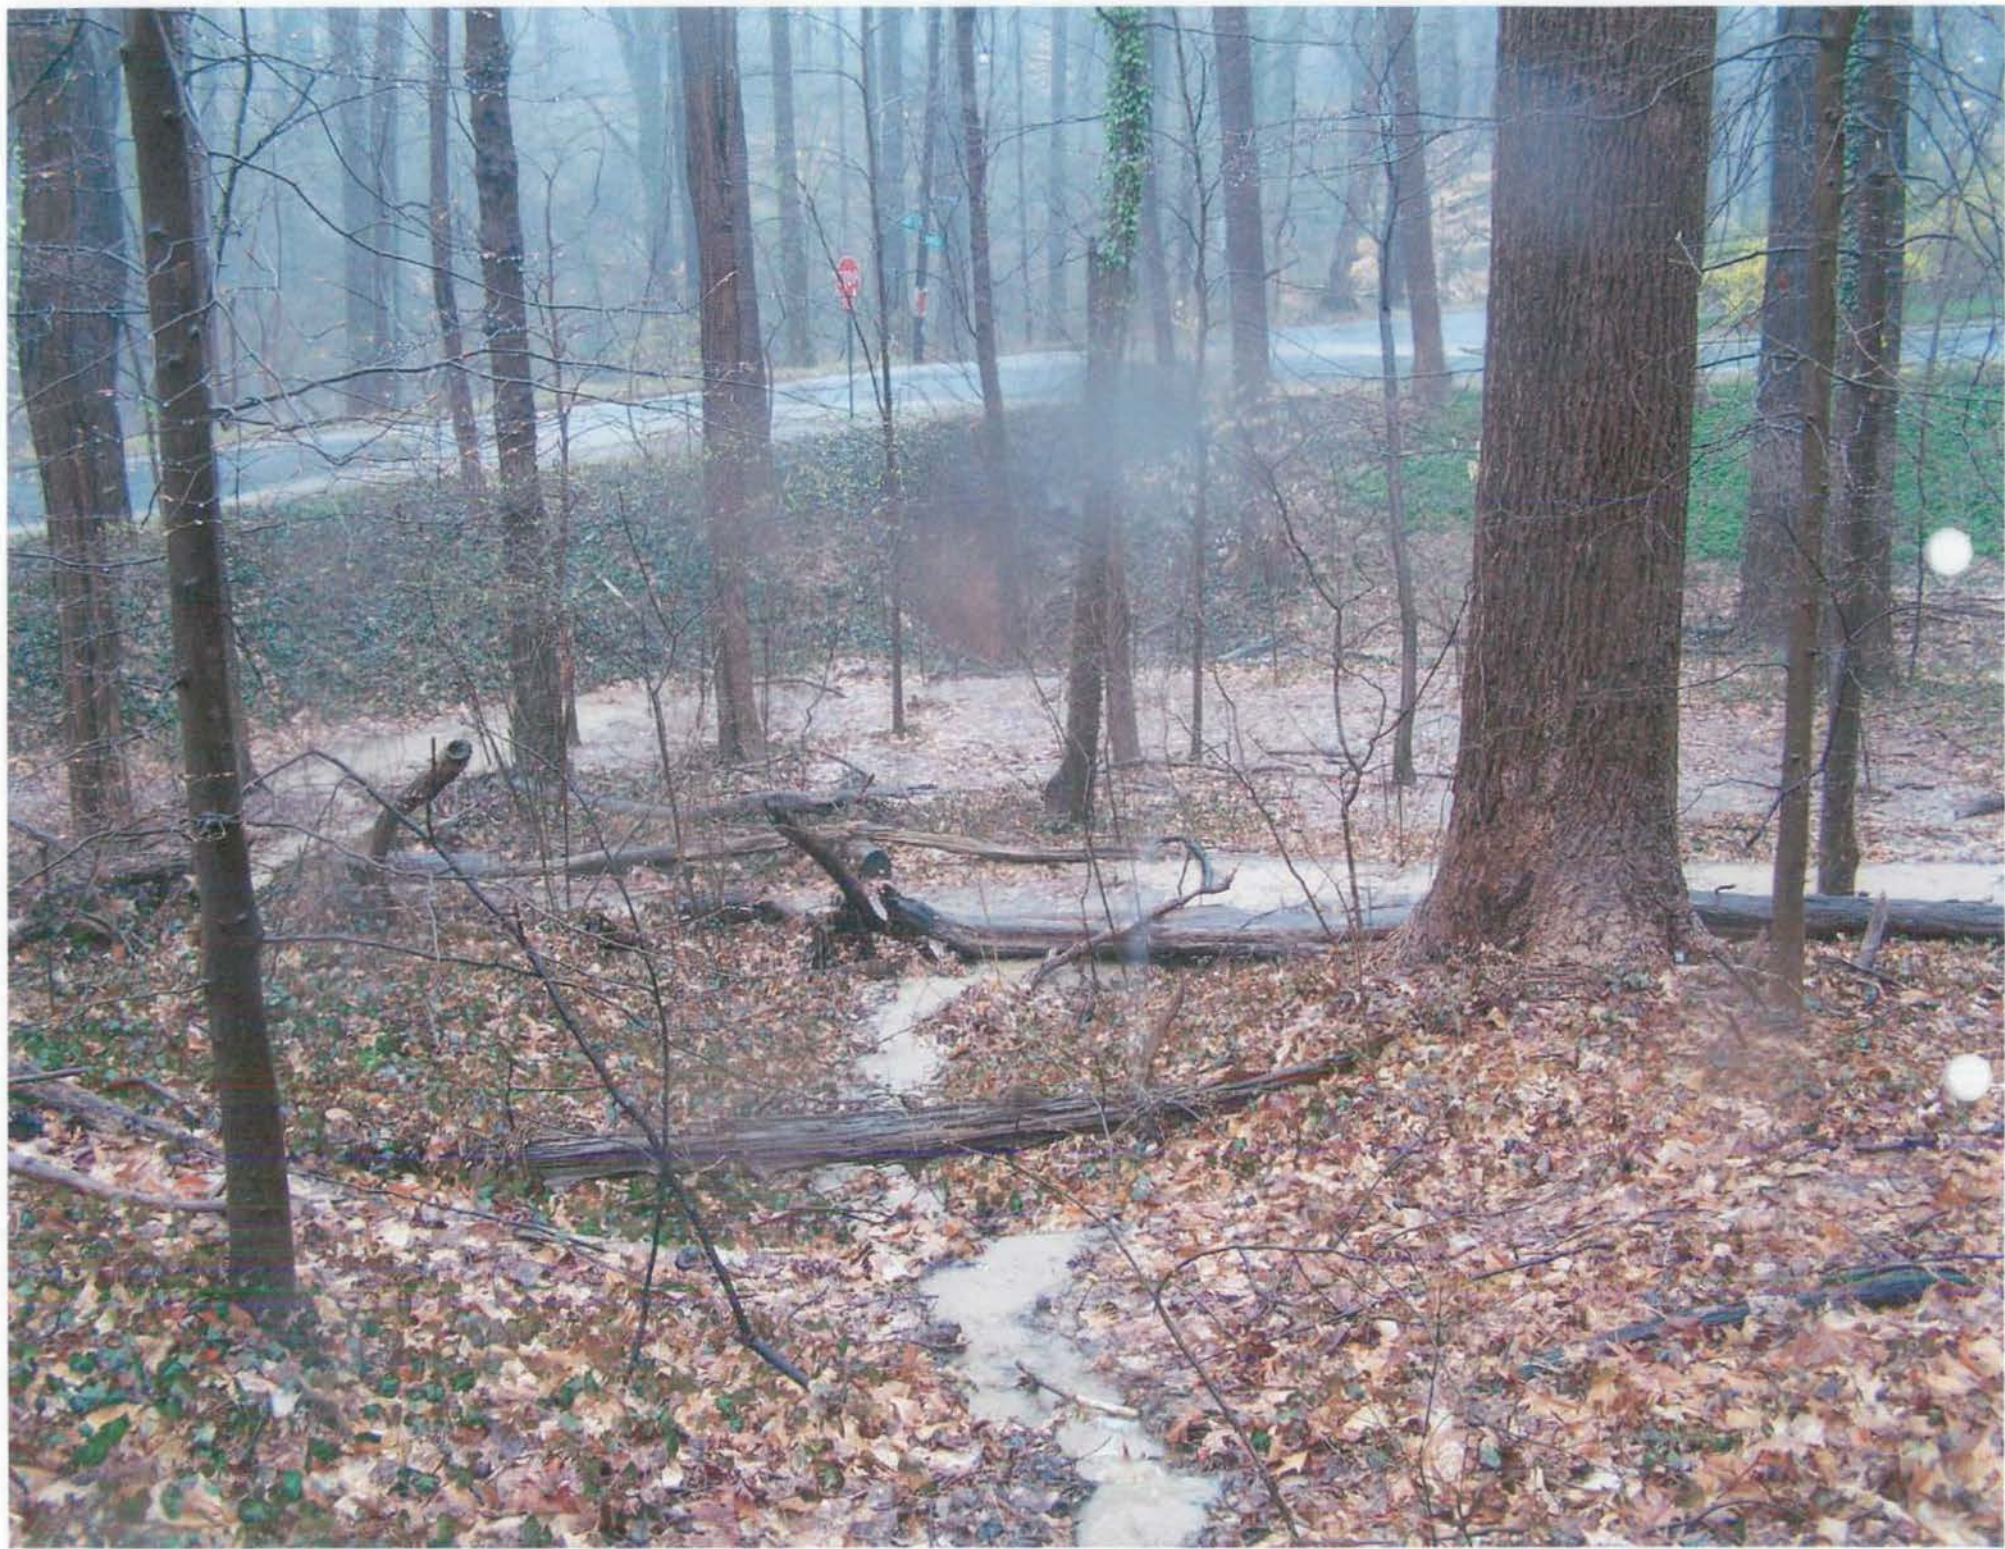
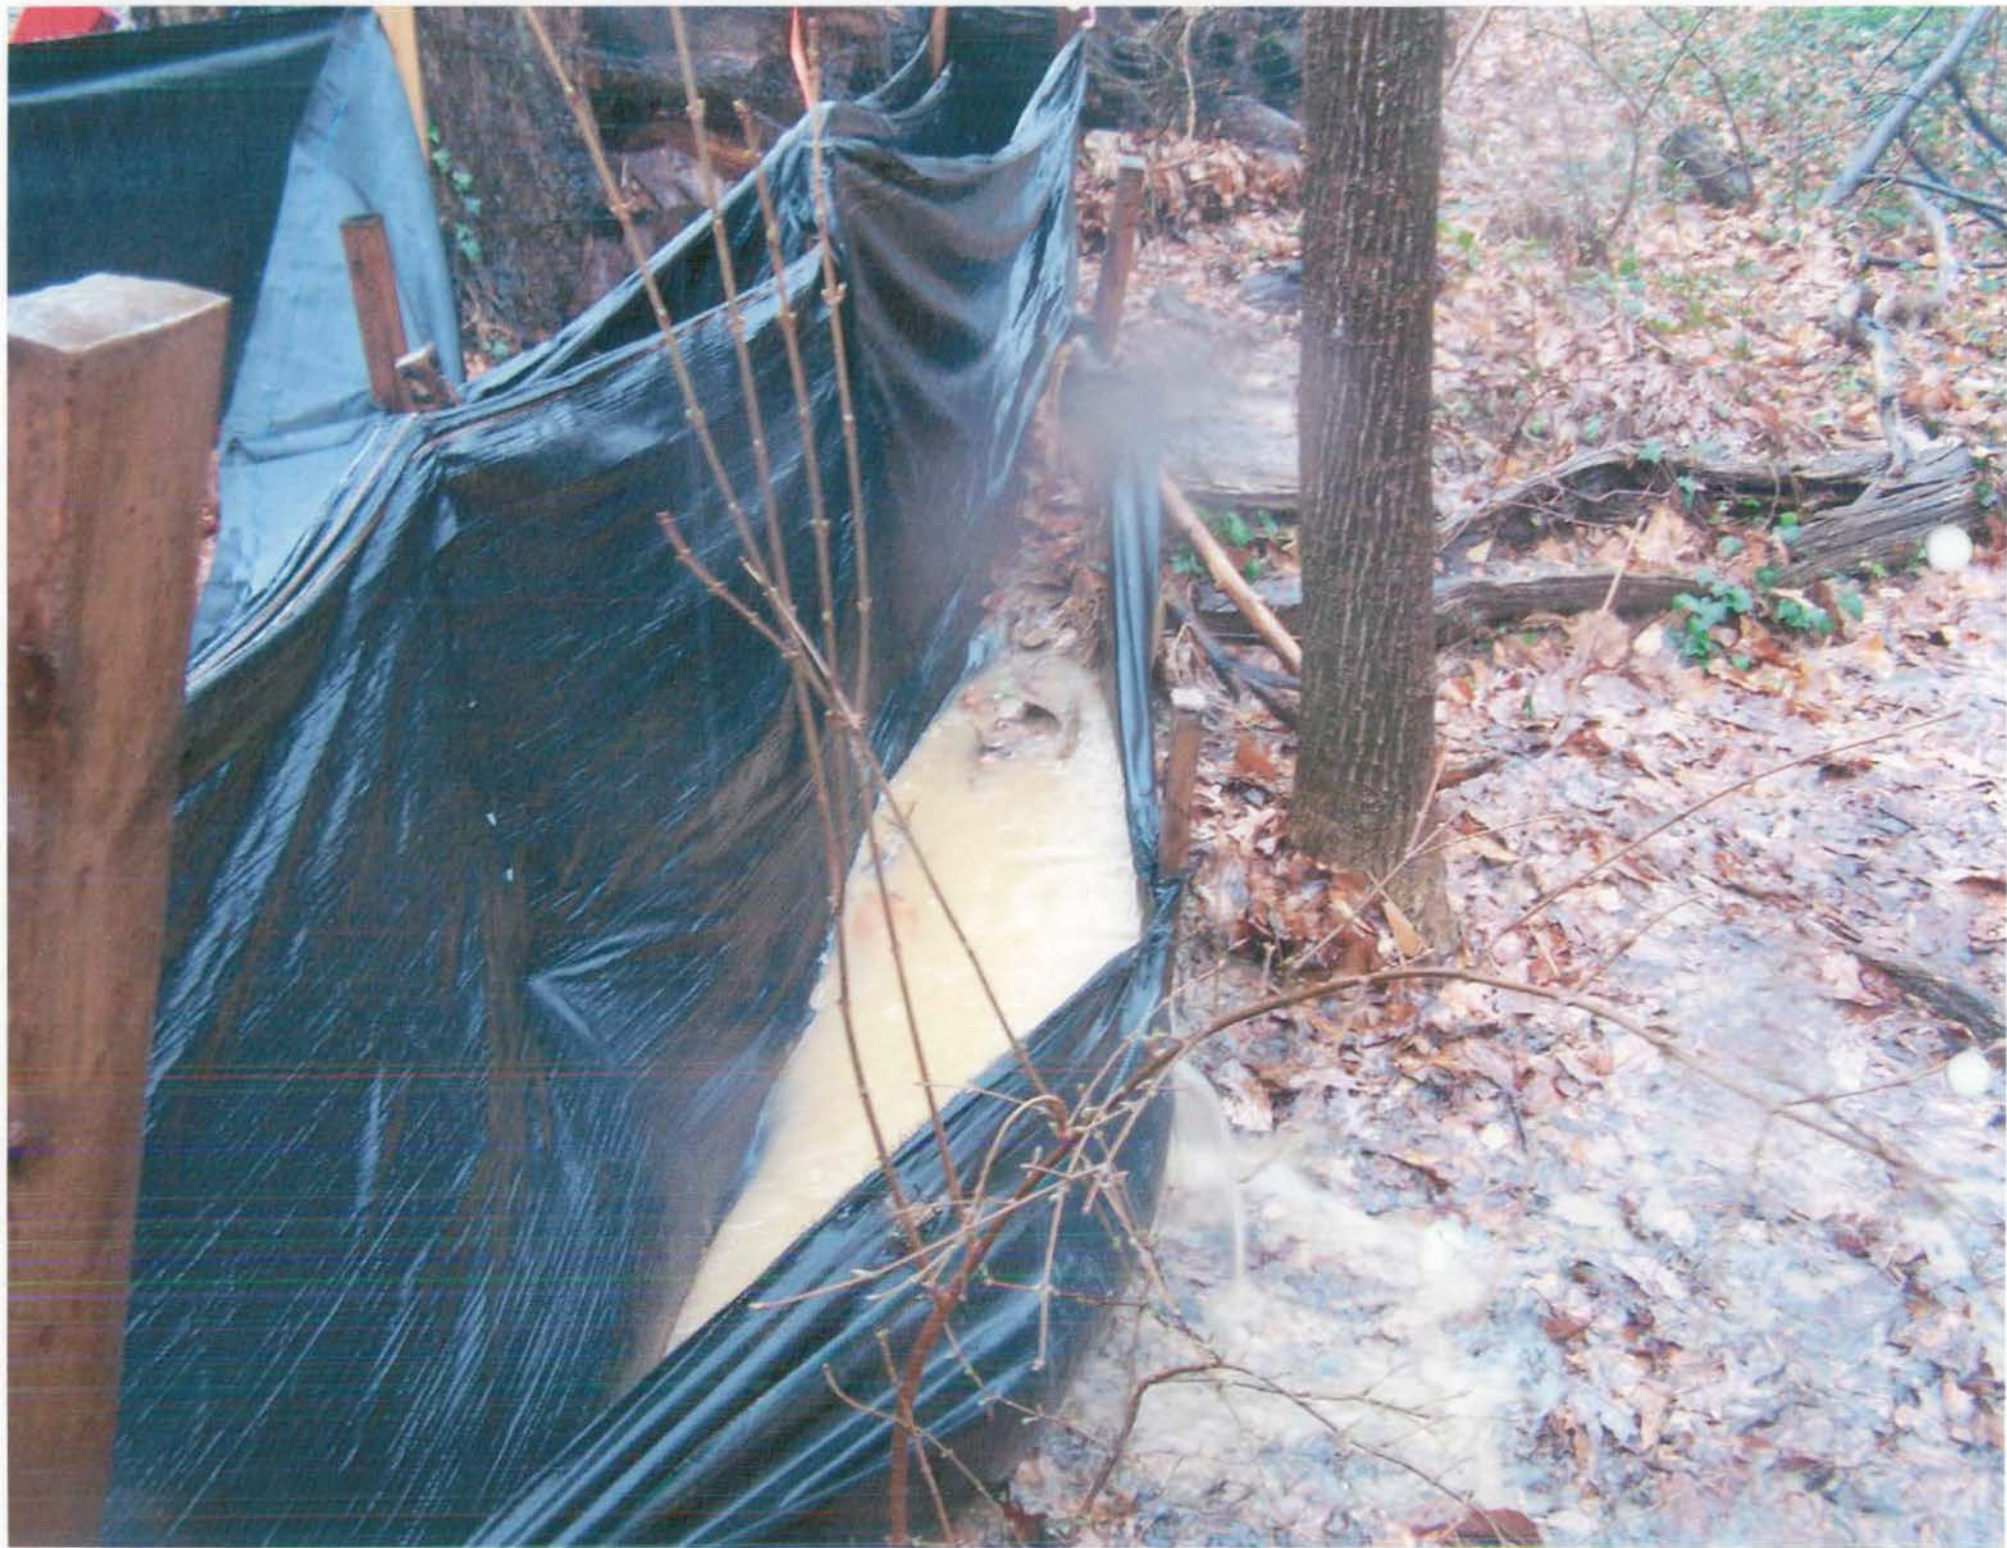
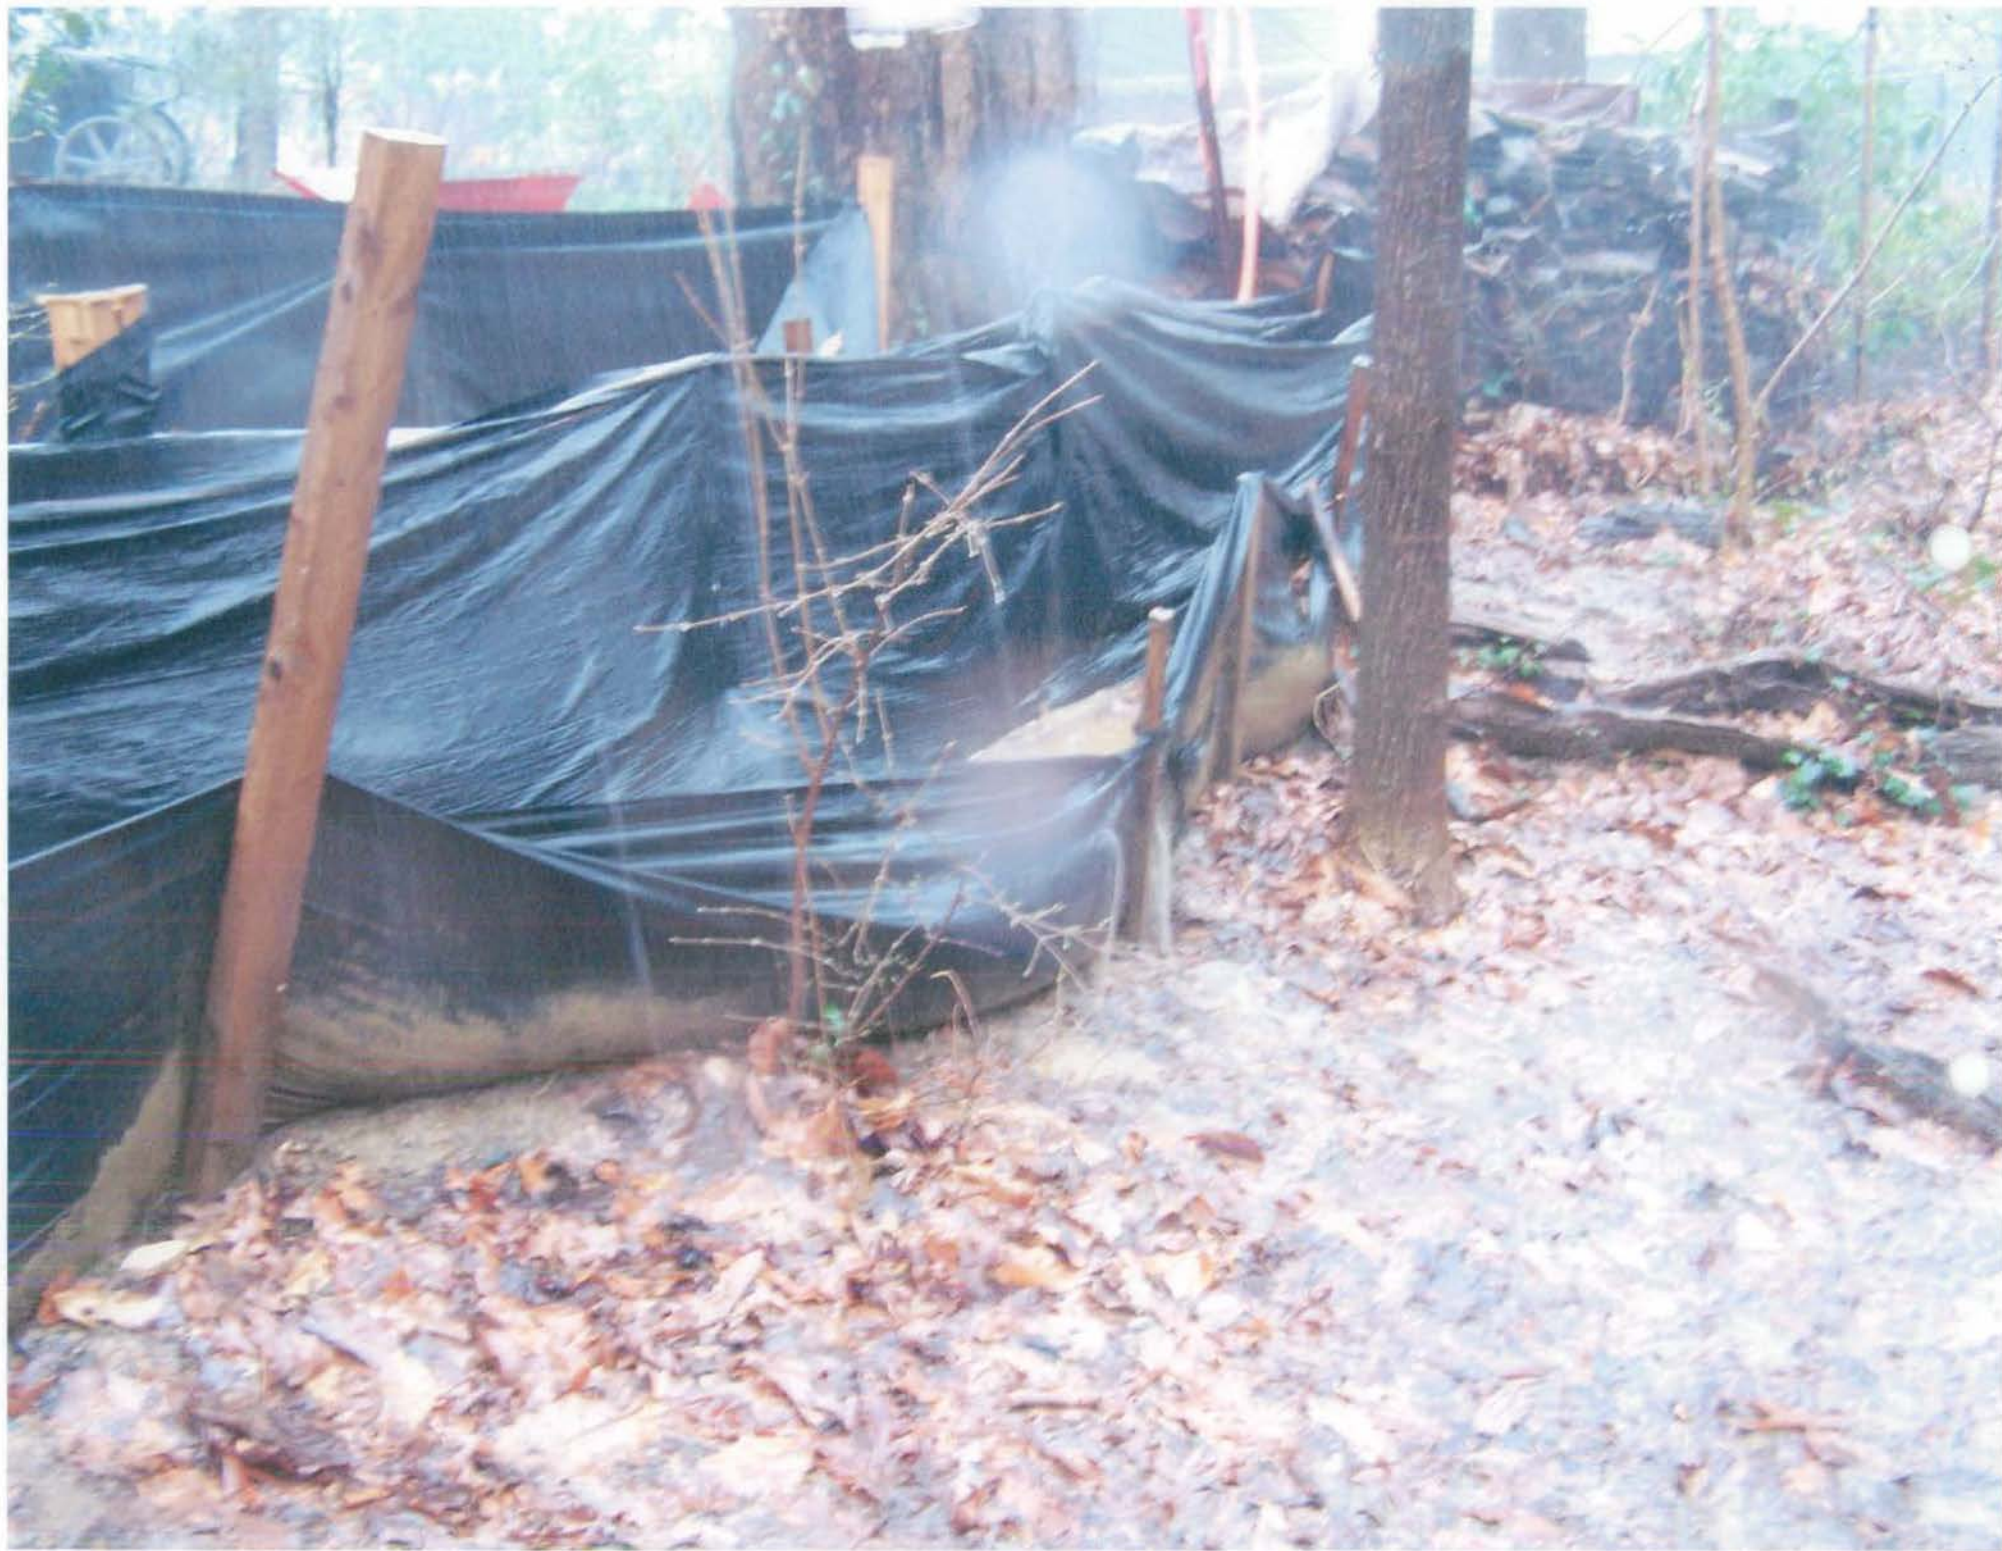
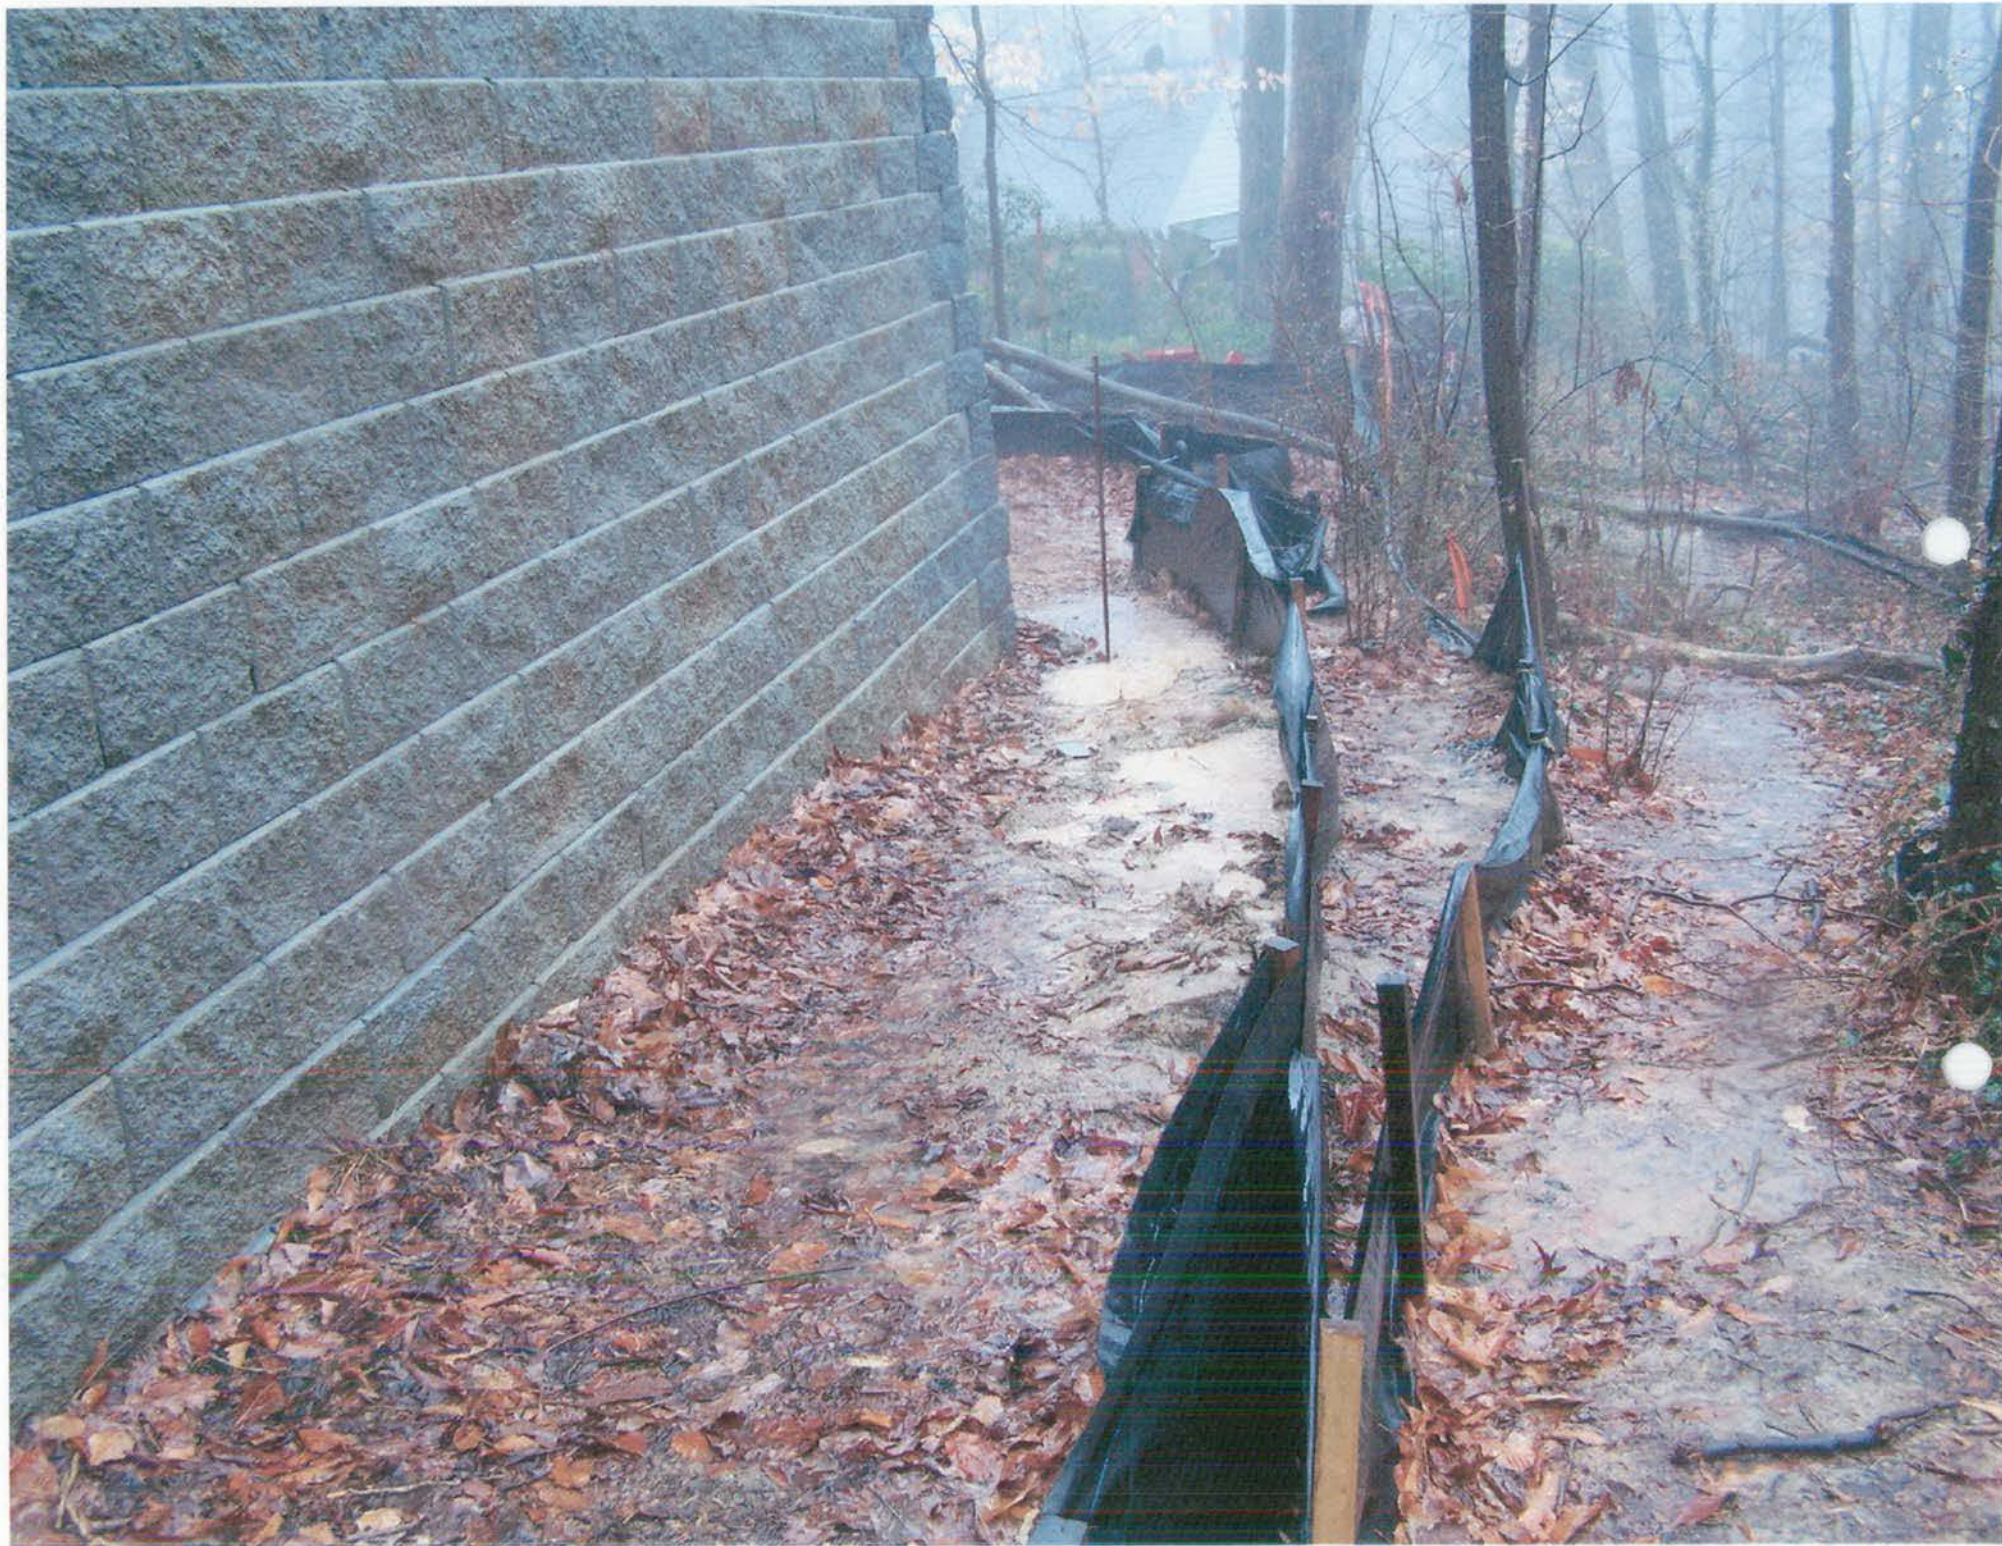
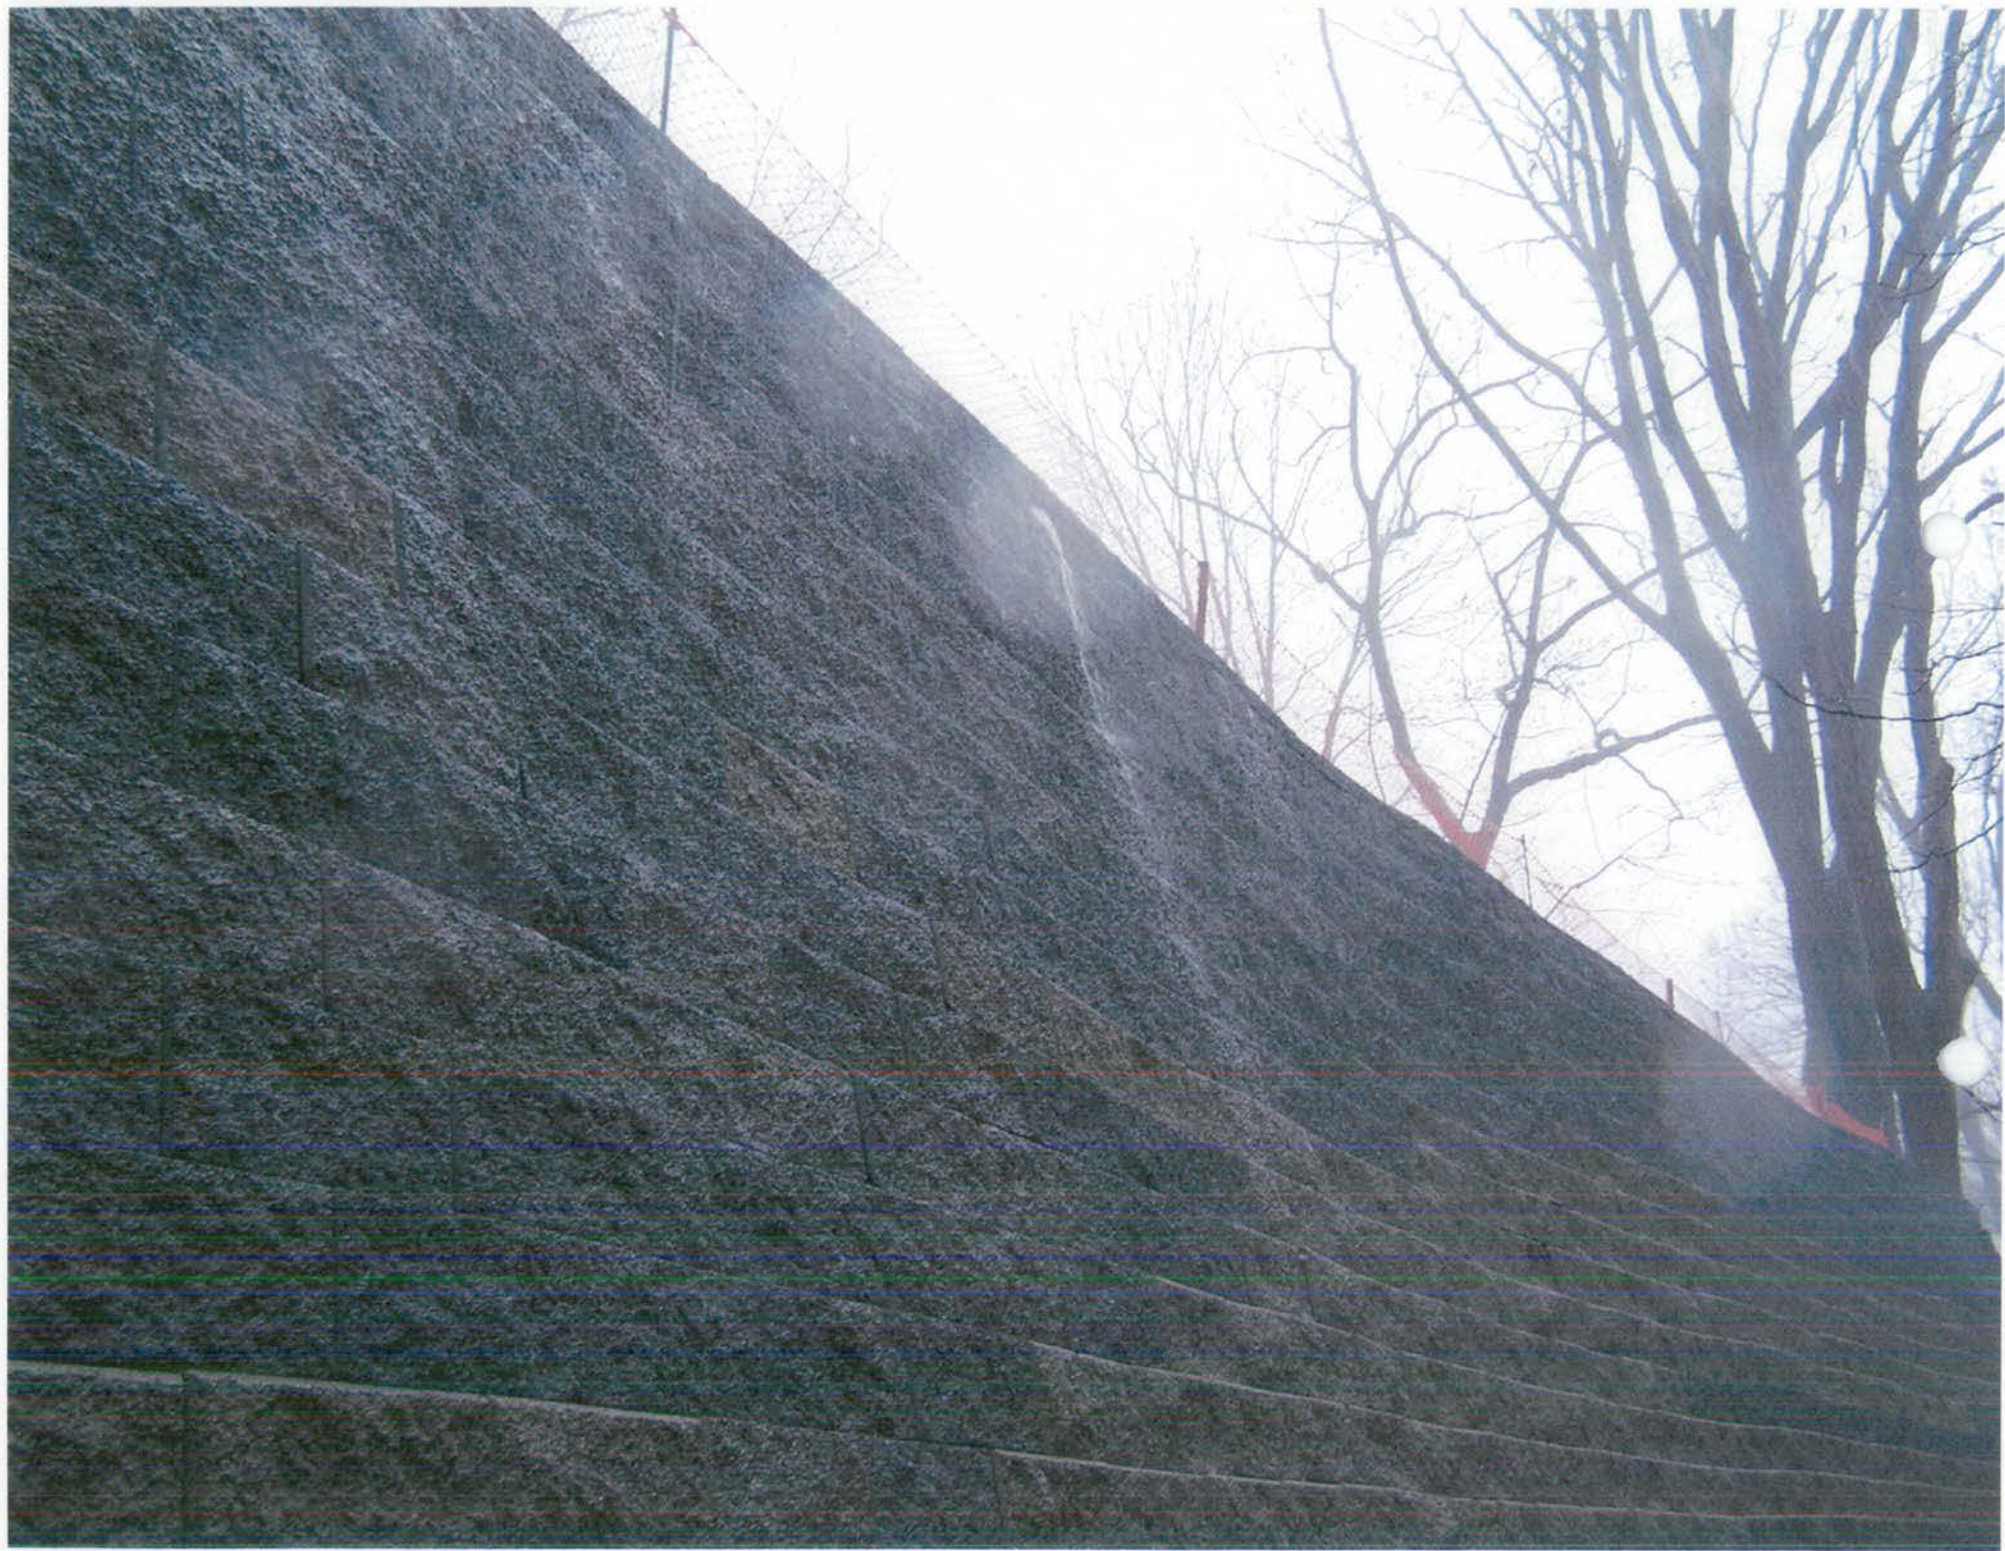
Patrick Carome has already alluded to the water runoff from beneath the wall. I visited the area with Mrs Alma Gates in the late afternoon Friday, April 1, during a rainy deluge and observed the muddy runoff and puddling running down to the stream bed in Acclimation Park and leading toward a culvert under 49<sup>th</sup> Street that feeds into the Battery Kemble Park stream. The opening to the culvert was plugged up with debris, mud and a stainless steel beer keg. As we watched, however, the dam broke and muddy water washed through an eroding opening around the culvert. It was raining so hard that I did not have my camera with me for documentation. The next days, on Saturday, April 2, I did have my camera when we had another flood warning in DC. Those photographs demonstrate the only slightly less fierce runoff through and beneath the wall.
