## SWM & Utility Installation Plan

### Chain Bridge Road Project

Square 1425 Lot 827, Parcels 12/63, 12/293 and 12/294  
 Washington, DC

Sept. 1, 2006

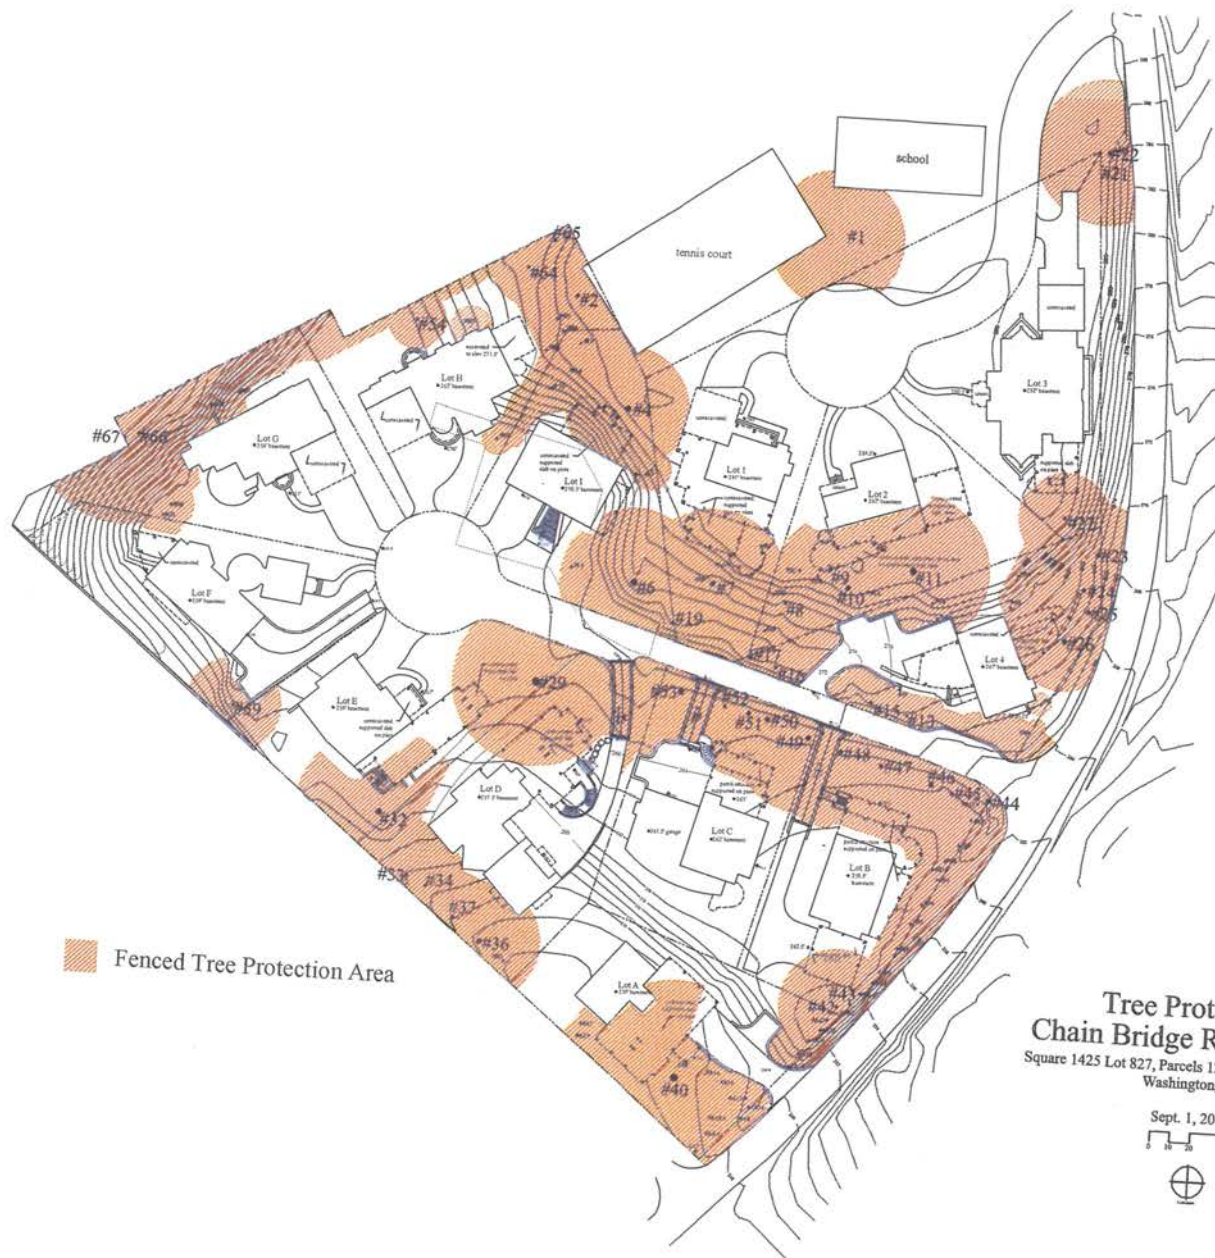
Tree Protection  
Chain Bridge Road Project  
Square 1425 Lot 827, Parcels 12/63, 12/293 and 12/294  
Washington, DC

Fenced Tree Protection Area
