Apartment + Access Stairs  
BZA Submission

ex. conditions - view from alley

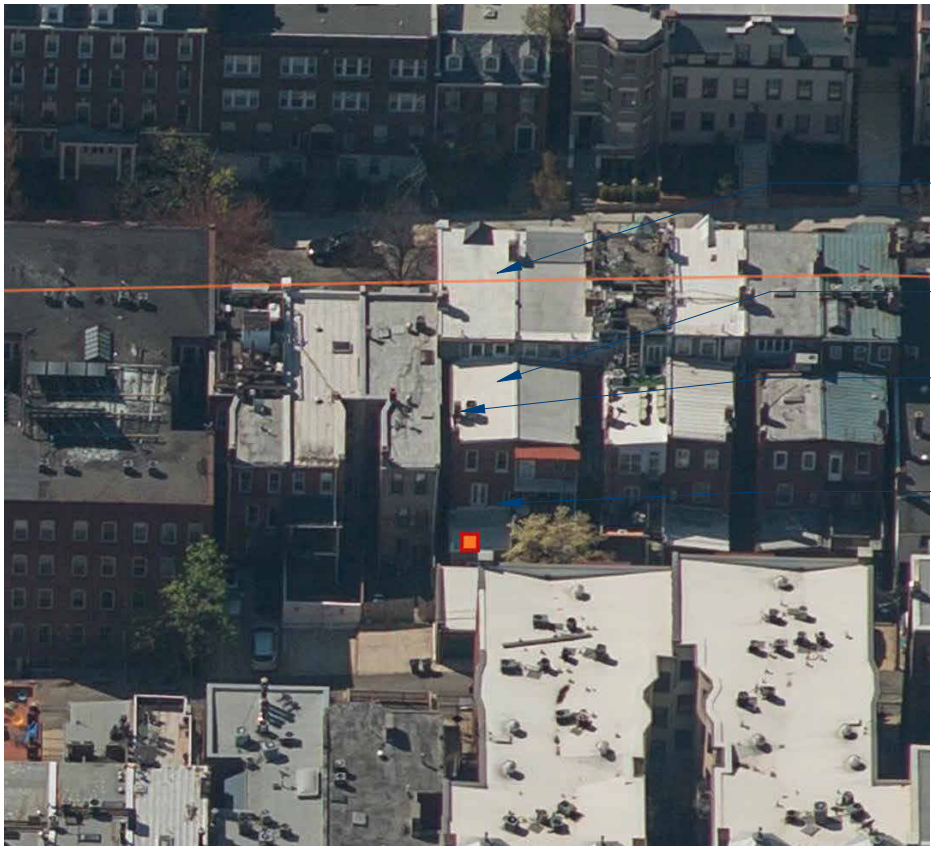
north looking south

- ex. 4th floor roof. partial demolition to accomodate code required 7'-0" ceiling heingt in habitable space (rear half)
- ex. 3rd floor roof. full demolition to accomodate new roof deck and stairs to 4th floor.
- ex. chimnies to be extended as required by code
- rear stairs and deck to third floor currently under construction. Permit #s:
  - B2010560
  - B2011432

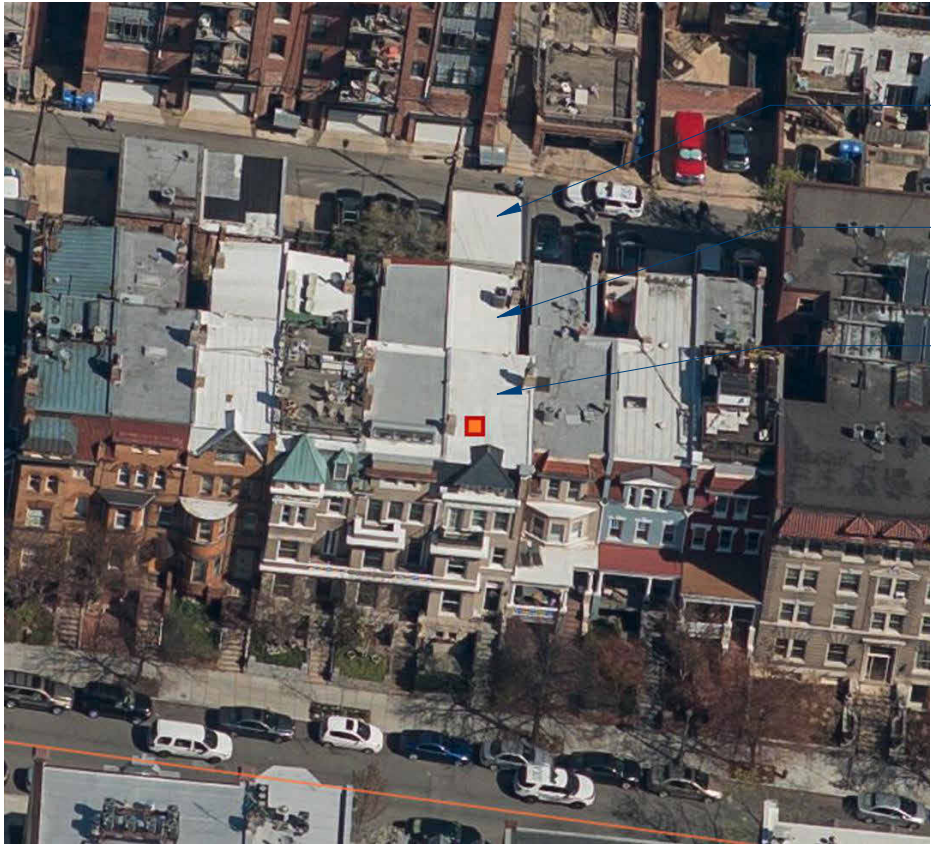
south looking north

- ex. garage, not in scope of work
- ex. 3rd floor roof. full demolition to accomodate new roof deck and stairs to 4th floor.
- ex. 4th floor roof. partial demolition to accomodate code required 7'-0" ceiling heingt in habitable space (rear half)
