JOHN BURROUGHS ELEMENTARY SCHOOL

BOARD OF ZONING ADJUSTMENT

APRIL 14, 2025

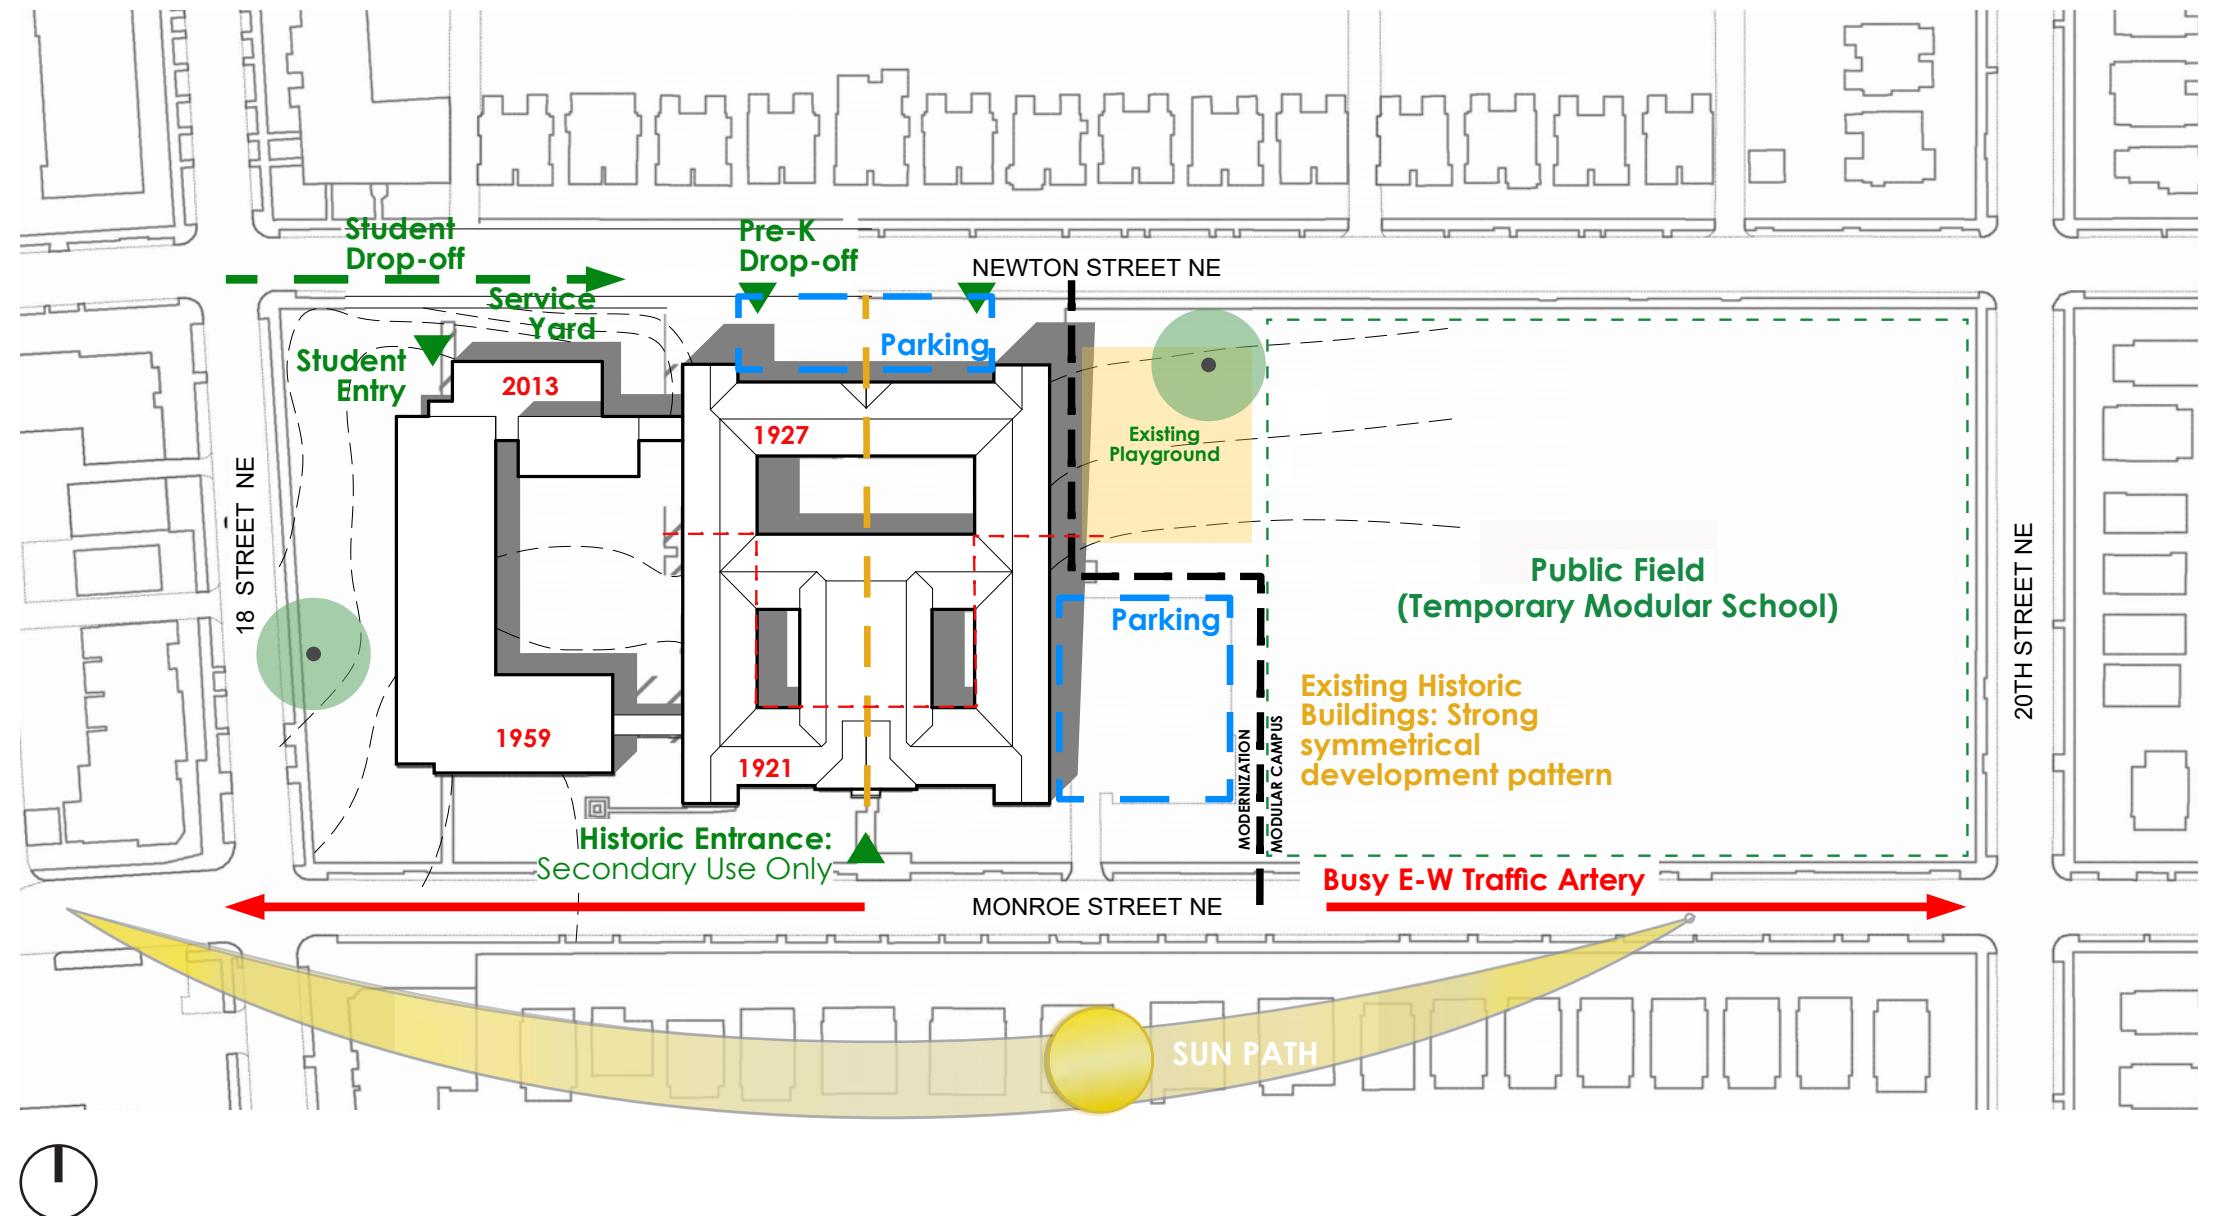
Existing Site Plan

- **Historic school entrance safety issues:** Monroe St. is a major traffic through-fare. School currently uses multiple doorways on Newton St for arrival/pick-up to mitigate risk.

- **Newton Street Vehicle Issues:** Teacher Parking and Loading/ Trash along Newton St present safety and aesthetic issues.
- **2 heritage trees in close proximity to the building.** Critical Root Zones significantly impact areas of potential development on the west end of the site.

- **East Constraints:** Site improvements to the East side are limited by temporary Modular School (on play field).
- **Addition Accessibility and Planning Issues:** 1950's and 2013 Additions have ADA issues. Student Dining location (2013 addition) drives the problematic service yard location.

- **Under-utilized Courtyards:** Historic building courtyards are concrete covered yards. The smaller courtyards are not used by students.
- **Strong North-South symmetrical development pattern in Historic Building:** Main Entrance, Gymnasium, the courtyards and north bay window are all on a formal NS axis.

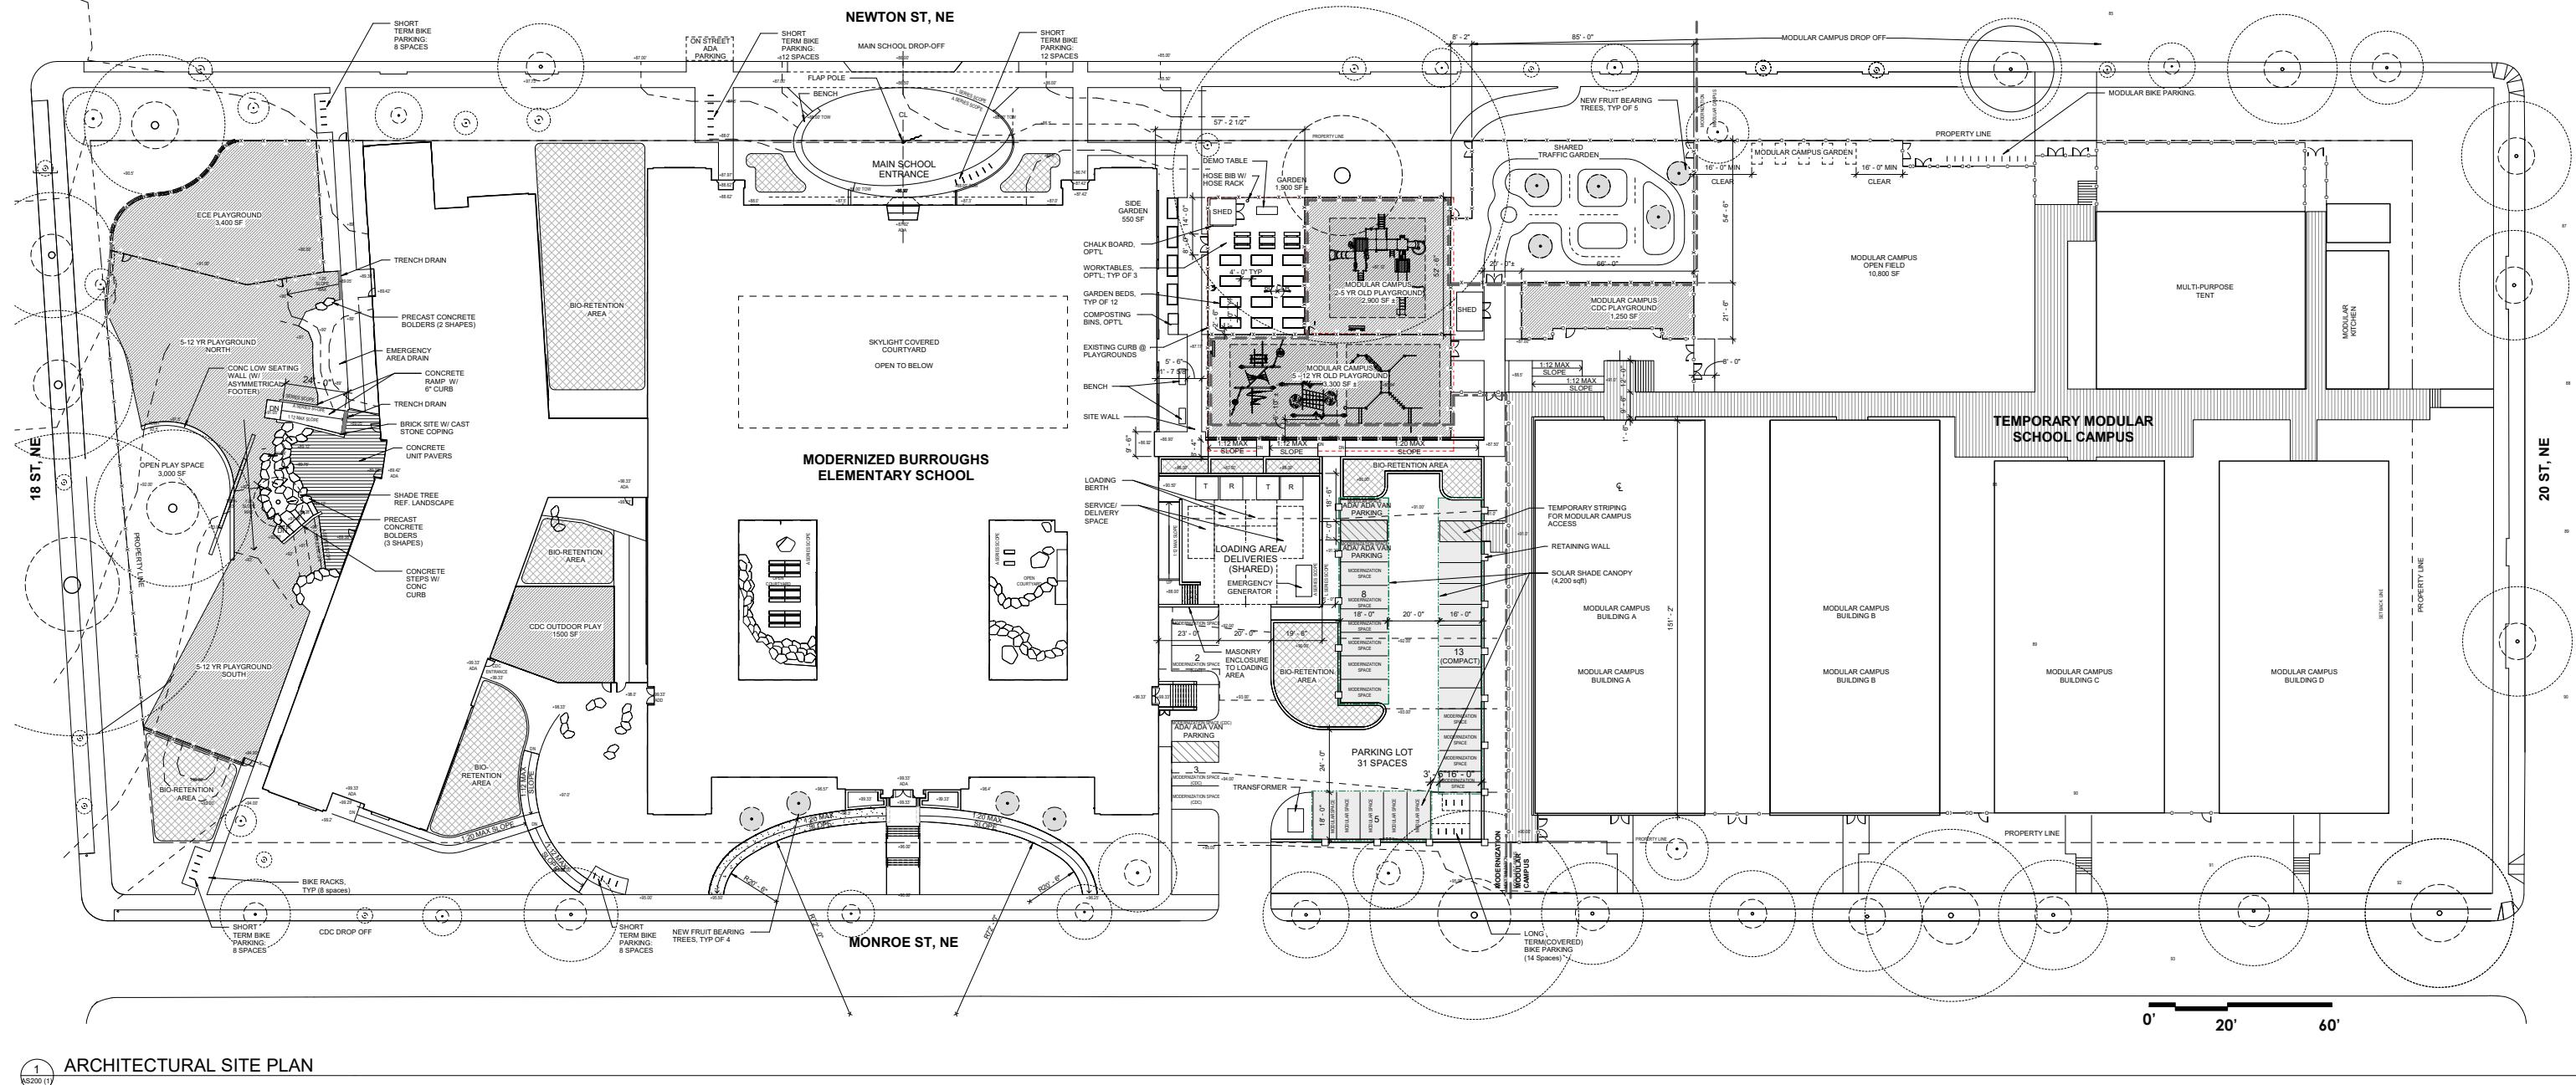
1 ARCHITECTURAL SITE PLAN

Site Plan (Modernization + Modular)
