PROPOSED DEMOLITION AND FACADE MODIFICATION LOCATIONS

CENTRAL BUILDING - MUSEUM ENTRANCE SECTION

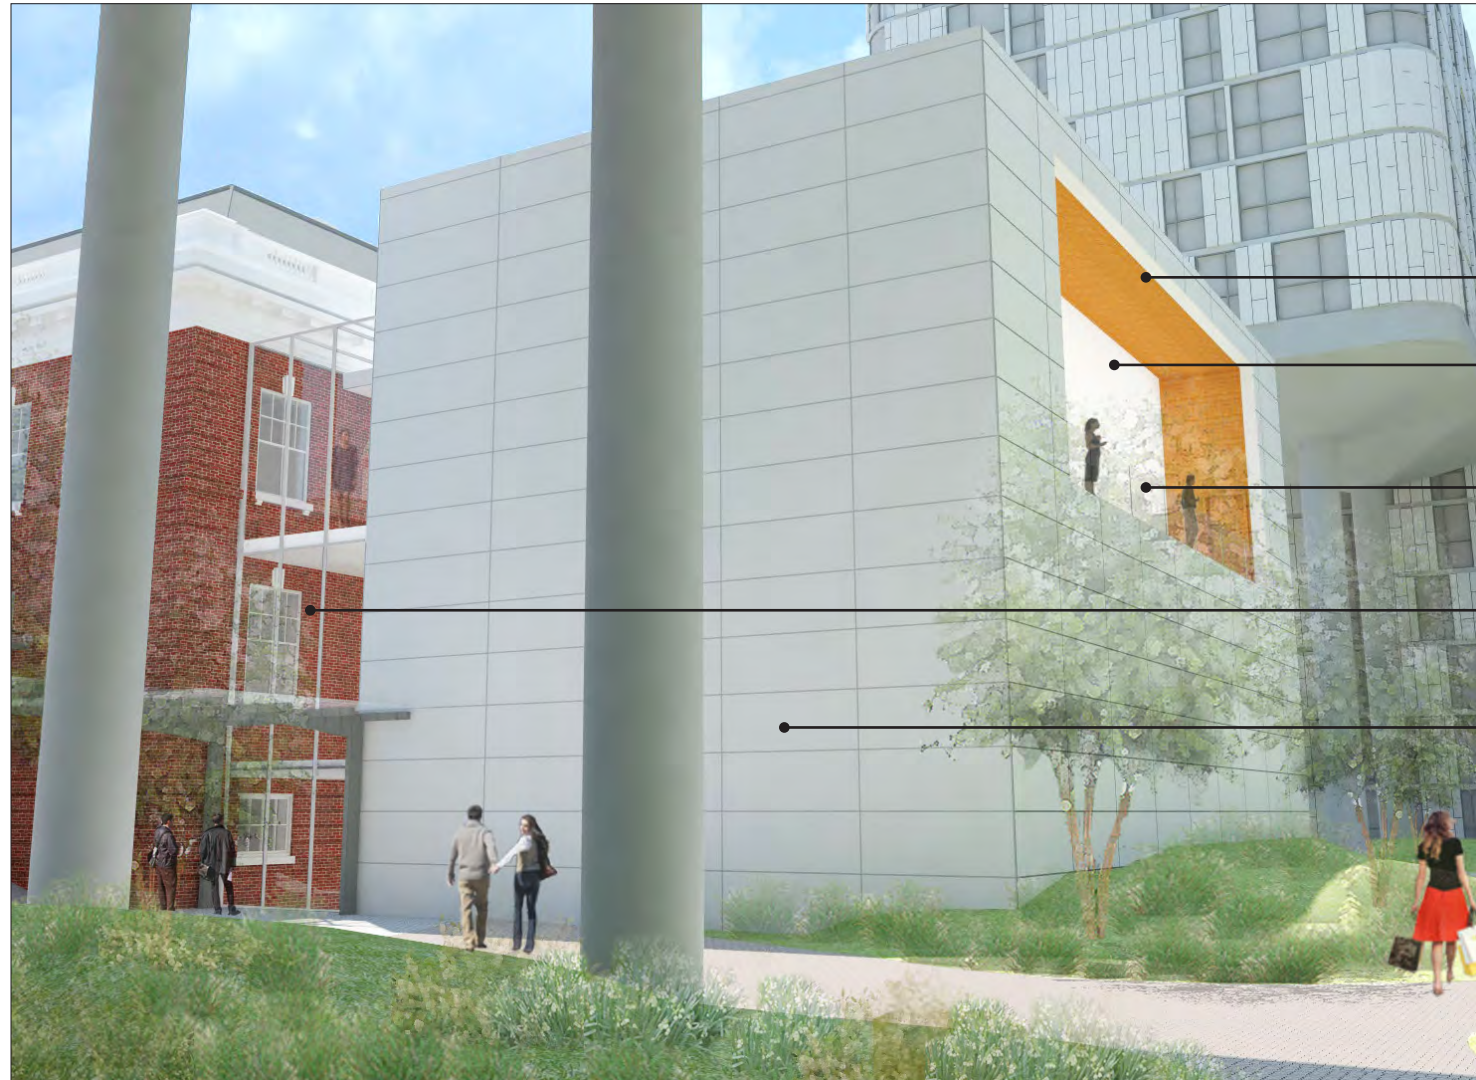
WOOD PANEL

TRANSLUCENT
MATTE GLASS

CLEAR GLASS RAILING

CLEAR GLASS

METAL PANEL

CLEAR GLASS GUARDRAIL

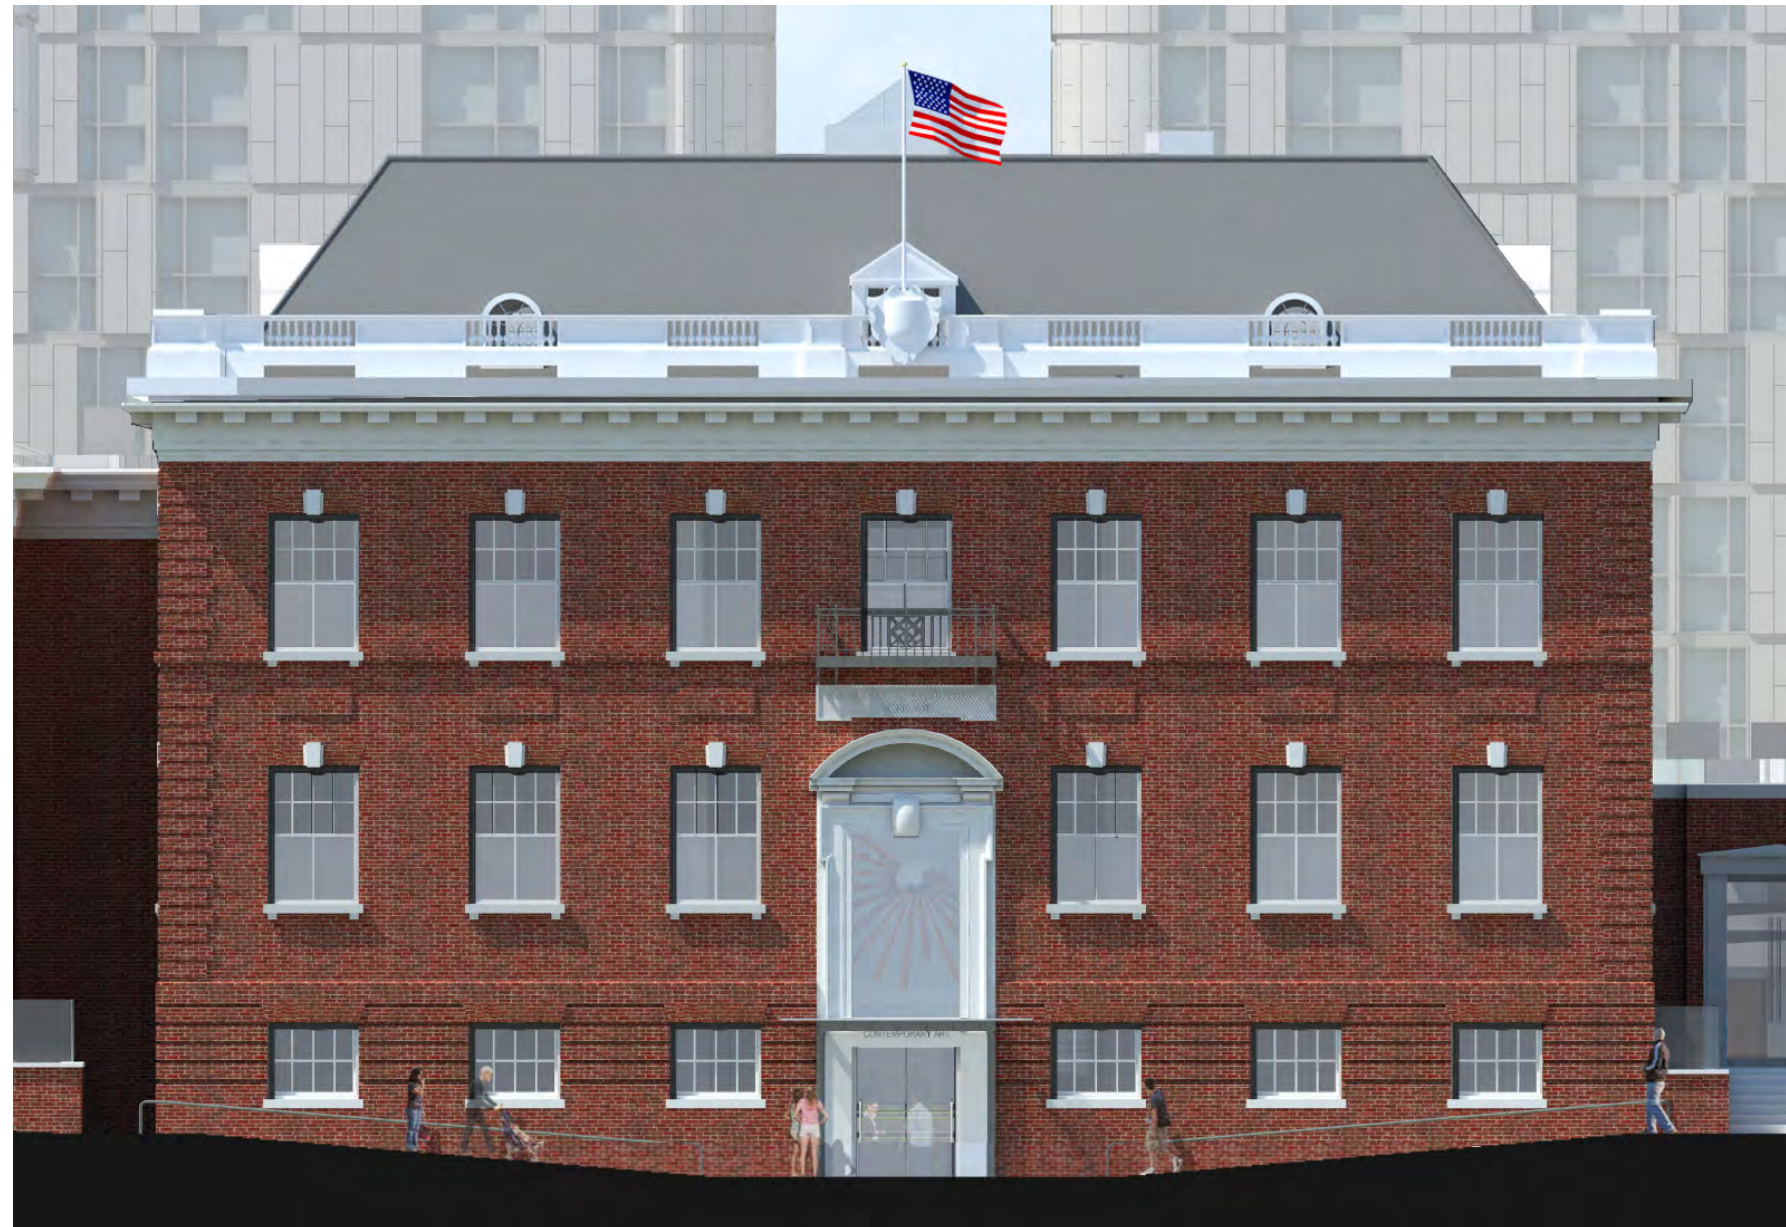
PROPOSED SOUTH ELEVATION

CENTRAL BUILDING -SOUTH ELEVATION (PROPOSED)

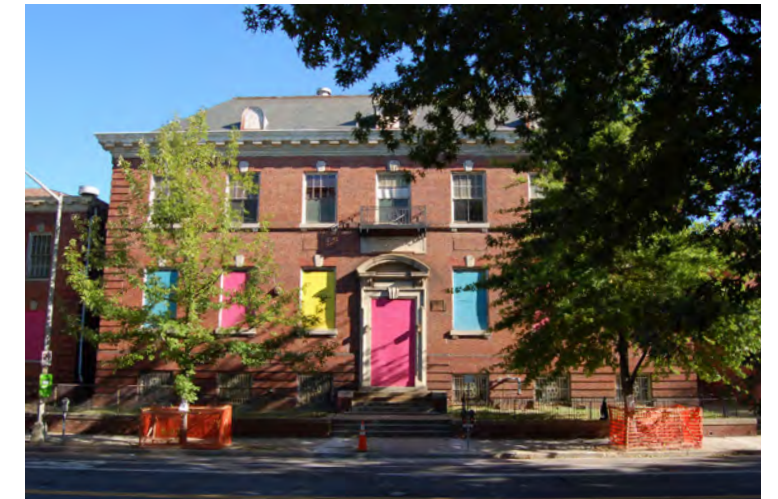
CENTRAL BUILDING - SOUTH ELEVATION (EXISTING CONDITIONS)

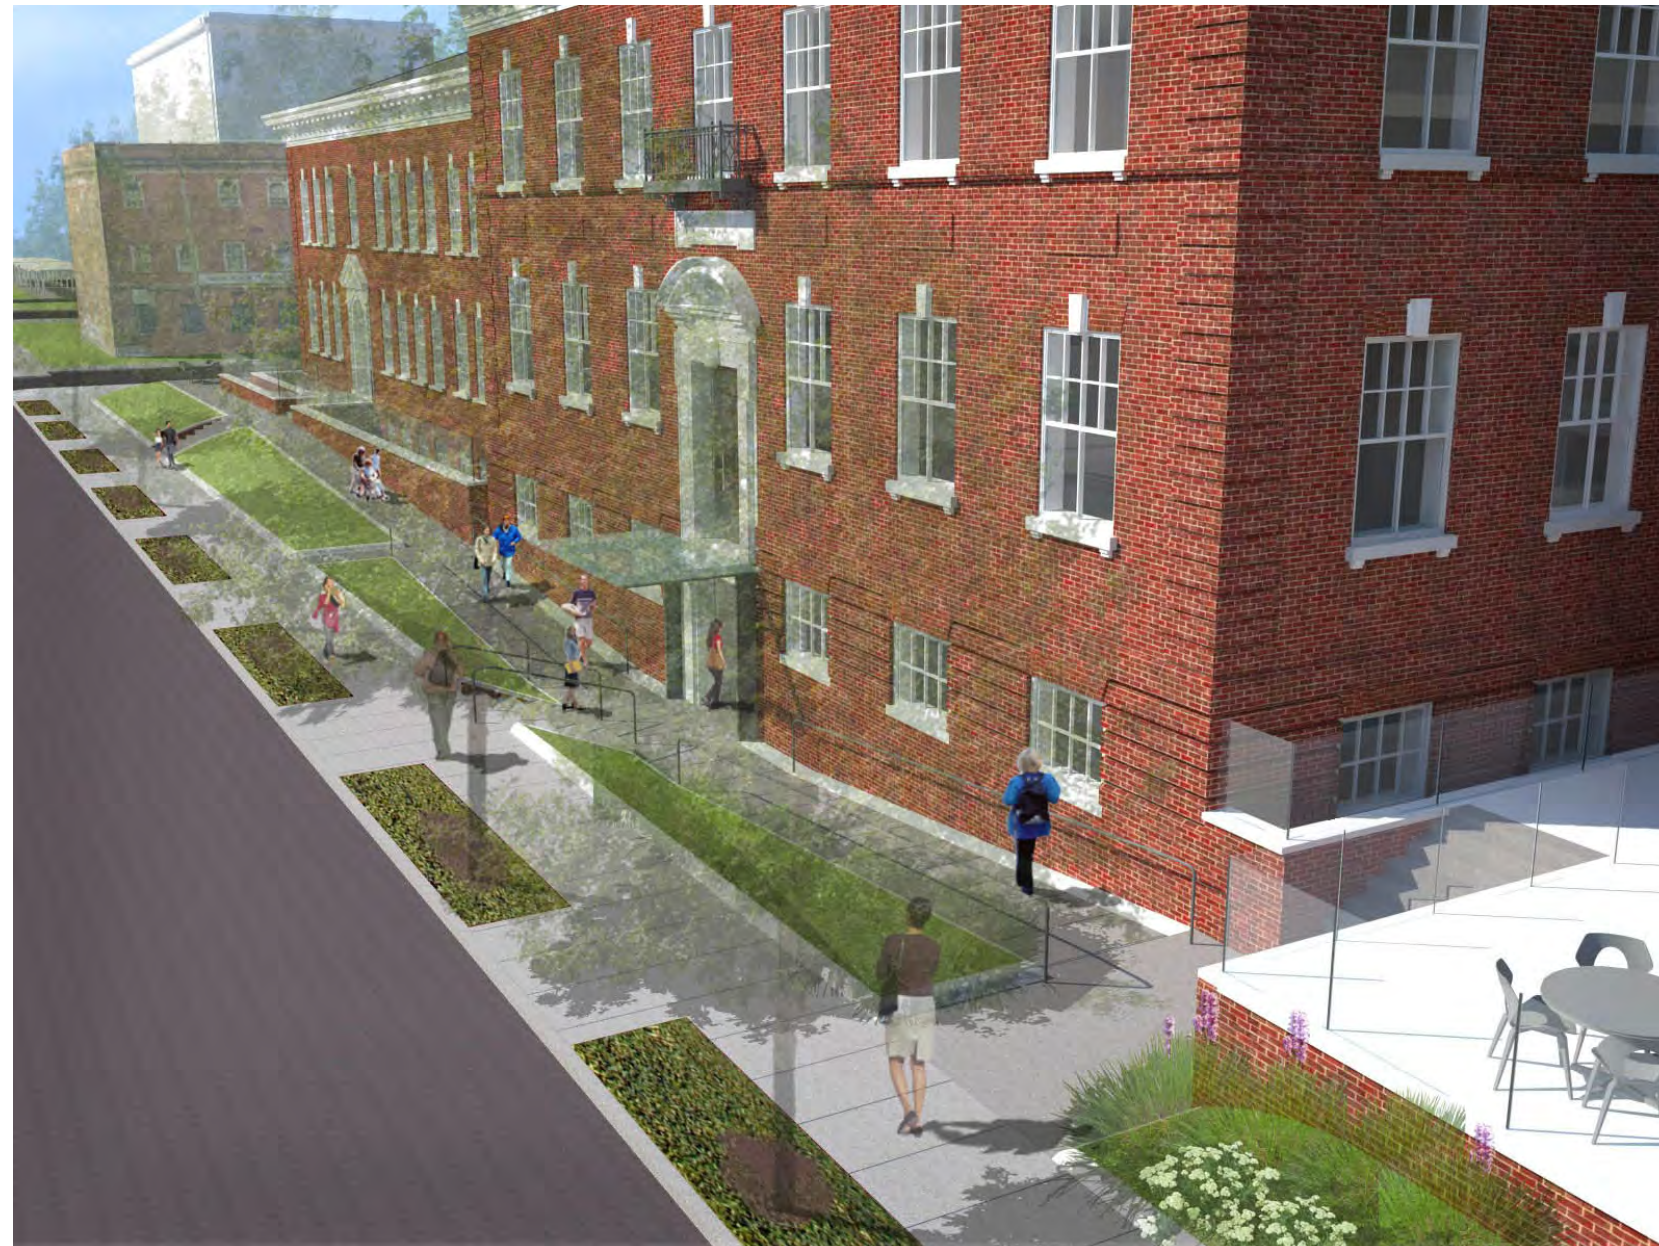
PROPOSED ENTRANCE RAMPS AT MUSEUM

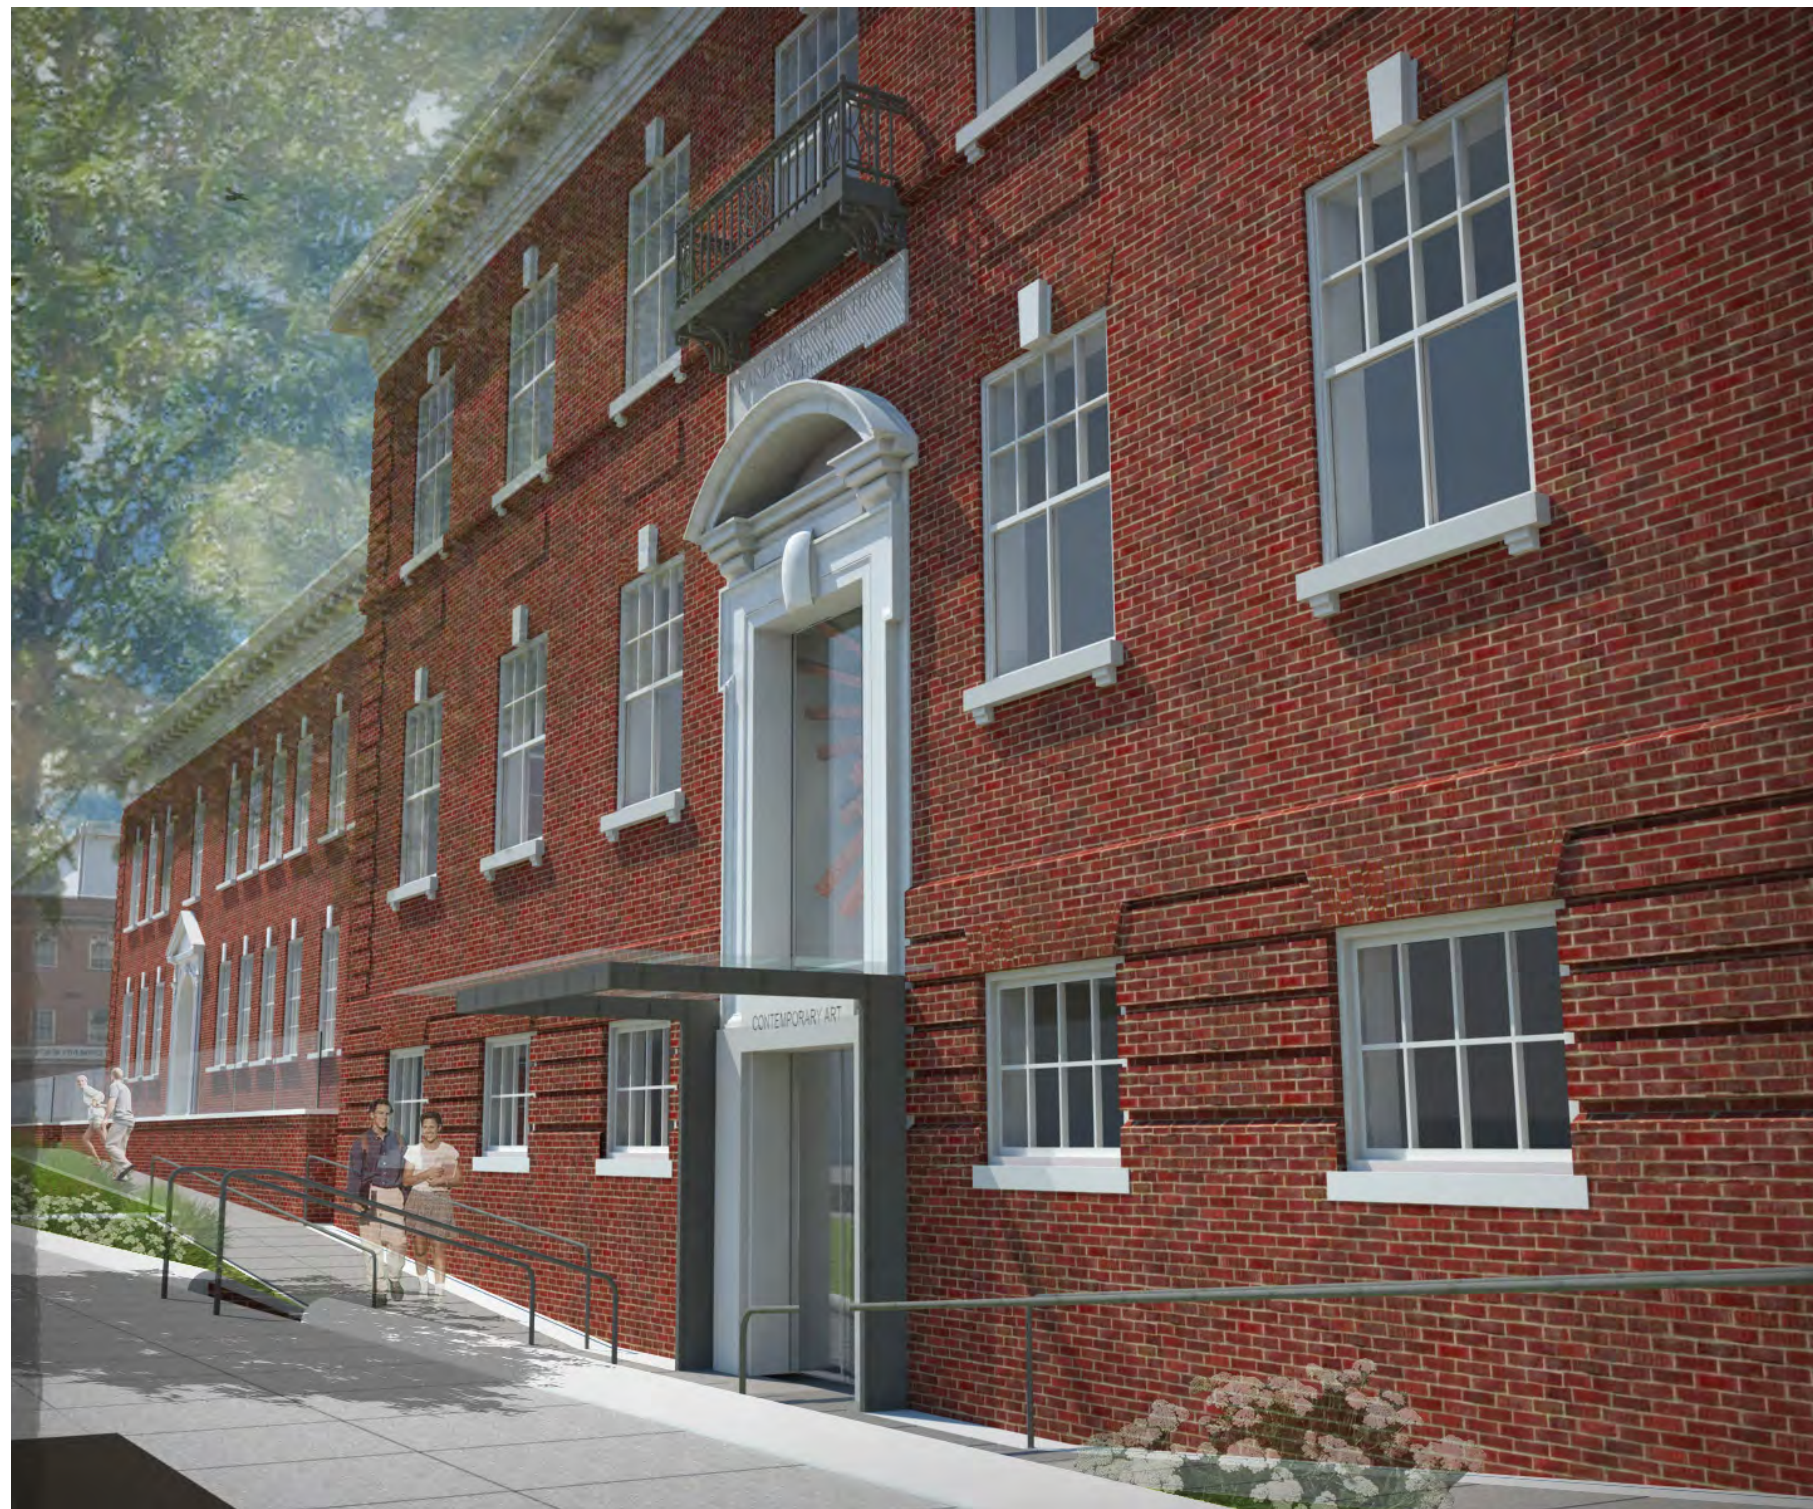
CENTRAL BUILDING - SOUTH MUSEUM ENTRANCE DETAIL

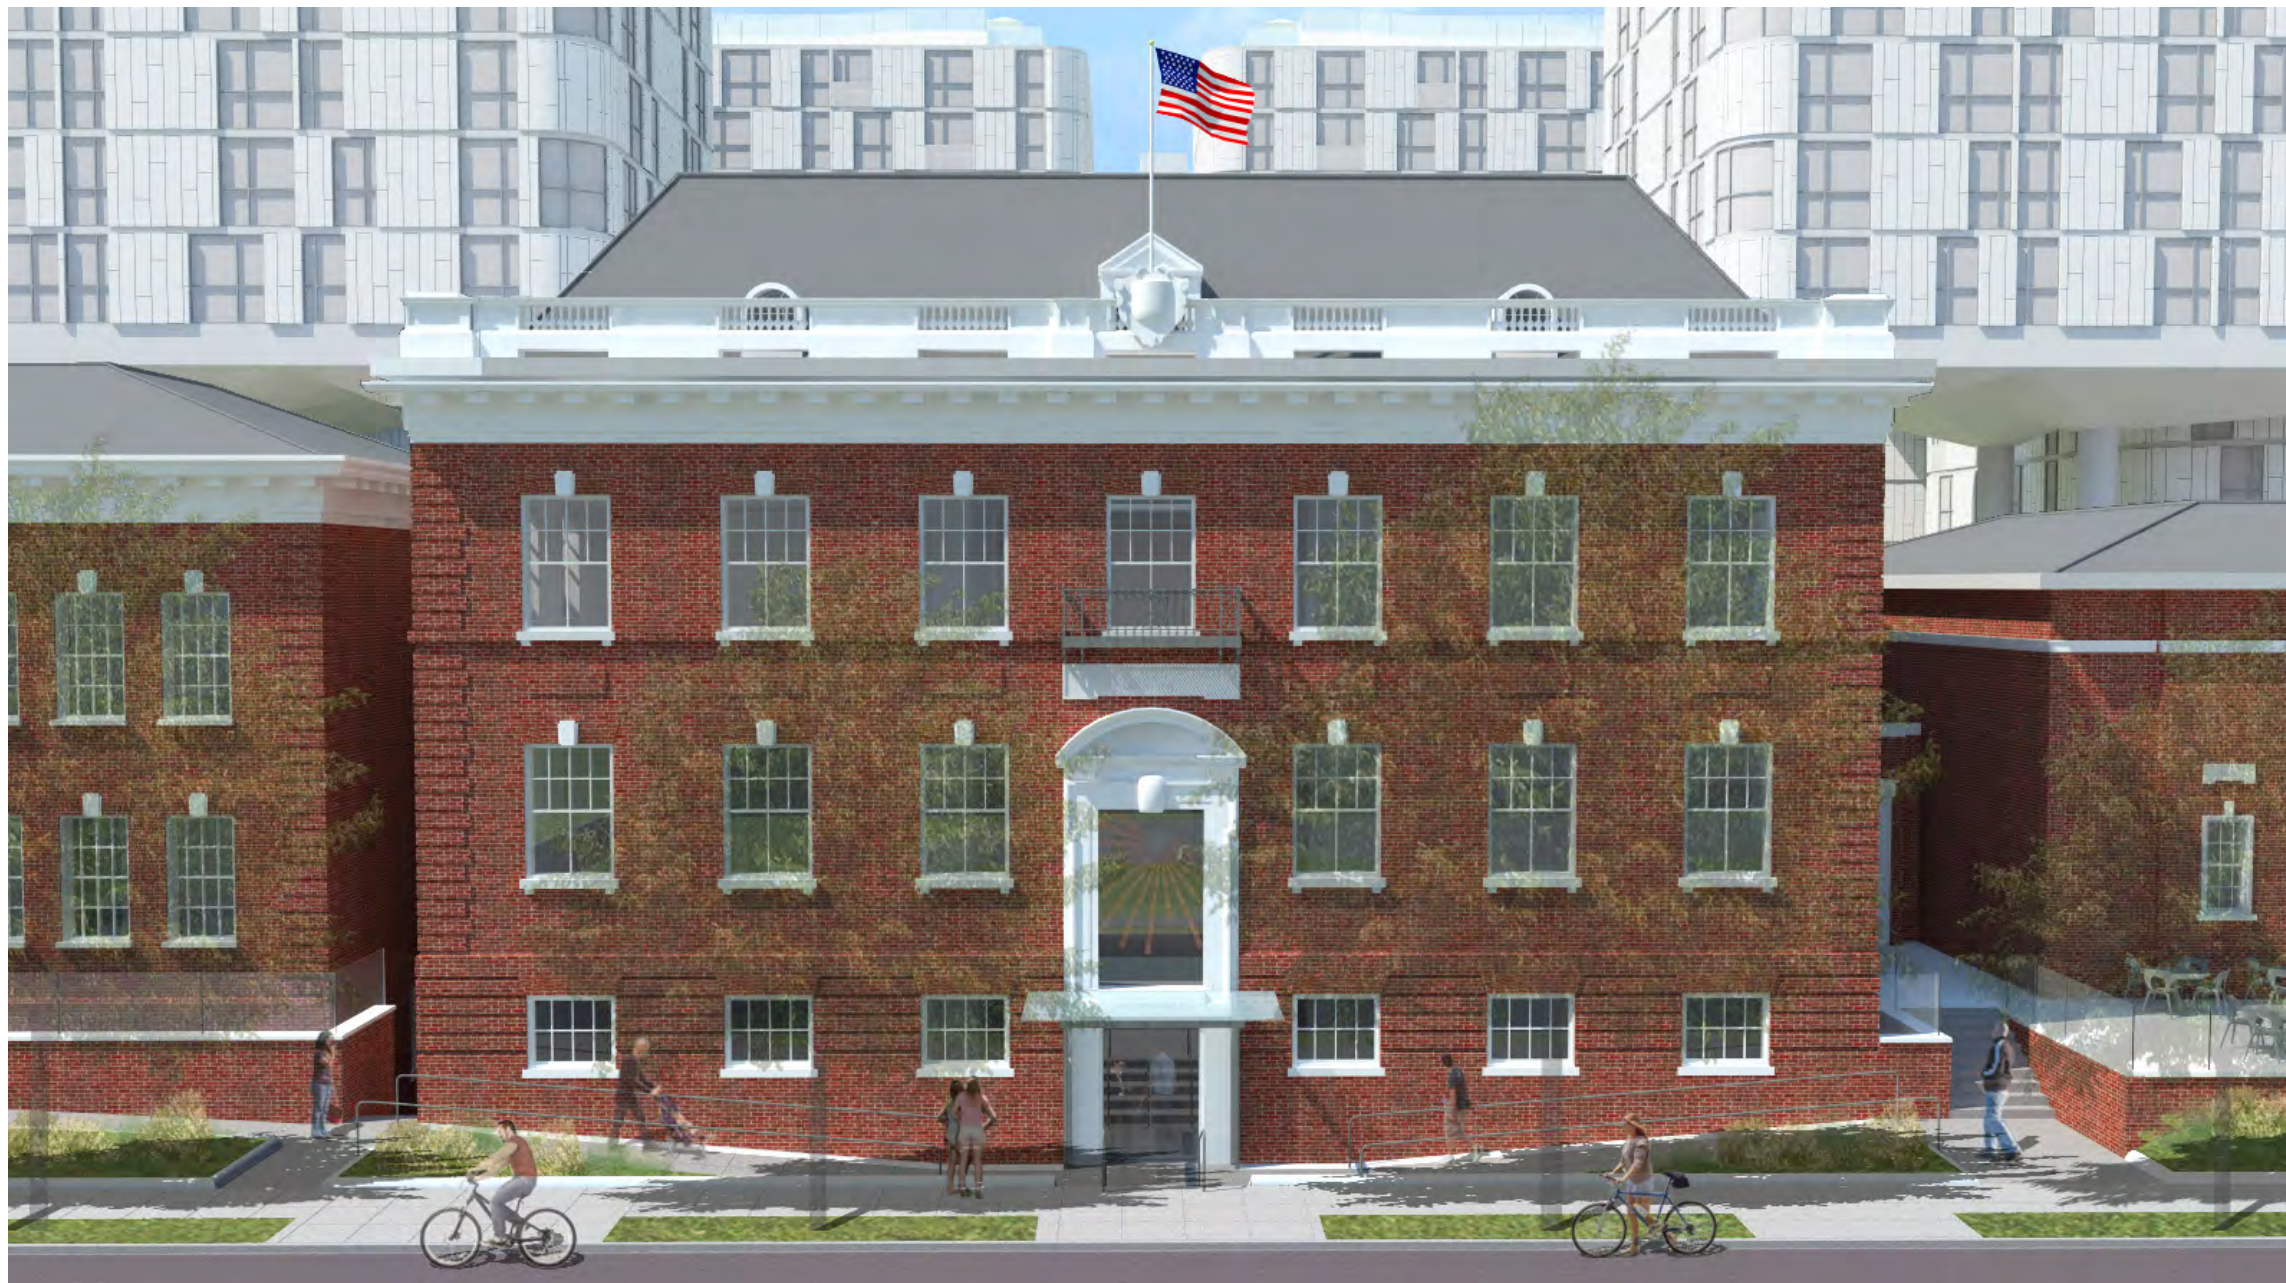
RESTORATION OF BALUSTRADE

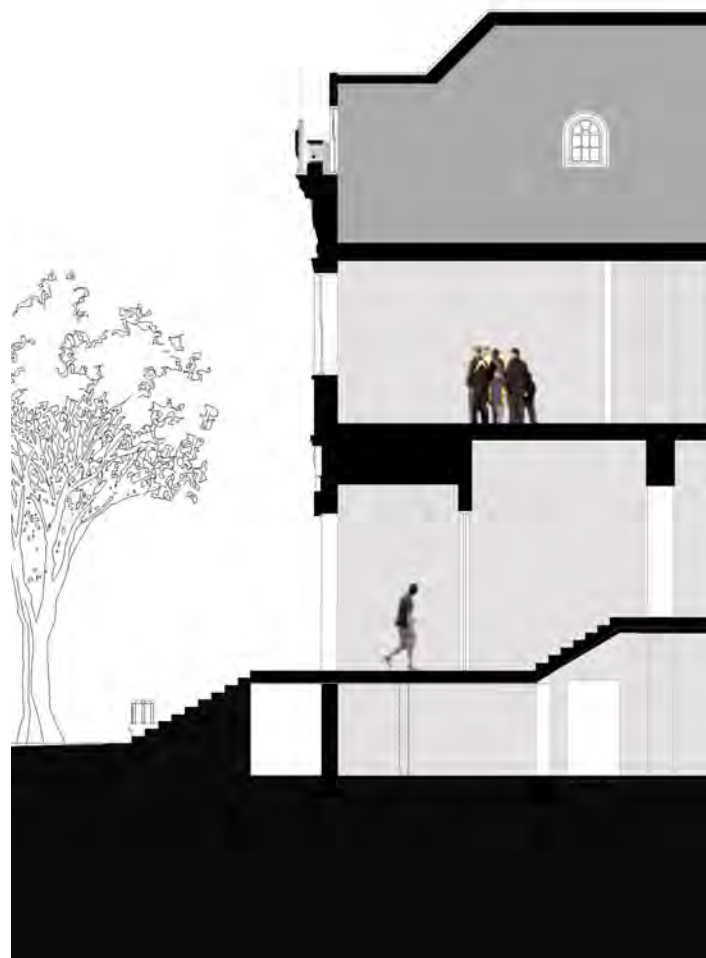
EXISTING ENTRANCE SECTION

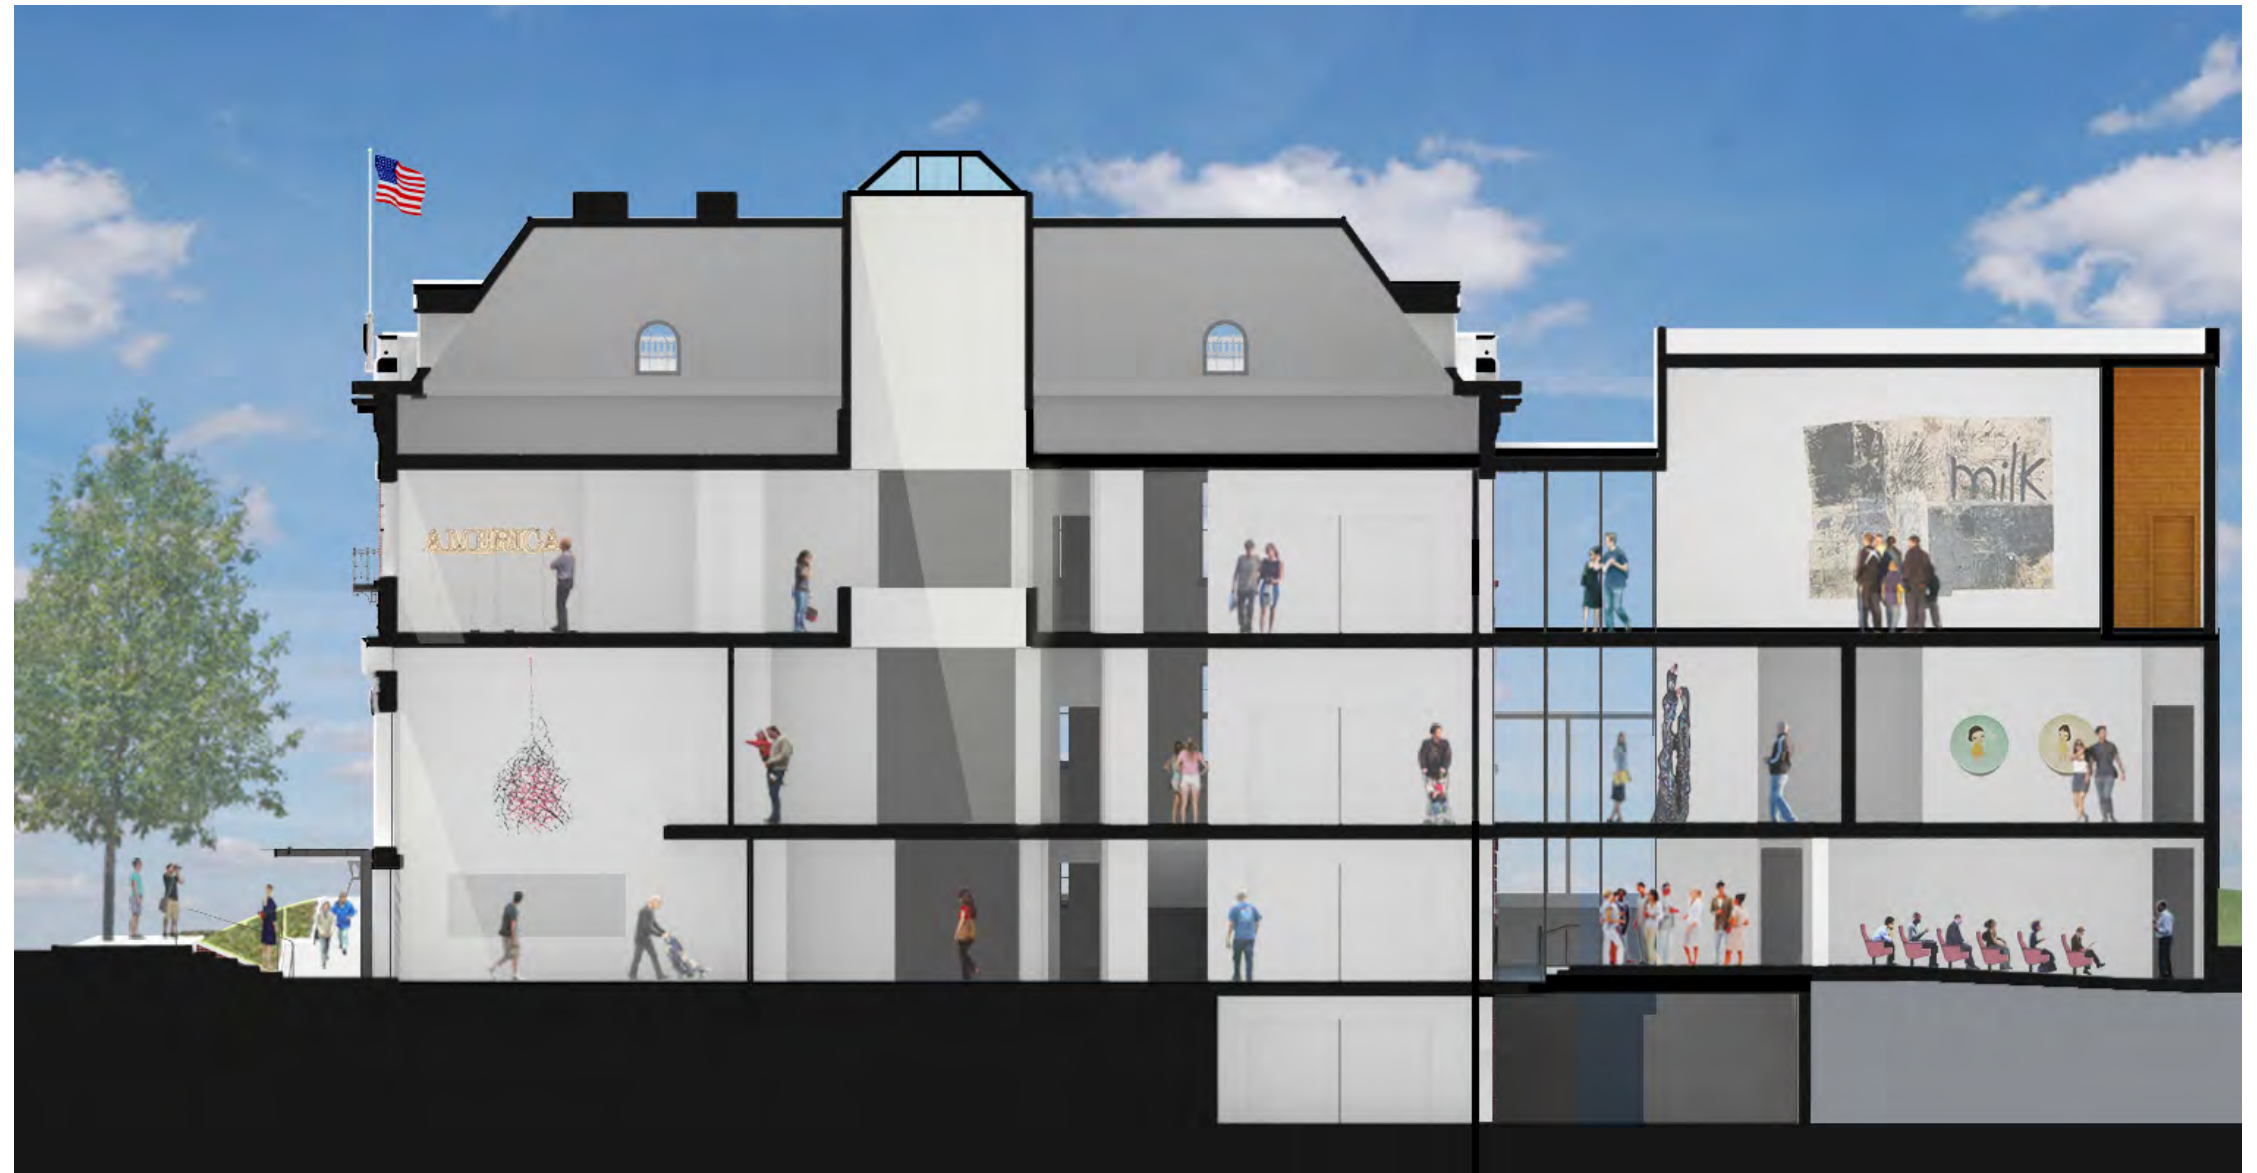
PROPOSED ENTRANCE SECTION

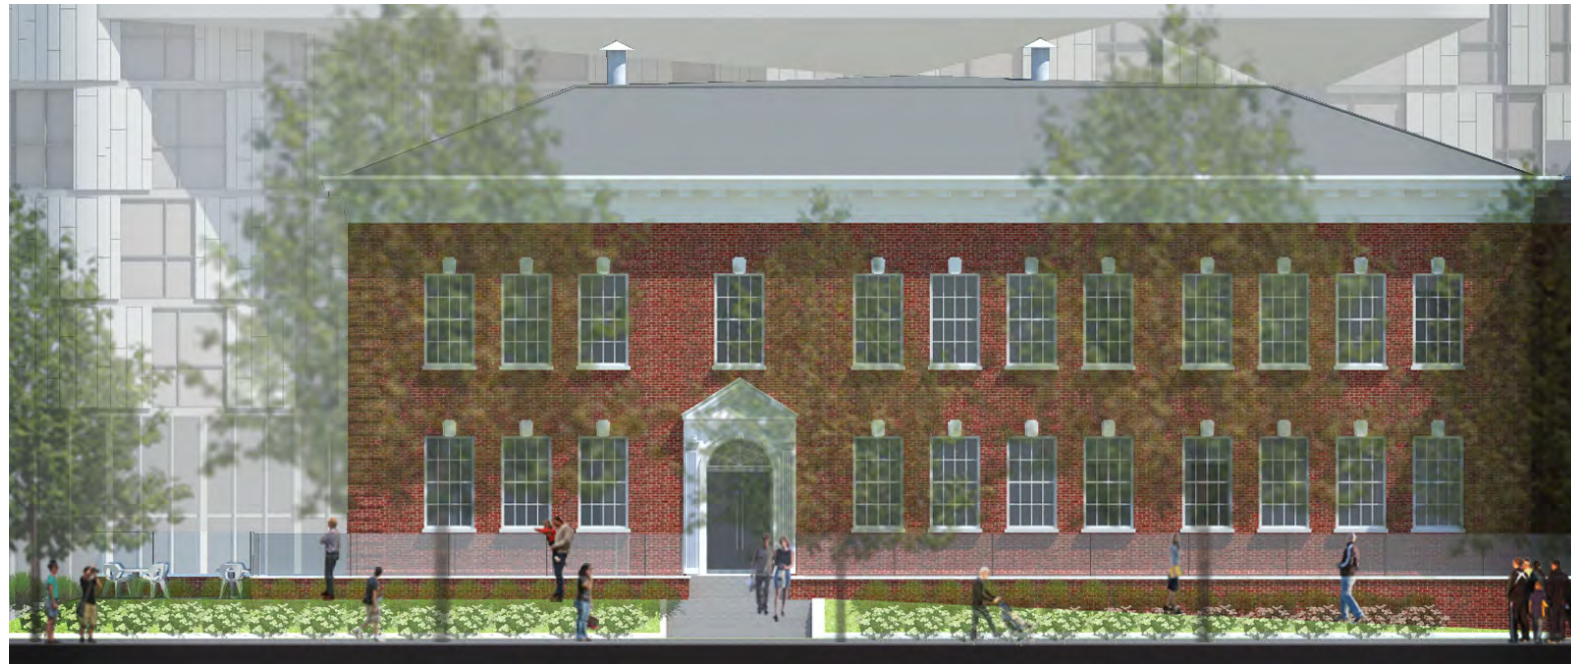
SOUTH ELEVATION

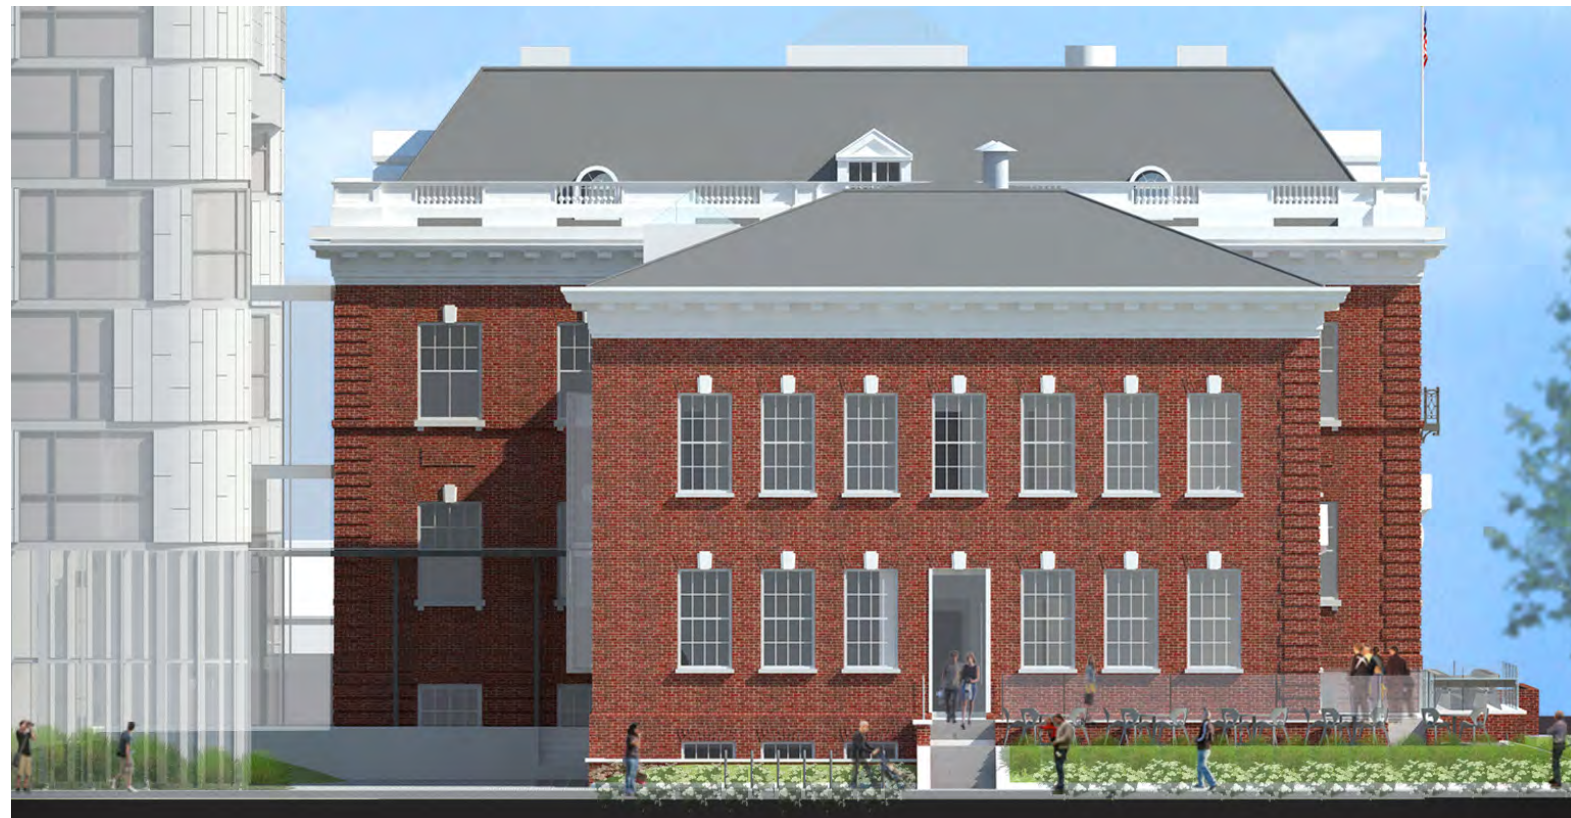
WEST ELEVATION AT TERRACE
