EXHIBIT FROM THE HISTORIC REHABILITATION TREATMENT REPORT PREPARED BY EHT TRACERIES DATED JULY 2011

EAST WING - ENTRY PLAN AND DETAILS
RANDALL SCHOOL | PUD Modification

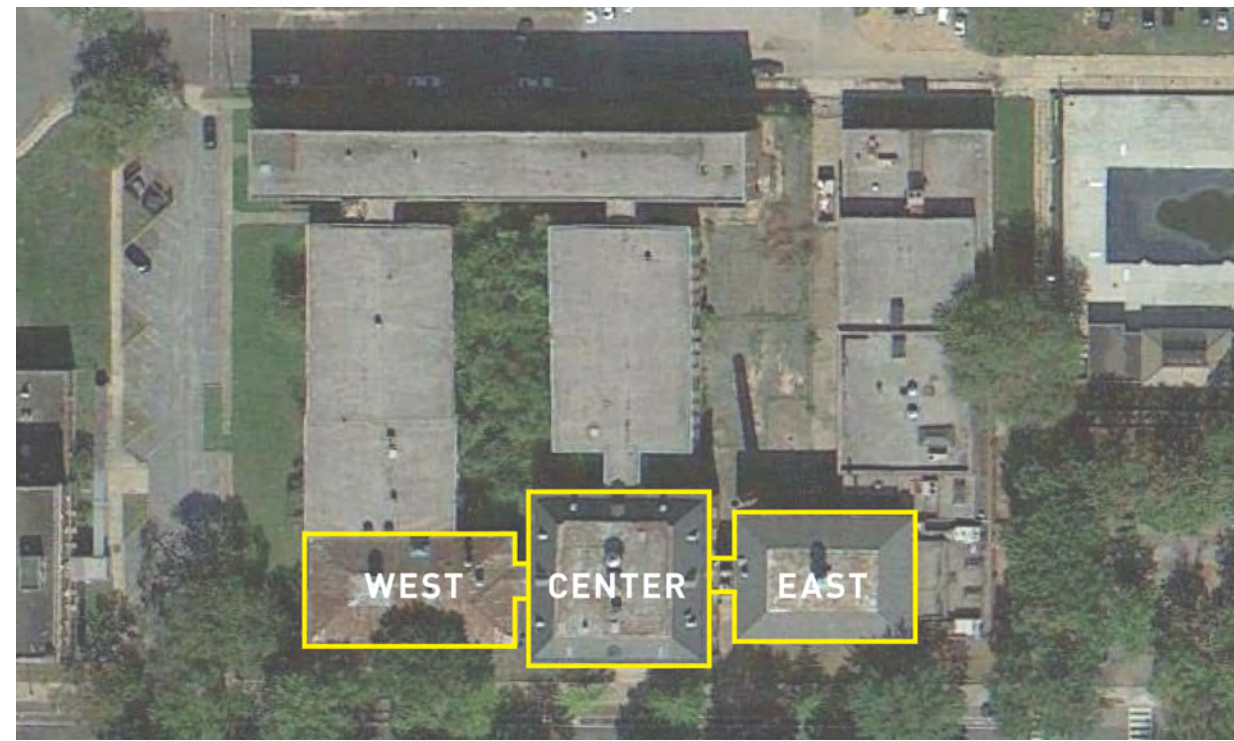
RETAINED HERITAGE BUILDINGS

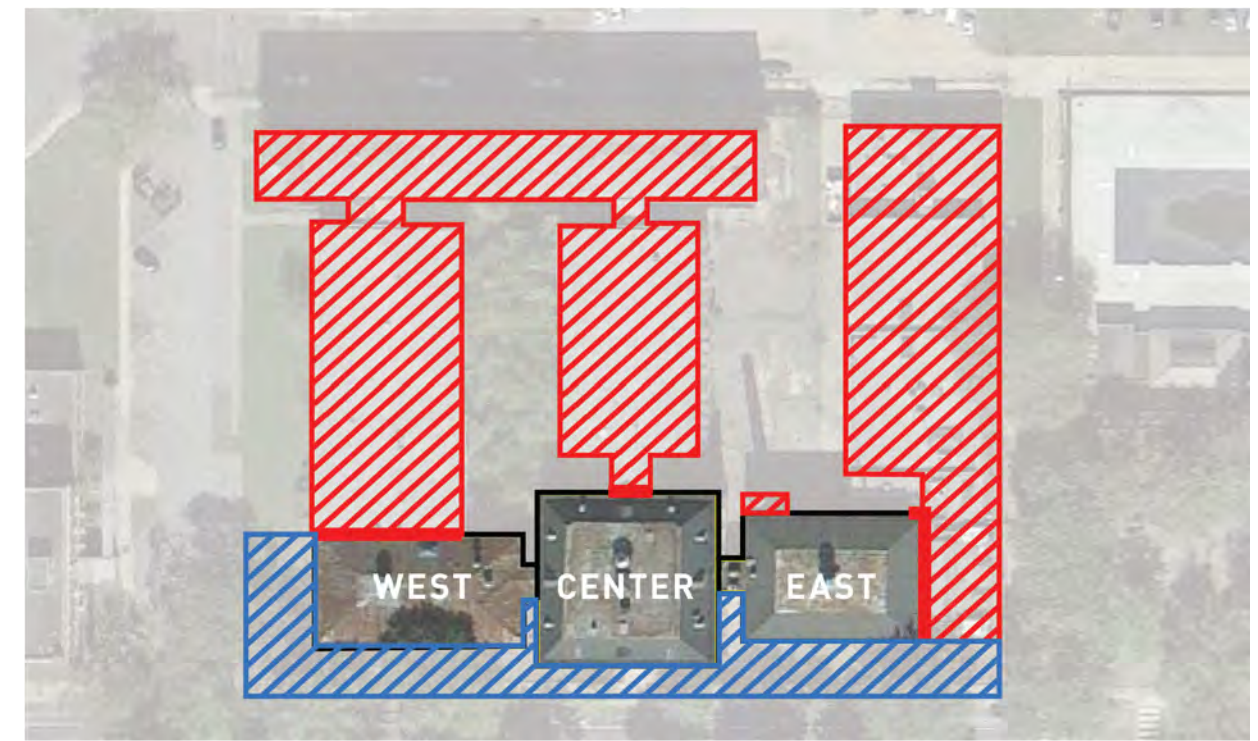
PROPOSED DEMOLITION AND FACADE MODIFICATION LOCATIONS

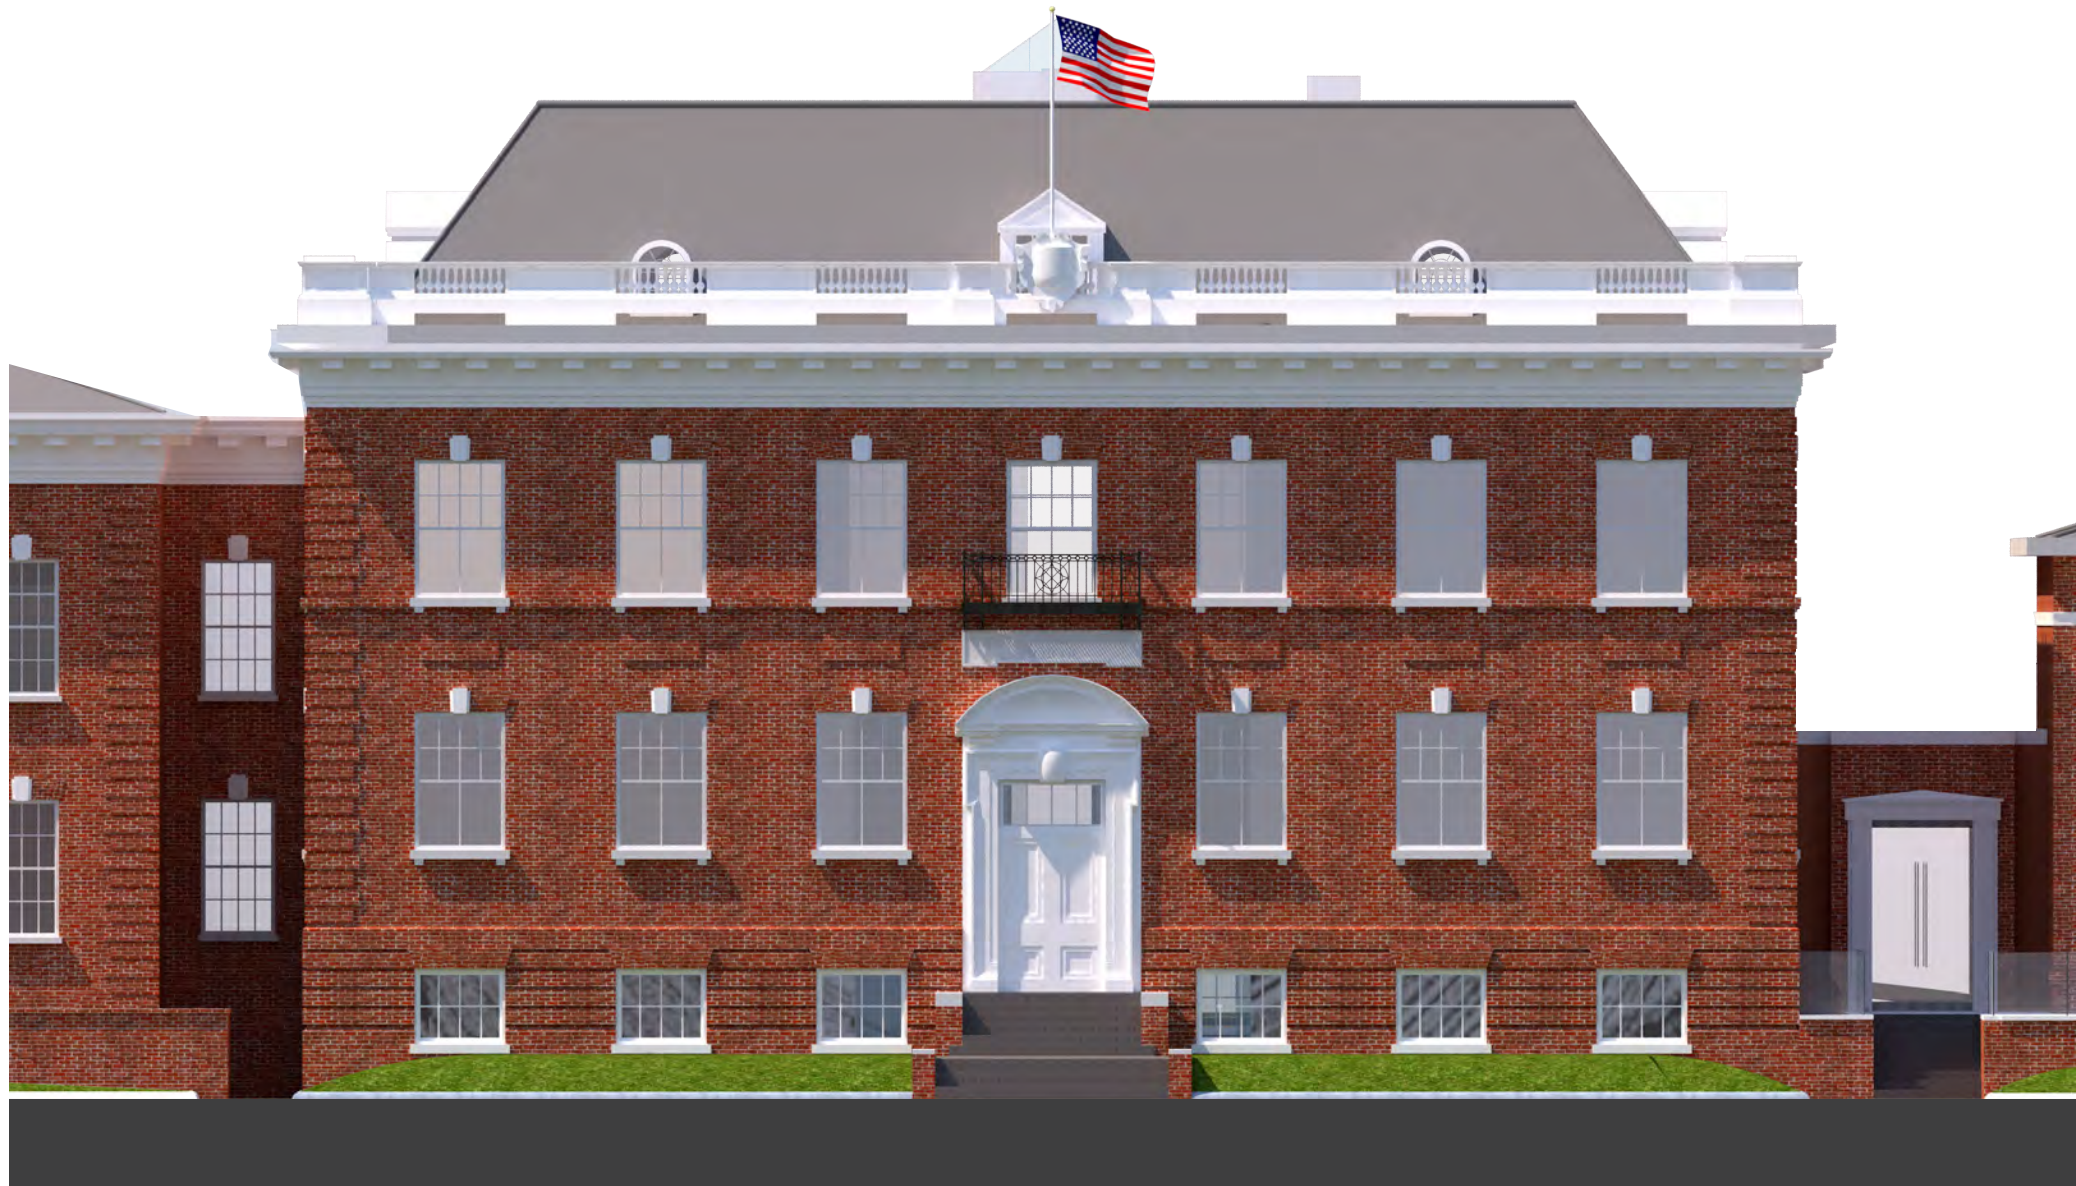
PROPOSED SOUTH ELEVATION

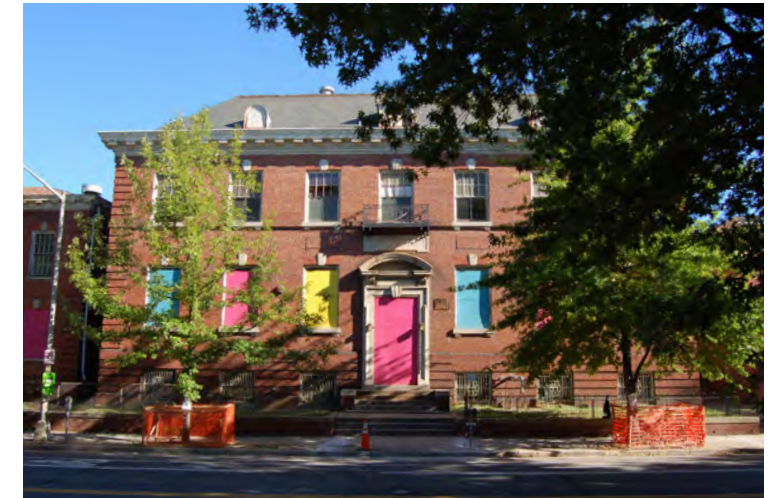
SOUTH ELEVATION (EXISTING CONDITIONS)

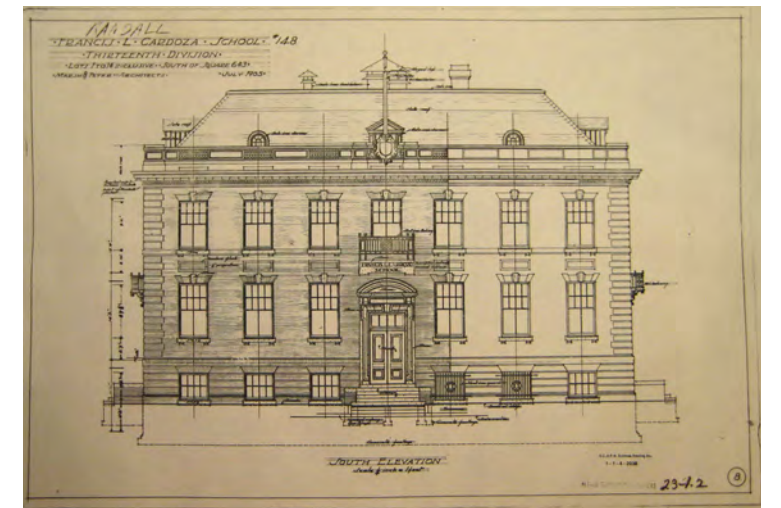
SOUTH ELEVATION - ORIGINAL DRAWING (1905)

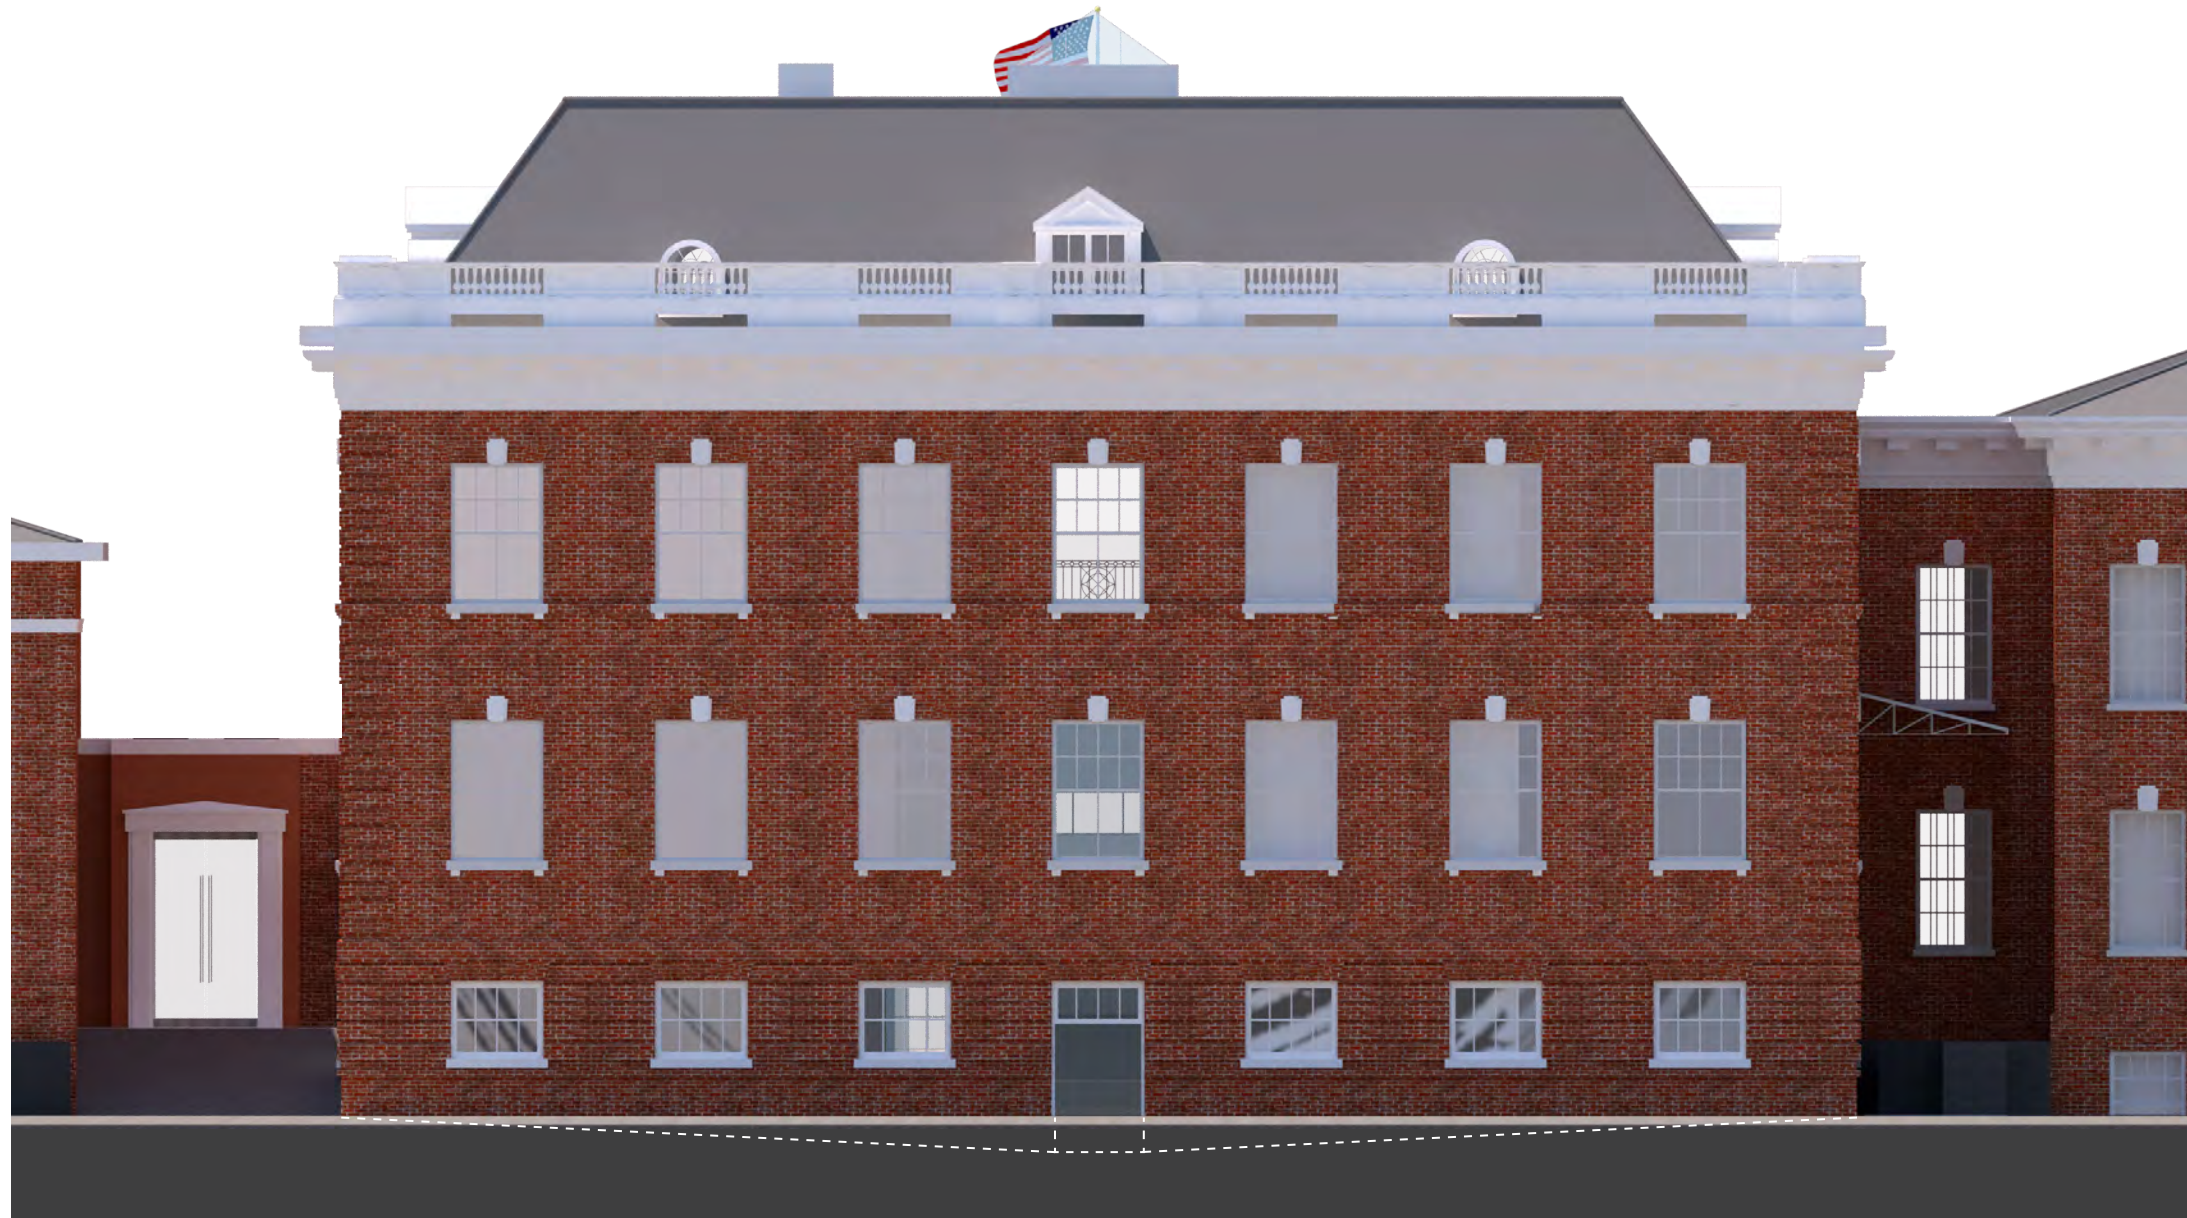
PROPOSED NORTH ELEVATION

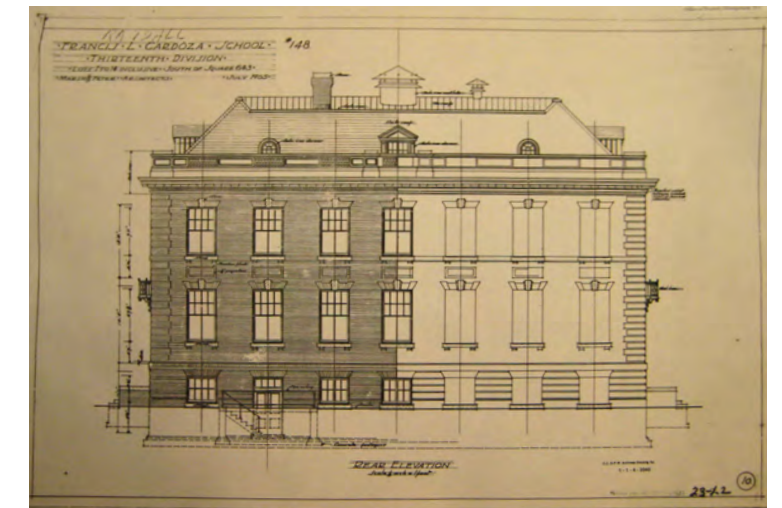
NORTH ELEVATION - ORIGINAL DRAWING (1905)

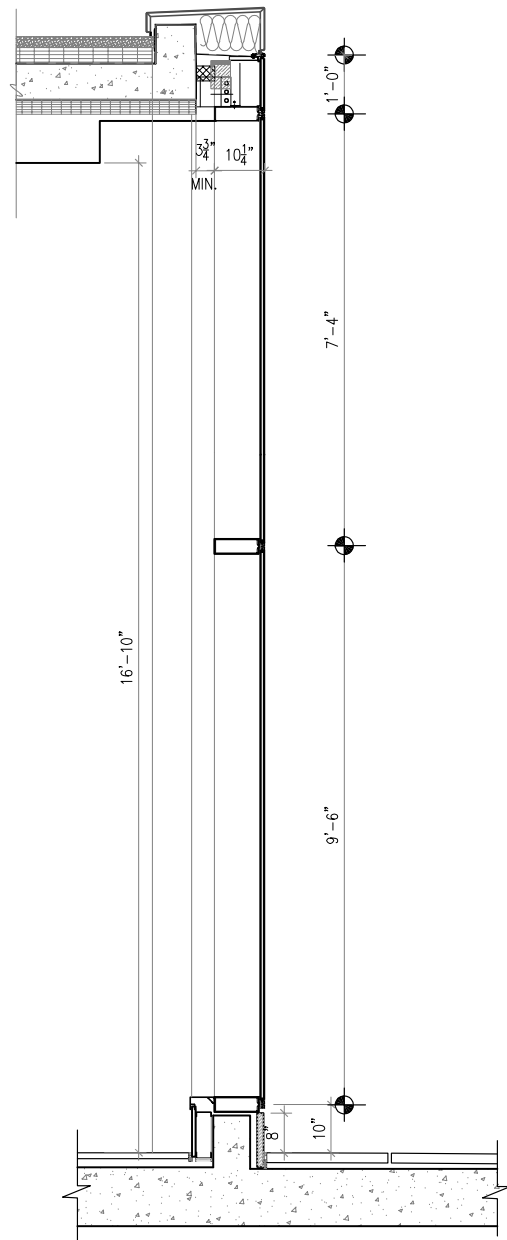
GLAZING WALL SECTION
SCALE: 1/4" = 1'

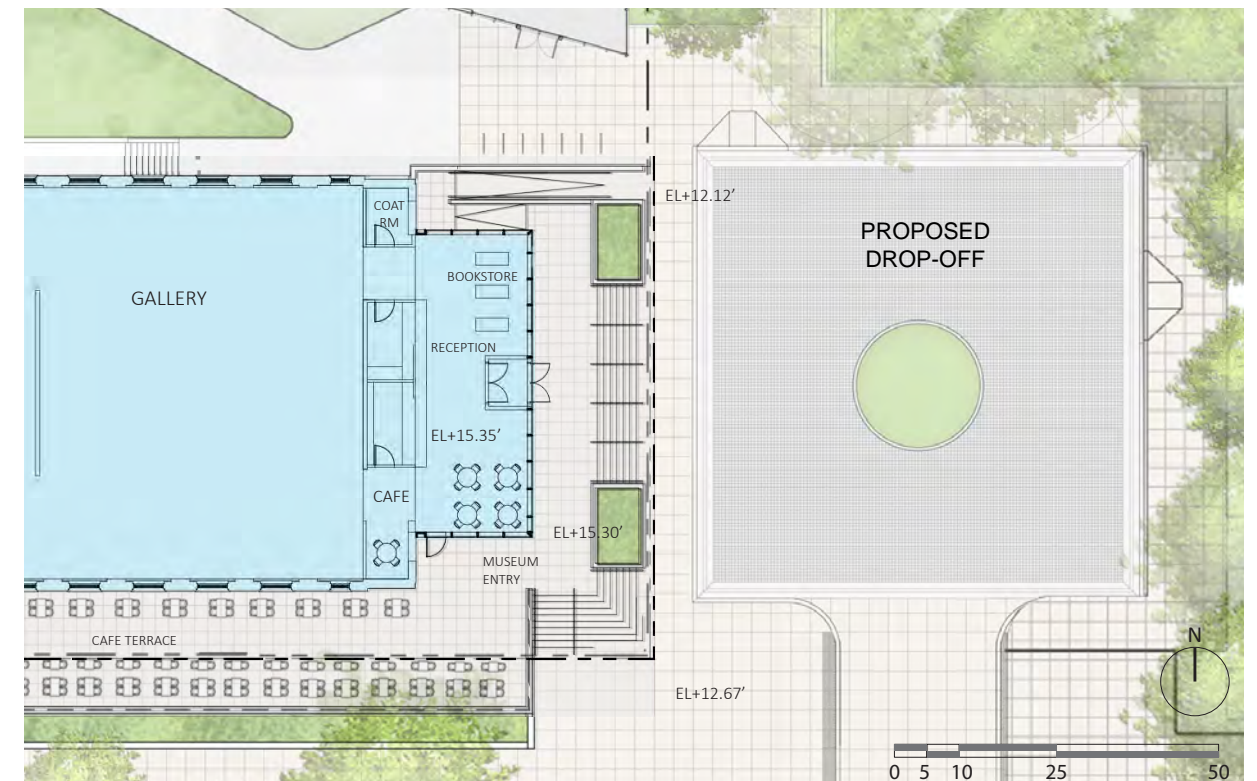
PROPOSED MUSEUM ENTRY PLAN

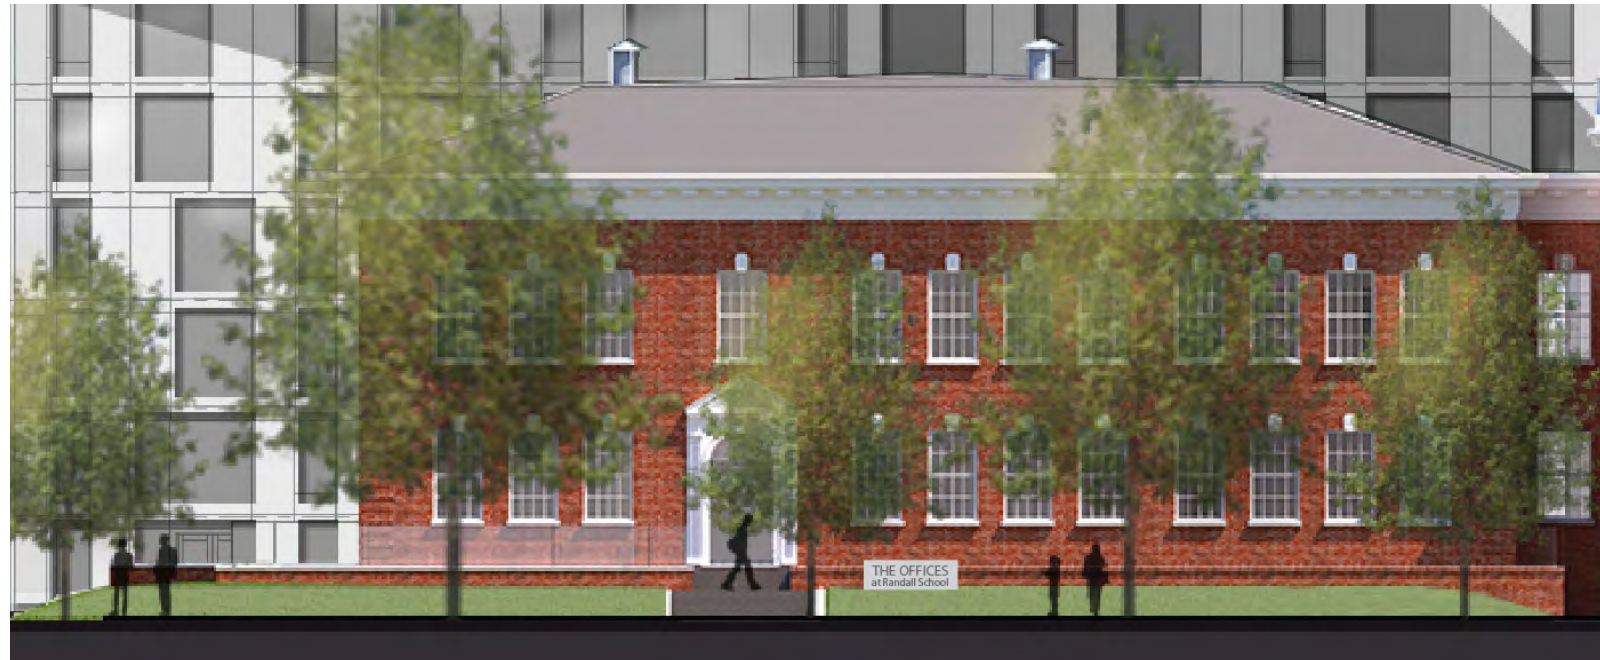
SOUTH ELEVATION

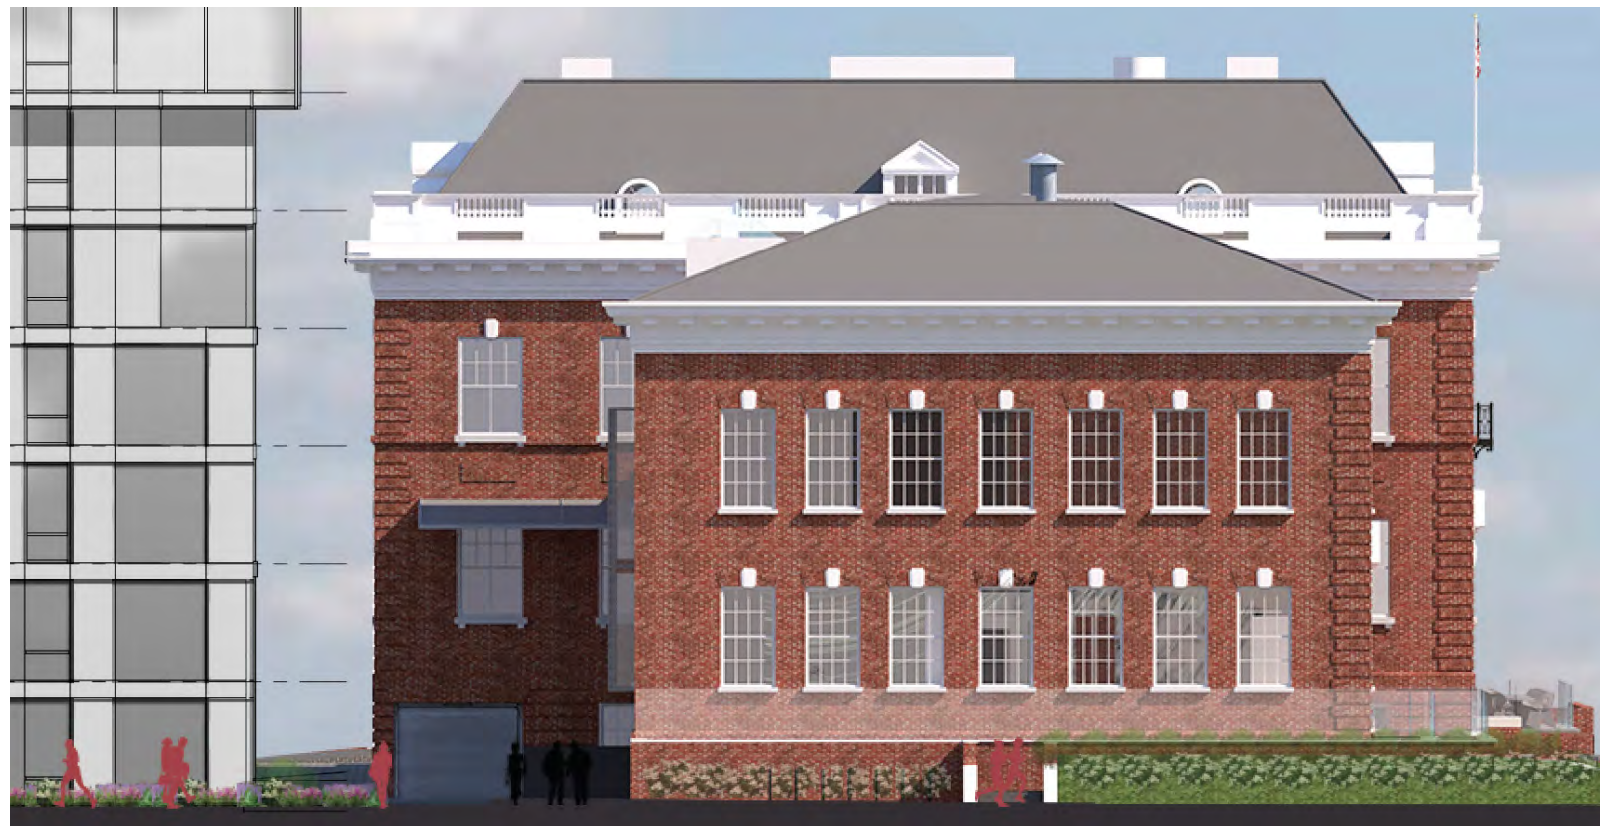
WEST ELEVATION

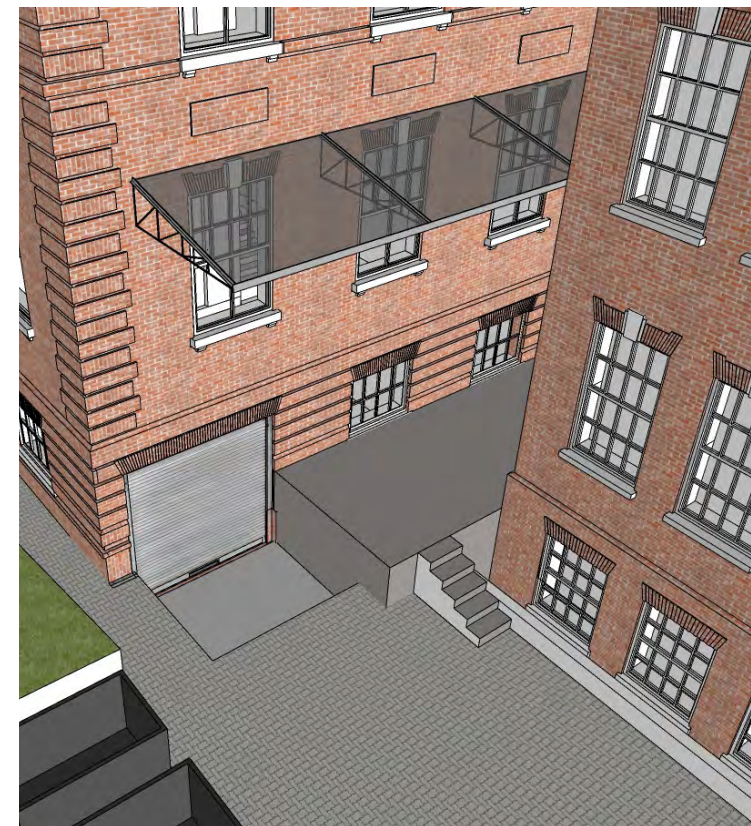
HISTORIC BUILDING LOADING

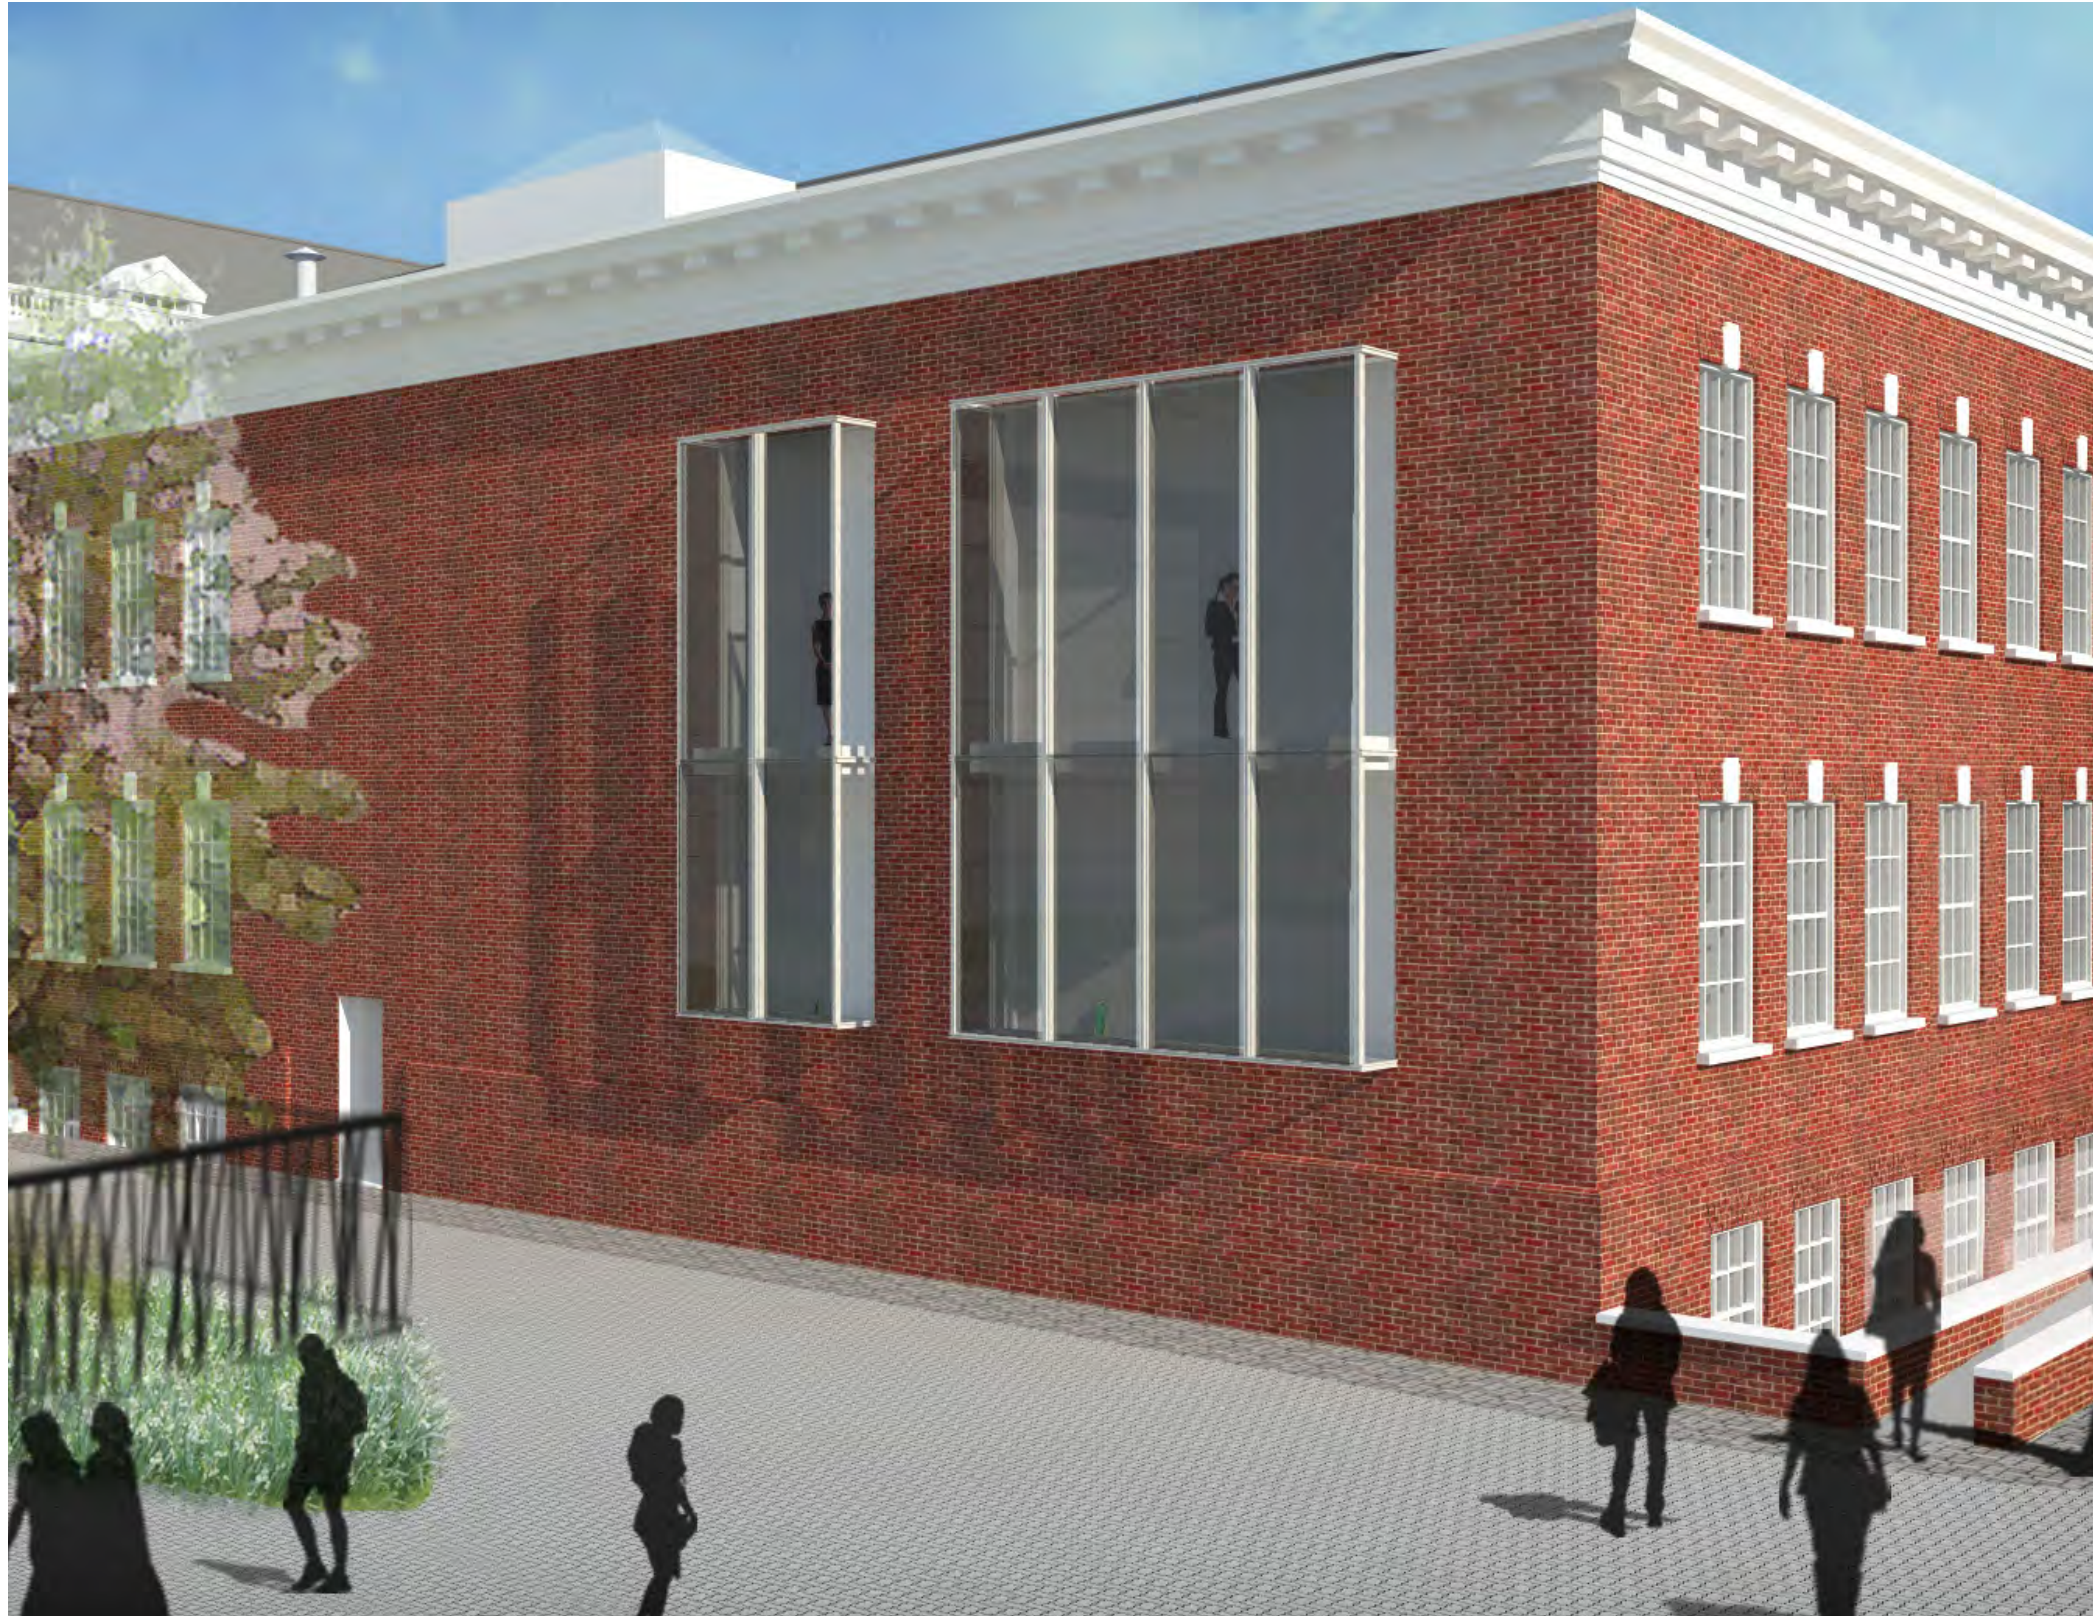
WEST WING NORTH ELEVATION

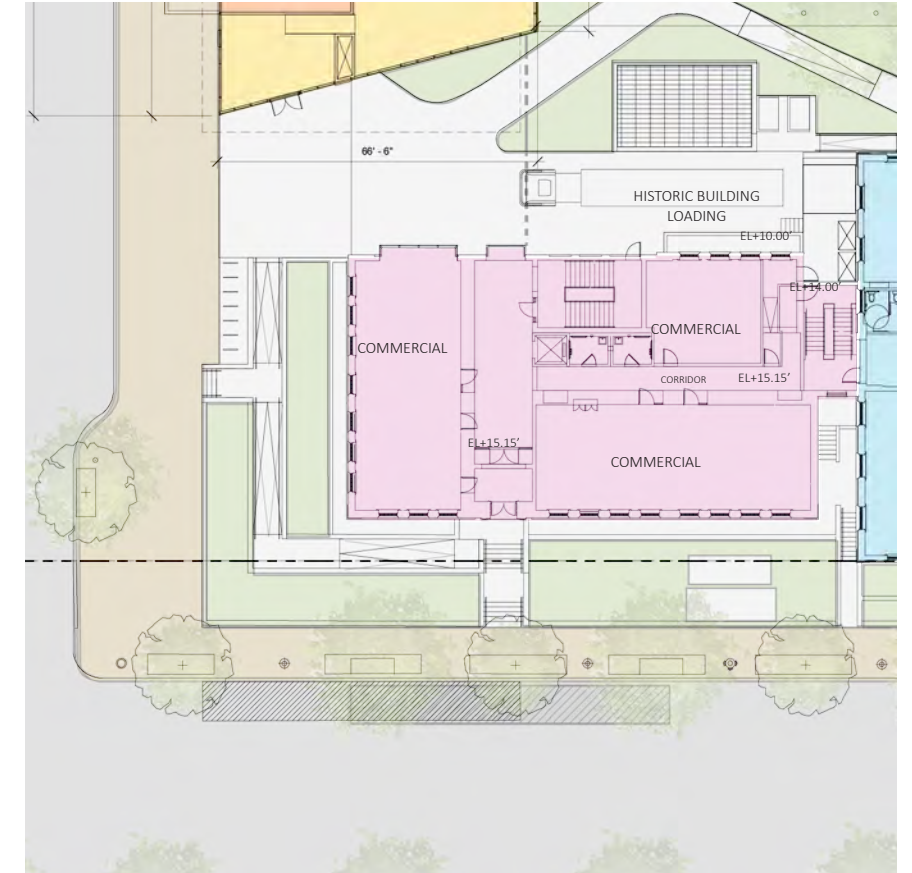
WEST WING FLOOR PLAN

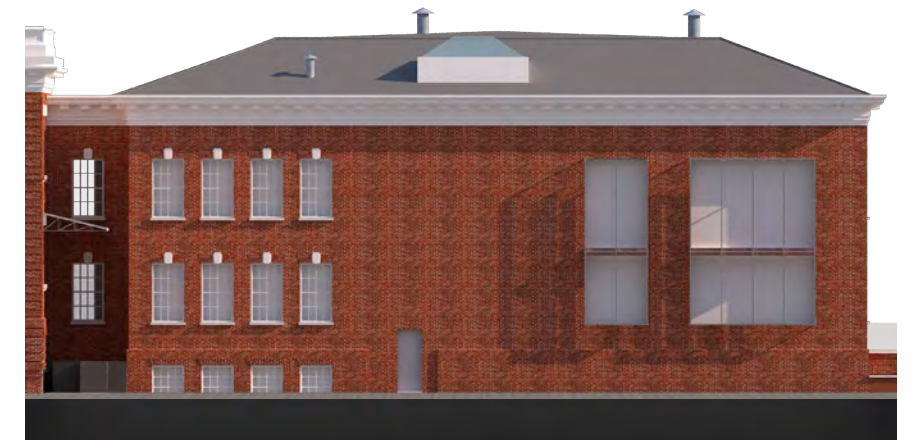
WEST WING NORTH ELEVATION
