Mews looking south - East end

1311 E Street, SE Washington DC 20003

ZONING COMMISSION
 District of Columbia
 CASE NO. 15-13
 EXHIBIT NO. 47B3
A. 38

30' Alley elevation - East end

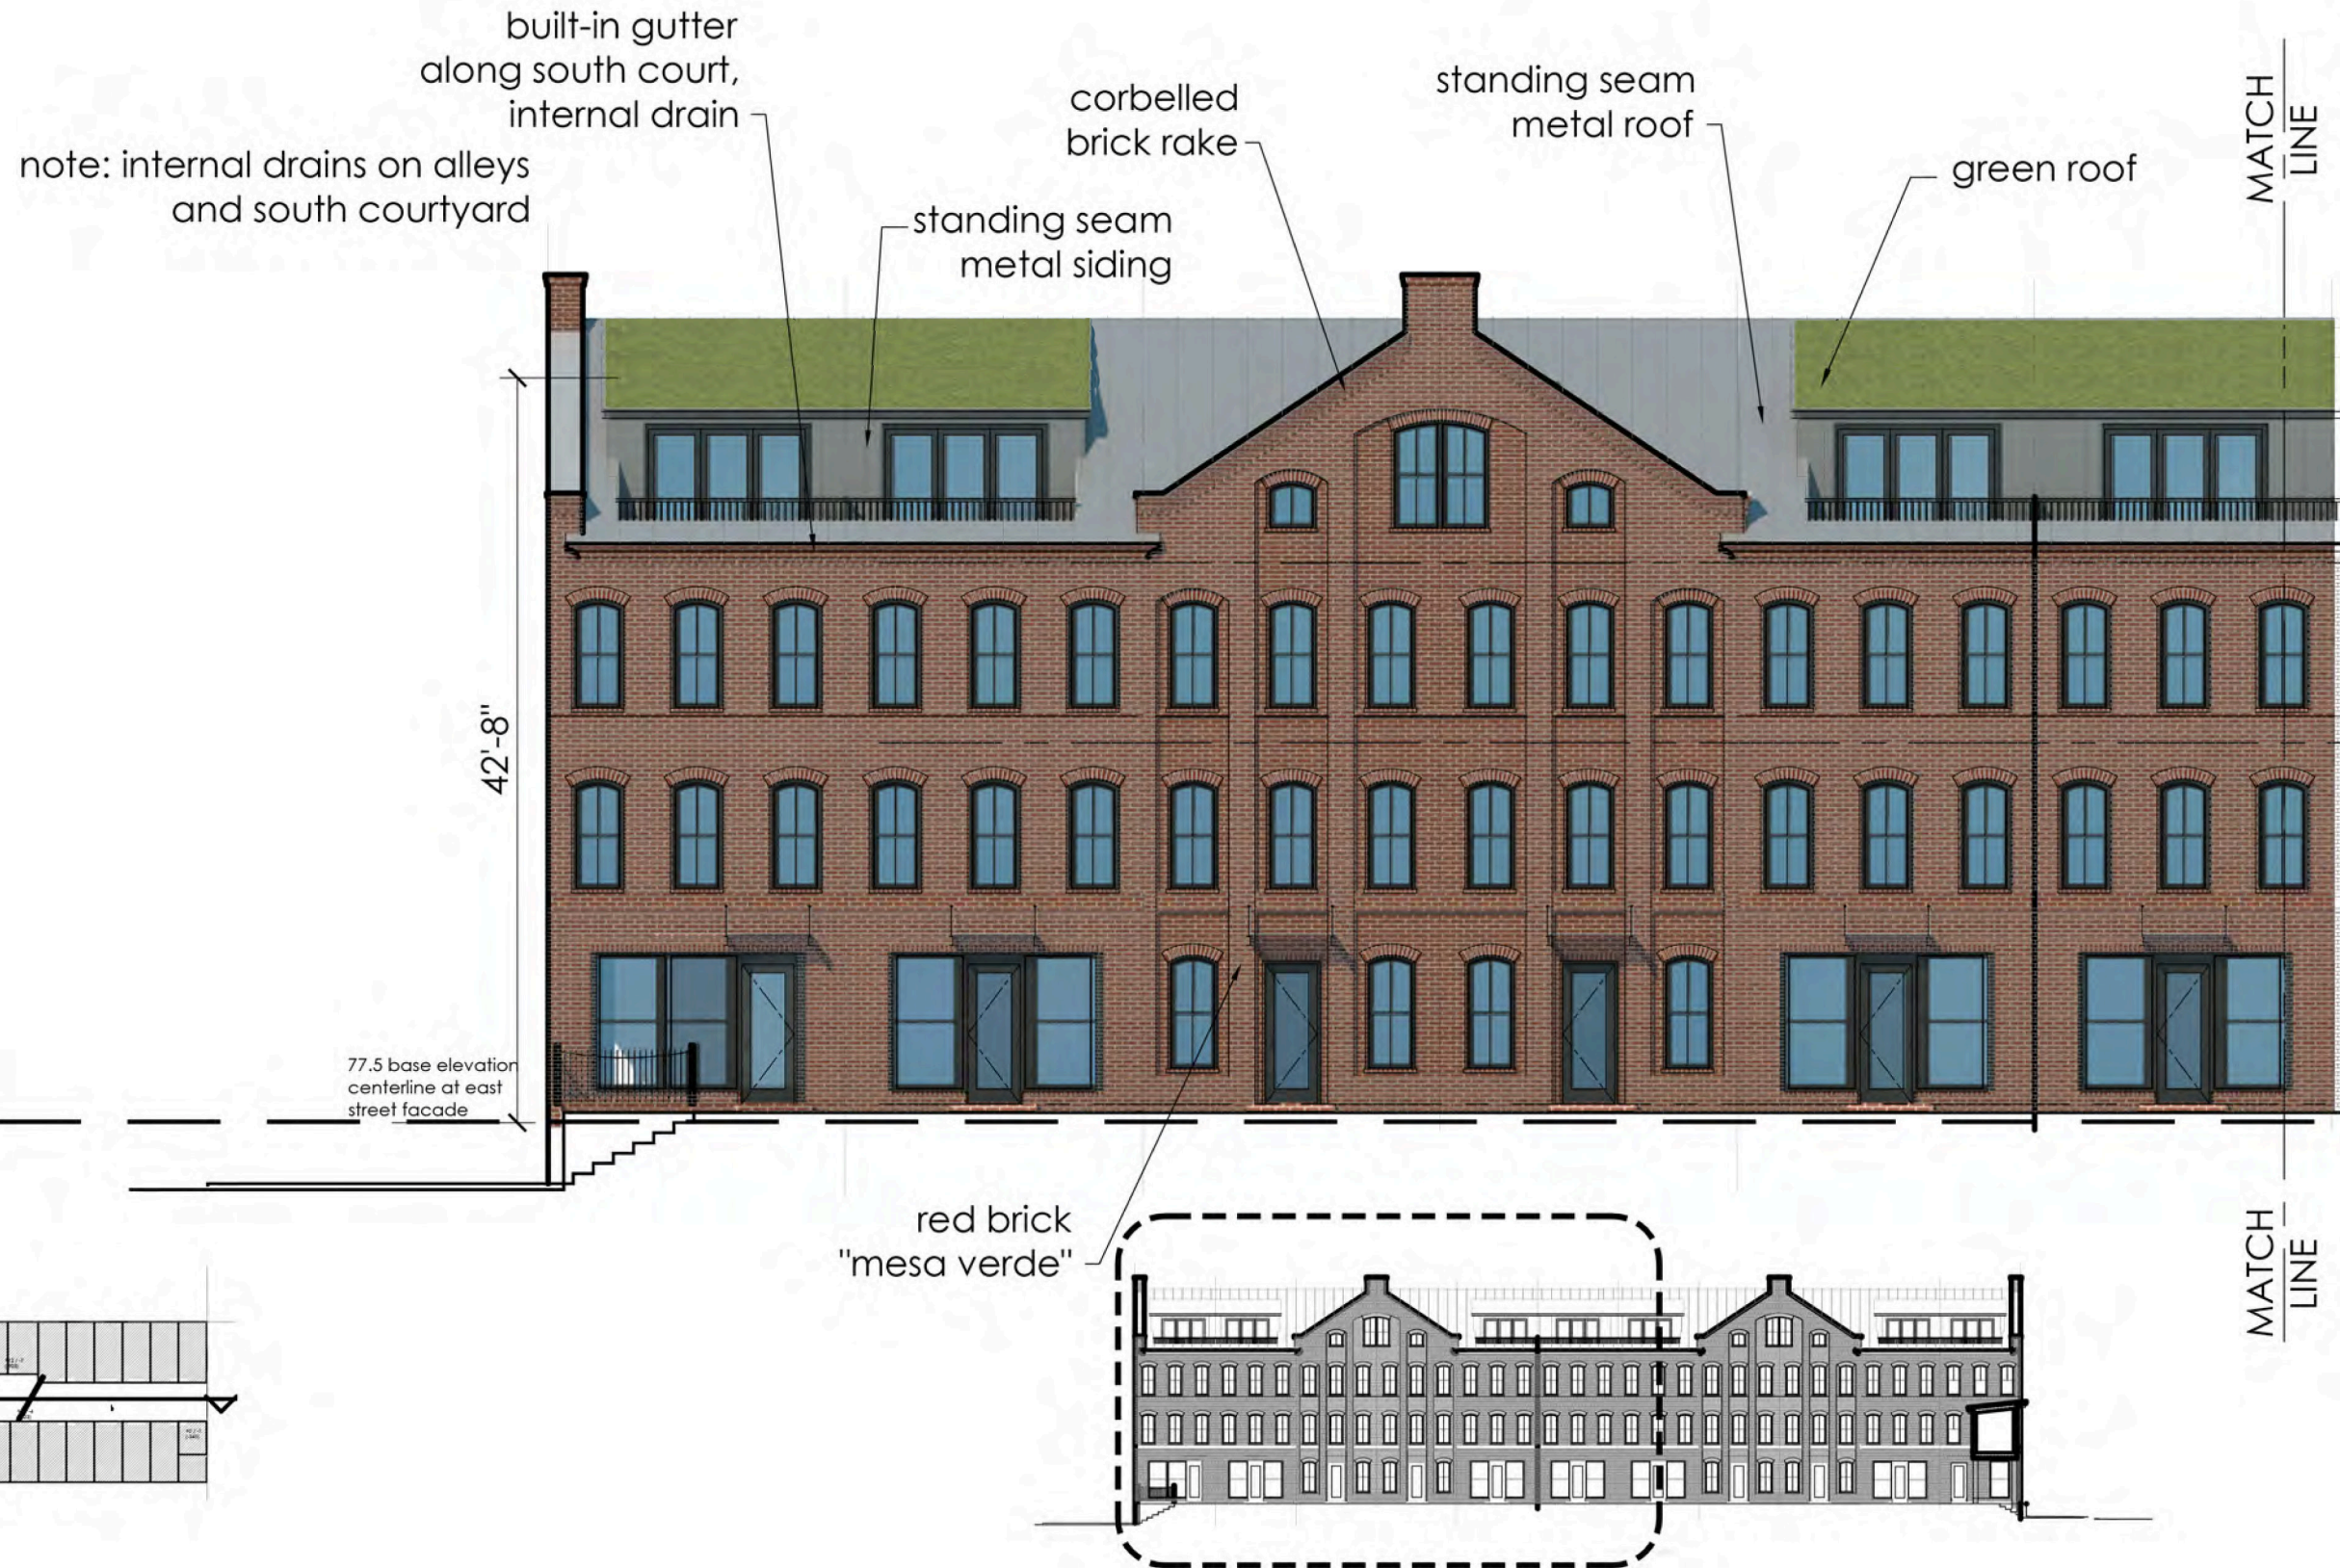
note: internal drains on alleys
and south courtyard

standing seam
metal roof

corbelled
brick rake

built-in gutter
along south court,
internal drain

green roof

standing seam
metal siding

red brick
"mesa verde"
