**BOARD OF ZONING ADJUSTMENT**  
District of Columbia  
CASE NO. 18446  
EXHIBIT NO. 9

# **SITE INSPECTION REPORT**

1308 Euclid St. NW  
Washington DC-20010  
Inspection date: June 20, 2012  
Report Prepared on: July 3, 2012

**Re: 1308 Euclid St. NW, WDC- 20010**

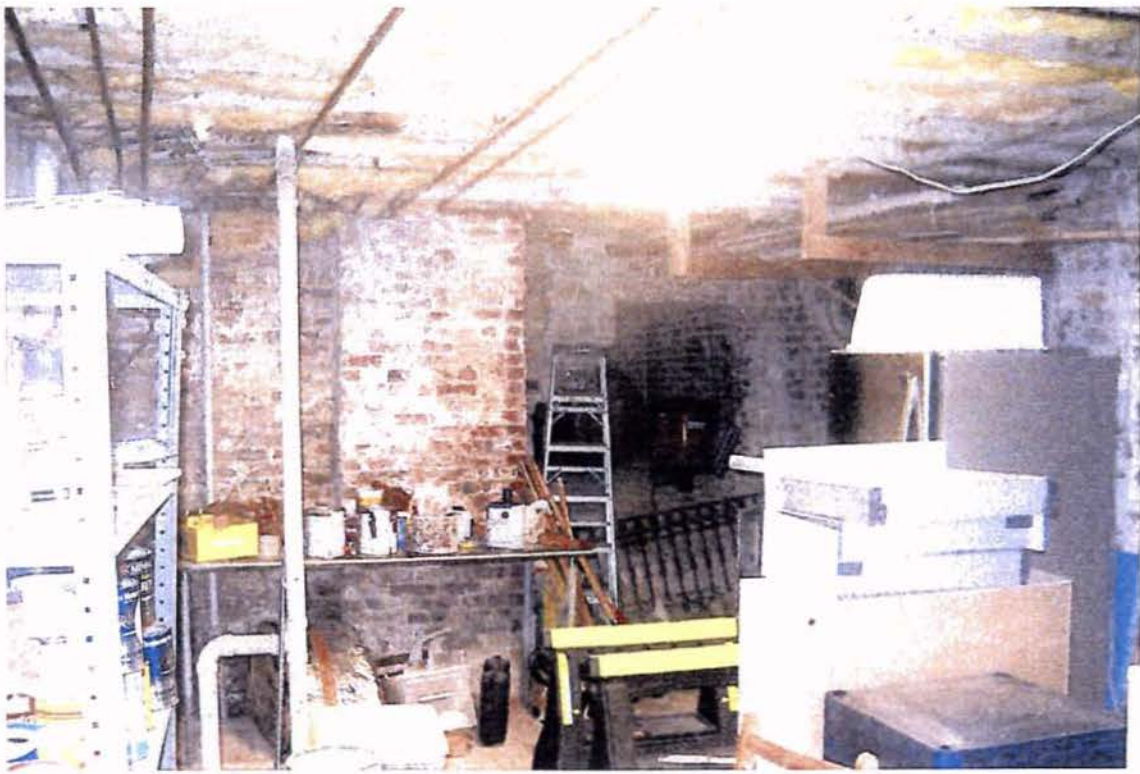
Basement

1. We noticed that mortar of brick wall of basement @ several locations was loose and few bricks were also missing. See Figs. (1) & (2). It can lead to the settlement of the wall and cause structural damage to the house. It should be addressed.

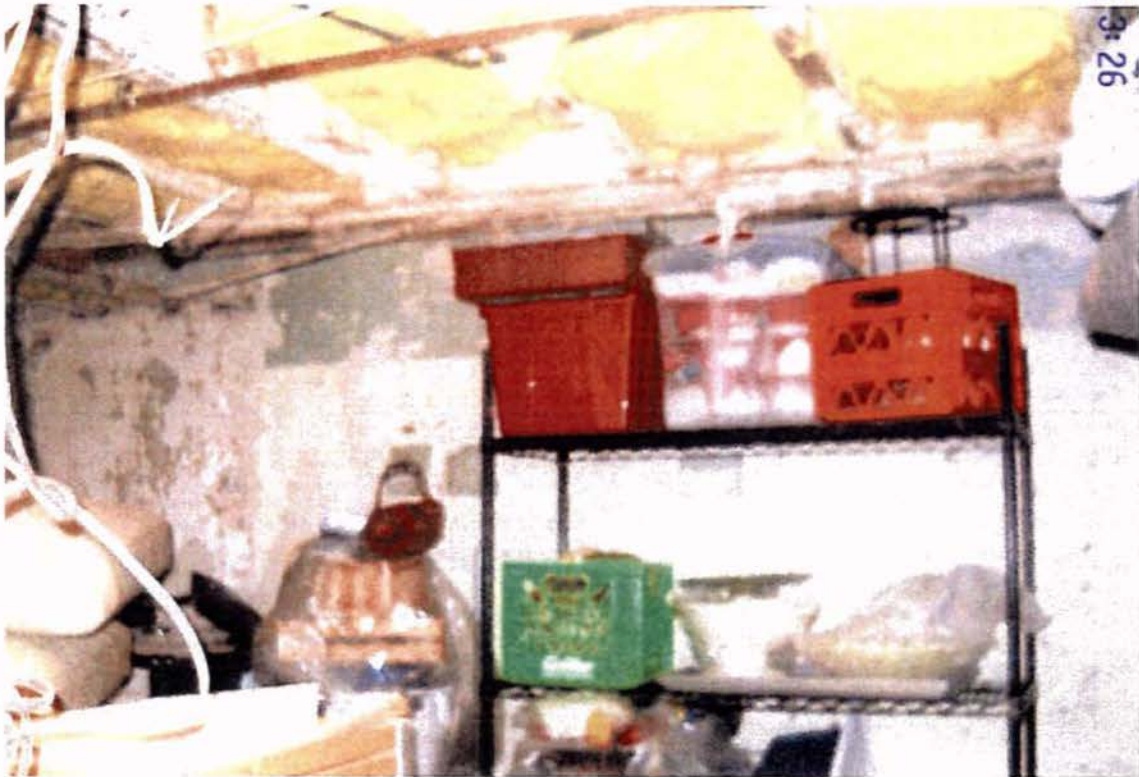
Basement Wall

2. We also observed the water seepage at the rear and left basement walls near the back door. See Figs. (3), (4), & (5). The brick wall in this area is structurally in poor condition. The water seepage could undermine the structural integrity of the house and should be addressed. We suggest parging and waterproofing of the wall, replacing the loose mortar and providing a proper drainage system behind the wall to minimize the water seepage.
