# Exhibit O

July 13, 2015

Re: Structural Concerns in your detached garage

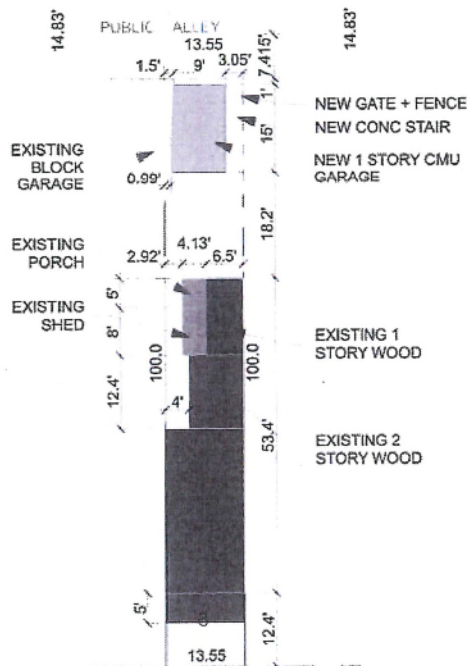
- b. There are three diagonal cracks in the East wall of the garage.
  - c. The top of the East Wall was checked and found to slope  $\frac{3}{4}$ " toward the front of the home.

Existing crack in the East Wall of the Garage.

The cracks in the exterior walls of the garage should be filled with mortar in a process known as tuck pointing and observed over time. This should be done to determine how quickly the foundations of the home are continuing to move and to deter water and insects from entering the garage. You can expect to need to plane and adjust the doors from time to time as part of normal maintenance. If a crack reappears four times, a structural engineering should be hired to determine if the East wall of the garage should be underpinned with helical piers. We are of the opinion that there is a low probability that the East foundation will settle to the point that it requires underpinning in the next 5 years.
