# Town Center Park - West Park

## Report of Current Conditions and Recommendations

Washington, District of Columbia

December 21, 2007

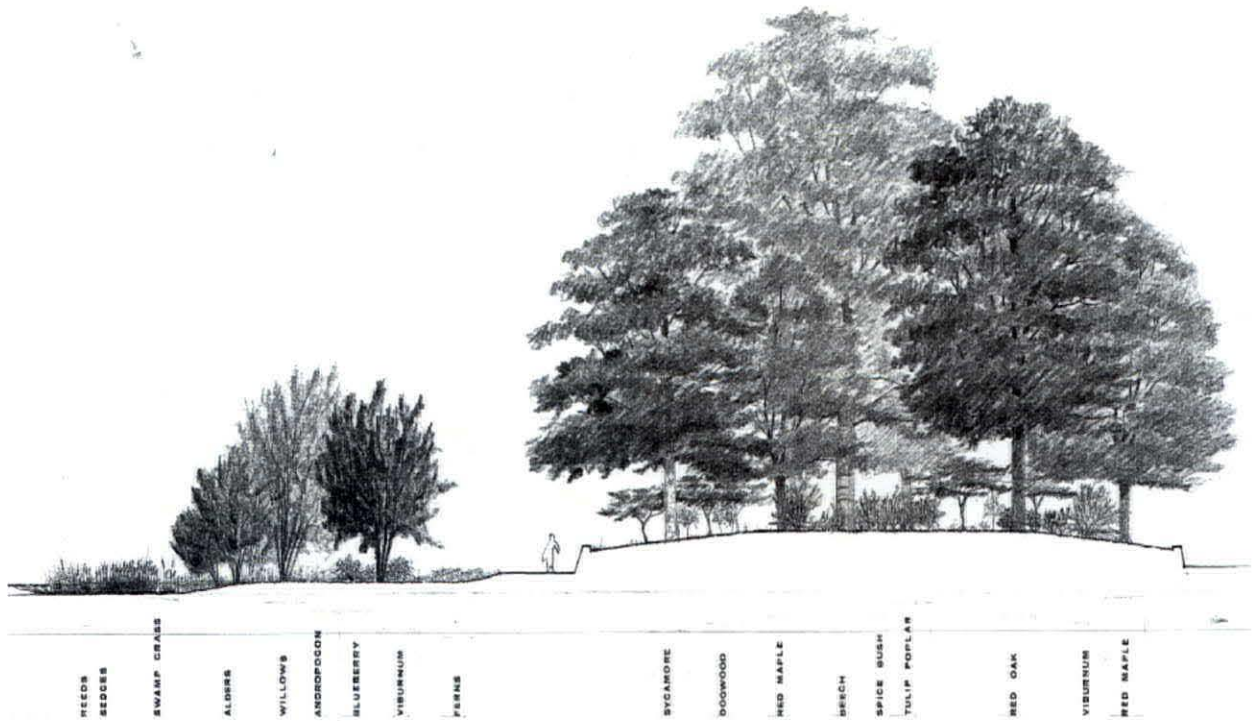
Figure 5  
Original planting concept (circa late 1960s)

When the park was first constructed, a very limited budget dictated that trees of two to four inch caliper to be installed; these were spaced closely together in order to create maximum effect in the near future. Lawn areas were not irrigated, another consequence of the constrained budget. In accordance with the regional theme, the original planting design was intended to include a variety of native groundcovers, shrubs, ornamental trees and canopy trees (Fig. 5).

As a result of the tight spacing during installation and lack of subsequent thinning, the park's trees are not fairing well. Though they have grown substantially, many suffer from root binding (Figs. 3 and 4) and all would benefit from professional pruning. Trees closest to the brick retaining walls are compromising the structural integrity and appearance of those walls, as discussed in the previous section. Aside from a few azaleas and other small shrubs, the park features few plants smaller than the large canopy trees – no sign of the multiple layers indicated in the original plans exists today.

Retaining an arborist to perform an extensive study of the current conditions of the plant material would help determine the health of the existing plants. Removal of some large trees would promote healthier growth in the remaining trees, and strategic pruning would thin the canopy (we suggest removing up to 30% of the existing canopy ), thus allowing other plants and lawn areas to grow in the

understory. The addition of a mixture of native ornamental trees and small shrubs (2-3' tall) into the park's plant palette would provide seasonal interest and help to further the concept of the space as an urban retreat. In areas without shrubs, a low-maintenance turf grass could be planted as long as irrigation was provided. In the promontories, the trees should be pruned up to permit better visibility; ornamental grasses along the edges of these spaces would add visual interest and help to further define the spaces.

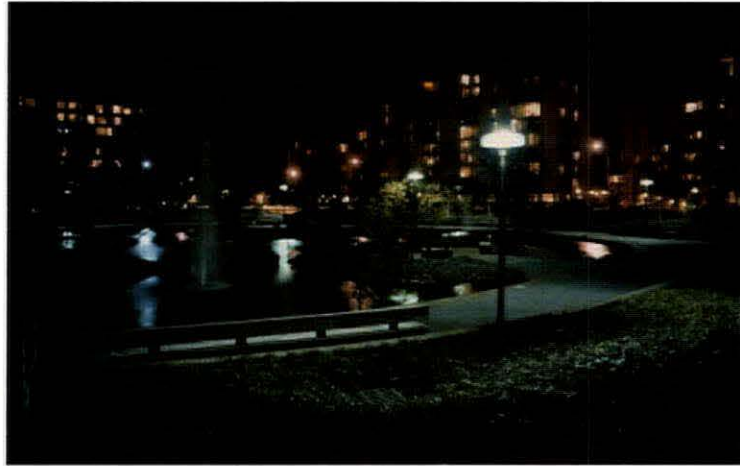
Figure 8  
Original pole-mounted lights - circa 1970

Site lighting and drainage systems appeared to have been designed appropriately for the park. Light fixtures conformed to the Modernist style that was popular at the time of the park's conception (Fig. 8).

Both the lighting and drainage systems need to be properly inspected to make sure they are functioning correctly. The drainage system should be cleaned out and renovated where required. At a minimum, any existing light fixtures that do not work should be replaced. A full lighting study should be performed to make sure that all areas of the park are adequately illuminated. New light poles and fixtures that relate to site furnishing requirements of the proposed AWI Transportation Architecture Design Standards should also be considered.

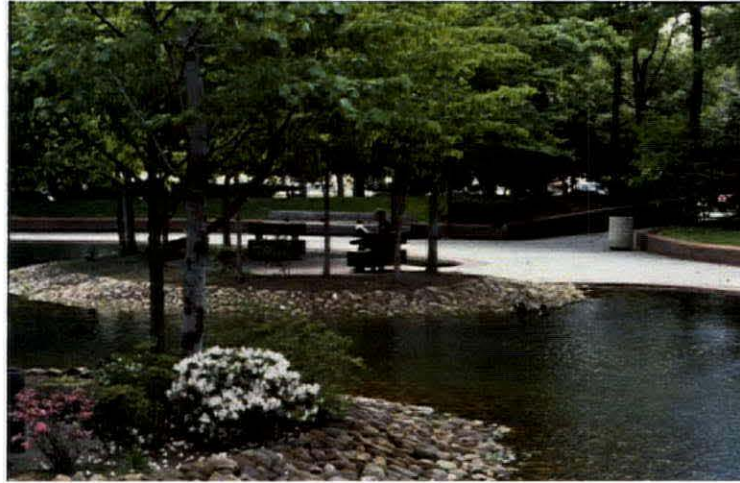
Figure 11  
Original park benches - circa 1980

Originally, West Park's site furnishings consisted of custom-made timber benches (Fig. 11), concrete trash receptacles, a concrete water fountain and a variety of marine-related items, such as an anchor and ship's wheel, made available by both the Navy and NPS. These elements were incorporated into the park to provide play structures for children and to connect, via the nautical theme, to the nearby Potomac River.

Almost all of the original site furnishings in the park have been removed or replaced. The custom timber benches have been substituted with standard NPS site furnishings (Fig. 12), and all of the original play structures have been removed. A nondescript plastic and aluminum slide (Fig. 13) has taken the place of the slide once located at the southeast corner of the park while nothing was put in place of the ship's wheel that used to occupy the northeast alcove. Though the water fountain remains, it is no longer functional. Only the concrete trash receptacles continue to be used as designed.

The addition of a long timber bench on the west side of the pond, similar to the one that was originally constructed and other new, contemporary benches and pole-mounted light fixtures would contribute to the unique character of the park (Figs. 16 and 17). These site furnishings should be coordinated with the AWI Transportation Architecture Design Standards once they are established to make sure that they can be properly maintained and fit with the character of other projects in the area. The water fountain should either be repaired or removed and replaced if repairs are not possible.
