Re: *BZA Appeal No. 17285*

4825 Dexter Terrace, NW  
Frank & Dina Economides, Owners

BZA Appeal No. 17285

**THIRD AFFIDAVIT OF PATRICK J. CAROME**

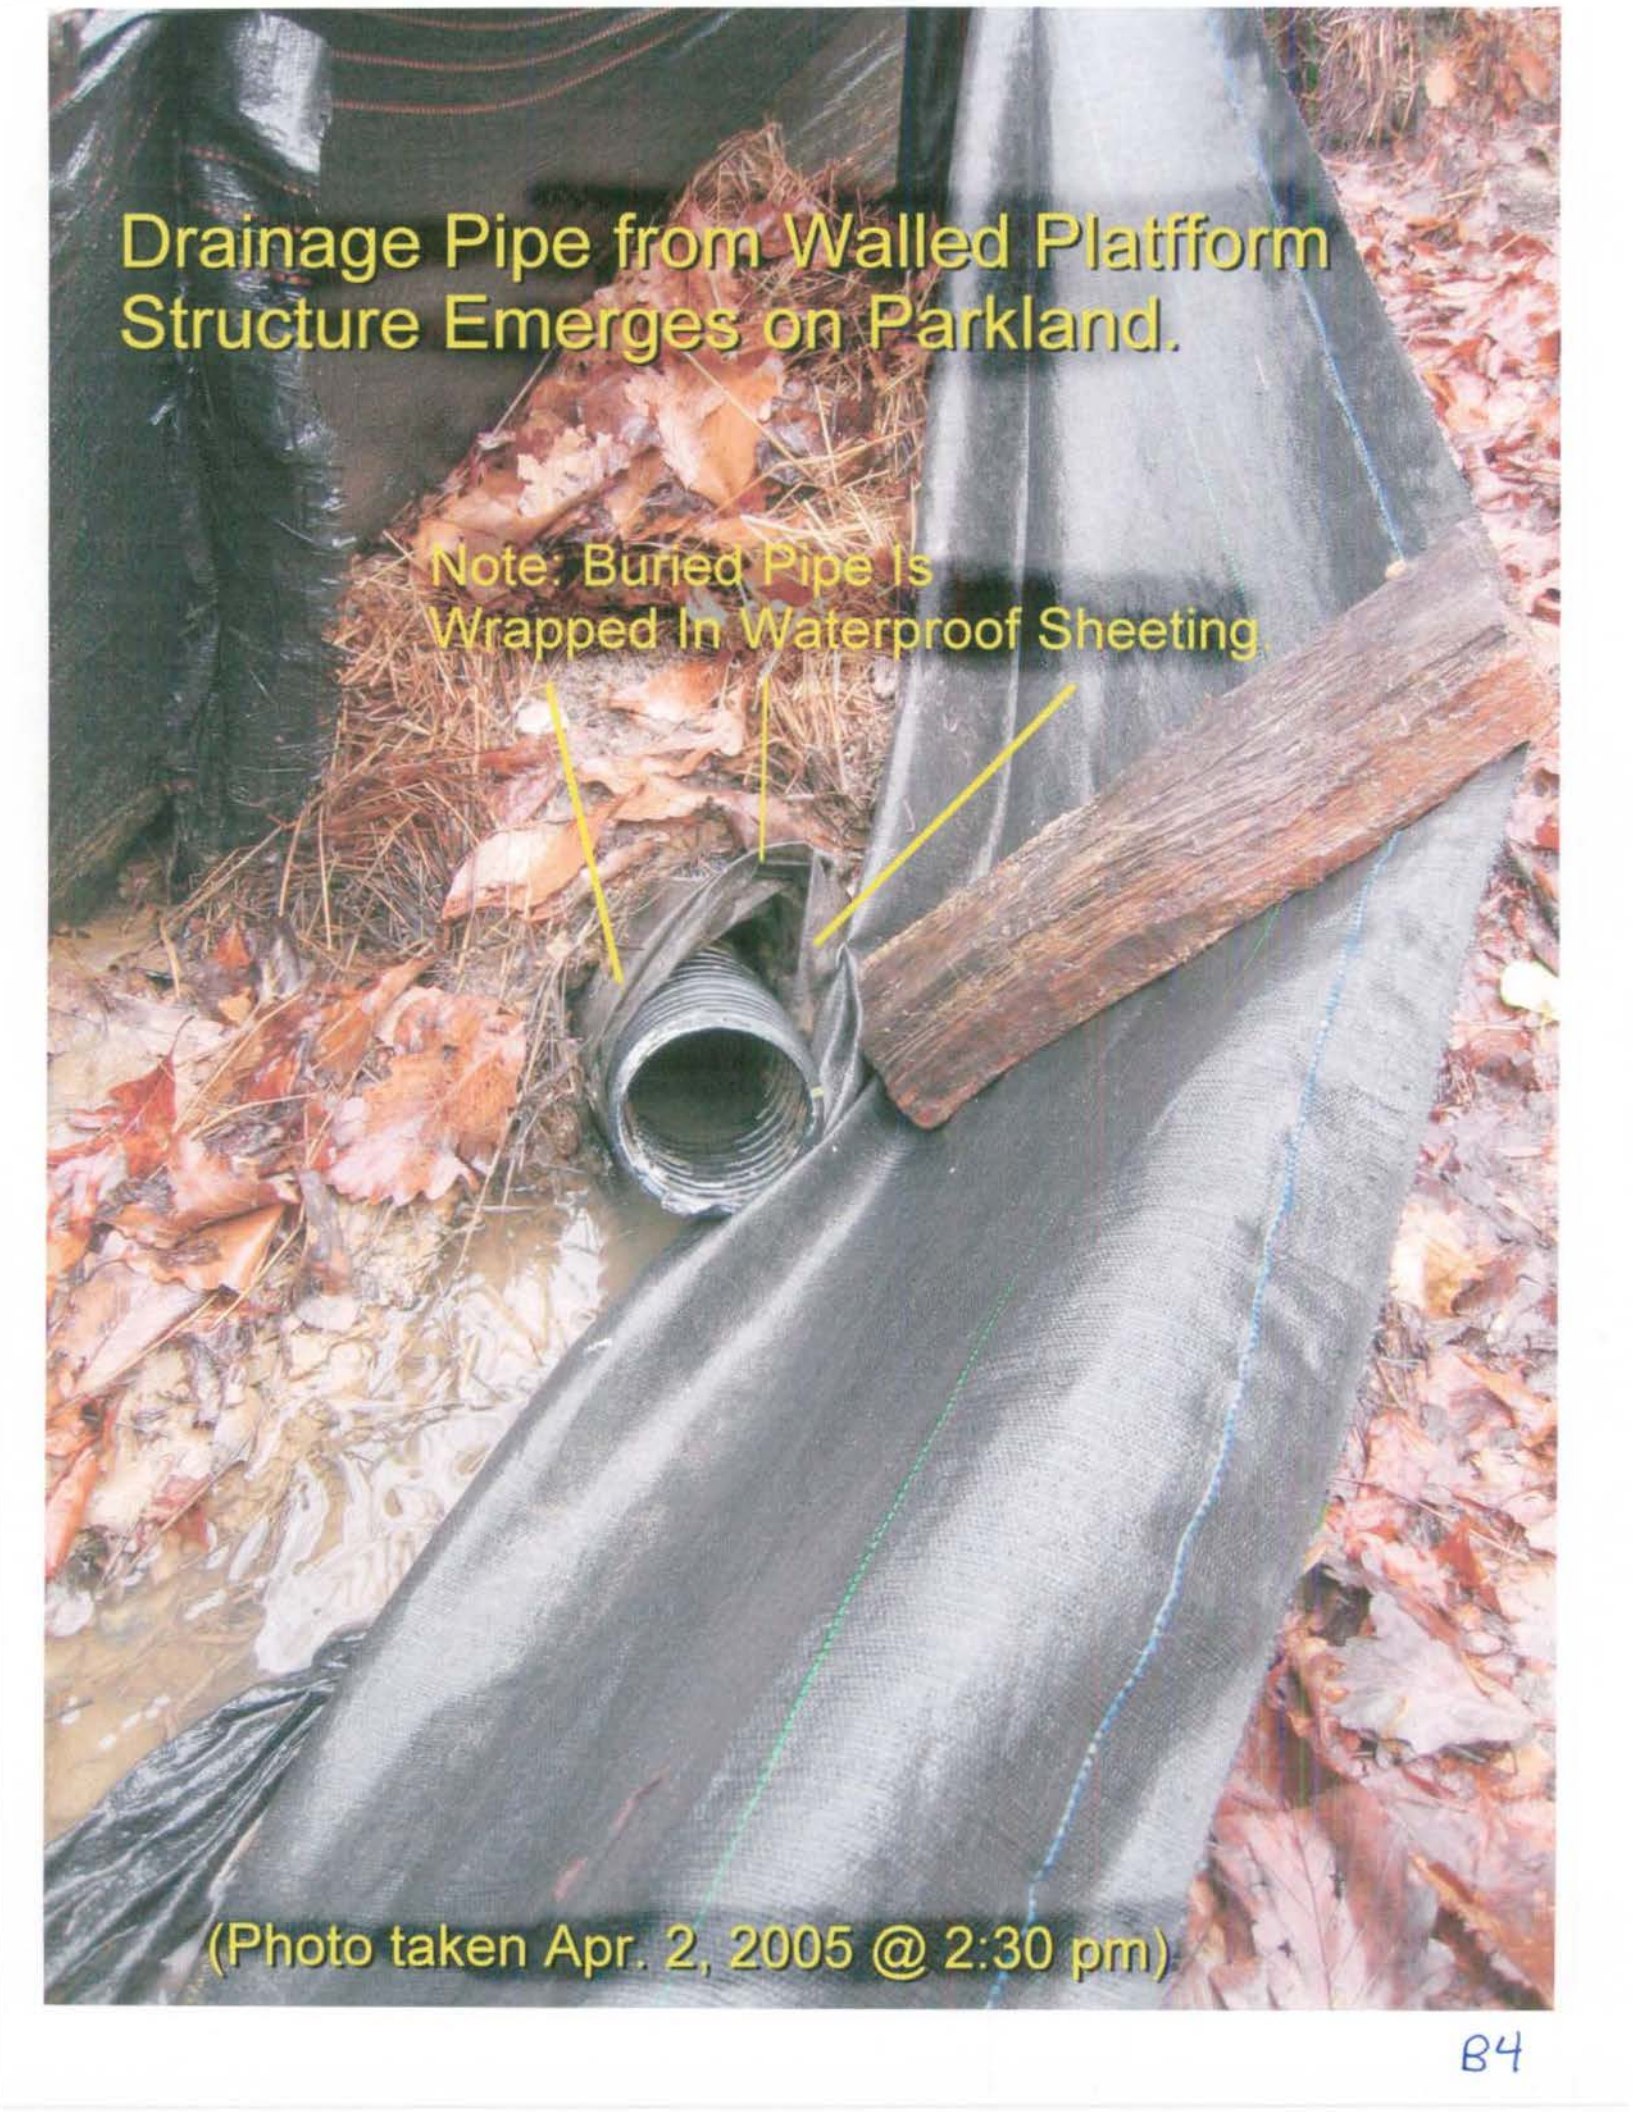
(Photo Taken Apr. 2, 2005 @ 2:36 pm.)

## Drainage Pipe from Walled Platform Structure Emerges on Parkland.

Note: Buried Pipe Is  
Wrapped In Waterproof Sheeting.

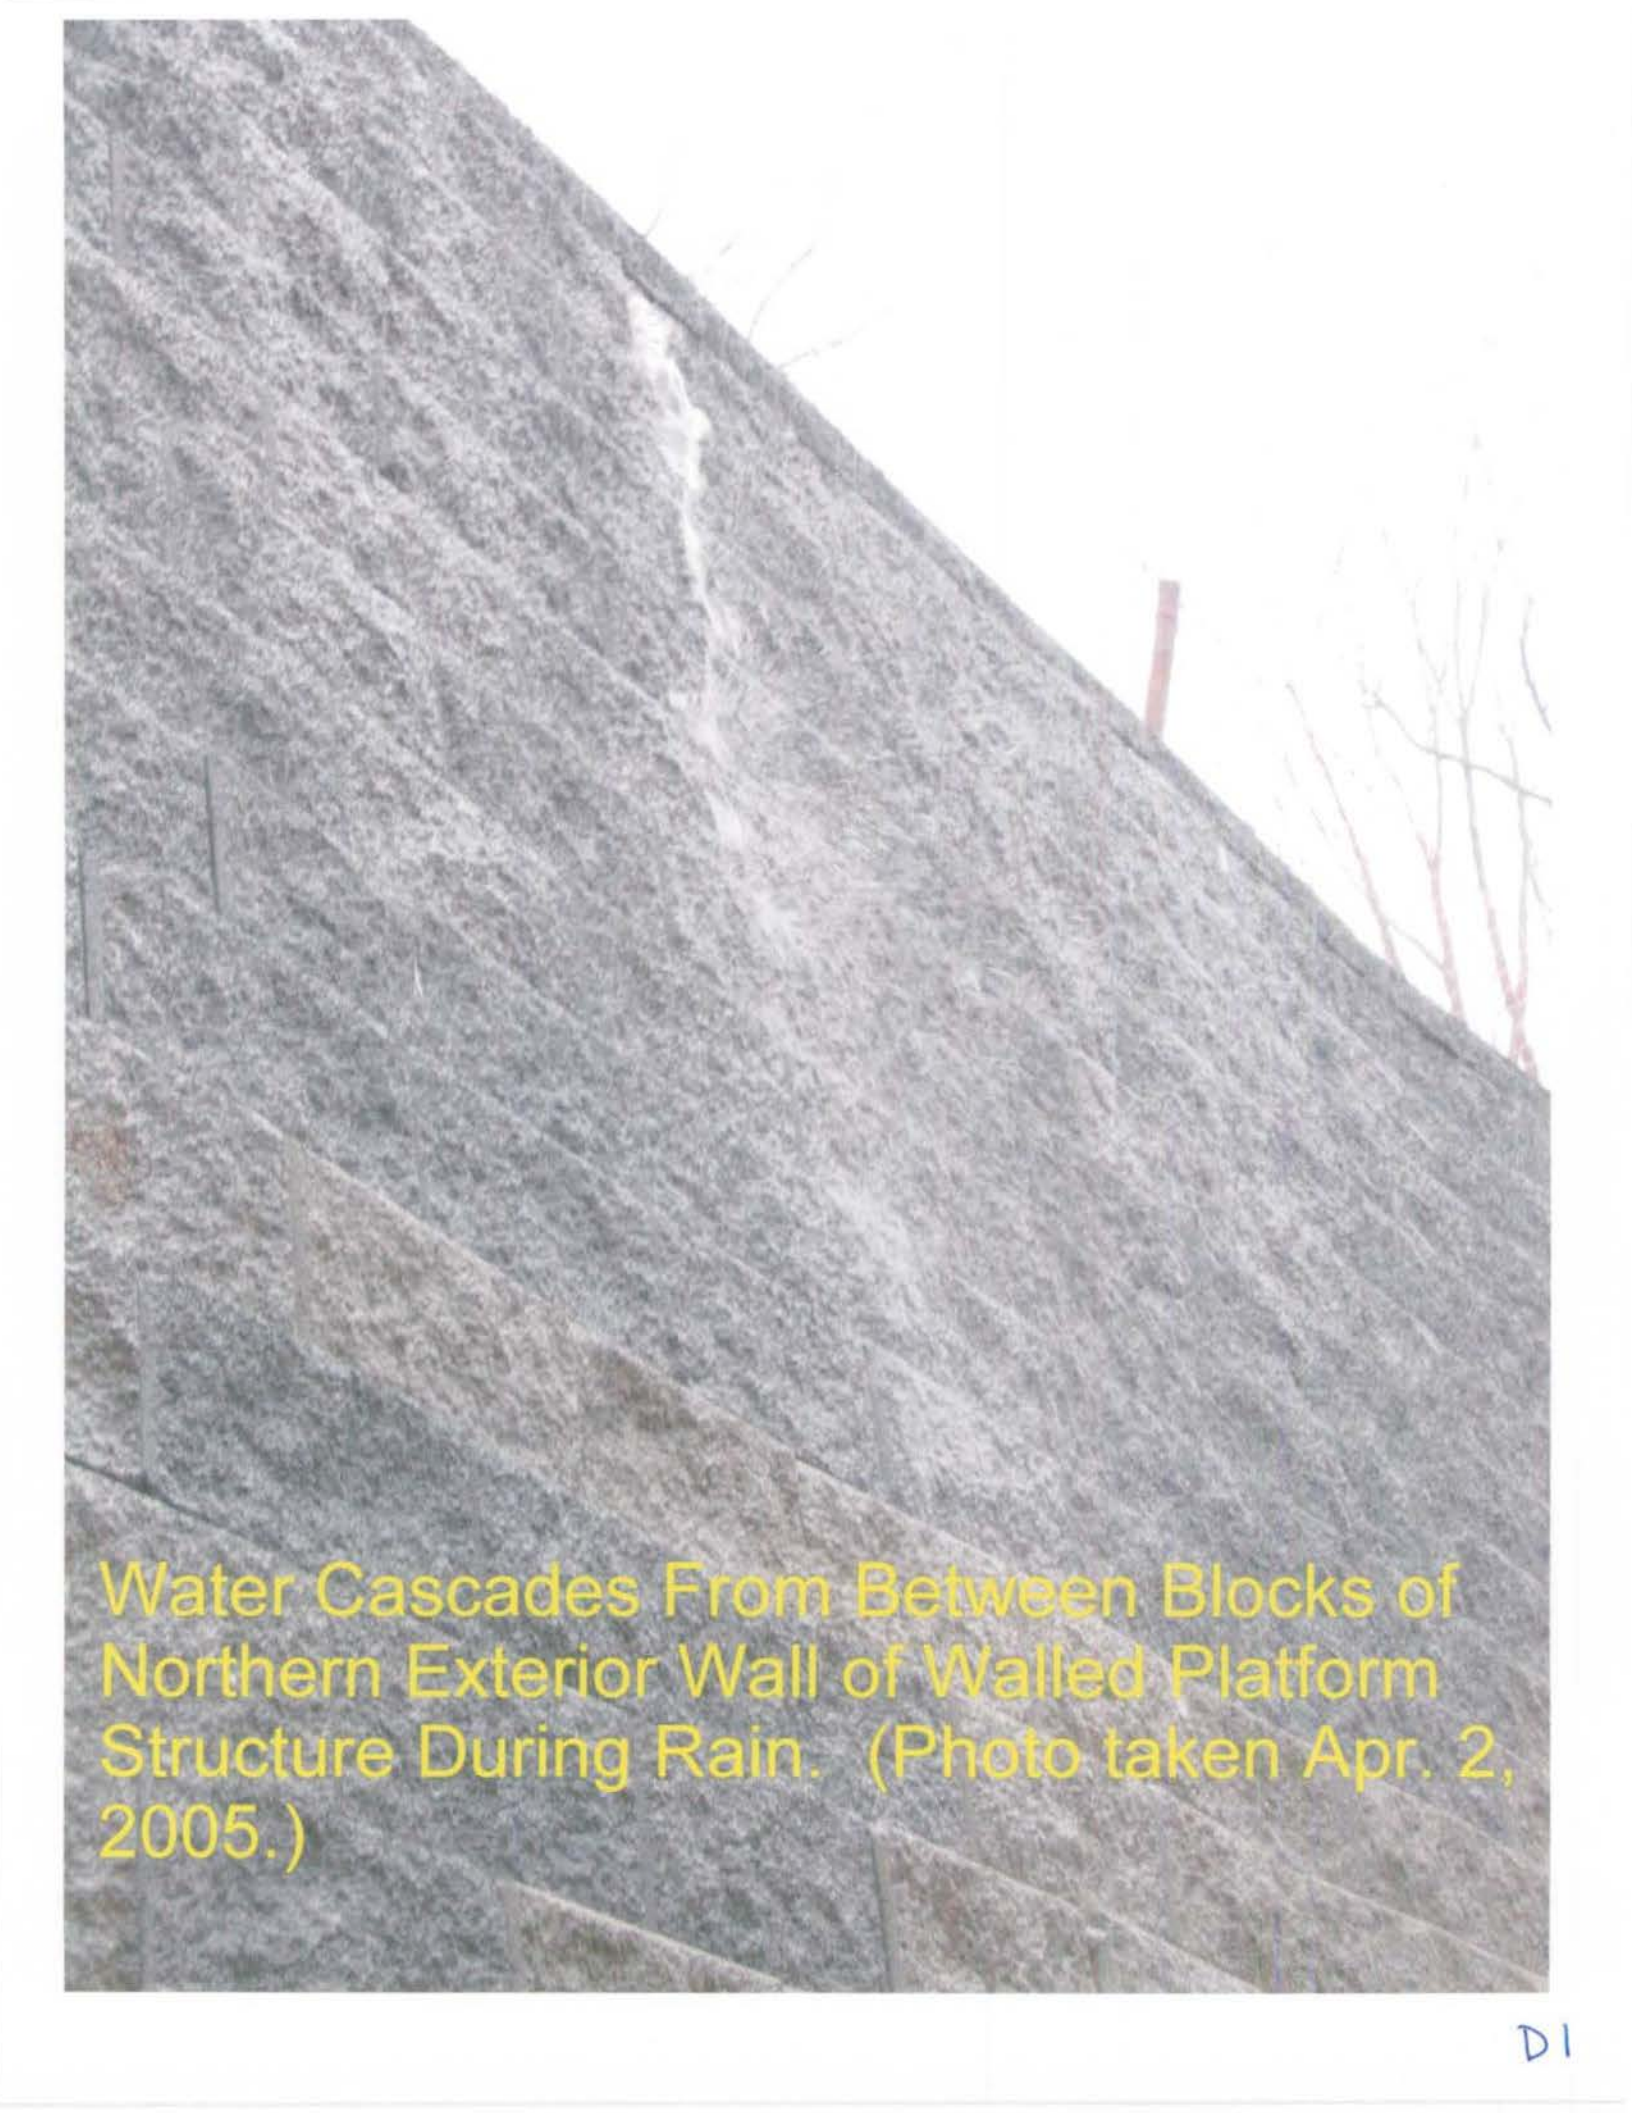
(Photo taken Apr. 2, 2005  
@ 11:43 a.m.)

Water Cascades From Between Blocks of Northern Exterior Wall of Walled Platform Structure During Rain. (Photo taken Apr. 2, 2005.)

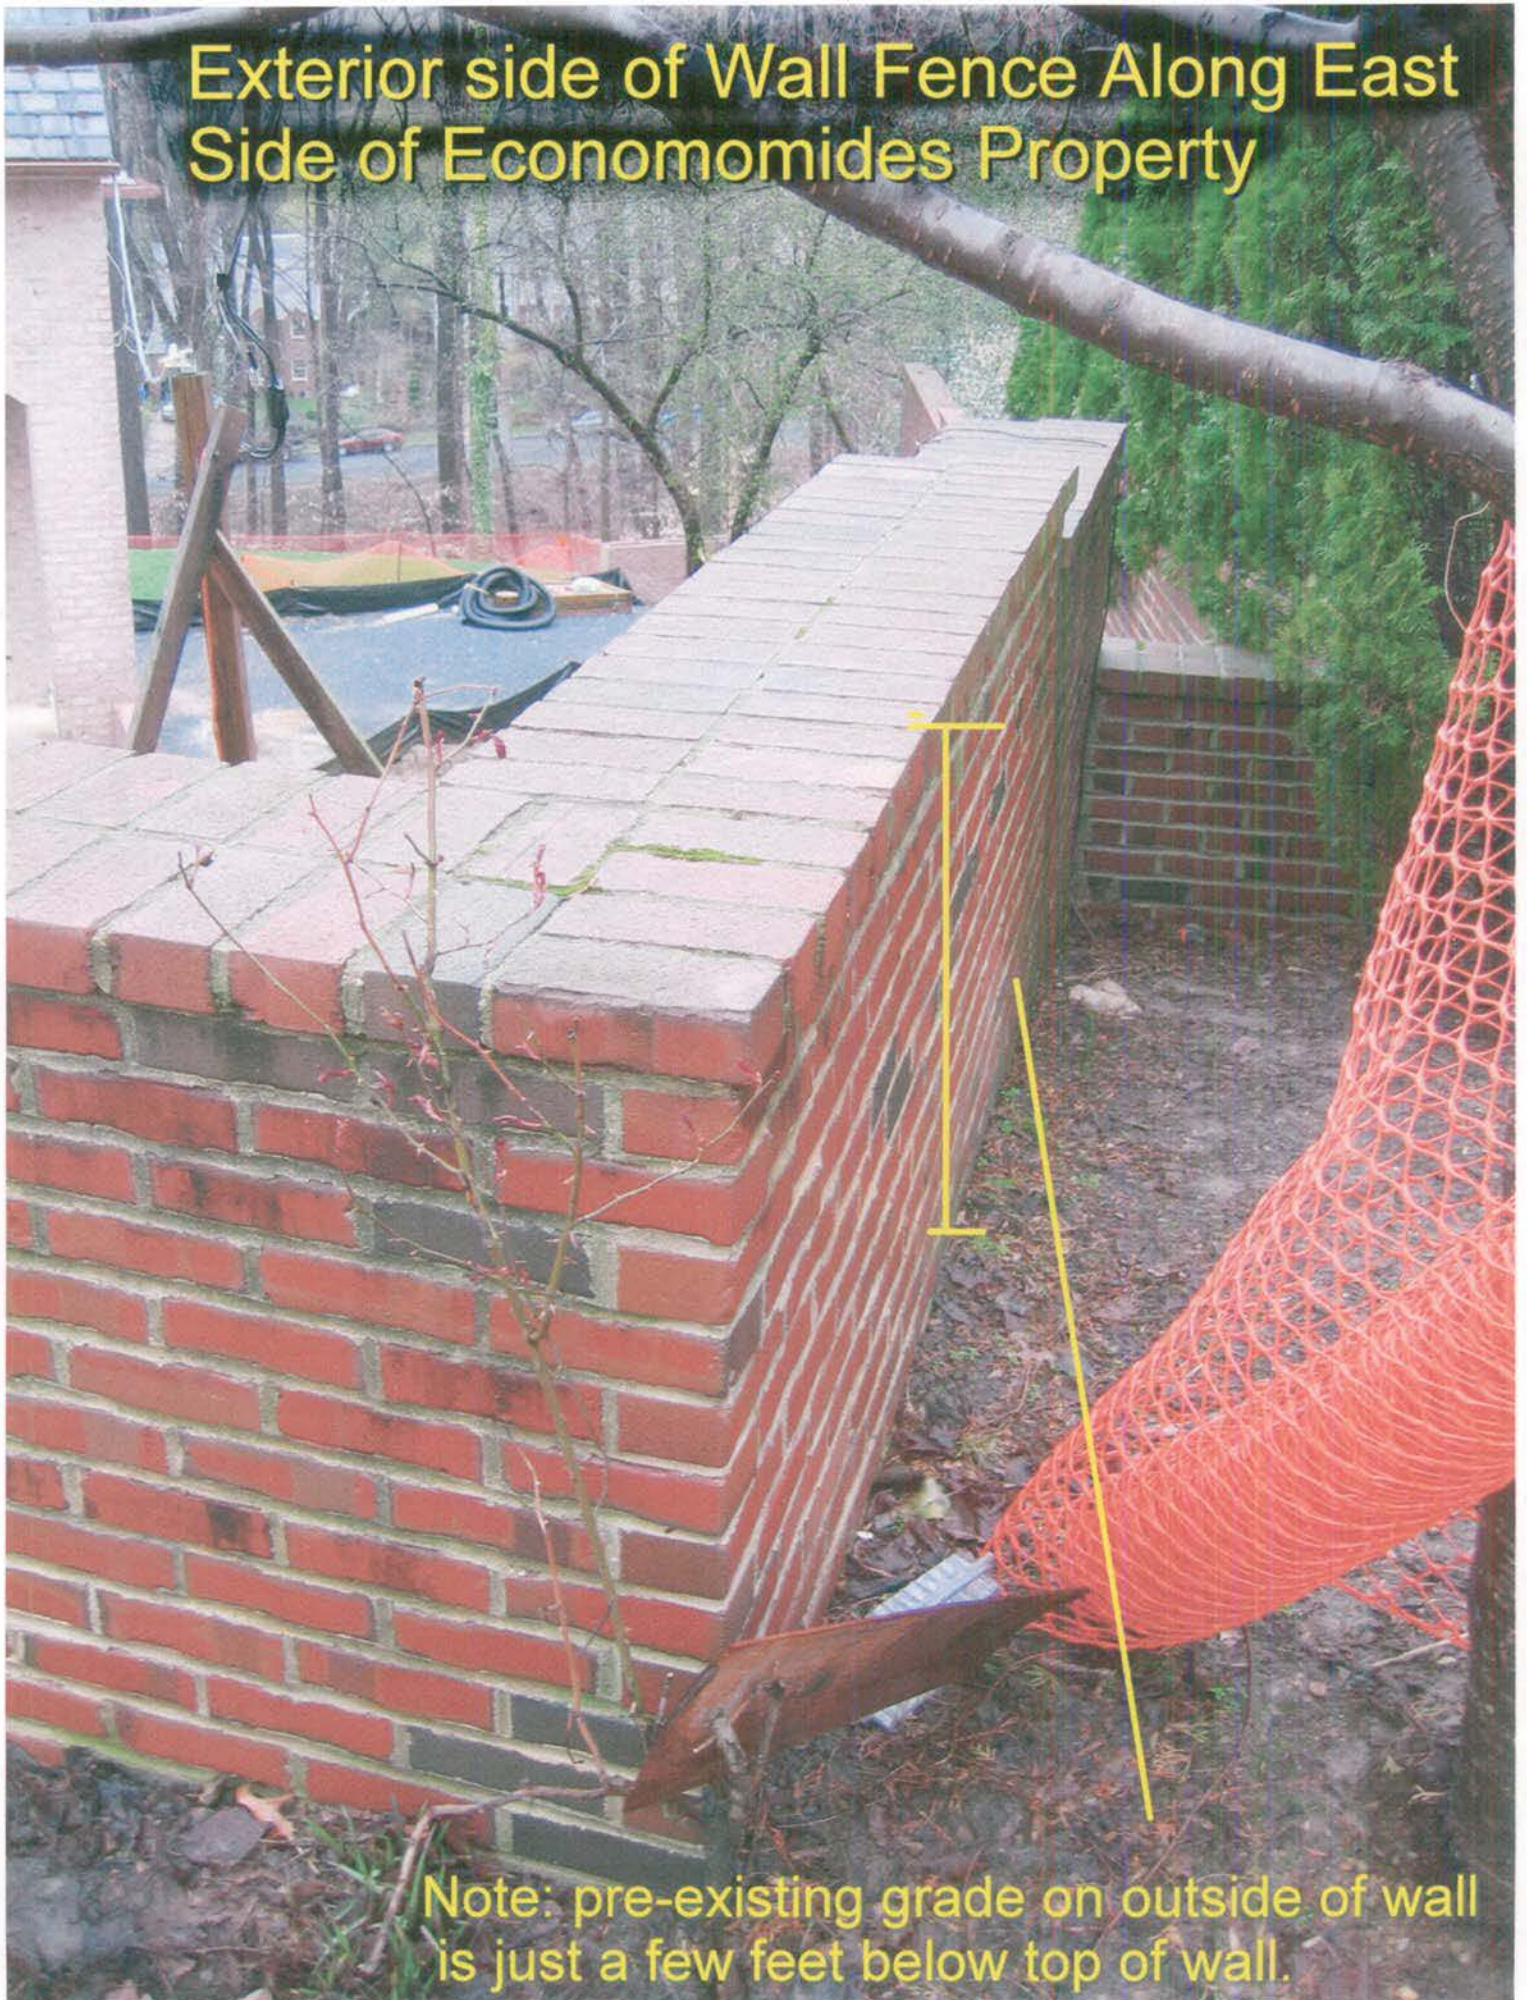
# Exterior side of Wall Fence Along East Side of Economomides Property

Note: pre-existing grade on outside of wall is just a few feet below top of wall.
