# ROYAL EMBASSY OF SAUDI ARABIA WASHINGTON

## 1. West Façade - New Hampshire Avenue, N.W., West Compound Access Control (WCAC)

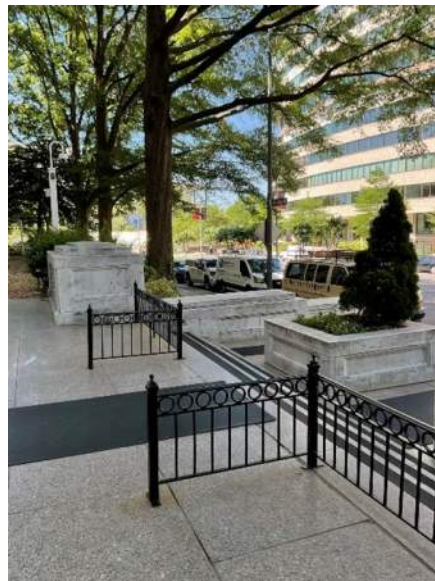
Fig. 8. 24" tall ornamental fences bordering the upper landing entrance stairway to WCAC (LE014)

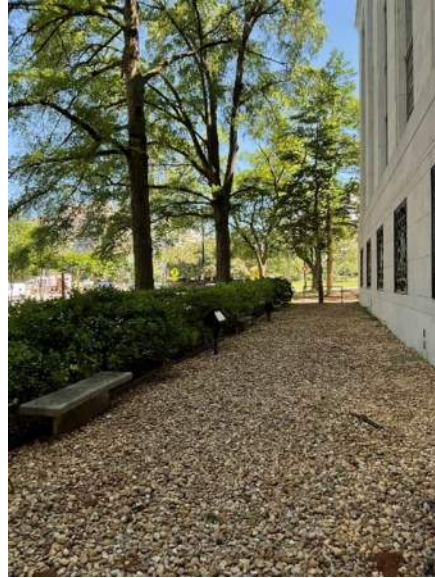
Fig. 10. View north of loose aggregate strip at foundation – three concrete benches situated among the euonymus shrub border (LE011 & LE012)

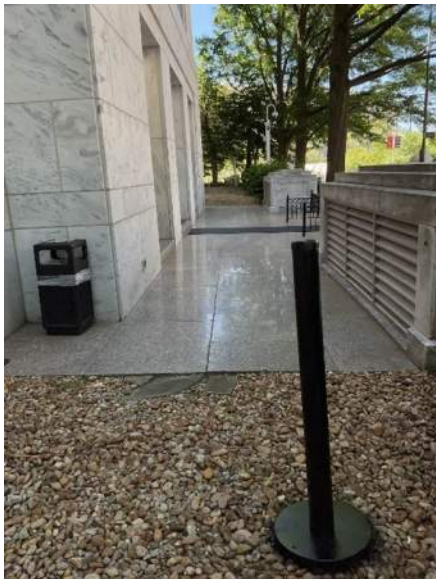
Fig. 11. View south from loose aggregate strip toward the WCAC upper landing. Ash/trash can located on the north side (LE015)

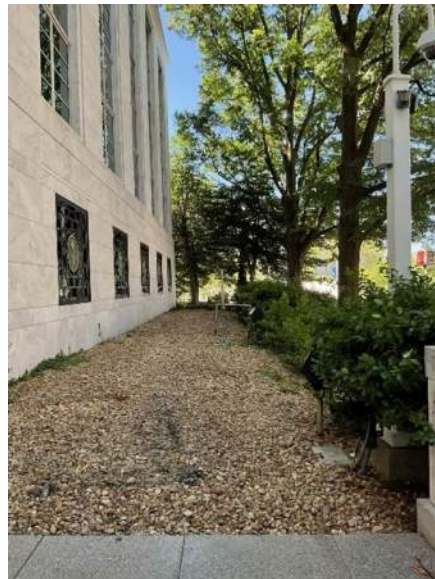
Fig. 12. View north to loose aggregate strip south of WCAC entrance stairway landing (LE011)

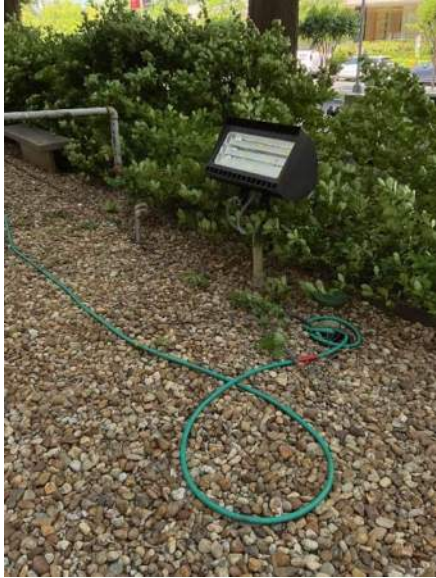
Fig. 13. Hose bib connection and uplight in loose aggregate strip south of WCAC entrance (LE011)

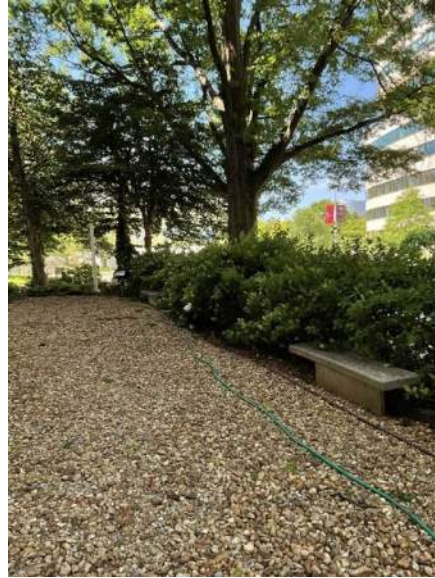
Fig. 14. View south of loose aggregate strip at foundation - two concrete benches situated along the euonymus shrub border (LE011 & LE012)

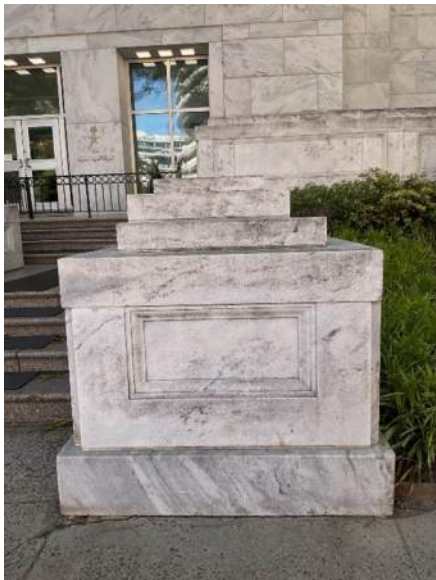
Fig. 15. Marble wall at south side of WCAC stairway (LE010)

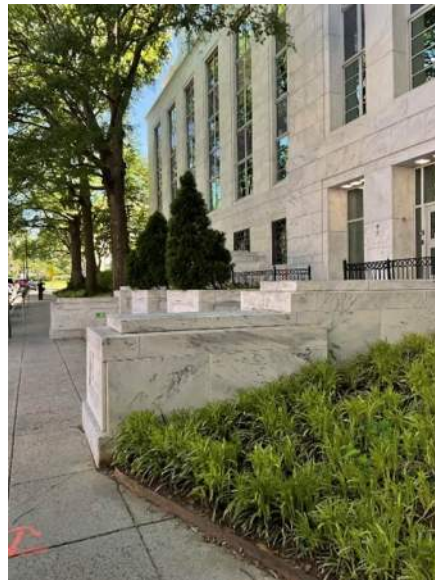
Fig. 16. View north of marble stairway at WCAC entrance; liriope groundcover at wall foundation; metal edging separating planting area from concrete sidewalk (LE010)

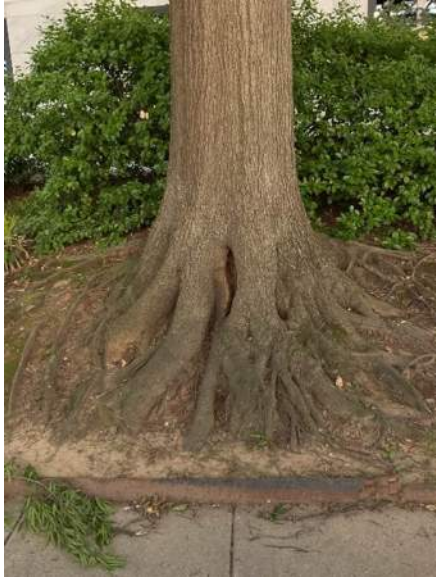
Fig. 17. Root system of willow oak at sidewalk, south of WCAC stairway (LE006)

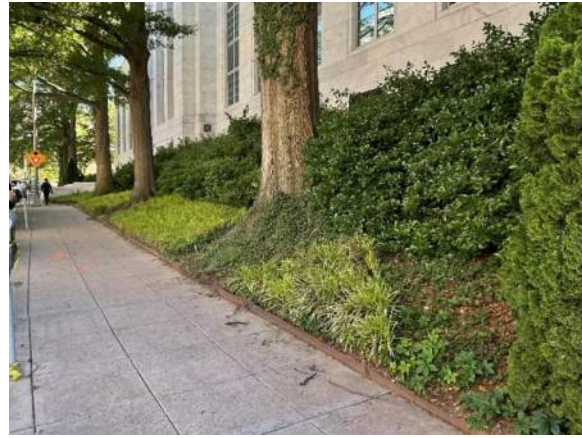
Fig. 21. Plantings at south corner of west façade includes evergreen shrubs - arborvitae (*Thuja spp.*), limbed-up, mature holly trees (*Ilex spp.*), 'Gold Dust' Acuba (*Acuba japonica*), and Goshiki osmanthus (*Osmanthus goshiki*). Groundcovers include liriope (*Liriope muscari* 'Variegata'), English ivy (*Hedra helix*) and turf grass (LE017)

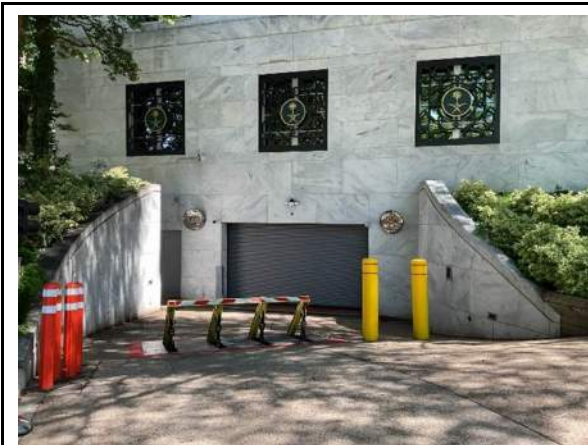
Fig. 23. PCAC Garage entrance with separate doors for vehicles and staff; sloping marble retaining walls (LE021)

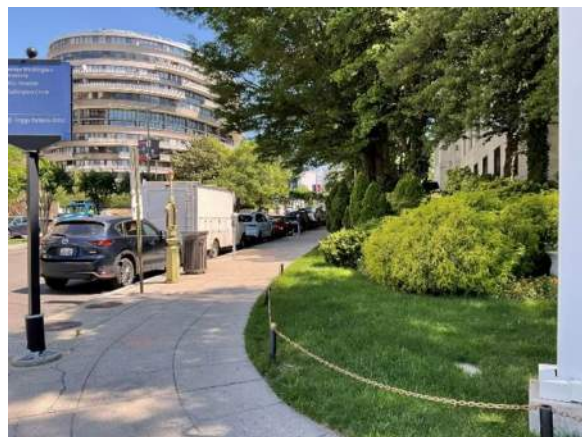
Fig. 24. View toward New Hampshire Avenue, N.W. and the Watergate Complex; a low, single chain border separates the sidewalk from the planting area (LE020, LE025)

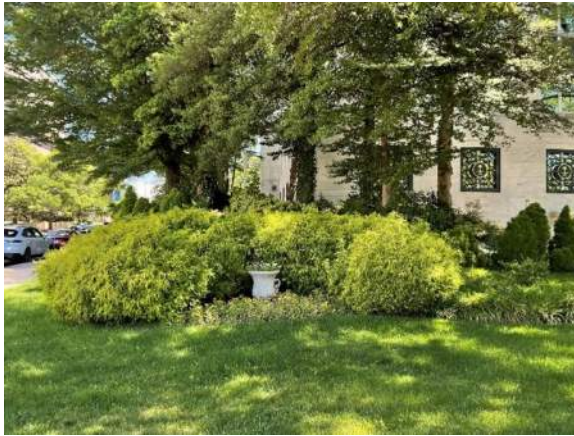
Fig. 25. Chartreuse Japanese false-cypress accentuate the corner planting bed surrounding a small urn and annual color (pansies); Holly trees are likely limbed up for visibility around the building (LE020, LE026-27).

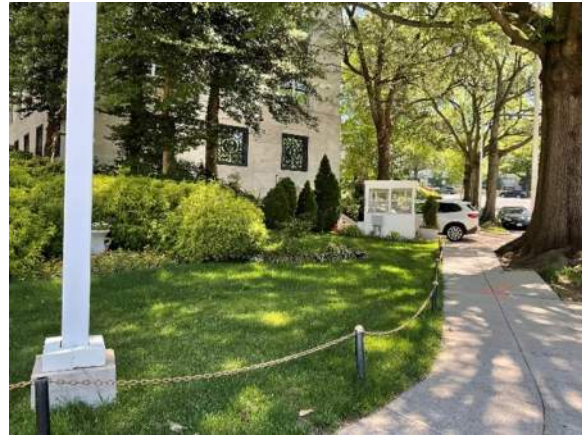
Fig. 26. View looking east along F Street, N.W.; The largest tree on site, a 3.8 m (151 inches) circumference willow oak (*Quercus phellos*), frames the right side of the photo (LE018). A white security camera pole appears on the left. A car enters the garage drive and stops at the PCAC small guard house (LE029).

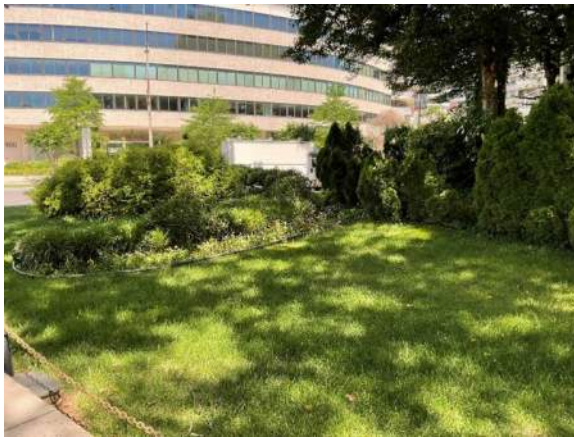
Fig. 27. View northwest toward the Watergate Complex. Shrubs and groundcovers in this planting bed have matured and maintaining a clean, formal design is challenging, as plants merge with neighboring plantings. Rubber edging forms a border around this amoeba-shaped bed (LE020).

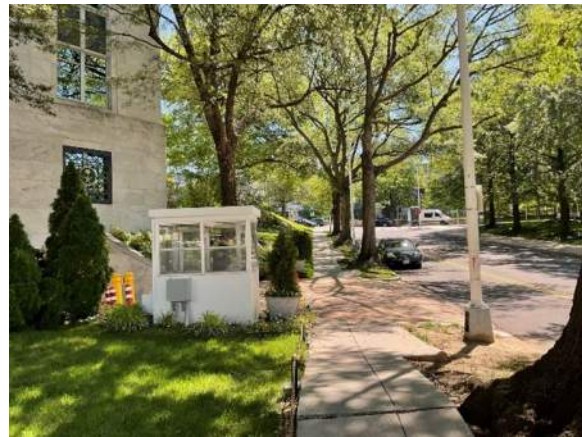
Fig. 28. View east along F Street N.W. toward mature water oaks of Heritage and Special Tree stature. The sidewalk buckles in the foreground at the largest tree on site, a 3.8 m (151 inches) circumference willow oak (*Quercus phellos*), root flare capture at the bottom right corner (LE018).

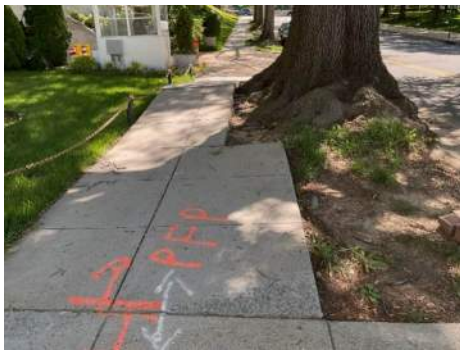
Fig. 29. View east along F Street N.W. The sidewalk buckles at the largest tree on site, a 3.8 m (151 inches) circumference willow oak (*Quercus phellos*), root flare capture at the bottom right corner (LE018).

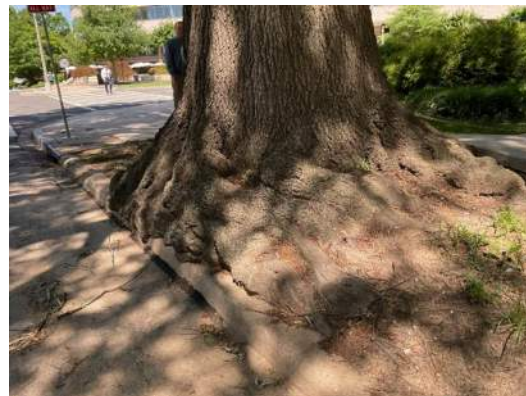
Fig. 30. View west along F Street N.W. Roots of the 3.8 m circumference willow oak tree envelop the curb along F Street, N.W. (LE018)

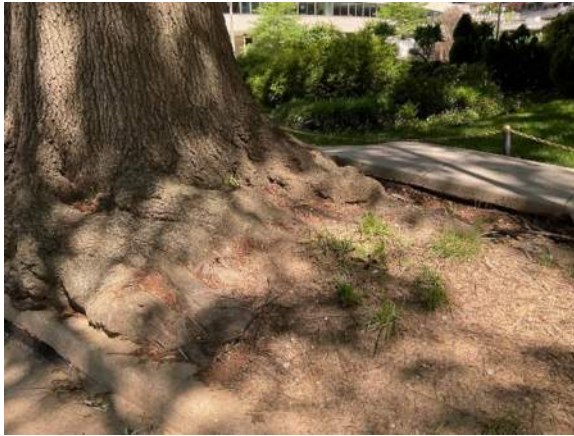
Fig. 31. View northwest along F Street N.W. at the 3.8 m (151 inch) circumference willow oak. The root flare lifts the adjacent concrete sidewalk (LE018).

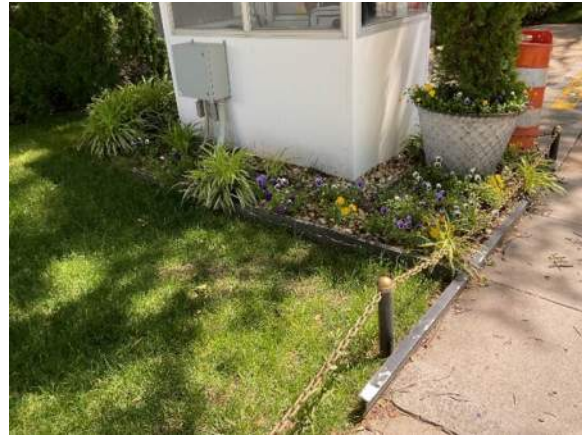
Fig. 32. Planting bed at the base of the PCAC guard house at the garage entrance on F Street N.W. Mix of edging materials - wood plank, metal strip, and chain link border. Pansies and liriop groundcovers with an aggregate mulch; potted arborvitae with pansies (LE029)

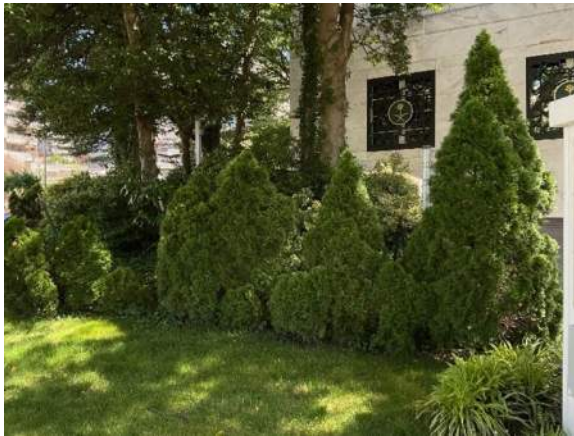
Fig. 33. View west toward the planting bed at the southwest corner. Conical arborvitae form a border around mature, limbed up holly trees (LE017, LE026-27).

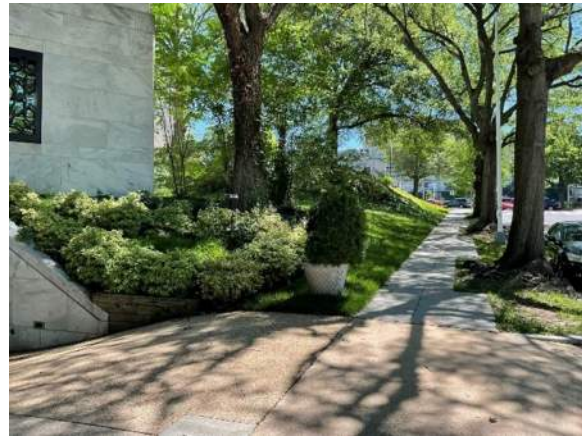
Fig. 34. View east along F Street N.W. toward mature water oaks and planting bed to the east of the garage entrance. A ring of variegated osmanthus shrubs encircle the liriop groundcover (LE022).

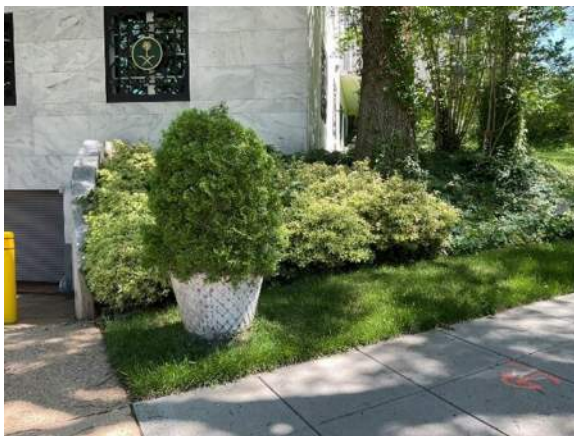
Fig. 35. View toward the southeast corner of the building. A potted arborvitae sits in the grass at the planting bed east of the garage entrance (LE022).

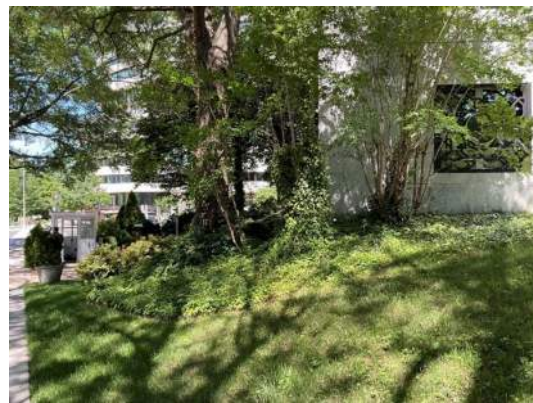
Fig. 36. View west along F Street N.W. toward the guard house and planting bed at the southeast corner of the building. English ivy and Virginia creeper climb the multi-stem crape myrtles and have an unkempt appearance. This location is too shady for crape myrtles (LE022).

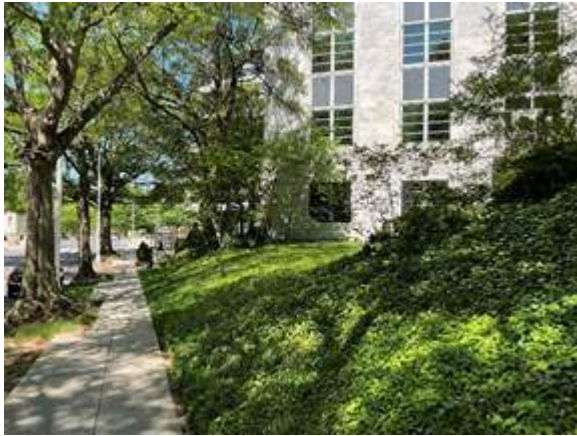
Fig. 39. View west on F Street, N.W. - Terrain slopes up to the north (LE040).

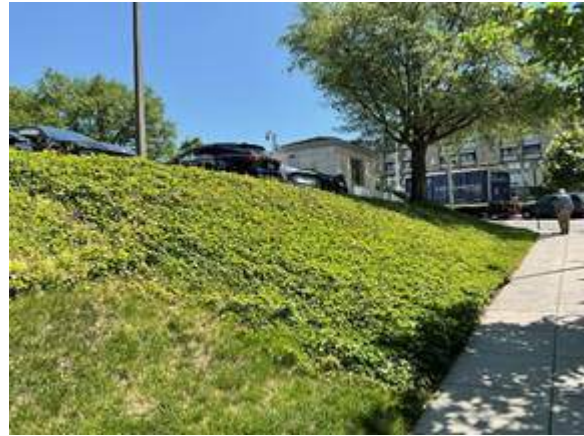
Fig. 40. View east toward 25th Street, N.W. - Parking at the top of the hill vegetated with turf grass and English ivy (LE040).

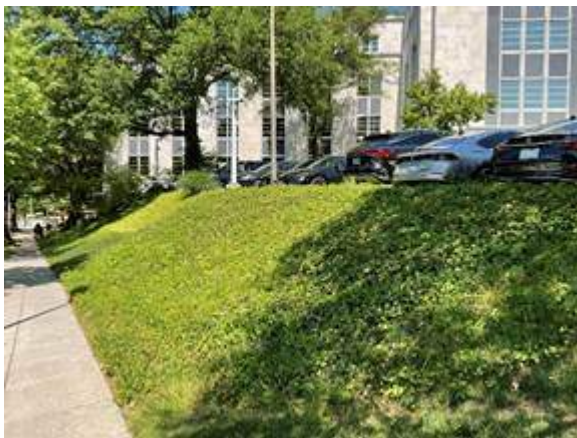
Fig. 41. View west on F Street, N.W. - Steep, vegetated hillside with parking lot at the top of the hill (LE040).

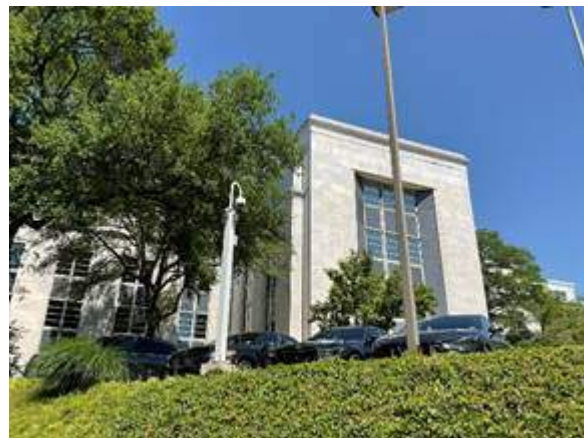
Fig. 42. View up toward the east façade from the public sidewalk on F Street, N.W. Mature water oaks are located to the north and south of the entrance (LE040).

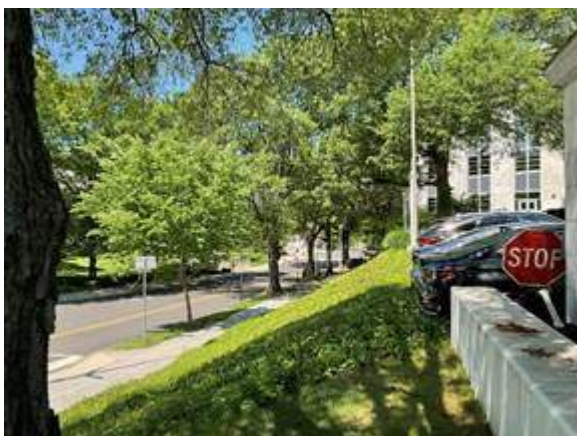
Fig. 43. View west along F Street, N.W. from the guard house - Steep, vegetated hillside with parking lot at the top of the hill (LE032).

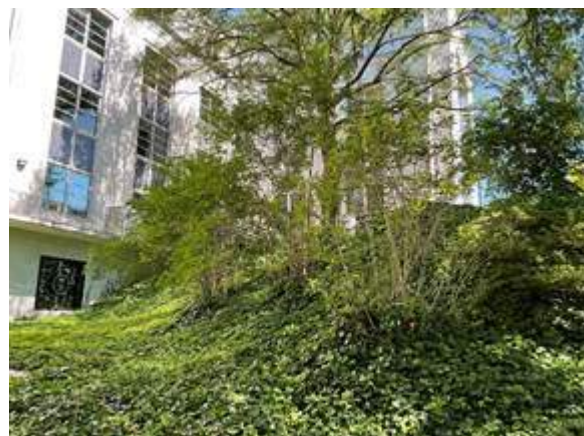
Fig. 44. View toward the southeast façade where the building emerges from the terrain. Non-native invasive English ivy vines cover the hillside and climb existing shrubs (LE039).

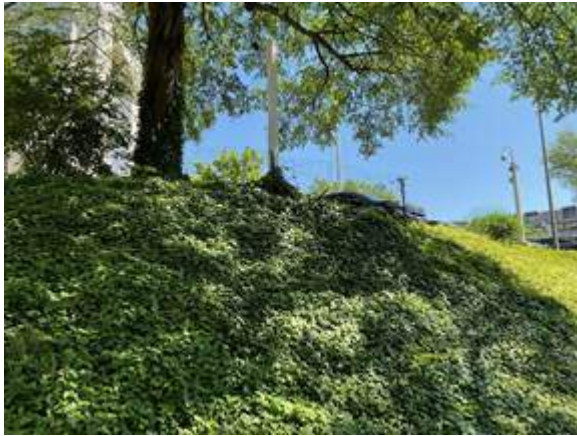
Fig. 45. View north from the public sidewalk toward the parking lot at the top of the hill. An aged wire fence stands at the edge of the parking lot (LE040).

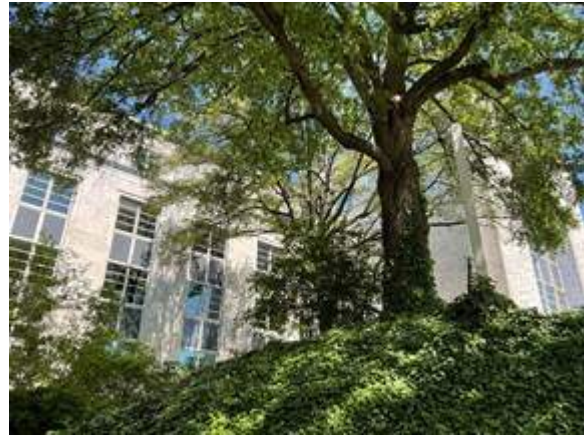
Fig. 46. View toward the southeast façade from the public sidewalk. Water oak trees (*Quercus nigra*) provide shade. Invasive English ivy spreads into the trees and forms an unruly mass at the base (LE040).

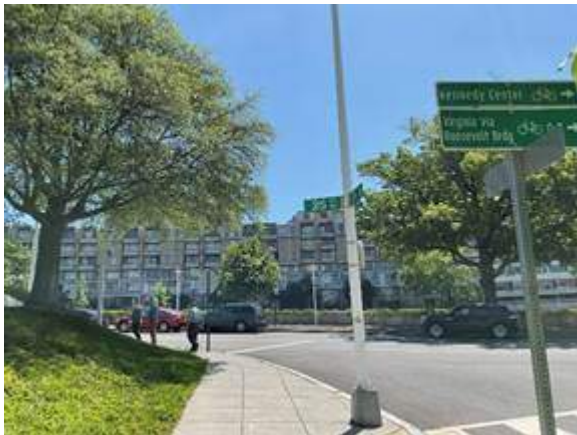
Fig. 47. View east toward the corner of 25<sup>th</sup> Street and F Street, N.W. A mature water oak anchors the corner next to the guard house (LE032).

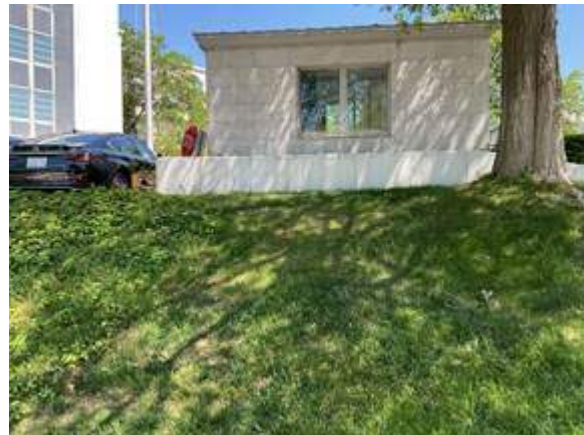
Fig. 48. View north toward the BCAC guard house from the sidewalk along F Street, N.W (LE032).

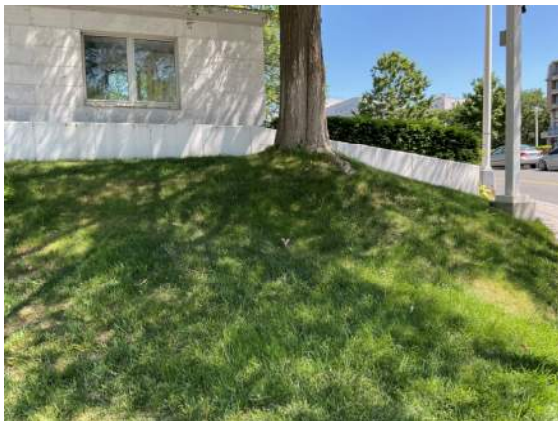
Fig. 49. View north toward the BCAC guard house and 25<sup>th</sup> Street, N.W., from the sidewalk along F Street, N.W. Mature willow oak at center. (LE032).

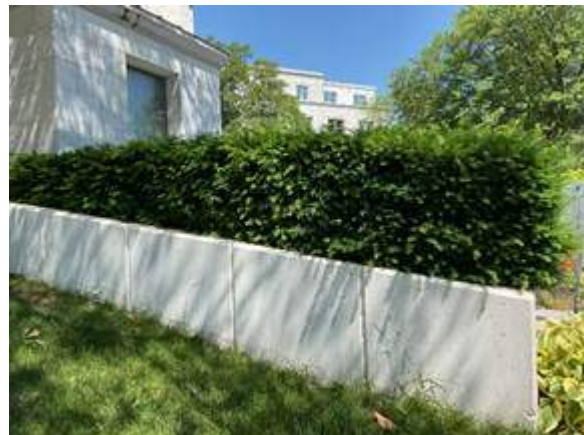
Fig. 50. View northwest toward the guard house. White concrete wall following the slope of the terrain and retaining a row of evergreen yews (LE041).

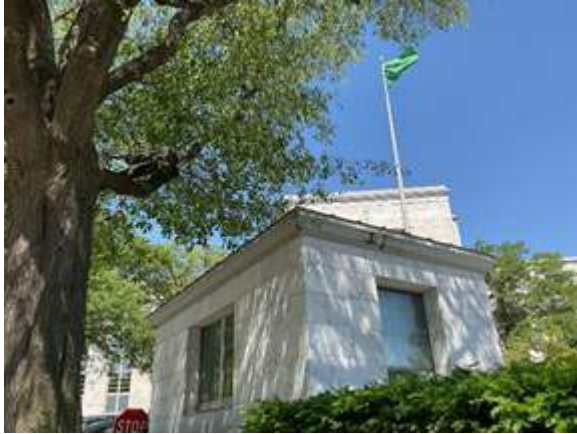
Fig. 51. View northwest from the corner of F Street, N.W., and 25<sup>th</sup> Street, N.W. toward the mature water oak (*Quercus nigra*) south of the BCAC guard house (LE032).

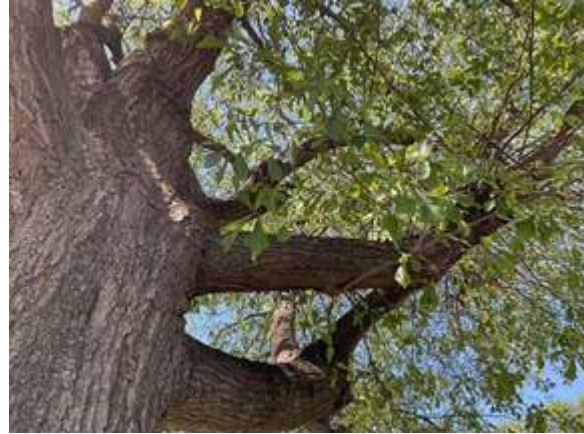
Fig. 52. View into the mature canopy of the 28" diameter water oak (*Quercus nigra*) south of the BCAC guard house (LE032).

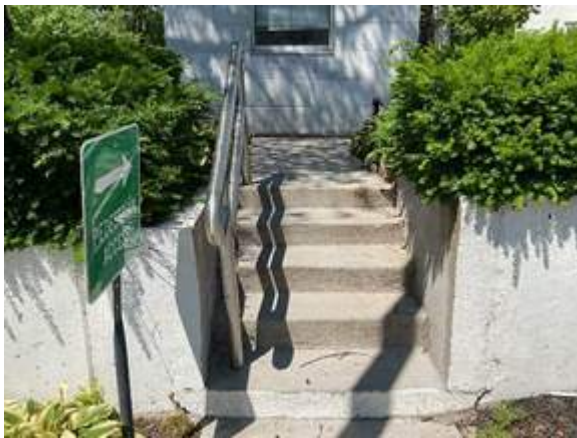
Fig. 53. Pedestrian access stairway to the BCAC guard house does not meet ADA standards (LE041).

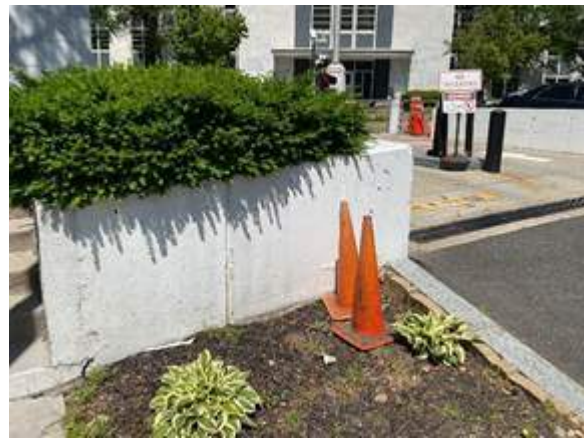
Fig. 54. Concrete wall north of the pedestrian access stairway, and south of the BCAC vehicle screening area (LE041).

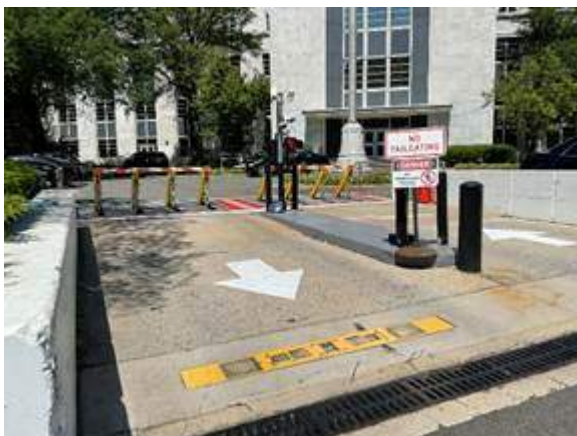
Fig. 55. BCAC vehicle screening accessed at 25<sup>th</sup> Street, N.W. (LE041)

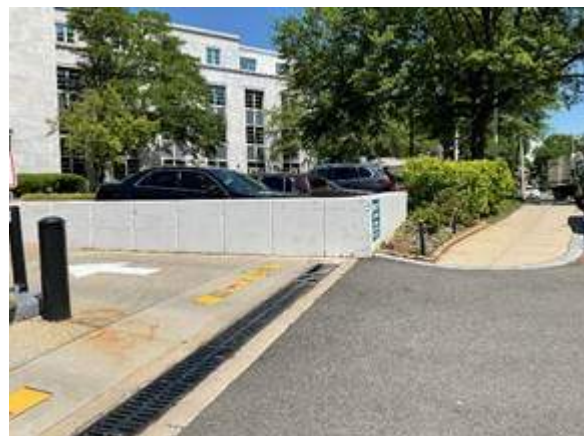
Fig. 56. View northwest to the southeast façade and concrete wall to the north of the BCAC vehicle screening area. View of the public sidewalk along 25<sup>th</sup> Street, N.W., at right (LE044).

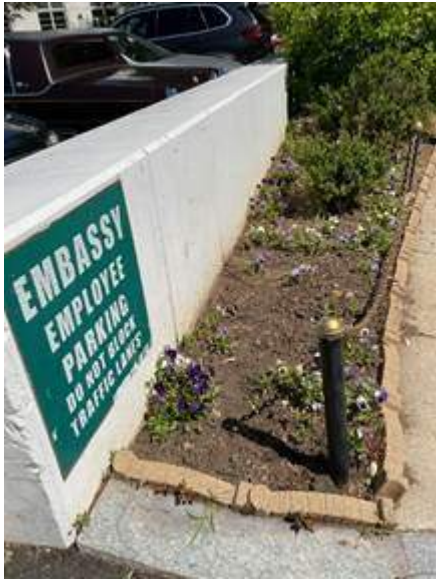
Fig. 57. Concrete wall north of the BCAC vehicle screening area with Embassy Employee Parking sign. Seasonal color (pansies) and bare soil are bordered with concrete unit edging stones and low, single chain barrier (LE044).

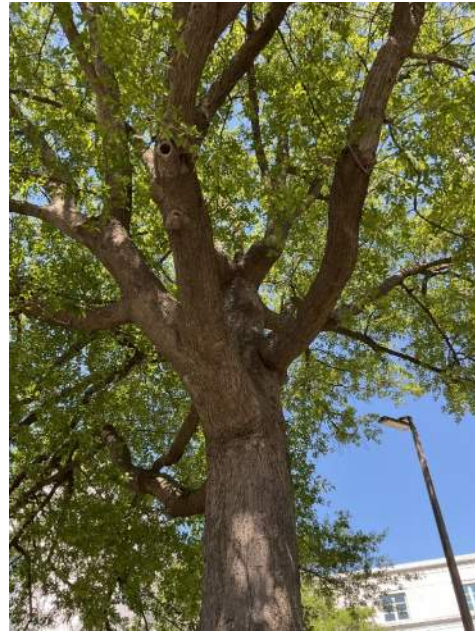
Fig. 58. Existing mature water oak tree in the public space, shading the parking lot (LE036).

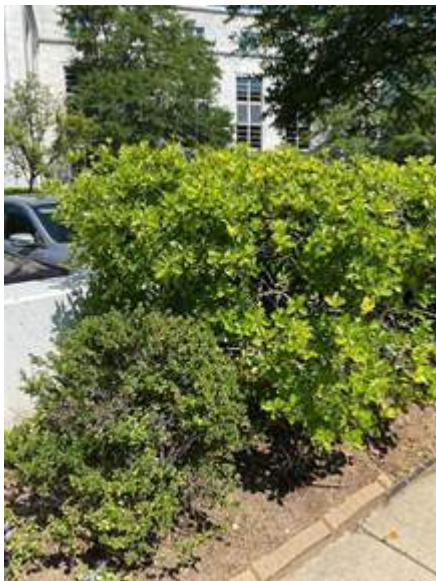
Fig. 59. Japanese holly (*Ilex spp.*) and euonymus (*Euonymus kaimtschovicus* 'Manhattan') shrubs soften the concrete wall at the perimeter of the parking lot when viewed from 25<sup>th</sup> Street, N.W. (LE044).

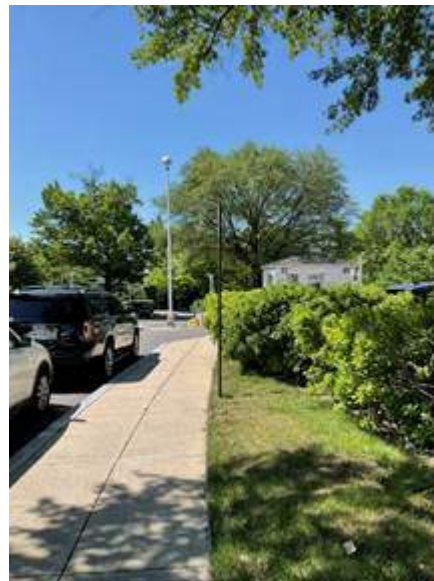
Fig. 60. View south along 25<sup>th</sup> Street, N.W., toward the BCAC and corner of F Street, N.W. Evergreen shrubs filter the view of the concrete wall and parking lot. (LE044).

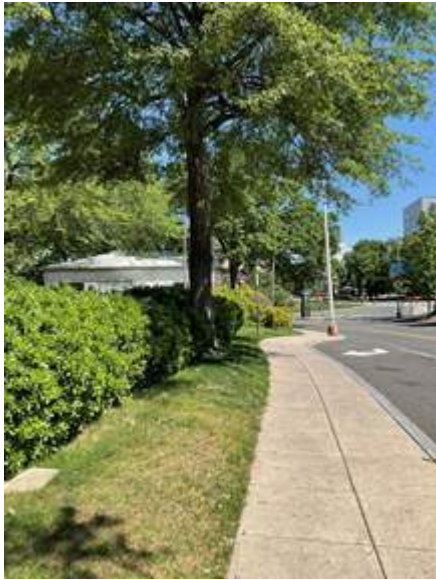
Fig. 61. View north along 25<sup>th</sup> Street, N.W., toward the MCAC (Mail Compound Access Control). Evergreen euonymus shrubs filter the view of the concrete wall and parking lot. A mature water oak (*Quercus nigra*) provides some shade (LE044, LE037).

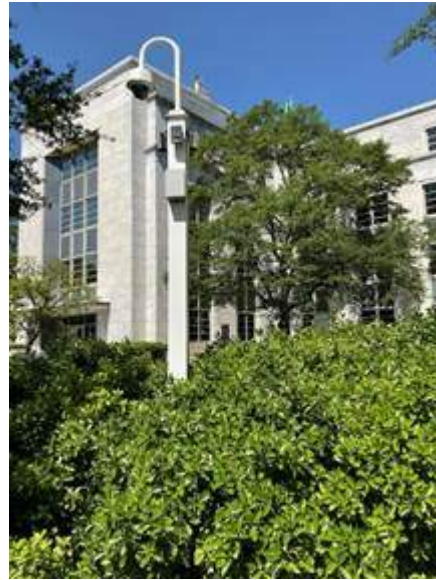
Fig. 62. View toward the mature water oak (*Quercus nigra*) (LE035) to the north of the southeast façade entrance. Euonymus (*Euonymus katuschovicus* 'Manhattan') shrubs obscure the view to the parking lot from the public sidewalk along 25<sup>th</sup> Street, N.W.

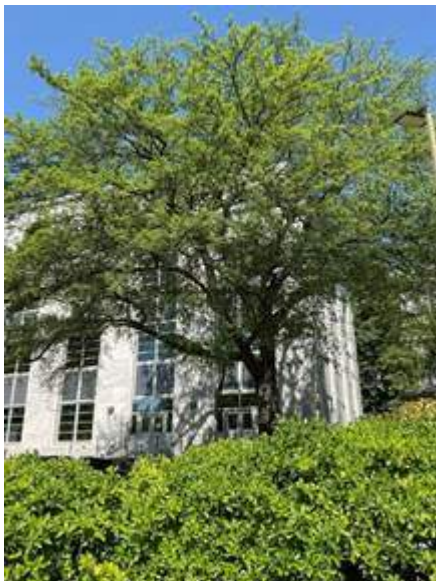
Fig. 63. View to the northeast corner of the building and a mature water oak (LE038)

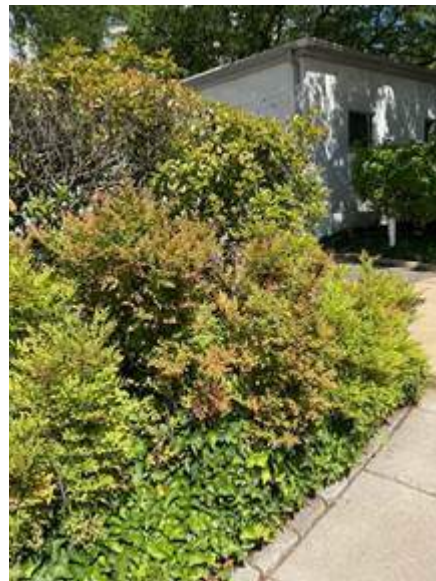
Fig. 64. View from the public sidewalk on 25<sup>th</sup> Street, N.W. toward the evergreen shrub border at the terminus of the concrete perimeter wall surrounding the parking lot, south of the entrance to the MCAC. Mail screening building in the background (LE057).

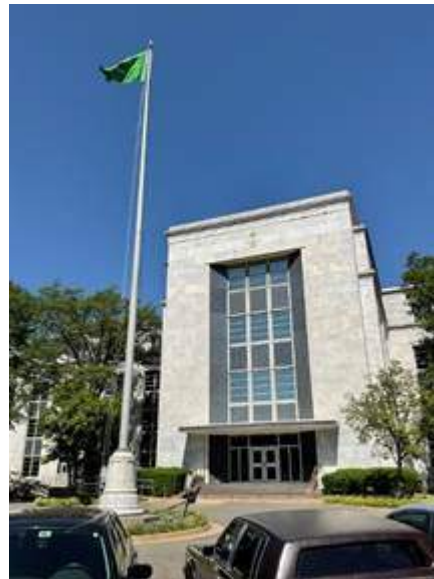
Fig. 68. View northwest to the southeastern façade main entrance (from the public sidewalk on 25<sup>th</sup> Street, N.W.) flanked by small magnolia trees in the front and mature water oaks at the sides (LE043, LE042).

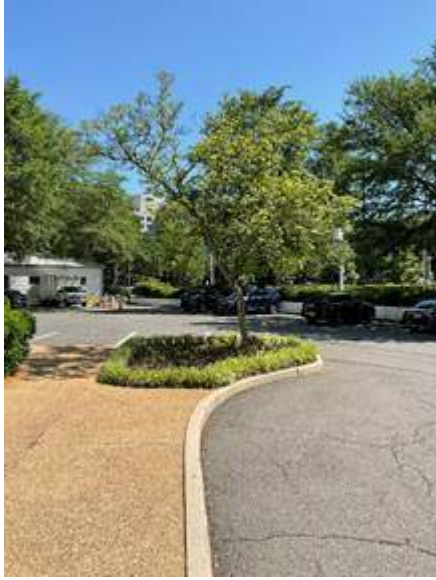
Fig. 69. Saucer magnolia and liriopie planting bed to the north of the drop off. Exposed aggregate paving and concrete curb at the southeast entrance, and asphalt paving in the parking lot. MCAC at center left (LE042).

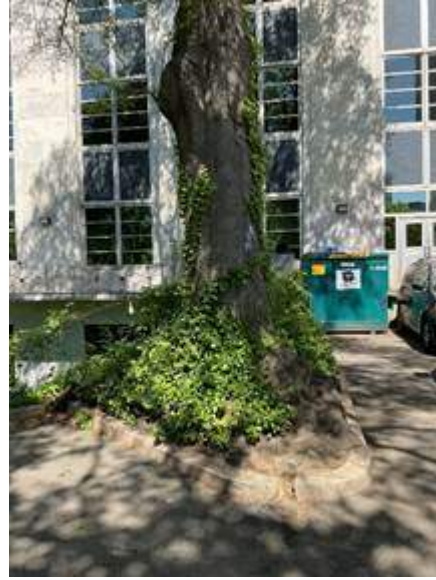
Fig. 70. Ivy covered roots of a water oak fill the small planting area in the parking lot, south of the entrance, near the dumpster area (LE034).

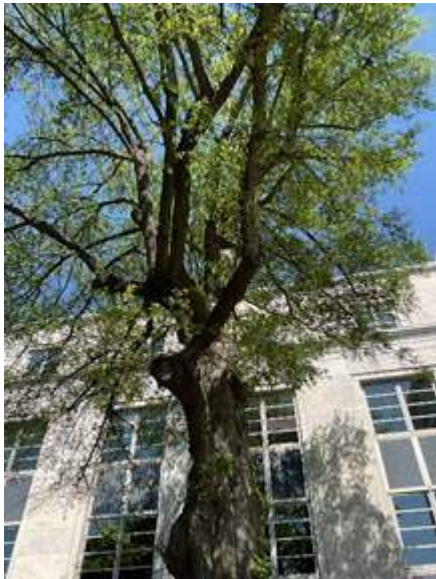
Fig. 71. Canopy of the mature water oak in the small planting area in the parking lot, near the dumpster area (LE034).

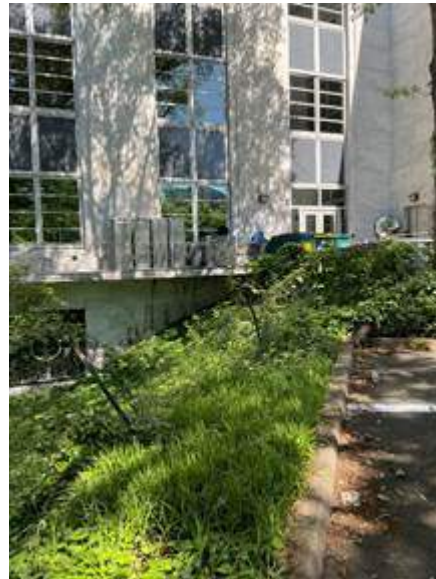
Fig. 72. Sloping terrain south of the parking lot, near the dumpster, with a dilapidated wire fence along the perimeter (LE056).

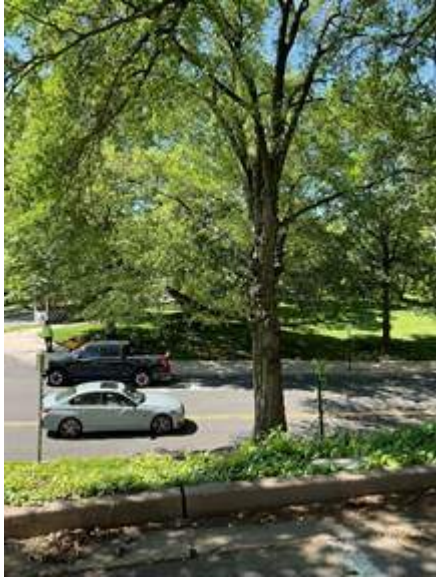
Fig. 73. View down toward F Street, N.W., from the parking lot and toward an existing water oak along the sidewalk (LE056, LE031).

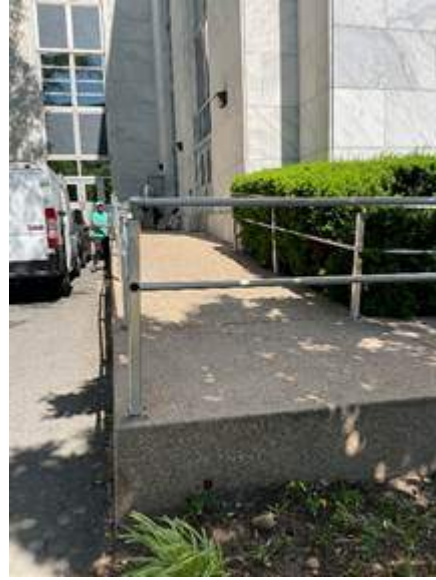
Fig. 74. Exposed aggregate ramp at the south side of the main entrance at the southeast façade (LE046).

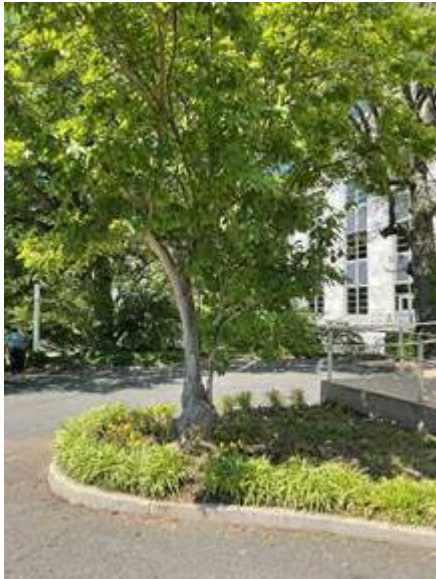
Fig. 75. Saucer magnolia and liriop planting bed to the south of the drop off. Exposed aggregate ramp pictured at right. Parking and two mature water oak trees in the background (LE046, LE042).

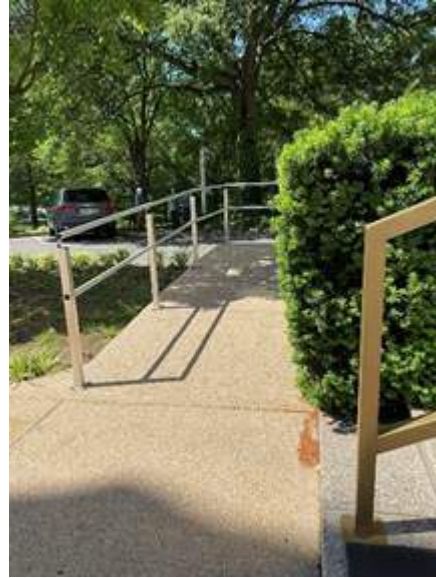
Fig. 78. Exposed aggregate ramp to the south of the main entrance at the southeast façade (LE046, LE045). The stair handrail and yew foundation plantings are pictured at right. Parking and mature water oaks are in the background.

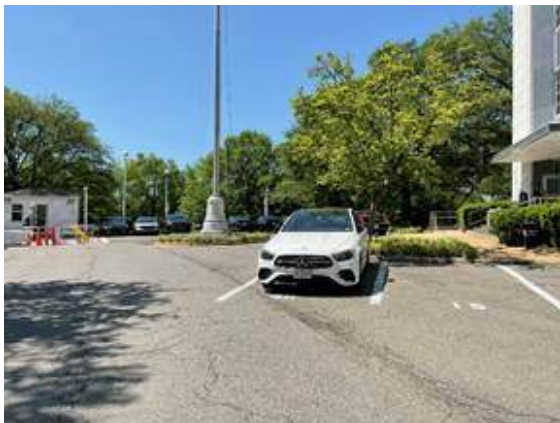
Fig. 79. View southwest toward parking at the southeastern façade main entrance. The BCAC guard house is pictured at left and flag pole (LE043) at center. No accessible parking spaces observed.

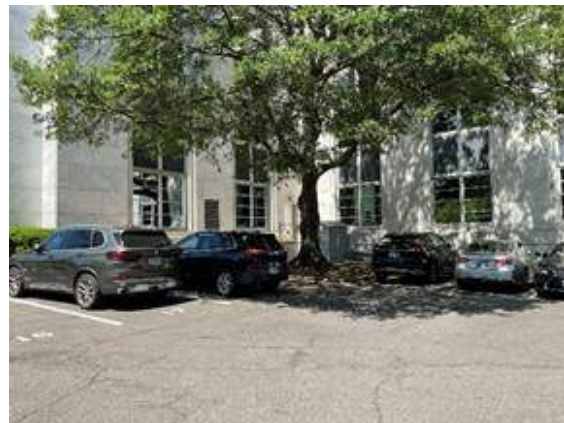
Fig. 80. View west toward a mature water oak (LE035) and parking to the north of the southeast façade main entrance.

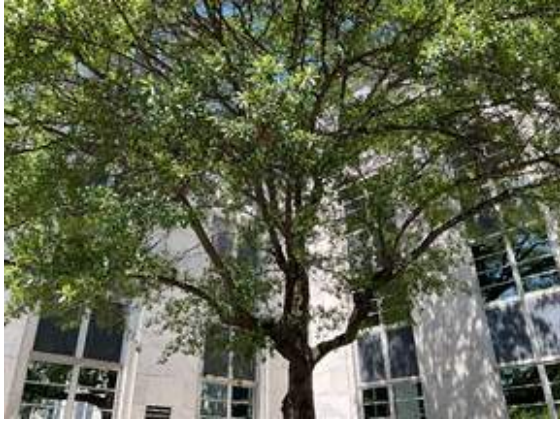
Fig. 81. View toward the canopy of the mature water oak to the north of the southeast façade main entrance (LE035).

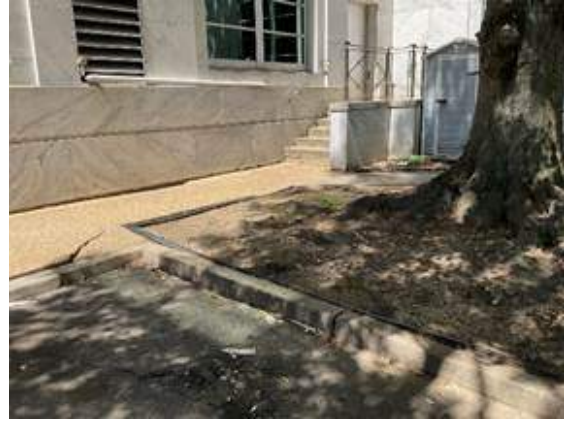
Fig. 82. Pavement at the corner of the parking lot, north of the southeast façade main entrance. Stairs lead to a door at the north side of this façade (LE048).

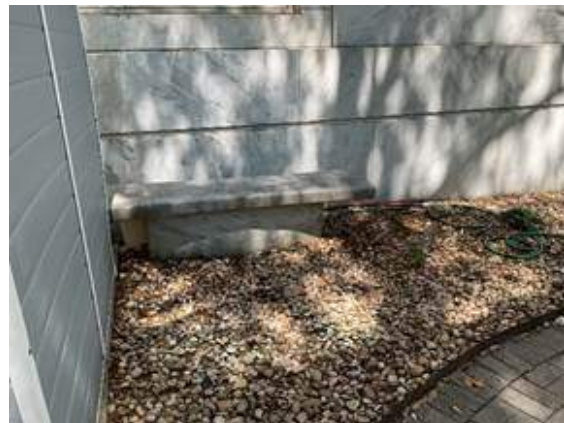
Fig. 84. A marble bench and hose sit near the façade, behind the shed in a loose aggregate bed (LE051).

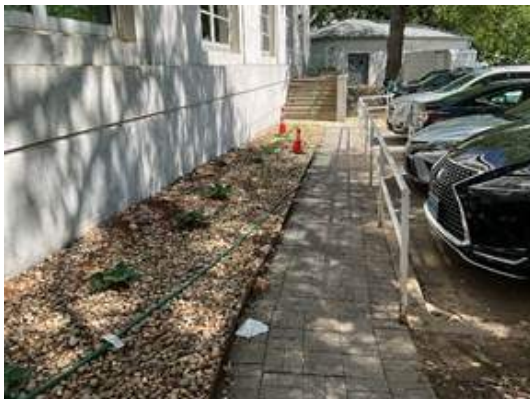
Fig. 85. Parking along the southeast façade is separated from the narrow paver walkway by a white metal railing (LE052). The paver surface is uneven and likely upended by nearby oak roots (LE049). MCAC building and stairs to two separate doorways pictured in the background (LE053).

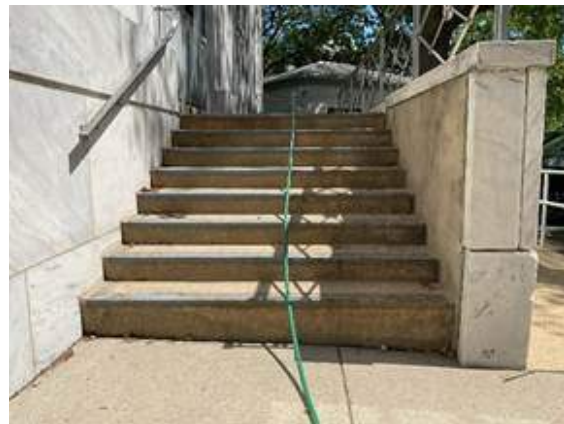
Fig. 86. View north toward the MCAC. Marble veneer on the stair wall is in disrepair, and the stairs do not meet accessibility standards (LE053).

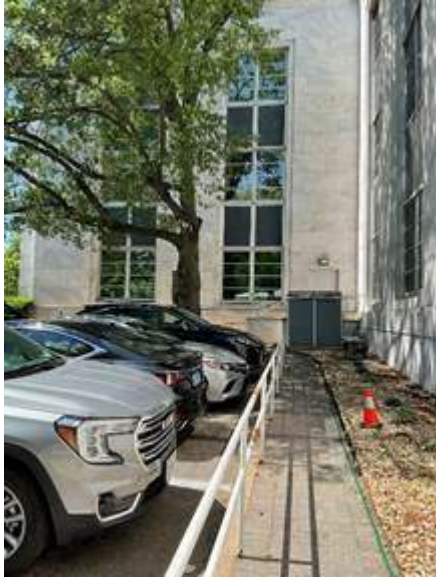
Fig. 87. View south at the parking lot along the north side of the southeast façade. The concrete paver path (LE049) leads to the shed and stairway a single door. Branches have been removed from the water oak to maintain clearance from the building.

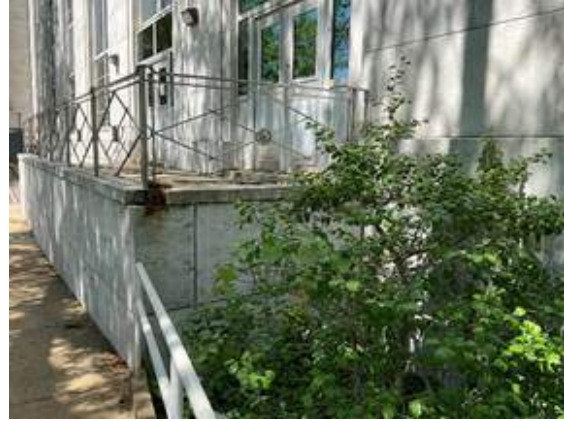
Fig. 88. Small holly at the foundation of the marble stair wall, north of the double doorways on the southeast façade (LE053).

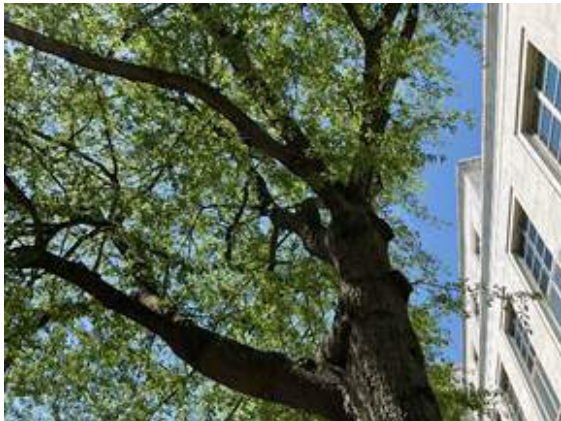
Fig. 89. View to the canopy of the water oak north of the southeast façade main entrance. Limbs have been removed to provide clearance from the building (LE035).

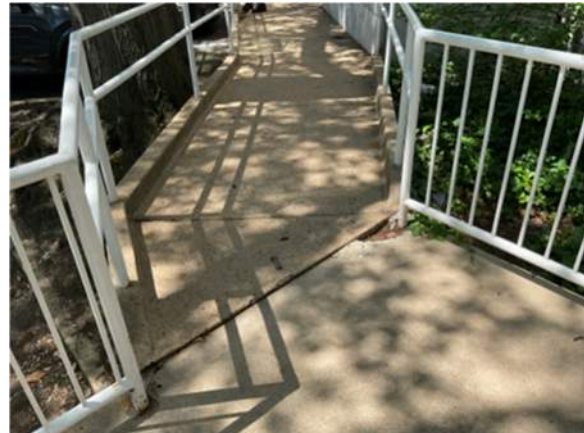
Fig. 90. Walkway connected to the ramp at the north corner of the southeast façade, leading toward the MCAC (LE054).

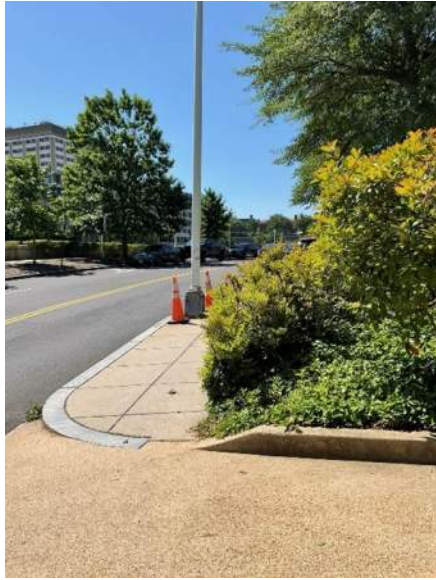
Fig. 91. View south along 25th Street N.W. from the MCAC access drive. Narrow public sidewalk with shrub border (*Cleyera japonica* and *Nandina domestica*) (LE057)

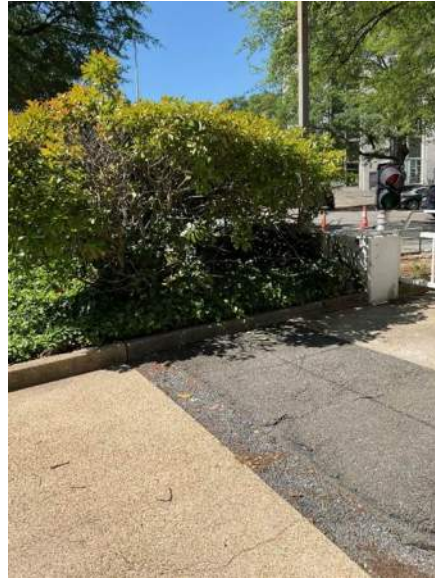
Fig. 92. View northeast toward from the MCAC access drive toward 25th Street, N.W. A mature cleyera shrub and English ivy fill the planting bed (LE059).

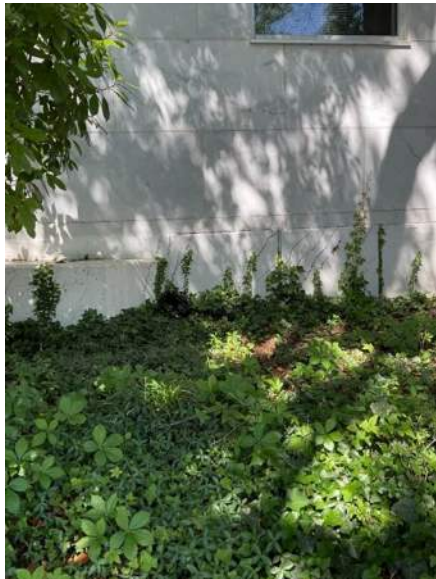
Fig. 93. Vines along the foundation of the mail room façade viewed from 25<sup>th</sup> Street, N.W. sidewalk (LE059).

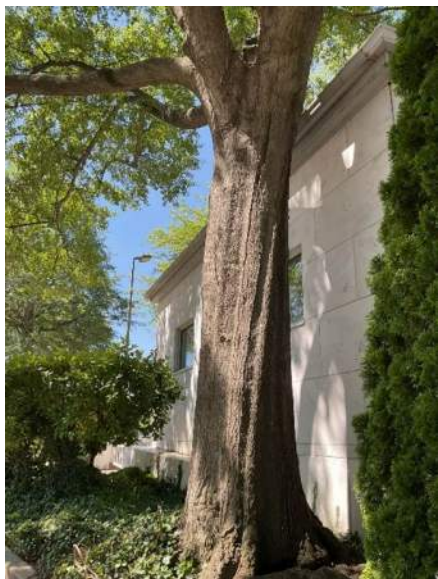
Fig. 95. 76 cm (30 in) diameter water oak to the east of the mail room meets the DDoT Urban Forestry Special Tree size qualifications (LE060).

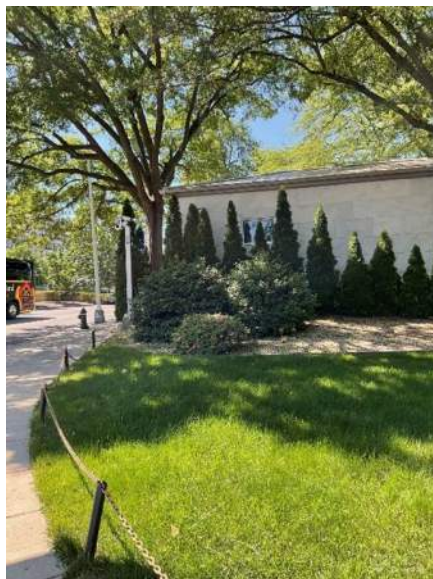
Fig. 96. View south on 25<sup>th</sup> Street, N.W., toward the mail room. 76 cm (30 in) diameter water oak is at the building corner. Conical arborvitae, hollies, and blooming azalea compose the foundation planting. Turf grass and a single chain fence meet the public sidewalk (LE059-67).

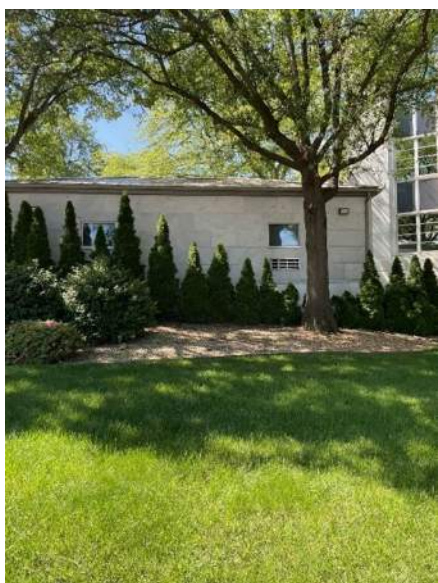
Fig. 97. View south from the public sidewalk toward the east side of the mail room. Conical arborvitae, hollies, and flowering azalea are surrounded by aggregate mulch and metal edging forms a curvilinear planting bed (LE061-62).

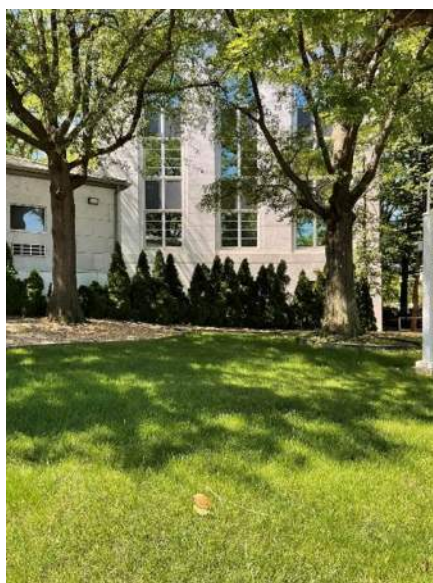
Fig. 98. View south from the public sidewalk toward the north façade of the Embassy and the mail room. A row of arborvitae shrubs are framed by two water oaks (LE062-63, LE066).
