# ROYAL EMBASSY OF SAUDI ARABIA WASHINGTON

## 1. West Façade - New Hampshire Avenue, N.W., West Compound Access Control (WCAC)

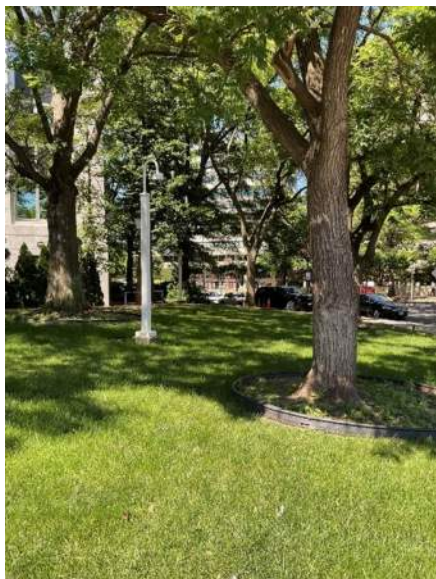
Fig. 99. View southwest from the public sidewalk toward the north façade of the Embassy. An ash tree is pictured at right (LE068); a water oak at left (LE066); and a Kentucky coffee tree is in the background (LE069). Willow oaks line the streetscape in front of the Embassy along New Hampshire Avenue, N.W.

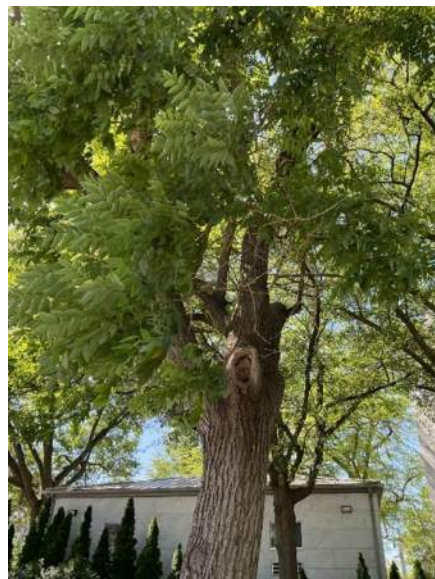
Fig. 100. View south from the public sidewalk toward the canopy of the ash tree (*Fraxinus* spp.) and north façade of the mail room. The tree was surveyed at 160 cm (63 in) in circumference, meeting the size qualifications for Special Tree designation (LE068).

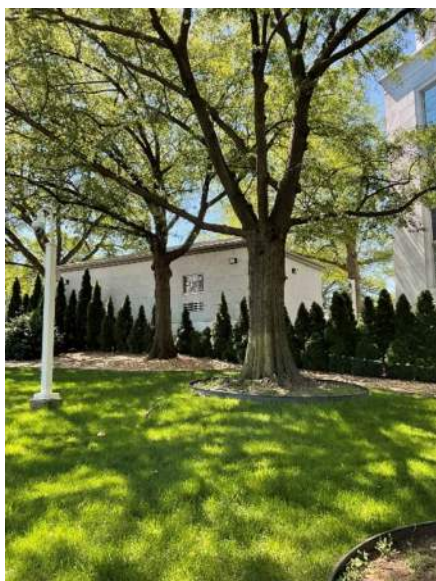
Fig. 101. View southeast from the public sidewalk toward the mature water oak surveyed at 335 cm (132 in) west corner of the mail room (LE066). This tree meets the size requirements for Heritage Tree designation.

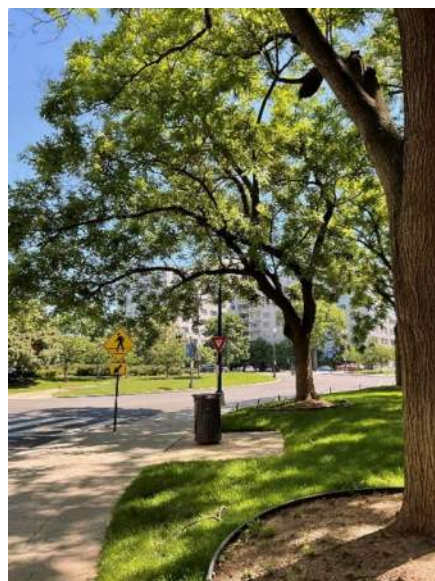
Fig. 102. View northeast from the public sidewalk on New Hampshire Avenue, N.W., toward two Kentucky coffee trees (*Gymnocladus dioica*) (LE069-70). A concrete pad with trash receptacle located +/- 14.6 meters (48 feet) from the north corner of the Embassy (LE074).

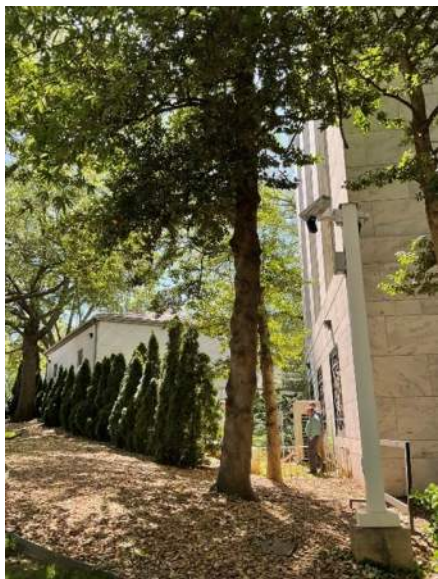
Fig. 103. View east toward the west façade of the mail room and north façade of the Embassy, from the public sidewalk. Row of conical arborvitae shrubs descends the terrain to a mature, limbed up holly tree. A/C unit pictured at the foundation of the Embassy (LE071).

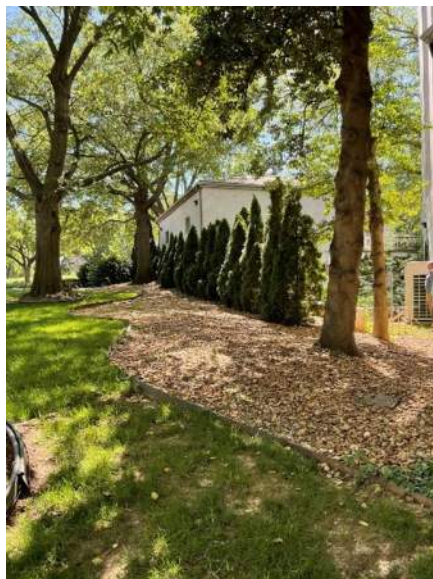
Fig. 104. View east toward the west façade of the mail room and north façade of the Embassy, from the public sidewalk. Aggregate mulch covers the curvilinear planting bed formed with metal edging. A mature water oak (Heritage Tree) is pictured on the left (LE0 66) and a mature holly tree (Special Tree) is pictured at right (LE071).

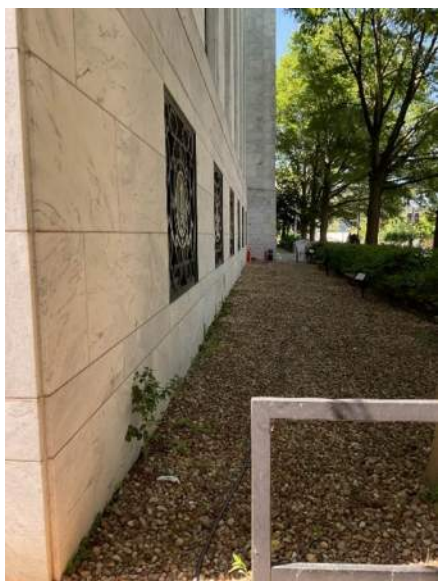
Fig. 105. View southwest along the southwest façade of the Embassy (New Hampshire Avenue, N.W.) from the northern corner of the building. Access to the aggregate foundation area is blocked by a metal fence (LE071, LE011).

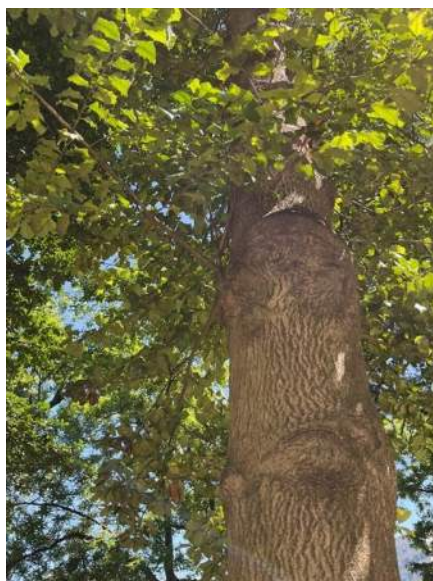
Fig. 106. View toward the canopy of the 127 cm (50 in) English holly at the north corner of the Embassy (LE071).

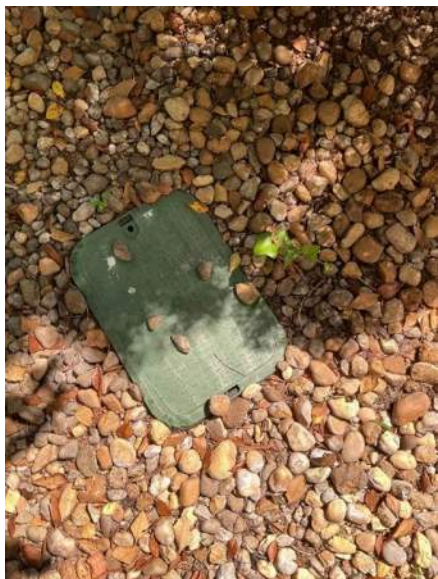
Fig. 107. Irrigation control valve box in the loose aggregate surface at the north corner of the Embassy (LE073).

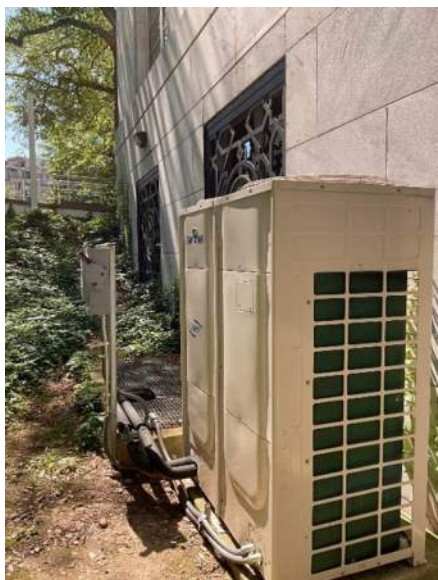
Fig. 109. A/C unit and window well at the north façade of the Embassy (LE076).

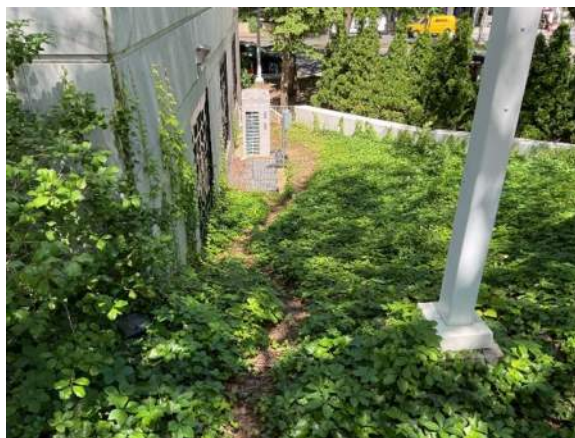
Fig. 110. View west from the concrete walk near the mail room loading dock toward the A/C unit and window well along the north façade of the Embassy. Virginia creeper vines and ivy cover the sloping terrain and prevent erosion. The white concrete retaining wall is pictured at the top right, extending down toward New Hampshire Avenue, N.W. (LE076).

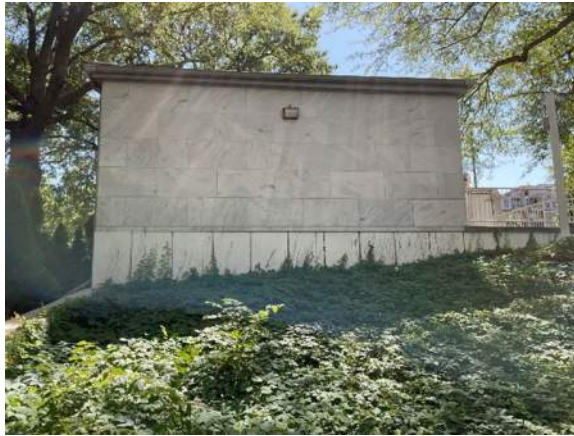
Fig. 111. View east from the utility area LE076), toward the west wall of the mail room. Virginia creeper and ivy cover the ground. A mature willow oak surveyed at 239 cm (94 in) circumference is pictured at left of the mail room (LE063).

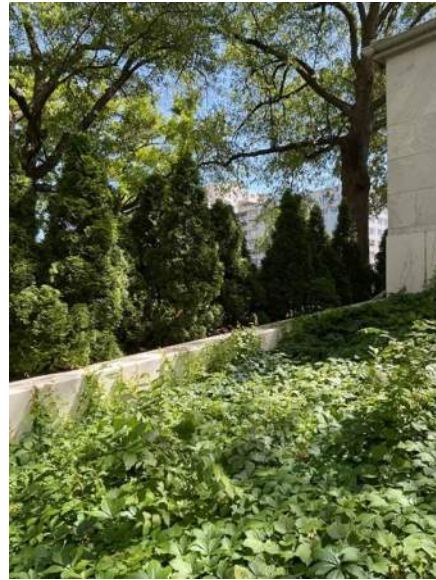
Fig. 112. View toward the concrete retaining wall west of the mail room (LE077). Arborvitae form a row along the north side, and Virginia creeper covers the sloping ground behind the wall (LE076).
