# Town Center Park - West Park

## Report of Current Conditions and Recommendations

Washington, District of Columbia

Submitted by  
Wallace Roberts & Todd, LLC  
1700 Market Street  
28th Floor  
Philadelphia, PA 19103  
December 21, 2007

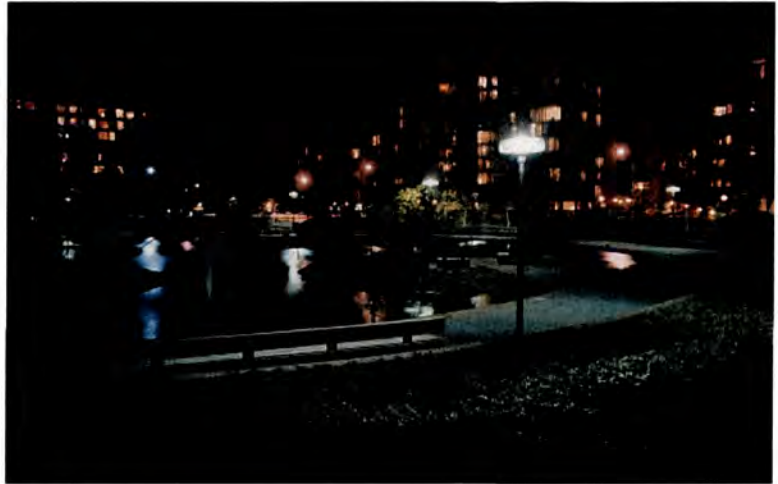
Site lighting and drainage systems appeared to have been designed appropriately for the park. Light fixtures conformed to the Modernist style that was popular at the time of the park's conception (Fig. 8).

Due to the lack of available utility information, WRT could only evaluate the visible appearance of the park's infrastructure. An obvious concern for the park is its drainage. Many area drains were surrounded by dirt and debris, which is both aesthetically unappealing and indicative of drainage problems (Fig. 9). NPS standard pole-mounted lights have taken the place of the original fixtures (Fig. 10). A nighttime inspection of the park lighting was not performed for this report, so current lighting may not adequately illuminate all areas of the park.

Figure 8  
Original pole-mounted lights - circa 1970

Both the lighting and drainage systems need to be properly inspected to make sure they are functioning correctly. The drainage system should be cleaned out and renovated where required. At a minimum, any existing light fixtures that do not work should be replaced. A full lighting study should be performed to make sure that all areas of the park are adequately illuminated. New light poles and fixtures that relate to site furnishing requirements of the proposed AWI Transportation Architecture Design Standards should also be considered.

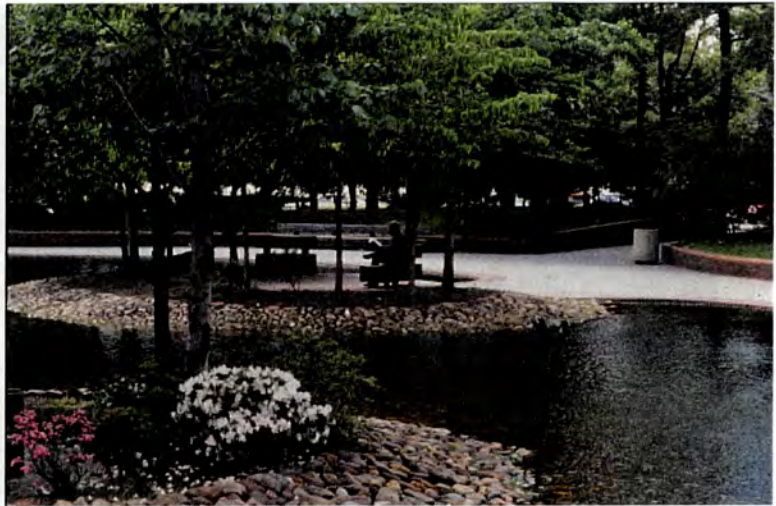
Originally, West Park's site furnishings consisted of custom-made timber benches (Fig. 11), concrete trash receptacles, a concrete water fountain and a variety of marine-related items, such as an anchor and ship's wheel, made available by both the Navy and NPS. These elements were incorporated into the park to provide play structures for children and to connect, via the nautical theme, to the nearby Potomac River.

Almost all of the original site furnishings in the park have been removed or replaced. The custom timber benches have been substituted with standard NPS site furnishings (Fig. 12), and all of the original play structures have been removed. A nondescript plastic and aluminum slide (Fig. 13) has taken the place of the slide once located at the southeast corner of the park while nothing was put in place of the ship's wheel that used to occupy the northeast alcove. Though the water fountain remains, it is no longer functional. Only the concrete trash receptacles continue to be used as designed.

Figure 11  
Original park benches - circa 1980

Though the standard NPS site furnishings make the park less distinctive, they do not detract from the character of the space. The lone play structure, however, has an ad hoc quality that is not appropriate for the park. Any improvements to the park should include new play equipment because neither of the other two parks features any. Also, children were observed playing on the slide during WRT's second site visit, so there appears to be
