EXISTING CONDITIONS ASSESSMENT & FEASIBILITY EVALUATION

McMillan Slow Sand Filtration Plant Site
Washington, DC

April 10, 2014

prepared by
Robert Silman Associates
1053 31st Street NW
Washington, DC 20007

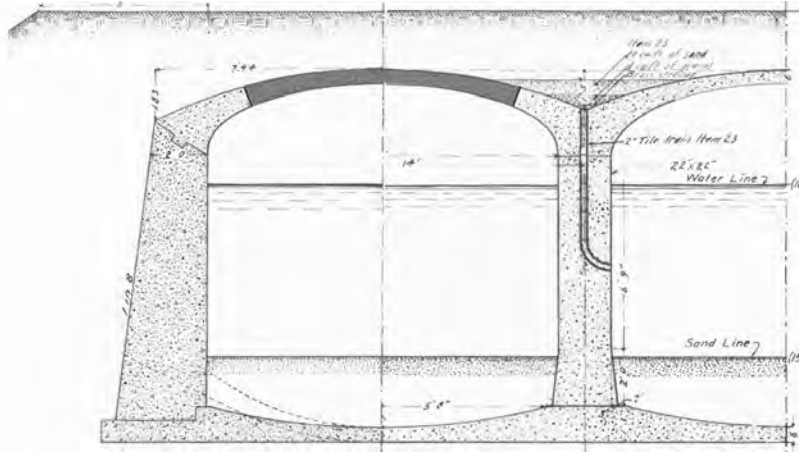
FIGURE 10A : COLLAPSE MECHANISM: INITIAL CRACKING

Areas with collapsed vault slabs and areas where collapse appears imminent. Collapsed areas were observed by RSA along the eastern bays of filters Nos. 19 and 24 adjacent to North Capitol Street. As additional bays have collapsed since the most recent survey in 2000, it was apparent that severe damage continues to propagate to other areas at these filters, particularly near the collapsed areas where collapse appears imminent. See Figure 10 for graphic depiction of collapse mechanism, and section ___ for structural stability results and discussion.

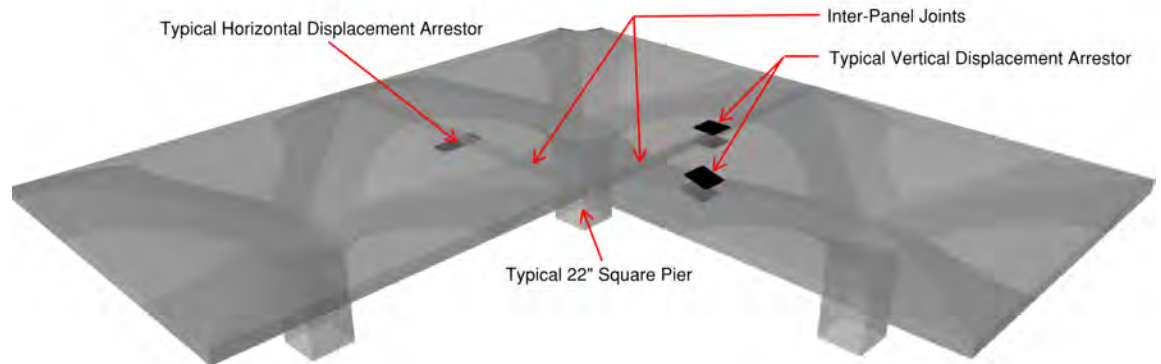
FIGURE 11: HORIZONTAL AND VERTICAL DISPLACEMENT CRACK ARRESTORS

Based upon available documentation, "displacement arrestors" made of thick metal blocks and thin square metal plates were installed sometime before 1967 to arrest vertical movements due to settlement or the formation of collapse mechanisms across cracks and some joints. The intent of the retrofit repair was to clamp the vault together along crack lines and along the vault joints between adjacent concrete panels to limit the potential for crack propagation and differential movement. It appears that this approach can be effective in the short term, as it does address the important need to maintain a continuous thrust line across the vaulted span. However, the approach did not address the root causes of the vault distress, which are likely related to support movements.

To arrest horizontal and vertical shifting, two types of "displacement arrestors," consisting of steel plates bolted to the ceiling slab at either side of an inter-panel joint, were also added sometime before 1967. The apparent intent of these connectors was to provide tensile resistance across the joint to limit horizontal or vertical separation. The effectiveness of this approach again appears to have been short-lived, as cracks have developed near the joints and these connectors eliminating their effectiveness. Due to the moist environment, the iron components were observed to have section loss often accompanied by localized damage to surrounding materials.

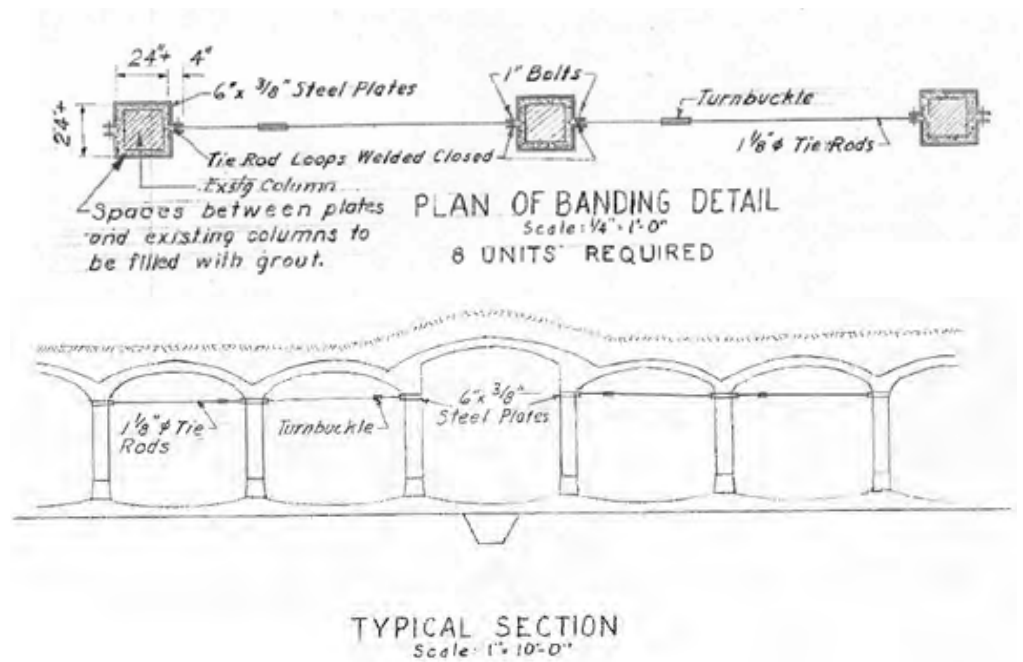
FIGURE 12: BANDING DETAIL

A system of metal straps, tie rods and turnbuckles were observed in a few cells at or near the entrance portals. Review of documents indicated that these components near the interface between the pier and the ceiling were part of a banding system added sometime after 1951, and were intended to provide additional thrust resistance for the groin vaults abutting the center bay. As depicted in Figure 12, the barrel vault of the center bay springs from a point higher than the adjacent groin vaults. The added tie rods appear to be intended to resolve the resulting imbalanced thrust forces.

The banding system approach can be effective at balancing these forces, however it was noted at the site that piers at the entrance portal with these straps had typically cracked as depicted in Figure 13. At other filters where these restraints were not present, a rotation at the entrance ramp pier-to-vault joint was observed without any pier cracks (see Figure C-5, in the appendix). Thus, although the banding may have limited some lateral movement or rotation, the unreinforced piers did not have sufficient capacity to transfer forces at this added connection.

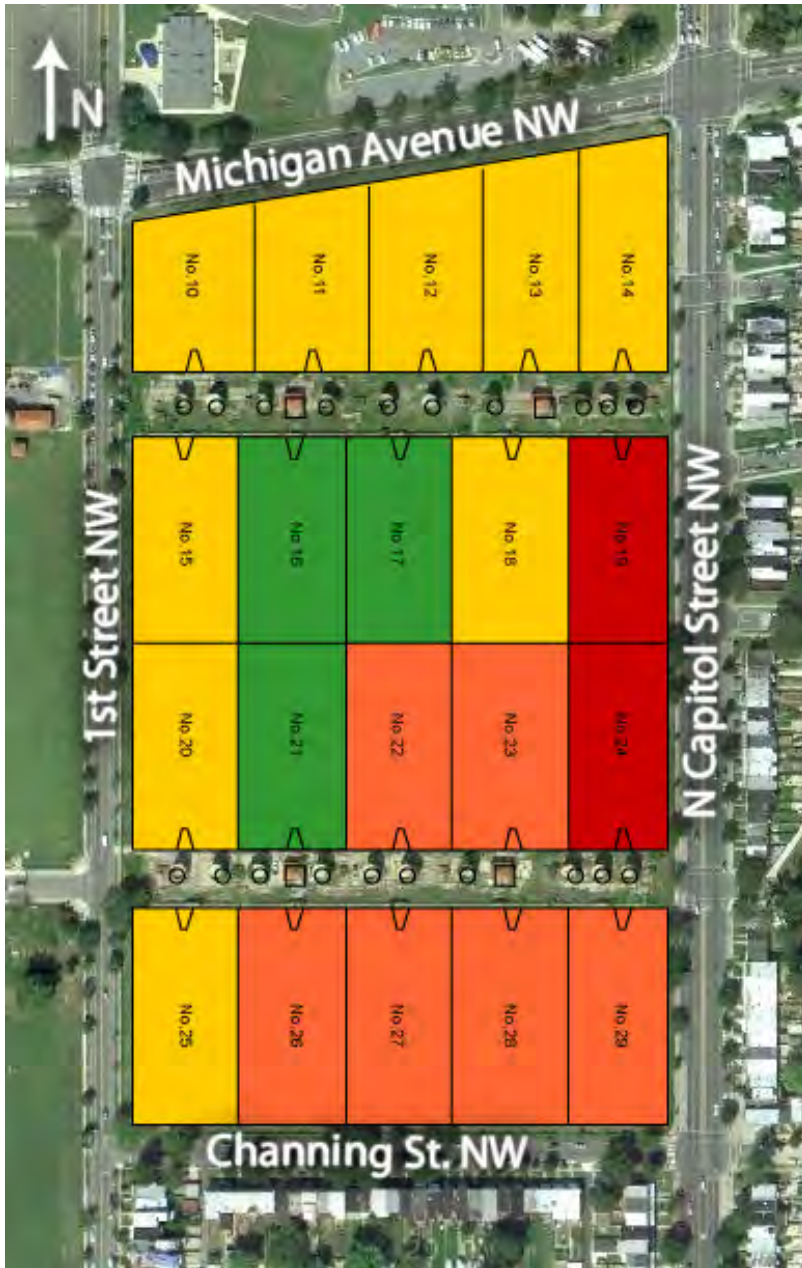
FIGURE 14: SLOW SAND FILTERS DAMAGE CATEGORIES

Based on level of damage observed during the 2012 field condition assessment the slow sand filters investigated were divided into four categories:

Figure 14, below, depicts the categories of the slow sand filters investigated.

These collapsed areas are concentrated along the eastern bays adjacent to North Capitol Street at both filters. It was not safe to perform a detailed investigation at the filters in the immediate vicinity of the collapsed vaults. Adequate bracing or shoring of these severely damaged areas is not present. However, based on RSA's observations from a safe setback distance, it was apparent that severe damage continues to propagate, and other areas at these filters are at risk of imminent collapse. Collapsed areas were found in filters Nos. 19 and 24.

This level of damage includes filters with items described as minor and moderate damage, but with more significant conditions such as areas where collapse appears imminent. Filters within this category are filters Nos. 22, 23, 26, 27, 28 and 29. A summary of observations of the more representative filters in the severe damage category is included in Appendix D.

In general, the damage observed by RSA was similar to the conditions documents in 1944, 1967, and 2000. Further damage, consistent with earlier observations, included additional cracks, crack lengthening, continued shifting of the vault joints, and additional concrete spalling. Filters within this category include those with cracks having widths measuring $\frac{1}{16}$ in. up to $\frac{3}{16}$ in., and typically includes moderate shifting at vault joints, concrete spalls, and rotations at the pier-to-ceiling slab interface. Filters assessed within this category are Nos. 10, 11, 12, 13, 14, 15, 18, 20, and 25. A summary of observations from the more representative filters within the moderate damage category is included in the Appendix D.

In general, damage at these filters is mainly limited to hairline cracking as previously reported in 1944, 1967 and 2000, and confirmed by RSA in 2012. Minor damage, noted on previous surveys, appears to have increased only marginally. This category includes filters Nos. 16, 17, and 21, which are all interior filters founded on firm substrate soils. A summary of observations of the more representative filters in the minor damage category is included in Appendix D.

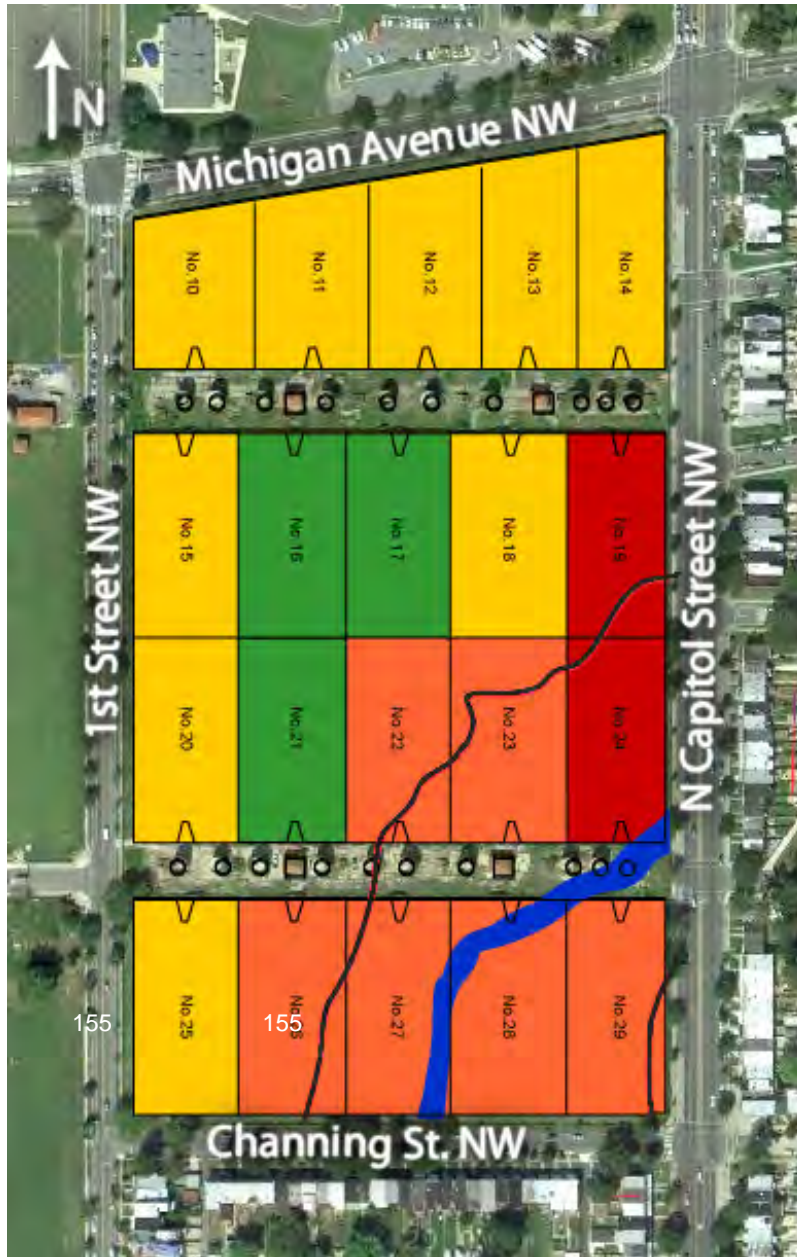
FIG. 18 - LEVEL OF DAMAGE VS. 1894 GRADE ELEVATIONS

Review of existing reports and historic documentation reveals a consistent correlation between the location of the filters, their level of damage, and the 1894 topographic survey elevations. There is a clear correlation between the grade elevations recorded by the 1894 topographic survey and the level of settlement-related damage observed during the site investigation. Filters with severe deterioration and specifically areas where the ceiling vaults have collapsed were usually constructed on fill. In contrast, those filters with minor or moderate deterioration were typically constructed on areas where the original grade was at the highest elevations, so that the foundations were bearing on virgin soils as opposed to fill materials.

The southeast corner of filter No. 27 and southwest corner of filter No. 28 are located at the lowest elevation recorded in 1894. Filter No. 29 is located at a higher elevation but the east end wall of this filter is next to North Capitol Street. Filter 24 has sustained much more damage than filter Nos. 27 and 28. Filter No. 24, located at the lowest 1894 elevation of the four filters next to North Capitol Street, has sustained the most severe level of damage among all the filters investigated, with damage including the collapse of more than half of the bays framing into its east end wall (Figure 18). Filter No. 19, sharing a divider wall with filter No. 24, is also next to North Capitol Street, and it is believed that the redistribution of forces due to the severe damage sustained by filter No. 24 has accelerated the damage of filter No. 19, causing the collapse of an area near the southeast corner of this filter. On the other hand, the lowest level of damage was at filter Nos. 16, 17, and 21, which are located at the highest grade elevations reported in 1894, all of which are interior bays.

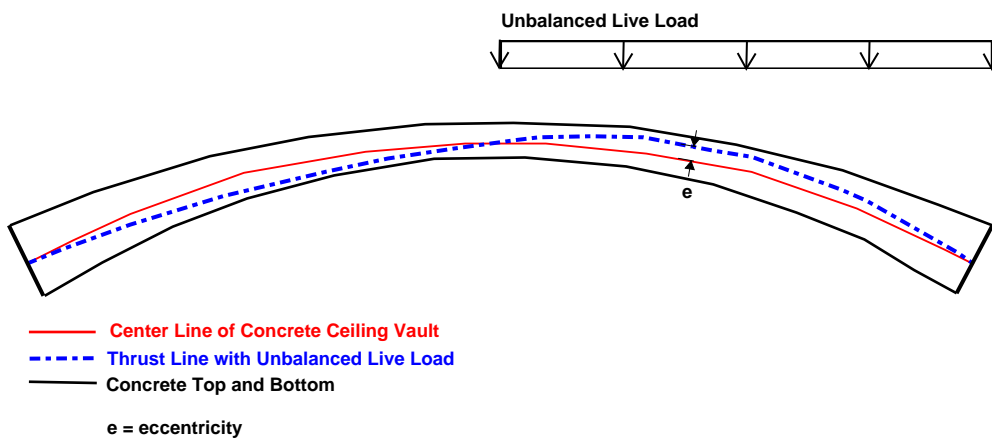
FIG. 21 - UNBALANCED LIVE LOAD ANALYSIS CASE

In keeping with the variable nature of live loads, the second case considered in the slow sand filter analysis is to assume unbalanced live loads by applying a uniform live load at only half the span of the vault. The variation of the load from the base uniform assumption shifts the thrust line away from the center of the vault section (see Figure 21), resulting in increasing compression stresses and potential cracking.

Analysis results for this case indicate that the end vaults can reach an allowable surface live load capacity of approximately 900 psf, before reaching the unreinforced concrete allowable compressive strength estimated at 900 psi. This value is still greater than common code-required live loads. However, other observed conditions such as pier settlement, or wall movement have reduced capacity even more.

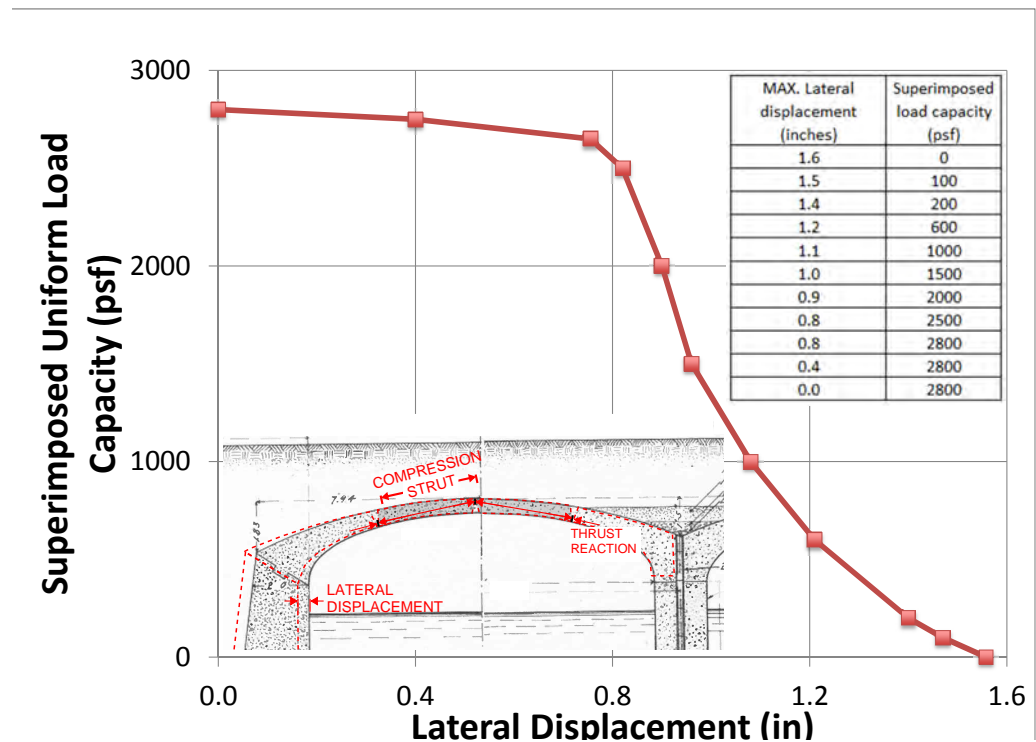
FIGURE 22: LOAD CAPACITY VERSUS LATERAL DISPLACEMENT

Because of the need to ultimately resist the vault thrust at the perimeter, this analysis focused on the behavior of the end bays, modeled as barrel vaults. RSA looked at the progressive effect of spreading the supports on the end vaults, starting from 1 inch displacement of each support end and increasing incrementally. For a 1 inch horizontal spread at the supports, the apex of the ceiling vaults drops approximately 4.5 inch, the compressive stresses at the apex increases by approximately 30%, and then by 50% for a spread of 1.5 inches. Although stresses are increasing appreciably corresponding to these initial movements, the overall vault section remains in compression and the stress levels are still below the allowable compressive capacity of 900 psi. Figure 19 depicts the typical location of the thrust line for this analysis case.

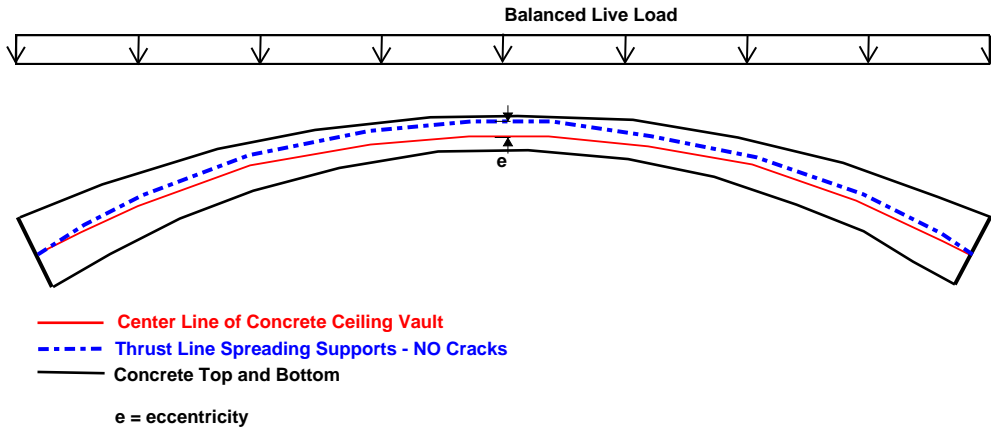
FIG. 23 - SPREADING SUPPORTS ANALYSIS CASE

As the lateral displacement of supports increases further, the apex continues to drop. As the vault becomes shallower, the horizontal thrust increases proportionally to resist the unchanging weight above being carried. Considering the geometric non-linearity of this progressive behavior, the analysis shows that prior to reaching two-inches of lateral displacement on each side (four-inch total spread), the vault will fail.

Separation at the vault apex results in the loss of restraint against lateral movement and initiates cantilever action of the vault. A cantilever is a beam that is fixed at one end and unsupported at the other and must function like a beam in bending which is always subject to tensile stresses. Therefore, given the lack of tensile capacity in the unreinforced concrete, we would expect the vault to crack along its top surface, begin to rotate and deflect further, and potentially re-establish contact with the adjacent panel until further lateral movement occurs. This mechanism formation can repeat as movement continues. In addition, the realignment of the joint, as discussed herein, can result in local stress concentrations between panels, and quickly generate further cracking and overstress. Given the inherent higher stiffness of the interior bays with respect to the end bays, thanks to the groin vault geometry, the end bay half-barrel vaults are more sensitive to horizontal displacements and more flexible when transitioning to cantilever behavior. This variation in vault stiffness, when subjected to lateral support displacement, appears to have led to panel misalignment, local overstress, and the onset of a collapse mechanism sequence.

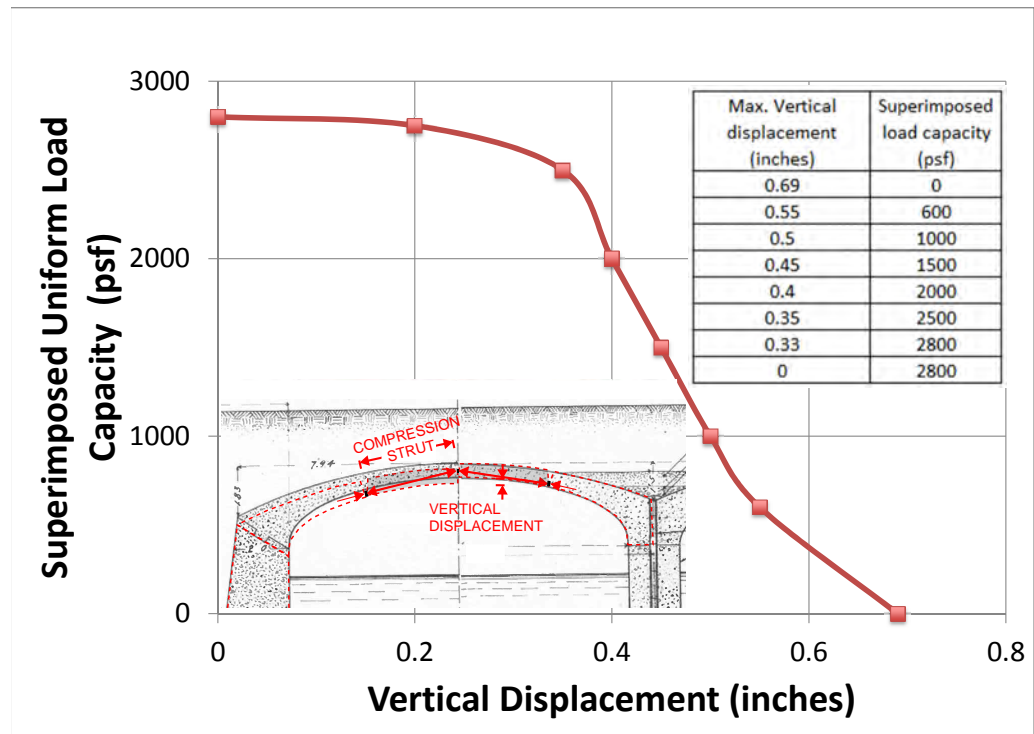
FIGURE 24: LOAD CAPACITY VERSUS VERTICAL DISPLACEMENT

Similar to the analysis of lateral displacement, RSA considered the progressive effects of differential settlement between supports. Again, because of the critical role played by the end bay vaults, this analysis focuses on the barrel vault behavior. The analysis revealed a pattern of structural response very similar to that for lateral displacement. For relatively small differential settlements, the vault structure can maintain stability and continue to support loads from above. As the differential settlement continues, the distance between support points on either side of the end bay vault gets greater. Considering the geometric non-linearity of this progressive behavior, the analysis shows that prior to reaching five-inches of differential settlement, the vault will fail. This assumes that the continuity between the panels at the high point of the vault remains intact throughout the movement. Although the joint represents distinct pours between panels without material continuity, the transfer of thrust across this joint and the resulting friction, can serve to maintain this contact surface. Exceptions to this were observed, where there was measurable misalignment between the panels at the vault apex. As much as three-inches of misalignment was documented in the vicinity of collapsed vaults.

Misalignment at the vault apex may be the result of multiple influences, ranging from shifting due to lateral displacement, foundation settlement, and potential flaws from the original construction. In addition, this condition was commonly observed in the area of the entrance portals. Here, it appears that the misalignment is the result of rotations generated by the eccentricity between thrust lines of the central bay barrel vault and adjacent groin vaults. Figure 20 depicts the condition where misalignment occurs, yet the vaults continue to bear against each other. With this thrust misalignment, local bending stresses are induced at the inter-panel joint which accelerate the formation of cracks or hinges in the vault structure and reduce the effective depth of the arch mechanism.

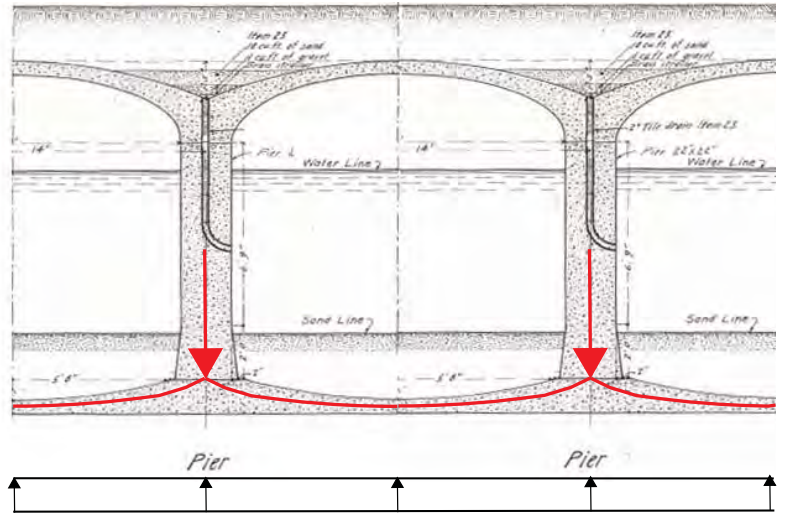
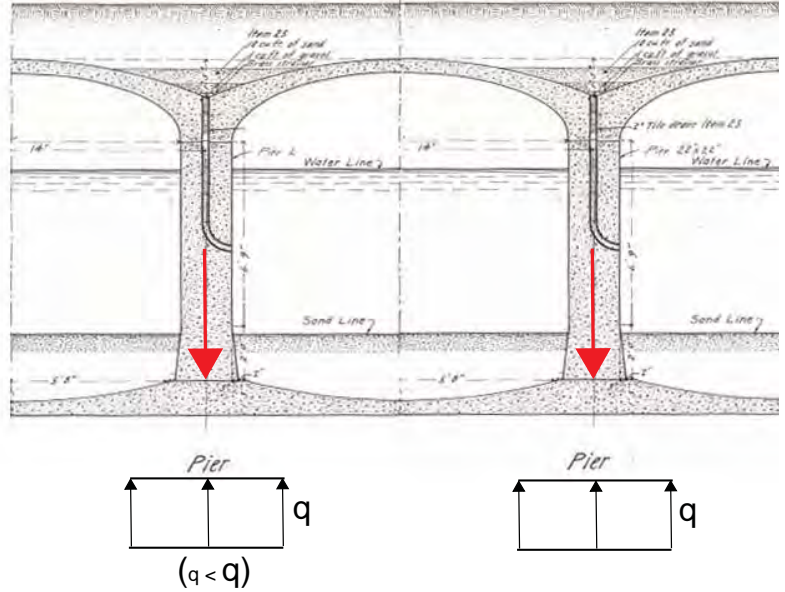
FIG. 26 - FOOTING ASSEMBLY

The foundations of the slow sand filters are inverted groin vaults in unreinforced concrete, very much like the vaulted roof structure above. This footing construction system is very effective in supporting the weight of the filtration sand and filler water. However, without the presence of reinforcement, the capacity of the footing in supporting topside loads coming from the piers, in combination with the realities of unbalanced loads and pockets of soil with low bearing capacity, compromise the functioning of the foundation as an inverted vault system. Accordingly the foundation is only able to distribute loads more directly around the pier areas resulting in an effective increase in soil pressure with respect to the even pressure distribution beneath the full inverted vault foundation (Figure 26).

When the foundation concrete cracks due to flexure, concrete punching shear, or settlements at pockets of badly compacted soil, in addition to reducing effective bearing area, the cracking also created an avenue for the filler water to travel through, further weakening the soil bearing capacity and consequently making the footing settle even more.

For these reasons the footing configuration of the slow sand filter structural assembly cannot be considered adequate without proper inspection of the vaults, testing of the soils and appropriate

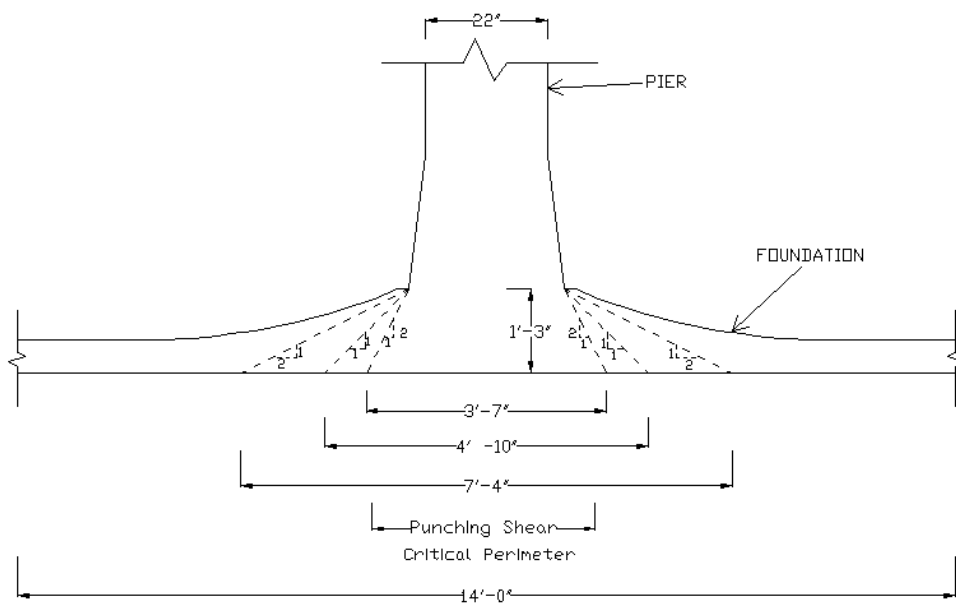
FIG. 27 - FOUNDATION SLAB: EQUIVALENT SPREAD FOOTING

A precise determination of an effective spread footing area is somewhat speculative. Figure 27 shows a range of sizes for equivalent modern spread footings, assuming load distribution planes emanating from the pier at ratios of 2:1, 1:1 and 1:2. The most generous distribution assumption reaches to an equivalent footing size of 7'-4" square, which reduces bearing pressures to less than the preliminary

allowable pressures reported by the CCJM geotechnical investigation of about 3000 psf. Although these would be reasonable sizes for modern reinforced concrete spread footings, analysis results indicate that the hypothetical spread footing, in isolation from the remaining foundation inverted vault, does not have sufficient flexural capacity.

The punching shear capacity of the footing is estimated, based on an unreinforced concrete allowable compressive shear stress of 40 psi [Kidder-Nolan, 1921], at 70 kips (service loads). This punching shear capacity is less than the self-weight of the concrete vault and pier plus the estimated weight of the topsoil above the vault. This limits the footing size to a 3'-7" square area which is equivalent to the critical perimeter for punching shear. For this footing size, the bearing pressure, not including topside live loads, was estimated to be 7500 psf. The higher bearing pressure exerted to the underlying soil consequently implies significant settlements. Figure 23 shows the capacities of the estimated 3'-6" square footing as a function of allowable bearing soil pressures.

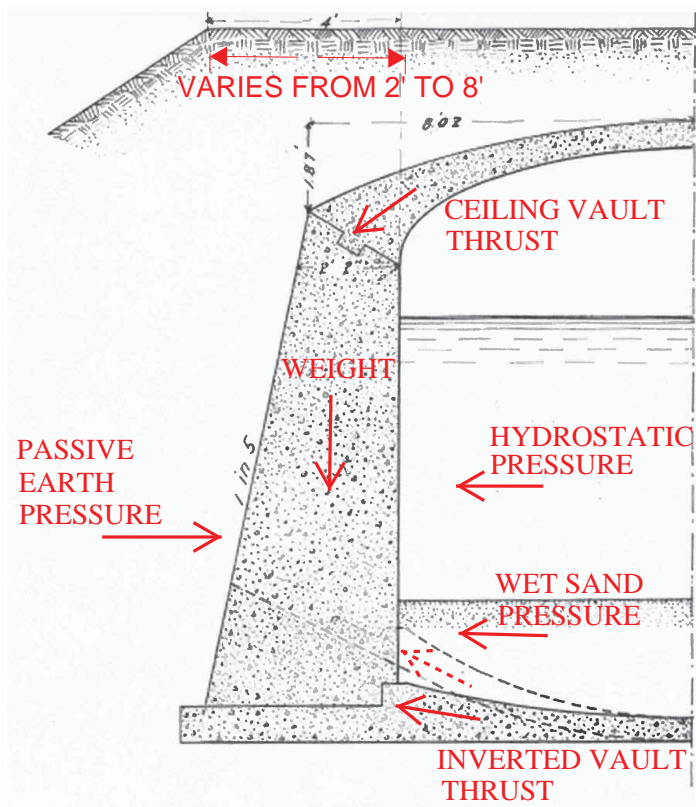
FIGURE 30: GRAVITY END WALL FREE BODY DIAGRAM

Field observations of damage and soil conditions highlight the susceptibility of the vault structures to support movements. To further understand the nature of such displacement, RSA performed a structural analysis of the end wall assemblies. Figure 30 depicts the general arrangement of forces that are imposed and resisted at this critical perimeter of the vaulted filters.

Different levels of passive pressures, which contribute to the stability of the gravity end walls against overturning and sliding, were considered to account for the different soil profiles at the site. Generally, the walls meet the required factors of safety against sliding and overturning when assuming that they will develop passive pressures when subject to thrust pressures from the vaults. However, these pressures assume a level of movement which will impact the behavior of the vaults as discussed below.

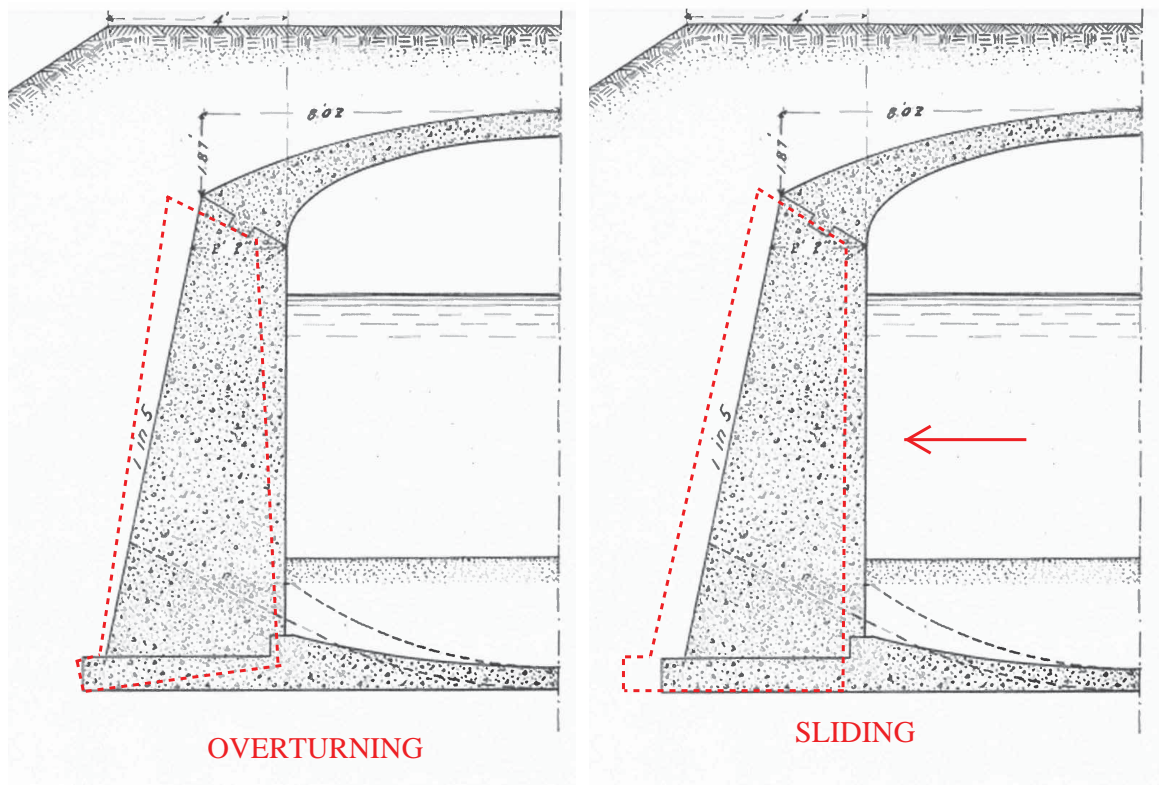
FIGURE 31: END WALL STABILITY LIMIT STATES

The initial trigger for the collapse appears to be the lateral and/or vertical movement of the end wall. It appears that the movement is sufficient to cause separation at the vault apex 'Step 1'. This separation precludes the transfer of arch thrust, and each side begins to behave like a cantilever. Unable to carry significant tensile stresses, cracking and hinge formation ensues 'Step 2'. 'Step 3' in the diagram shows the misaligned apex joint, highlighting the potential for new cracking and localized overstress as thrust tries to re-establish a path through the joint. The failure mechanism of the typical interior bays is also similar to the mechanism depicted in Figure 27. The fact that no interior bays have collapsed is attributed to the amount of restraint offered by the surrounding bays.

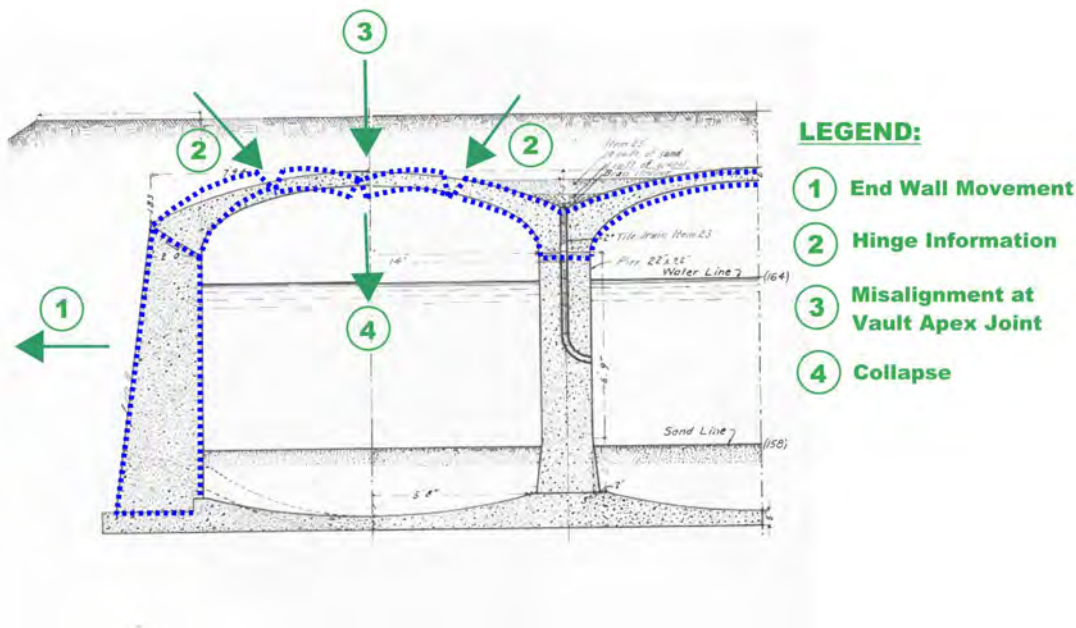
FIGURE 32: COLLAPSE MECHANISM SEQUENCE.

Observation at the collapsed bays has made it clear that a displacement of the end bay walls preceded the conditions causing collapse. Figure 32 depicts the observed hinge formations. Similar conditions were observed around the entrance portals. Hinge formation does not necessarily mean that collapse is imminent, but the presence of hinge mechanisms indicates that the ceiling vault is in a state of reduced capacity (Figure 32), and if enough hinges are formed, they are likely to lead to instability or collapse.

At the entrance portal the failure mechanism observed in several cells is attributed to the misalignment of forces due to the disruption of the structural symmetry. This affects the internal forces of interior groin vaults on either side adjacent to the entrance. The misalignment of forces creates a condition similar to that described at the end wall bays, where moments and tensile stresses are induced to the unreinforced concrete, which consequently hinges (cracks) and finds a new state of equilibrium. Similar to the end walls bays, if enough hinges formed, this will lead to instability or collapse.

The correlation of vault failures and distress to end bays and areas where filters were originally constructed on fill soils remains a strong indicator that movement of the supports may well be the most significant factor leading to vault instability. The reduced depth of the surrounding grade towards the south appears to be another significant factor contributing to the reduced effectiveness of soils in limiting both lateral and vertical displacement at the end walls.

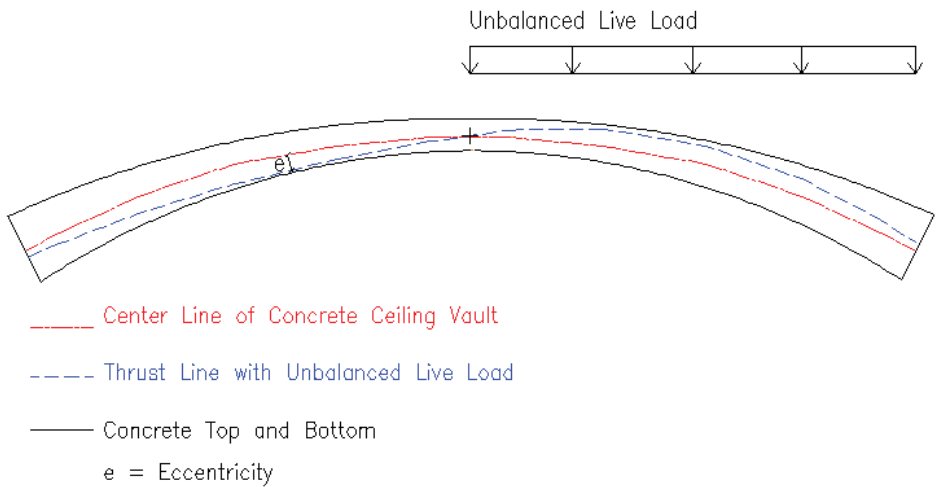
FIG. E.3 - UNBALANCED LIVE LOAD ANALYSIS CASE

When the thrust line does not coincide with the geometric center line of the vault, as depicted in Figure E.3 internal stresses are redistributed.

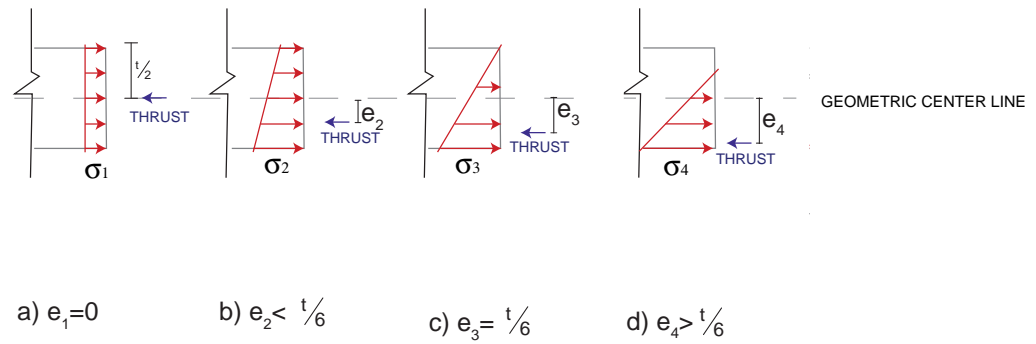
FIG. E.4 - STRESS DISTRIBUTION DUE TO ECCENTRIC LOADING

Figure E.4 depicts the typical stress diagram for different cases of eccentricities between the center line of the vault and the thrust line. Under ideal conditions, that is balanced loading, uniform soil bearing capacity, and no end wall or footing movement, the thrust line coincides with the geometric center line of the vault and there is uniform compression stress (Figure E.4a). The realities of uneven soil bearing capacities, unbalanced loads, or perimeter wall movement make the thrust line move away from the geometric center line of the vault, creating eccentricities 'e'. As the eccentricity between the center line of the vault and the thrust line increases, the compressive stresses increase on the side where the thrust line is located and decreases on the other (Figure E.4b, E.4c).

When the thrust line falls outside of the middle third of the vault section, the face opposite to the thrust line begins to experience tensile stresses. Because unreinforced concrete is very weak in tension, cracks will soon form, effectively reducing the thickness of the cross section that can carry load (Figure E.4d).

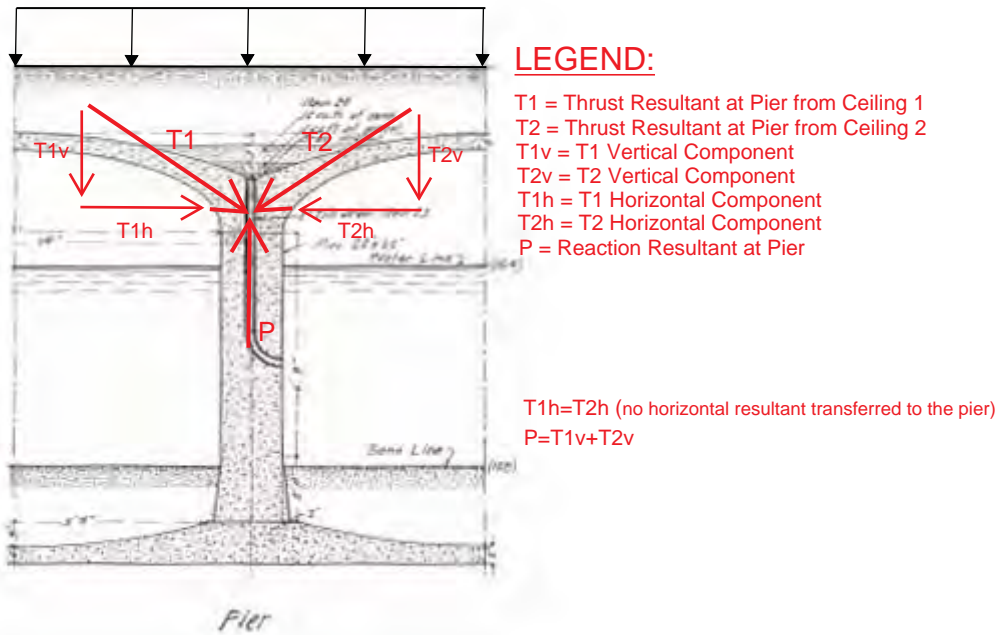
FIG. E.5 - FREE BODY DIAGRAM AT PIER WHEN VAULT IS SUBJECTED TO BALANCED LOADS

Under uniformly distributed loads the ceiling vault is intended to sustain pure compressive axial stresses. The horizontal reactions from the resultant thrust forces at the pier to ceiling vault interface, 'T1h' and 'T2h' depicted in Figure E.5 are equal on either side of the pier.

Given that the surface live loadings are typically transient and not uniform; this idealized scenario represents the upper limit of potential capacity. Preliminary analysis results demonstrate the vault configuration provides adequate capacity to sustain significant uniform live loads in addition to permanent loads. RSA employed traditional equilibrium methods to calculate the structural capacity of both the end bays and interior bays. The end bay analysis was based on a thrust line calculation using graphical statics.

The calculation of the thrust translates to a compressive stress in the concrete, which is compared to the allowable stress for the material. Under the idealized case of uniform distributed loading, analysis results indicate that the end vaults can reach an allowable uniform surface live load capacity of approximately 2,800 psf., before reaching the unreinforced concrete allowable compressive strength estimated at 900 psi. This value is much greater than typical code-required live load. However, as noted above, this represents a theoretical upper limit of capacity which the reality of unbalanced loadings, irregular geometry, pier settlement, or wall movement begins to quickly reduce.

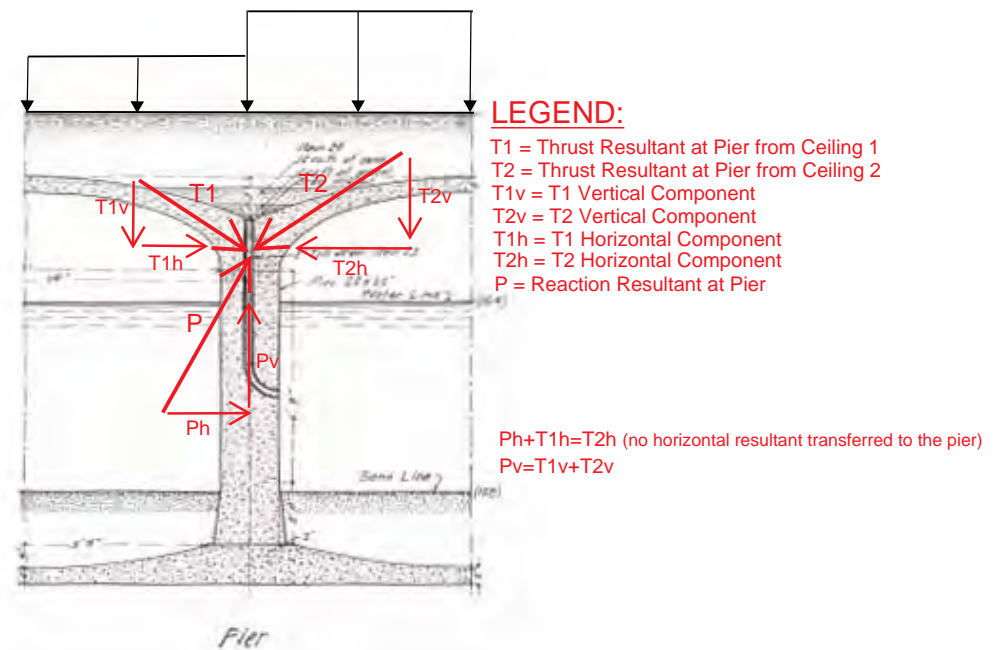
FIG. E.6 - FREE BODY DIAGRAM AT PIER WHEN VAULT IS SUBJECTED TO UNBALANCED LOADS

Under such unbalanced load conditions, the horizontal reactions from the resultant thrust forces at the pier to ceiling vault intersection are opposite in direction but not equal in magnitude on either side of the pier, thus there is transfer of lateral load to the pier, which undergoes compressive stresses and bending stresses (Fig. E.6). Subjected to bending, the piers are susceptible to rotation and cracking.

Analysis results for this case indicate that the end vaults can reach a theoretical allowable surface live load capacity of approximately 900 psf, before reaching the unreinforced concrete allowable compressive strength estimated at 900 psi. This value is still greater than common code-required live loads, however, other adverse conditions such as pier settlement, or wall movement would quickly reduce capacity even more. RSA performed stability investigations to estimate the influence of these conditions on upper bound load capacity estimates.
