Square 369

1100 Block Ninth Street, N.W., Washington DC

Building Preservation Plan

Final Report

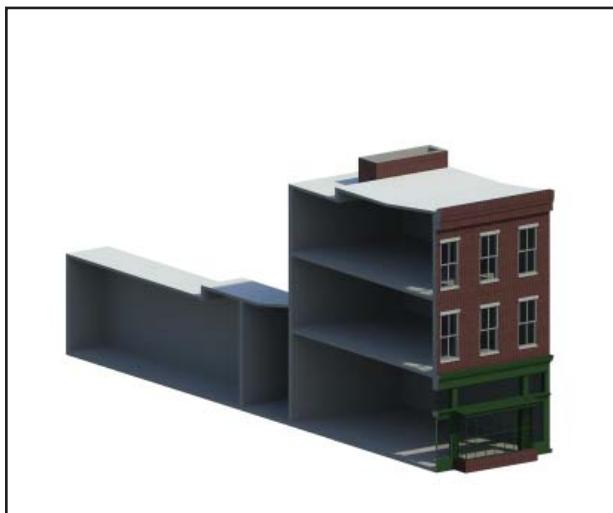
Existing Condition

Currently, the building as a whole is in poor to moderate condition, particularly compromised are the floor and roofing systems. Years of neglect and abandonment have compromised the systems, outlined in the following existing conditions. Most of the interior historic fabric has been removed from the building's interior, including a number of the original wood sash windows. The building falls within the period of significance and continues to be a contributing resource to the Shaw Historic District.

The most appropriate and logical place to introduce the connection between the original building and new construction will be at the rear of the original block of the building, located approximately 40' from the building facade. Also, the proposed new floor location hits only 3' below the historic second floor level. This will allow the facade and the original side walls and ceiling heights to continue to project the historic massing and fenestration of the building, while new safety and fire compliant walls, floors, and roof systems will allow the building to once again be safely occupied.

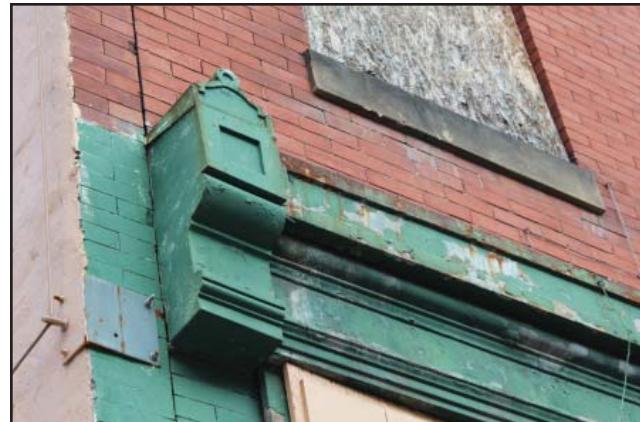
Image 2

Facade: The building facade (Image 1 and 2) is composed of red brick laid in two different configurations. The first floor of the building is laid in a stack bond, with thin, raked mortar joints, painted green to match the pressed metal stringcourse. The second and third stories of the facade are laid in a running bond with thin, raked mortar joints left unpainted. The brick is generally in good condition; there are no major cracks in the facade and only a few spots of efflorescence. Holes have been drilled in a few of the bricks located beneath the second floor windows, which most likely were used to secure an awning. Each second and third floor window has a simple stone, lug sill, as well as a simple flat, stone lintel; cracks are evident, however, the sills and lintels remain in fair condition. Above the third floor lies a corbeled brick cornice and frieze composed of normal and pressed brick, with alternating square and brick tiles of fluted and star medallion motifs. Four symmetrically placed false brackets embellish the frieze, with a brick corbel under each bracket. Decorative strings of dentils and bead and reel motif molding run the length of the cornice and frieze. The brick cornice and frieze remain in good condition, however, they should be further assessed from a closer point once scaffolding is erected.

- **Brick Facade:** Clean brick facade with low (<100 psi) pressured water. Repoint brick where necessary with thin, raked mortar joints and mortar similar in composition, texture, application, and color to the original to reduce spalling and noticeable color differentiation. Test patches should be undertaken to ensure that the cleaning method is not harmful to the historic masonry.
- **Stringcourse/Parapet Molding:** Remove flaking paint on the metal, reshape where necessary, and repaint. If upon closer inspection a new cornice must be fabricated the existing cornice will serve as a model. Make certain that the connections to the brick facade are sound,

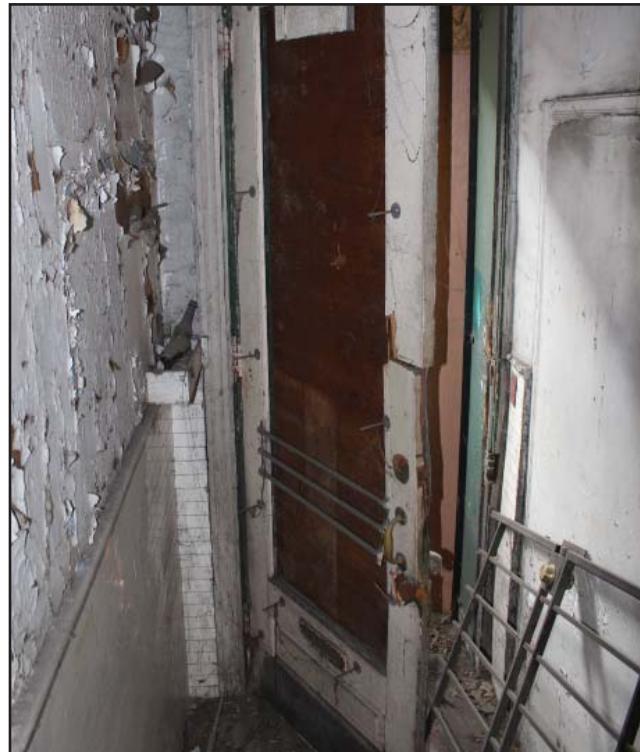
Image 3

Doors: There are two doors on the facade of the building: the door to the south leads to the commercial space on the first floor, and the door to the north leads to the apartments above. The door to the south is a contemporary, replacement glass door (Image 4). It was retrofitted into the original molded wood door frame that is still topped by the 1914 door transom. The transom window is a hopper window with metal grate covering the where the glass has been removed. The door to the north, which most likely dates to 1914, is a glass, panel wood door. This door however, has been severely damaged (Image 3) and contemporary

hardware has been drilled into the original wood in multiple places. This door is also set within its original molded wood frame and topped by a tall transom window. This transom, however, is fixed.

- **Doors:** Install two new wood entrance doors using the existing north entrance as a model. Clean and repaint the original door and transom frames and replace glass in transom windows. If not salvageable, replace in kind with like materials.

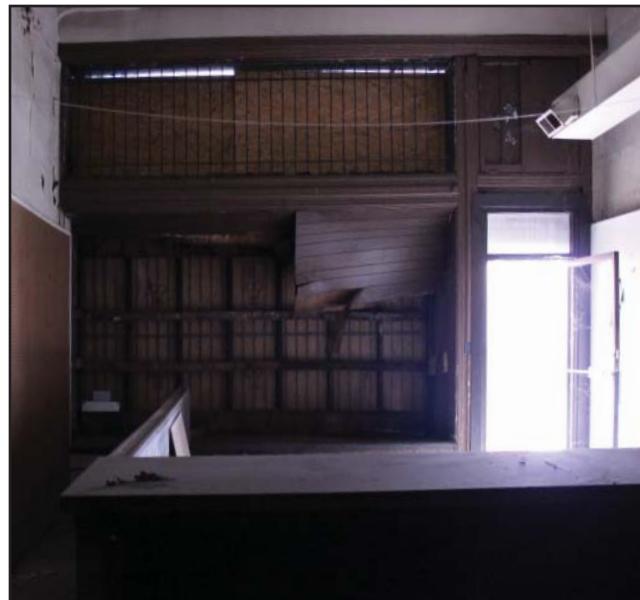
Image 4

Windows: The first floor facade holds one square, storefront window (Image 4), projecting 3' from the building line and capped by small pressed metal cornice and metal finial painted to match the stringcourse. The interior wood frame is topped by a long, continuous transom frame. The transom and storefront glass have all been removed and both are covered by what is most likely a contemporary metal safety grille. The extant wood paneling along the ceiling and base is also contemporary. The entirety of the storefront window is in poor condition.

- **Storefront Window:** Replace storefront window in kind based on surviving material and the 1914 permit drawings. Clean the metal cornice and finial atop the frame by removing the paint; repaint them to match the stringcourse. Reshape the finial if necessary. Replace, in kind, the transom windows over the storefront based on the remaining pieces of the original transom window, historic images, and adjacent 1914 building drawings.

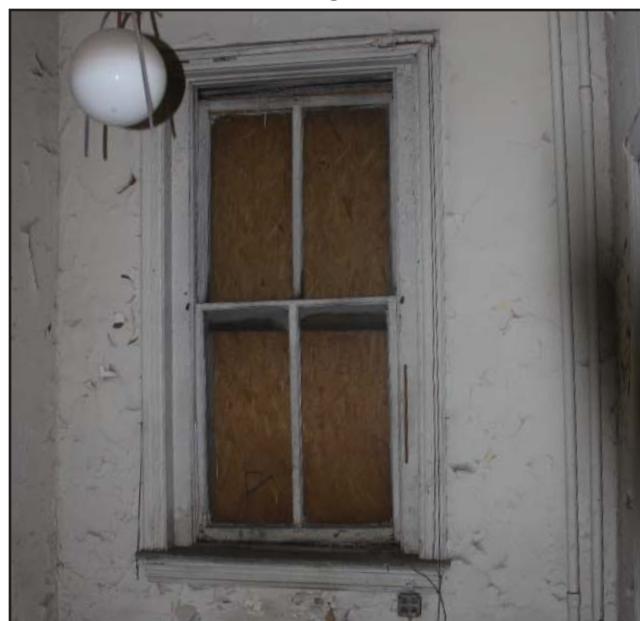
Image 5

The second and third floor facade windows are two-over-two, wood, sash windows (Image 5). A few of the windows are extant but are in severely deteriorated condition; a majority of the original windows have been removed altogether.

- **Second and Third Floor Windows:** Replace the six, two-over-two, wood sash windows to HPRB's standards and in consultation with DC HPO staff. Where necessary, patch the window sills and lintels and clean the stone along with the brick facade. If the stone is damaged beyond repair, replace in kind.

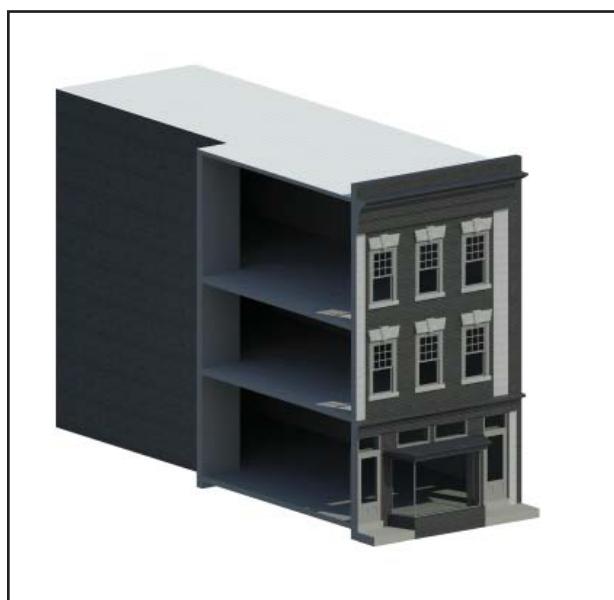
Existing Condition

The building is currently in extremely poor condition. The roof, third, second, and part of the first floor have collapsed into the small cellar. All of the structural systems have been compromised over the years of neglect and abandonment. There is no salvageable architectural fabric or material on the building's interior.

Due to the extreme damage suffered throughout the building's interior it is recommended that the facade be restored and new code-compliant floor and roof systems be put in place. The most logical place to introduce the connection between the original building and new construction will be at the rear of the original full width of the building, where the second and third floors set back on the south elevation is first introduced. This line is located approximately 35' from the building facade. The proposed new flooring, which is necessary as all of the original floors have collapsed, will be constructed at almost exactly the same height as the historic second floor (the original floor is 8" higher than the proposed floor). This in no way will affect the historic ceiling height of the first floor commercial space. The new safety and fire compliant walls, floors, and roof systems will allow for the building to once again safely be occupied while maintaining the historic character of the 1908 elevation.

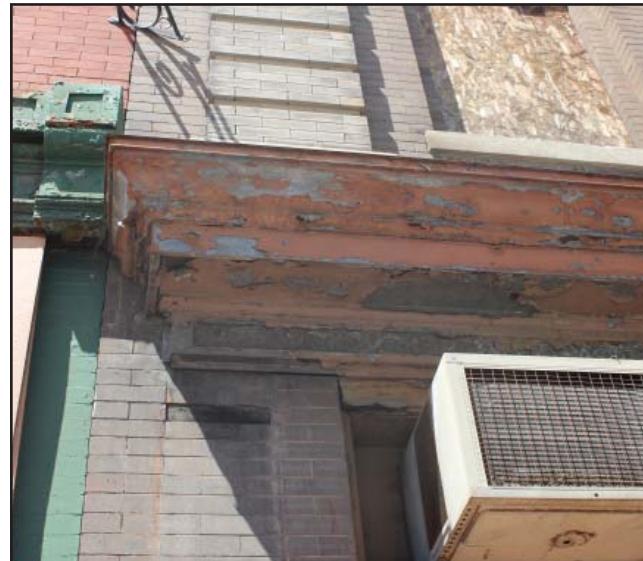
Image 2

The stringcourse (Image 2) is composed of galvanized iron painted red. The top portion is formed into an ogee pattern, while the bottom contains a Vitruvian scroll frieze. The entablature, composed of galvanized iron and painted red, is topped by an ogee cornice, with a row of guttae, above a frieze with rosettes. The parapet molding, also composed of galvanized iron and painted red, is also shaped in an ogee form. All three remain in moderate condition, with peeling paint and rust, however, the forms remain in good condition.

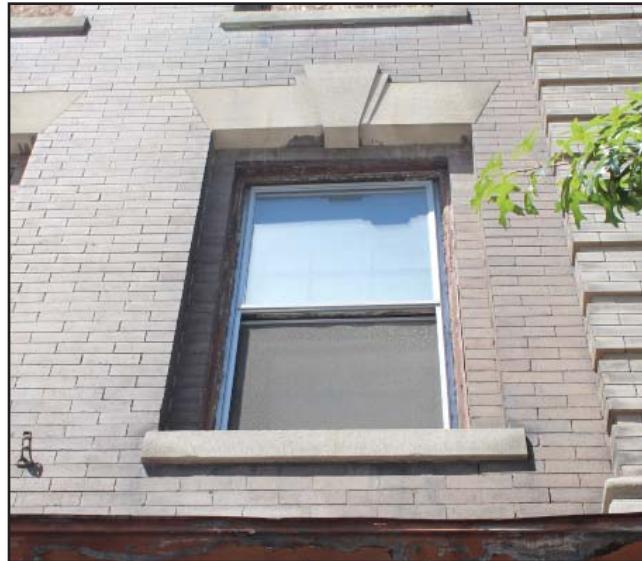
Image 4

The second and third floor windows were originally nine-over-one, wood sash windows, recessed within the brick facade (Image 4). The window openings are anchored by Indiana limestone, lug sills and Jack arched lintels with exaggerated, raised keystones, of the same material. The lintel and sills are in fair to good condition; however, windows themselves are severely deteriorated, with missing glass panes and rotted muntins.

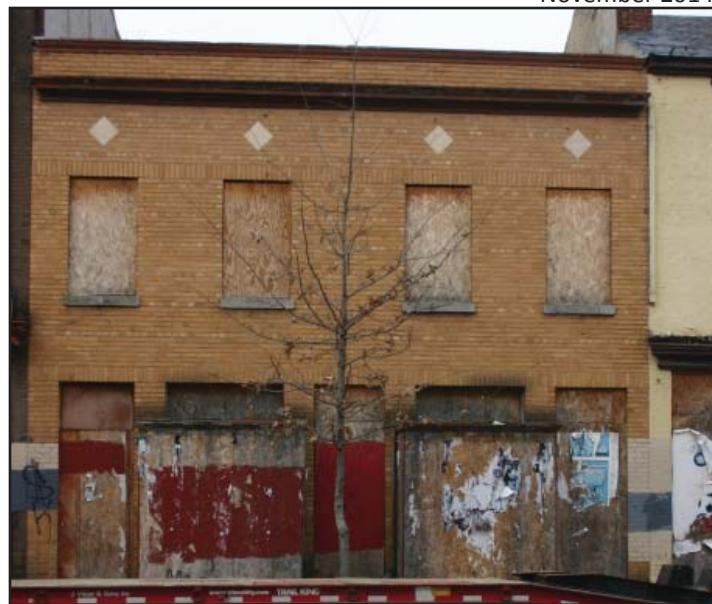
Image 1

Facade: The building facade (Image 1) is composed of yellow brick laid in two different configurations. The first floor of the building is laid in a standard, running bond with raked mortar joints, capped by a continuous soldier course that also functions as the window and door lintels. The second story of the facade is laid in a five course, common bond with raked mortar joints; the second floor is also capped by a soldier course that also serves as a continuous lintel for the second floor windows. Each second floor window has a stone, lug sill; cracks as well as patching are evident on all four (Image 6). Above the brick lintel a brick frieze, laid in a common bond, holds four limestone diamonds, one located above each second-floor window. The frieze is interrupted by a pressed metal cornice, but continues to a parapet wall capped by a pressed metal molding. Some of the masonry is covered by contemporary paint; the paint was most likely added to cover unwanted graffiti (Image 2). The original building permit states that the first floor wall is composed of 12" brick and the second floor is composed of 9" brick; there is no evidence at this time that this has been altered. The brick is generally in good condition; there are no major cracks in the facade. Holes have been drilled in a few of the bricks located beneath the second floor windows, which most likely were used to secure an awning.

Cornice/Parapet Molding: The pressed metal cornice is configured in an ogee shape. The paint has begun to flake off, however, the cornice is in good condition. The parapet molding, also composed of painted pressed metal, is in the same condition (Image 1 and 6).

- **Brick Facade:** If a test patch shows that the paint can be removed without harming the masonry, remove the paint from the brick facade, after testing for the safest approach, and clean with low (<100 psi) pressured water. Repoint brick where necessary with mortar similar in composition, texture, application, and color to the original to reduce spalling and noticeable color differentiation.
- **Cornice/Parapet Molding:** Remove flaking paint on the metal cornice and parapet molding, reshape metal where necessary, and repaint both. Make certain that the connections to the brick facade are sound, as they have not yet been assessed.

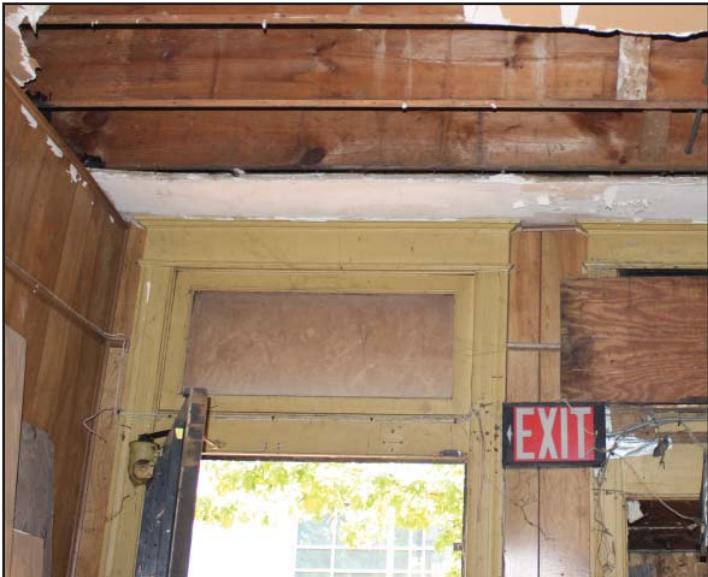
Image 7

Doors: There are three doors on the facade of the building: one leads to the south commercial space, one to the apartments on the second floor (located in the center), and one leads to the north commercial space. There are two additional doorways at the rear of the building, one in each commercial space, however, the door in the south commercial space has been removed altogether. The doors to the north and south commercial spaces are most likely original, however have been left to deteriorate over time. They are wood paneled and glass doors; the glass has been covered by metal safety grates. The central door to the apartments above is a replacement door, most likely added in the 1970s based on design. The remaining rear door is a half glass, three panel wood door; its condition is severely deteriorated. Each door, on the facade and rear, is set within the original molded wood frame topped by a transom light and a simple, molded wood entablature. The transom on the north commercial space facade is a functional hopper, transom window; the others are fixed (Image 7).

- **Doors:** Construct three new entrance doors to match the original design with like materials. Clean and repaint the original door and transom frames and replace glass in transom windows. If not salvageable, replace in kind with like materials.

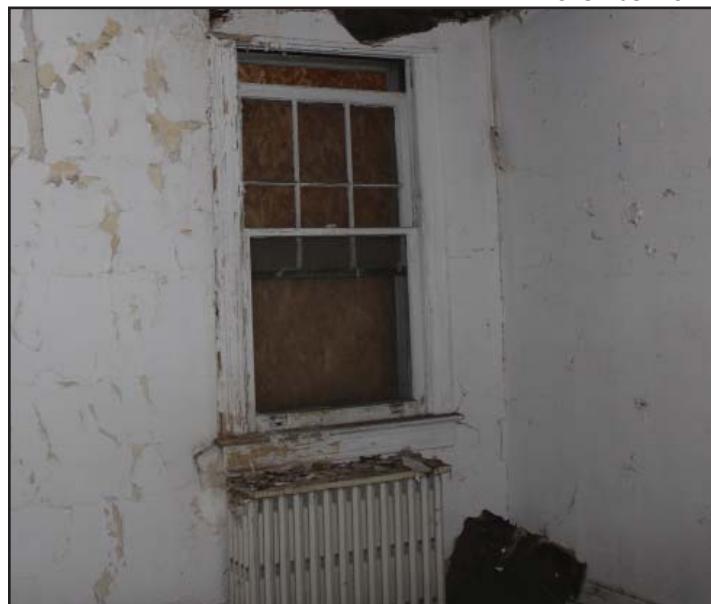
Image 9

The second floor facade windows (Image 9) are six-over-one, wood sash windows. All four the original windows are extant but have severely deteriorated and either do not close all the way or have broken glass panes.

- **Second Floor Windows:** Replace the four, six-over-one, wood sash windows to HPRB's standards and in consultation with DC HPO staff. Where necessary, patch the stone window sills and clean the stone along with the brick facade. If the stone is broken beyond repair, replace in kind.

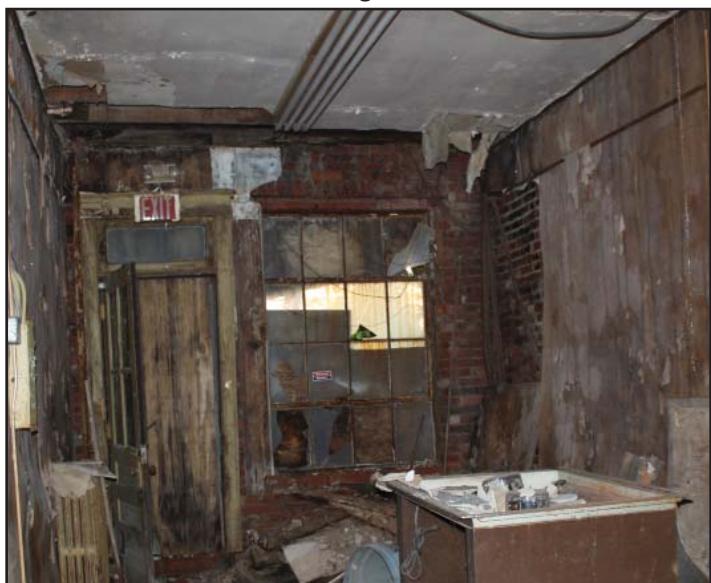
Image 10

There are two windows in the rear of the building on the first floor; they are sixteen-light, metal frame, hopper windows that have severely deteriorated (Image 10).

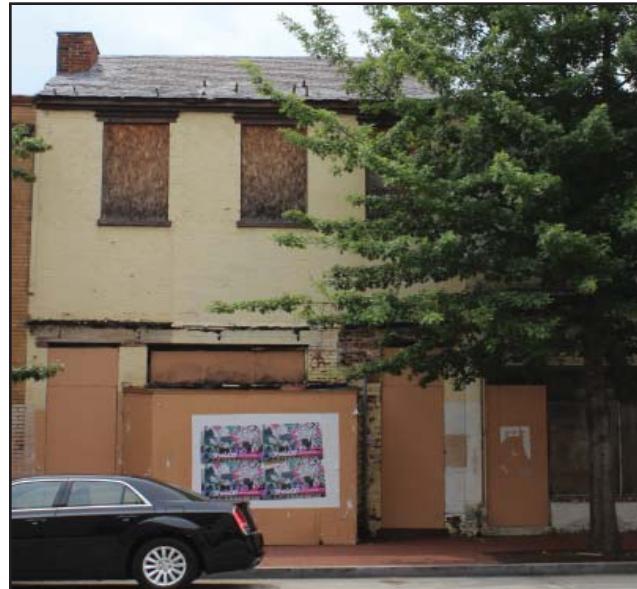
Image 1

Facade: The two-story building is composed of painted brick laid in a running bond with beaded mortar joints (Image 1). The first floor is punctured by three openings, two holding entrance doors, and the third holding a storefront window. The second floor is punctured by windows and capped by a simple cornice. The brick is in fair condition. It has been painted over multiple times, pointed without a beaded mortar joint, and spalling is present.

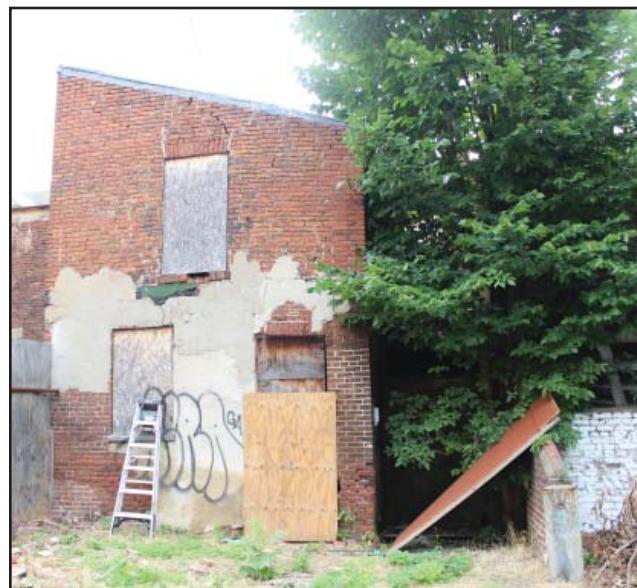
Image 2

The rear of the building (Image 2) is broken up into two plains, one protruding and the other recessed; both are composed of exposed brick. The protruding plain lies to the north, which is part of the building's addition, and the recessed plain lies to the south that is the rear wall of the original building. The north portion holds a door and a window on the first floor and another window on the second floor. Severe deterioration is evident in the form of large cracks. Also, the southwest corner has come loose and large swaths of the brick have been plastered over. The recessed rear wall, also shows signs of deterioration in the form of cracks and spalling.

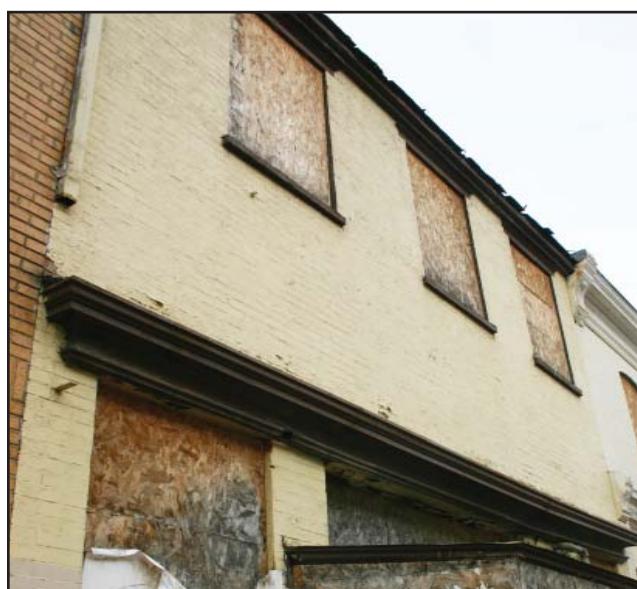
Stringcourse/Cornice: Both the stringcourse, located between the first and second floors, and the cornice are composed of pressed metal. The stringcourse is no longer extant, having been removed (sometime after Image 3 was taken in 2008), exposing a concrete beam (Image 4), which was most likely a contemporary addition for structural support, as it does not run the width of the building. The original stringcourse was an ogee design. The original cornice is extant and in fair condition. The simple pressed metal piece has begun to rust and is dented in a few places.

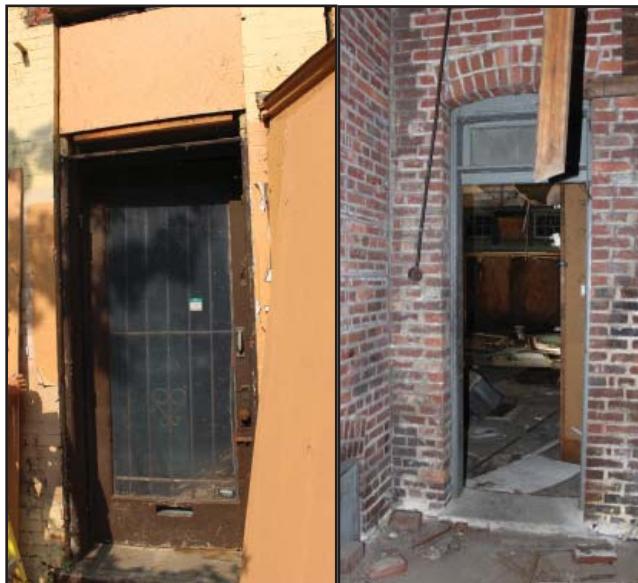
Image 5

construction, it most likely dates to the addition of the storefront facade. The door located in the south bay, which leads to the commercial space, is a full glass panel wood door (Image 5 on the left). It is topped by a hopper, transom window in a wood frame and similar to the other entrance door, both the transom and door are set within a molded wood frame. It too does not appear to date to the building's original construction.

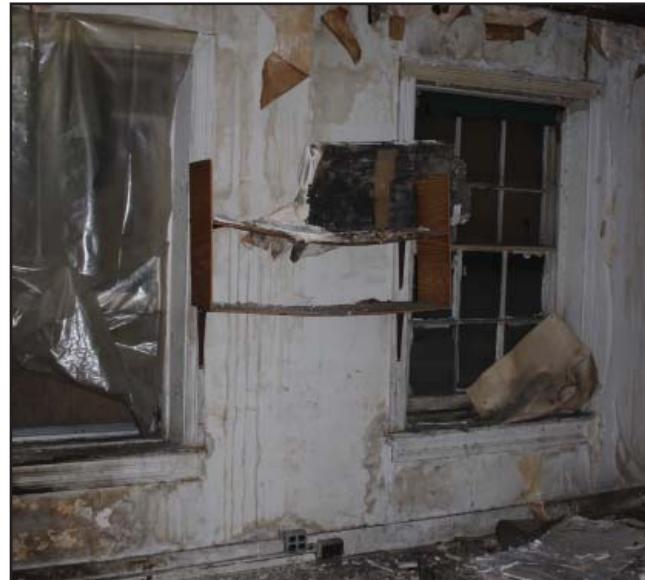
Image 7

The second floor windows (Image 7) each have a stone, lug sill, and a stone lintel. All are in fair condition but cracks are apparent through the stone. The windows are six-over-six wood sash windows, which are most likely original. Two of the three windows on the facade are extant, the central window was previously removed. The windows at the rear of the building are in the same condition. Two windows on the south elevation, part of the addition, are in deteriorated condition, and the third window, on the rear elevation has been removed.

- **Second Floor Windows:** Replace the three, six-over-six wood sash windows to HPRB's standards and in consultation with DC HPO staff. Clean the stone, lug sills and lintels along with the brick facade. If the stone is broken beyond repair, replace in kind.

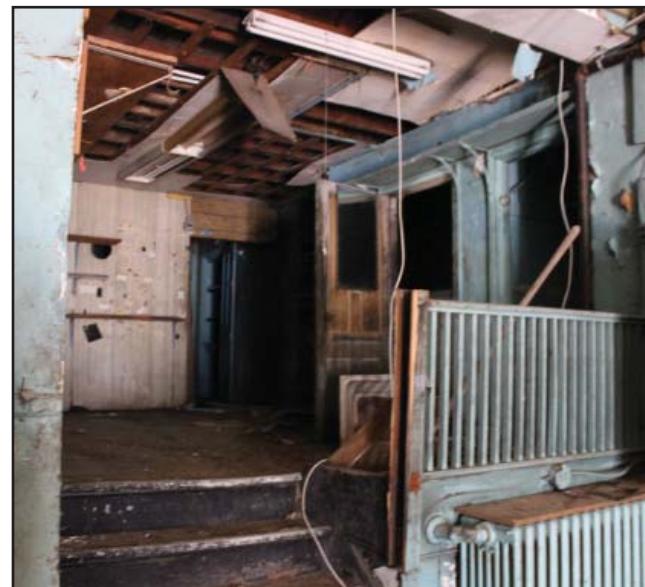
Image 8

Flooring Structure: The floor structures between both the cellar and first floors, as well as the first and second floors, have been left to deteriorate. Both systems, composed of wood beams, have holes and are sagging in multiple places (Image 8).

- **Floor Structure:** Due to severe deterioration of the second floor structural system, replace the floor structure with contemporary system that is cohesive with the new construction and adheres to the current fire and safety codes.

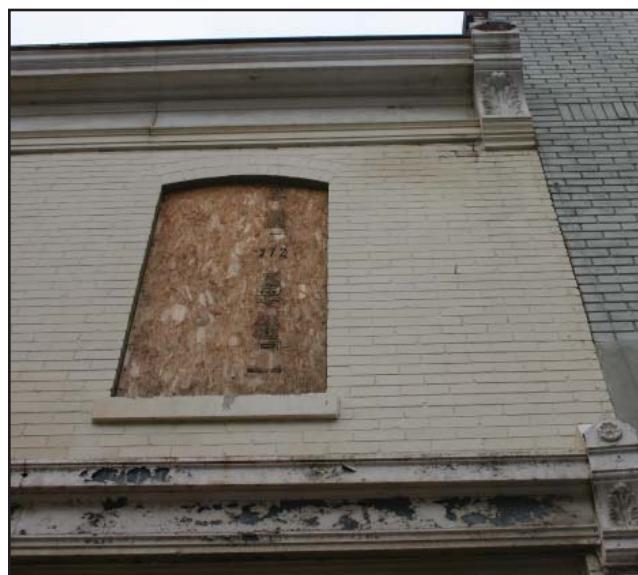
Image 3

The second floor windows (Image 3) each have a stone, lug sill, all of which have been painted over but appear to be in good condition. They are topped by double, soldier course, segmentally arched lintels. The windows themselves were originally six-over-one wood, sash windows, however, they are in severely deteriorated condition.

- **Second Floor Windows:** Replace the three, six-over-one, wood sash windows to HPRB's standards and in consultation with DC HPO staff. Clean the stone, lug sills along with the brick facade. If the stone is broken beyond repair, replace in kind.

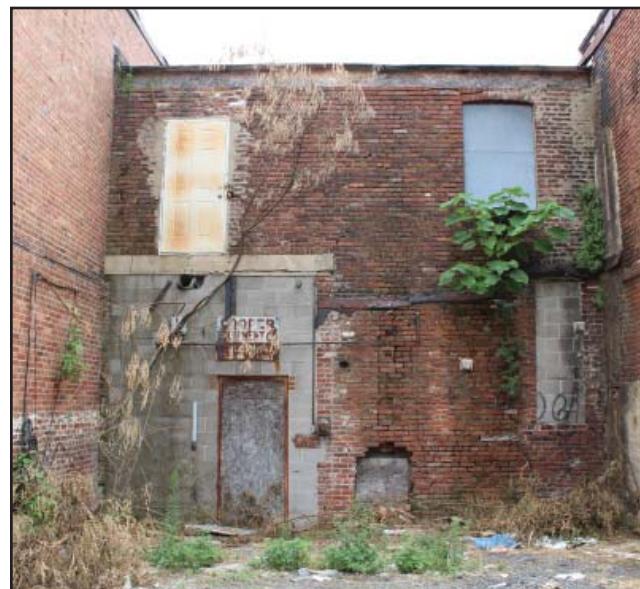
Image 4

The rear of the building is in very poor condition and has been altered numerous times over the years (Image 4). The rear was originally composed of exposed brick, however large sections have been removed and patched with cinder blocks. All of the rear doors and windows have been removed or replaced. Large sections of the mortar has been repointed and the rear cornice has been removed and the empty space simply covered with plywood. Vegetation overgrowth, numerous cuts in the brick, and patches of missing brick have compromised the structural integrity of the wall.

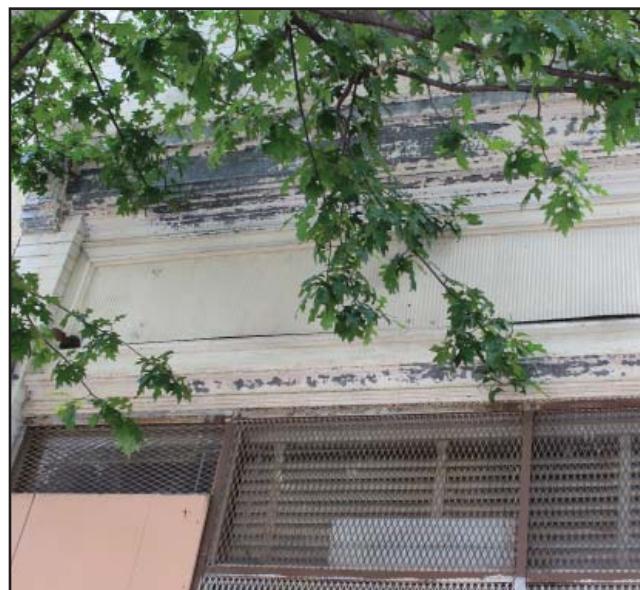
Image 5

There is also an additional galvanized iron entablature, located in the south bay, above the transom window and below the wood paneling (Image 5). Its is howev-

er, unlikely that this piece is original as that part of the facade has been altered numerous times.

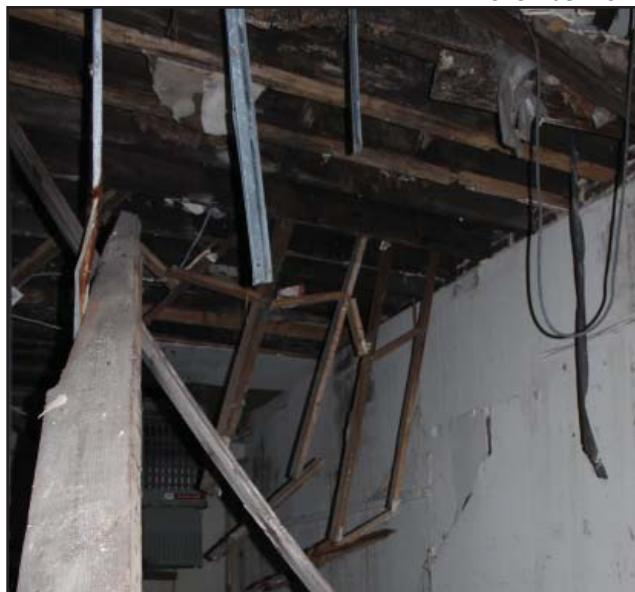
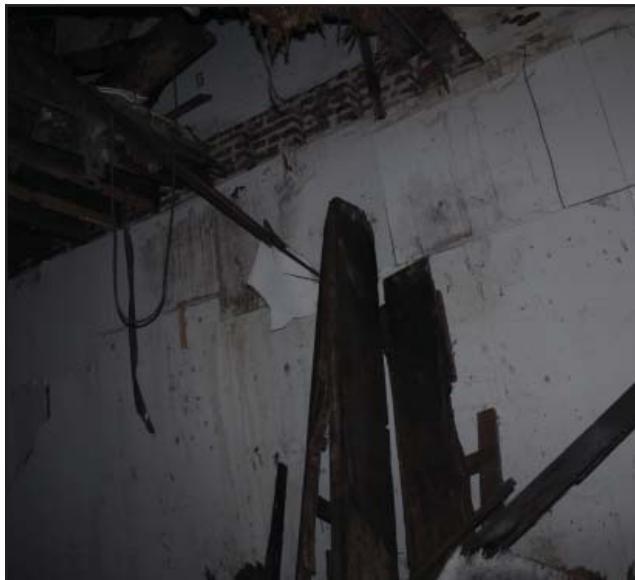
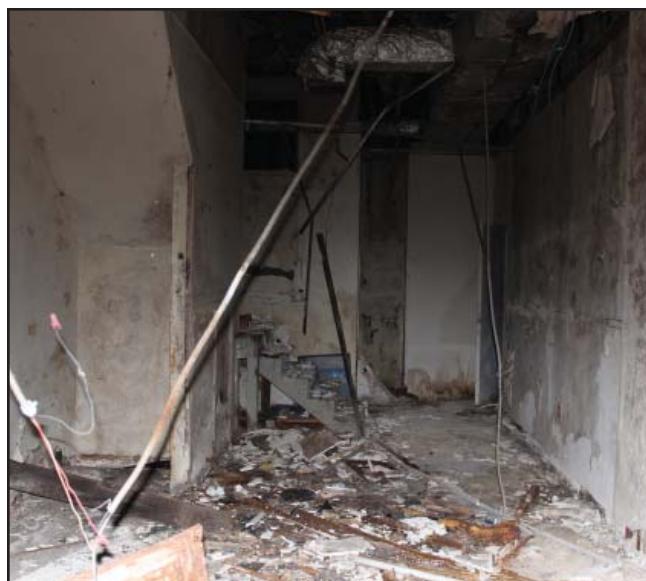
Flooring Structure: The second floor is severely compromised as large sections of the floor have rotted out and collapsed. The entire north side of the building is blocked by debris from the collapse of the ceiling/ second floor structure (Images 8, 9, and 10).

- **Floor Structure:** Due to severe deterioration of the second floor structural system, replace the floor structure with contemporary system that is cohesive with the new construction and adheres to the current fire and safety codes.

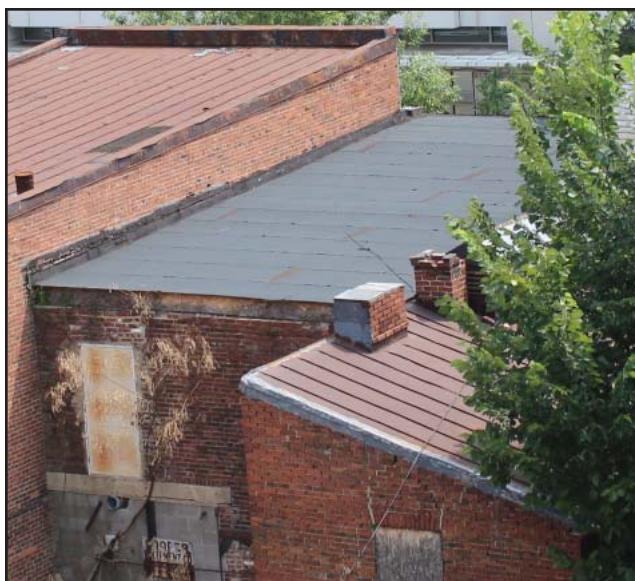
Image 11

Roof Structure: The original tin roof has been removed. The contemporary roof is rolled asphalt (Image 11), however, as the second floor is not accessible due to structural instability, the roof structure beneath the asphalt has yet to be assessed.

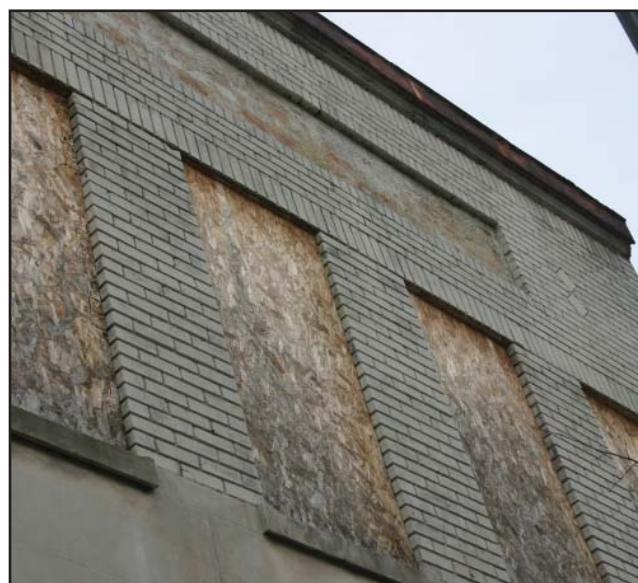
Image 3

The second floor facade is composed of brick, painted white, laid in a running bond with raked mortar joints (Image 3). The brick is punctured by four windows that are topped by a continuous, soldier-course brick lintel that almost spans the entire facade. Above the windows lies a rectangular recess within the brick, flanked by decorative diamond tiles, and framed in a row of brick laid in a soldier course. This recess most likely held the original business name, but is currently empty. A second soldier brick course creates a simple frieze just below the plain, pressed metal cornice. The second floor brick facade, which is described in the original building permit at 13" thick, is in good condition; there are no visible cracks.

Cornice: The plain, pressed metal cornice on the building facade, has begun to rust, and the paint is flaking off. (Image 3).

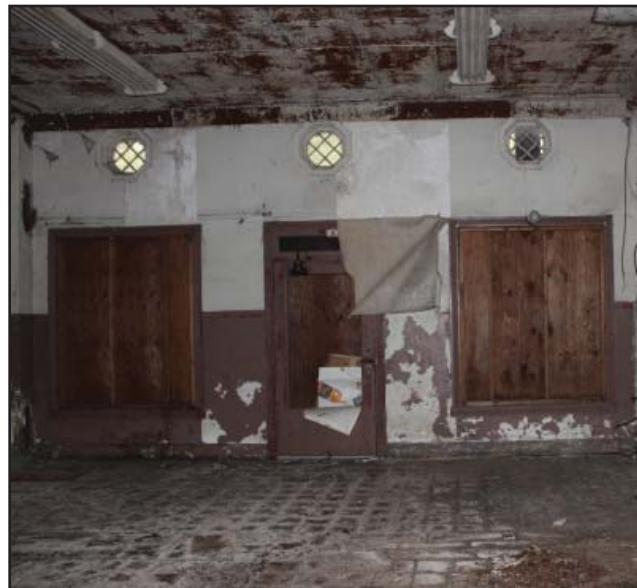
Image 5

Doors: There is one door on the facade, located in the central bay (Image 5), that most likely dates to 1938. The opening is covered on the exterior by plywood, as well as cinder blocks. The door is a glass pane wood door with a wood, hopper transom window, set in a molded wood frame. The door, transom, and frame have all been painted numerous times and the wood is severely deteriorated. The glass pane has been removed from the door as well. The door closer and hinges appears to be original, however, the other hardware seem to be replacements.

Flooring Structure: The first floor system is a concrete foundation covered in severely deteriorated tile flooring (Image 5). The tile flooring only remains on the front half of the floor. The second floor system is composed of severely compromised and deteriorated wood beams. Access has been completely cut off as the stairs have been removed. There are clear signs of distress in the flooring system, as the entire floor sags (Image 8).

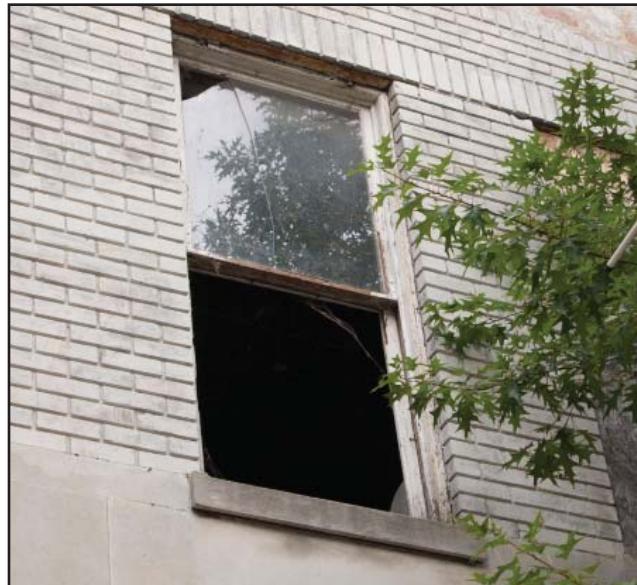
Image 6

The second floor windows have stone lug sills that appear to be in good condition, as does the continuous soldier course, brick lintel that runs above all of the second floor windows. The windows themselves were originally nine-over-nine, wood sash windows, however, those have been removed and replaced with single-light, double-hung, wood windows, although these too have been severely damaged over the years (Image 6).

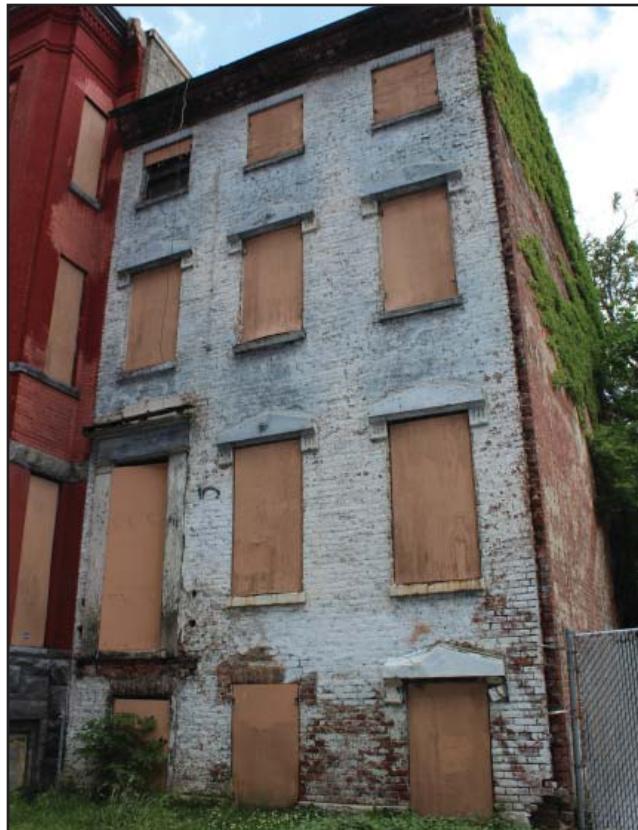
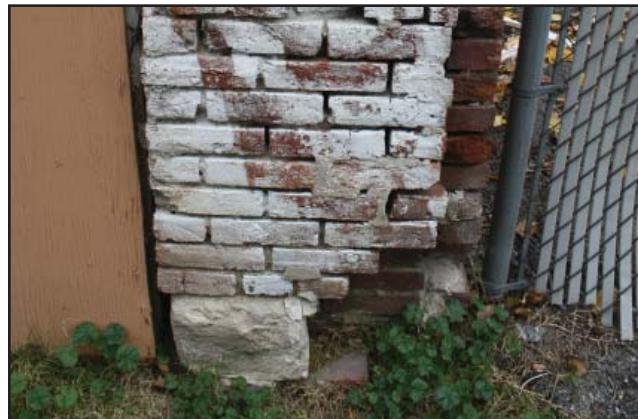
Facade: The building facade (Image 1 and 2) is composed of red brick laid in a five-course, common bond and painted white. The brick has raked mortar joints; however, the workmanship is hard to see as it is either very degraded or covered by numerous layers of paint. The brick and mortar are in very poor condition. The building rests on a stone foundation that is also deteriorating in multiple locations (Image 2). The windows have flat-arched, brick lintels; though only a few are exposed, the eastern most arches on the basement level, and those located on the third floor. The hoods are composed of a pressed metal and feature small pediments decorated with raised metal ball flowers, supported by simple, fluted brackets (Image 3). The first floor windows sills are also covered by simple, pressed metal covers.

- **Brick Facade:** If test patches show that the paint can be removed without harming the historic masonry remove the paint from the brick facade, after testing for the safest approach, and clean with low (<100 psi) pressured water. Repoint brick where necessary with mortar similar in composition, texture, application, and color to the original to reduce spalling and noticeable color differentiation.

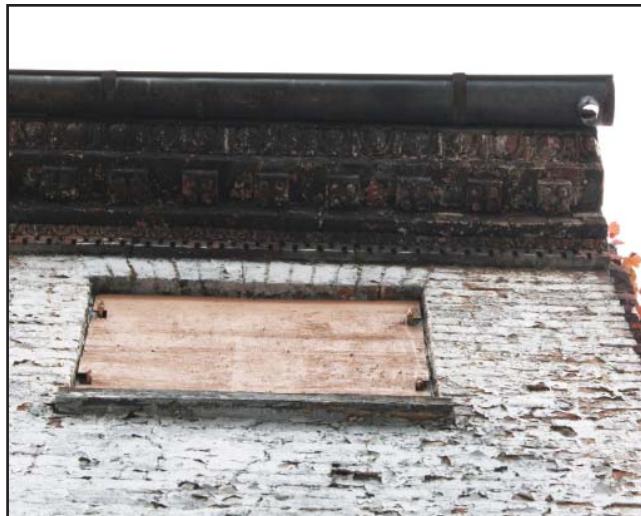
Image 4

Cornice: The cornice is an ornate, pressed metal cornice, that was originally painted (Image 4). The cornice is of a Classical design with bands of egg and dart and block modillion molding. Since the paint has mostly flaked off, the cornice has been exposed to the elements and rust covers much of the surface. Attached to the top of the cornice is a contemporary half-round gutter. The gutter has also rusted out in places and is missing its downspout.

- **Cornice/Lintel Hoods:** Remove flaking paint, reshape metal where necessary, and repaint. Replicate those that have been removed from the facade. For the cornice, make certain that the connections to the brick facade and roof are sound, as they have not yet been assessed.

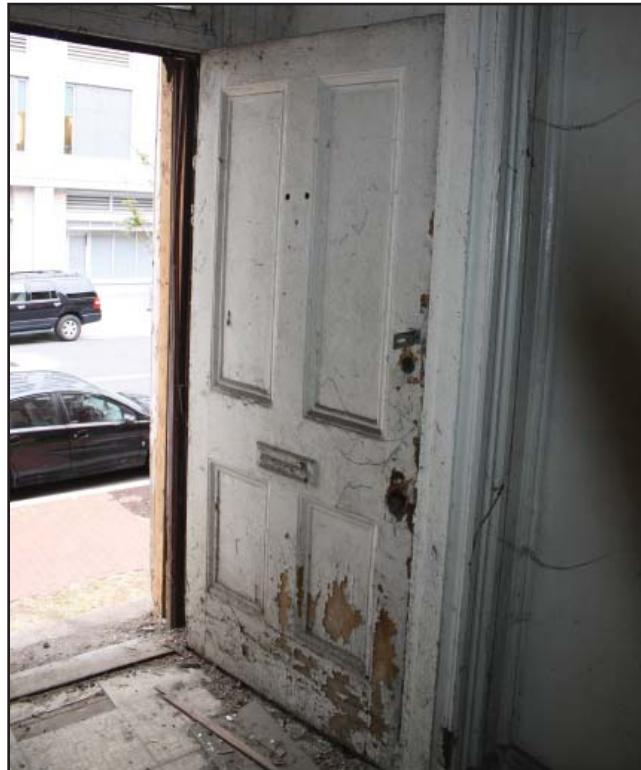
Image 5

Door/Entrance: There is one door on the buildings facade (Image 5). It is a four panel, wood door set in a wood frame. It is topped by a fixed transom window, and both the door and the transom are set within a molded wood frame. The small entranceway, which is denoted by another opening topped by another fixed, transom window, contains a decorative, wood char rail (Image 6).

- **Door:** Construct new entrance doors based on a historically sensitive design as the appearance of the original entrance design is unknown. Replicated the wood surround and entablature that has deteriorated beyond repair.

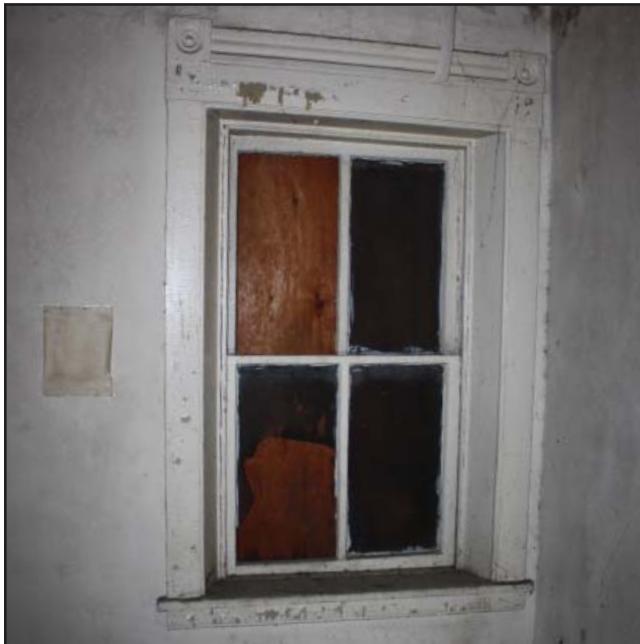
Image 7

Windows: The first and second floor windows on the facade are two-over-two, double-hung wood windows (Image 7). They most likely date to 1904, when the repair permit was issued. The rear wall of the original building holds an original, six-over-six, double hung window, that is now an interior window, looking in on the addition (Image 8). The other window in this image is on the east elevation. The rear windows on the

- **Windows:** Replace the building's historic windows to HPRB's standards and in consultation with DC HPO staff. The basement, first, and second floor windows should be two-over-two, double hung windows, and the third floor windows should be three-over-three, double-hung windows. Clean the stone, lug sills along with the brick facade, and for those that had pressed metal covers (the first floor windows), clean and replace them. If the stone is broken beyond repair, replace in kind.

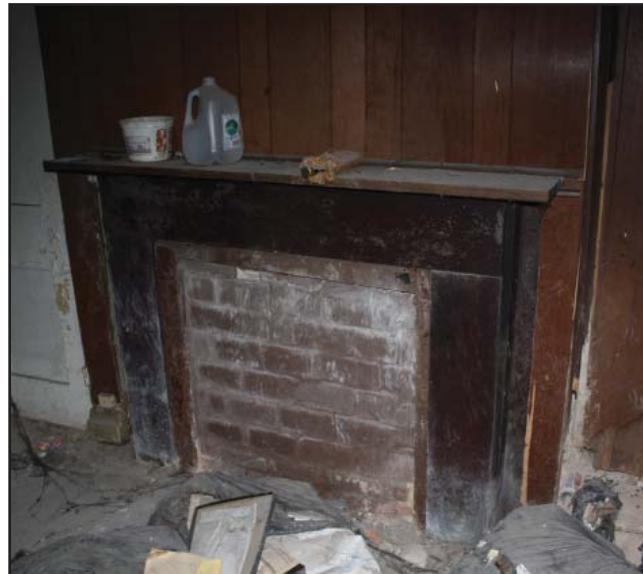
Image 10

The two fireplaces on the first floor have been removed, however, those in the basement, second, and third floors remain. They are simple, wood mantel pieces with no ornamentation. There is one located in the basement (Image 10), two located on the second floor, and two located on the third floor.

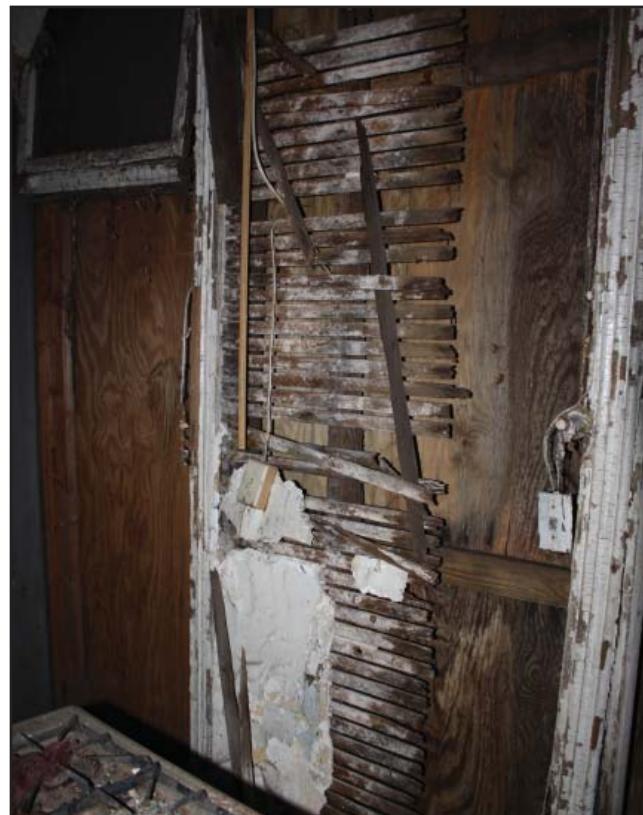
Image 11

The rear of the building is in very poor condition; most of the wall has collapsed and is boarded over.

Flooring Structure: The rear of the building shows severe deterioration (Image 11); the entire wall is exposed with wood lathe boarded over, the structural integrity is most likely compromised.

- **Floor Structure:** Due to deterioration of the floor structural system, replace the floor structure with contemporary system that is cohesive with the new construction and adheres to the current fire and safety codes.

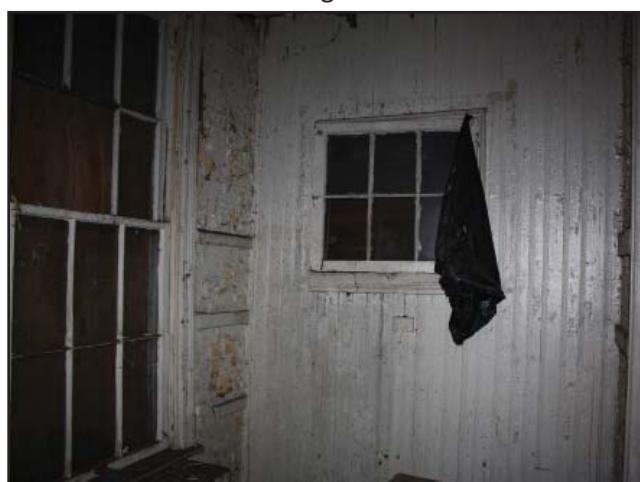
Image 9

circa 1880s addition is also a six-over-six, double-hung, wood window. There is another windows on the east elevation; it is a six-pane, wood hopper window that most likely dates to the 1880s, as it is located in the buildings rear addition (Image 9).

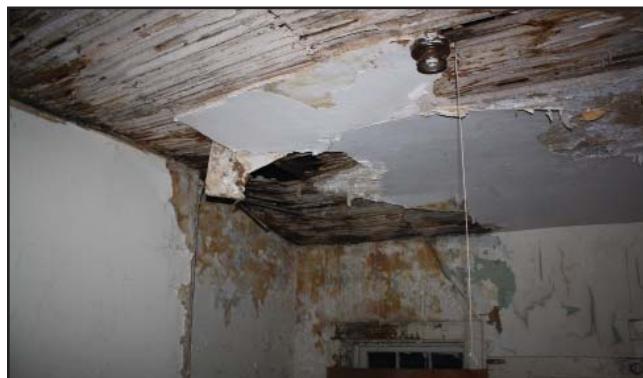
Image 12

Roof: The roof, is a rolled, asphalt roof that is in very poor condition; water penetration is evident throughout the building (Image 12).

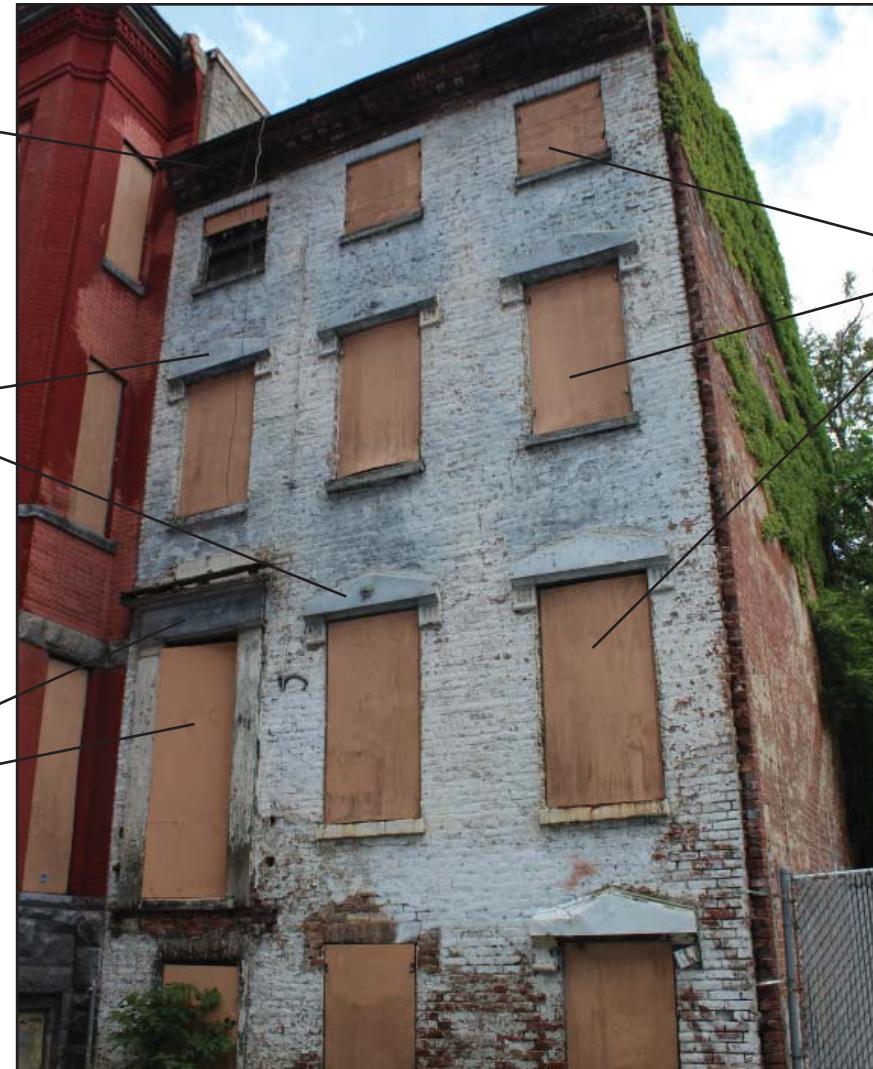
**1114 Ninth
Street, N.W.**

The following elements of the building facade will be documented prior to any work on the building being undertaken. This documentation will include detailed photographs, measurements, and profiles, that along with historic drawings, photographs, and research, will provide detailed information to guide the rehabilitation and allow for in-kind replacements when conditions warrant.
