EMBASSY OF HUNGARY ANNEX Brodhead-Bell-Morton House

1500 Rhode Island Avenue, NW, Washington, DC 20005

Historic Preservation Plan

Second Draft Submission
April 2018

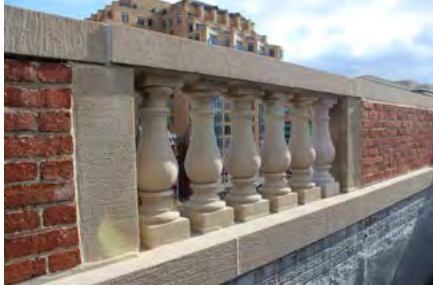
Limestone balusters line openings along the upper roof parapet. These balusters show staining and vertical fissures, particularly along the upper surface. In some cases, these have been patched or infilled with mortar. In other cases, entire units have been replaced with cast stone substitutes, as visible in the baluster at far right.

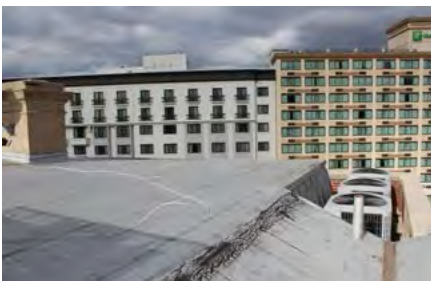
The upper roof surface is a combination of flat and sloping surfaces. The roof is predominantly coated in a bituminous membrane that has been painted with a metallic silver coating (possibly to reduce roof's solar heat gain or the visibility of the roof from grade). Appearing to be in poor to fair condition, the roof exhibits a variety of condition issues, including patched or damaged seams, areas of missing coating, and standing water.

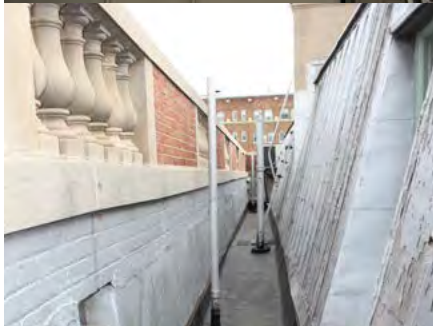
The metal-clad mansard roof on the fourth floor of the building exhibits extensive loss of surface paint finish. Loss of exterior coating has resulted in accelerated oxidization of the underlying metal substrate. In some cases, the metal cladding has been bent or dislodged.

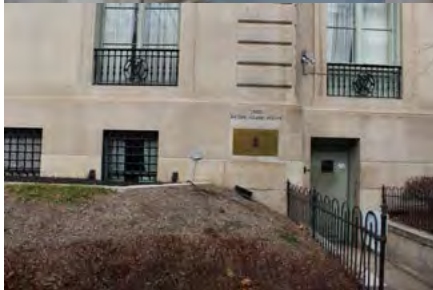
The wood door on the south elevation of the building provides access to the ground floor. The door's painted surface is mostly intact but has faded over time.

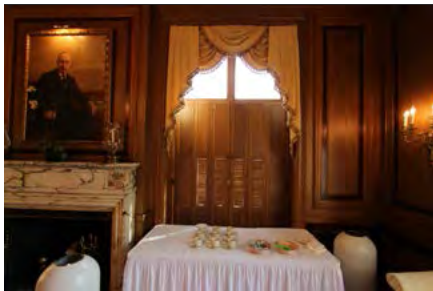
Integrated Window Shutters

Wood shutters are located in several spaces on the first floor. They are integral to the window surrounds and can be opened to be concealed from view. In some spaces, the shutters have been painted shut and are not operable.

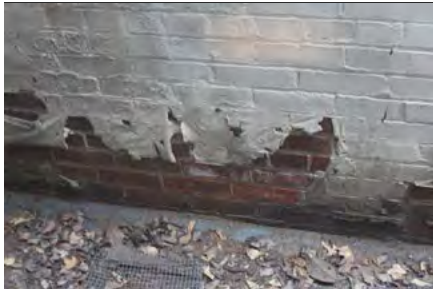
In the open areaways surrounding the subbasement and basement floors, peeling of the outer paint surface from the masonry walls is evident, possibly resulting from moisture or rising damp around the base of these walls.

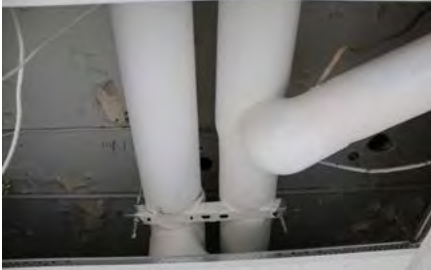
Surfaces throughout the building exhibit minor peeling and chipping of paint. The example shown at left is behind a suspended ceiling panel on the basement floor.
