# DAWN LEA PARTY IN OPPOSITION BZA APPLICATION NO. 20380

JULY 14, 2021

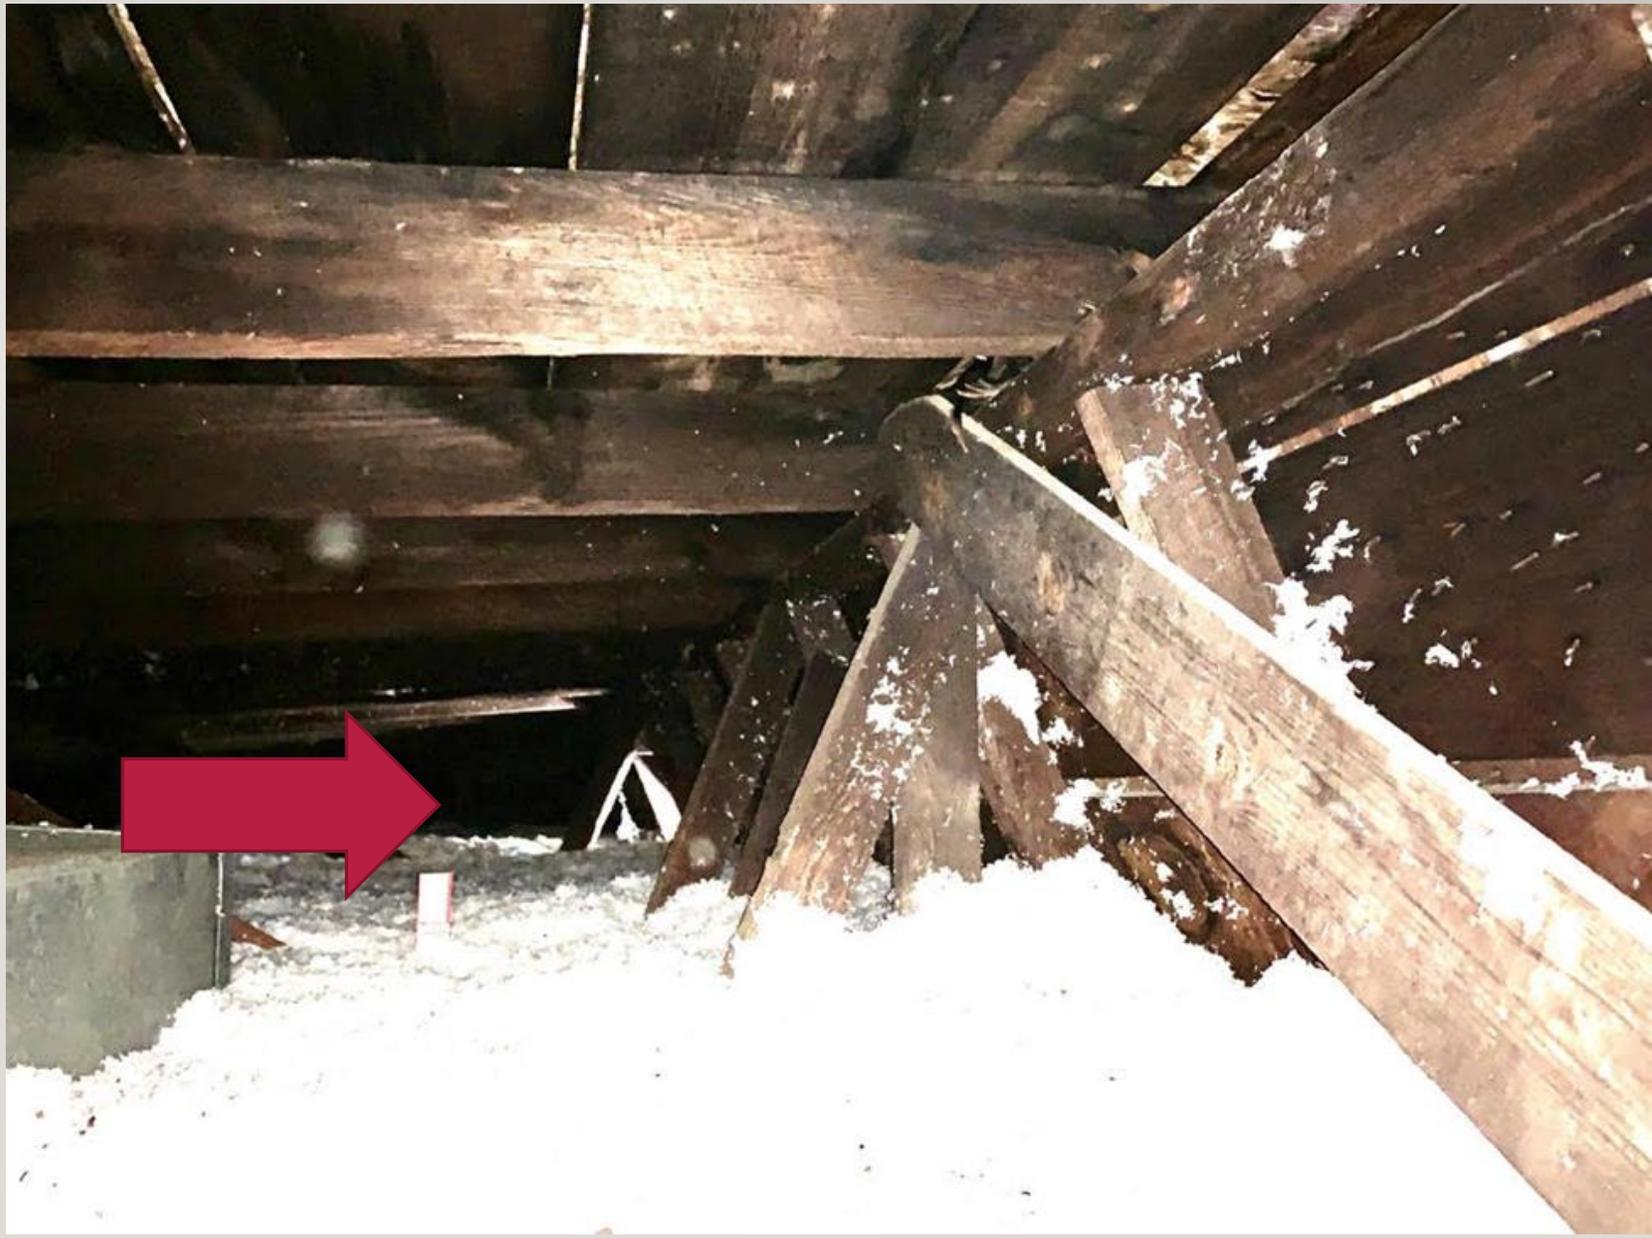
10

*Common attic of 4457 – 4459*

*Arrow indicating the attic vent for 4457 when viewed through 4459 side of the attic.*

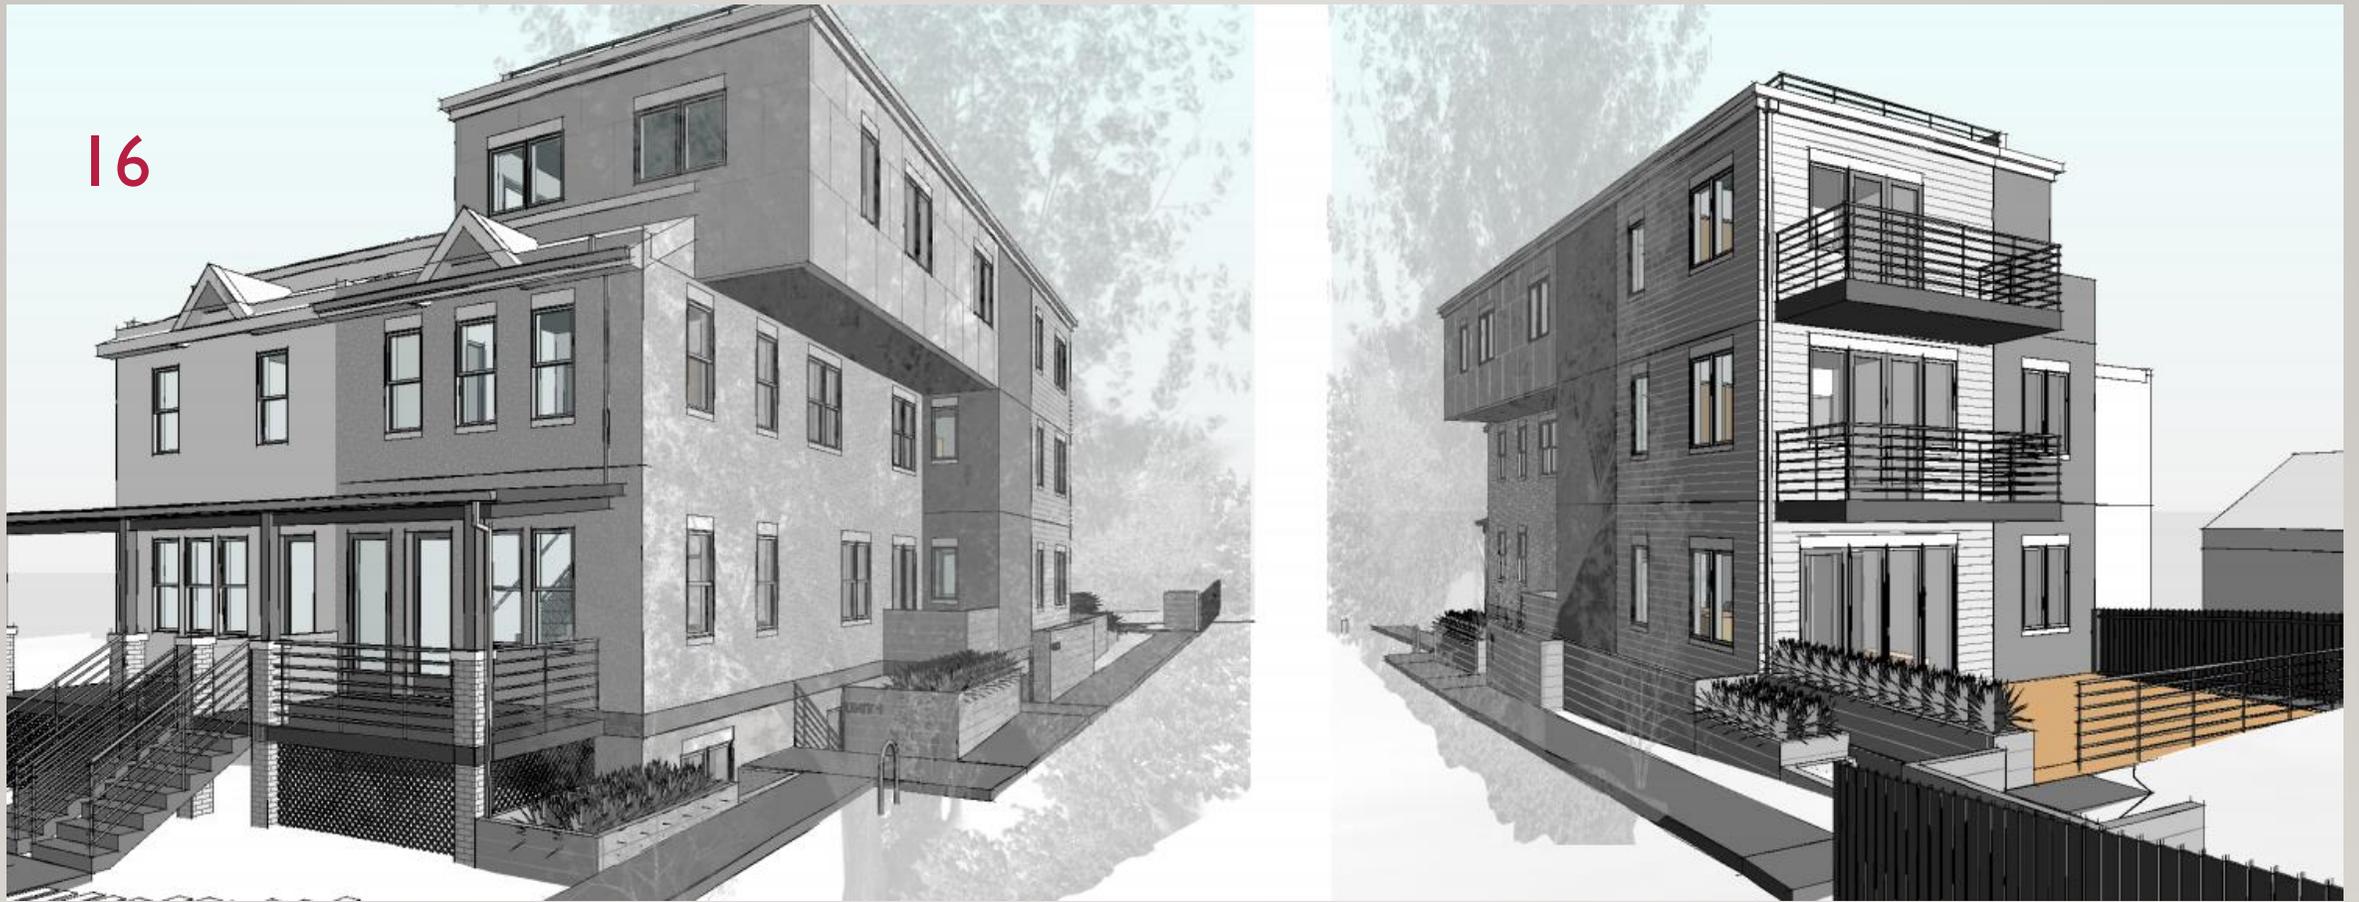
16

- Drawing from page 11 identified as “southwest (street elevation): Cantilevered third floor indicated in other drawings **is not evident on the street view.** Can you confirm that the **penthouse still exist in this drawing** from page 11 identified as “southwest (street elevation)?

Front and rear perspectives from Drawing 1

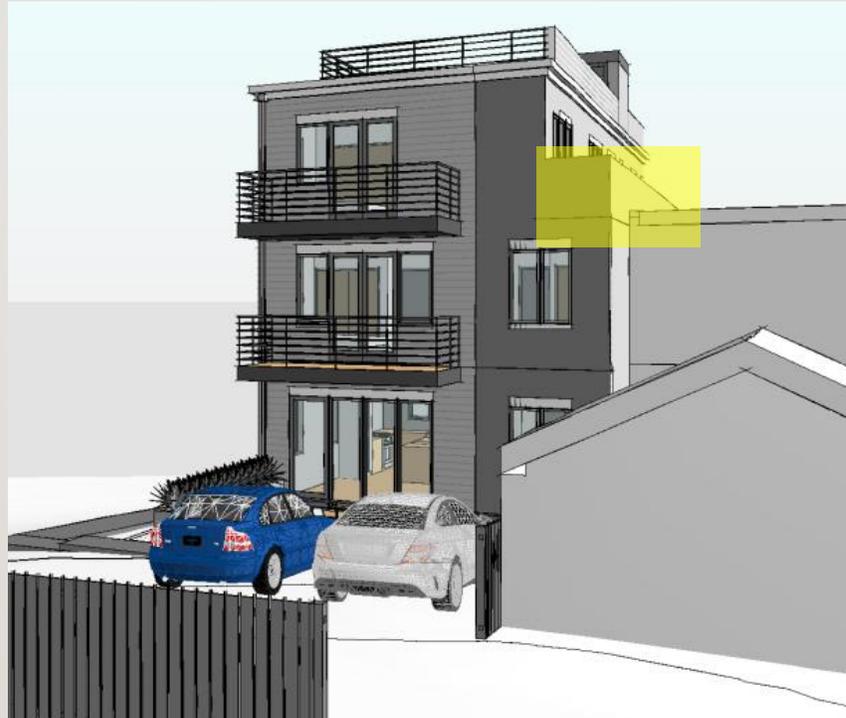
Rear Parking Perspective, Drawing I

1. Despite set back on the last floor, the Snowdrift issue is not eliminated. The parapet on the upper floor will still cause snow drift accumulation. This is obvious in Isometric view 2 of Drawing 17, Cross Section 3 on Drawing 14, and Cross Section 2 on Drawing 13.

The snowdrift horizontal length is 6.5 feet. Therefore, any obstacle placed within 6.5 feet of the property line will cause snowdrift accumulation.
