McMillan Sand Filtration Plant

Historic Preservation Plan

May 2016

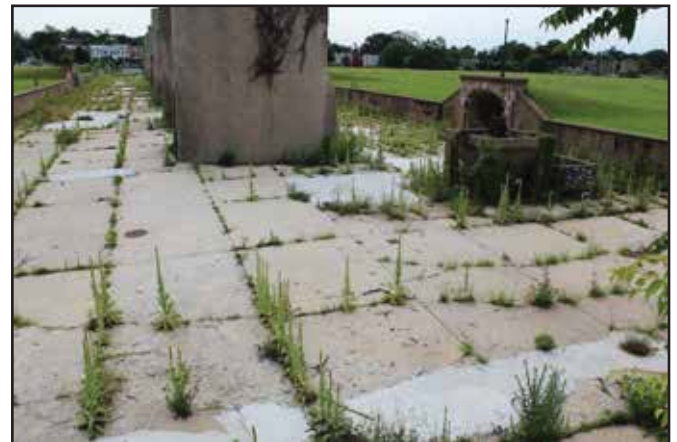
Detail of paving at Service Court 2, looking southeast from First Street. 2015.

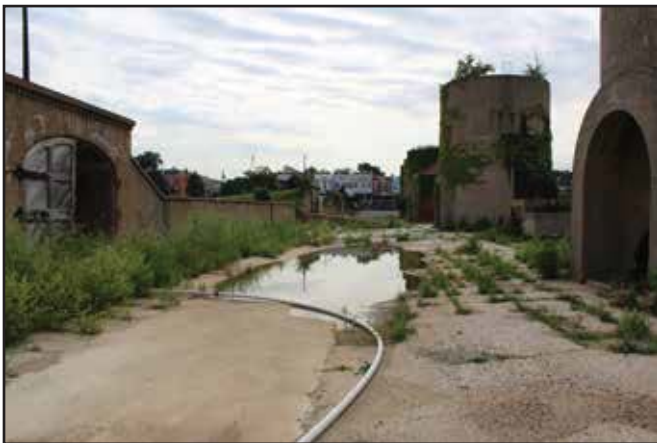
Detail of paving at Service Court 3, looking east from Sand Bin 14. 2015.

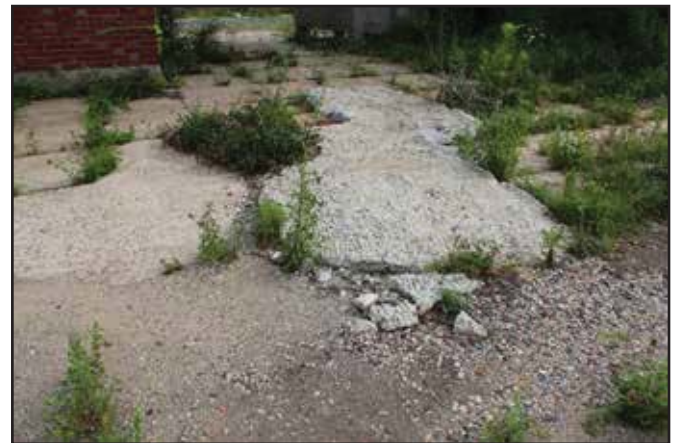
Detail of paving at Service Court 2, looking north from Regulator House 5. 2015.

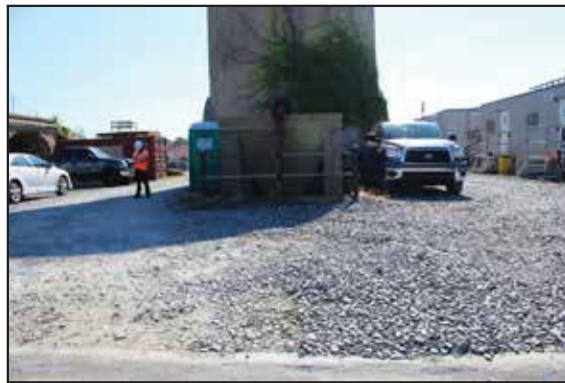
Detail of paving at Service Court 3, looking east from First Street. 2015.

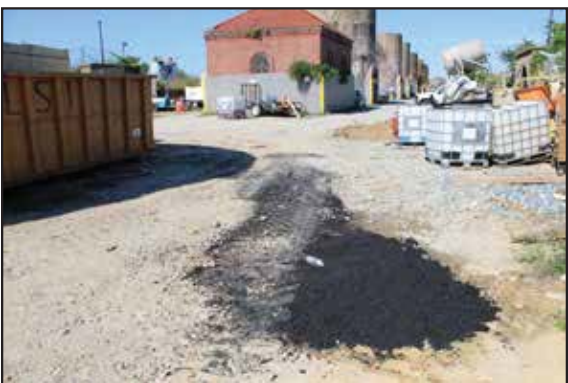
Detail of paving at Service Court 3, looking southwest from Sand Bin 27. 2015.

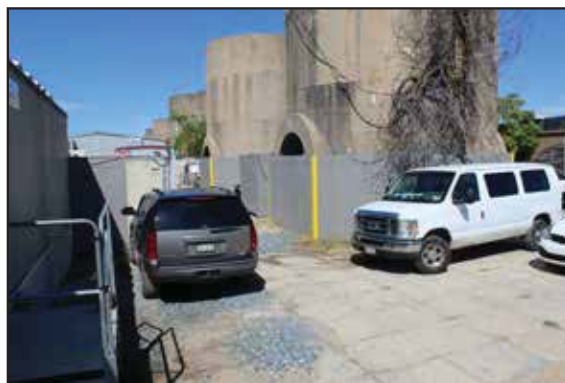
Detail of paving at Service Court 3, looking west from Ramp 14. 2015.

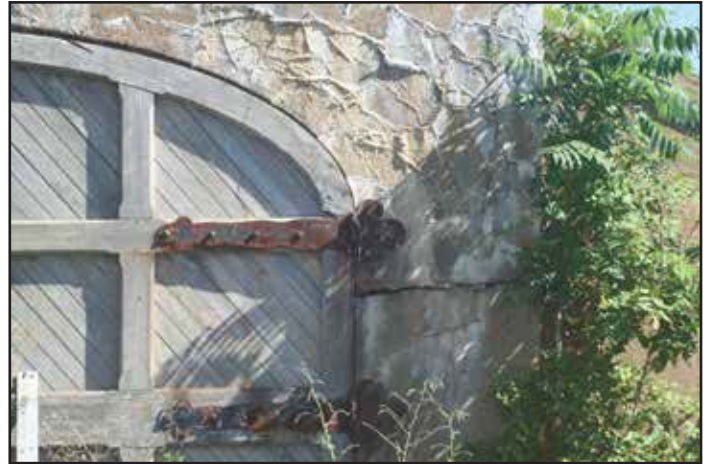
Wood door and hardware at Filter Bed Portal 24. 2015.

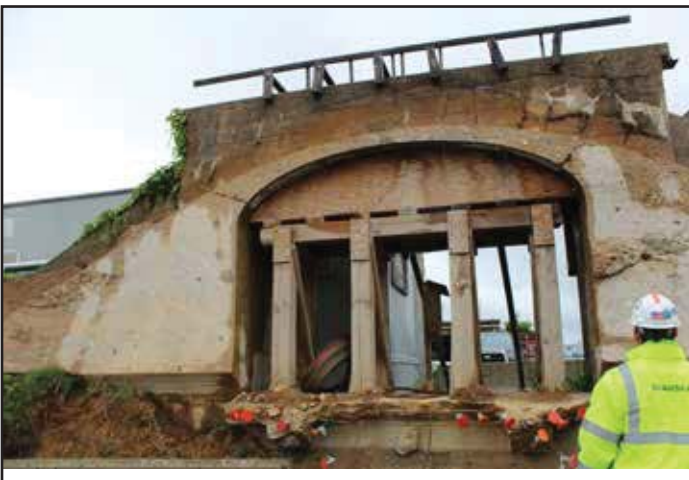
Temporary supports at Filter Bed Portal 25. 2015.

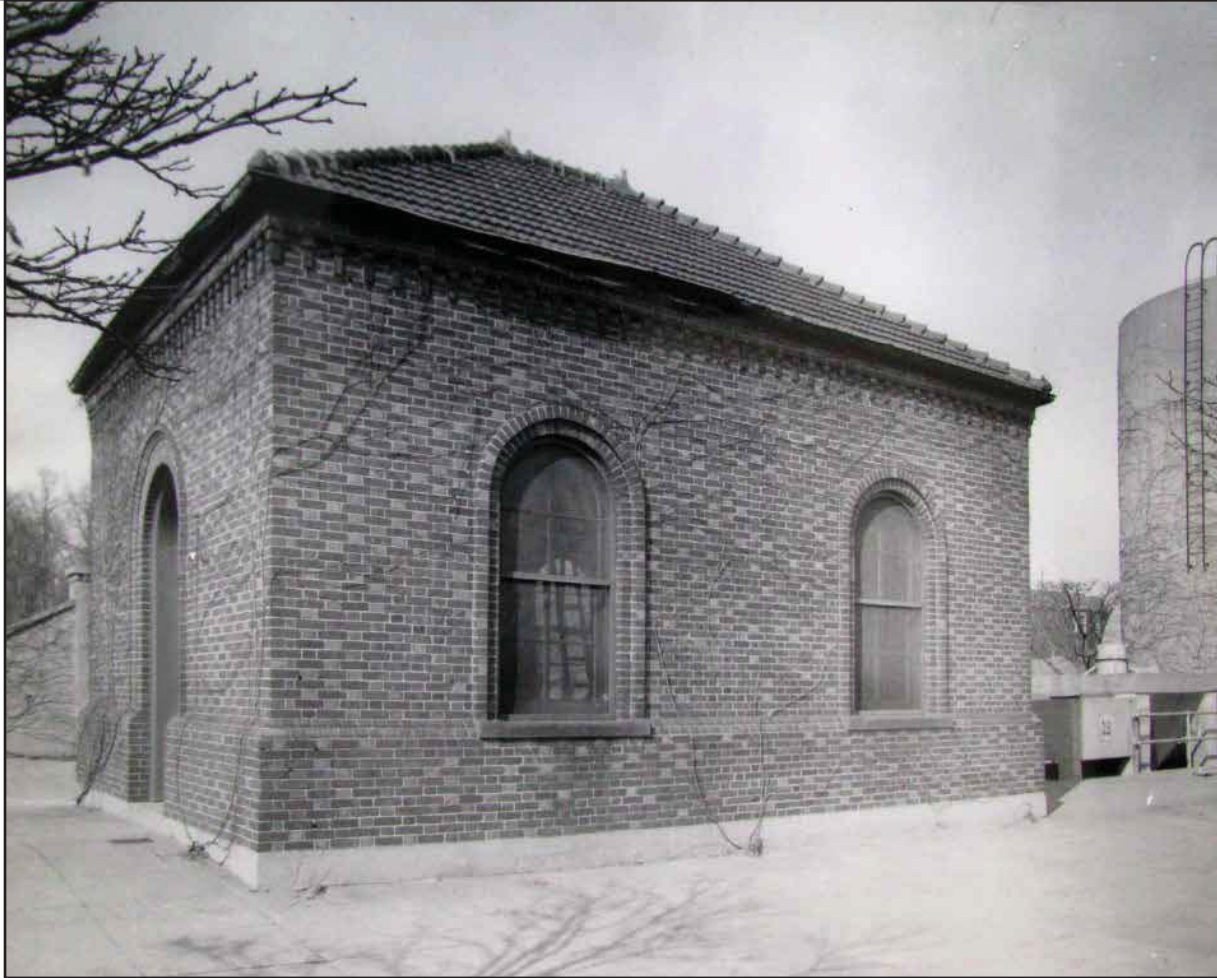
Regulator House 5, looking northeast. Circa 1944. Courtesy of the Washington Aqueduct Archives.

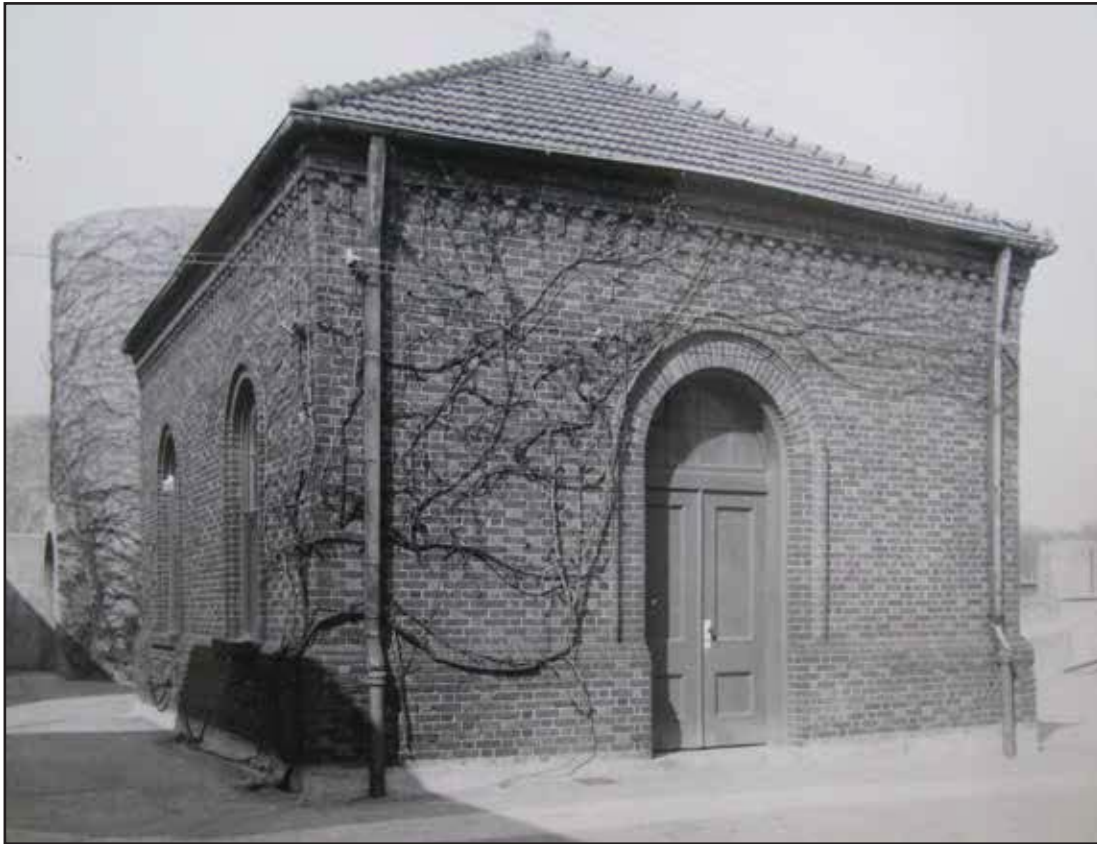
Regulator House 5, looking southeast. Circa 1944. Courtesy of the Washington Aqueduct Archives.

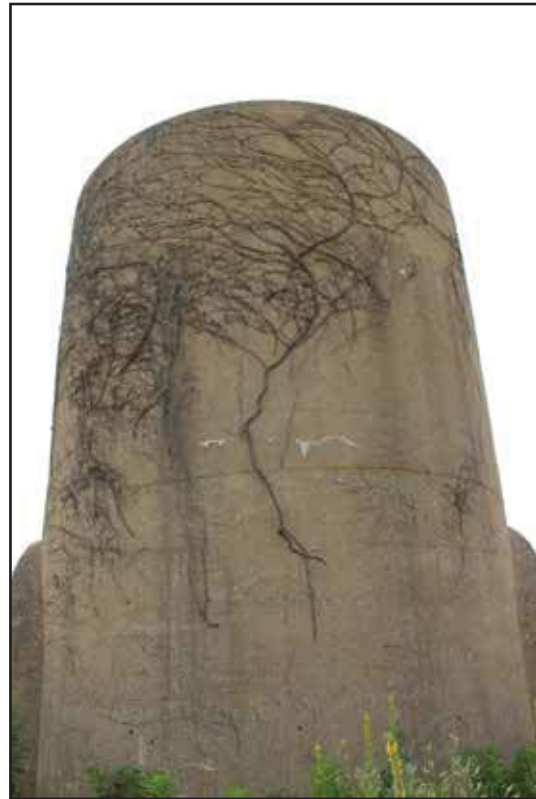
Sand bin 11, looking east. 2015.

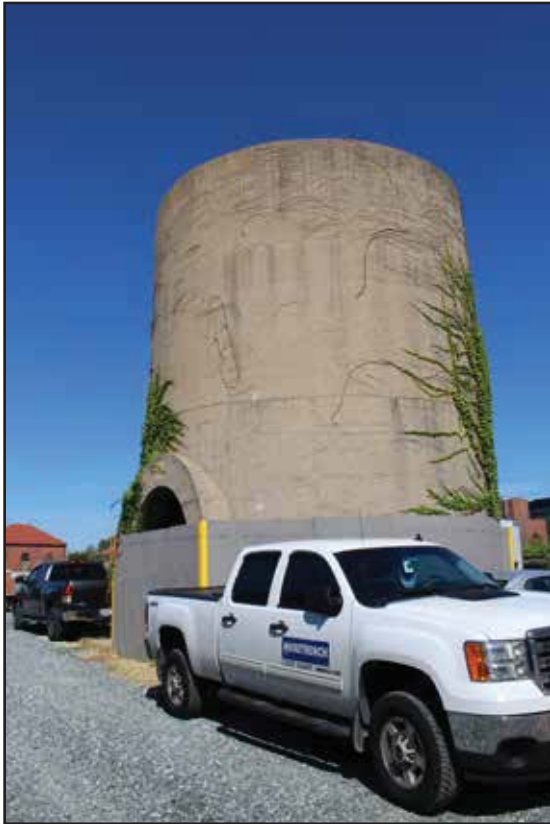
Sand bin 20, looking northwest. 2015.
